Building Inspection Report

Inspection Date: Fri, 30 Jan 2026

Property Address: 2/23 Wallace Ave, Toorak VIC 3142,
Australia

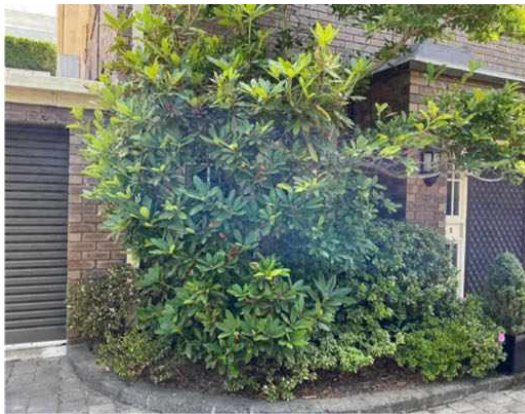
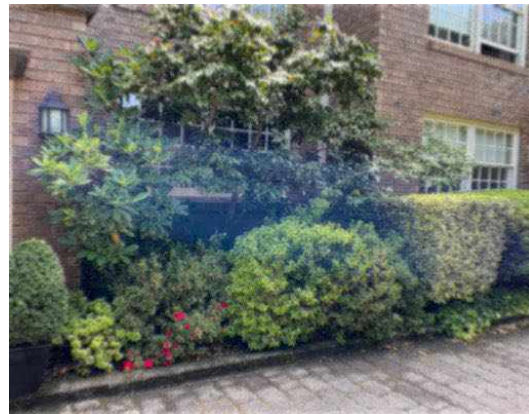
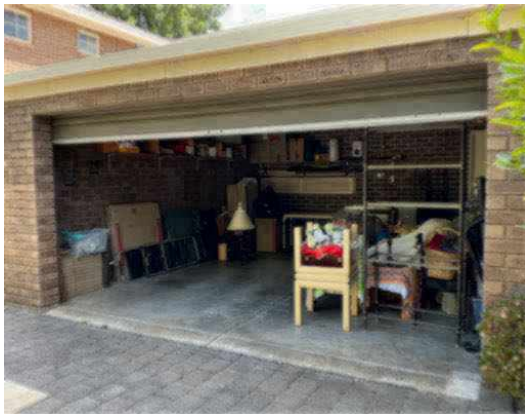
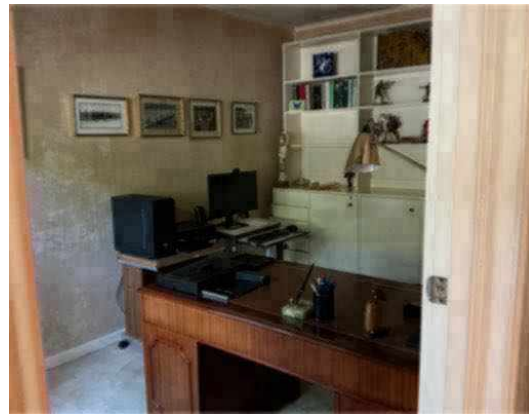
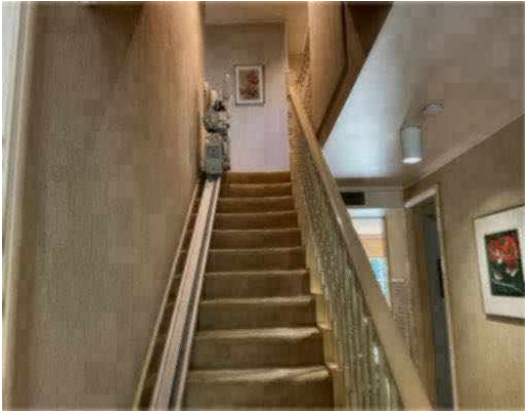
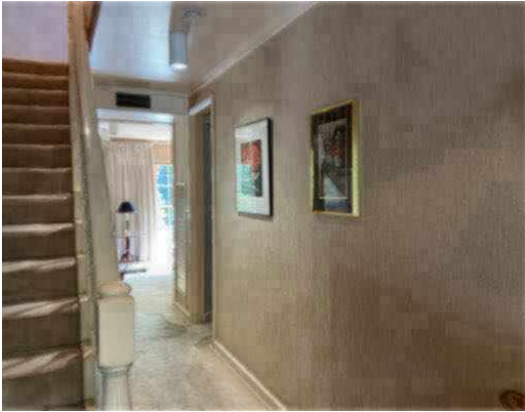
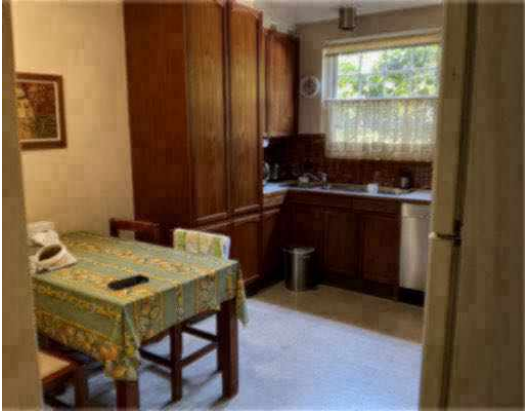
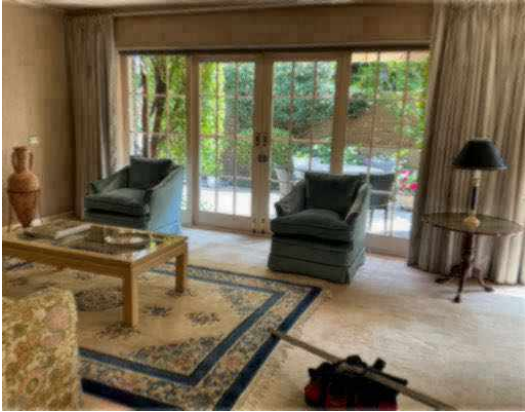
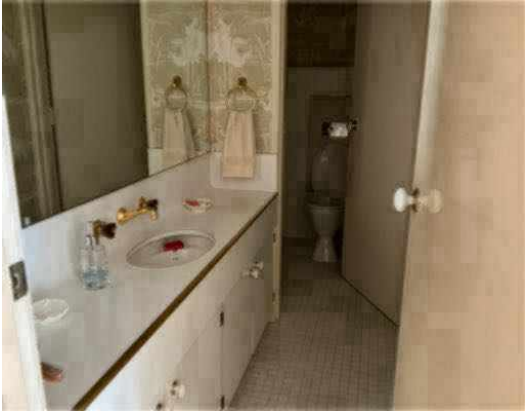
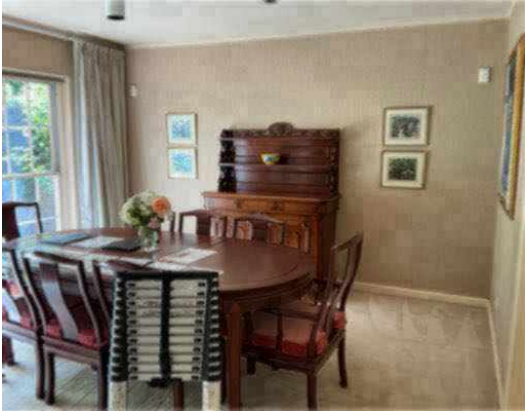
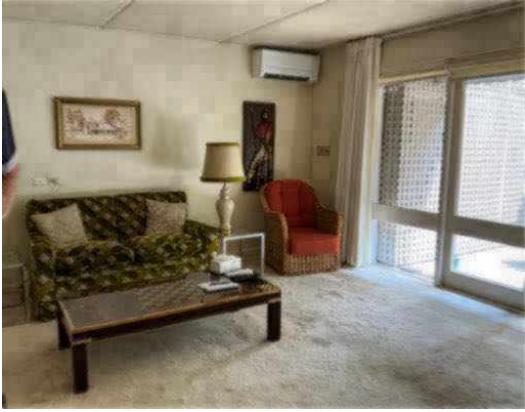
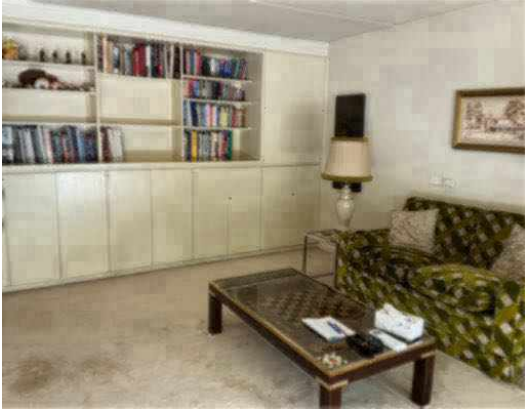
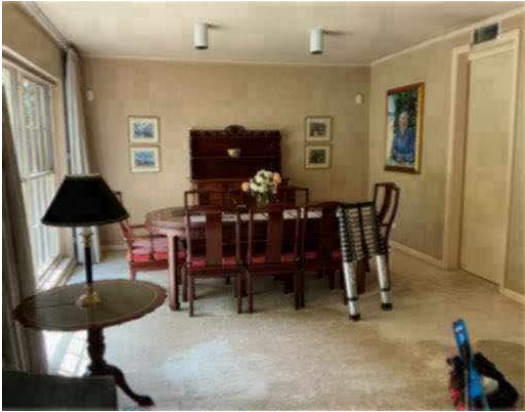
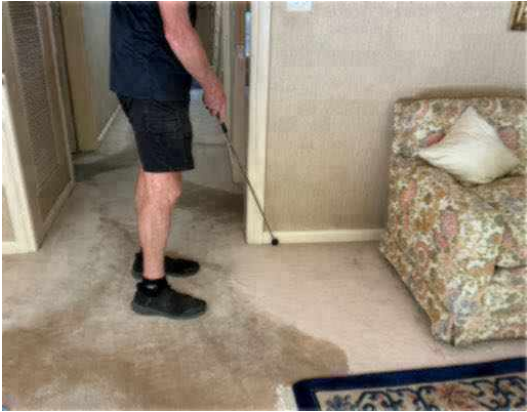
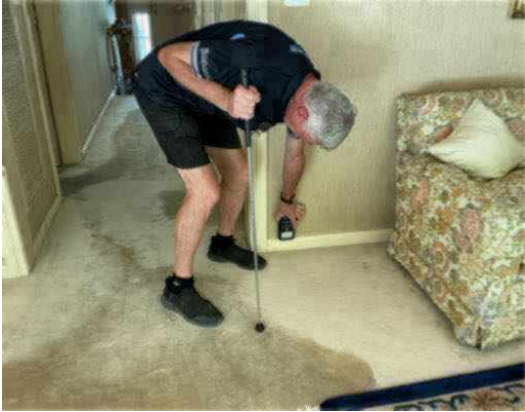
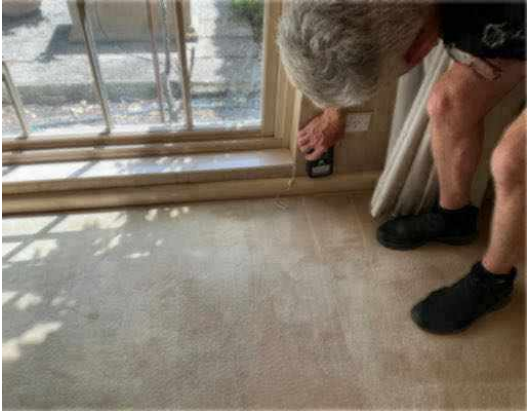
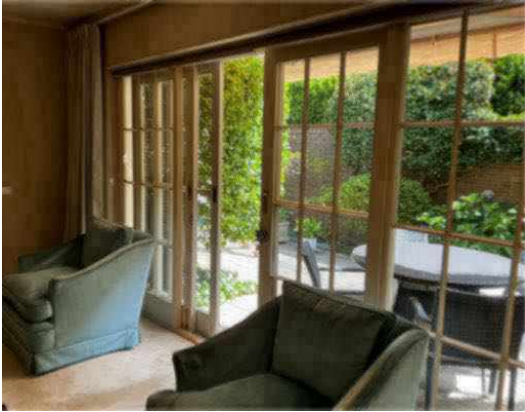
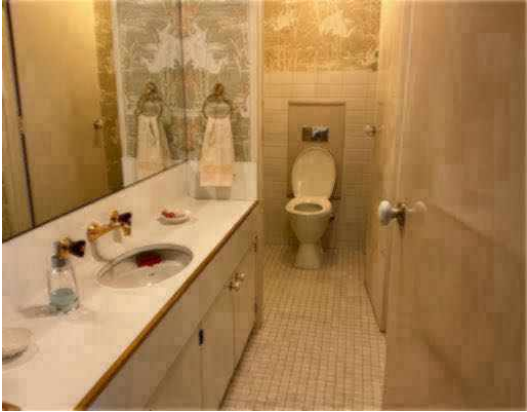
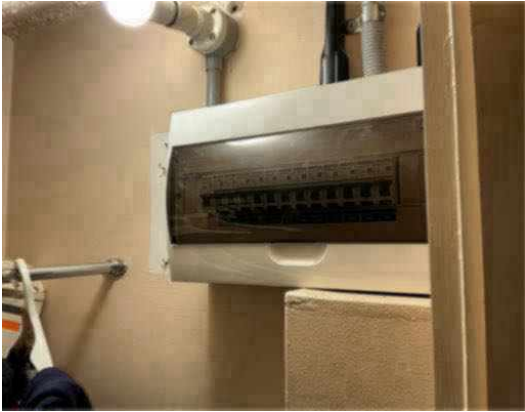
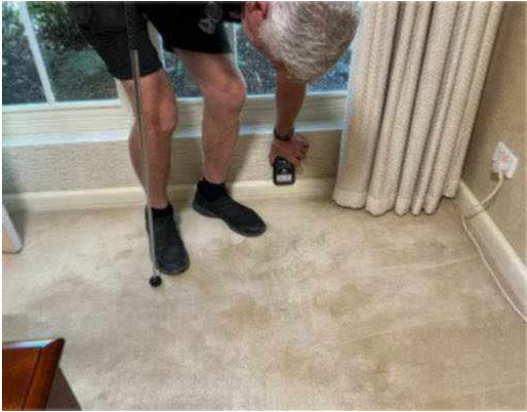
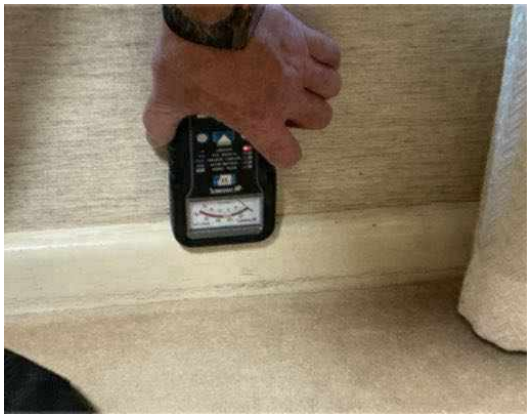
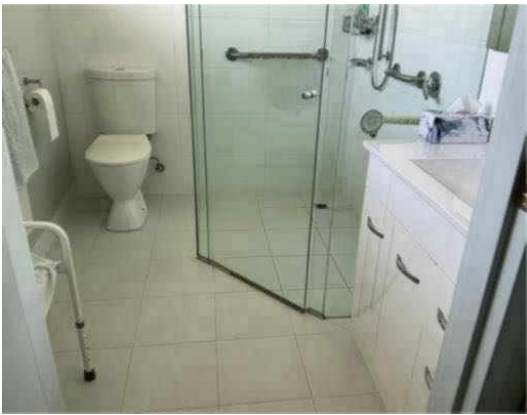
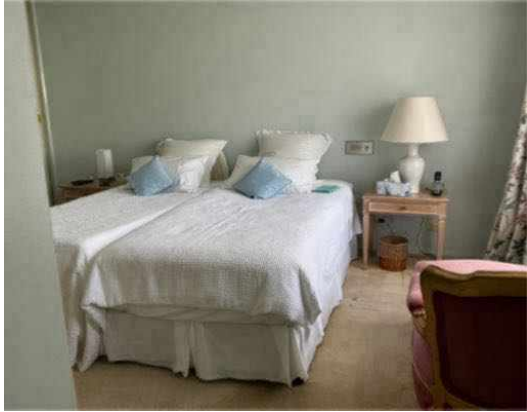
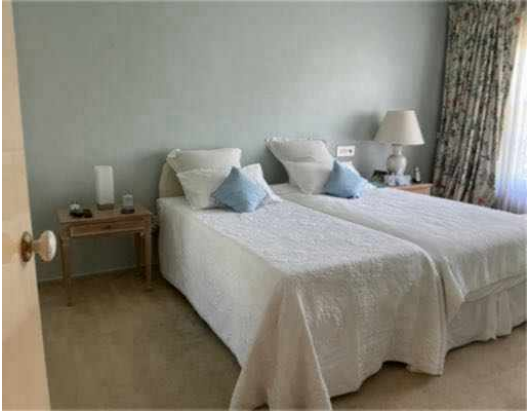
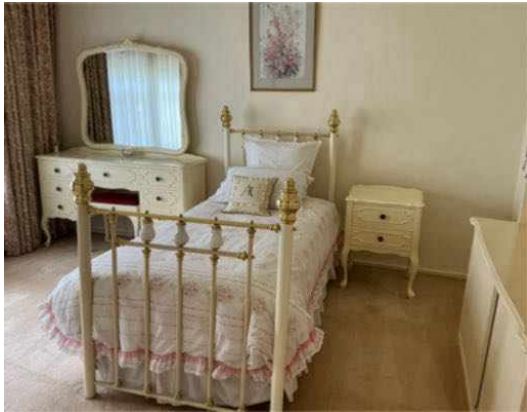
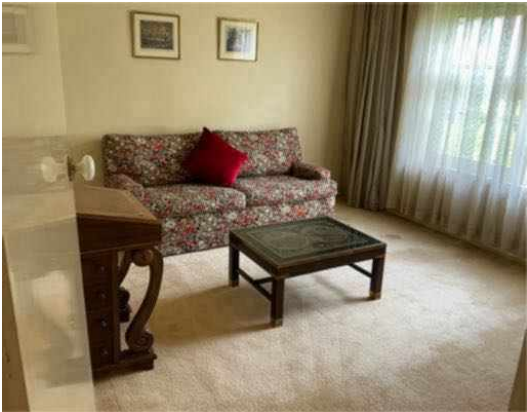
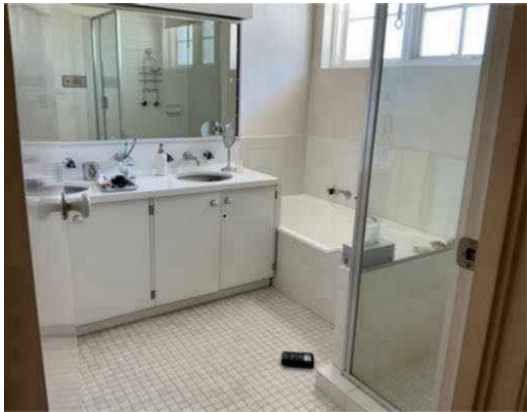
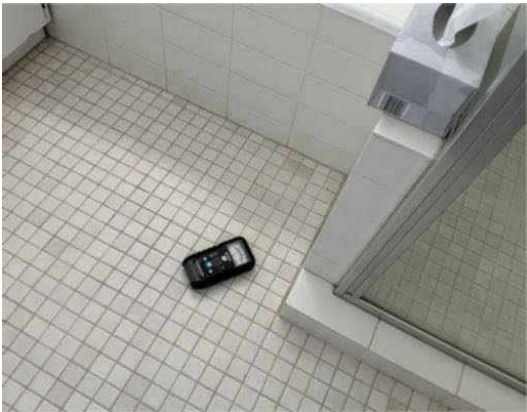
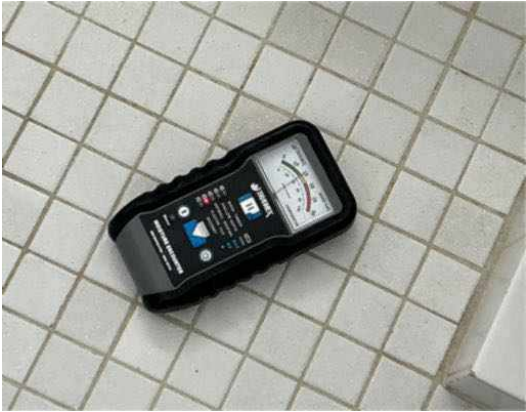
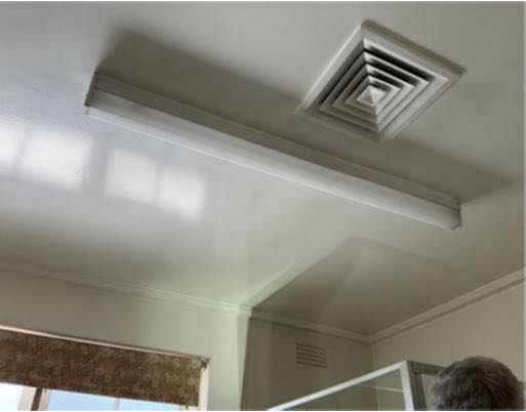
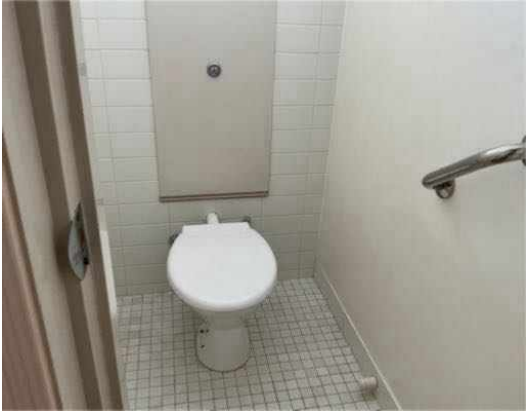
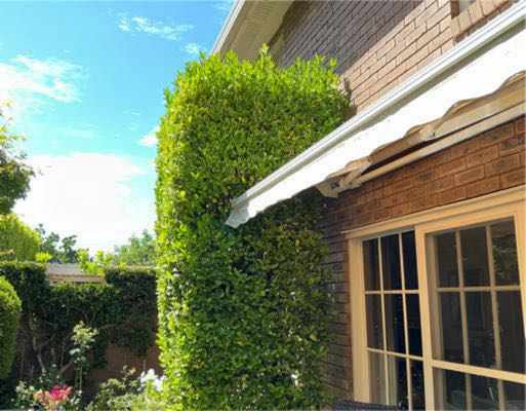
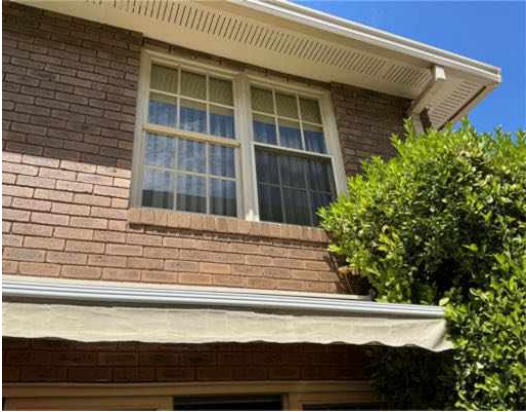
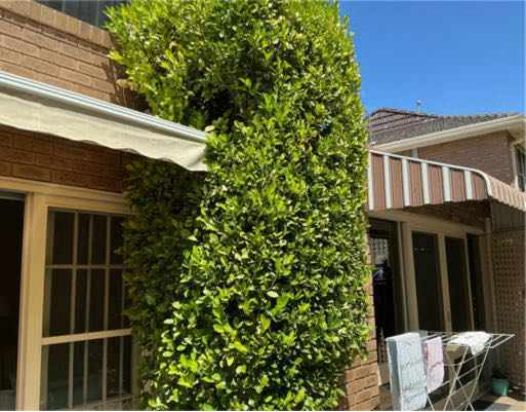
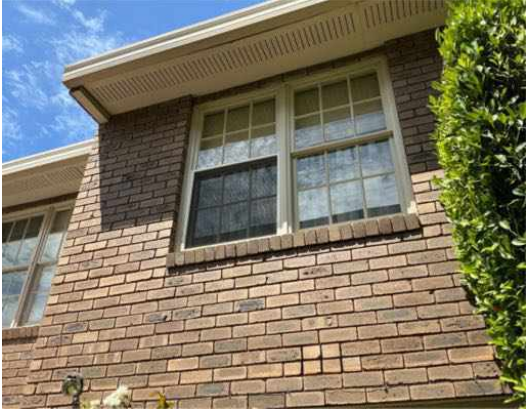
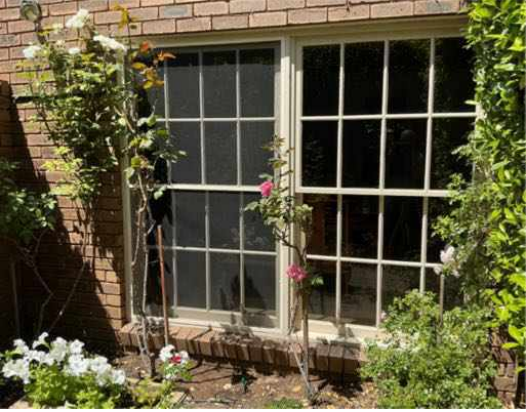
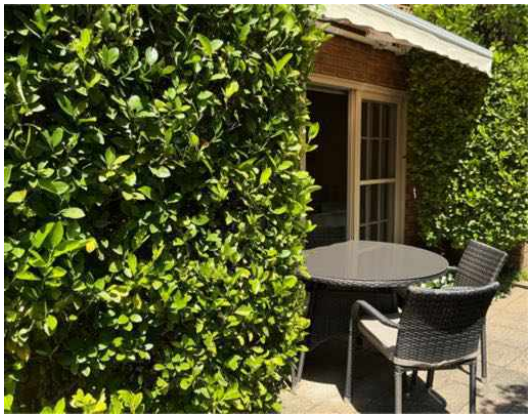
Noted Item

Building: Main Building
Location: All Areas
Finding: Additional Photos - Obstructions and Limitations
Information: These photographs are an indication of the obstructions and limitations which impeded full inspection of the property at the time of inspection. These obstructions can hide an array of defects and should be removed to allow full inspection to be carried out. A re-inspection is recommended once the areas are made accessible.

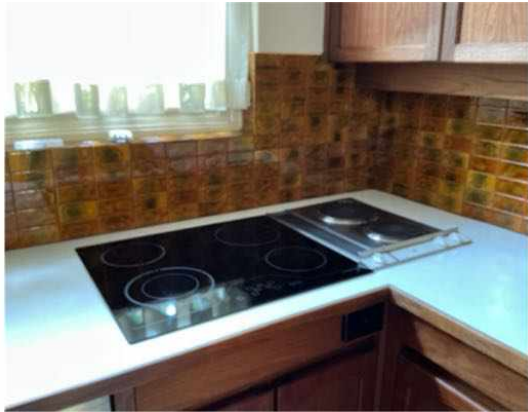
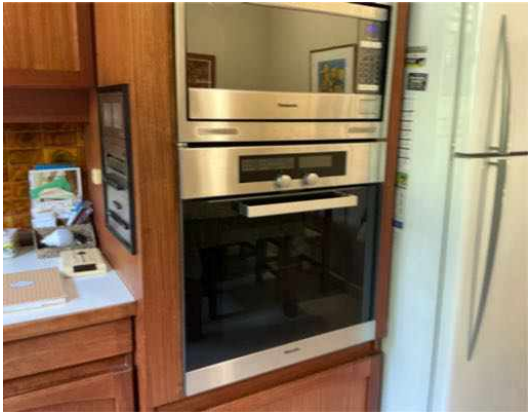
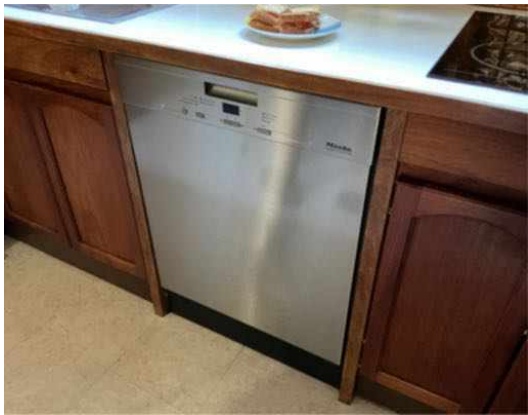
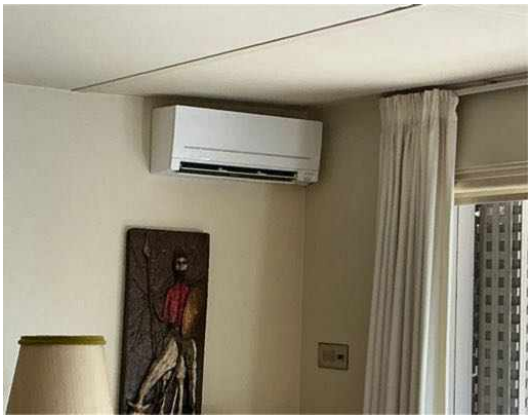
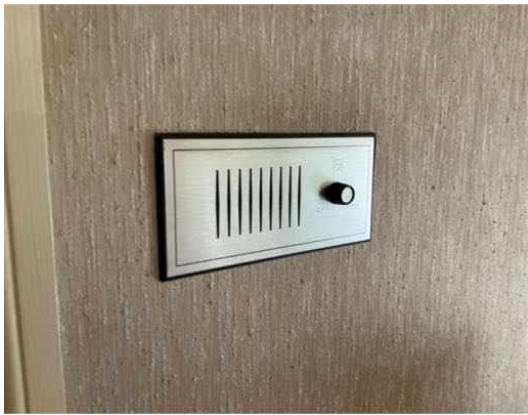
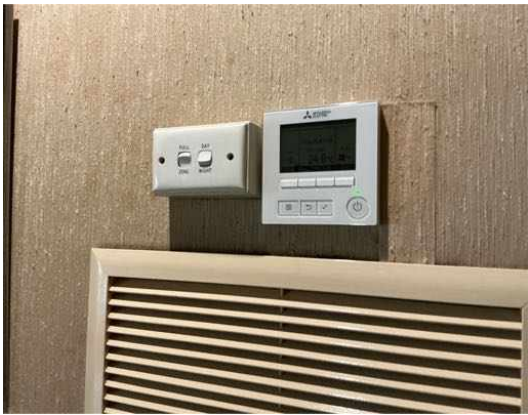
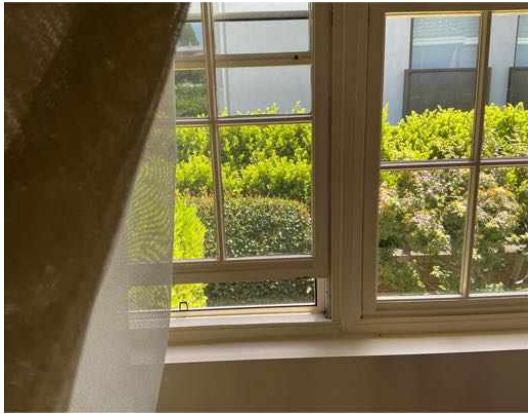
Building: Main Building
Location: Appliances
Finding: Warranty - Expired
Information: Where appliances are beyond their warranty period, the owner should be prepared to meet the cost of replacement or repair of the item at any time. The operation of the appliance can not be guaranteed and further inspection by an appropriately qualified tradesperson may be required.

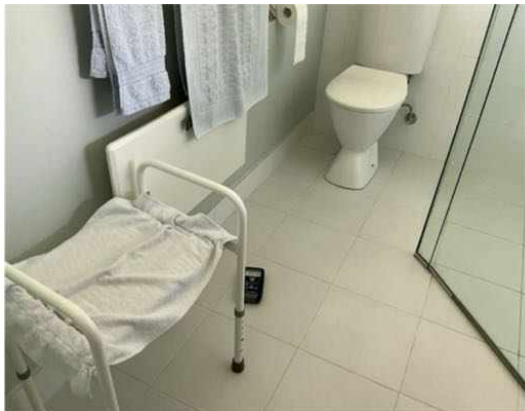
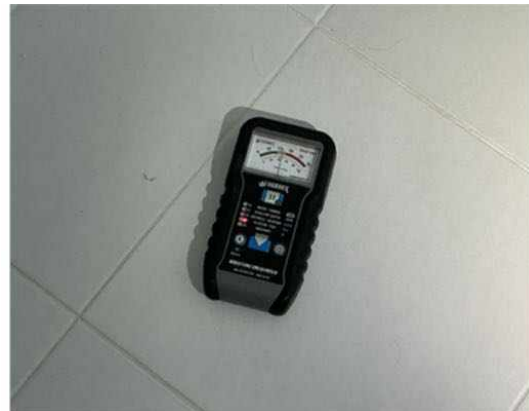
Building: Main Building
Location: All Areas
Finding: Additional Photos
Information: Additional photos are provided for your general reference

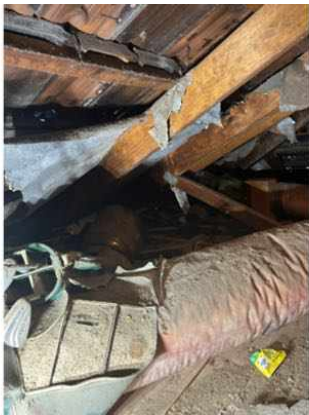
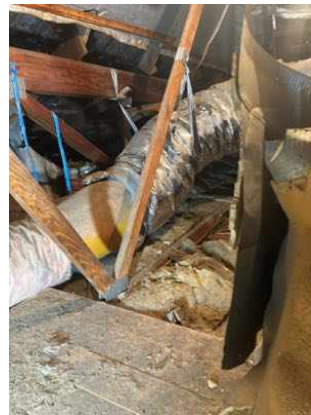
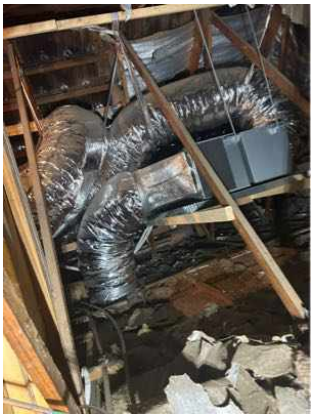
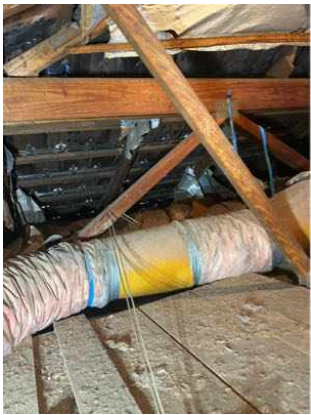
Building: Main Building
Location: All Areas
Finding: Additional Photos - Obstructions and Limitations
Information: These photographs are an indication of the obstructions and limitations which impeded full inspection of the property at the time of inspection. These obstructions can hide an array of defects and should be removed to allow full inspection to be carried out. A re-inspection is recommended once the areas are made accessible.
