Building and Timber Pest Inspection Report

Inspection Date: Fri, 30 Jan 2026

Property Address: 61 Tindale Rd, Artarmon NSW 2064,
Australia

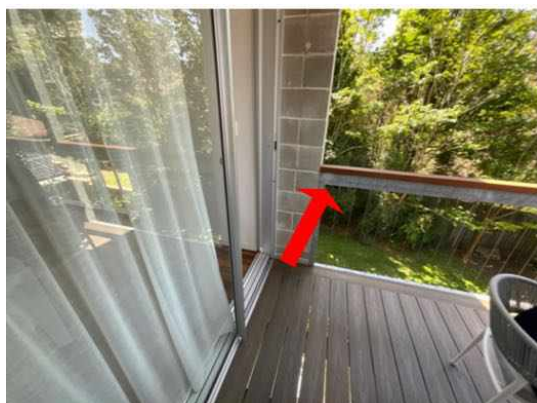
Building:	Main Building
Location:	Balcony
Finding:	Loose handrail — Fall from heights
Information:	The handrail was lacking appropriate support and fixing to the adjacent wall or floor at the time of inspection.

The handrail was further loose and moving upon minimal force applied with hand.

These handrails pose a risk and persons coming in contact may fall from heights if these handrails fail, thus causing sever injury.

A licensed builder must be appointed as soon as possible to rectify any non-compliance.

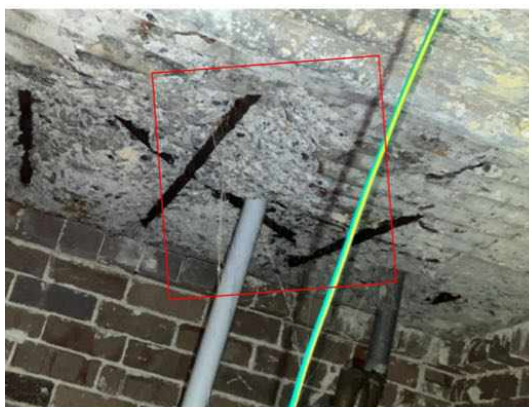
Finding 2.01

Building:	Main Building
Location:	Bathroom
Finding:	Concrete - Cancer
Information:	Concrete cancer is the common term used to describe a number of factors which cause concrete construction to deteriorate. Generally, water penetration causes the concrete reinforcement to rust and expand, creating stresses on the surrounding concrete and in turn causing it to spall (or break away). Alternatively, if the cement component is too alkaline, reactions with the general atmosphere occurs and star-shaped cracks appear which allow rainwater to penetrate. Concrete cancer may also

In some instances, repairs are possible; however, repair works will generally involve extensive works, including removal of affected concrete and the treatment or replacement of any exposed steel. Some injection of resins or special mortars may also be possible, however this depends on the size and extent of consequent damage.

Ultimately, the cause of the concrete cancer (e.g. poor water proofing) must also be addressed, otherwise the problem is likely to recur. Treatment of concrete cancer can be expensive and, left unmanaged, the problem is likely to worsen over time, potentially leading to the development of major structural defects or safety hazards.

The client is advised to exercise caution and to prepare for the potential cost of remedial and / or replacement works. A structural engineer should be appointed to provide estimates on the required works.

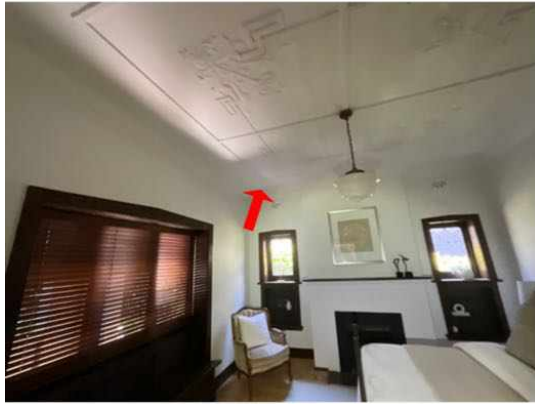
Finding 3.01

Building:	Main Building
Location:	Bedroom 2
Finding:	Ceiling - Water stained
Information:	Water staining to ceiling linings in this area was evident at the time of inspection. Water staining indicates that surfaces have been exposed to excessive moisture over time. The minerals and other elements in the water lead to staining, which may graduate to corrosion and deterioration if left unmanaged.

While mostly an appearance defect, water staining can be indicative of more serious defects, which may be currently concealed by interior ceilings.

Where water staining is active, a licensed plumber must be consulted to identify the cause of the staining and to provide advice on any reparation works that may be

required. Replacement of any damaged structures is advised.

Conversely, where water staining is old and inactive, affected building materials may be repaired or replaced at client discretion.

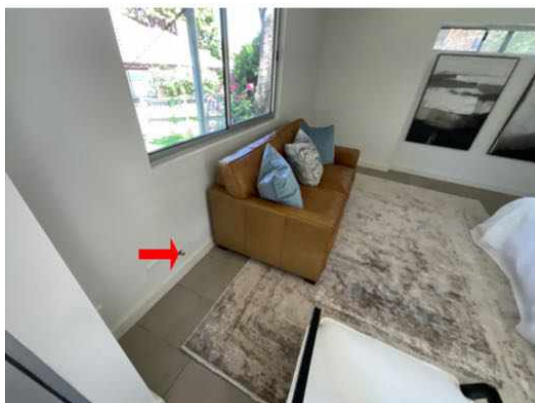
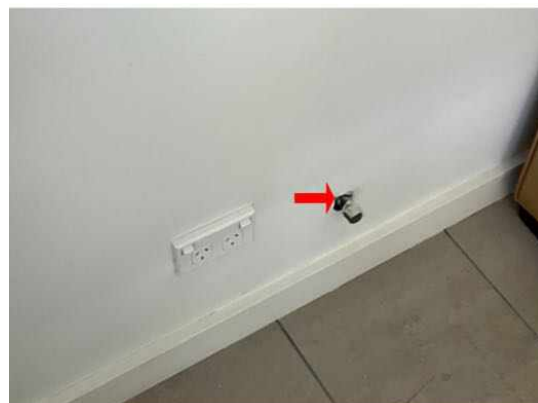
Finding 3.02

Building:	Main Building
Location:	Extension
Finding:	Incomplete or substandard works
Information:	The works to this area appear to be incomplete or have been completed to a substandard level.

Works that have not been completed to a satisfactory level create potential for the development of building defects and may impede on the safety and integrity of the overall structure.

It is highly recommended that the relevant trades be appointed to complete these works and ensure the safety of the area and the longevity of all associated building elements.

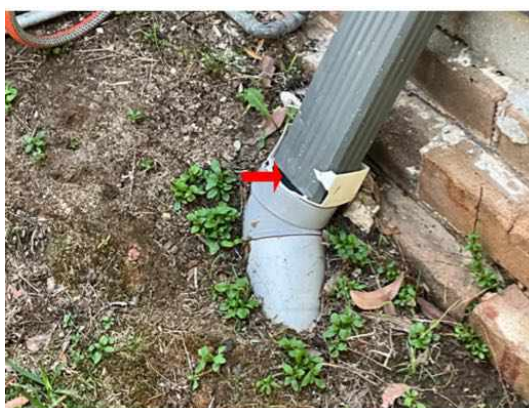
Finding 3.03

Building:	Main Building
Location:	Yard - LHS
Finding:	Stormwater drain - Damaged
Information:	The roof plumbing is not adequately connected to stormwater drainage on the site. This disconnection negatively impacts the functional capacity of the roof plumbing.

Where roof plumbing doesn't drain adequately, the area at the base perimeter can become excessively damp, potentially creating an environment that is susceptible to rust and corrosion of surrounding building elements, as well as attracting termites and other pests.

It is highly recommended that a plumber be appointed to further inspect the area and to install adequate drainage equipment where necessary.

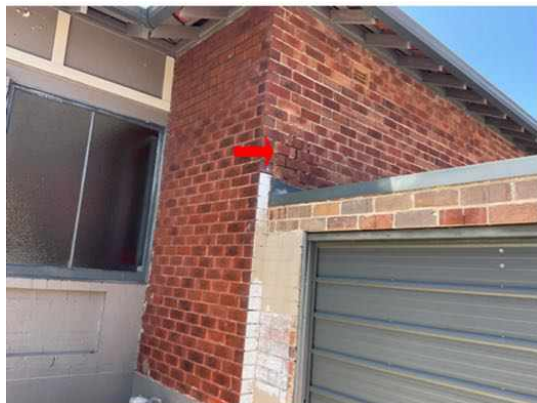
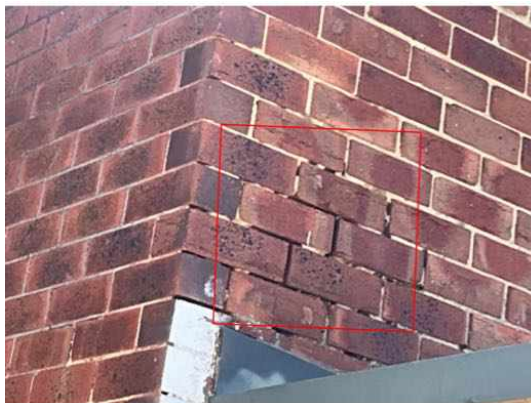
Finding 3.04

Building:	Main Building
Location:	Exterior walls - left side
Finding:	Brickwork and Mortar - Deteriorated (Erosion)
Information:	The brickwork and mortar in this area was found to be deteriorated. Mortar, or 'bedding', is the material which fills joints and intersections between bricks in masonry walls and structures.

Commonly referred to as corrosion or erosion, the bricks and mortar are aged and likely to have been affected by a variety of factors, including moisture, salt-based deterioration, and more.

Mortar and brickwork should be replaced to ensure the structure remains in their intended location and to prevent gaps, which would allow water or moisture ingress and secondary damage as a result.

This can be addressed by a licensed bricklayer where areas of deterioration are localised and easily accessible.

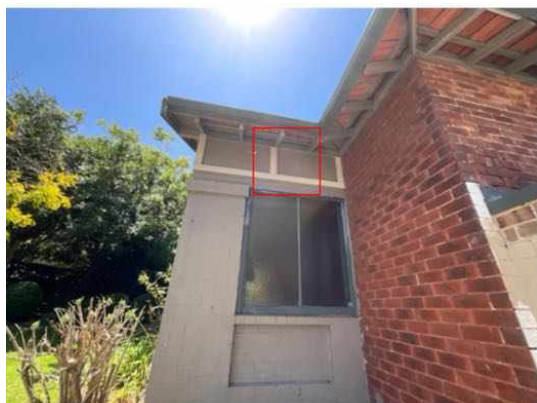
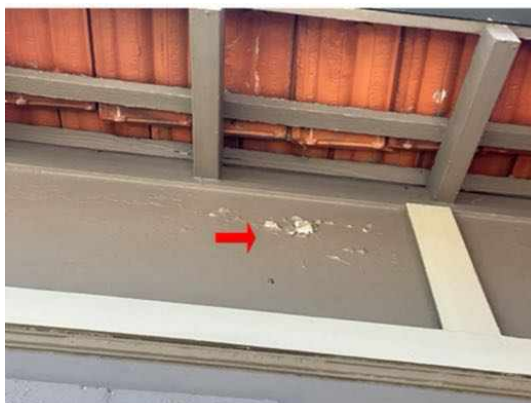
Finding 3.05

Building:	Main Building
Location:	Multiple areas
Finding:	Paint cracking and peeling
Information:	Cracking and ultimately flaking of paint can occur for a variety of reasons. Often these failures are due to the fact that the paint has inadequate adhesion and flexibility, both common problems with lower quality exterior flat paints.

When timber is involved, moisture intrusion results in swelling of the wood surface followed by contraction as the wood dries. The expansion and contraction cycles, can result in cracking and subsequent paint failure by flaking and peeling.

Cracking and flaking can also result when paint is applied too thinly due to overspreading (higher-than-recommended spread rate) or excessive thinning. These practices tend to diminish the paint's final film thickness, so that it is more vulnerable to cracking and flaking.

Inadequate surface preparation can also cause these failures, especially when paint is applied to bare wood or a very porous surface without first applying a primer.

A qualified painter should be appointed to rectify the problem.

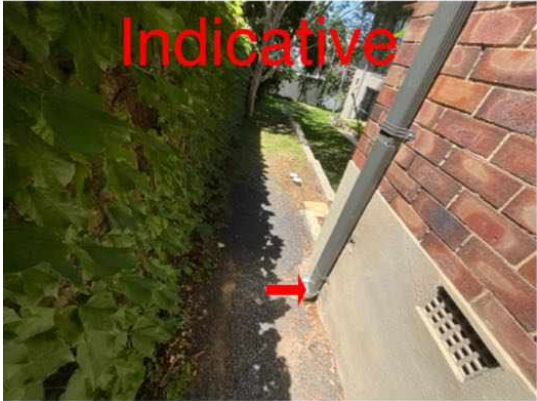
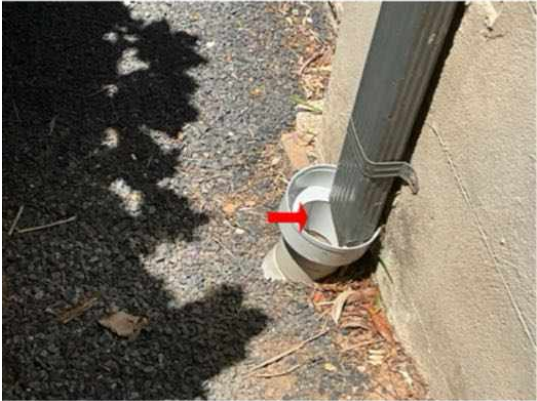
Finding 3.06

Building: Main Building
 Location: Multiple areas
 Finding: Plumbing - Point of connection non-compliant
 Information: At the time of inspection it was noted that connections between above ground pipe work and below ground sewer/storm water systems were incomplete.

Additionally, where sewer pipes are concerned, gases can escape from unsealed connections which can pose a serious health risk.

Engagement of a certified plumber is strongly recommended to ensure all connection points are sealed in accordance with the plumbing construction guidelines.

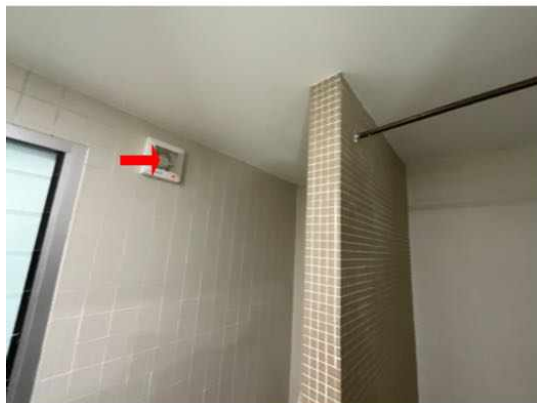
Finding 3.18

Finding: Building element - Missing

The appropriate tradesperson should be appointed as soon as possible to replace the missing building element.

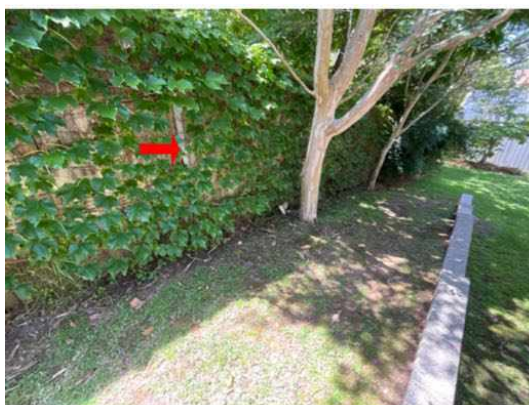
Finding 6.05

Building:	Main Building
Location:	
Finding:	Surrounding bushland - Conducive
Information:	Home and or building is situated in a high risk area for termite activity, due to close proximity to surrounding bushland.

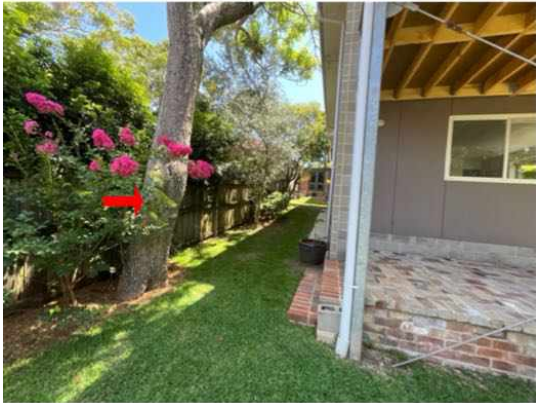
Finding 6.06

Building:	Main Building
Location:	Vegetation
Finding:	Vegetation - Abutting property
Information:	Vegetation against external wall may have an invasive root system. If there are weak points in the brick work or concrete slab, it is possible for the roots to gain entry into these areas. Once the roots have gained entry, it is possible for termites to gain

concealed entry via these roots. It is recommended to remove the vegetation and root system where possible.

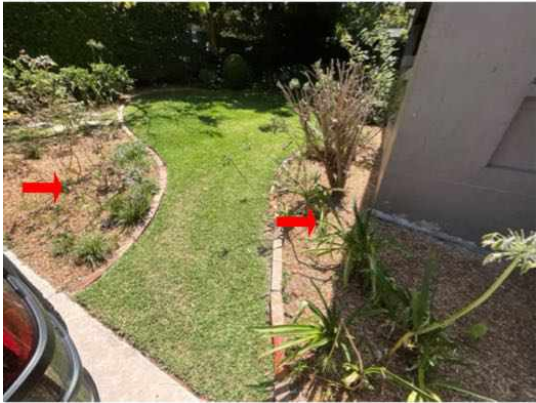
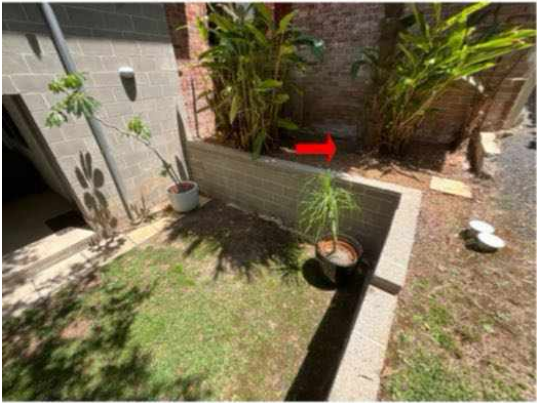
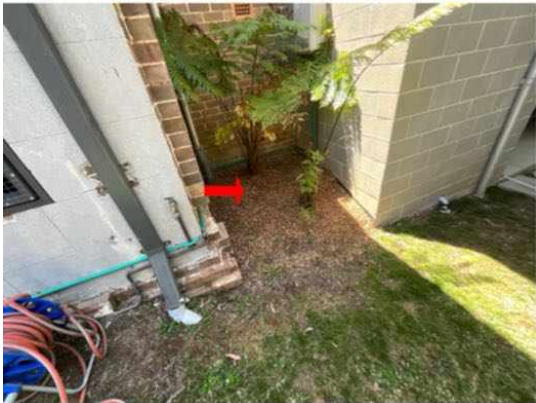
Finding 6.07

Building: Main Building
Location: Garden beds
Finding: Garden Beds
Information: Garden beds were found to be evident in the garden area. These garden beds can include untreated timber, and with a combination of moisture from watering hosing can make conditions conducive to termite activity and termite ingress.

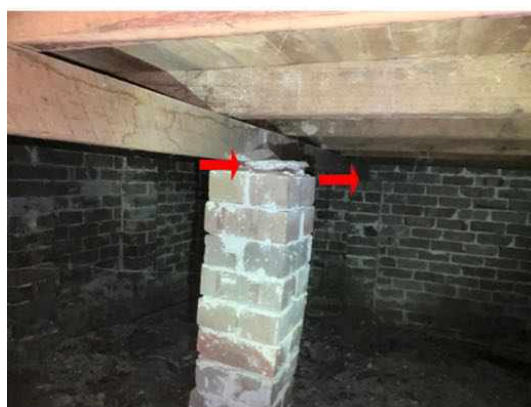
Finding 6.11

Building:	Main Building
Location:	Subfloor
Finding:	Subfloor - Debris
Information:	An array of debris was found in the subfloor area at the time of inspection. Debris in this area restricts subfloor ventilation and creates potential for concealed pest entry.

Stored timbers and other materials may also make the area susceptible to termite activity and wood rot.

A clear and empty subfloor will be better ventilated and easier to maintain in a dry condition. The removal of any timber debris is vital in minimising the risk of termite or wood borer activity.

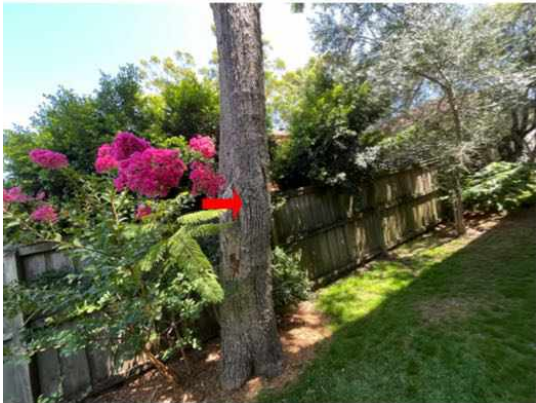
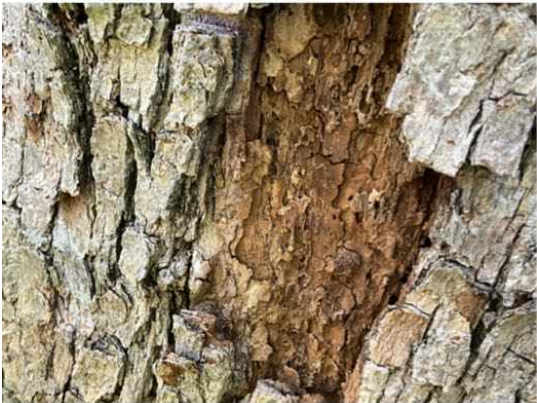
Building:	Main Building
Location:	Trees
Finding:	Evidence of wood borer activity identified
Information:	Wood borers small beetles that colonise in exposed timber elements are a common timber pest that are regularly mistaken for termites. Although wood borer activity is generally not detrimental to the affected timber they may lead to serious damage and necessitate replacement of certain building elements if left unattended.

The other commonly known borer the Anobium borer is more likely to attack floorboards and may cause severe structural damage to flooring areas.

As no live wood borer activity was identified treatment is not required at this time. Replacement of affected timbers may be considered by the client for superficial reasons.

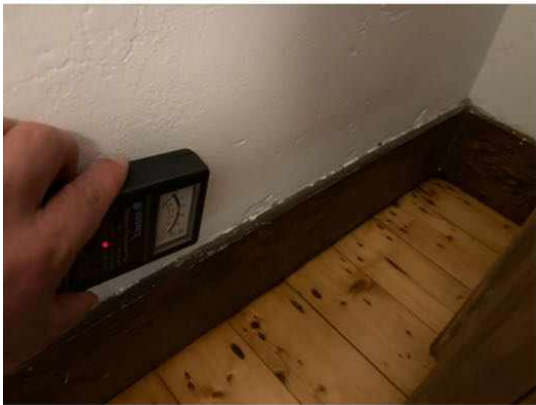
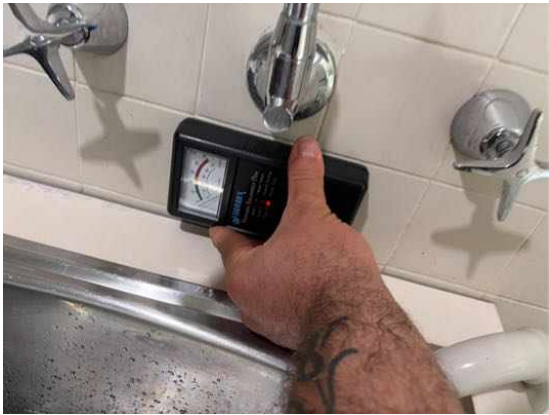
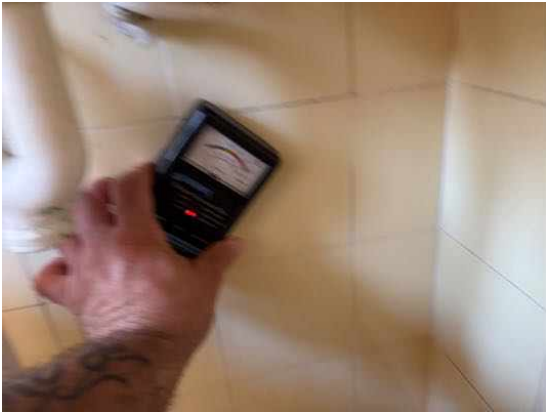
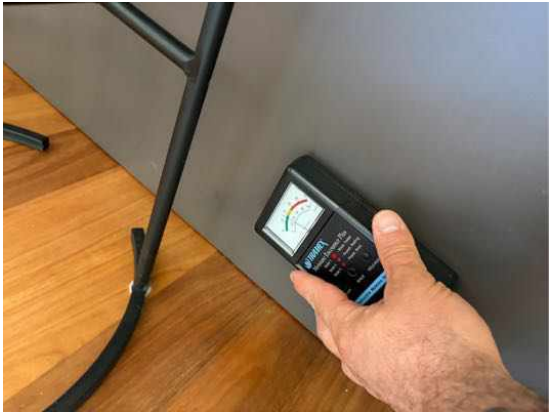
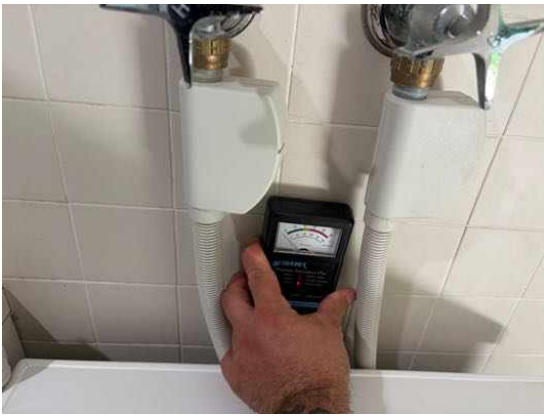
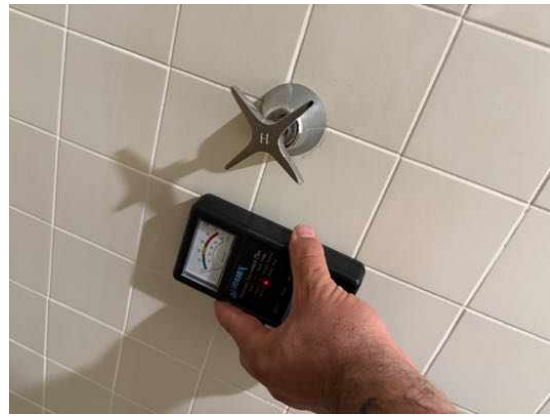
Building: Main Building
Location: All Areas
Finding: Moisture metre
Information: During the inspection the property was checked for moisture using a moisture metre.

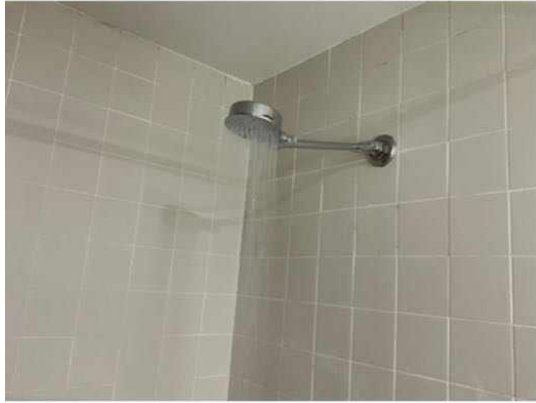
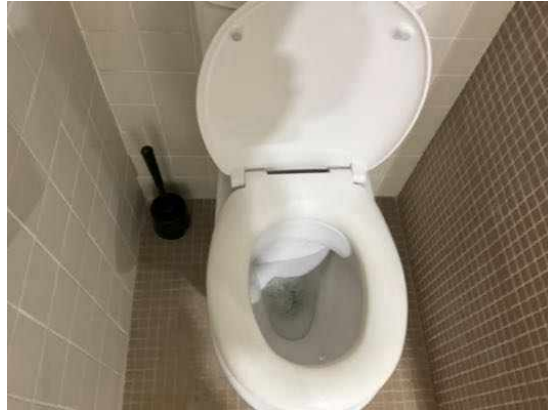
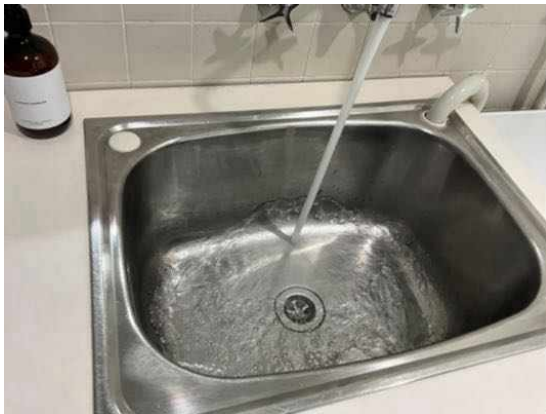
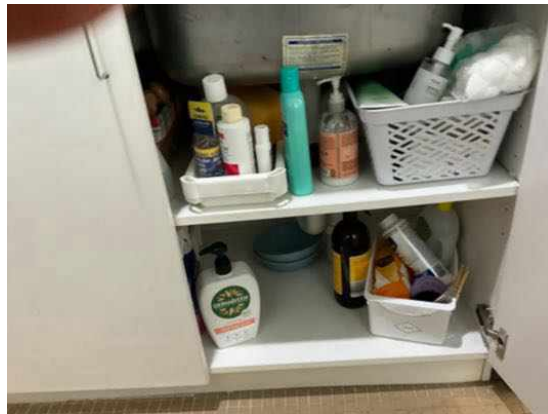
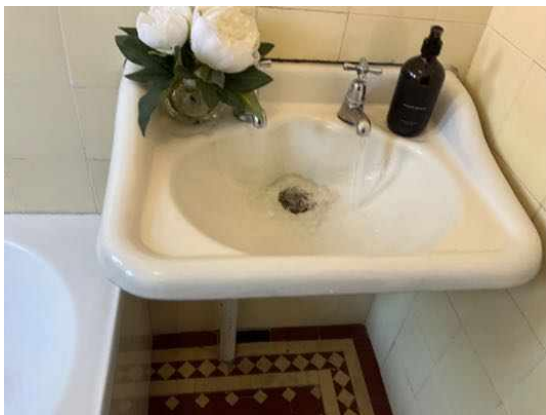
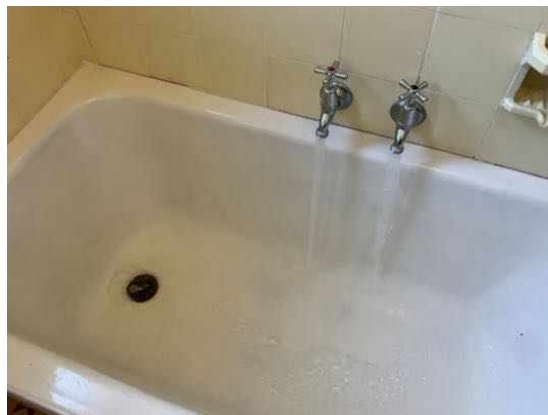
All taps, mixers and toilets were tested for operation, except for those obstructed. The waterproofing to the shower recess was assessed by checking the walls in and around the shower recess for varying moisture content. There were no significant variations across the tested areas. No sign of recent water damage was evident upon a visual inspection of the surrounding walls, where the visual nature of the inspection was possible.

Consequently, there is no conclusive evidence of any current shower recess leakage other than those which may have already been mentioned earlier in this report. It is reasonable to assume the shower waterproofing is sound. Note that if the shower is not used, or has not been used for some time, moisture readings would not vary significantly and this can lead to erroneous results. It is not possible under the visual inspection criteria (under which a prepurchase inspection is carried out) to categorically determine if there are leaks. If a more accurate assessment is required, a special purpose inspection should be requested. Alternatively, the assumption should be made that the shower may leak.

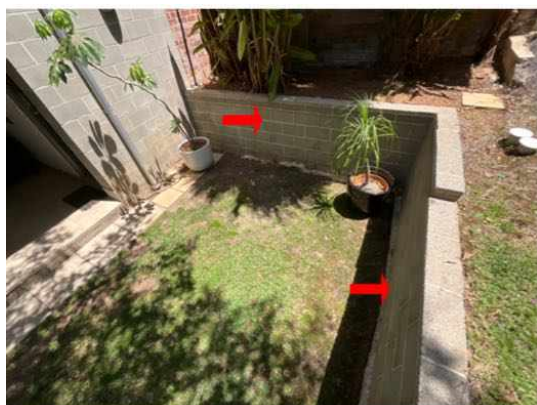
Building:	Main Building
Location:	Retaining walls
Finding:	Retaining walls
Information:	At the time of inspection the retaining walls were checked and no defects were observed other than those which May have been mentioned earlier in this report.

AS4349.1-2007 requires all retaining walls in excess of 700mm to be inspected by a licensed and practicing structural engineer.

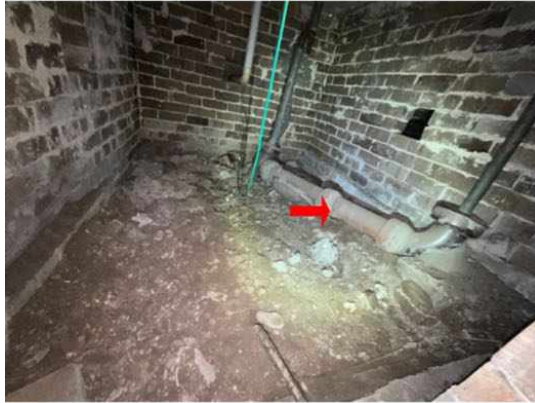
Finding: Pipework - Old urban wear pipes

Information: Old urban wear pipes were identified at the time of inspection.

Consultation with a licensed plumber is advised. CCTV inspection on pipes may be required.

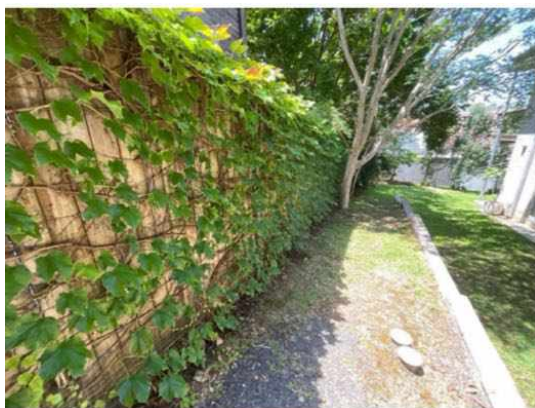
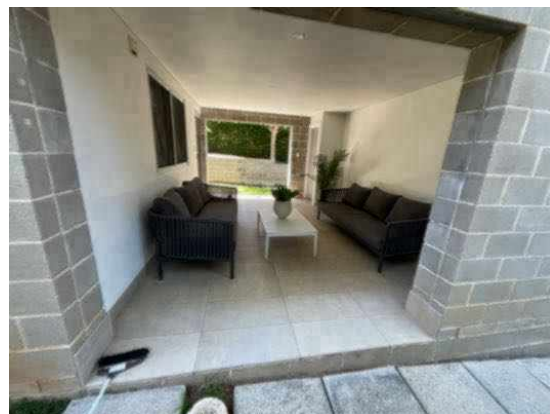
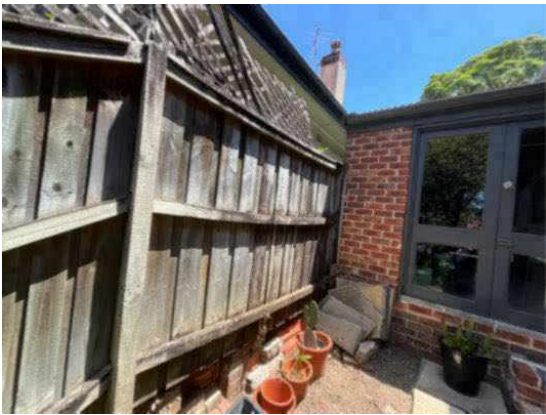
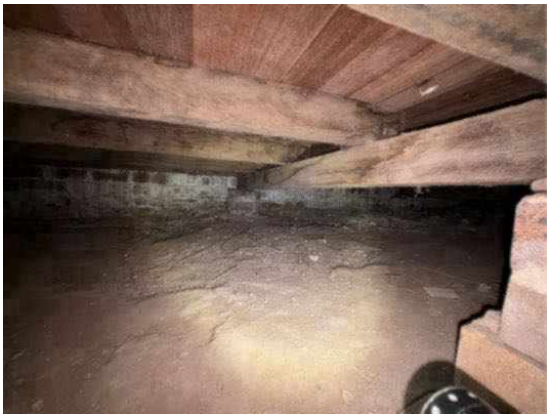
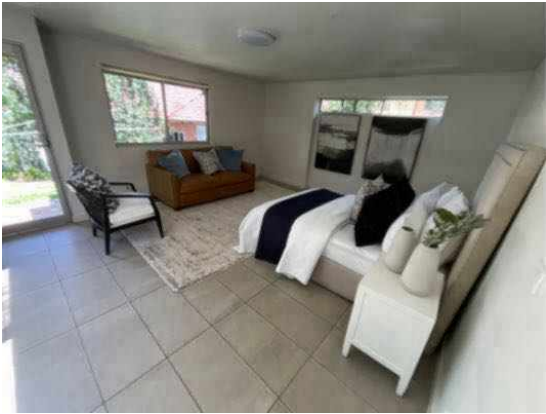
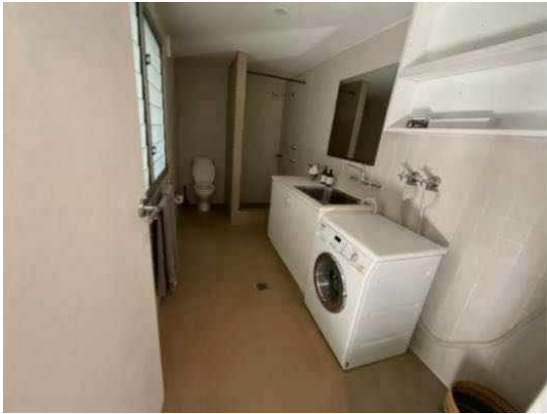
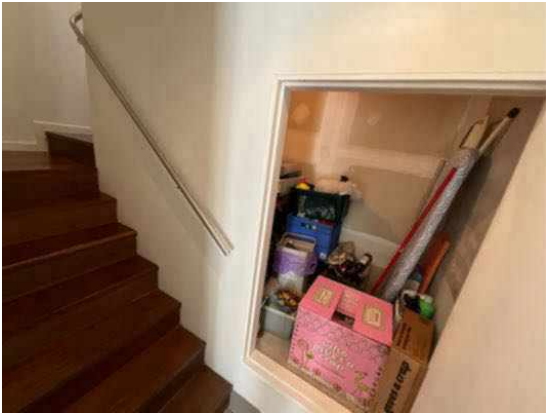
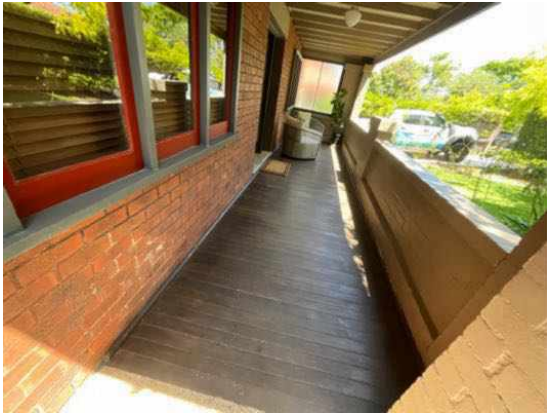
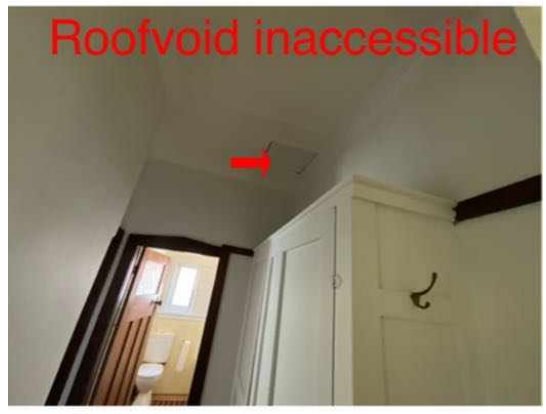
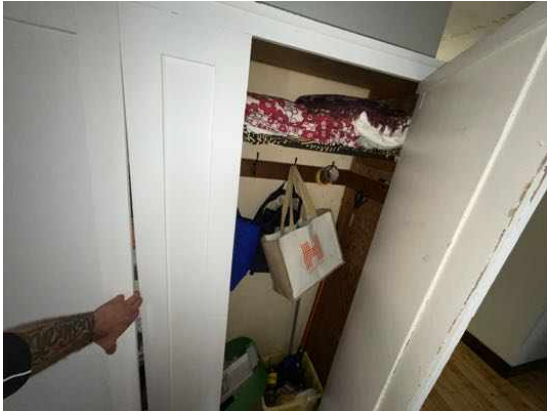
These photographs are an indication of the obstructions and limitations which impeded full inspection of the property at the time of inspection. These obstructions can hide an array of defects and should be removed to allow full inspection to be carried out. A re-inspection is recommended once the areas are made accessible.

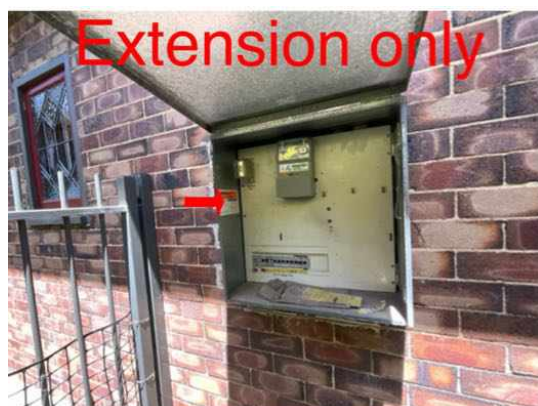
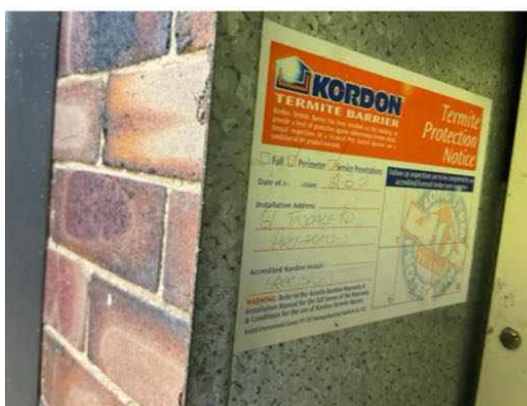
The following items were noted as - Evidence of a previous termite management program

Where a Termite Management System has been identified you should refer to the type of barrier date of installation warranty conditions and any documentation provided by a builder or past owner. Consult the company who installed the barrier to confirm whether the system is still under warranty.

Most chemical termite management systems expire and require replenishment and all physical systems are primarily designed to prevent concealed entry.
