Building Inspection Report

Inspection Date: Tue, 10 Feb 2026

Property Address: 105 Campbell Hill Rd,CHESTER
HILL,NSW,2162,Australia

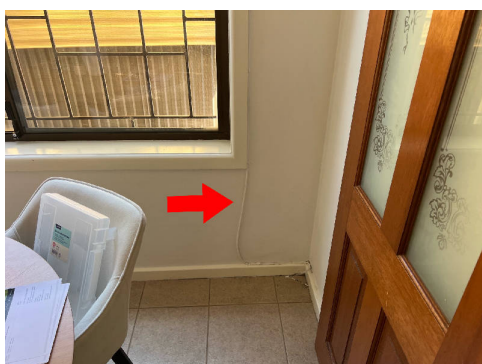
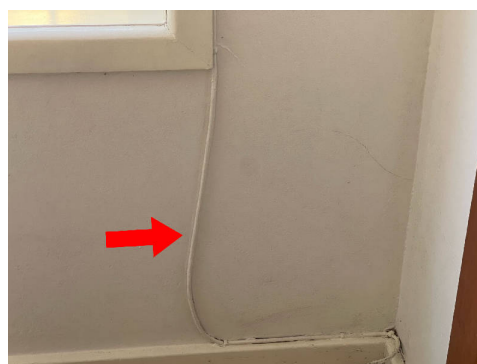
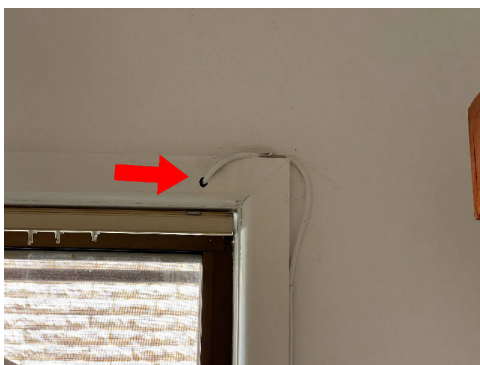
Defects 1.01

Information: An electrical cable was observed running externally along the internal wall surface and into the window architrave, rather than being concealed within the wall cavity or suitably enclosed in compliant conduit. The cabling was surface-mounted and partially exposed within the habitable area.

Surface-mounted and exposed electrical cabling of this nature is vulnerable to accidental damage and may not comply with current electrical safety standards. Penetrations into wall linings and architraves can also compromise the integrity of finishes and increase the risk of deterioration over time. While the installation may have been functional at the time of inspection, its condition and method of installation raise concerns regarding safety and workmanship.

It is recommended that a suitably qualified licensed electrician be engaged to assess the installation, confirm compliance with current standards, and carry out rectification works as required. This assessment should be undertaken in the short term.

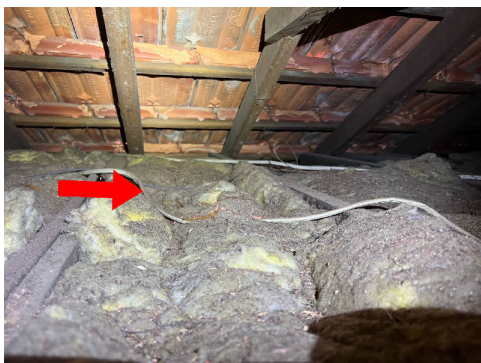
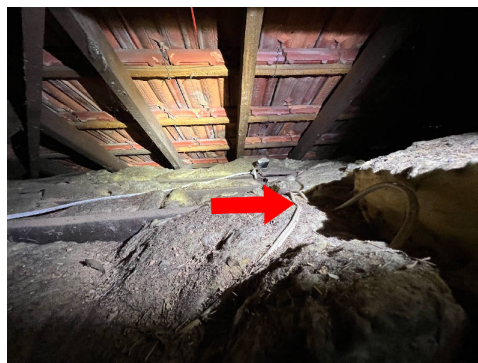
Defects 1.02

Information: Electrical wiring was observed within the roof space that was not adequately secured or supported, with loose cables resting on ceiling joists and insulation. The wiring did not appear to be clipped, supported, or protected in a consistent manner in the accessible areas inspected.

Unsecured wiring may be subject to mechanical damage, movement, or deterioration over time, particularly where it comes into contact with insulation or structural members. This condition may increase the risk of electrical faults or damage to the wiring system. It is recommended that a suitably qualified licensed electrician assess the roof space wiring and secure or rectify it as required to ensure it is adequately supported and compliant. Rectification should be carried out in the short term.

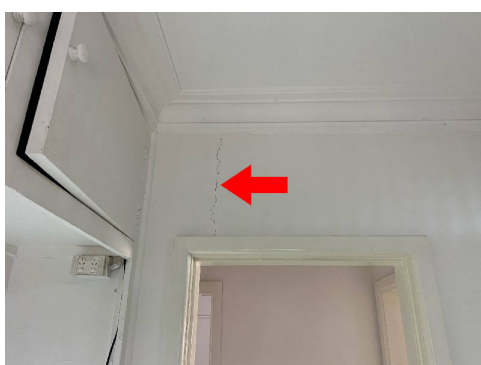
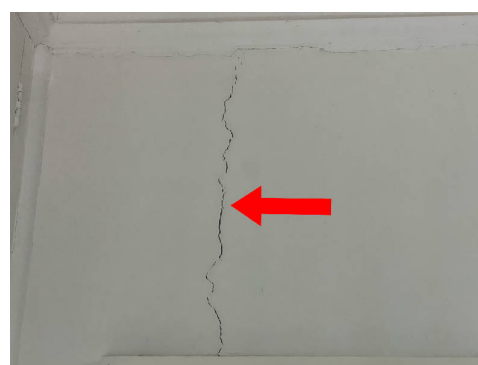
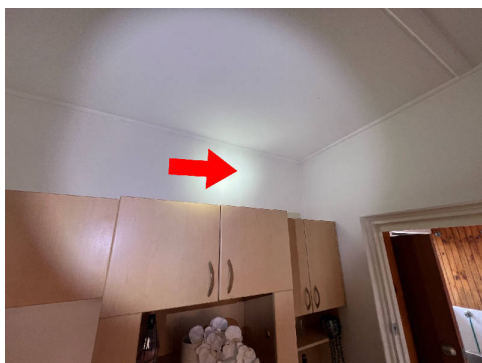
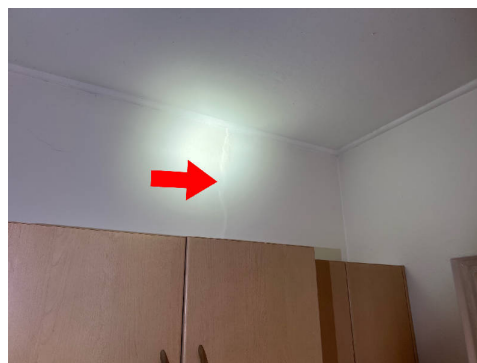
Defects 2.01

Finding: Internal Wall Cracking – Multiple Locations

Information: Multiple vertical and stepped cracks were observed to the internal masonry walls throughout the dwelling, including walls adjacent to door openings and areas near the ceiling line. The cracking appears to extend through the internal wall finishes and is consistent across several internal locations within the double brick structure.

Cracking of this nature may be associated with building movement, differential settlement, or age-related deterioration of wall materials. While the dwelling is of double brick construction, internal wall cracking can indicate ongoing or past movement and may affect the long-term performance and serviceability of the structure if left unaddressed. The extent and pattern of cracking warrant further assessment to determine whether the movement is progressive or historic.

It is recommended that a suitably qualified structural engineer be engaged to further assess the cracking, determine the underlying cause, and provide advice regarding any necessary rectification works. This assessment should be undertaken prior to settlement or as soon as practicable.

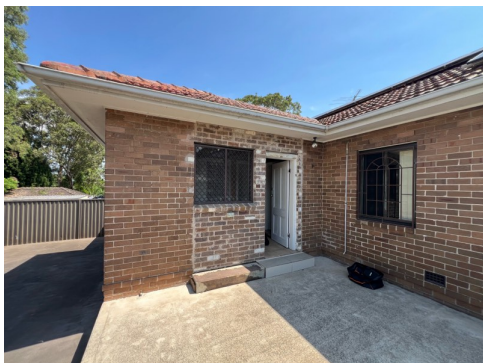
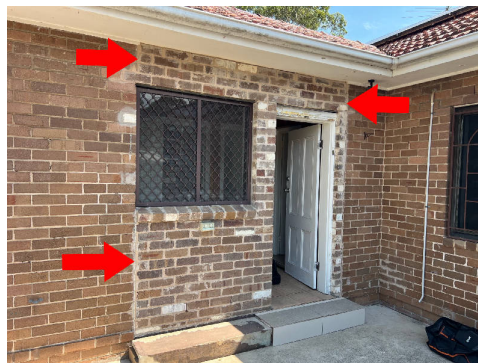
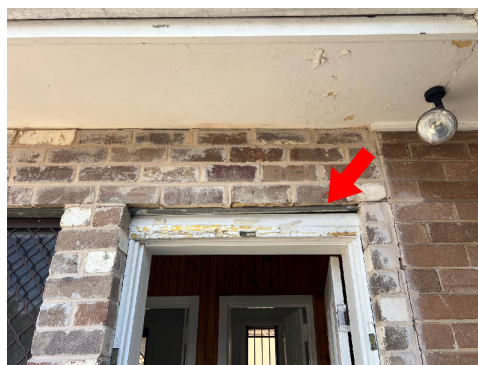
Defects 2.02

Building:	Main Building
Location:	Exterior walls - rear
Finding:	Cracking and Poor Workmanship to External Brickwork Adjacent to Doorway
Information:	Cracking and separation were observed to the external brickwork adjacent to the doorway opening, including stepped and vertical cracking through the mortar joints and along the junction between the brickwork and the door frame. Evidence of patch repairs and inconsistent mortar finishes was also noted, indicating prior rectification attempts.

Cracking of this nature around openings can be associated with building movement, inadequate articulation detailing, or poor workmanship during construction or subsequent repairs. Separation at the brickwork-to-frame interface may allow moisture ingress and can contribute to ongoing deterioration of masonry, internal finishes, and door framing if left unaddressed. The visible repairs suggest the issue may be recurrent rather than isolated.

It is recommended that a suitably qualified structural engineer or experienced brickwork contractor be engaged to further assess the cracking, determine whether the movement is ongoing, and provide appropriate repair recommendations. Any rectification works should ensure adequate movement control and weather sealing. This matter should be addressed as a priority.

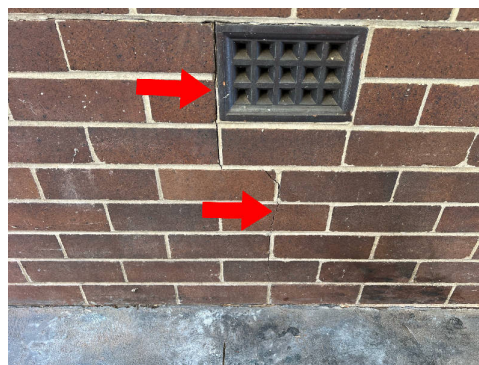
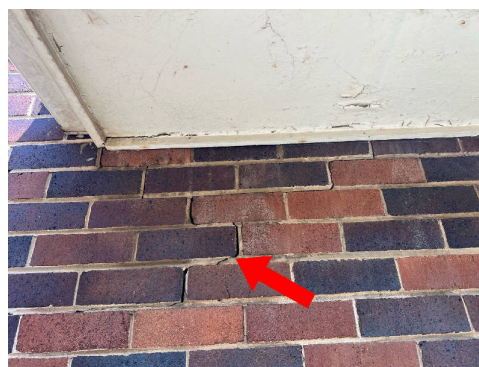
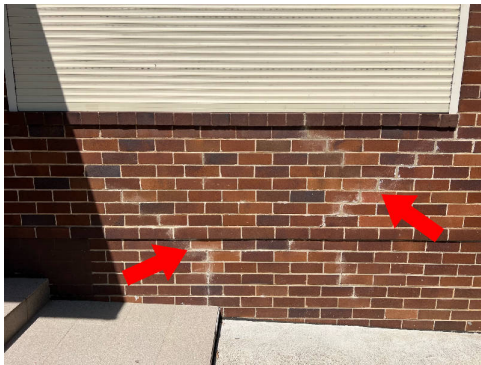
Defects 2.03

Building: Main Building
Location: All External Areas
Finding: Brickwork - Step cracking

Step cracking was identified to the brickwork in this area at the time of inspection. Step cracking, which is similar to other forms of cracking, has a variety of possible causes. However, the most common is the subsidence of adjacent footings.

Step cracking is a relatively common defect, and is most likely to occur adjacent to windows, doors and other openings. Mortar failure in the gaps between affected bricks indicates the stresses and tensions affecting the wall.

Where step cracking is extensive or severe, the client is advised to consult a structural engineer. Minor step cracking can be used as a warning sign to address factors causing stress to the wall, which can include the effect of surrounding trees, water leaks, soil erosion, or even the presence of reactive soils in the surrounding area.

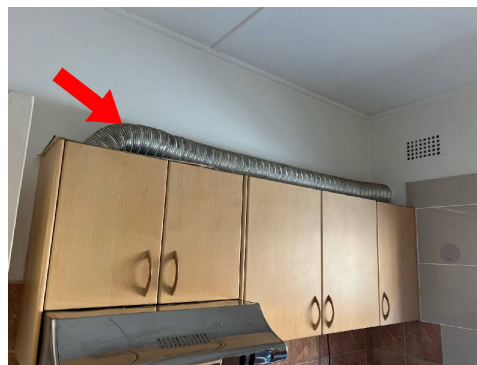
Defects 3.01

Information: The kitchen rangehood exhaust ducting was observed to be exposed above the overhead cupboards, rather than being concealed within cabinetry, ceiling space, or a purpose-built bulkhead. The flexible metal ducting was visible along its length within the kitchen area.

Exposed ducting of this nature detracts from the finish of the kitchen and may be more susceptible to grease accumulation, damage, or dislodgement over time. In addition, flexible ducting that is not adequately supported or concealed may be less effective in maintaining airflow efficiency and can contribute to increased noise or reduced performance of the rangehood system.

It is recommended that a suitably qualified contractor be engaged to assess the ducting installation and consider enclosing or rerouting the ducting to improve durability, performance, and overall presentation. This should be addressed as part of general maintenance or during future kitchen upgrades.

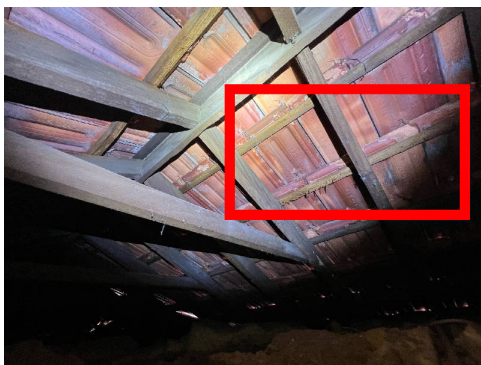
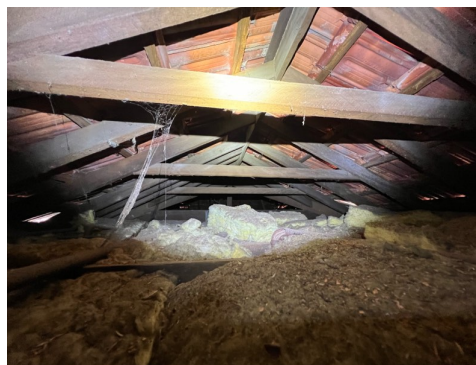
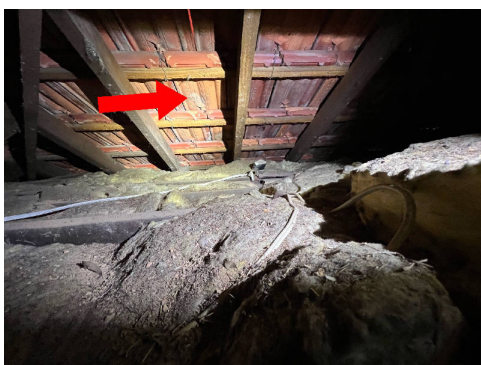
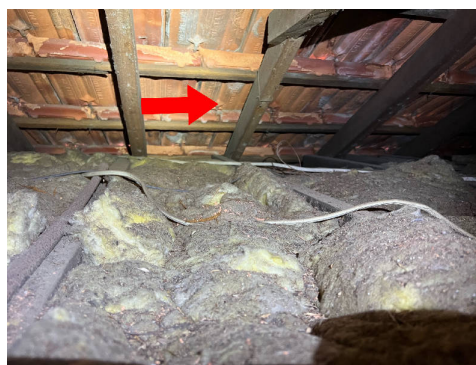
Defects 3.03

Within the roof space, the underside of the roof covering was observed to be installed without sarking (roof underlay). The roof tiles were directly fixed to the battens, with no moisture barrier present between the roof covering and the roof framing.

The absence of sarking may increase the risk of wind-driven rain, dust, and debris entering the roof space. This can contribute to moisture exposure of roof timbers, insulation contamination, and potential long-term deterioration of building materials. Sarking also assists with condensation control and thermal performance, which may be reduced where it is not installed.

While this configuration may reflect the construction practices at the time of installation, it does not align with current building standards and performance expectations. It is recommended that this condition be noted for future consideration, with advice sought from a suitably qualified roofing contractor should roof works or upgrades be undertaken.

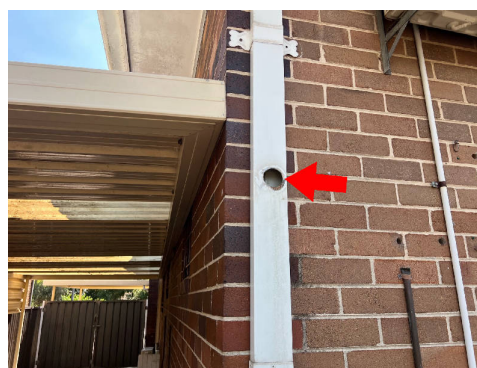
Defects 3.04

Location:	Exterior walls - rear
Finding:	Damaged Downpipe
Information:	The external downpipe was observed to be damaged and incomplete, with an open section and missing connection preventing effective conveyance of roof water to the stormwater drainage system. The downpipe was not fully functional at the time of inspection.

A damaged or incomplete downpipe can result in uncontrolled discharge of roof water at the base of the dwelling. This can contribute to moisture issues, erosion, and potential foundation movement over time, particularly in reactive soil conditions. Ineffective roof drainage also increases the risk of dampness to adjacent walls and footings.

It is recommended that the downpipe be repaired or replaced and properly connected to an appropriate stormwater discharge point by a suitably qualified contractor. This should be addressed in the short term to ensure effective roof water management.

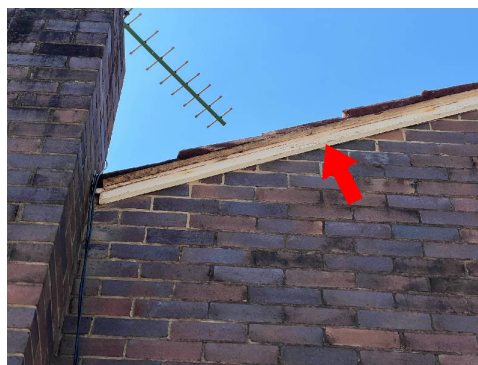
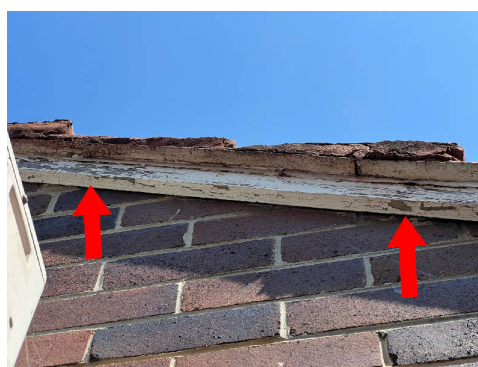
Defects 3.05

Building:	Main Building
Location:	Exterior walls - Sides
Finding:	Fascia wood rot

Sections of the fascia board were noted to be affected by timber rot and deterioration. The damage appears to be associated with prolonged exposure to moisture, likely from roof or gutter overflows in this area. Rotting timber can weaken structural integrity, compromise the support for gutters, and provide entry points for pests.

If left untreated, the decay may spread to adjoining timber elements and result in more extensive repairs being required. It is recommended that the affected sections be removed and replaced with new, treated timber, and that the source of moisture ingress (such as leaking or overflowing gutters) be identified and rectified.

Repairs should be carried out by a licensed carpenter or builder, with further inspection of roof plumbing by a roof plumber if leaks are contributing to the issue.

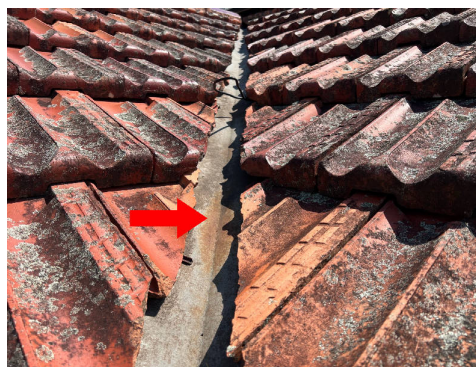
**Defects 3.06**

Finding: Corroded Valley Flashing

Information: At the time of inspection, corrosion was observed along the metal valley flashing, indicating prolonged moisture exposure and inadequate protective coating. The rust has begun to compromise the flashing's durability and may lead to water ingress during heavy rainfall, particularly where debris accumulation is also present.

It is recommended that a licensed roofing contractor remove debris, assess the extent of corrosion, and repair or replace the affected valley flashing to restore proper water management and prevent further deterioration.

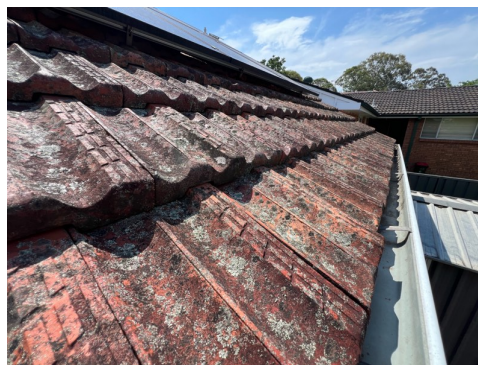
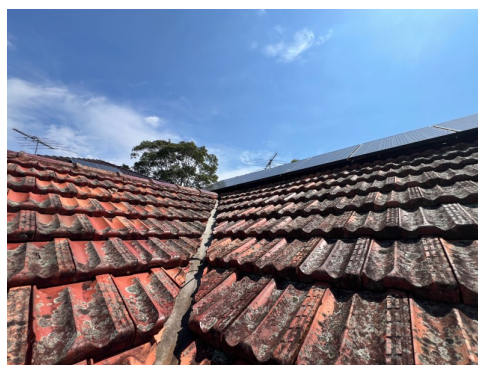
Defects 3.07

The exterior tiled roof covering was generally observed to be in fair condition for its apparent age; however, isolated deterioration was noted to the mortar bedding and pointing, particularly within valley areas. Minor cracking and areas of loose or degraded mortar were evident at the time of inspection, indicating that previous pointing materials have begun to break down due to age and weather exposure.

Deteriorated or cracked mortar within roof valleys can compromise the weatherproofing performance of the roof covering and may allow water ingress during heavy rainfall. If left unaddressed, this condition may lead to secondary defects such as minor roof leaks and moisture exposure to internal roofing components. Re-pointing and re-sealing of affected areas may be considered as an interim maintenance measure to assist in preserving and extending the service life of the existing roof tiles. It is recommended that a suitably qualified roofing contractor assess the roof and provide advice regarding appropriate remedial works required in the short to medium term.

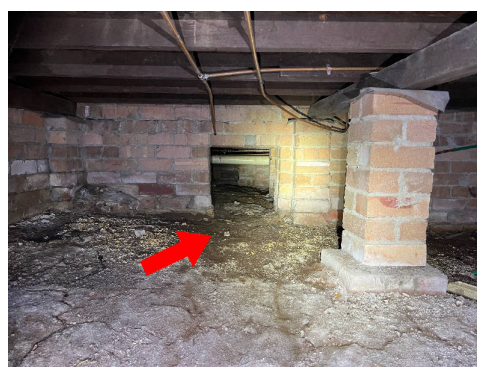
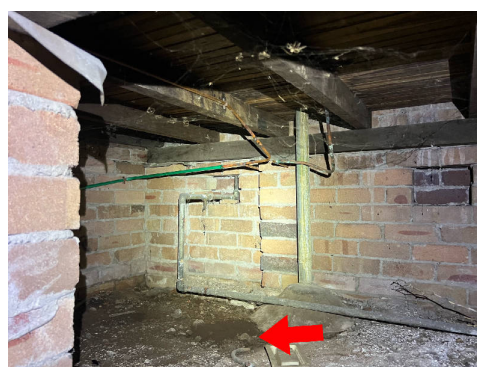
**Defects 3.08**

Information: Dampness to localised sections of the subfloor area was identified. While no active leaks were observed at the time of inspection, the pattern of moisture suggests that leaking pipes in this area may have been the source, potentially worsened by poor site drainage and inadequate subfloor ventilation.

This level of dampness is likely to lead to wood rot and general deterioration of structural elements within the subfloor space. Elevated moisture also creates conditions conducive to termite activity and other pest infestation.

A licensed plumber should be appointed immediately to assess and repair any pipes that may be leaking. Addressing plumbing issues promptly will help ensure a dry subfloor environment and improve the overall water efficiency of the property.

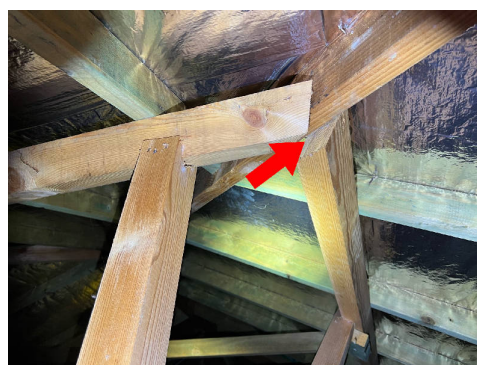
Defects 3.09

Building:	Granny-Flat
Location:	Roof Void
Finding:	Inadequate Fixing to Roof Framing Member
Information:	<p>A roof framing member was observed to be fixed by face-nailing only, with limited bearing and no visible structural support or connector at the junction. The fixing method appeared minimal and not consistent with best practice for roof framing connections.</p>

Inadequate fixing and limited bearing at framing junctions can reduce the load-carrying capacity of the roof structure and may lead to movement or loosening of the connection over time. While the member was fixed at the time of inspection, the adequacy of the connection could not be confirmed and may not meet current structural standards.

It is recommended that a suitably qualified structural engineer or experienced carpenter be engaged to assess the connection and provide advice regarding strengthening or rectification if required. This should be addressed as part of ongoing maintenance or prior to future roof works.

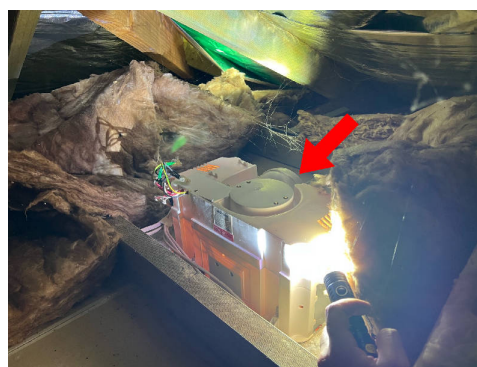
Defects 3.10

Building:	Granny-Flat
Location:	Roof Void
Finding:	Bathroom Exhaust Fan Discharging Into Roof Space

Information: The bathroom exhaust fan unit was observed installed within the roof space. No clear evidence was observed of the fan being ducted to discharge externally from the dwelling, and insulation was noted surrounding the fan housing.

Bathroom exhaust fans are intended to vent moist air to the exterior of the building. Where moist air is discharged into the roof space, it can contribute to increased humidity, condensation, and moisture accumulation. Over time, this may lead to deterioration of roof timbers, insulation, and ceiling linings, and can increase the risk of mould growth within the roof space.

It is recommended that a suitably qualified contractor be engaged to assess the installation and ensure the exhaust fan is correctly ducted to an appropriate external discharge point. This should be addressed in the short term to reduce the risk of moisture-related issues.

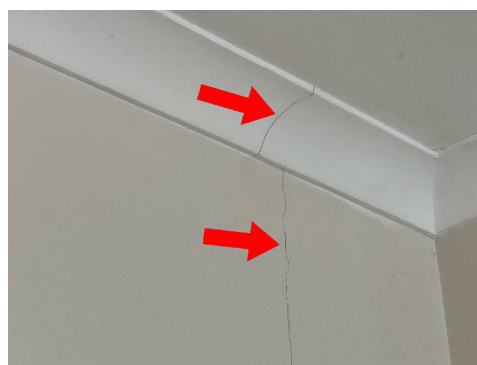
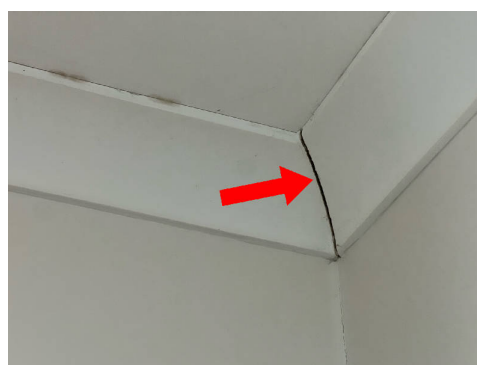
Defects 3.11

Building: Granny-Flat
Location: Living rooms 1 & 2
Finding: Cracking to Internal Walls and Ceiling Junctions – Living Room

Cracking was observed to the internal wall and ceiling junctions within the living room, including fine vertical cracking extending down the wall and cracking through cornice lines and ceiling joints. The cracking was present in multiple areas within the room and was not isolated to a single location.

Cracking of this nature may be associated with building movement, differential settlement, or age-related movement of materials. While some minor cracking can be common in older dwellings, the repeated pattern and distribution of cracking within the living area indicate movement that may affect internal finishes over time if ongoing. Cracking at cornice and ceiling junctions may also reoccur following cosmetic repairs if the underlying cause is not addressed.

It is recommended that the cracking be monitored for any signs of progression and that a suitably qualified structural engineer or building professional be engaged to assess whether the movement is ongoing and to provide advice regarding appropriate rectification. This should be considered prior to undertaking cosmetic repairs.

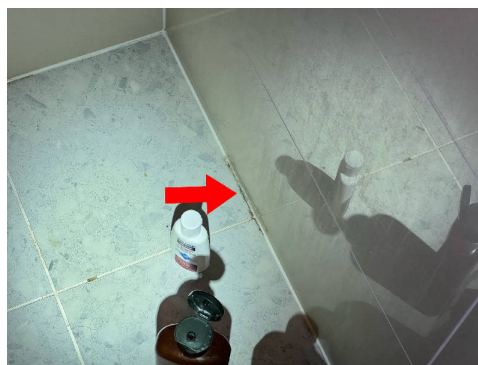
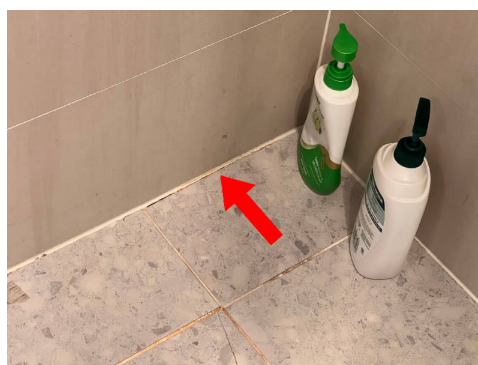
Defects 3.12

Building:	Granny-Flat
Location:	Bathroom 1 & 2
Finding:	Sealant and grouting - Missing or damaged
Information:	It was noted on inspection that sealant or grout is degraded to the tiled shower alcove and or other areas of the bathroom.

Different materials and floor areas move at different rates, generally causing cracking to grout or sealant at this point. A flexible sealant is required to allow for expected expansion and contraction, while keeping the joint water tight and protective of all associated building materials.

There appears to be excessive mould to the sealant and grout which will likely require scraping out and replacement.

Flexible and mould resistant materials should be applied to affected areas to prevent any subsequent water damage that is likely to occur. Regular maintenance and replacement of damage or missing or damaged sealant and grout is highly recommended to the wet areas, as this is a regular wear and tear defect. Sealant and grouting in areas that come into regular contact with water should be maintained for the long term care of your property.

A sealant specialist or tiling contractor should be appointed to complete these works as soon as possible

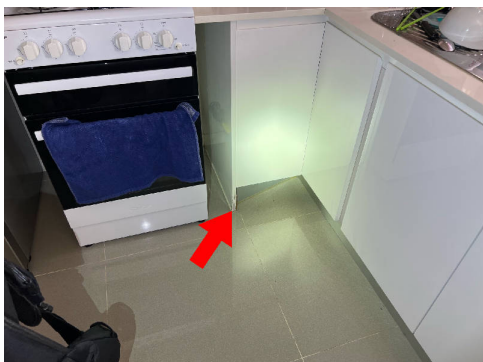
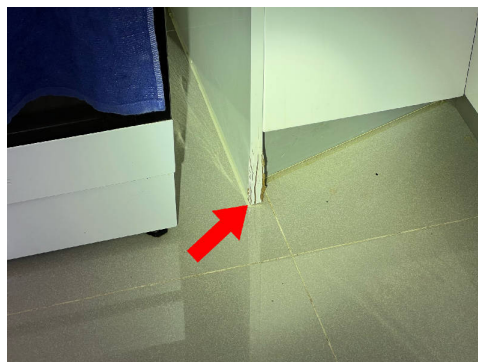
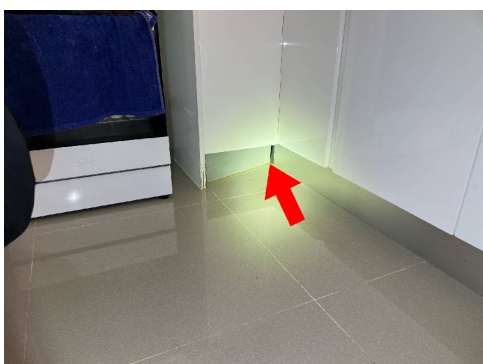
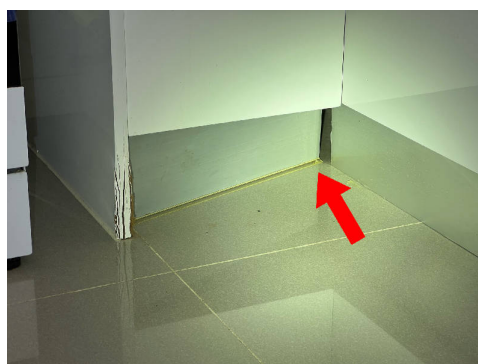
Defects 3.13

Building: Granny-Flat
Location: Kitchen
Finding: Moisture Damage and Timber Deterioration to Kitchen Kickboard

Damage and deterioration were observed to the kitchen kickboard and lower cabinetry, including swelling, staining, and timber breakdown consistent with moisture exposure. The affected area was located at floor level beneath the kitchen cabinetry.

Timber materials exposed to ongoing or repeated moisture can deteriorate over time, leading to loss of material integrity and reduced serviceability of cabinetry components. Moisture damage at kickboard level may be associated with spills, cleaning practices, or leaks from nearby plumbing fixtures or appliances. If moisture exposure continues, further deterioration and concealed damage may occur.

It is recommended that the affected kickboard and any damaged cabinetry components be repaired or replaced and that the source of moisture be identified and rectified to prevent recurrence. This should be addressed in the short term. Where plumbing is suspected, further assessment by a suitably qualified tradesperson is recommended.

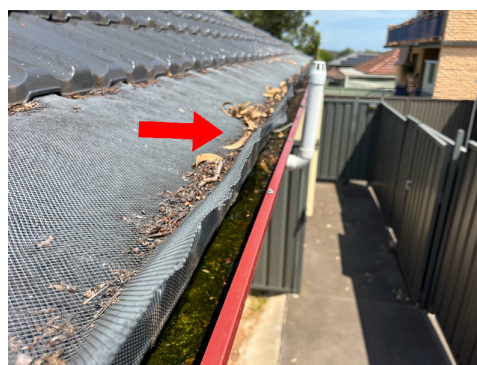
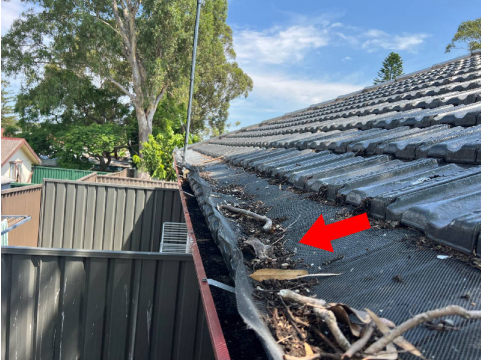
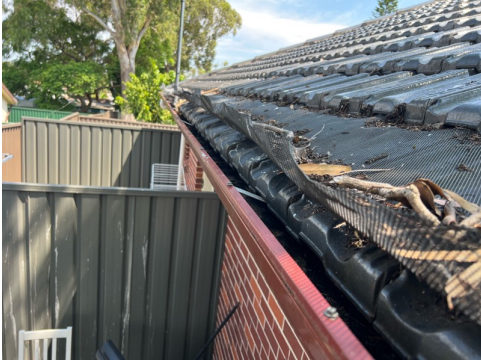
Defects 3.14

Building:	Granny-Flat
Location:	Roof Exterior
Finding:	Debris Accumulation to Gutters Despite Gutter Guard Installation
Information:	Debris, including leaves and organic material, was observed accumulating along the gutters, despite the presence of gutter guard. The accumulation was evident along sections of the roof edge, with material collecting on top of the guard and at gutter inlets.

Where debris accumulates, gutters may not function effectively, potentially leading to restricted water flow, overflow during rainfall, and increased moisture exposure to fascia boards, eaves, and external walls. Gutter guards do not eliminate the need for ongoing maintenance and can still allow debris build-up, particularly in areas with overhanging vegetation.

It is recommended that the gutters and gutter guards be cleaned and maintained regularly and that the suitability and effectiveness of the existing gutter guard system be reviewed. This should be addressed as part of routine property maintenance to reduce the risk of water-related issues.

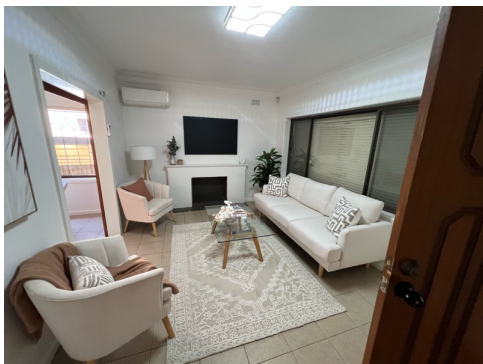
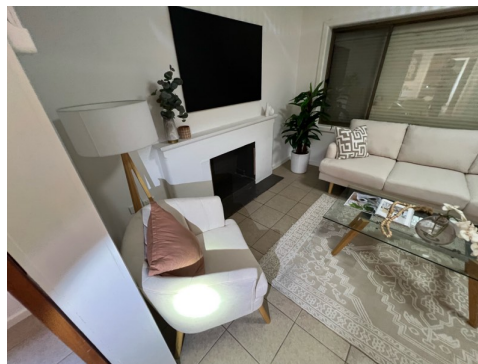
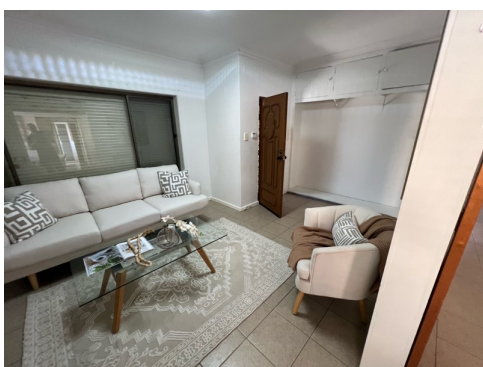
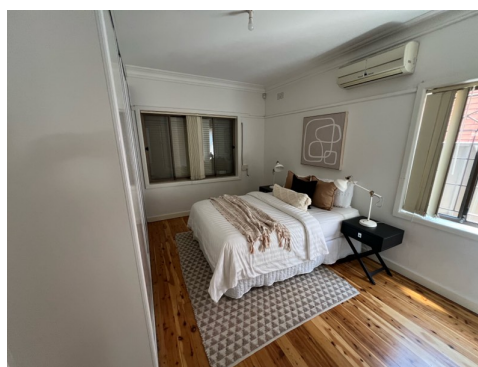
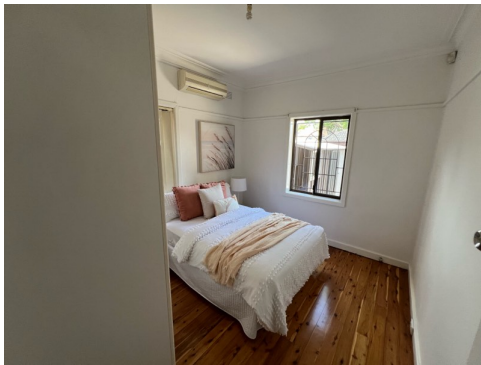
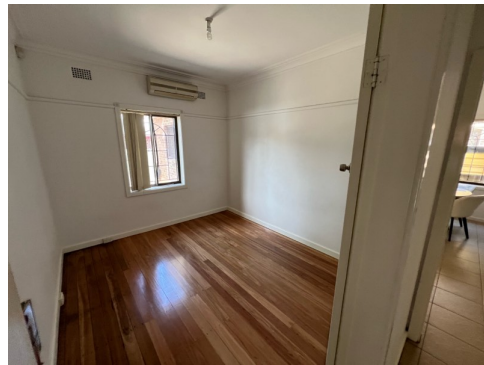
Finding: Additional Photos - Obstructions and Limitations

Information: These photographs are an indication of the obstructions and limitations which impeded full inspection of the property at the time of inspection. These obstructions can hide an array of defects and should be removed to allow full inspection to be carried out. A re-inspection is recommended once the areas are made accessible.

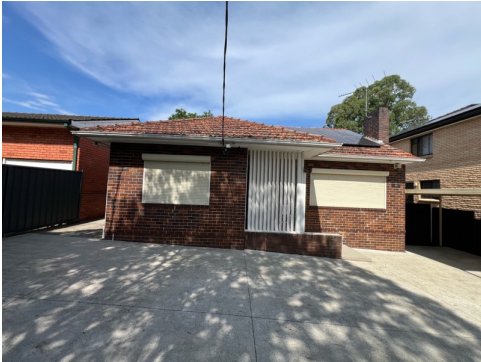
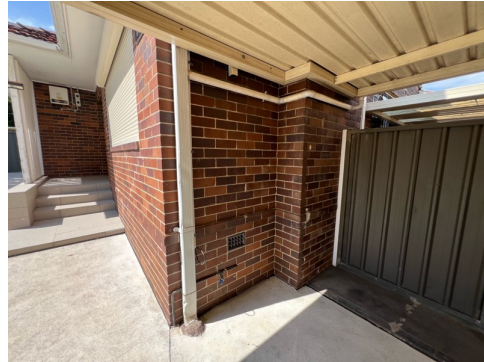
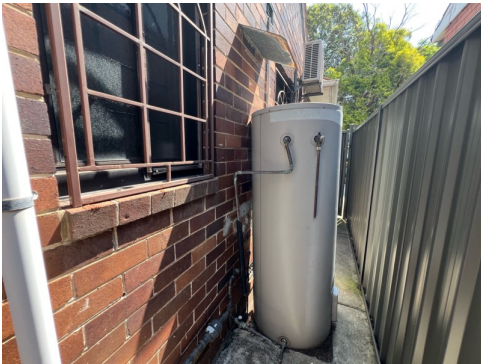
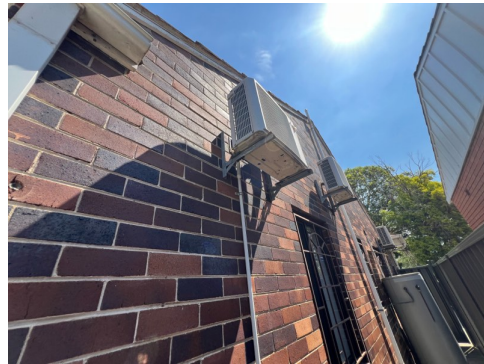
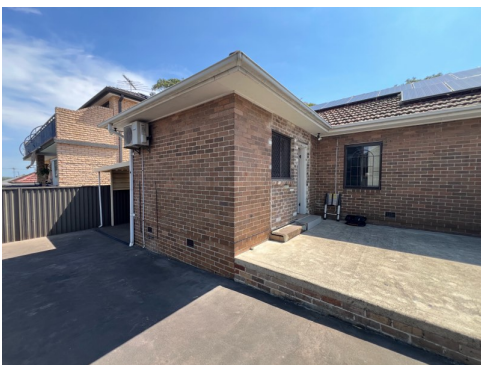
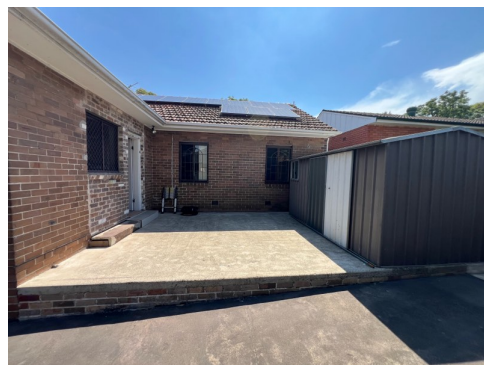
Finding: Additional Photos - Obstructions and Limitations

Information: These photographs are an indication of the obstructions and limitations which impeded full inspection of the property at the time of inspection. These obstructions can hide an array of defects and should be removed to allow full inspection to be carried out. A re-inspection is recommended once the areas are made accessible.

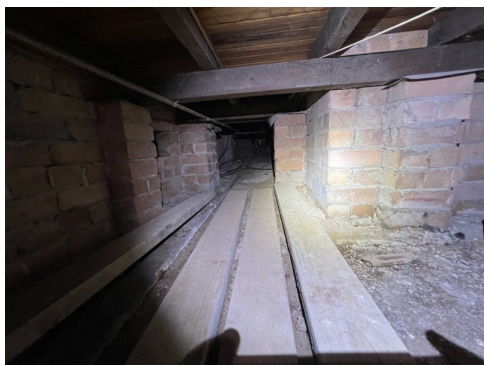
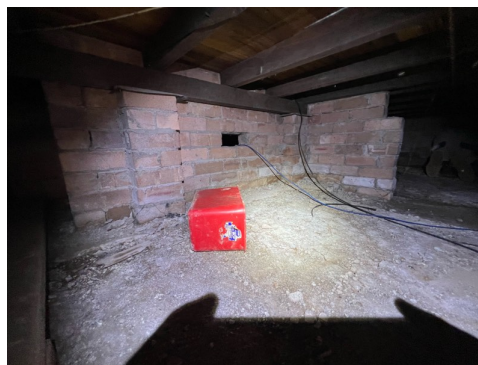
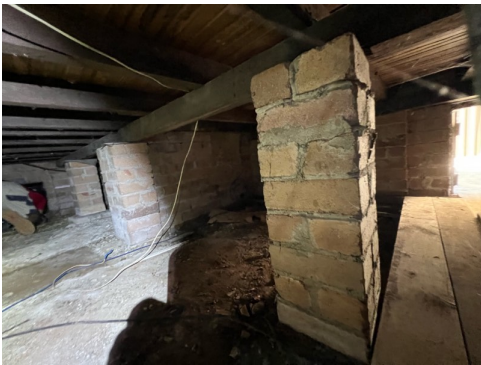
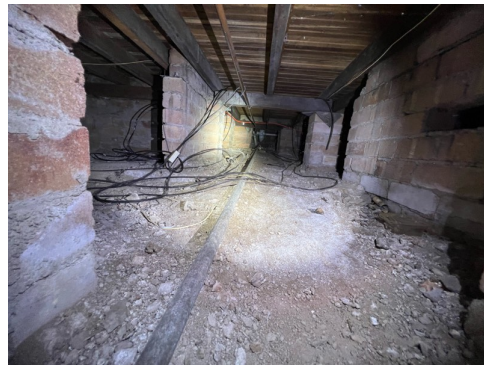
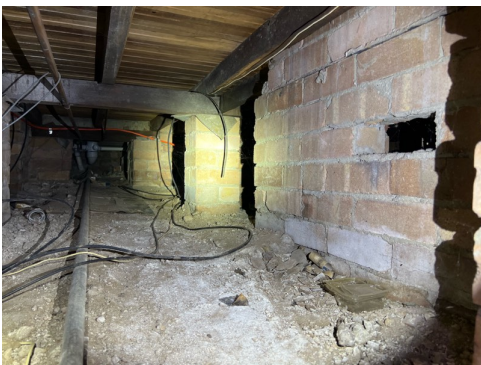
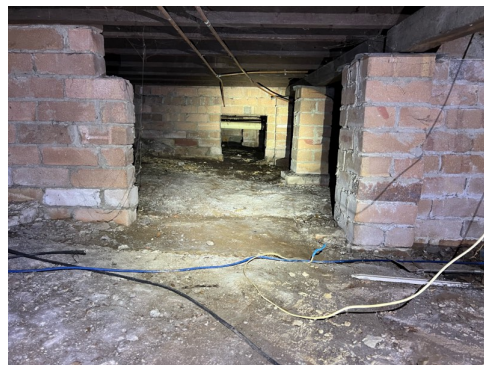
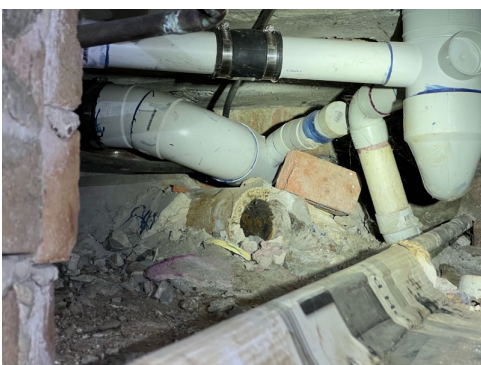
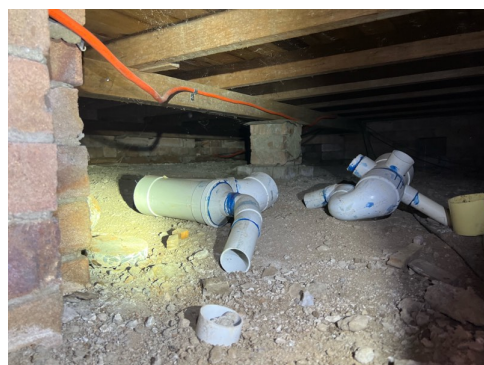
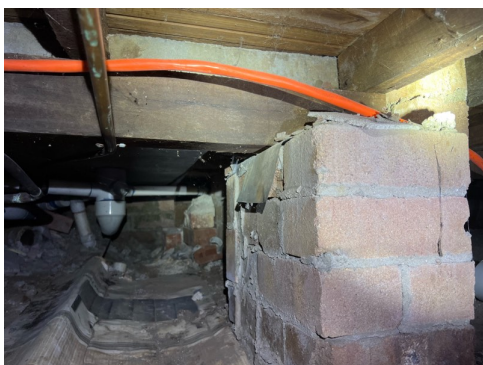
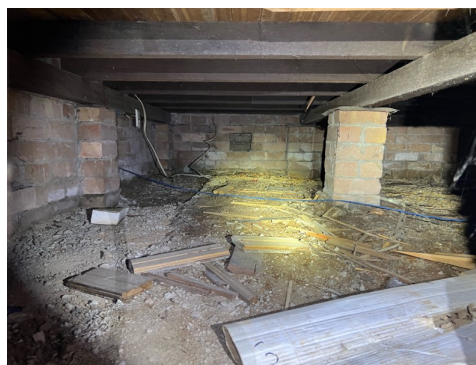
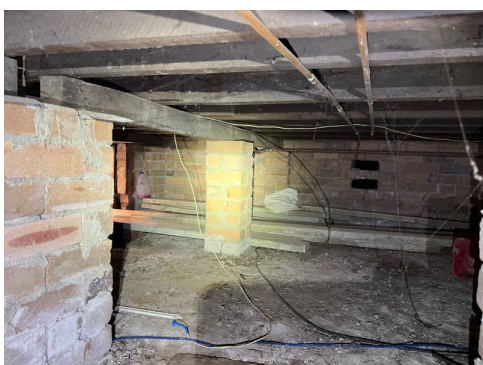
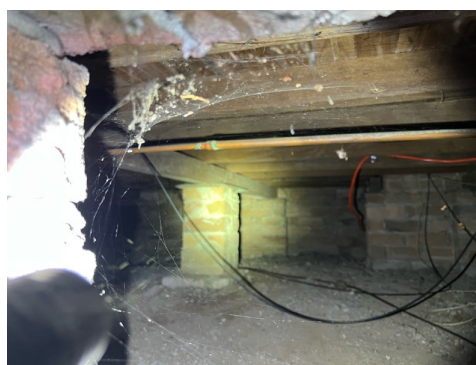
Finding: Additional Photos

Information: Additional photos are provided for your general reference

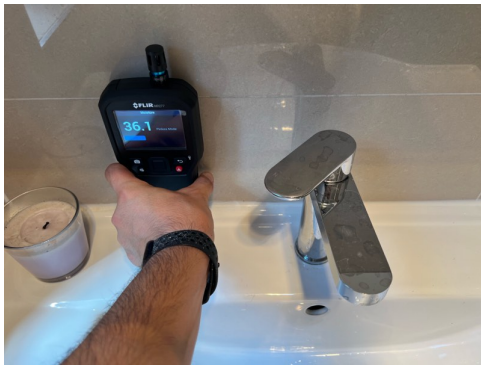
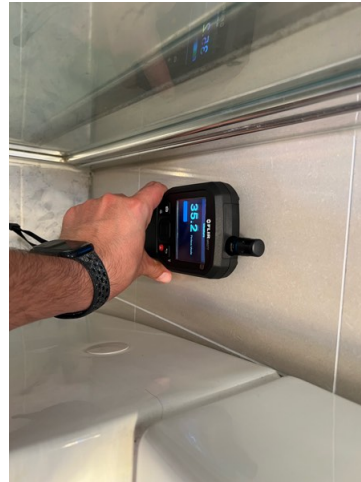
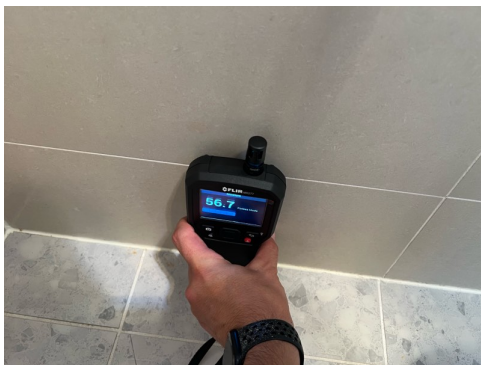
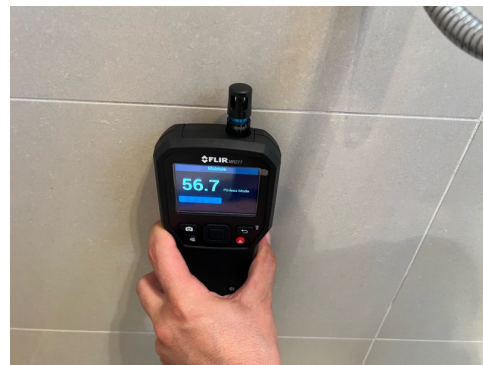
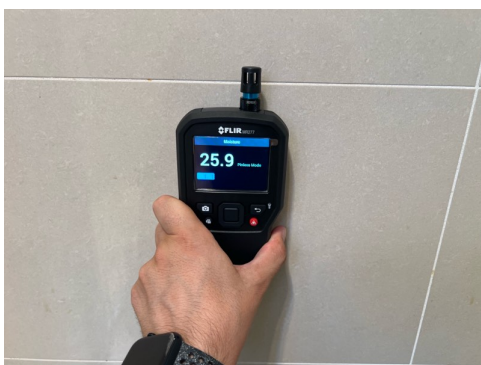
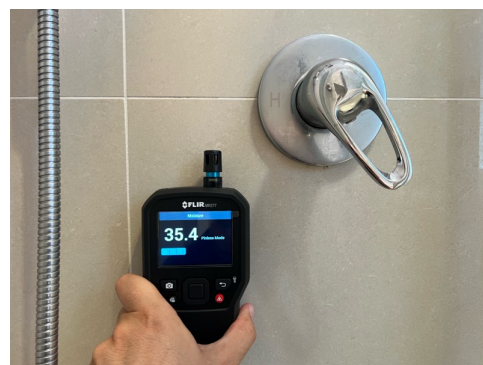
Finding: Moisture Meter Readings - For Information Only

Information: Moisture testing was undertaken to selected accessible internal surfaces using a noninvasive moisture meter at the time of inspection. Readings obtained provide an indicative assessment only and are intended as a guide to assist in identifying areas that may warrant further investigation.

No invasive testing was carried out, and moisture readings can be influenced by a range of factors including material type, surface finishes, environmental conditions, and recent use of wet areas. As such, the results are provided for information purposes only and do not constitute a definitive assessment of concealed moisture conditions. Concealed defects may exist that were not evident at the time of inspection.

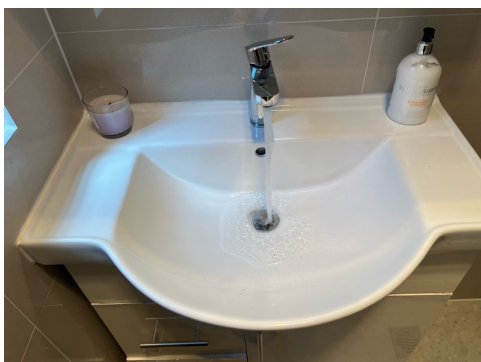
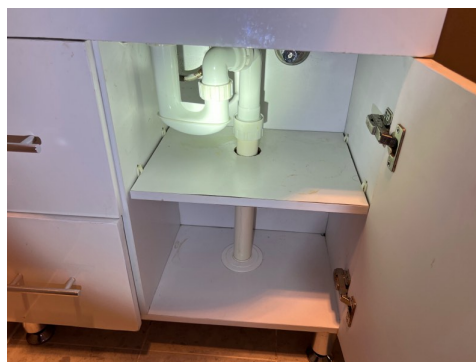
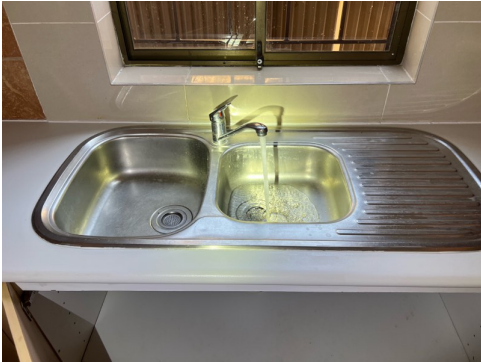
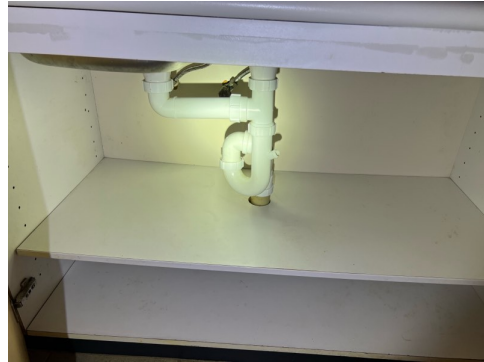
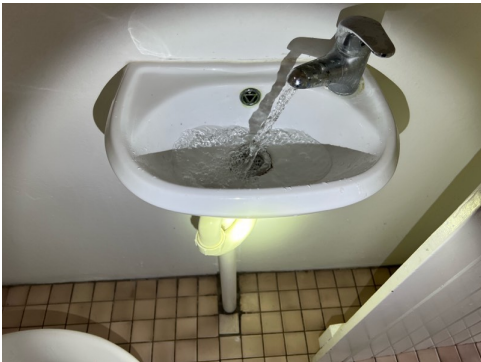
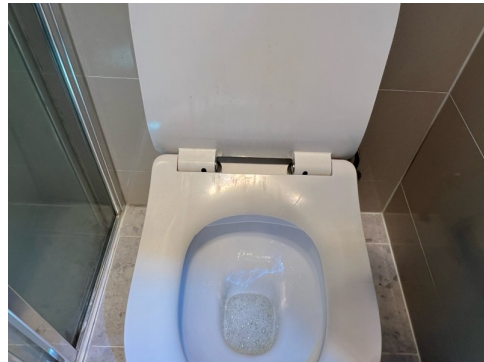
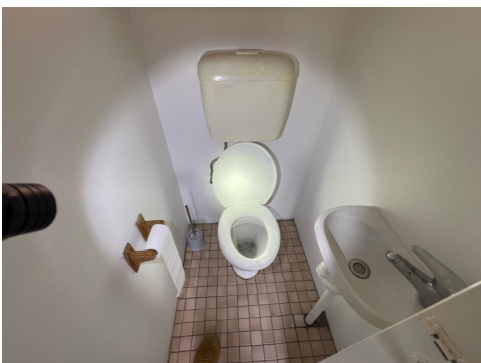
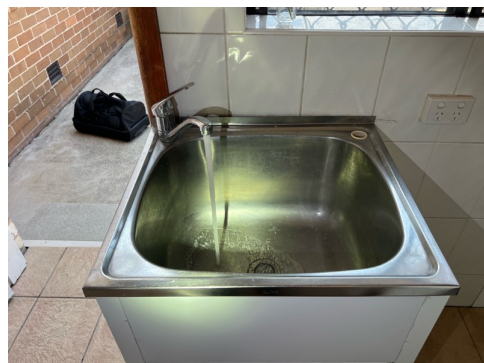
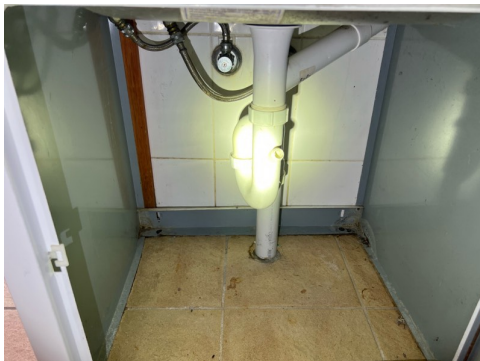
Information: All taps, mixers, and toilets were tested for correct operation, except where access was restricted. The shower recess waterproofing was assessed by conducting noninvasive moisture readings to the walls in and around the shower recess. No abnormal or significant moisture variations were detected within the areas tested. In addition, a visual inspection of the surrounding wall surfaces did not reveal any visible signs of recent or ongoing water damage where inspection was possible.

Based on the above observations, there is no conclusive evidence to suggest the presence of an active shower recess leak at the time of inspection, other than any issues already identified elsewhere in this report. It is therefore reasonable to assume that the shower waterproofing is currently performing as intended. However, it should be noted that if the shower has not been used for an extended period prior to the inspection, moisture readings may not accurately reflect underlying conditions and may result in misleading outcomes. As this inspection is limited to visual and noninvasive methods in accordance with pre-purchase inspection standards, it is not possible to definitively confirm the absence of leaks. If a higher level of certainty is required, a specialist invasive inspection is recommended

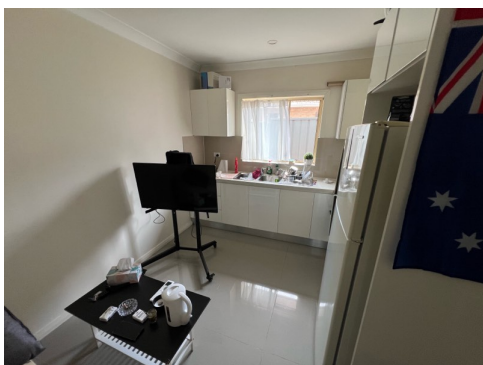
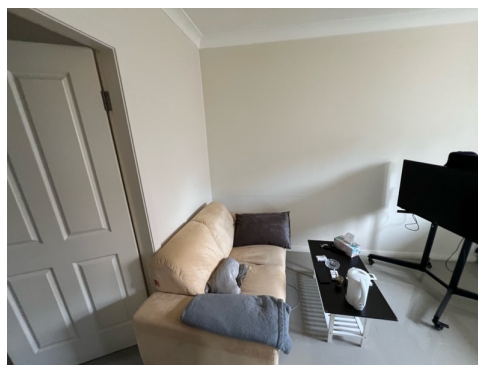
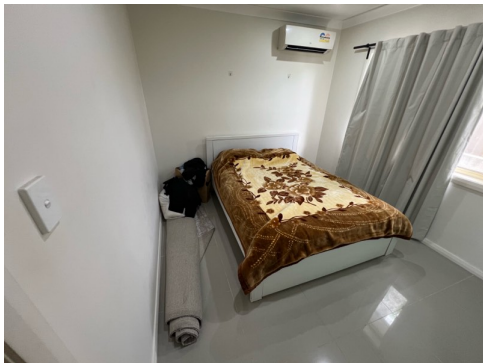
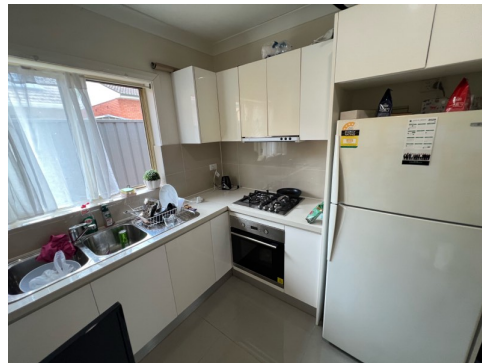
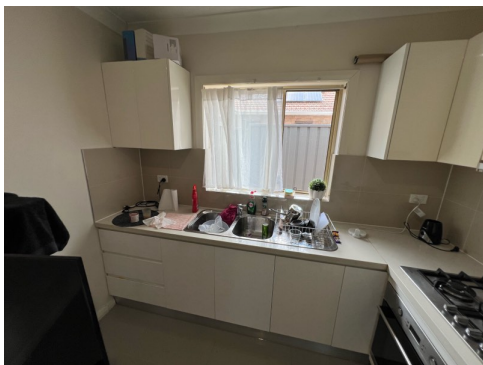
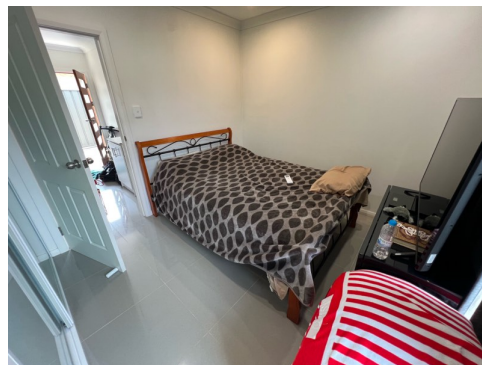
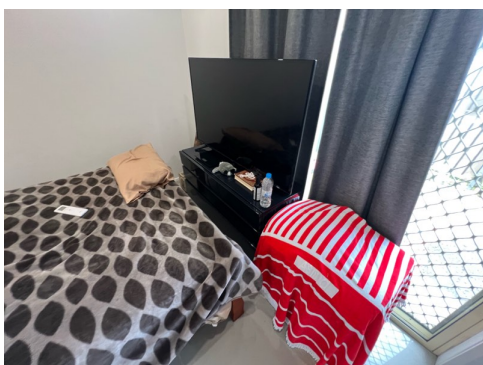
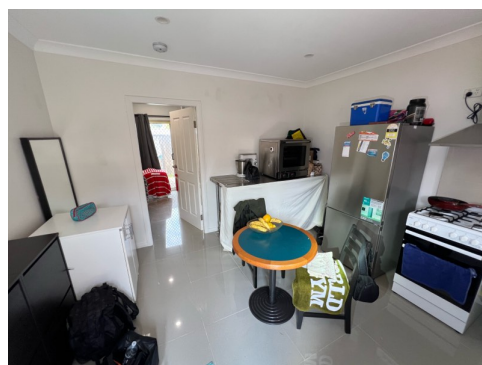
Finding: Additional Photos - Obstructions and Limitations

Information: These photographs are an indication of the obstructions and limitations which impeded full inspection of the property at the time of inspection. These obstructions can hide an array of defects and should be removed to allow full inspection to be carried out. A re-inspection is recommended once the areas are made accessible.
