Building Inspection Report

Inspection Date: Tue, 10 Feb 2026

Property Address: 105 Campbell Hill Rd,CHESTER
HILL,NSW,2162,Australia

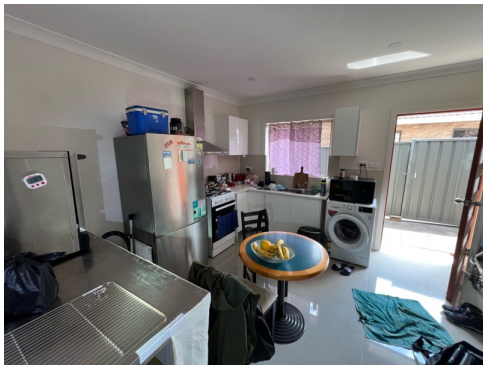
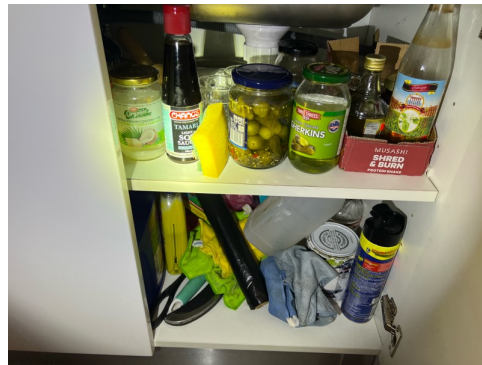
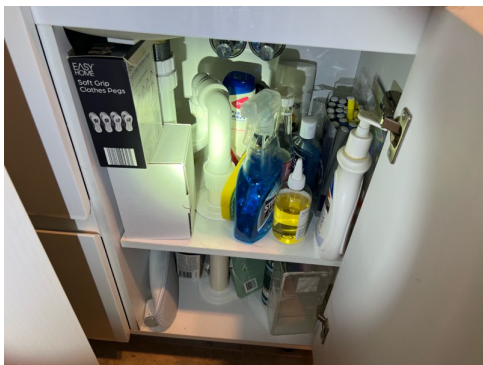
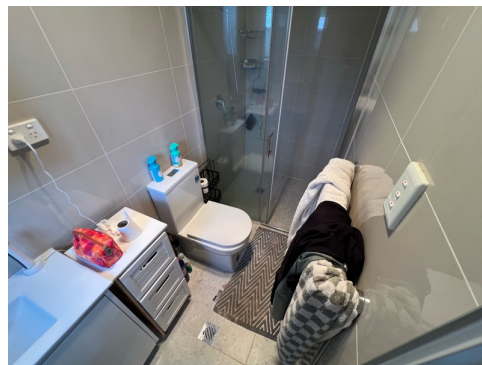
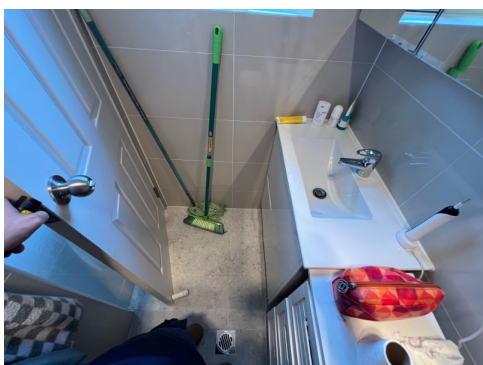
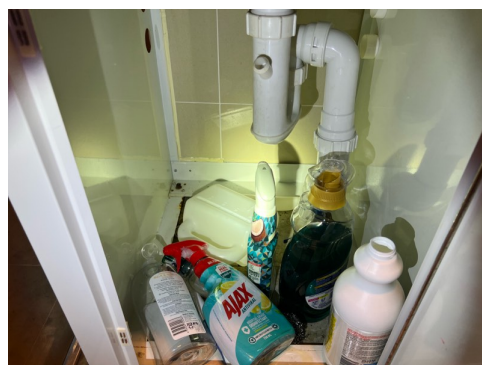
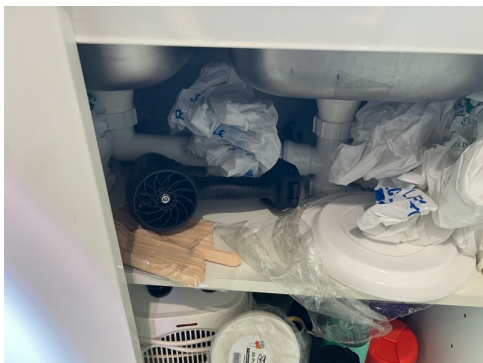
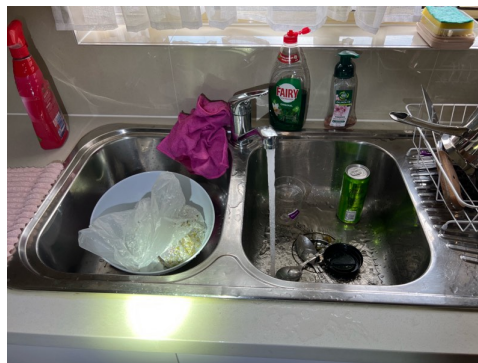
Information: These photographs are an indication of the obstructions and limitations which impeded full inspection of the property at the time of inspection. These obstructions can hide an array of defects and should be removed to allow full inspection to be carried out. A re-inspection is recommended once the areas are made accessible.

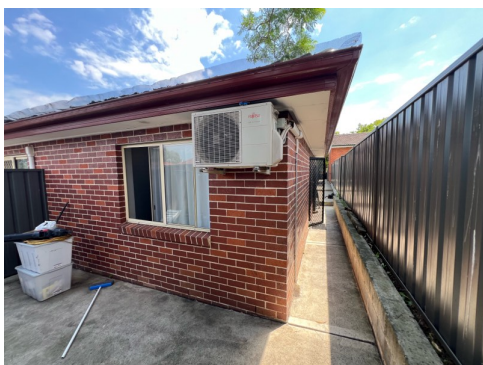
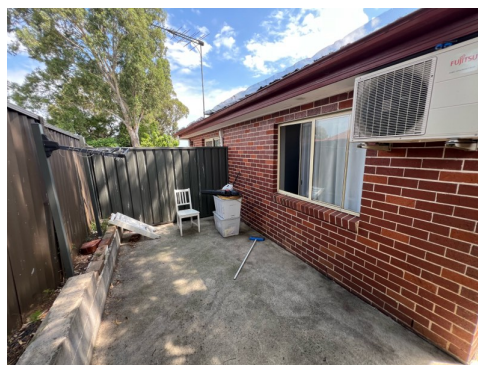
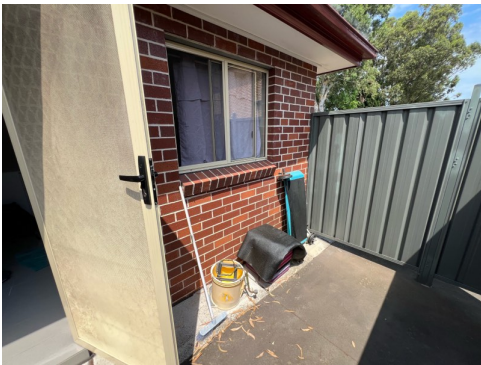
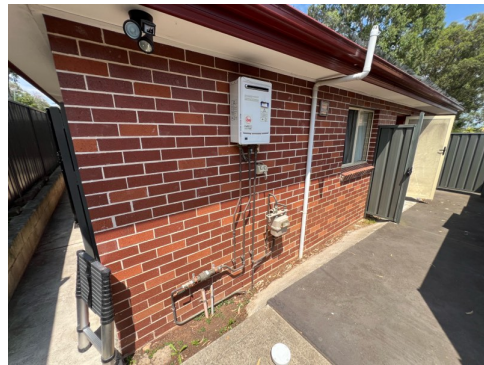
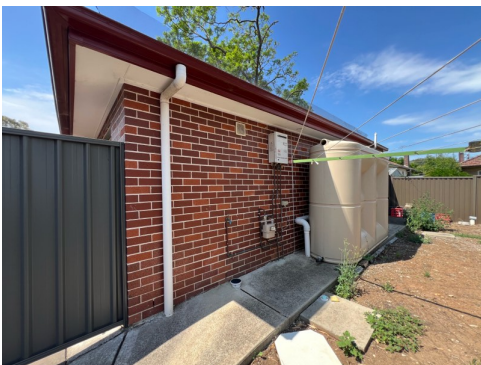
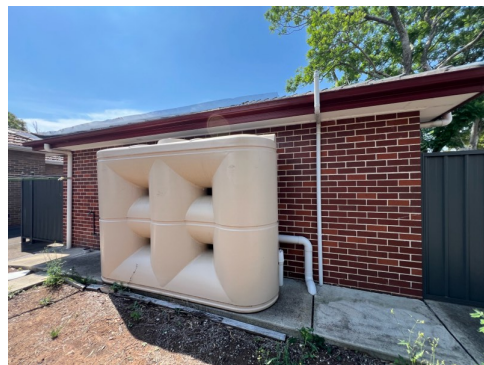
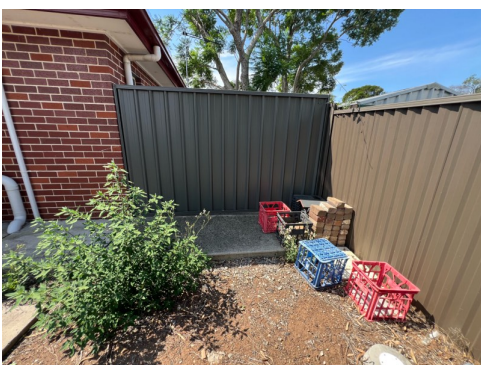
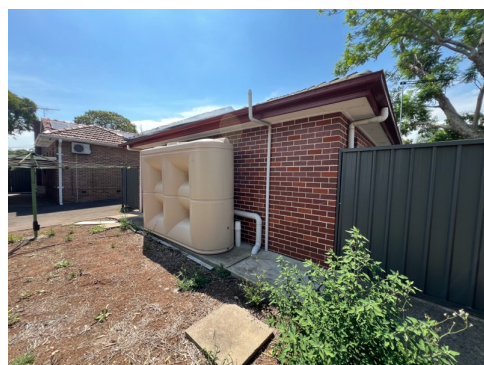
Information: These photographs are an indication of the obstructions and limitations which impeded full inspection of the property at the time of inspection. These obstructions can hide an array of defects and should be removed to allow full inspection to be carried out. A re-inspection is recommended once the areas are made accessible.

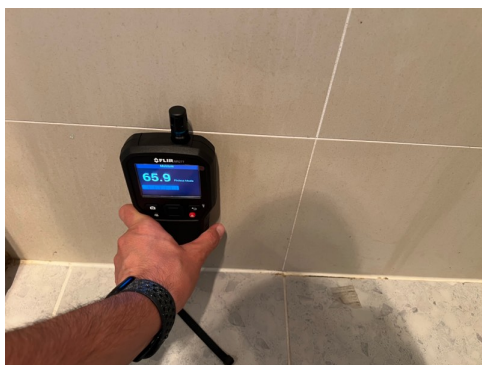
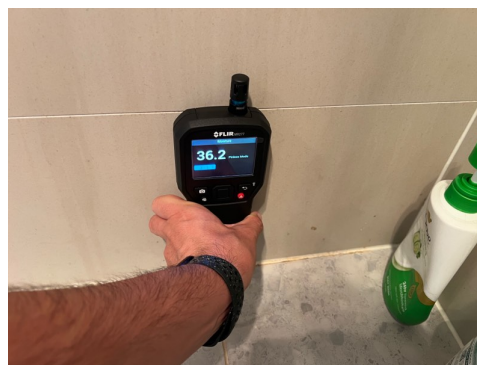
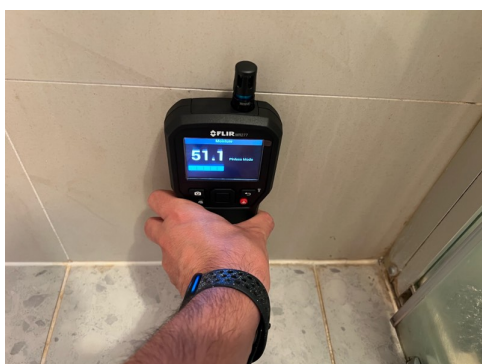
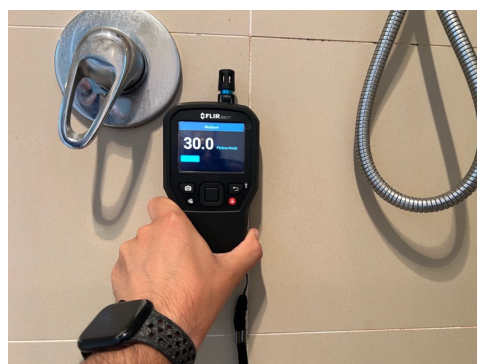
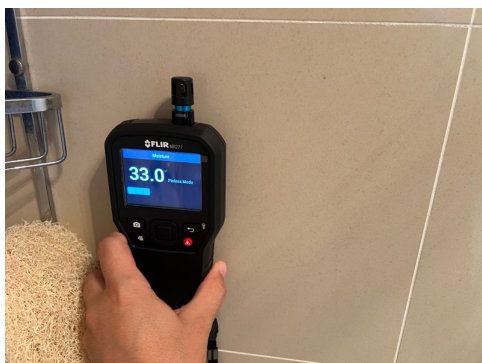
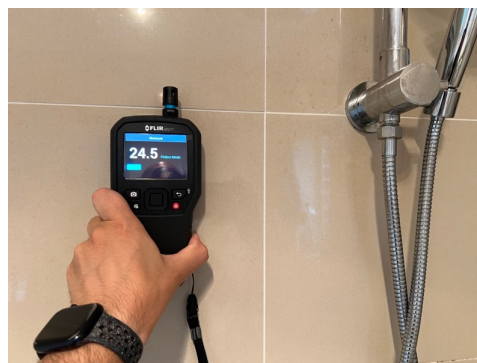
Building: Granny-Flat
Location: Bathrooms
Finding: Moisture Meter Readings - For Information Only

Information: Moisture testing was undertaken to selected accessible internal surfaces using a noninvasive moisture meter at the time of inspection. Readings obtained provide an indicative assessment only and are intended as a guide to assist in identifying areas that may warrant further investigation.

No invasive testing was carried out, and moisture readings can be influenced by a range of factors including material type, surface finishes, environmental conditions, and recent use of wet areas. As such, the results are provided for information purposes only and do not constitute a definitive assessment of concealed moisture conditions. Concealed defects may exist that were not evident at the time of inspection.

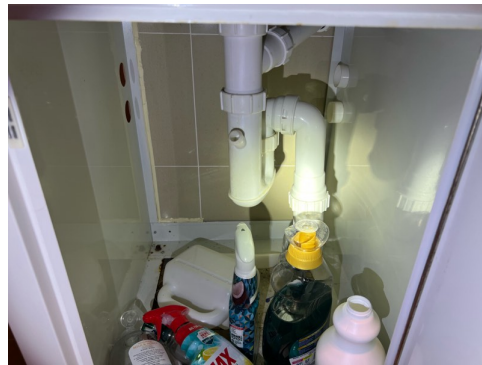
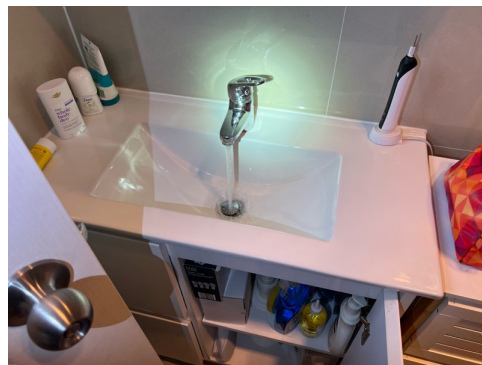
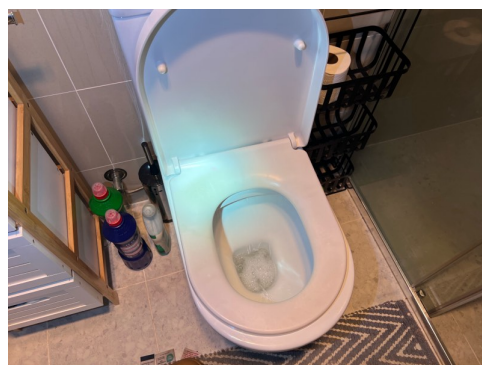
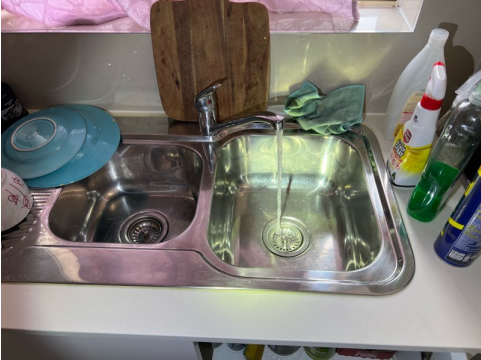
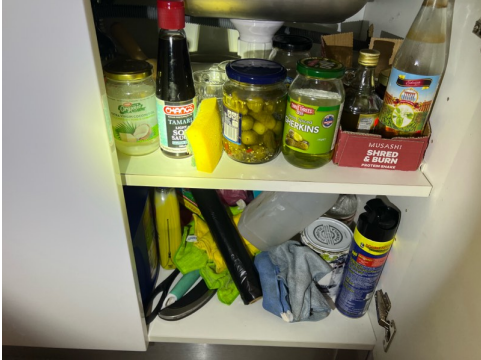
Information: All taps, mixers, and toilets were tested for correct operation, except where access was restricted. The shower recess waterproofing was assessed by conducting noninvasive moisture readings to the walls in and around the shower recess. No abnormal or significant moisture variations were detected within the areas tested. In addition, a visual inspection of the surrounding wall surfaces did not reveal any visible signs of recent or ongoing water damage where inspection was possible.

Based on the above observations, there is no conclusive evidence to suggest the presence of an active shower recess leak at the time of inspection, other than any issues already identified elsewhere in this report. It is therefore reasonable to assume that the shower waterproofing is currently performing as intended. However, it should be noted that if the shower has not been used for an extended period prior to the inspection, moisture readings may not accurately reflect underlying conditions and may result in misleading outcomes. As this inspection is limited to visual and noninvasive methods in accordance with pre-purchase inspection standards, it is not possible to definitively confirm the absence of leaks. If a higher level of certainty is required, a specialist invasive inspection is recommended.
