Building and Timber Pest Inspection Report

Inspection Date: Tue, 10 Mar 2026

Property Address: 6 Stuart Mould Cres, Lalor Park NSW 2147,
Australia

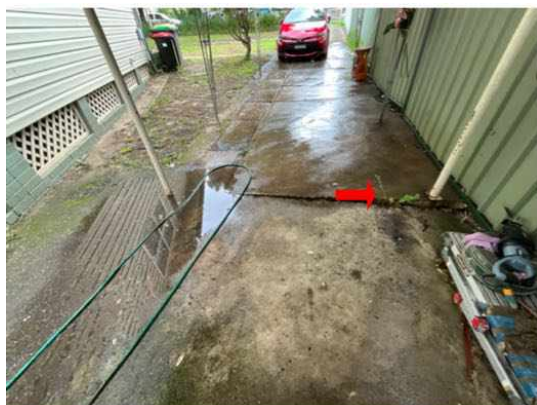
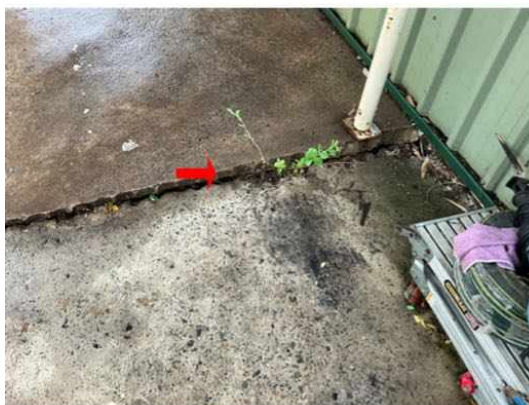
Building: Main Building
 Location: Carport
 Finding: Paving -- Uneven (Safety hazard)
 Information:

Sections of the external paved area are uneven, creating a potential trip hazard. It appears as though the area has been subject to rough installation, or that paving sections have lifted due to movements in the foundation.

Where paving creates a trip hazard, personal injury may ensue if due caution is not taken by all persons within this area.

Re-paving of the area is required urgently to remedy this situation. Further consultation with a specialist concreter is highly advised.

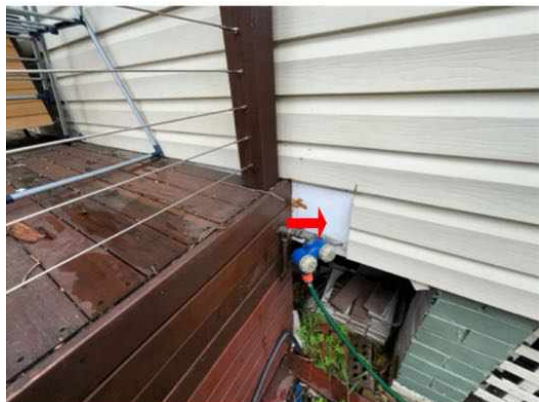
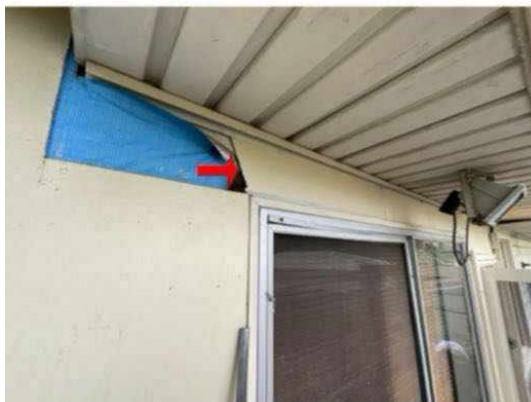
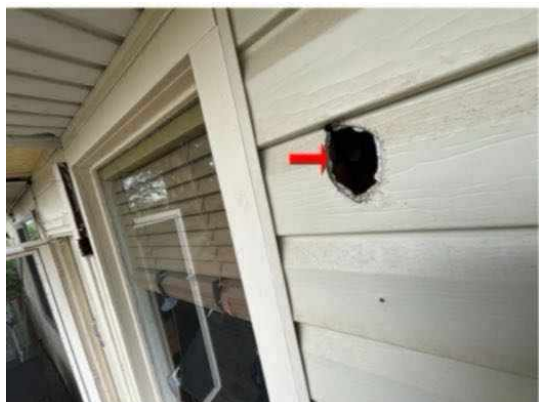
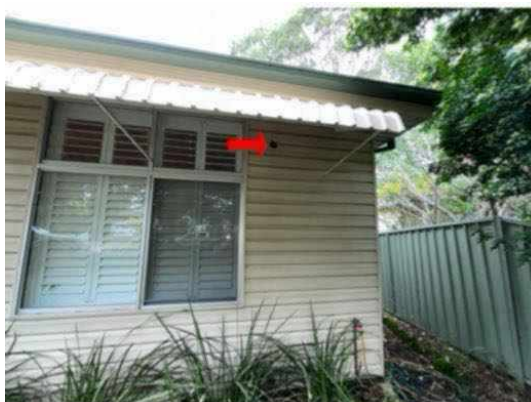
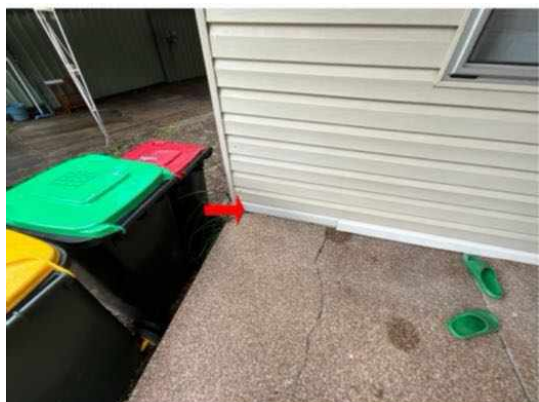
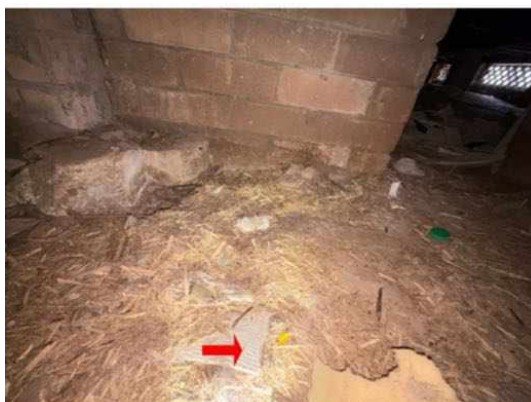
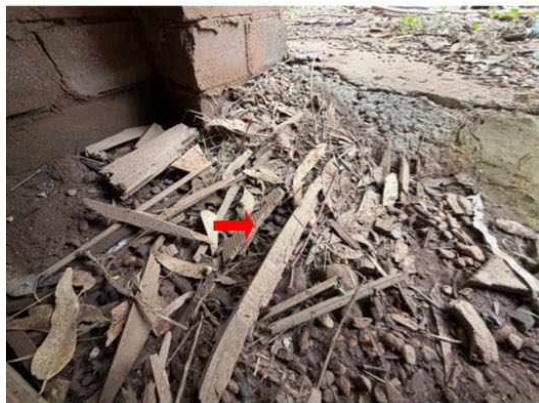
Finding 1.02

Building: Main Building
 Location: Multiple areas
 Finding: Asbestos - Suspected ACM Identified on Site
 Information:

Reporting on Asbestos is outside the Scope of this Report. This suspected defect is highlighted as a caution only. We suspect, based on our experience in the building industry, that there is a higher risk of the identified building element containing asbestos.

As Asbestos Reporting is outside the scope of this report, we advise that you consider a separate Asbestos Inspection and Condition Audit, which can include the taking of samples for definitive confirmation of the presence of Asbestos.

In the interim, the client is advised to act with caution, especially when considering any damage to building materials general wear and tear renovations extensions demolition and general maintenance activities due to the suspected presence of Asbestos.

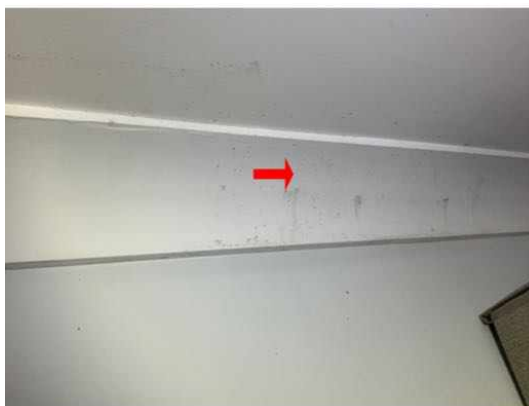
Finding 1.03

Building:	Main Building
Location:	Laundry
Finding:	Mould present - Ventilation
Information:	Evidence of mould growth was noted, which is believed to have grown due to lack of ventilation to the area.

Generally, the client is advised to ensure that the general environment is free of moisture and humidity to aid in the prevention of mould formation and development. Any mould found during the inspection should be cleaned immediately by a cleaning contractor or the homeowner as applicable.

Although the exhaust fan was found to be working at the time of inspection, however a licensed electrician May be appointed to ensure the full exhaust fan operation.

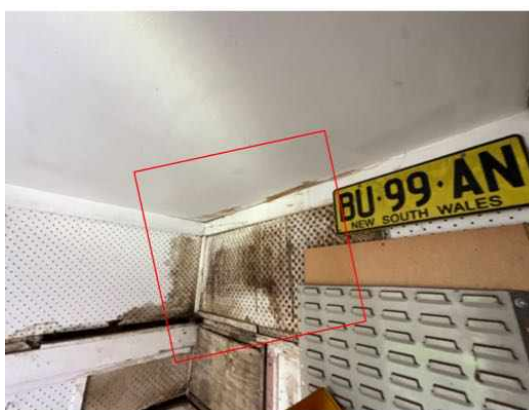
Finding 2.01

Common causes include faulty or missing flashing, cracked tiles, degraded pointing, lack of sealant and blocked weep holes. Rain penetration can also occur when water tracks horizontally under the lip of eaves and roof linings with insufficient angles, or by tracking across wall ties.

The cause of the water leak should be addressed immediately to prevent further damage. It is recommended that the water leak be resolved prior to any repairs of the damaged area, which may require localised replacement of building materials and refinishing.

Trades responsible for such works may include licensed builder, licensed plumber, roof restoration specialist and landscaper.

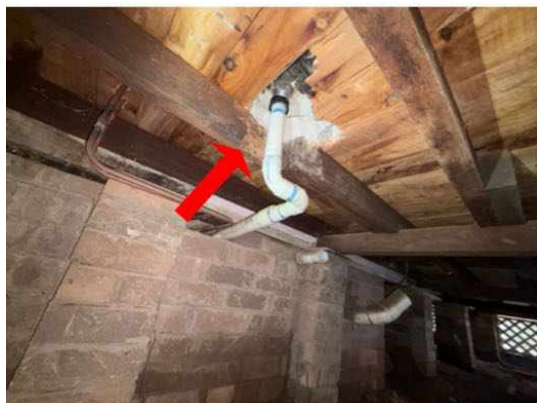
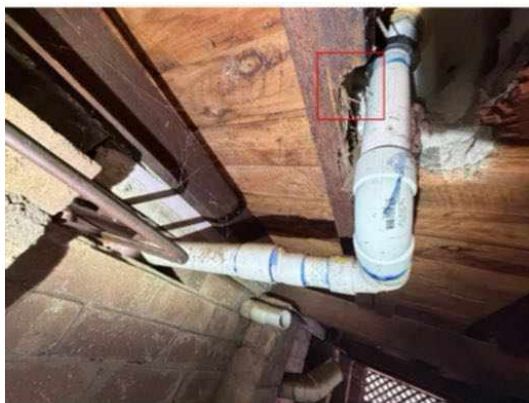
Finding 2.02

Building: Main Building
 Location: Subfloor
 Finding: Building element - Damaged
 Information: Breakage occurs generally when the building materials have either aged and decayed,

or as a result of damage (accidental or deliberate).

Repair and/or replacement of broken elements is advised to ensure that additional secondary defects do not arise as a consequence. Such works are necessary, as all building elements play a key role in the operation and function of the overall structure and its performance.

A relevant tradesperson should be appointed to repair or replace the affected building element prior to any subsequent damage being caused.

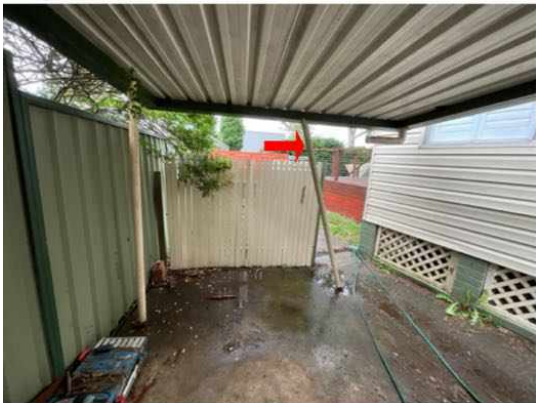
Finding 2.03

Building:	Main Building
Location:	Carport
Finding:	Building element - Damaged
Information:	Breakage occurs generally when the building materials have either aged and decayed, or as a result of damage (accidental or deliberate).

Repair and/or replacement of broken elements is advised to ensure that additional secondary defects do not arise as a consequence. Such works are necessary, as all building elements play a key role in the operation and function of the overall structure and its performance.

A licensed builder should be appointed to repair or replace the affected building element prior to any subsequent damage being caused.

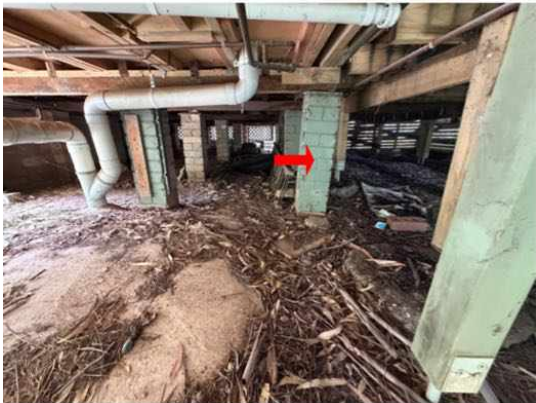
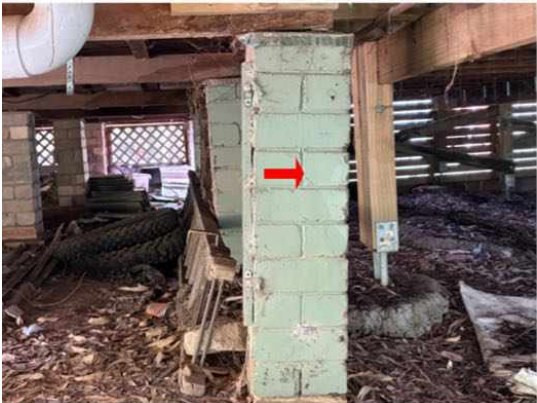
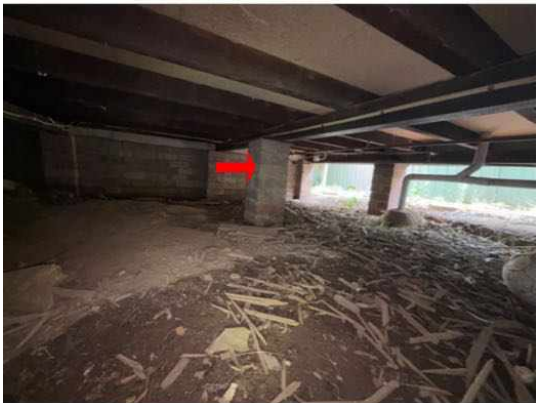
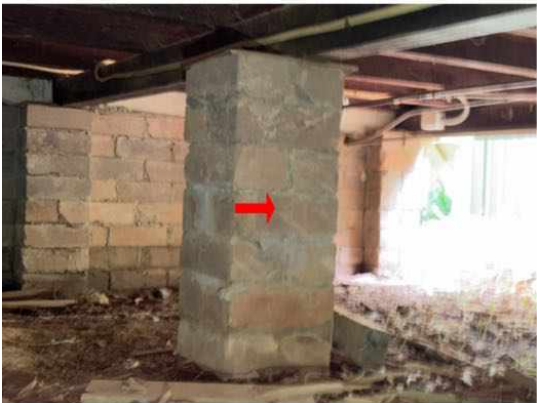
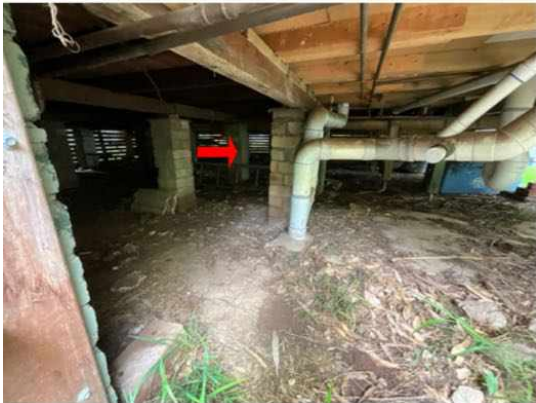
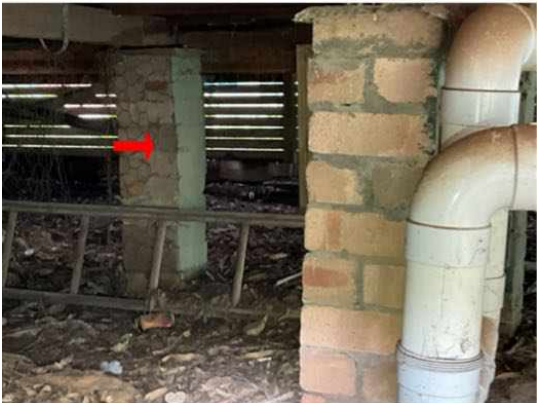
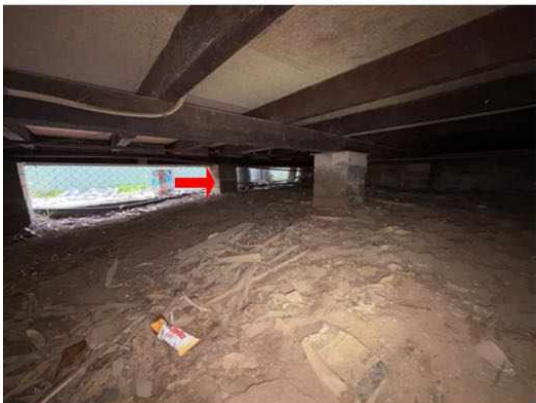
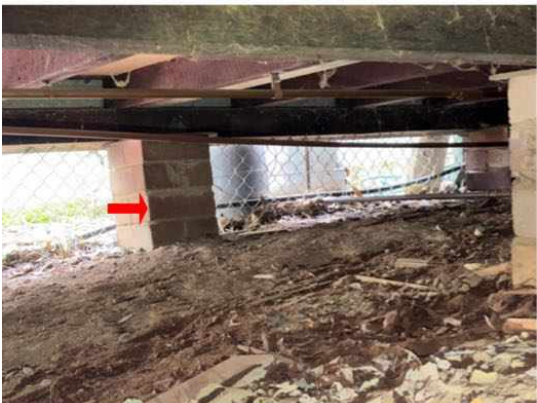
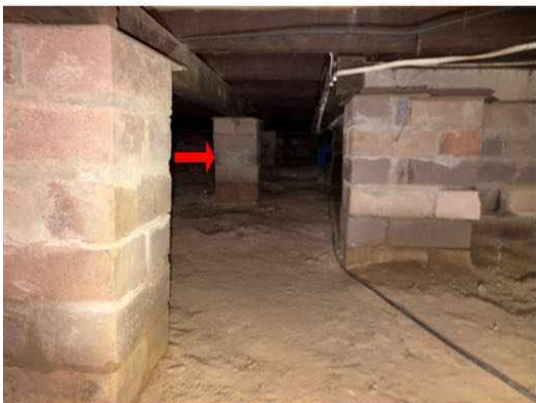
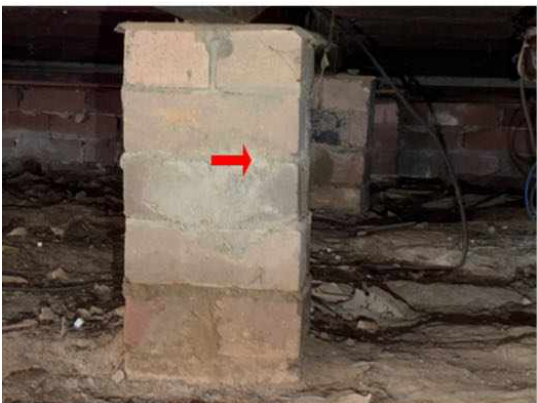
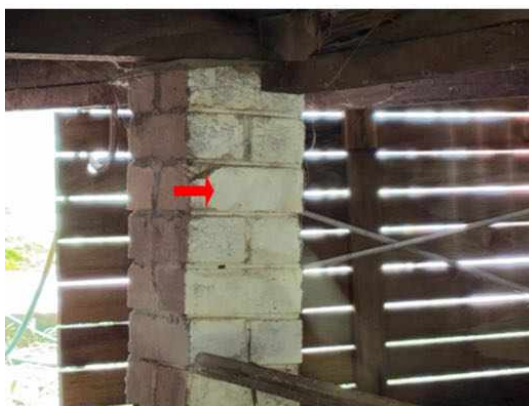
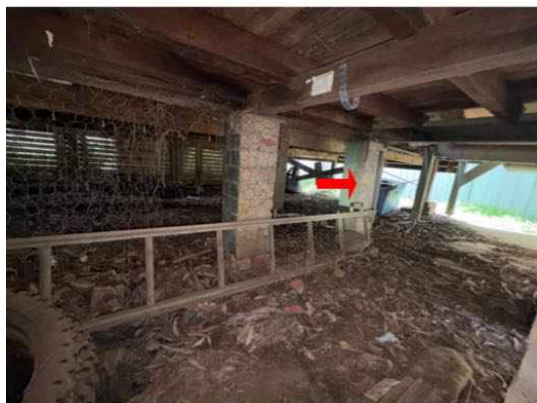
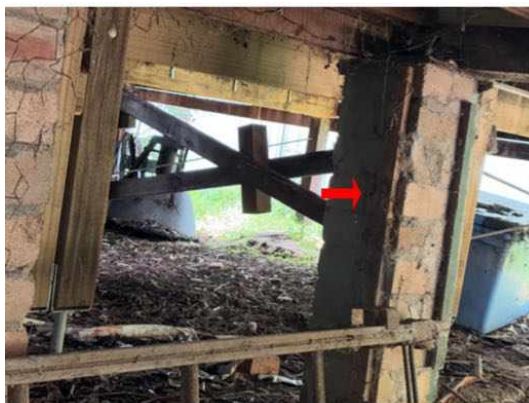
Finding 2.04

Building: Main Building
Location: Subfloor
Finding: Piers -- Leaning (major)
Information: Some piers to the subfloor are not supporting the suspended structure adequately, indicating that their structural integrity have been affected. The cause of this instability is likely to be caused by movement / subsidence of the pier due to moisture.

Inadequate support is likely to lead to a range of other secondary major and minor defects and hence immediate rectification to this pier is required by a registered builder. Monitoring and when required improving site drainage is recommended to avoid further movement / subsidence of the affected piers.

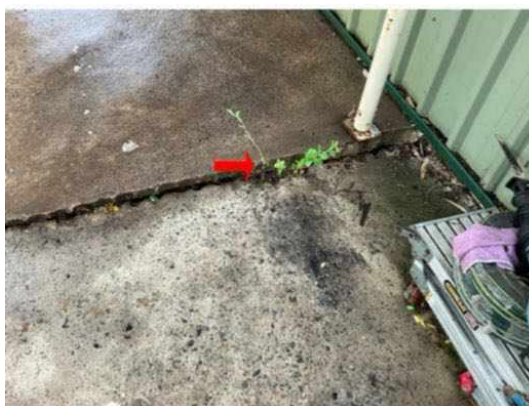
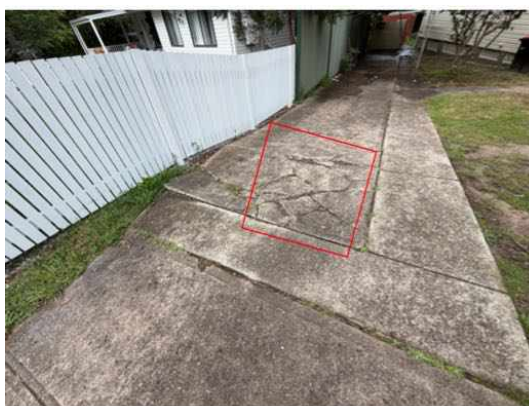
Finding 2.05

Building:	Main Building
Location:	Carport & driveway
Finding:	Subsidence - Local trees and vegetation
Information:	Trees and other vegetation can have a significant local effect on drying of soils. Over a number of years, especially during drought conditions, adjacent trees and vegetation may draw excessive moisture from the soils. The opposite may also occur, where swelling of the soil results when the trees decline or are removed.

As the cumulative moisture deficient is reversed, the surface level around the tree (and adjoining subfloor) will rise and expand laterally. This is often damaging to structures unless the foundations have been strengthened or designed to cope with the effect.

Subsidence can have complex and varying causes, which will influence the required remedial works. It is advised to begin by consulting a structural engineer to determine the required scope of works. This generally includes some form of underpinning, as well as addressing the underlying cause. Consultation with a geotechnical engineer may also be necessary.

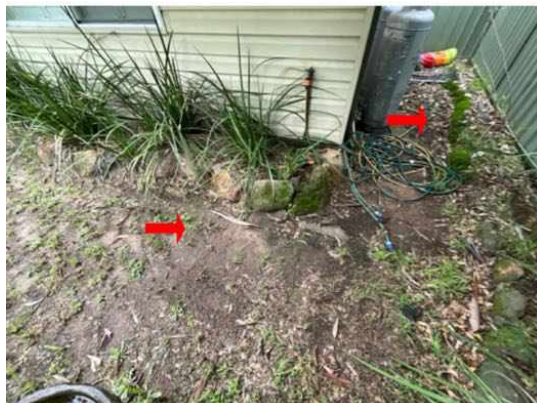
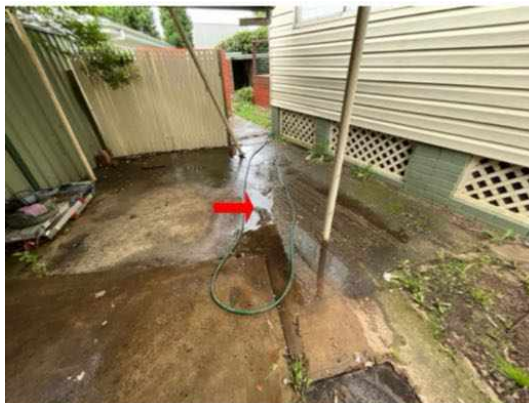
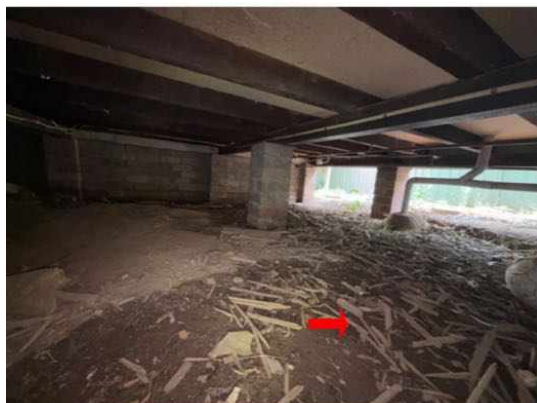
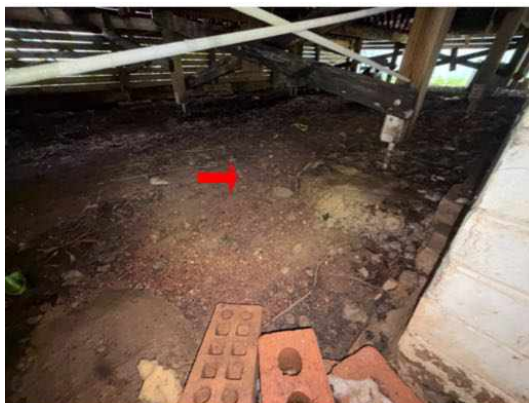
Finding 3.01

Building:	Main Building
Location:	Yard
Finding:	Site drainage— Inadequate
Information:	The site drainage in this area was found to be inadequate at the time of inspection, creating potential for subsequent water damage to associated building elements. This is additionally conducive to termite activity.

It is important that water does not lie against the base of walls; surrounding paths and ground levels should be sloped to drain water away from walls. Downpipes should not discharge stormwater onto lower walls or plinths. Stormwater should be carried away by large, regularly cleaned drains. Ground levels may need to be lowered to expose a buried DPC.

Where site drainage is inadequate, installation of an Agricultural (Aggie) Drain may be required. A licensed plumber should be appointed to further inspect the property and perform any remedial works as necessary. Water damage and secondary defects are likely to occur if left unmanaged.

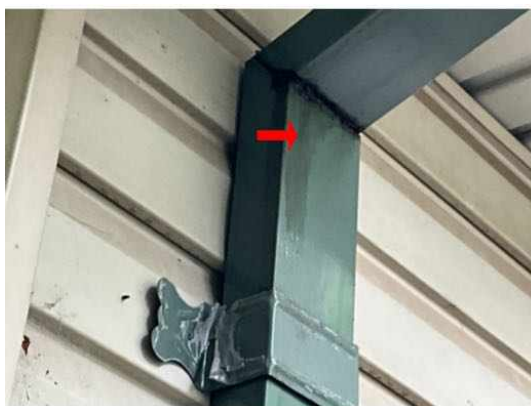
Finding 3.02

Building:	Main Building
Location:	Multiple areas of roof plumbing
Finding:	Water leak - External
Information:	Water leaks were found to be present to exterior plumbing work. Leaks are generally caused by deterioration of the plumbing elements over time, due to exposure to weather conditions, but may have also been caused by minor impact damage.

Such leaking creates damp conditions in the affected area, causing potential for water pooling and subsequent water damage if left unattended. These conditions may also attract termite attack, particularly if the area is subject to minimal levels of sun throughout daylight hours.

It is highly advised that a licensed plumber be appointed to rectify any water leaks that may be present. Areas of repair and replacement of plumbing fittings and fixtures may be required and, as such, a quotation should be sought.

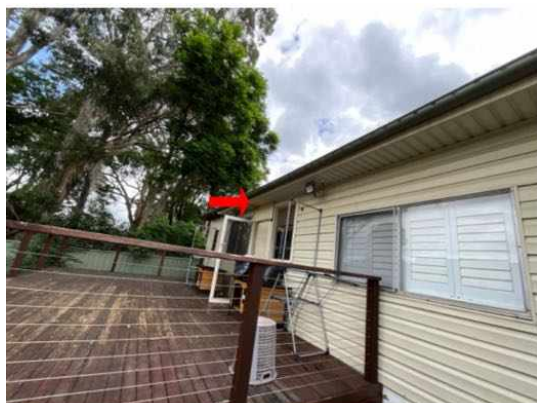
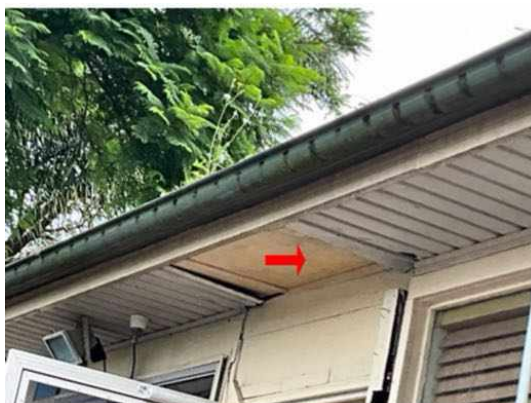
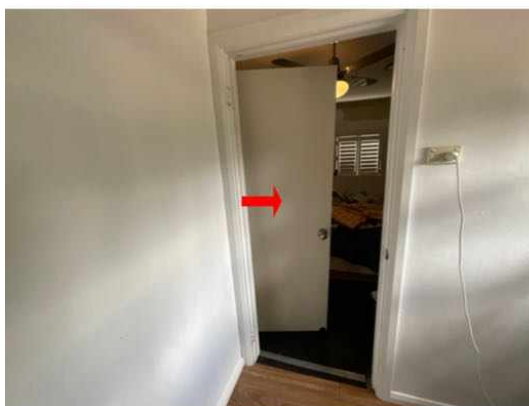
Finding 3.03

Building:	Main Building
Location:	Multiple areas
Finding:	Building element - Damaged
Information:	Breakage occurs generally when the building materials have either aged and decayed, or as a result of damage (accidental or deliberate).

Repair and/or replacement of broken elements is advised to ensure that additional secondary defects do not arise as a consequence. Such works are necessary, as all building elements play a key role in the operation and function of the overall structure and its performance.

A relevant tradesperson should be appointed to repair or replace the affected building element prior to any subsequent damage being caused.

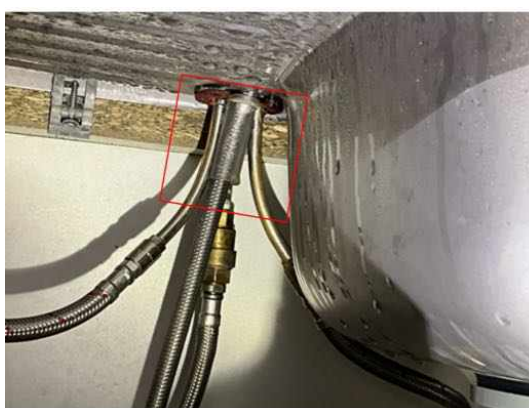
Finding 3.04

Finding: Water leak - Active

Information: Generally, water leaks occur when a particular area of the property is not weather or water tight. As the surrounding area was found to be damp at the time of inspection, the leak is considered ongoing and hence requires urgent action.

Regardless of the location, even minor leaks that are left unmanaged can lead to serious damage of associated building elements and result in the need for replacement of building materials. Mould and other hazards such as electrical hazards may also arise if the leak is left to develop.

It is highly advised that the cause of the leak be identified and resolved immediately by a licensed plumber to prevent any further damage. Depending on the extent of the damage previously sustained, repair and/or replacement of any affected building materials may be required.

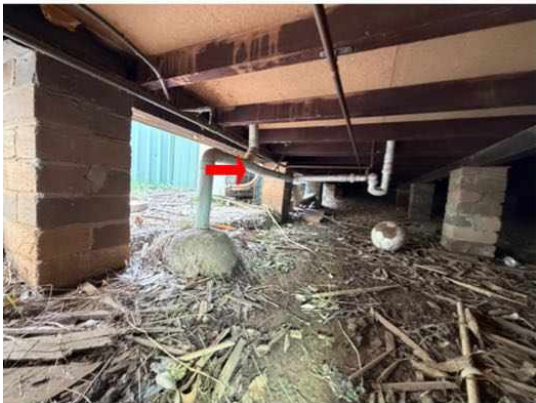
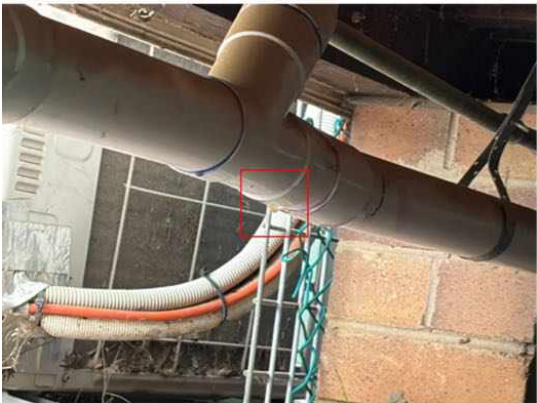
Finding 3.07

Building: Main Building
Location: Multiple areas
Finding: External surfaces — Holes
Information: Significant hole and penetration was identified to this area.

Whether intentional or not, gaps and holes to external surfaces are susceptible to insect and vermin ingress, as well as allowing water penetration to the cavity wall. As such, associated building elements are likely to deteriorate at an accelerated rate, and major implications are expected if holes around the pipework are left unmanaged.

All excessive holes, gaps or cracks should be adequately filled by a suitable sealant or trimmings as soon as possible to prevent any further damage. Such works may be conducted by a general handyperson or licensed carpenter.

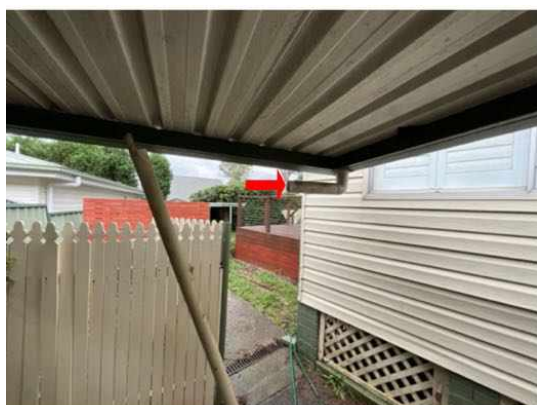
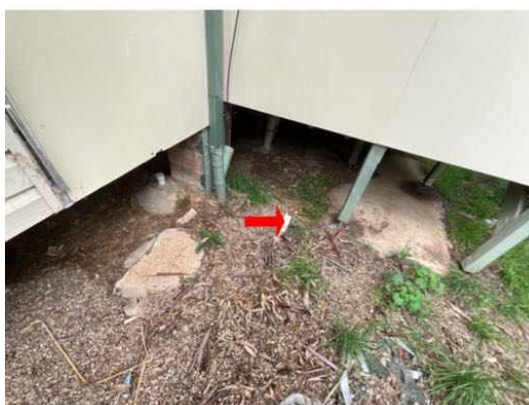
Finding 3.10

Building:	Main Building
Location:	Subfloor
Finding:	Plumbing - Point of connection non-compliant
Information:	At the time of inspection it was noted that connections between above ground pipe work and below ground sewer/storm water systems were incomplete.

Additionally, where sewer pipes are concerned, gases can escape from unsealed connections which can pose a serious health risk.

Engagement of a certified plumber is strongly recommended to ensure all connection points are sealed in accordance with the plumbing construction guidelines.

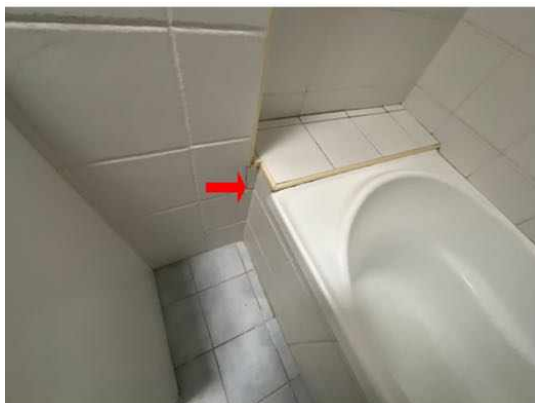
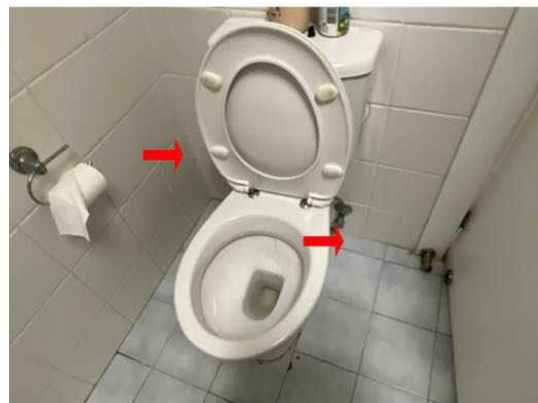
Finding 3.14

Finding: Sealant and grouting - Missing or damaged

It was noted on inspection that sealant or grout is degraded to this area.

Different materials and floor areas move at different rates, generally causing cracking to grout or sealant at this point. A flexible sealant is required to allow for expected expansion and contraction, while keeping the joint water tight and protective of all associated building materials.

Flexible and mould resistant materials should be applied to affected areas to prevent any subsequent water damage that is likely to occur. Regular maintenance and replacement of damage or missing or damaged sealant and grout is highly recommended to the wet areas, as this is a regular wear and tear defect. Sealant and grouting in areas that come into regular contact with water should be maintained for the long term care of your property.

A sealant specialist should be appointed to complete these works as soon as possible.

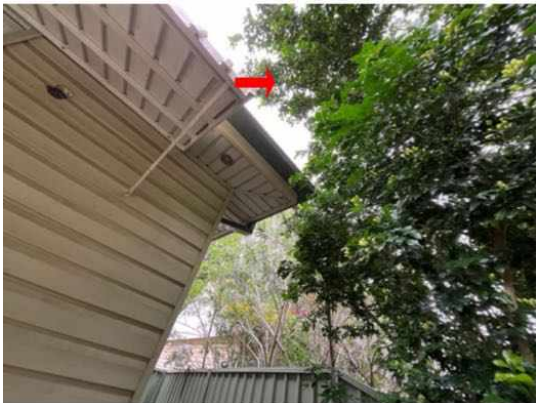
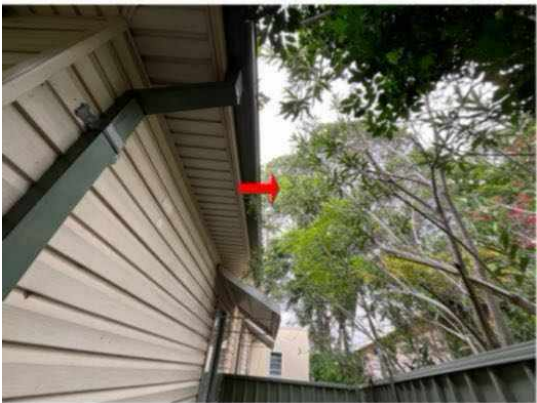
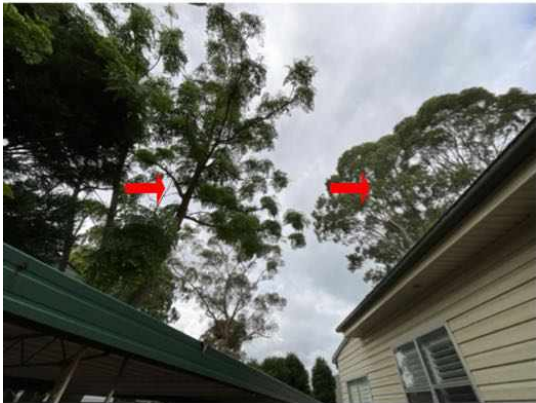
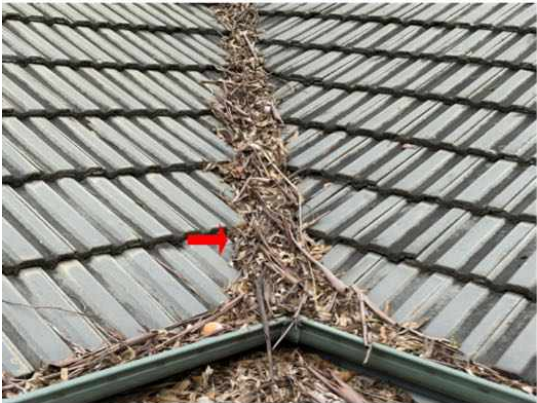
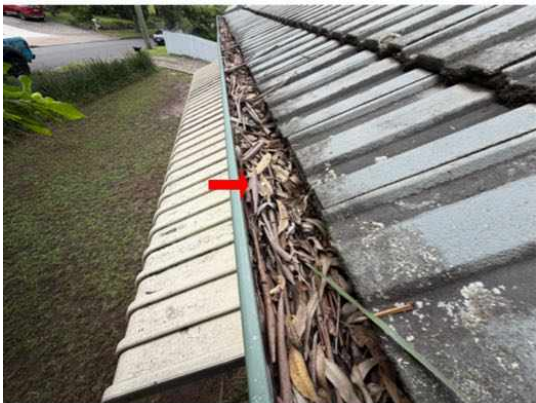
Finding 3.18

Building: Main Building
Location: Shed, deck
Finding: Roof plumbing - Missing
Information: Some sections of the roof are not adequately drained via gutters and downpipes. Gutters and downpipes that are not installed adequately are likely to result in excessively damp conditions against the exterior surfaces and around the base perimeter of the building.

Excessive moisture creates an environment which accelerates the deterioration of building elements in the area, as well as being conducive to termite and pest infestation. Such an environment is likely to necessitate repair and/or replacement of

building elements, which are prone to sustaining wood rot, rust or corrosion.

A roofing plumber should be appointed as soon as possible to install relevant roof plumbing materials. Depending on the extent of the damage, repair and/or replacement of damaged building elements may be required.

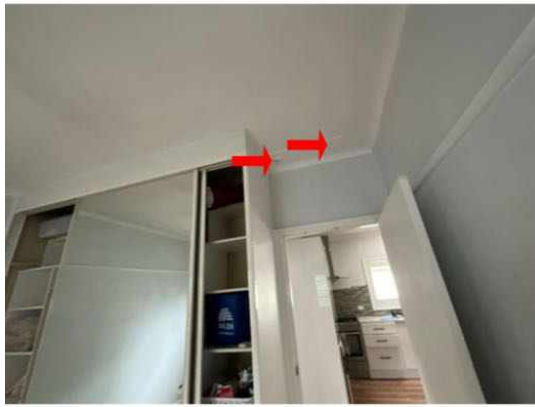
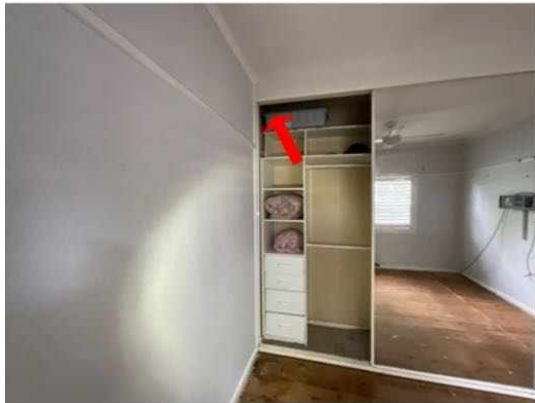
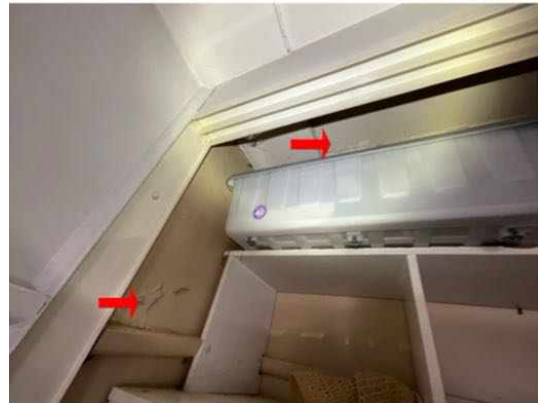
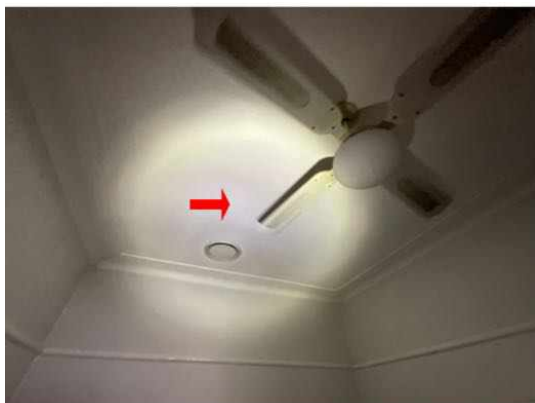
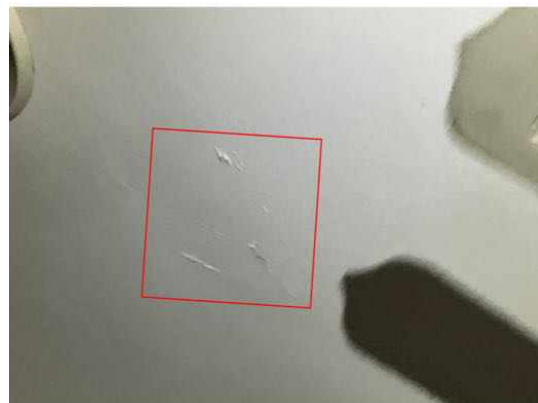
Finding 3.23

Finding: Damage to Masonry Walls (Cracks) - Category 1

Information: It has been observed that damage to masonry walls caused by movement of slabs, footings, or other causes, has occurred. The degree of damage falls within Category 1, described as fine cracks, which are less than 1.0mm in width limit, and that do not need repair.

Damage of this category is not considered a defect for rectification. Always contact your building inspector should cracks widen, lengthen, or become more numerous.

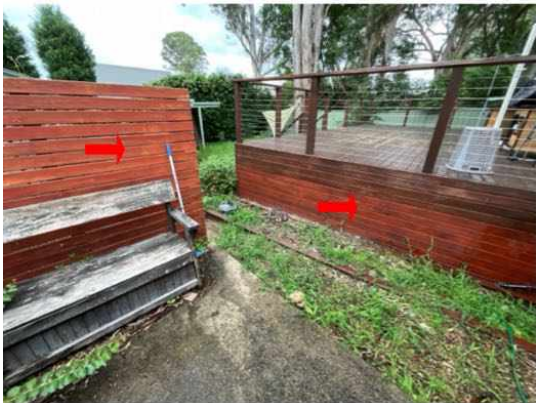
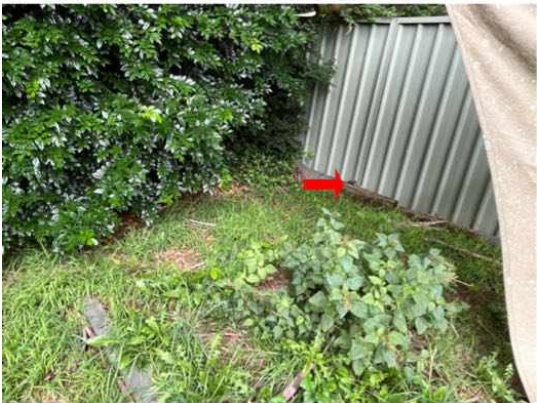
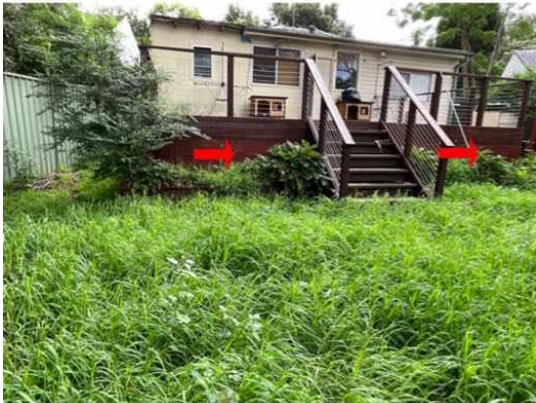
Finding 6.08

Building: Main Building
Location: Garden beds
Finding: Garden Beds - Conditions Conducive to Termites
Information: Garden beds were found to be evident in the garden area. These garden beds can include untreated timber, and with a combination of moisture from watering hosing can make conditions conducive to termite activity and termite ingress.

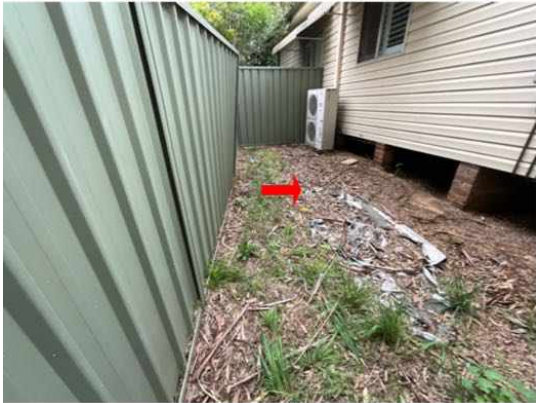
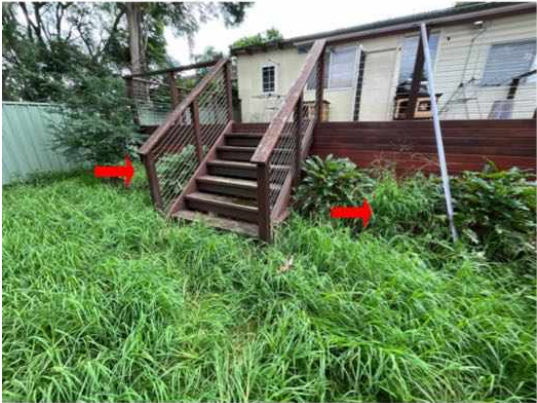
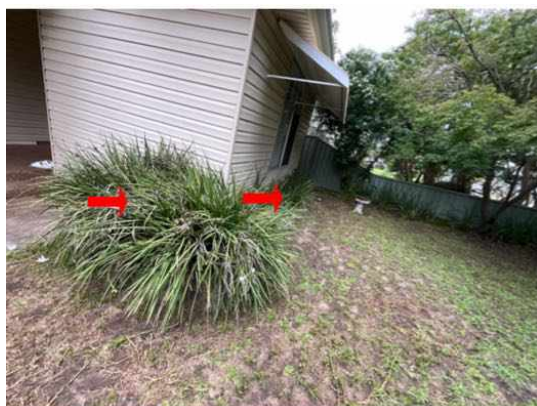
Finding 6.09

Information: The storing of timbers in the subfloor space or around the external property increases the risk of termite activity being present. As they are likely to come into contact with weather conditions or excessive moisture wood rot is likely to develop on timbers that are not treated.

It is highly recommended that any stored timbers be immediately removed from areas in which they may attract any termite / timber pest attack. Minimisation of risk / prevention of termite attack is far more adequate than dealing with the presence of termite activity.

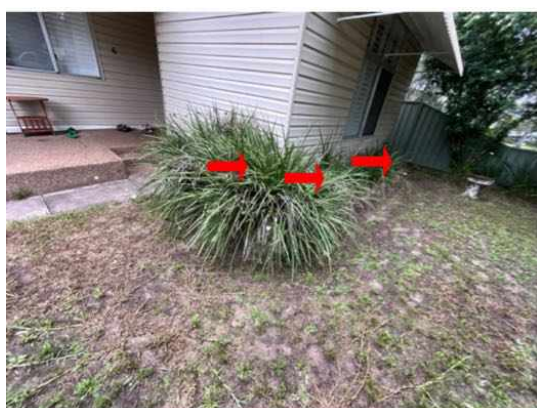
Finding 6.11

Building:	Main Building
Location:	Surrounding bush

Finding: Surrounding bushland - Conductive
 Information: Home and or building is situated in a high risk area for termite activity, due to close proximity to surrounding bushland.

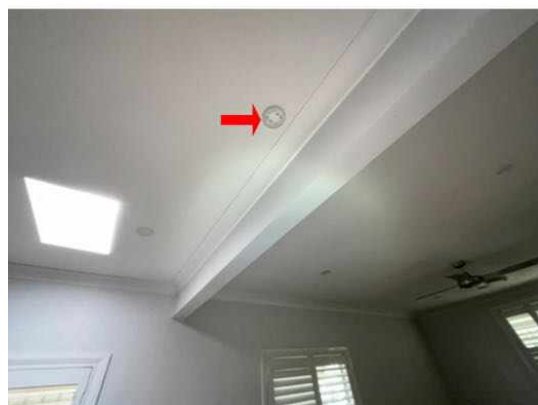
Noted Item

Building:	Main Building
Location:	All Areas
Finding:	Moisture metre
Information:	During the inspection the property was checked for moisture using a moisture metre.

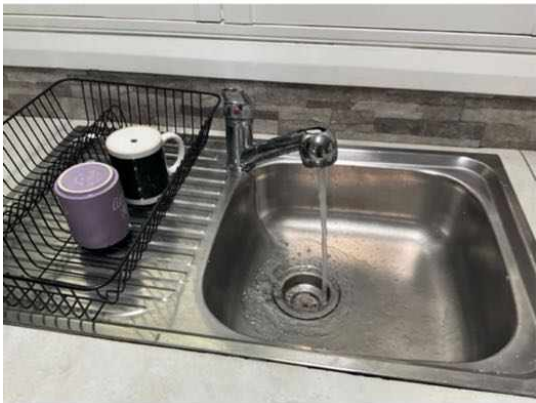
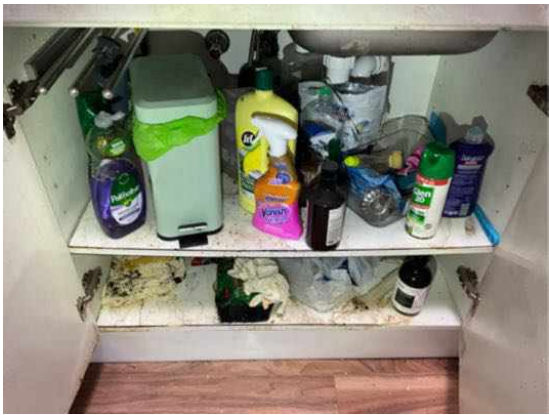
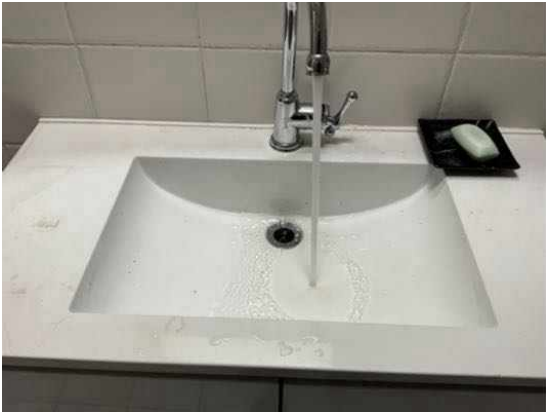
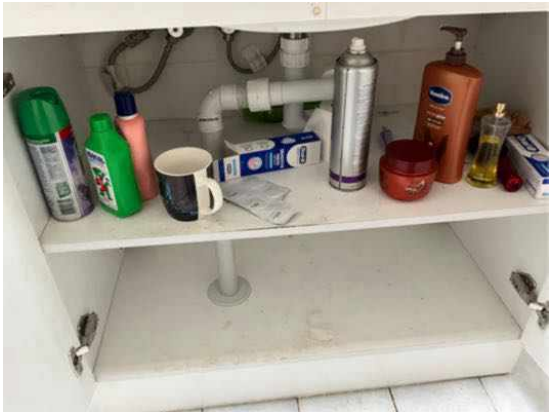
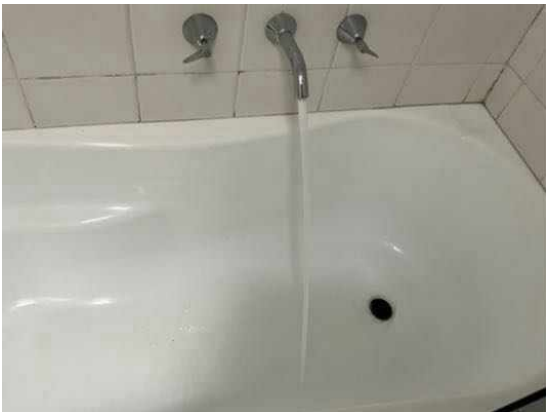
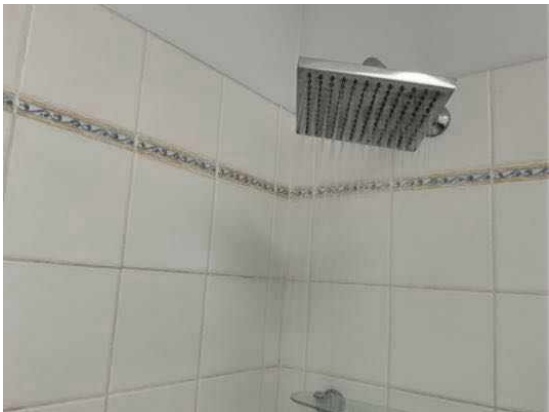
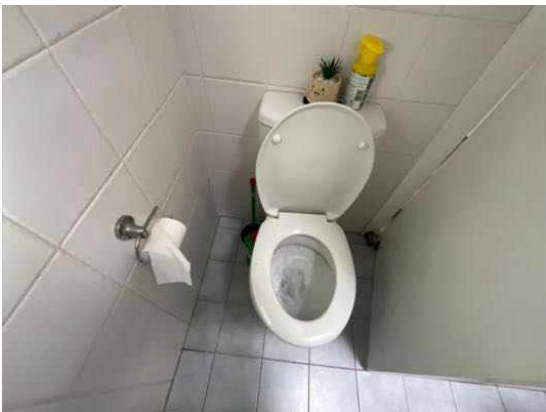
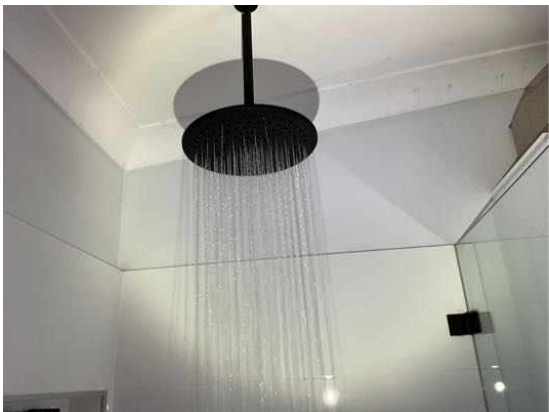
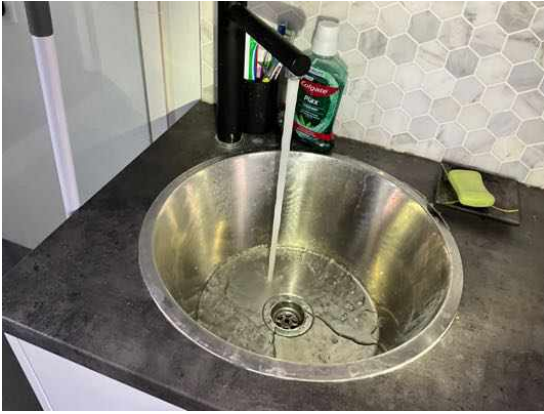
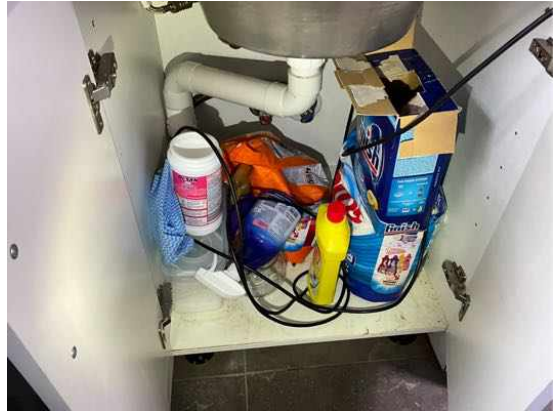
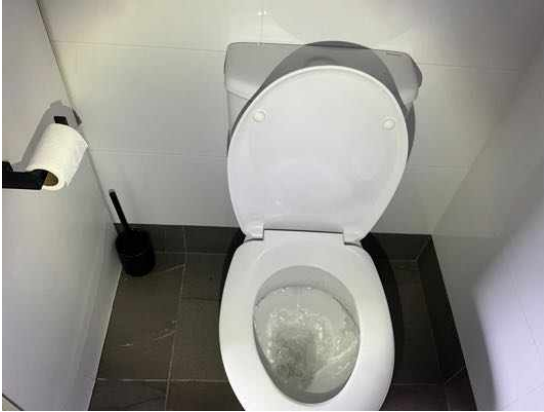
Building: Main Building
 Location: All Wet Areas
 Finding: Additional Photos
 Information:

Additional photos are provided for your general reference.

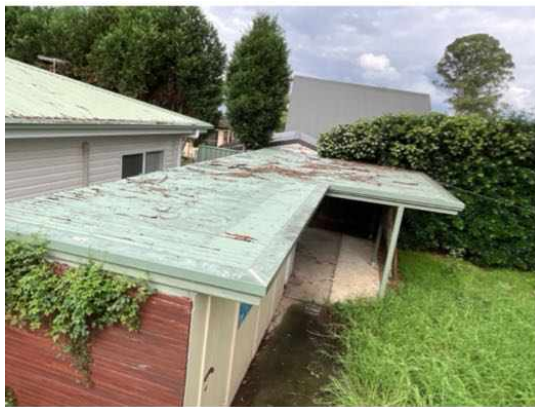
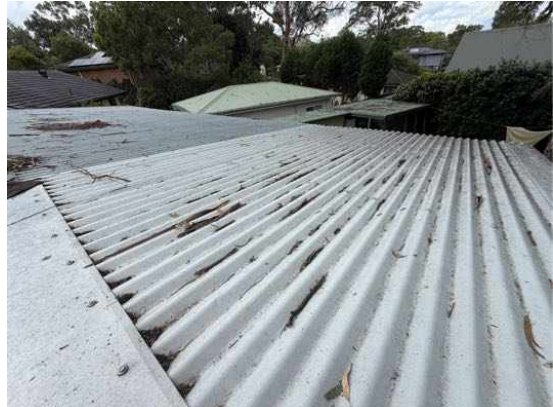
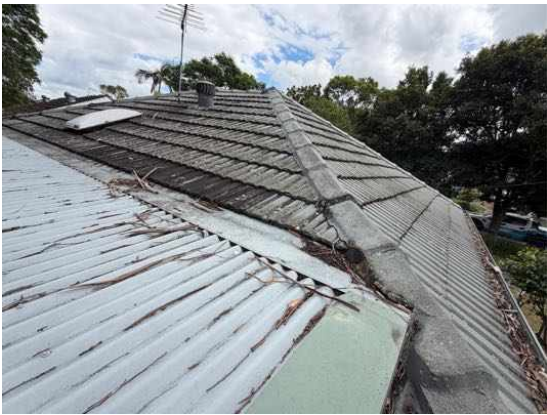
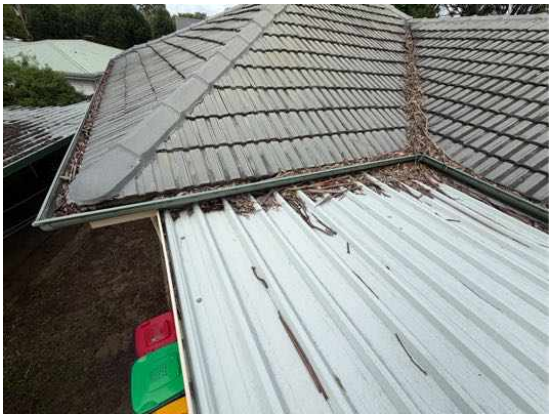
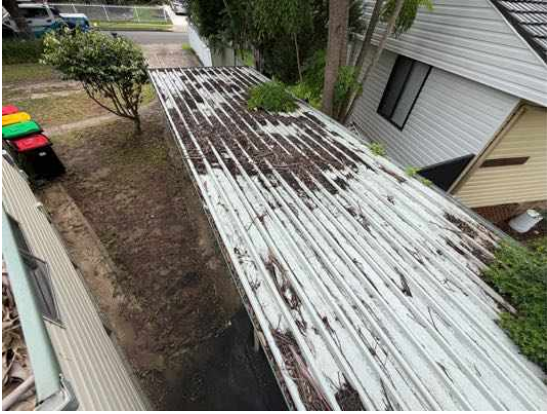
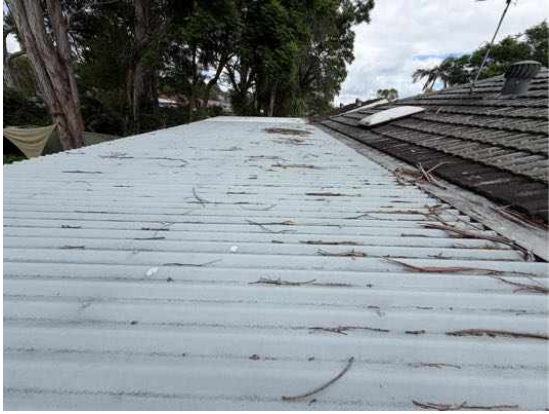
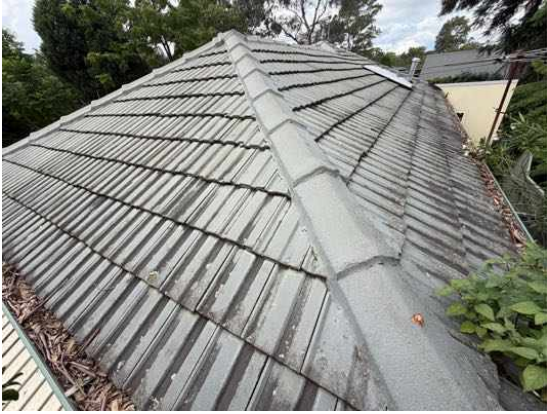
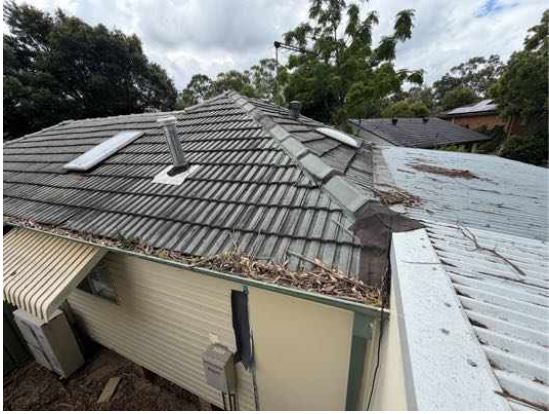
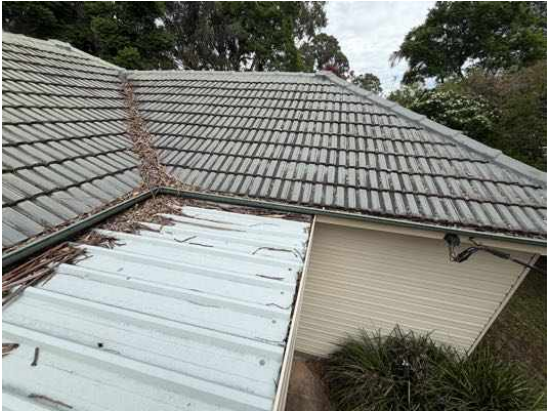
Building: Main Building
Location: Roof Exterior
Finding: Additional Photos
Information:

Additional photos are provided for your general reference.
