Building and Timber Pest Inspection Report

Inspection Date: Tue, 10 Mar 2026

Property Address: 6 Stuart Mould Cres, Lalor Park NSW 2147,
Australia

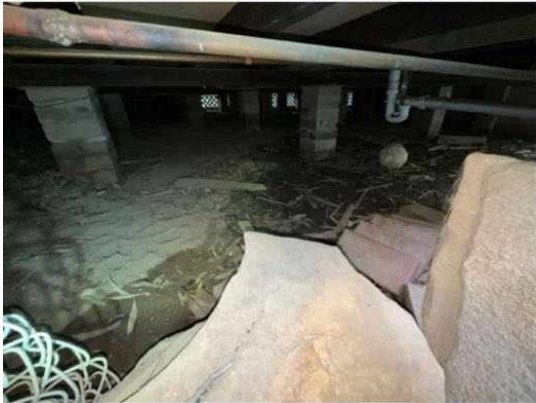
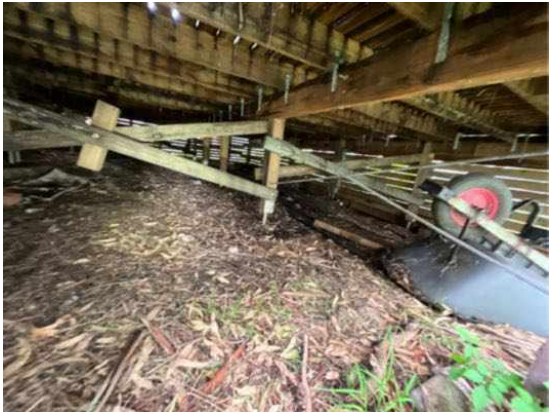
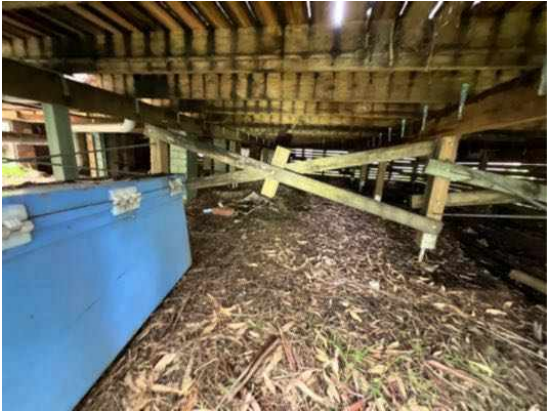
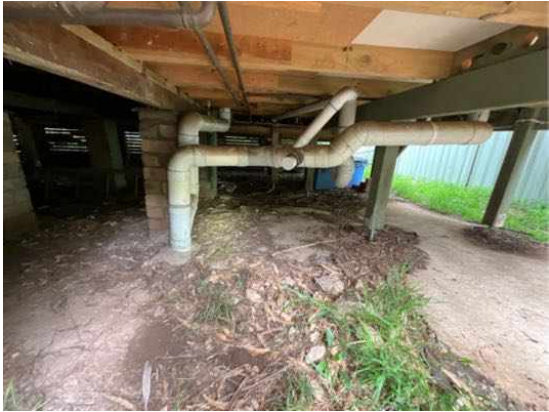
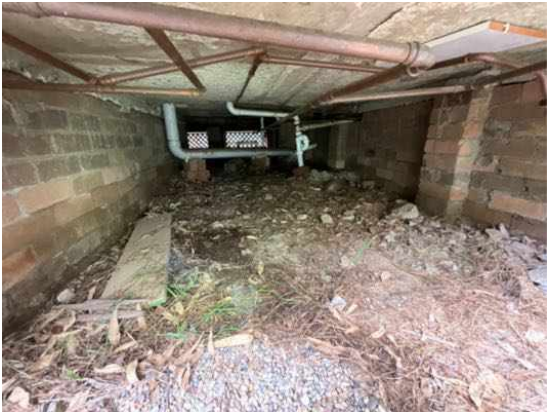
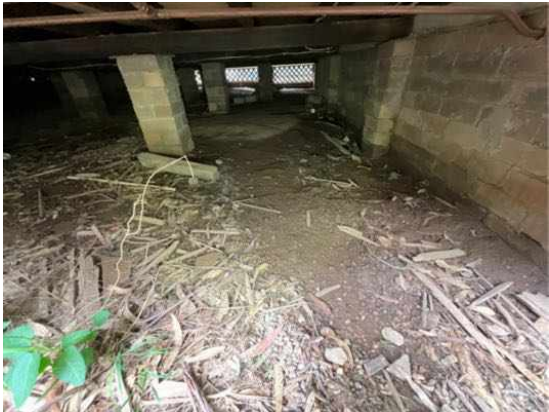
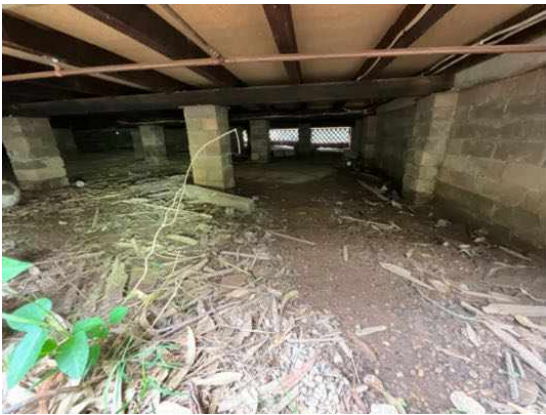
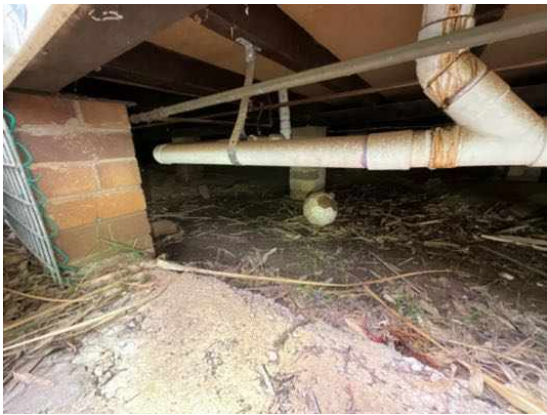
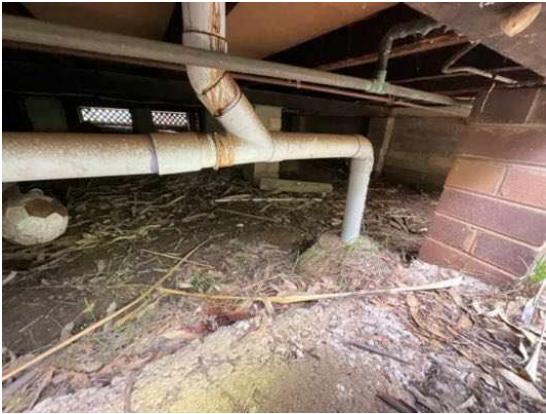
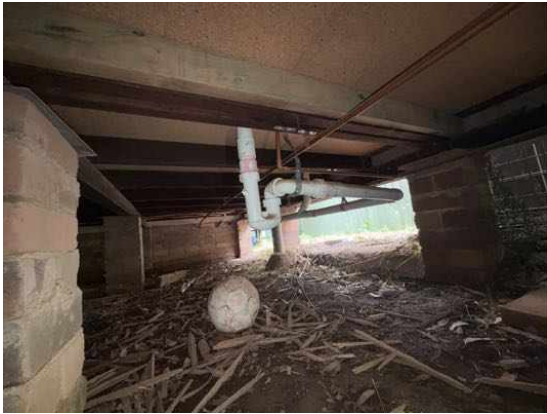
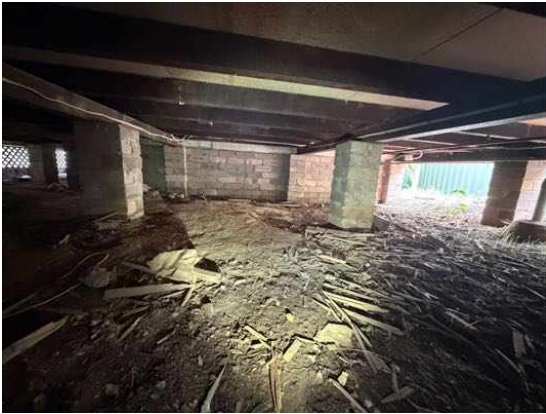
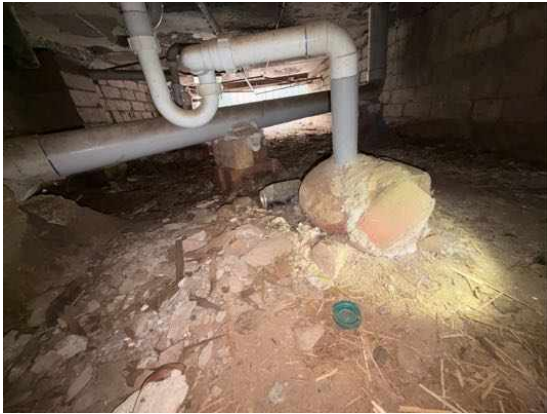
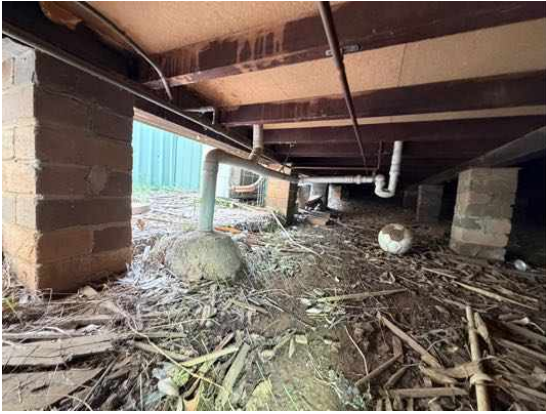
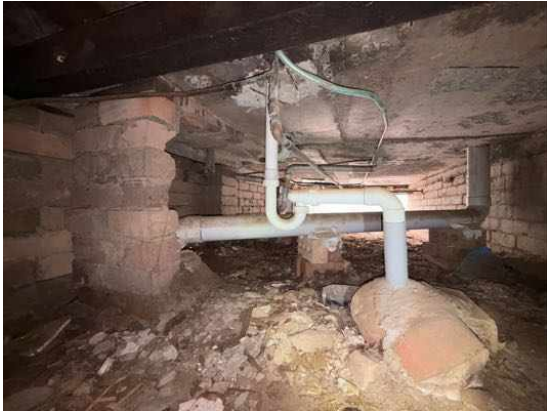
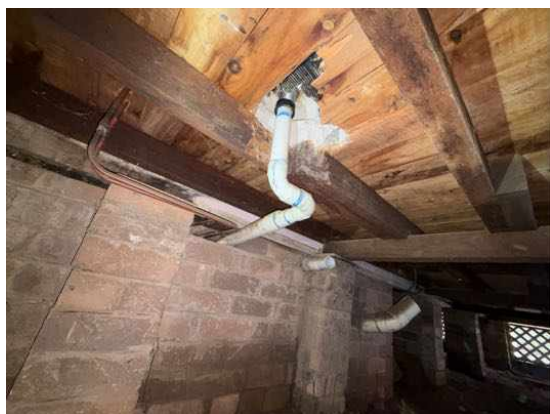
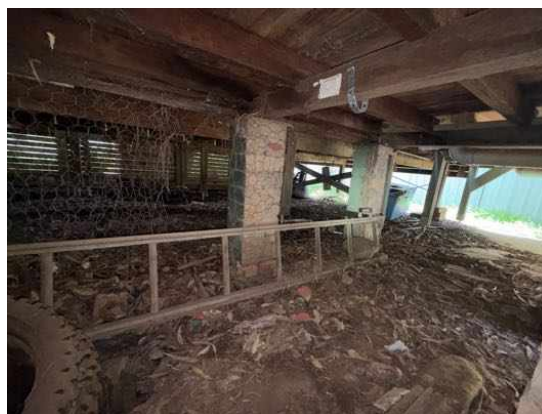
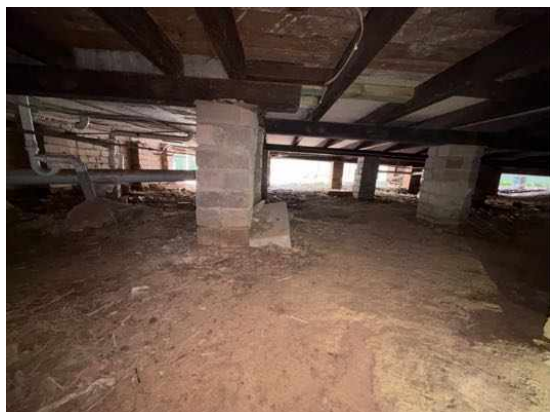
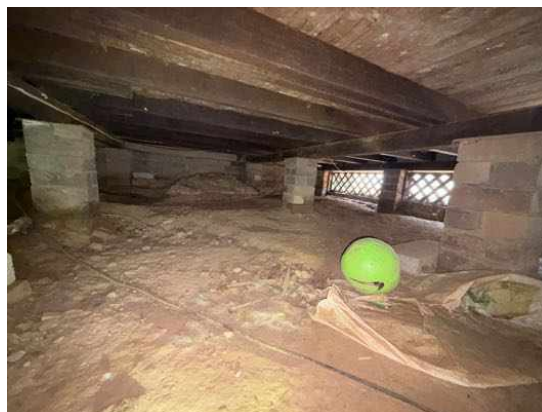
Building: Main Building
Location: Subfloor
Finding: Additional Photos
Information:

Additional photos are provided for your general reference.

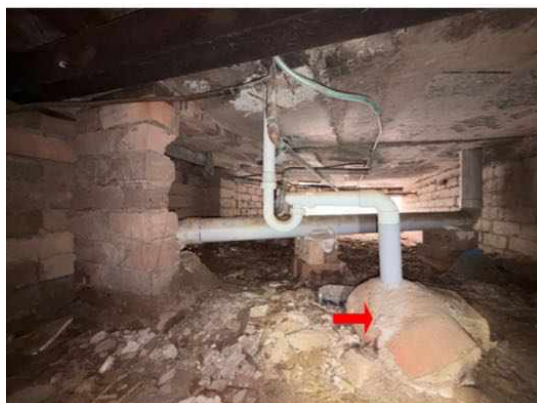
Building: Main Building
 Location: Pipework
 Finding: Pipework - Old urban wear pipes
 Information: Old urban wear pipes were identified at the time of inspection.

Consultation with a licensed plumber is advised. CCTV inspection on pipes may be required.

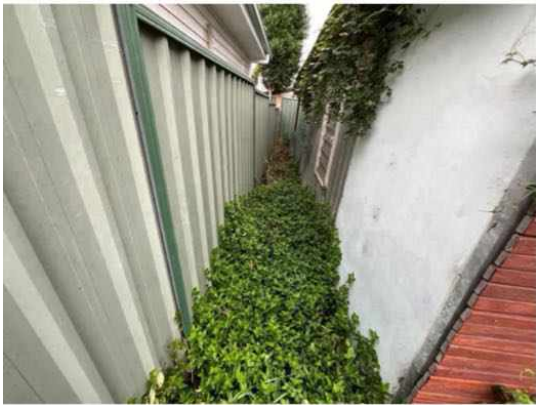
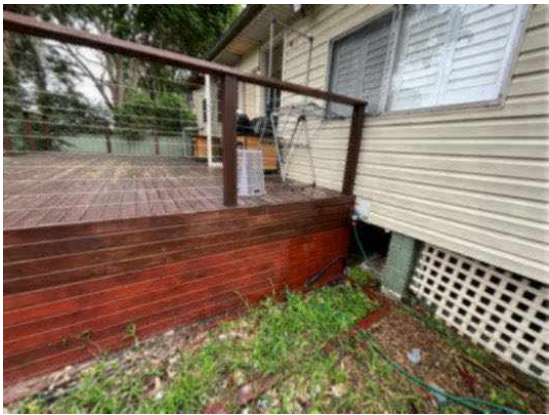
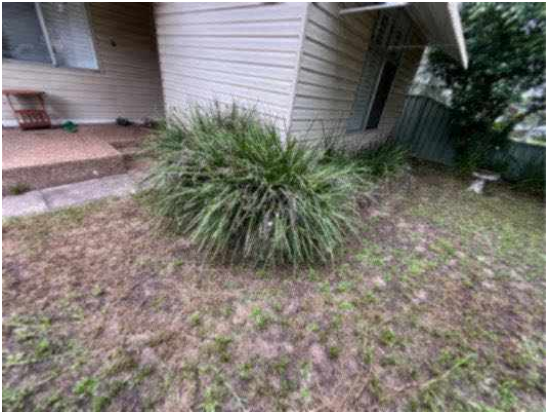
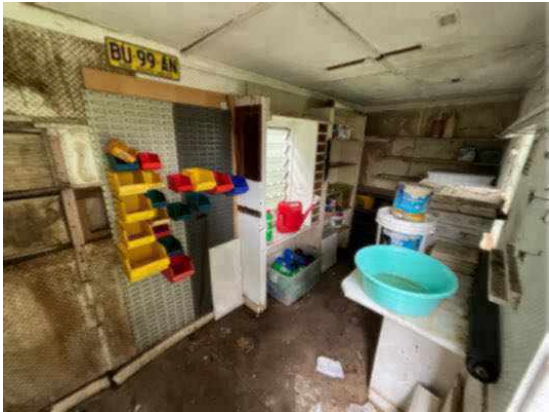
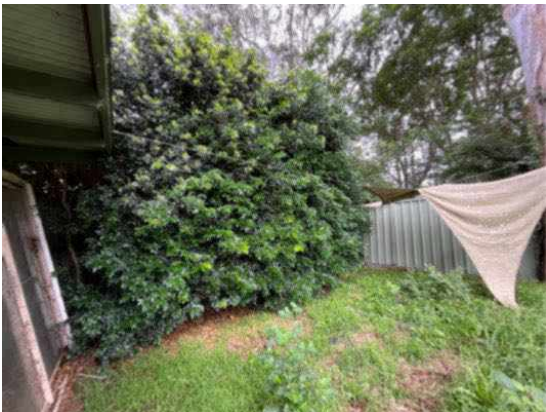
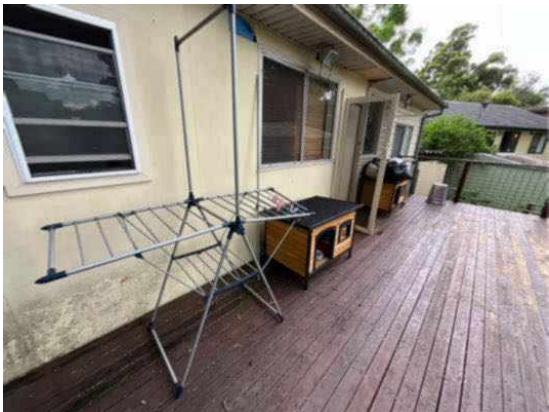
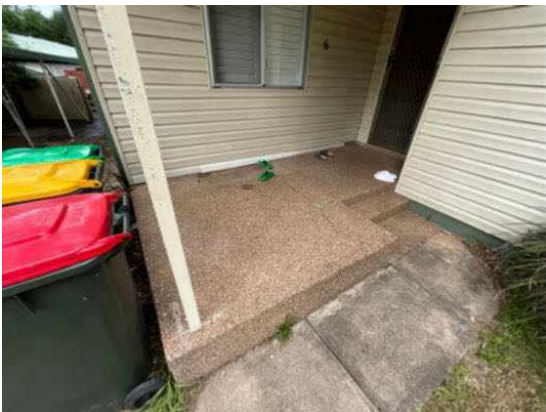
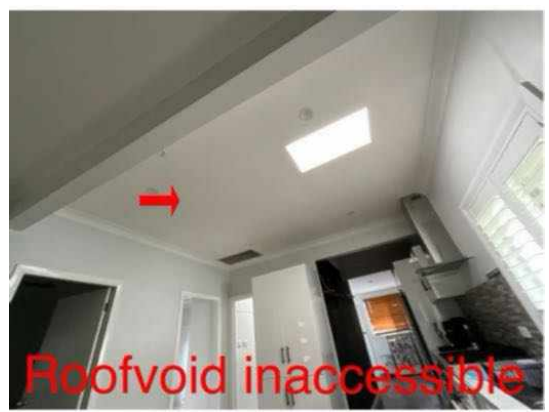
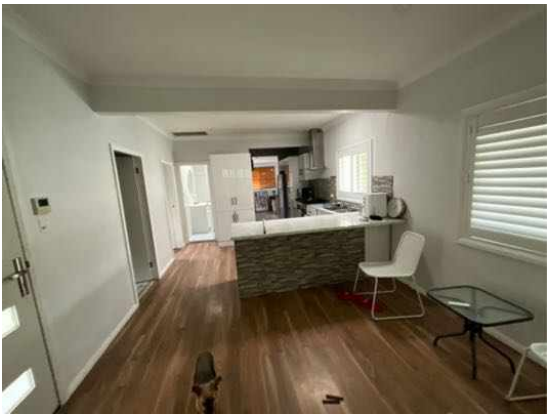
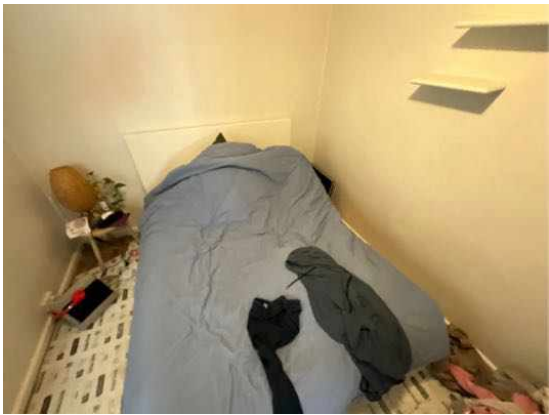
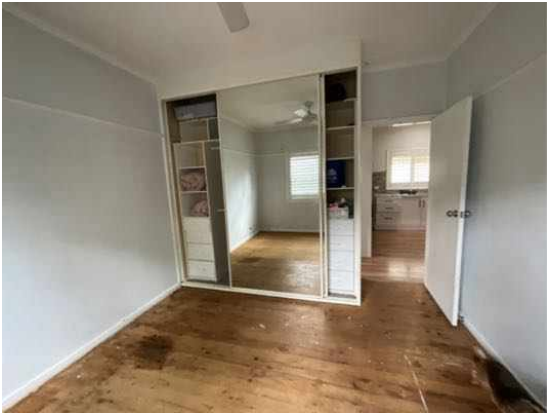
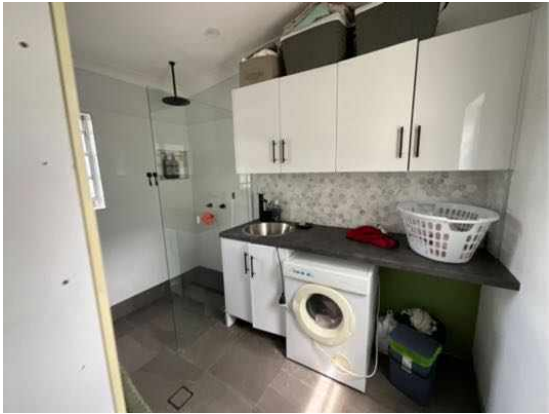
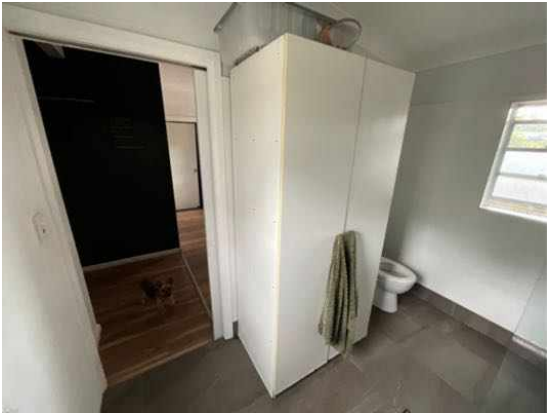
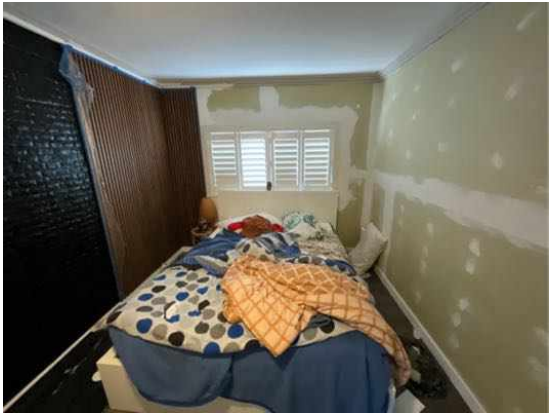
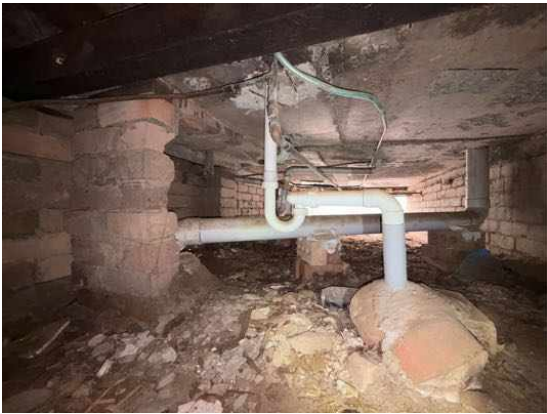
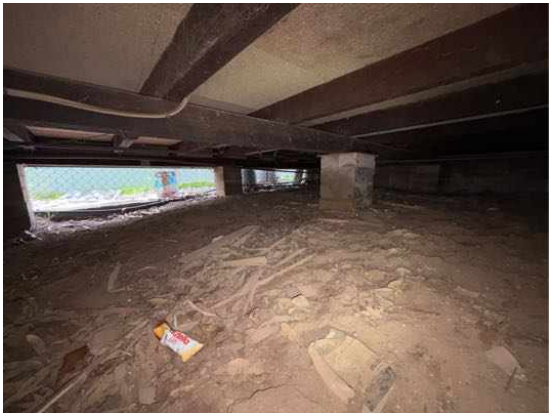
Building: Main Building
 Location: All Areas
 Finding: Additional Photos - Obstructions and Limitations
 Information:

These photographs are an indication of the obstructions and limitations which impeded full inspection of the property at the time of inspection. These obstructions can hide an array of defects and should be removed to allow full inspection to be carried out. A re-inspection is recommended once the areas are made accessible.
