Building and Timber Pest Inspection Report

Inspection Date: Thu, 22 Jan 2026

Property Address: 13 Durali Road, Glenmore Park NSW 2745

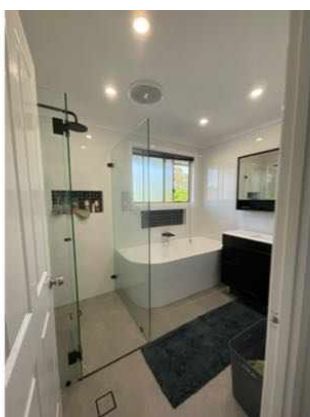
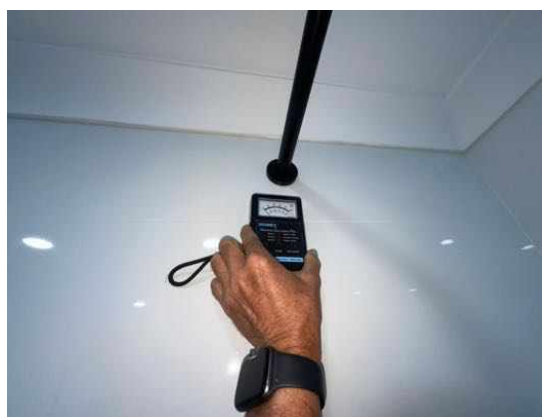
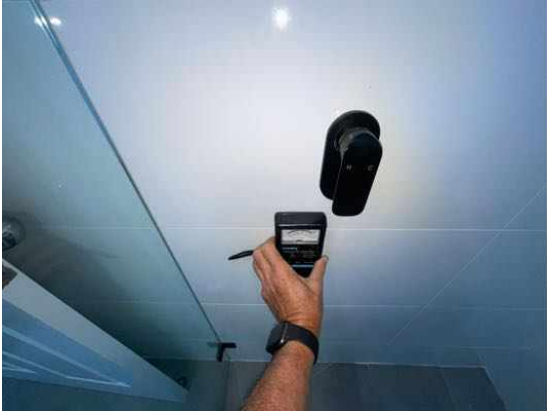
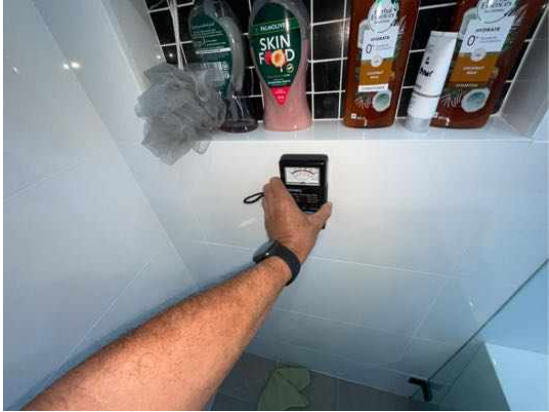
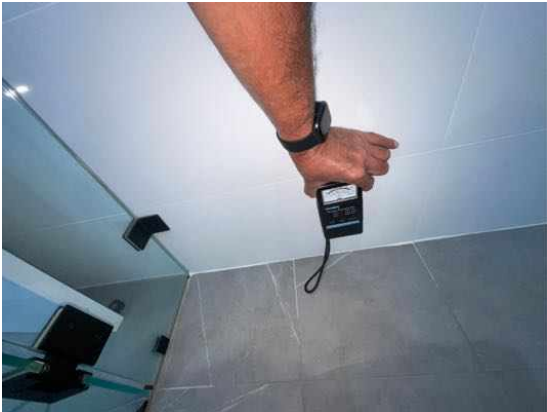
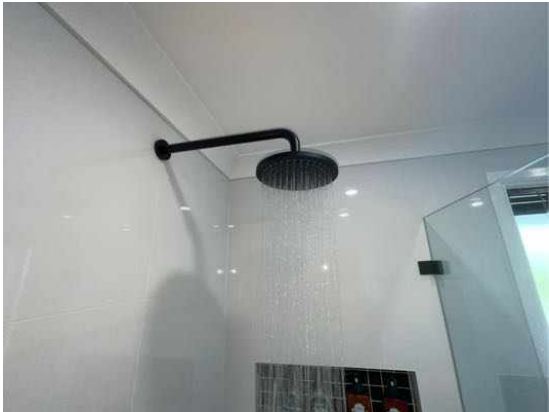
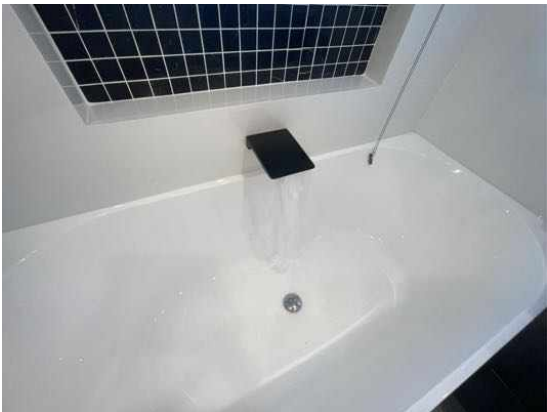
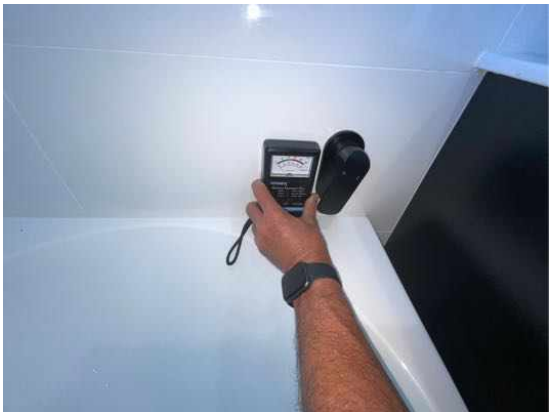
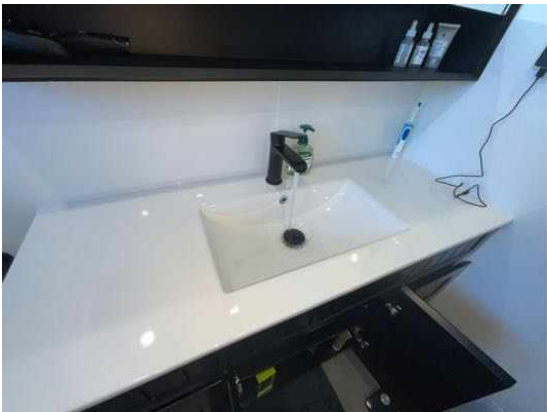
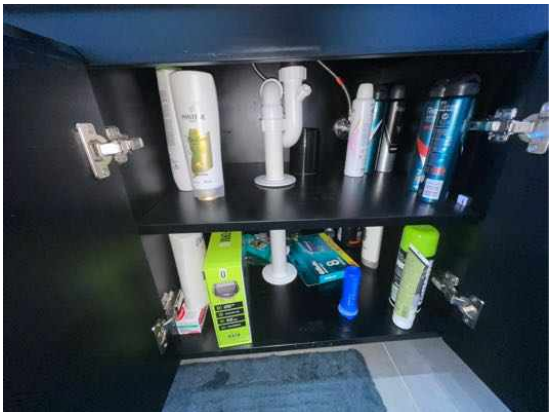
Building: Main Building
 Location: Bathroom
 Finding: Wet Areas - Bathroom(s) - Overall Condition & Recommendations.
 Information: Overall Condition & Recommendations

It is not possible under the visual inspection criteria of a standard pre-purchase report to categorically determine if leaks are present. If a more detailed or accurate assessment is required, a special-purpose inspection should be undertaken.

Alternatively, the assumption should be made that leakage may occur, particularly where historical or environmental conditions are conducive. The visual nature of this inspection cannot detect issues concealed behind wall/floor linings or cabinetry, and invasive investigation may be necessary to confirm the true condition of adjacent or hidden structures.

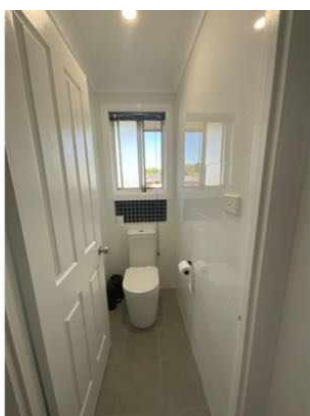
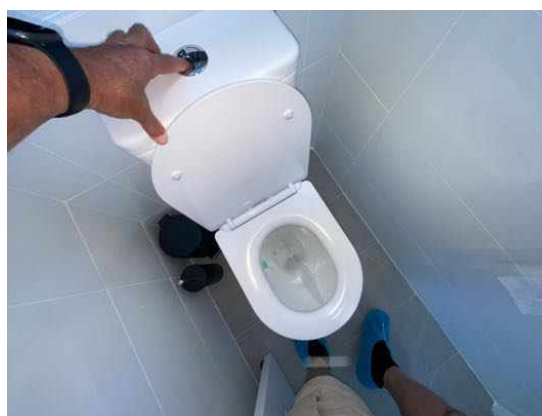
Building: Main Building
 Location: Toilet (WC)
 Finding: Overall Condition: Toilet.
 Information: TOILET ASSESSMENT

Toilet:

- No leaks were observed during the flushing process.
- The toilet operated normally with no signs of malfunction or abnormal water flow.
- The toilet pan was securely fixed to the floor at the time of inspection.

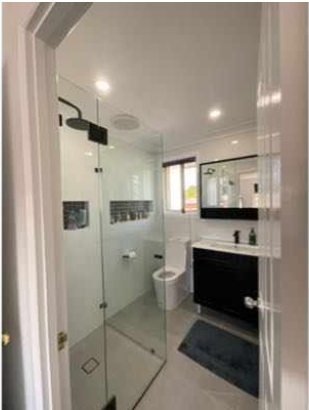
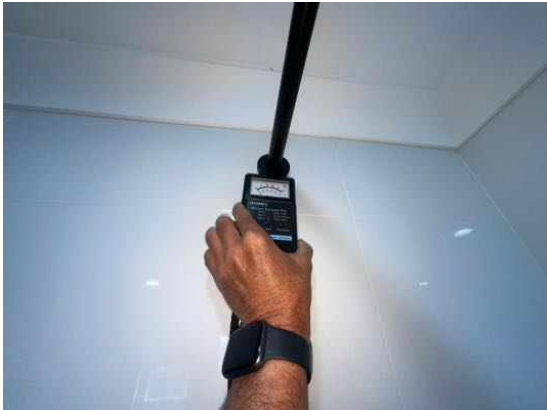
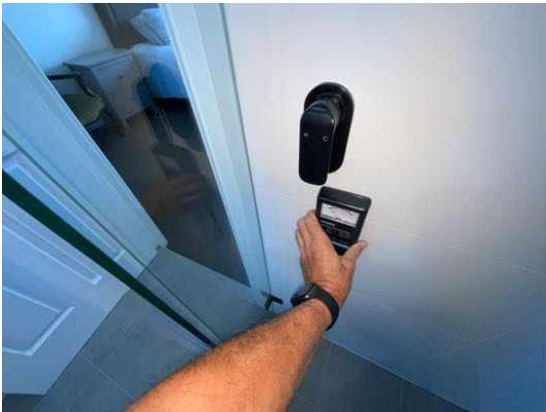
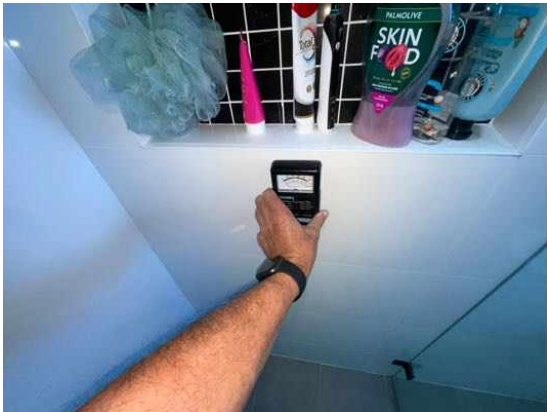
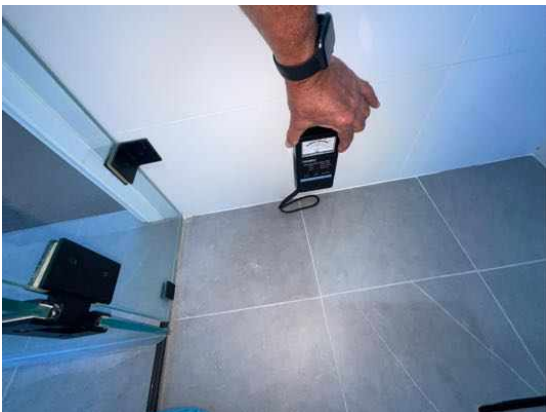
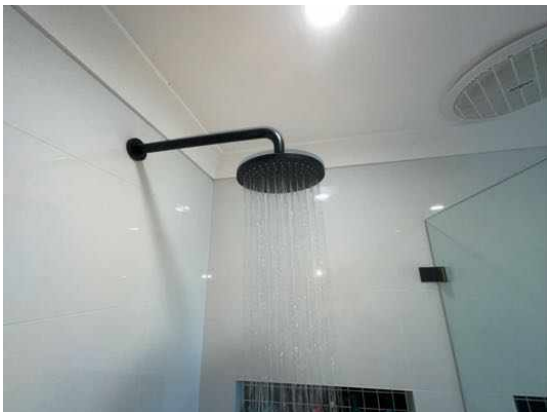
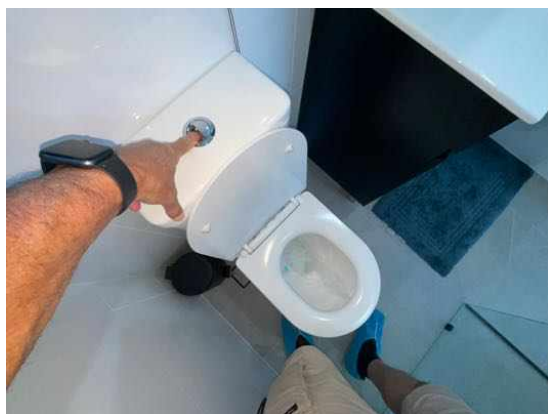
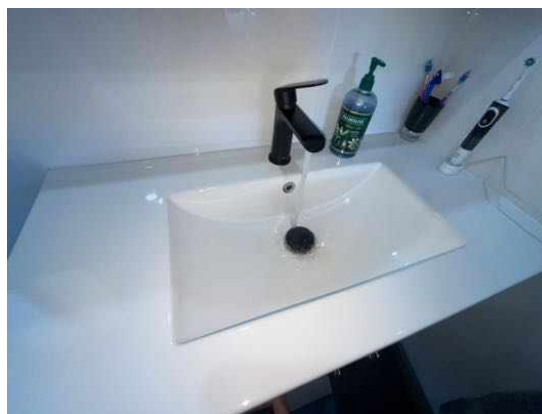
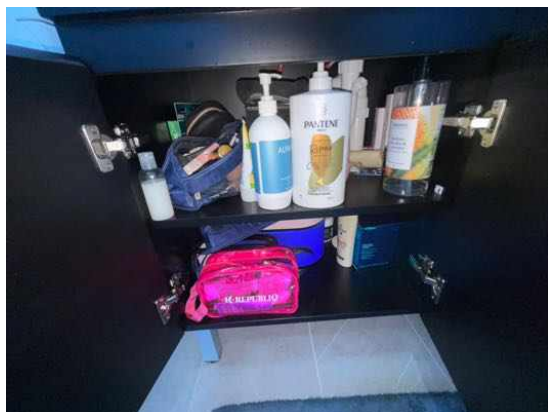
Building: Main Building
 Location: Ensuite
 Finding: Wet Areas - Bathroom(s) - Overall Condition & Recommendations.
 Information: Overall Condition & Recommendations

assessment is required, a special-purpose inspection should be undertaken.

Alternatively, the assumption should be made that leakage may occur, particularly where historical or environmental conditions are conducive. The visual nature of this inspection cannot detect issues concealed behind wall/floor linings or cabinetry, and invasive investigation may be necessary to confirm the true condition of adjacent or hidden structures.
