Building and Timber Pest Inspection Report

Inspection Date: Tue, 20 Jan 2026

Property Address: 251 Gundurimba Rd, Monaltrie NSW 2480, Australia

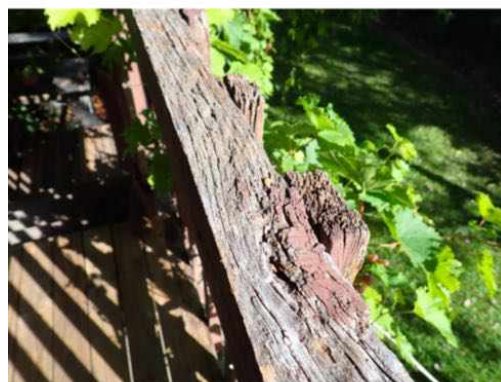
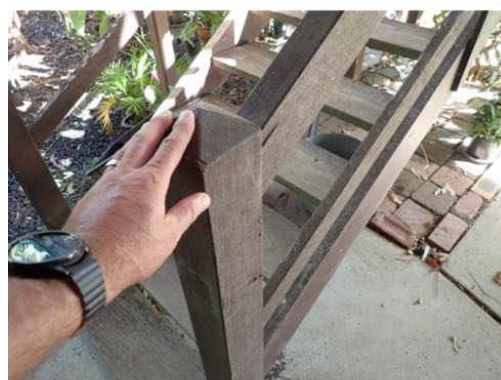
Finding: Side Decked Area – Timber Stairs and Balustrade Age-Related Deterioration

Information: The timber stairs and balustrade to the side decked area were found to show age-related deterioration at the time of inspection. This may affect the structural integrity, safety, and appearance of the area if left unaddressed. It is recommended that a suitably qualified carpenter carry out repairs, maintenance, or replacement of affected components as deemed necessary to ensure the stairs and balustrade remain safe and serviceable.

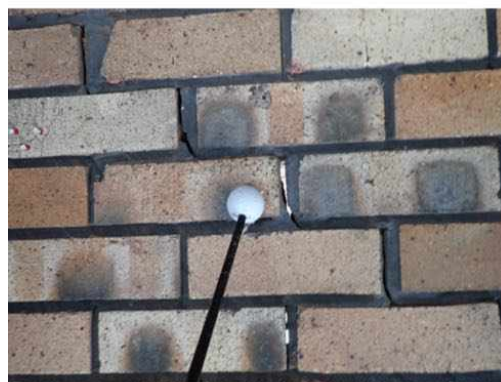
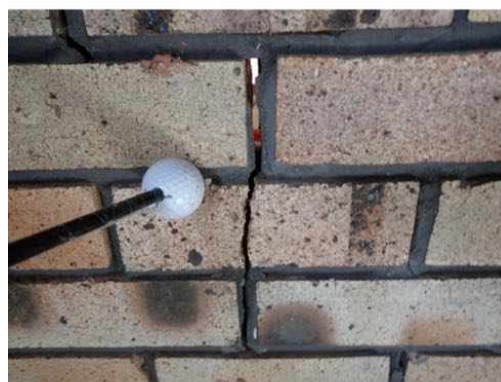
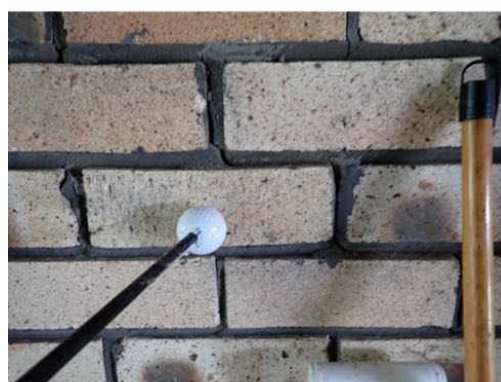
Finding 2.03

Building: Main Building
Location: Brick wall in middle of building
Finding: Brick Wall – Structural Cracks Identified
Information: Several cracks were identified to the brick wall in the middle of the building, and the cracking is considered to be structural in nature. This may indicate underlying movement or stress within the building structure. If left unaddressed, further deterioration and structural issues may occur. It is recommended that a suitably qualified structural engineer or builder assess the cracking and carry out any necessary repairs or remedial works as deemed necessary.

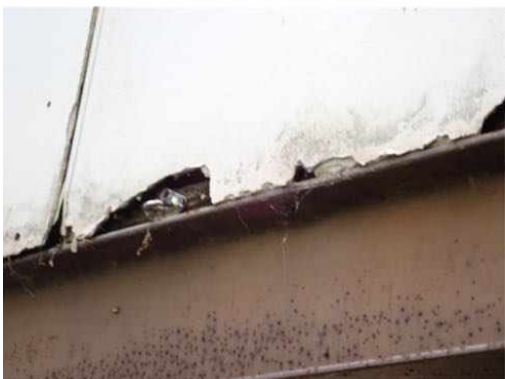
Building: Main Building
Location: External walls
Finding: External Cladding – Damage at Multiple Locations
Information: Damage was identified to the external cladding at multiple locations at the time of inspection. This may allow moisture ingress and lead to further deterioration of the building materials if left unaddressed. It is recommended that a suitably qualified carpenter or builder repair or replace the affected cladding as deemed necessary to maintain the integrity of the building exterior.

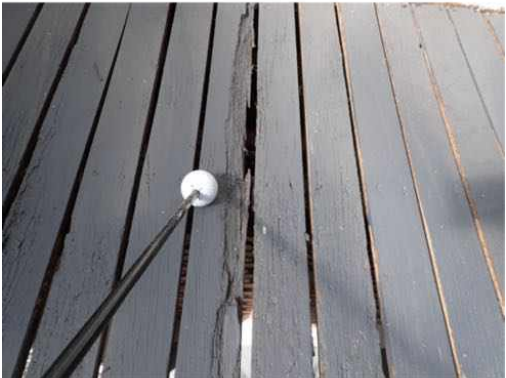
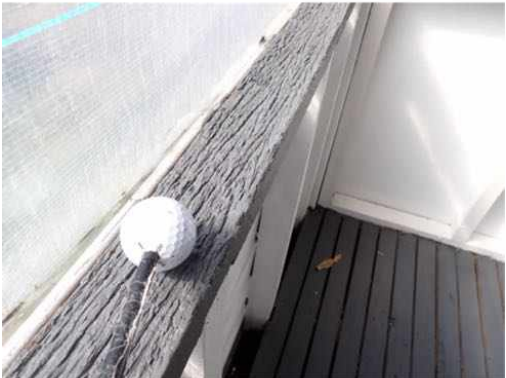
Finding 2.06

Building: Main Building
Location: Front decked area
Finding: Front Timber Decked Area – Age-Related Deterioration to Decking and Handrail/Balustrade
Information: Age-related deterioration was identified to the front timber decking and the handrail/balustrade at the time of inspection. This is consistent with prolonged exposure to weathering over time. If left unaddressed, the condition may continue to deteriorate and affect the safety and serviceability of the deck. It is recommended that a suitably qualified carpenter carry out maintenance, repairs, or replacement of affected components as deemed necessary.

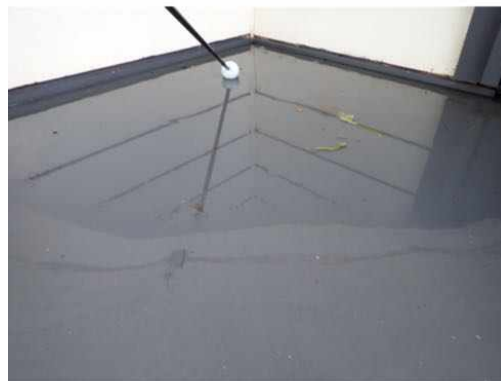
Finding 2.07

Building:	Main Building
Location:	Front decked area
Finding:	Top Floor Entry Area – Water Pooling
Information:	Water pooling was observed in the top floor entry area at the time of inspection. This may be due to poor drainage, surface levels, or inadequate fall away from the building. If left unaddressed, ongoing moisture exposure may lead to deterioration of surrounding building materials. It is recommended that a suitably qualified tradesperson assess the area and carry out drainage or surface repairs as deemed necessary to prevent further water accumulation.

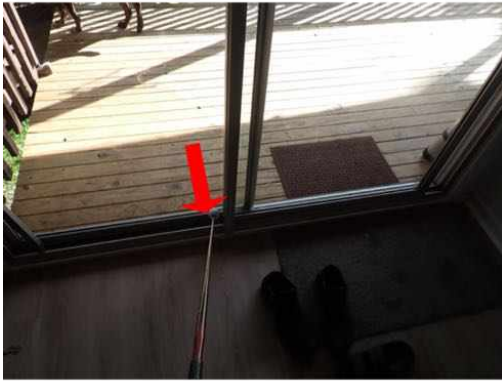
Finding 3.01

Building:	Main Building
Location:	Side door out to decked area
Finding:	Sliding Door to Deck Area – Difficult to Operate
Information:	The side sliding door providing access to the decked area was hard to open and close at the time of inspection. This is likely due to worn rollers, debris in the track, or poor alignment. It is recommended that a suitably qualified carpenter, glazier, or general handyman inspect and repair the door as deemed necessary to restore smooth operation.

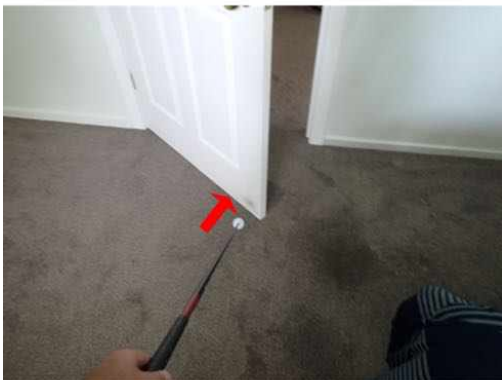
Finding 3.02

Building:	Main Building
Location:	Bedroom
Finding:	Bedroom Door – Catching on Carpet
Information:	The bedroom door was observed to be catching on the carpet when opening and closing at the time of inspection. This is likely due to carpet height, poor door clearance, or minor door/frame misalignment. It is recommended that a suitably qualified carpenter or general handyman adjust or trim the door as deemed necessary to allow smooth operation and prevent further wear to the door or floor coverings.

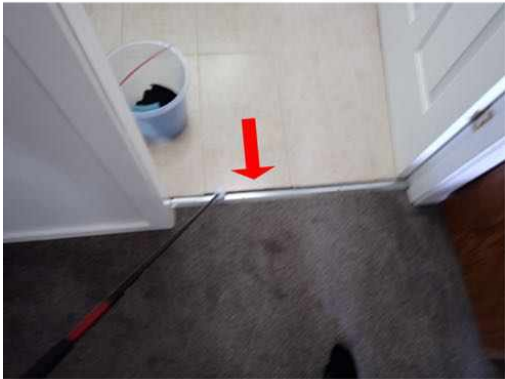
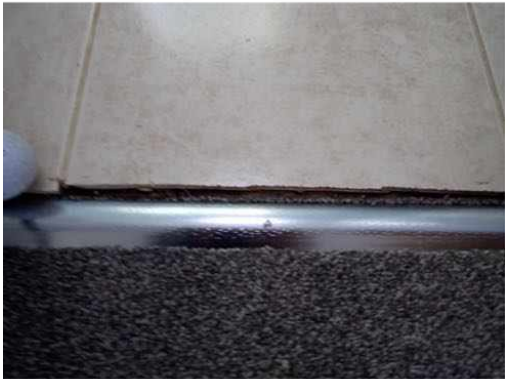
Finding 3.03

Building:	Main Building
Location:	Bathroom
Finding:	Tile to Carpet Transition – Poor Finish
Information:	The transition between the tiled flooring and carpeted flooring was found to be poorly finished at the time of inspection. This may create a trip hazard and lead to premature wear of the floor coverings. It is recommended that a suitably qualified carpenter, floor installer, or general handyman improve the transition as deemed necessary to provide a safer and more durable finish.

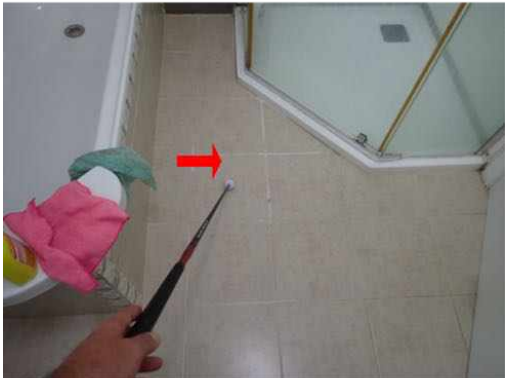
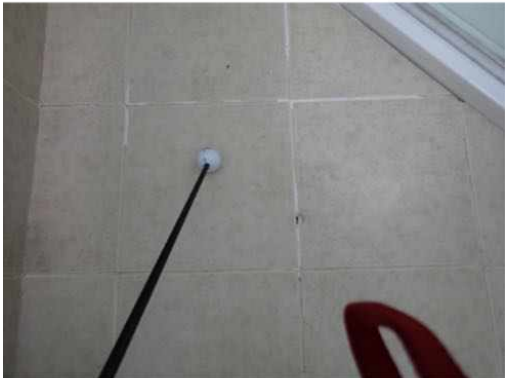
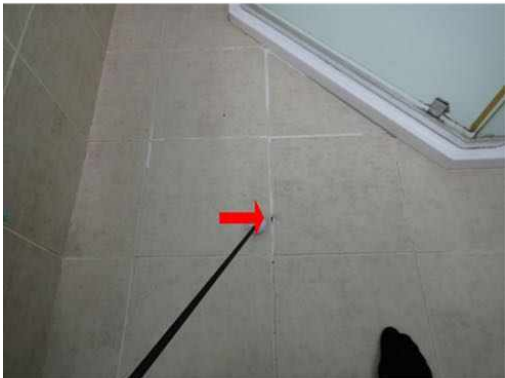
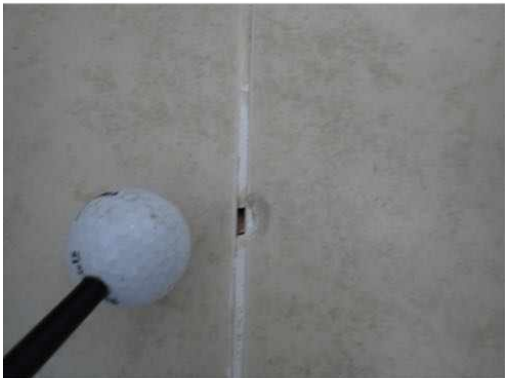
Finding 3.04

Building: Main Building
Location: Bathroom
Finding: Bathroom Floor Tiles – Drummy and Damaged
Information: Several floor tiles in the bathroom were found to be drummy and damaged at the time of inspection. This indicates poor adhesion and possible moisture-related issues, which may lead to further tile failure if left unaddressed. It is recommended that a suitably qualified tiler inspect the area and carry out repairs or replacement of the affected tiles as deemed necessary.

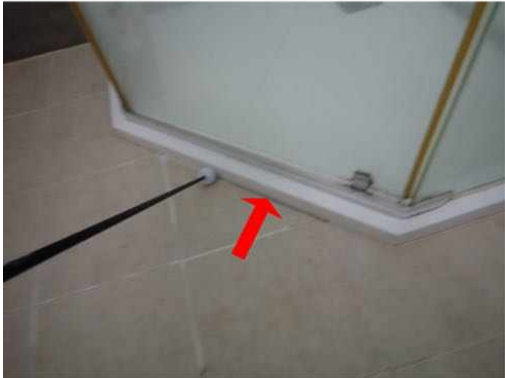
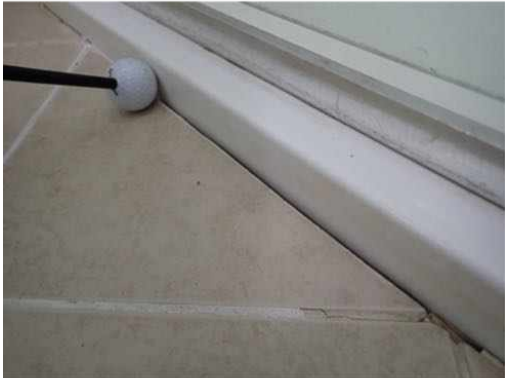
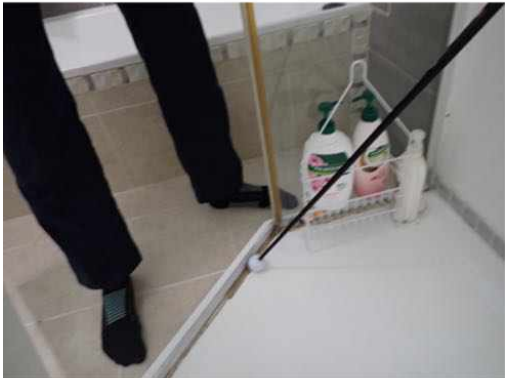
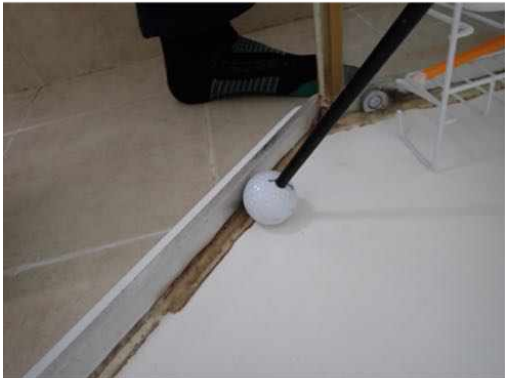
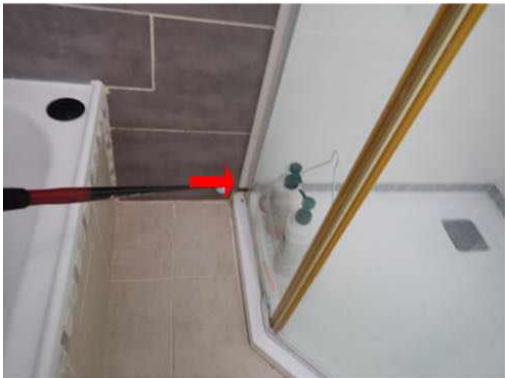
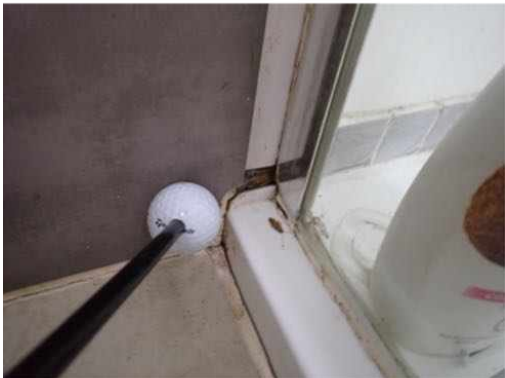
Finding 3.05

Building: Main Building
Location: Bathroom
Finding: Shower Base – Deteriorated or Missing Silicone
Information: The silicone seal around the shower base was found to be deteriorated or missing at the time of inspection. This may allow water to penetrate into surrounding building materials and cause moisture damage over time. It is recommended that a suitably qualified tradesperson re-seal the shower base with appropriate waterproof silicone as deemed necessary to prevent further deterioration.

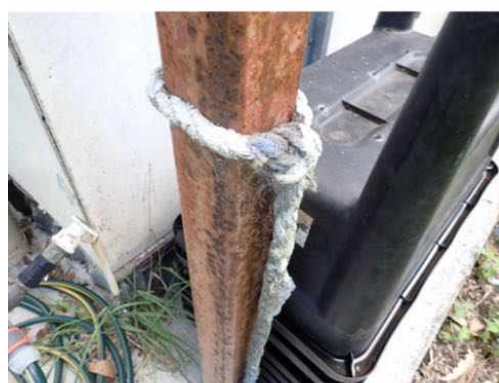
Finding 3.06

Building:	Main Building
Location:	Rear of building
Finding:	Rear of Building – Surface Rust to Steel Post and Beam
Information:	Surface rust was observed on the steel post and beam at the rear of the building at the time of inspection. While the rust appeared to be superficial, ongoing corrosion may lead to deterioration of the steel over time if left unaddressed. It is recommended that a suitably qualified tradesperson clean, treat, and protect the affected steelwork as deemed necessary to prevent further corrosion.

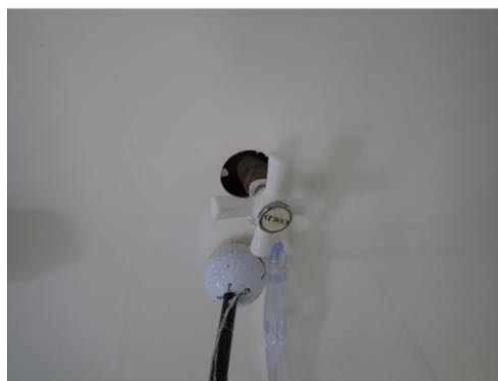
Finding: Shower Tap Wall Penetrations – Not Sealed

Information: The wall penetrations around the shower taps were not sealed at the time of inspection. This may allow moisture to enter the wall cavity and cause damage to internal building materials over time. It is recommended that a suitably qualified tradesperson seal the penetrations with appropriate waterproofing materials as deemed necessary to prevent further deterioration.

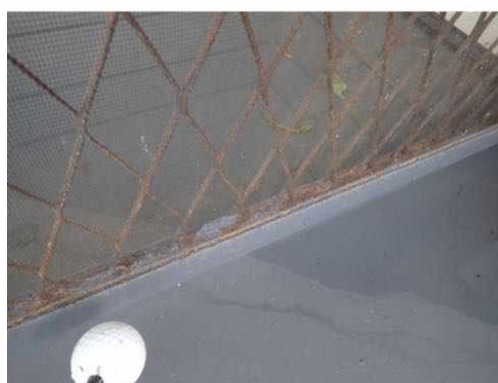
Finding 3.10

Finding: Security Screen Door – Rusted

Information: The security screen door was found to be rusted at the time of inspection, indicating age-related deterioration and exposure to weathering. If left unaddressed, the corrosion may worsen and affect the door's operation and appearance. It is recommended that a suitably qualified tradesperson repair, treat, or replace the door as deemed necessary to prevent further deterioration.

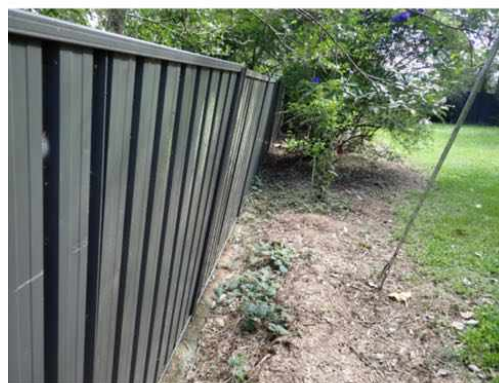
Finding 3.11

Location:	Rear fence
Finding:	Rear Colourbond Fence – Leaning Out of Plumb
Information:	The rear Colourbond fence was observed to be leaning out of plumb at the time of inspection. This may be due to ground movement, deteriorated footings, or impact damage. If left unaddressed, the fence may continue to lean and lose stability. It is recommended that a suitably qualified fencing contractor or general handyman realign, repair, or replace the fence as deemed necessary to restore stability.

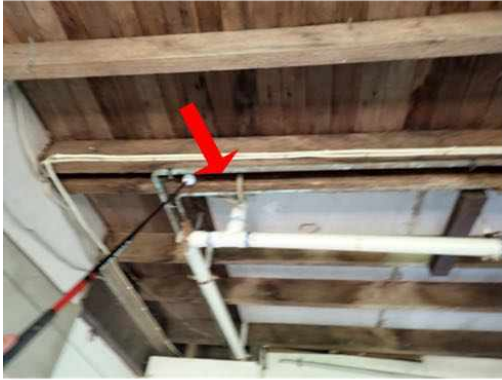
Finding 7.01

Building:	Main Building
Location:	Flooring system below bathroom
Finding:	Bathroom Subfloor – Wood Rot to Timber Flooring Beam
Information:	Wood rot was identified to a timber flooring beam below the bathroom, although the area was dry at the time of inspection. This is likely due to past moisture exposure from previous water leaks. If left unaddressed, the deterioration may compromise the structural integrity of the floor. It is recommended that a suitably qualified carpenter or builder investigate the cause, repair or replace the affected timber, and carry out any necessary remedial works as deemed necessary to prevent further deterioration.

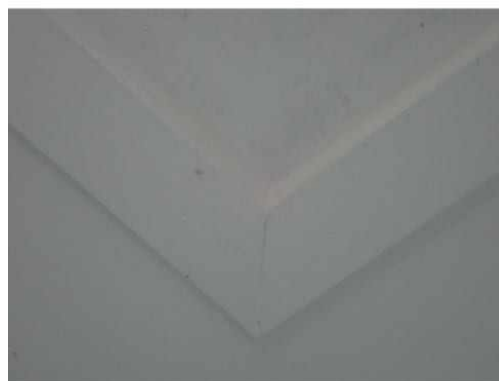
Building:	Main Building
Location:	Bedroom
Finding:	Ceiling Manhole – Sealed Shut
Information:	The ceiling manhole was found to be sealed shut at the time of inspection, restricting access to the roof void. This prevents proper inspection, maintenance, and monitoring of the roof space. It is recommended that a suitably qualified tradesperson make the manhole accessible as deemed necessary to allow safe and proper access to the roof void.
