Building and Timber Pest Inspection Report

Inspection Date: Sat, 17 Jan 2026

Property Address: 12 Michie St, Elmore VIC 3558, Australia

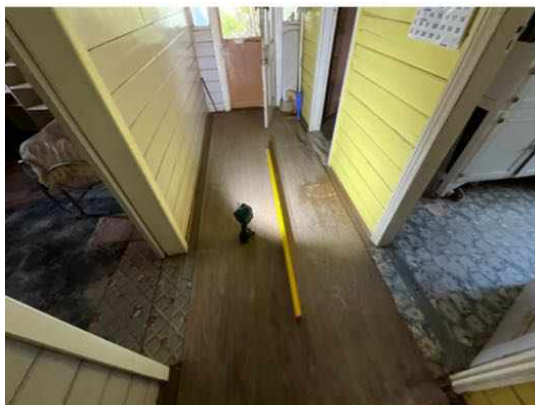
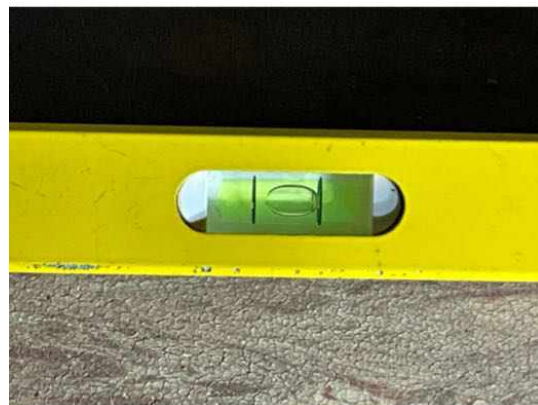
Building: Building 1
Location: All Internal Areas
Finding: Flooring - Uneven
Information: The internal flooring in this area is out of level and uneven. Uneven flooring is likely to indicate minor defects such as expected movement of the foundations of the property, but may also indicate subsidence of the associated subfloor stumps.

It is advised that the flooring be closely monitored to identify any further movement. Where flooring remains relatively unchanged for an extended period of time (i.e. several months), it is likely that this defect has been caused by expected movement of the foundations of the property.

However, where flooring is uneven further, potentially invasive inspection of the subfloor structures and stumps in this area is required. In this case, works to repair are likely to be required, and would be carried out by a registered builder specialising in re-stumping.

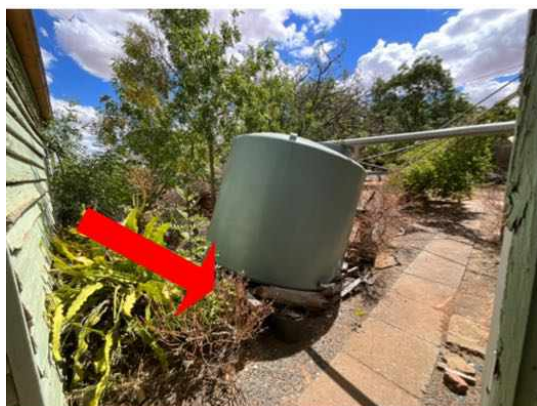
Finding 2.02

Building: Building 1
Location: Yard - Side
Finding: Tank leaning
Information: The water tank in this area is poorly supported. This has caused the tank to lean over. This instability could become dangerous if left unattended.

A plumber or tank specialist should be contacted as soon as possible to improve the support and prevent potential damage.

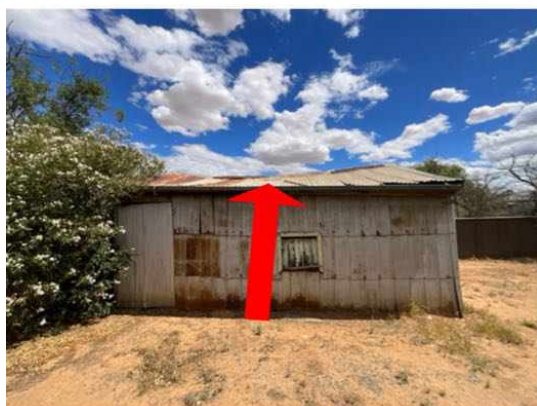
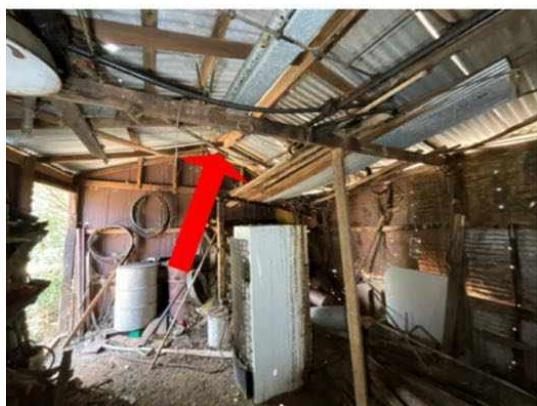
Finding 2.03

Information: The roofing structure was found to be sagging in sections at the time of inspection. This sagging is likely due to the lack of support to the roof members (rafters). These support members are referred to as under purlins and struts. While this type of construction is common for the era of building, additional support may be required.

Sagging roof structures are likely to create strain on associated building elements, creating potential for secondary damage including the deterioration of roof coverings. The roof is also unlikely to have sufficient support, which may lead to further sagging if left unmanaged.

It is advised that a Registered Builder be appointed to provide remedial advice and pricing for any necessary work.

While it would appear that this defect has been present for a long period of time repair is recommended in the short term to ensure the longevity and structural integrity of the dwelling.

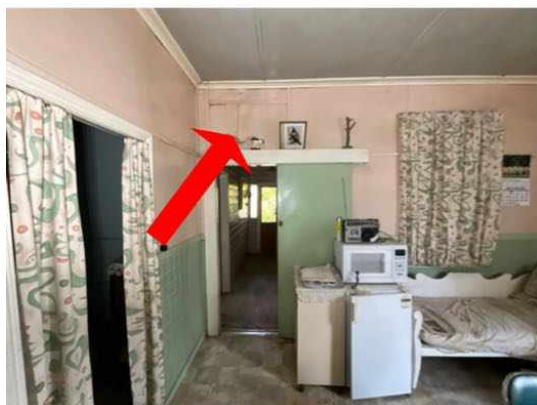
Building:	Building 1
Location:	Kitchen
Finding:	Wall- Water damaged
Information:	Water damage to the wall lining is generally an indication of excessive moisture being present in the roof void, usually via a leak to the roof covering.

Where water damage is evident to the wall, the primary requirement is to identify and rectify the source of the leak. A roofing plumber should be appointed as soon as possible to identify the leak and perform rectification works as necessary, ensuring the water damage is restricted.

Once the leak is repaired, consultation with relevant tradespeople, including painters, is advised. Rectification works may include replacement of lining board or minor repainting, depending on the extent of the damage.

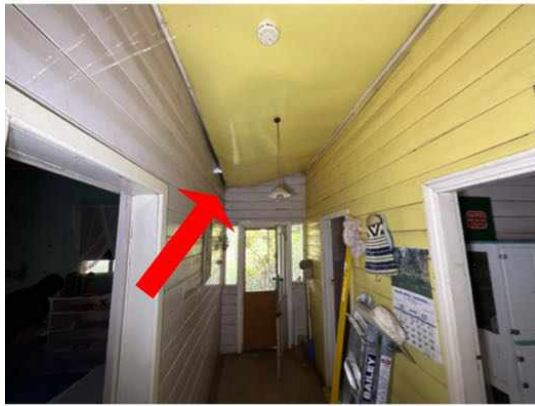
Finding 3.03

Building:	Building 1
Location:	Hallway 2
Finding:	Ceiling - Sagging
Information:	Sections of the ceiling were found to be sagging at the time of inspection. Sagging to the fixed ceiling structure generally indicates that the building materials have swollen, due to contact with water, or that fixings (e.g. nails or glue) have become loose and require reattachment.

Where minor sagging is evident, comparatively minor works, such as re-gluing of ceiling sheets, may be required. Such works may be performed by relevant tradespeople, such as plasterers and painters. Where excessive moisture has caused the roofing structure to swell and sag, the source of the water leak should primarily be identified prior to any remedial works being performed.

The appropriate action should be taken by the client as soon as possible to ensure that any potential further damage is limited.

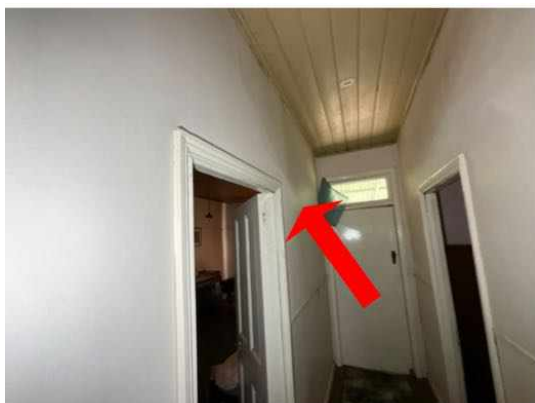
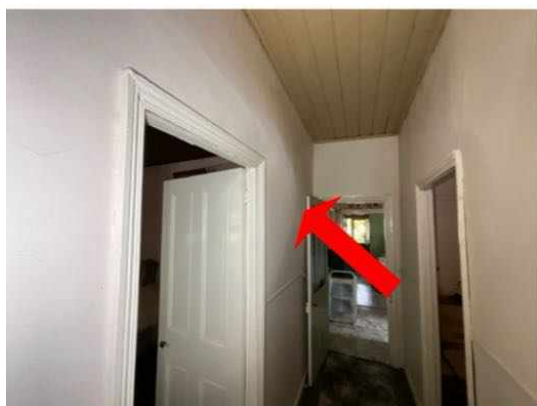
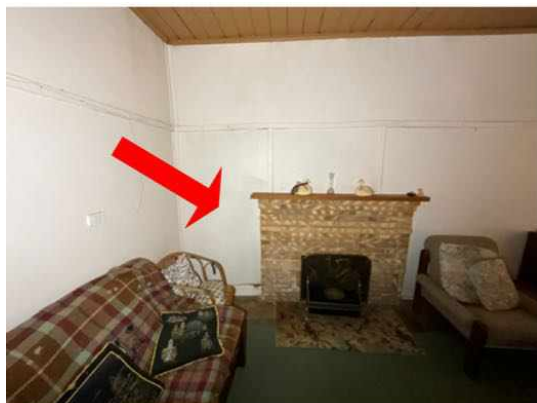
Finding 3.04

Information: Sagging and uneven surfaces generally indicate that the building materials have swollen, due to contact with water, or that fixings (e.g. nails or glue) have become loose and require reattachment. In some cases, sagging and uneven surfaces may also indicate that there are structural issues causing surfaces to warp, twist, or sag.

Where sagging appears to be major, appointment of a structural engineer is advised to further inspect the property. Otherwise, minor works such as re-gluing of wall/ceiling sheets may be required and should be performed by an aptly qualified plasterer or carpenter.

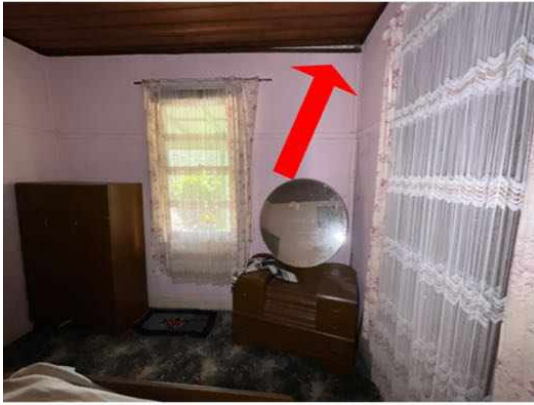
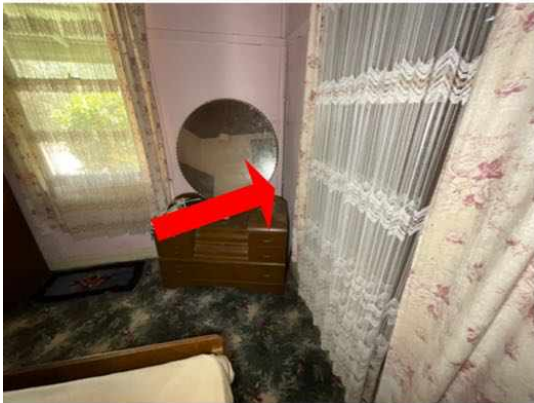
Finding 3.05

Building:	Building 1
Location:	Bedroom - Master
Finding:	Cracking - Damage
Information:	Noticeable cracks are a common occurrence as a result of many primary defects. Such causes may include age, general wear and tear, expected building movement, general expansion/contraction of building materials in different weather conditions, and/or minor failings in the installation or application of building materials.

Noticeable cracks may result in minor sticking or jamming of associated doors and windows, which require easement. However, noticeable cracks are easily filled and repaired. A plasterer can be consulted to install an expansion joint at this point to allow for this movement during different weather conditions.

Monitoring of all cracking should be conducted frequently. Always contact a building inspector should cracks widen, lengthen, or become more numerous. Additionally, your building inspector should also be contacted if associated building elements such as doors and windows become more difficult to operate over time.

Relevant tradespeople, such as carpenters, painters and plasterers, should be appointed to perform remedial works, as deemed necessary.

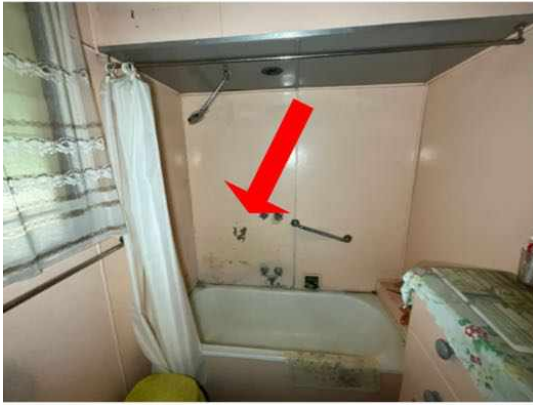
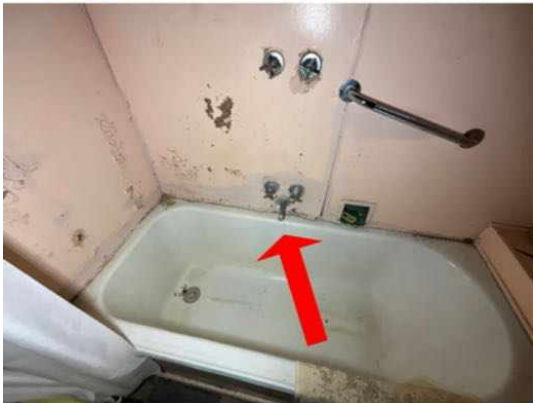
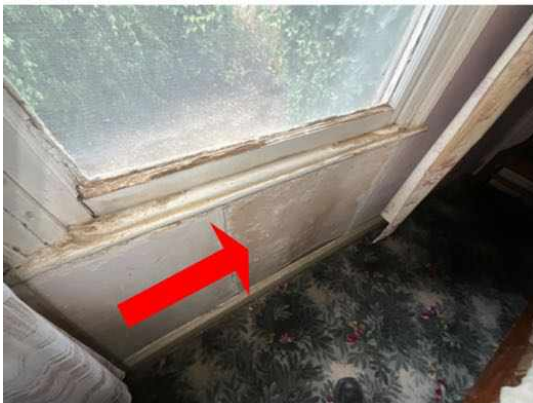
Finding 3.06

Building: Building 1
 Location: Bathroom, bed 1
 Finding: Paint- Flaking
 Information:

Sections of paint in this area was found to have deteriorated. Paint flaking is generally an indication of excessive moisture in the area, that is currently hidden by the painted surface.

The presence of excessive moisture can have major implications on associated building elements if left unattended. While only seemingly minor at this stage, the damage cannot be determined due to the paint obstructing any further inspection of the damage.

A qualified Painter should be contacted at the Owner's discretion to re-paint the area.

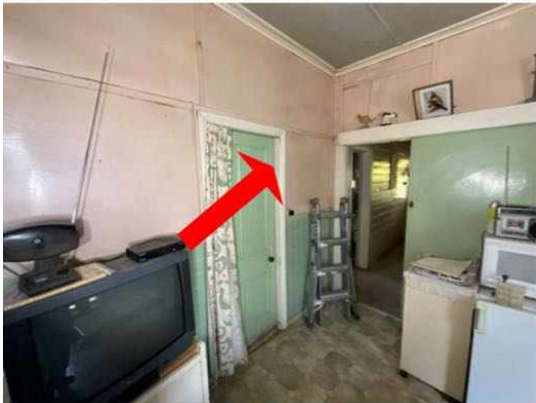
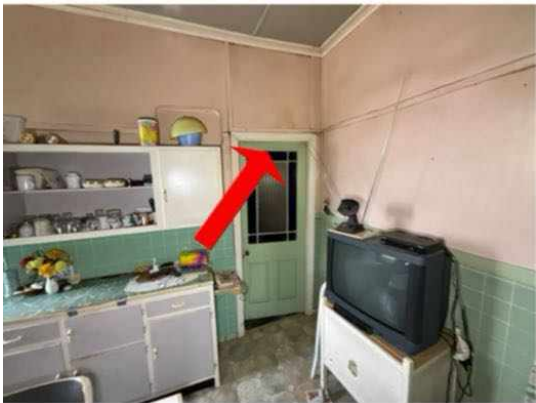
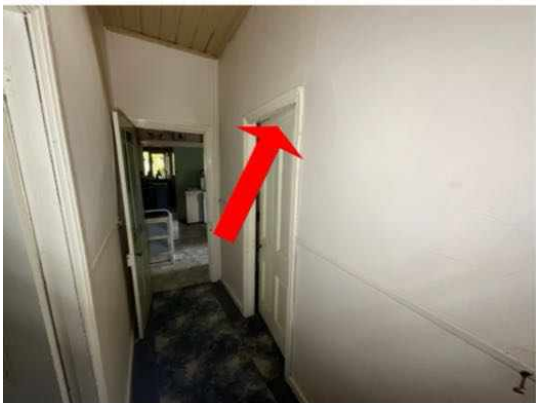
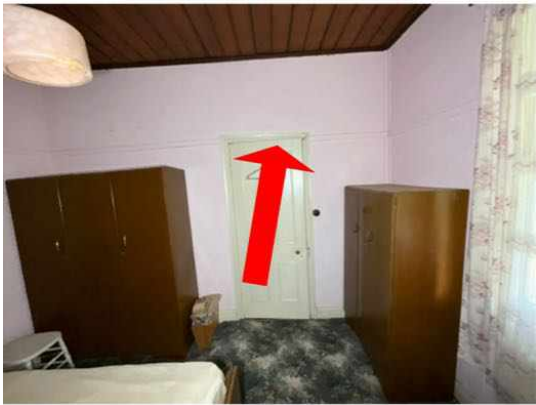
Finding 3.07

Building: Building 1
 Location: Bedroom 1, 2, hall, living
 Finding: Door- Binding/jamming
 Information: Binding and/or jamming of this door is evident during standard operation. This defect inhibits the functionality of the affected door as well as creating potential for secondary defects to associated building elements, such as damage to the floor covering.

A door that binds to flooring or to the associated door frame may have several causes, ranging from minor defects, such as poor installation of the door or deteriorated hinges, through to major structural issues, such as damage to subfloor structures.

A qualified carpenter or general handyperson should be appointed to perform minor rectification works at client discretion.

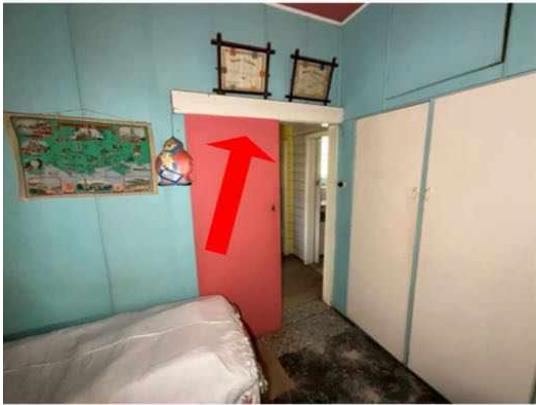
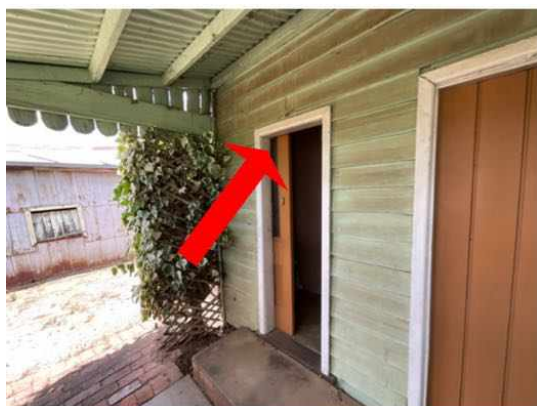
Finding 3.08

Building: Building 1
Location: Bedroom 2, Wc
Finding: Door- Stiff to slide
Information: The door in this area was jammed and difficult to slide along the associated tracks at the time of the inspection. Restricted function of the affected door may pose as a potential safety hazard if required for emergency egress from the building.

Generally, factors such as general age of the building element and a lack of maintenance are the usual causes for this type of defect.

Replacement of door hardware or tracks may be required, as well as minor repairs and cleaning. A registered builder or general handy person will be required to repair the affected doors.

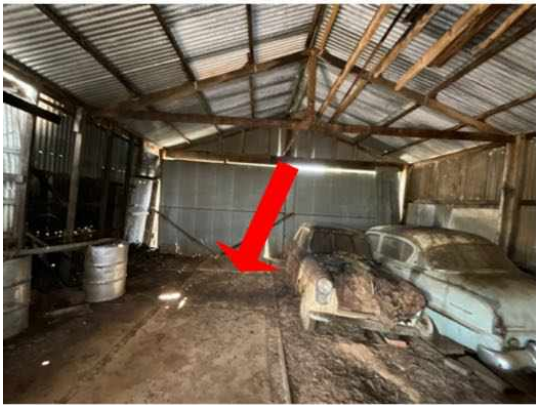
Finding 3.09

Building:	Building 1
Location:	Garage 2
Finding:	Cracking - External Concrete Paving Damage Category 4 - Gaps in Slab (4mm - 10mm +)
Information:	Gaps in the slab were identified in external concrete paving. Gaps in the slab are significant and are likely to lead to the development of safety hazards and secondary defects if left unmanaged, such as the creation of a trip hazard.

General age and expected deterioration of the paved areas is a common cause of this type of cracking. However, expansion and contraction of the slab may also have occurred due to environmental factors. Such factors include variable moisture and weather conditions, the presence of trees and their roots having a settling or lifting affect on the soil, or the effect of load bearing, e.g. heavy vehicles over a sustained period of time.

Cracking to this degree may also be due to poor original installation of the concrete. Factors such as poor compaction of the sub surface and/or inadequate reinforcing of the slab may create cracking and other secondary defects. Gaps in the concrete paving may also have a more significant structural cause, such as subsidence of soils.

Where gaps in the concrete paving are adjacent to structural elements of the building, the advice of a Structural Engineer is advisable before undertaking repairs. Significant repair and likely replacement of the concrete paving is probable.

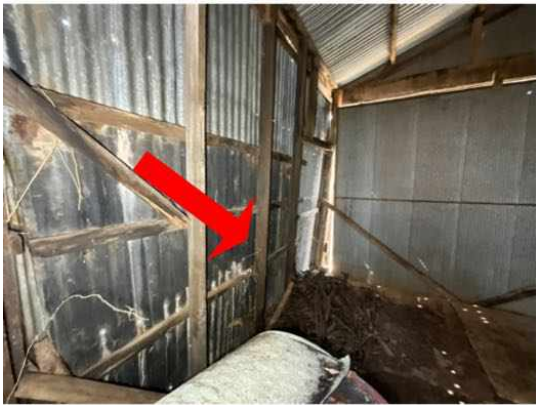
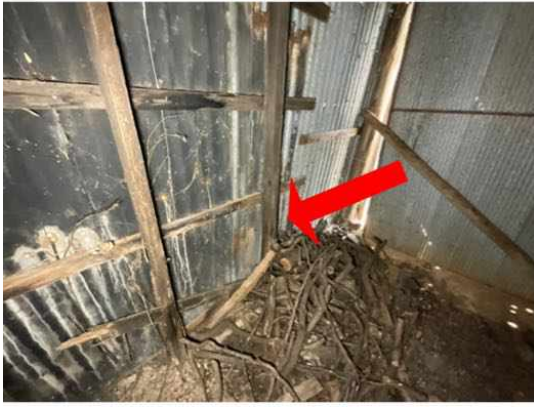
Building: Building 1
 Location: Garage 2
 Finding: Evidence of termite damage - minor
 Information: Despite no live termite or timber pest activity being indicated, previous termite damage was found to have affected this area. This damage is considered to be inactive and is minor in nature.

It is advised that the area be visually inspected frequently to ensure that the condition of affected building materials does not worsen. At the time of inspection, damage is not structural and is only considered to be superficial.

A building contractor may be appointed to provide a further invasive inspection if further damage is evident.

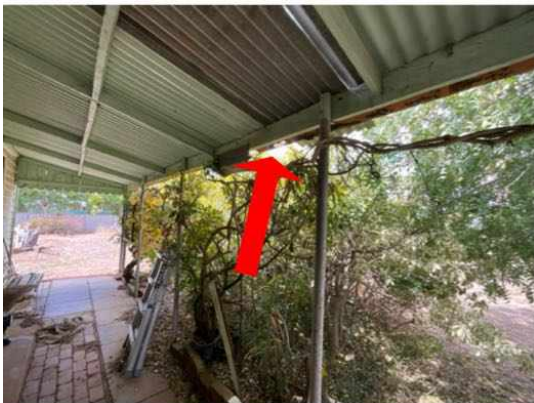
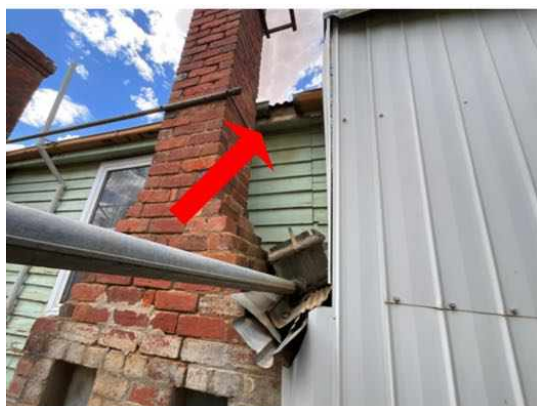
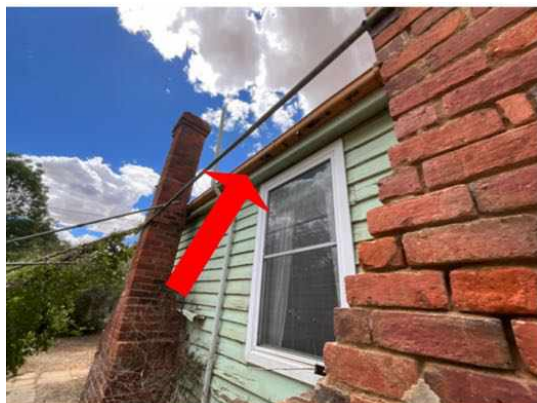
Finding 6.01

Building:	Building 1
Location:	Verandah, eaves
Finding:	Gutters- Deteriorated
Information:	The guttering and some downpipes have deteriorated.

Although not a major problem now, they will deteriorate further if left for an extended period.

Sagging can be seen in the rear gutter.

A Licensed Plumber should be engaged as soon as possible to advise on any repairs or maintenance that may be required.

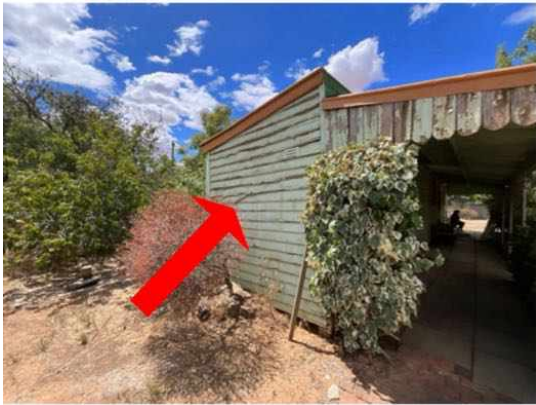
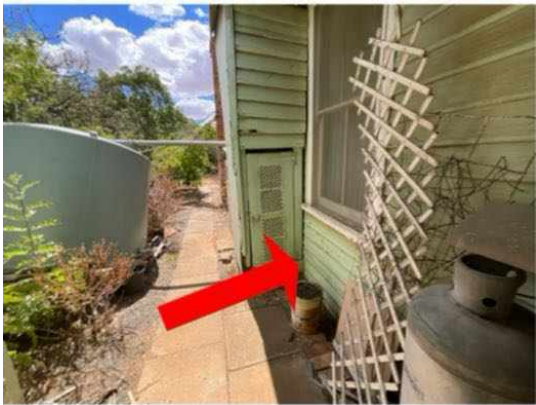
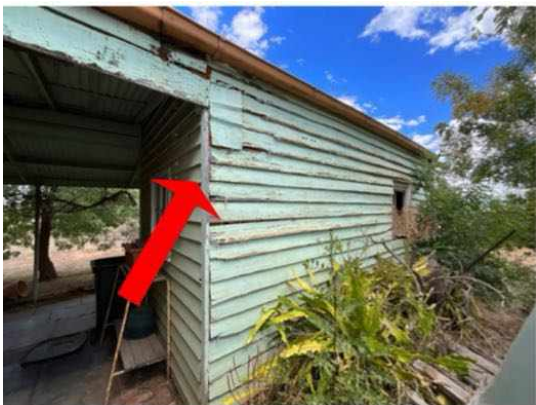
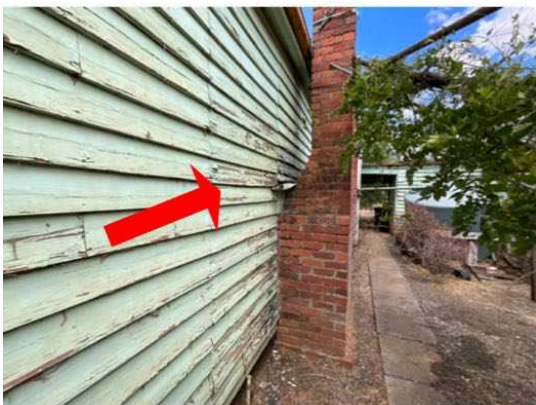
Finding 6.02

Building:	Building 1
Location:	All External Areas
Finding:	External painting deteriorated
Information:	Much of the external paintwork including but not limited to windows, fascias, guttering, veranda and other external fitments have been neglected and require attention to prepare and re-paint.

Whilst incomplete or missing paint finish is generally an appearance defect, it can also lead to the development of secondary building defects over time. Incomplete areas of paint finish expose the area to moisture, potentially accelerating the deterioration of underlying building materials.

Degraded paint finishes should be sanded back, filled, leveled and painted, as applicable. Where inadequate or missing paint protection has led to the deterioration of the associated building element, repair and/or replacement of this building element may be required.

A painting contractor should be appointed as soon as possible to perform necessary works to aid the appearance of the affected area and to ensure the area is protected against further deterioration. Alternatively, the homeowner following manufacturer instructions may perform these works.

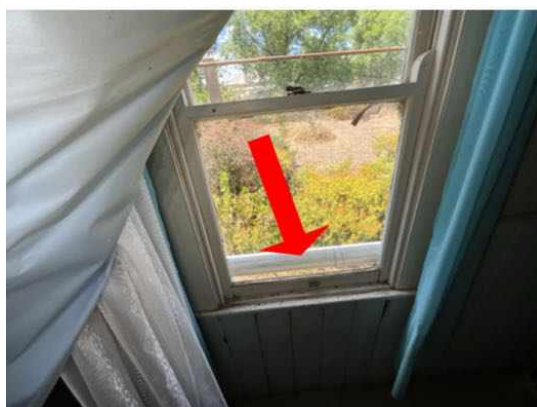
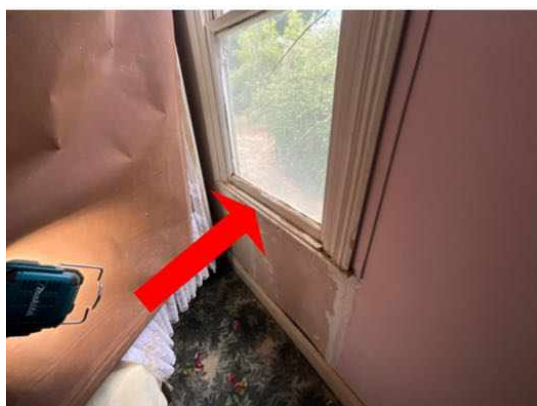
Finding 6.03

Building: Building 1
 Location: Bedroom 1,2
 Finding: Timber - exposed to weather
 Information: External timbers that are frequently exposed to harsh weather conditions require adequate protection in order to maintain their condition. Where timbers have not been painted or treated adequately, general deterioration is likely to occur at an accelerated rate.

If left unattended, replacement of these timbers is likely to be necessary in the short-term future. Adequate treatment of these timbers is required as soon as possible by a painting contractor or general handyman.

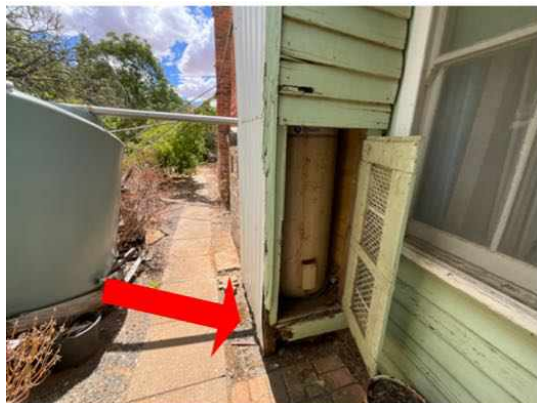
Finding 6.04

Building: Building 1
 Location: Yard - Side
 Finding: HWS Overflow - Not Connected
 Information: The Hot Water System (HWS) overflow was found to be disconnected from storm water drainage and is creating excessive moisture in the surrounding area.

These damp conditions can lead to secondary defects such as rot, rust or corrosion of associated building elements, the formation of fungal decay, or even the creation of potential slip hazards. When coupled with poor site drainage, pooling of water may

also attract termite activity to this area.

It is highly recommended that a licensed plumber be appointed to connect the HWS overflow in order to prevent such an environment from being created. These minor works should be carried out as soon as possible.

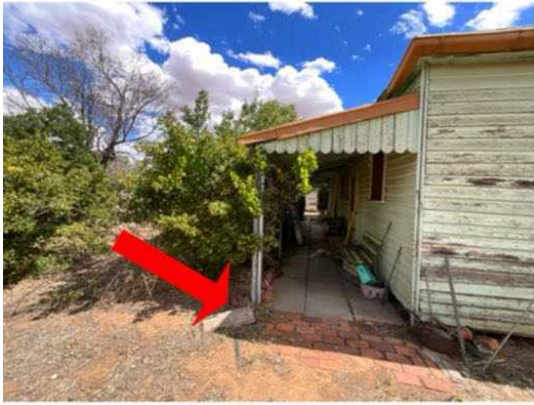
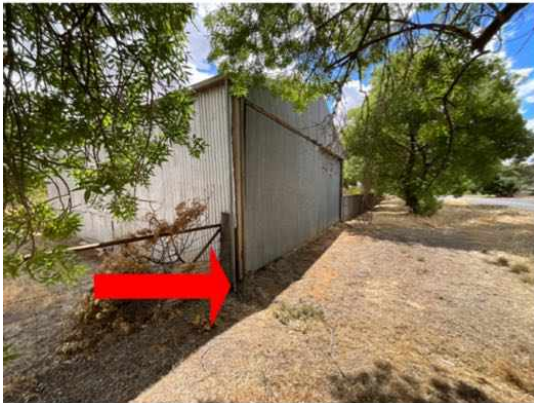
Finding 6.05

Building:	Building 1
Location:	Verandah, garage 2
Finding:	Stormwater drain - Not connected
Information:	The roof plumbing is not adequately connected to stormwater drainage on the site. This disconnection negatively impacts the functional capacity of the roof plumbing.

Where roof plumbing doesn't drain adequately, the area at the base perimeter can become excessively damp, potentially creating an environment that is susceptible to rust and corrosion of surrounding building elements, as well as attracting termites and other pests.

It is highly recommended that a plumber be appointed to further inspect the area and to install adequate drainage equipment where necessary.

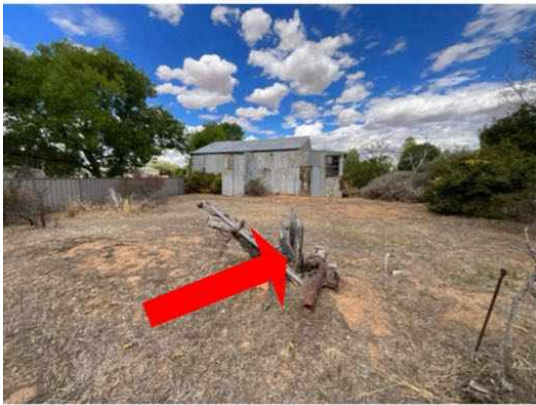
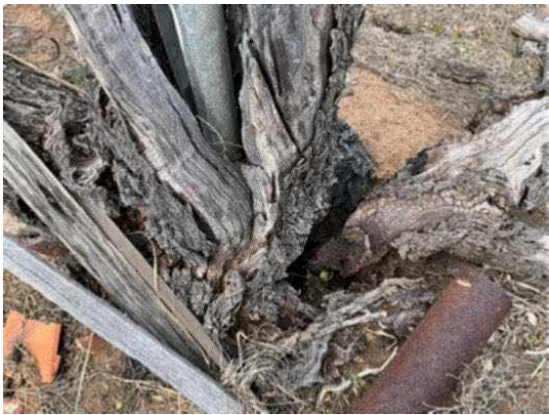
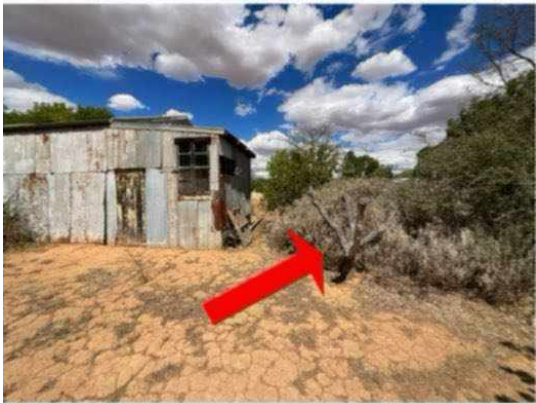
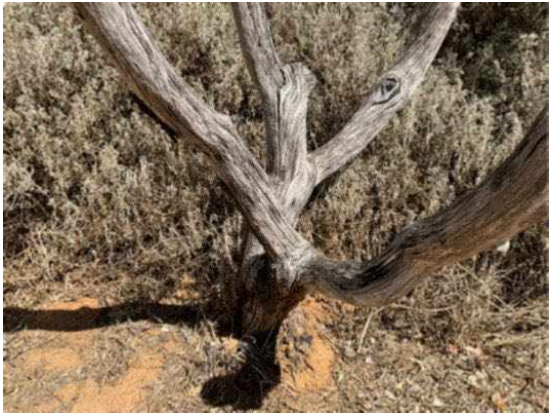
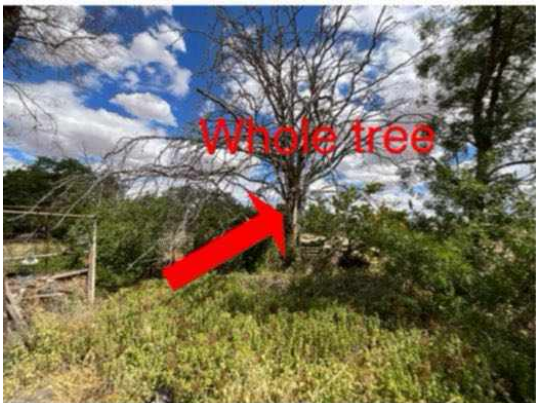
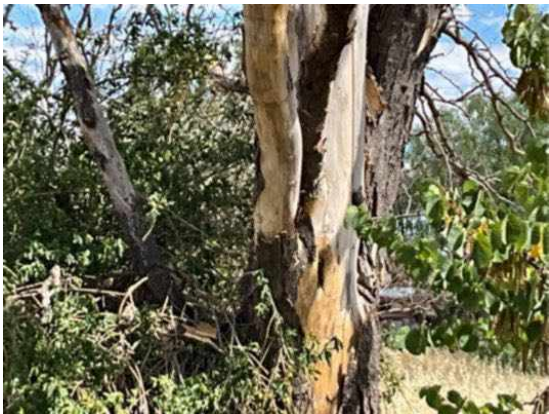
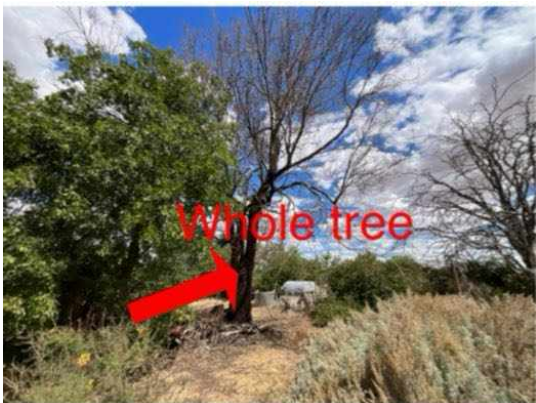
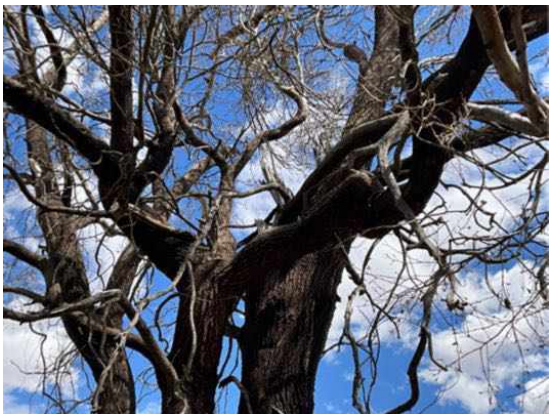
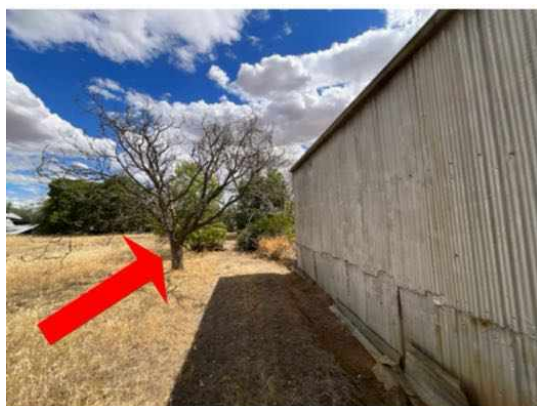
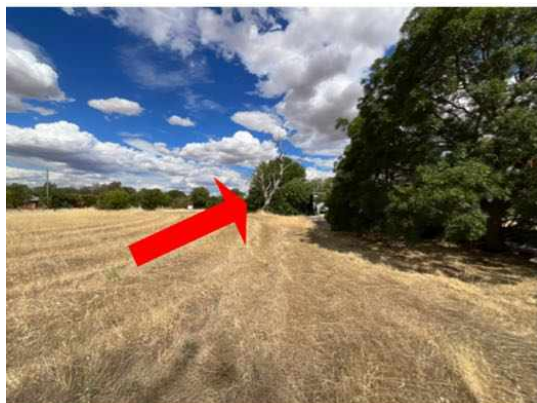
Building:	Building 1
Location:	Yard - Back
Finding:	Tree Stump in Ground
Information:	Any tree stumps in the yard not removed during the tree removal process provides the opportunity for Termite infestation and is likely to be subject to decay from damp conditions against the stump.

All tree stumps should be removed by professional tree removal services where possible. Meanwhile regular inspections are advised to identify any termite activity in the areas identified.

Services for tree stump removal should be contacted as soon as possible to reduce the risk of timber pest attack.

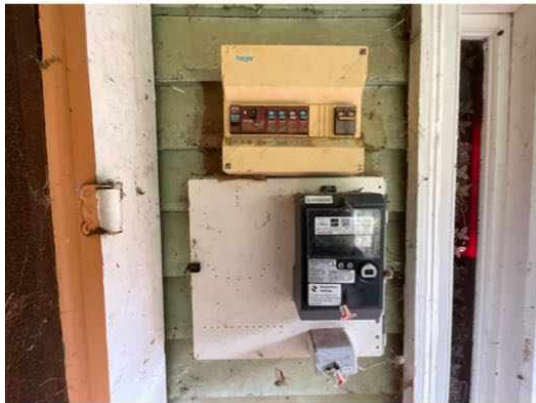
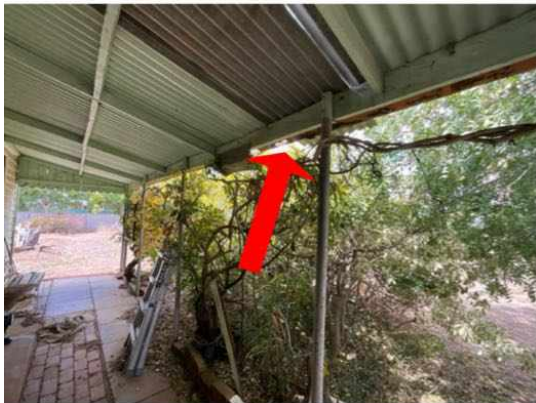
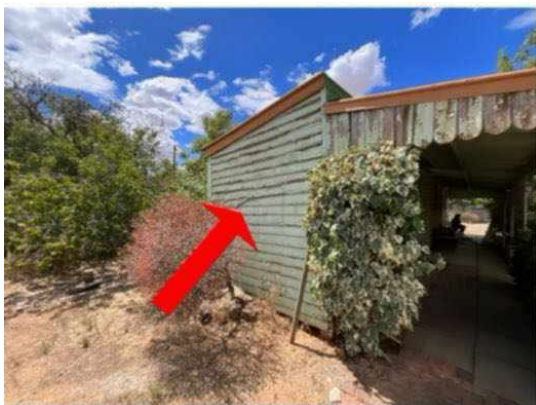
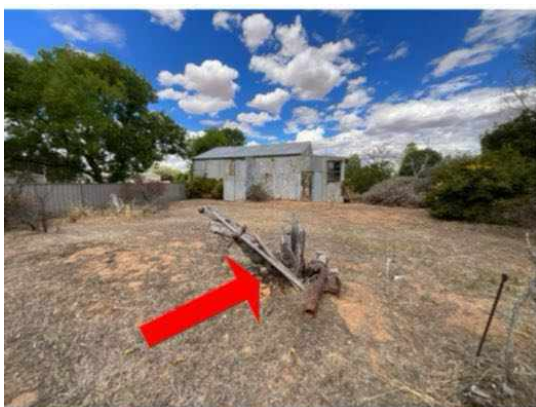
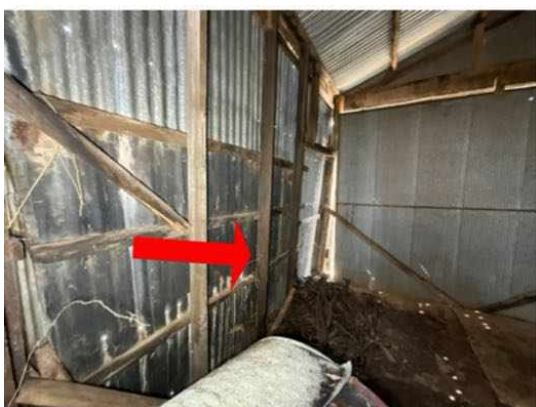
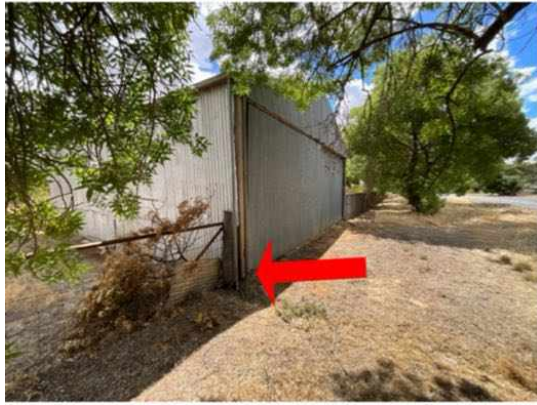
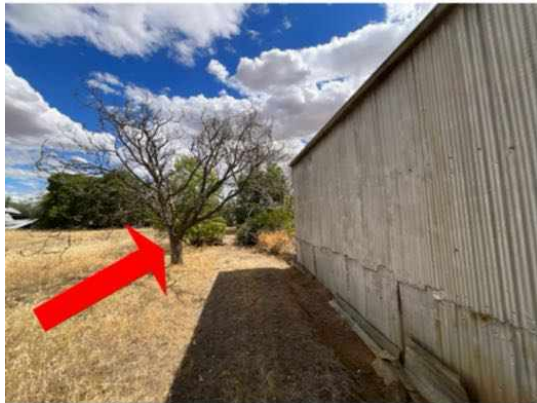
Finding 6.07

Building:	Building 1
Location:	All External Areas
Finding:	Termite Management System - no evidence of a chemical installation
Information:	The application of a post-construction chemical termite barrier is highly recommended for all properties, particularly if live termite activity has been found on the site previously. Such barriers are highly effective in preventing termite attack on any timber building elements throughout the property.

A durable notice should be placed in the switchboard unit to indicate current termite barriers. At the time of inspection, it appeared as though no termite management system has been installed, with no evidence to suggest preventative works taking place.

The client may consider gaining further advice from a pest controller as to the costs and procedures involved with this application. It is recommended that obtaining such advice be a short-term priority.

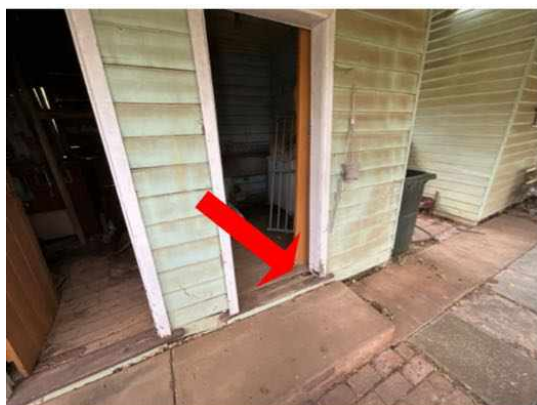
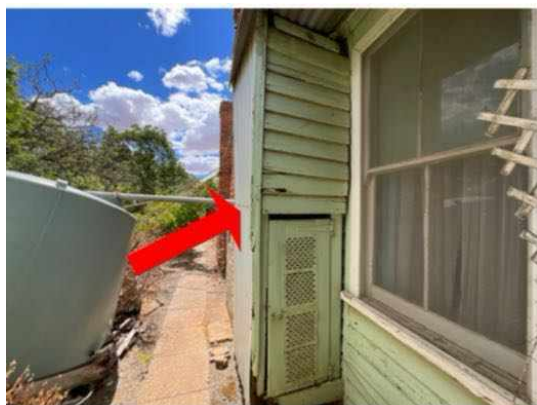
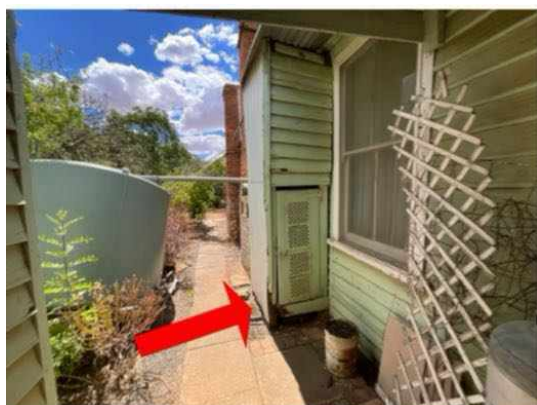
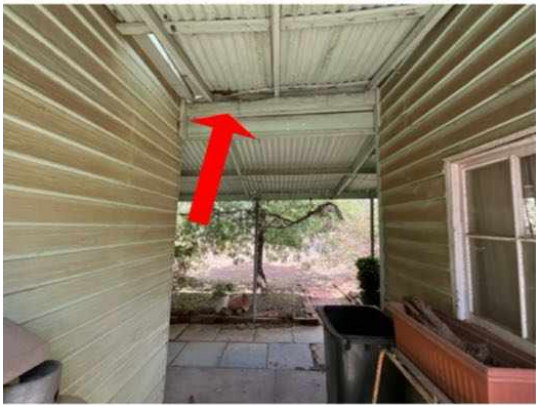
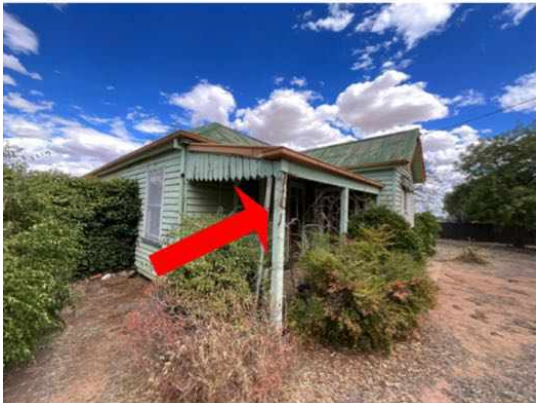
Finding 7.01

Building:	Building 1
Location:	Laundry, side yard, verandah
Finding:	Fungal decay - present (localised)
Information:	Fungal decay also known as wood decay or wood rot generally refers to the deterioration of timber elements when in contact with excessive levels of moisture for a prolonged period of time.

In this case although the affected timber element is in a decaying state the extent of any visible damage appears to be localised to a specific area and is yet to spread to other parts of the building element or affect adjoining structures. The fungal decay is therefore likely to be of a relatively superficial nature with minimal impact on the structural integrity or tensile strength of the timber element.

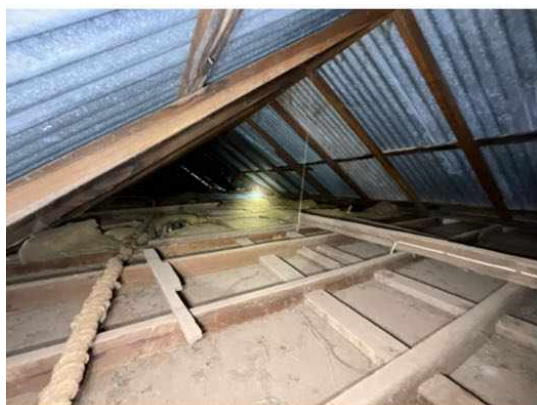
Building:	Building 1
Location:	Roof Void, rear rooms
Finding:	Insulation - Missing
Information:	Upon inspection of the roof void it was noted that insulation is not present.

Insufficient insulation will result in a comparatively higher cost to heat and cool a property as there is a lack of Insulation (or uneven coverage of insulation) which works as a barrier to heat transfer. This helps to keep out unwanted heat in summer and preserves warmth inside your home in winter. It can also help soundproof your home from unwanted airborne noise transfer.

Where insulation is absent, the area does not meet current Australian Standards. Installation of adequate insulation is required and should be conducted as soon as possible.

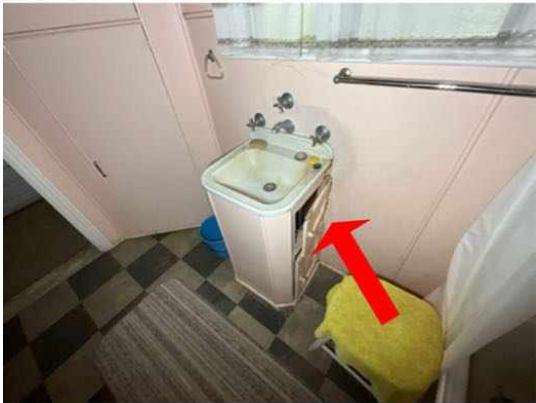
Building:	Building 1
Location:	Bathroom
Finding:	Cabinets- moisture affected.
Information:	The structure of the Cabinets in this area was found to be deteriorating due to the effects of excessive moisture. Replacement of any damaged board materials is recommended. Parts of the Cabinetry not badly damaged or swollen may be re-sealed or painted.

The source of the moisture must be identified and rectified before repairs and replacement is carried out. The services of a Cabinet maker or General Handy Person should be sought at the discretion of the owner.

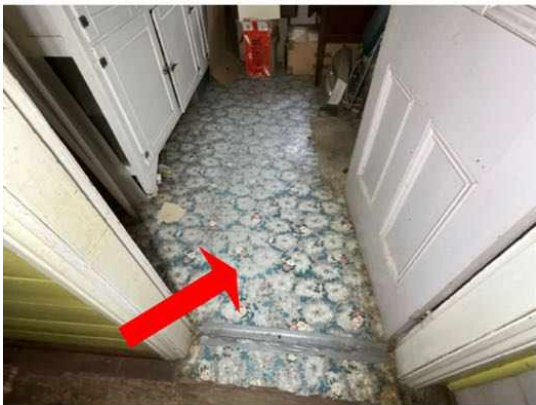
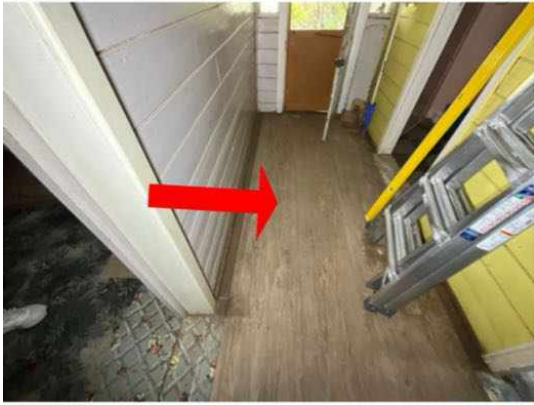
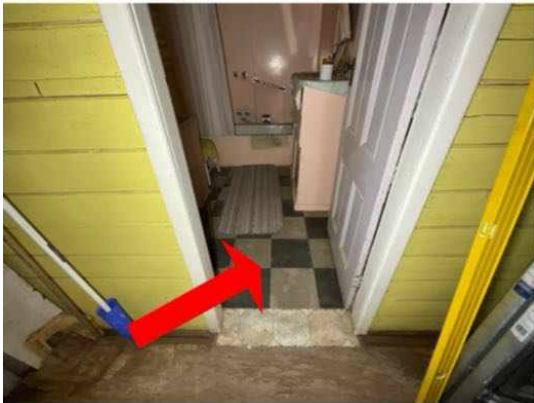
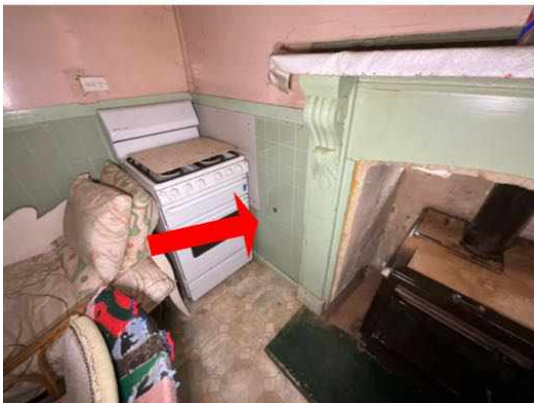
Building: Building 1
Location: Rear hall area, kitchen
Finding: Asbestos - Suspected ACM Identified on Site
Information: Reporting on Asbestos is outside the Scope of this Report. This suspected defect is highlighted as a caution only. We suspect, based on our experience in the building industry, that there is a higher risk of the identified building element containing asbestos.

As Asbestos Reporting is outside the scope of this report, we advise that you consider a separate Asbestos Inspection and Condition Audit, which can include the taking of samples for definitive confirmation of the presence of Asbestos.

In the interim, the client is advised to act with caution, especially when considering any damage to building materials general wear and tear renovations extensions demolition and general maintenance activities due to the suspected presence of Asbestos.

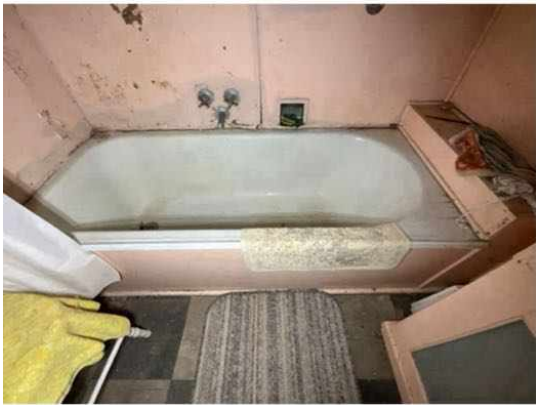
Building:	Building 1
Location:	All Areas
Finding:	Additional Photos - Obstructions and Limitations
Information:	These photographs are an indication of the obstructions and limitations which impeded full inspection of the property at the time of inspection. These obstructions can hide an array of defects and should be removed to allow full inspection to be carried out. A re-inspection is recommended once the areas are made accessible.
