# Building and Timber Pest Inspection Report

Inspection Date: Thu, 12 Mar 2026

Property Address: 4 Thackeray Cl, Wetherill Park NSW 2164,  
Australia

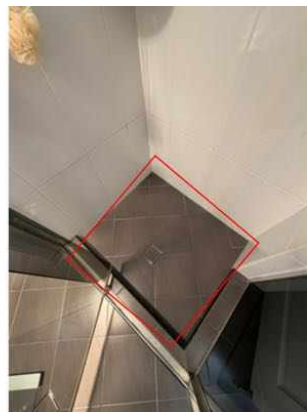
Building: Main Building  
 Location: Shower  
 Finding: Shower-Re Grouting/Sealing required  
 Information: The tiled shower floor was observed to have significant deterioration of the grout

between the tiles. In many areas the grout has washed away over time, leaving open joints between the tiles. This condition allows water to penetrate beneath the tiles and may lead to moisture ingress, deterioration of the substrate, and potential water damage to surrounding building elements.

The shower base requires the removal of any loose or remaining deteriorated grout, followed by regrouting and proper sealing to restore the integrity and waterproof performance of the shower floor. Repairs should be carried out by a suitably qualified tradesperson.

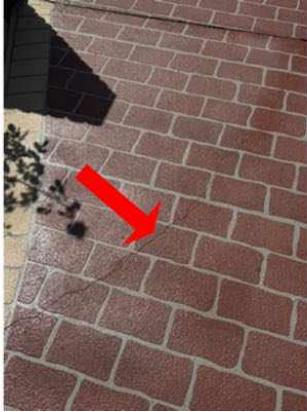
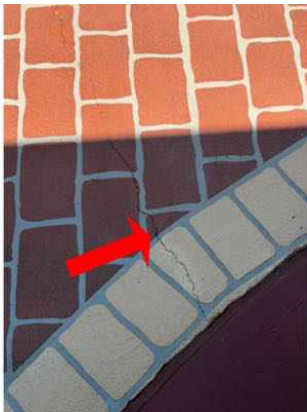
| Finding: | Cracking - External Concrete Paving Damage Category 0 - Hairline (less than 1 mm) |
| Information: | Hairline cracks were identified in external concrete paving. Hairline cracks are very minor in nature and generally are only ever an appearance defect. To be classified as a Category 0 or hairline crack, the crack width would be less than 0.3mm. While such cracking may be noticeable in some cases, it is common and does not indicate any structural damage. |

Generally the cause of a hairline crack in existing concrete paving such as driveways and pathways is indicative of the expansion and contraction of the concrete. Such causes are generally due to environmental factors, such as moisture levels, weather conditions, root systems of nearby trees or the soil types on which they are laid.

Hairline cracks may also be due to poor original installation of the concrete. Factors such as poor compaction of the sub surface and/or inadequate reinforcing of the slab may create cracking and other secondary defects.

Monitoring of all cracking should be conducted frequently. Always contact a building inspector should cracks widen, lengthen, or become more numerous.

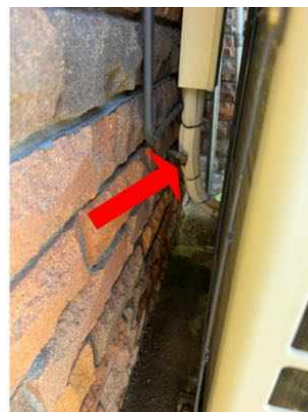
These damp conditions can lead to secondary defects such as rot, rust or corrosion of associated building elements, the formation of fungal decay, or even the creation of potential slip hazards. When coupled with poor site drainage, pooling of water may also attract termite activity to this area.

It is highly recommended that a qualified plumber be appointed to install adequate drainage to the overflow. These works will ensure that the area remains dry and free of any secondary defects.

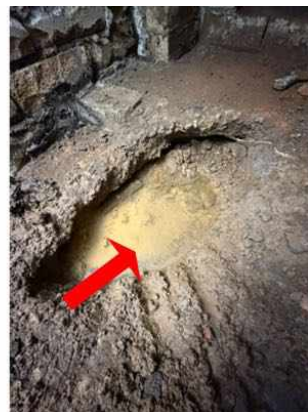
### Finding 6.03

| Finding: | Excessive subfloor moisture |
| Information: | Excessive moisture can attract termites and produce conditions that promote termite attack fungal growth and wood decay. |

Excessive moisture is generally caused by inadequate subfloor ventilation and poor site drainage.

The installation of additional surface drainage to the property would also be beneficial to keeping the subfloor dry.

It is highly recommended that both subfloor ventilation and site drainage be improved and maintained regularly in order to prevent excessive moisture being present in the external / internal property.

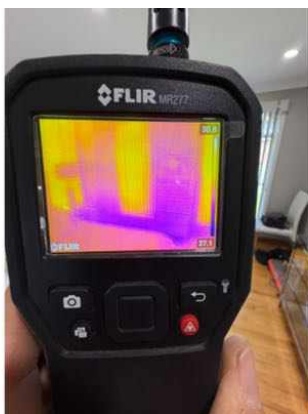
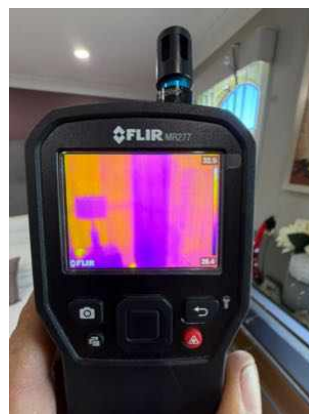
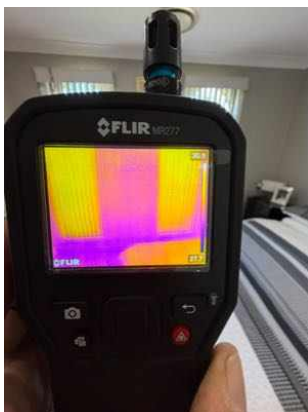
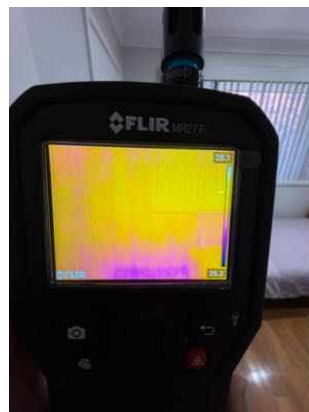
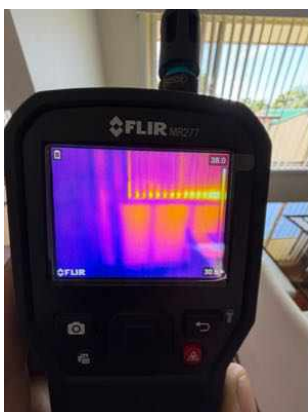
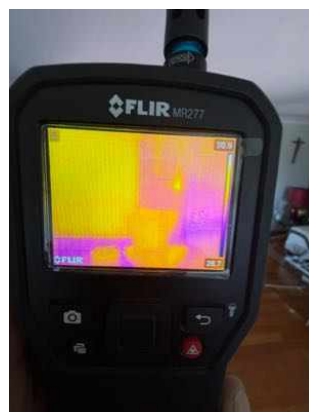
| Information: | AS 3660.2:2017 is the recommendation for the carrying out of 'Additional Tests' using specialist non-destructive tools: |

A thermal imaging inspection was carried out throughout the interior of the house using a Flir MR277 thermal camera. No thermal anomalies were noted that would be consistent with any current termite activity, however various factors must be taken into effect which may hamper or impede the reading obtainable by the imager. These factors include obstructions, ambient temperature, wall material and thickness etc. If any surface is restricted visually or otherwise, a proper thermal reading is not possible and is not within the scope of this inspection. Any findings or otherwise is reported on at the time of the inspection only.

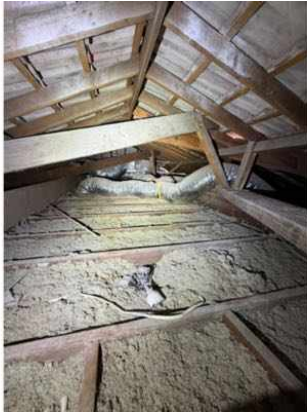
| Information: | These photographs are an indication of the obstructions and limitations that impeded the full inspection of the roof cavity at the time of inspection. Note that the insulation covered nearly all the ceiling joists, which are a major structural element of the ceiling; the inspection was also limited to areas with an allowable crawl space of 600mm x 600mm, in particular towards the external walls where the roof line diminishes, it was not accessible. These obstructions and limitations can hide an array of defects and should be removed to allow a full inspection to be carried out. A re-inspection is |

recommended once areas are made accessible.

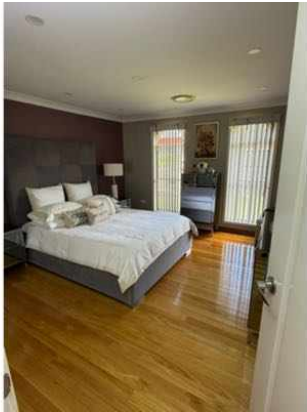
Finding: Obstructions and Limitations-Internal areas

Information: These photographs are an indication of the obstructions and limitations which impeded full inspection of the internal areas at the time of inspection. These obstructions can hide an array of defects and should be removed to allow a full inspection to be carried out. A re-inspection is recommended once the areas are made accessible.

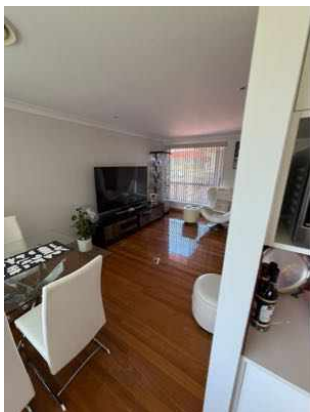
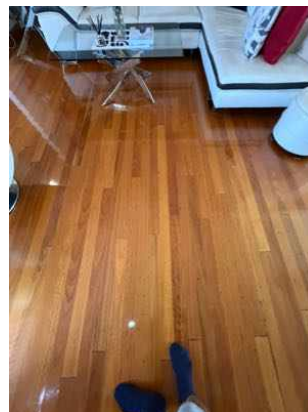
Building: Main Building  
Location: All Internal tiling  
Finding: FYI-Internal Timber Flooring  
Information: At the time of inspection, the internal hardwood timber flooring throughout the dwelling was observed to be in good overall condition. No significant defects, excessive movement, or notable deterioration were identified at the time of the inspection. The flooring appeared to be serviceable and performing as intended.

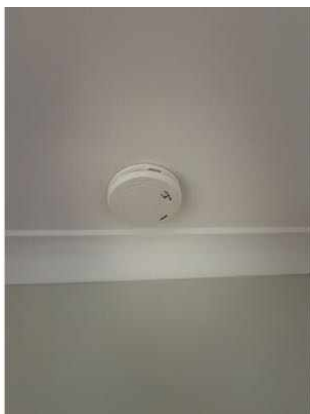
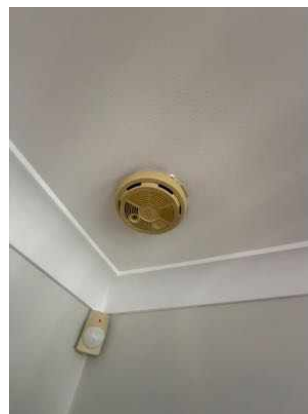
Building: Main Building  
 Location: Smoke Detectors  
 Finding: FYI-Smoke Detectors and Alarms  
 Information: Reporting on Smoke Detectors or Alarms, including hard wired smoke detection systems and their legislative requirements, is outside the Scope of this Report.

Please note that this defect is highlighted as a caution only. We suspect, based on our experience in the building industry, that the absence of smoke detectors, or their poor condition, should be addressed as a matter of urgency to improve occupant safety.

Always ensure sufficient working and suitable smoke detectors are installed prior to occupying any building. Additionally, it is advised that all smoke detectors be tested by the homeowner on a monthly basis.

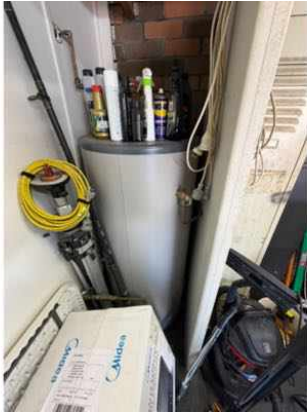
Building: Main Building  
Location: Hot Water System  
Finding: FYI-Hot Water Unit  
Information: The HWS appeared to be in good condition at the time of inspection. For the date of manufacture - (see attached photo)

Water pressure appears to be normal, however, this is not an opinion of a licensed plumber. No water hammer was noted when taps are turned off fast.

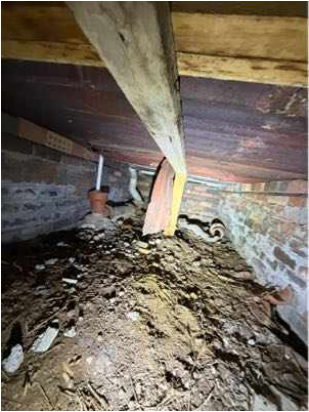
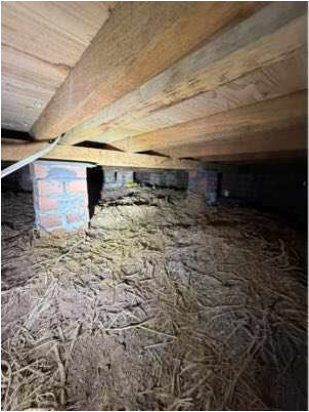
Building: Main Building  
Location: All Areas  
Finding: FYI-Additional Photos  
Information: Additional photos are provided for your general reference and may include obstructions, testing of water and windows, moisture readings or minor maintenance items.
