Building Inspection Report

Inspection Date: Thu, 26 Feb 2026

Property Address: 3/8 Central Ave, Boronia VIC 3155,
Australia

Company Name: Jim's Building Inspections (Croydon)

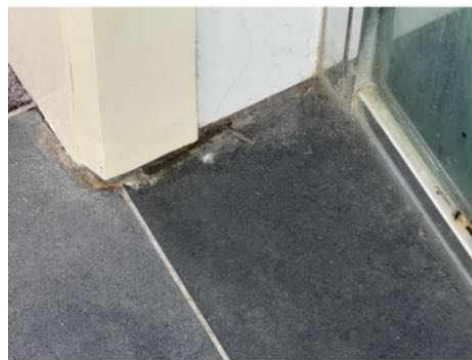
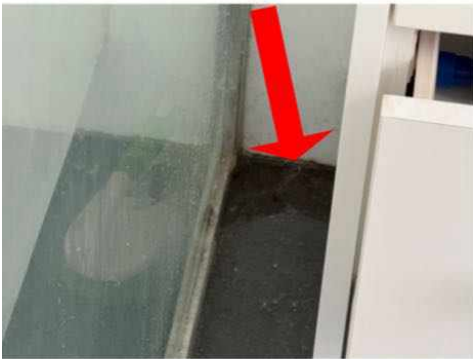
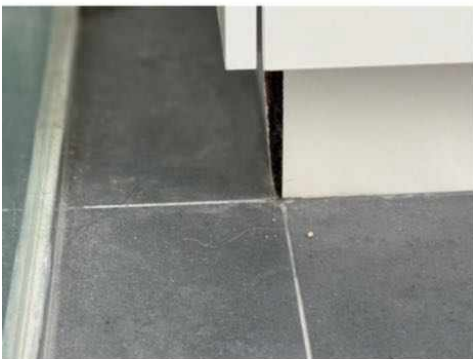
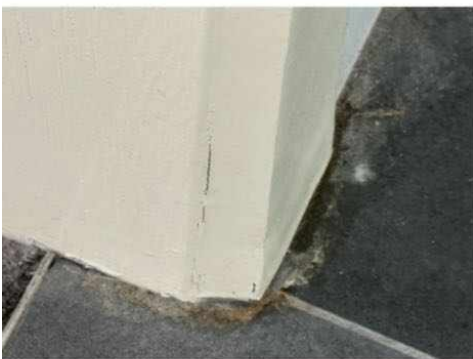
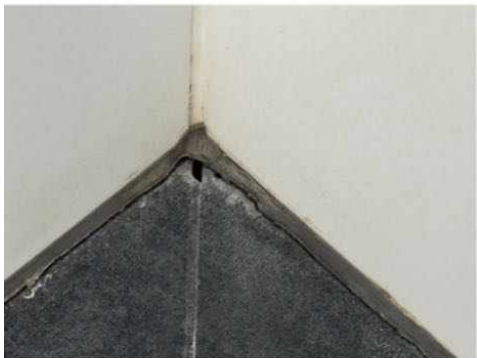
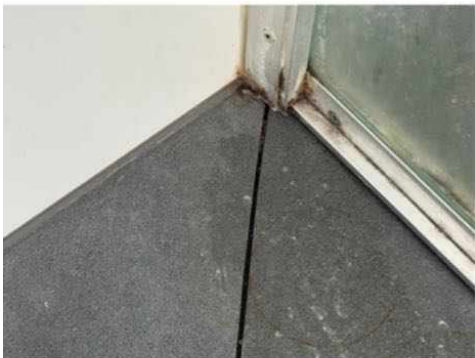
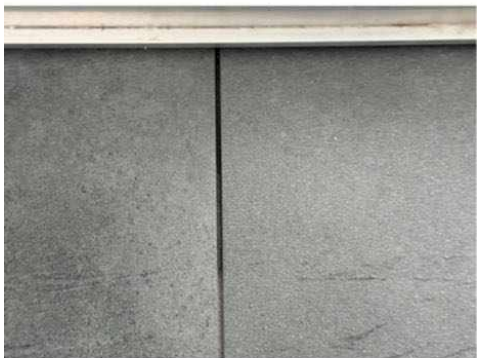
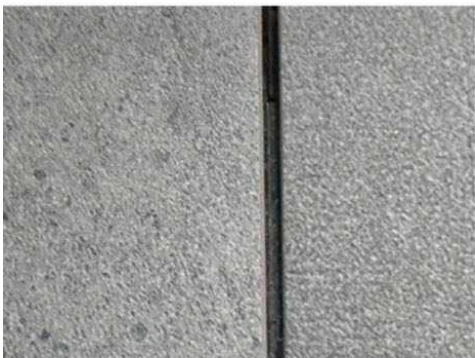
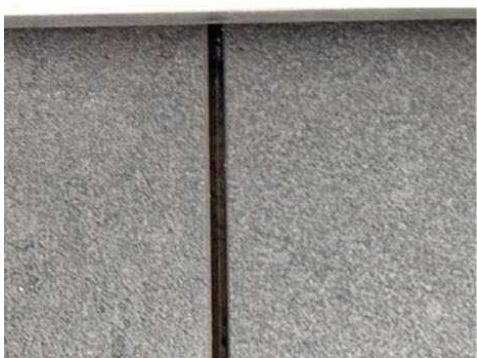
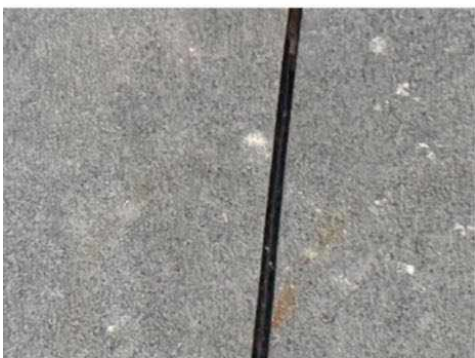
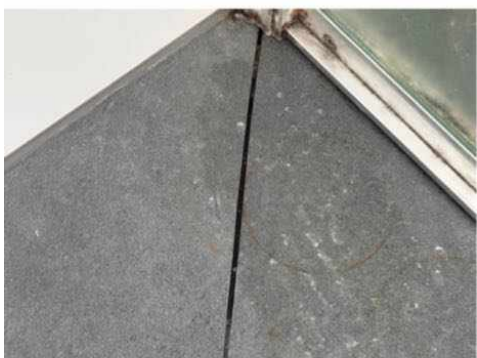
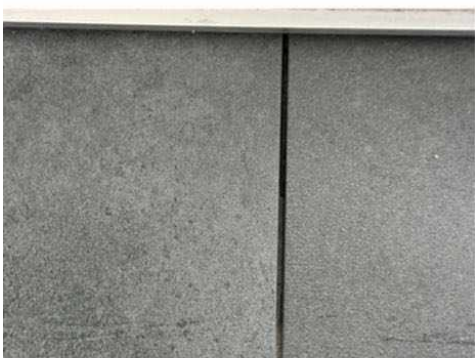
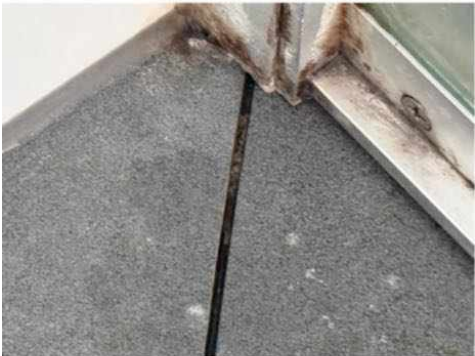
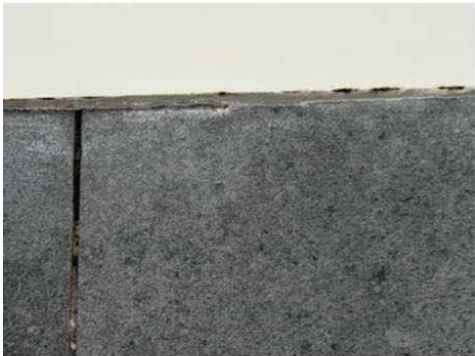
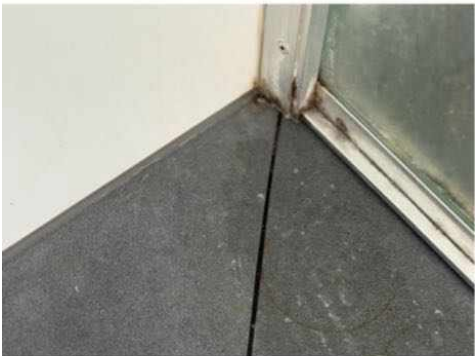
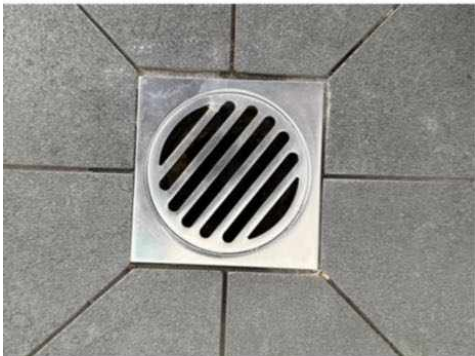
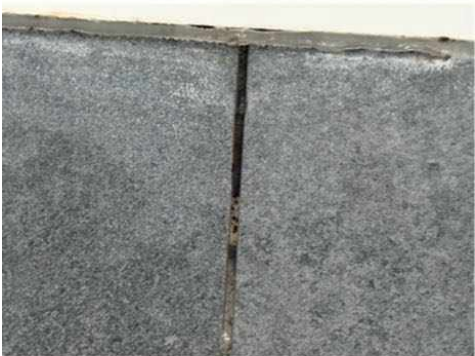
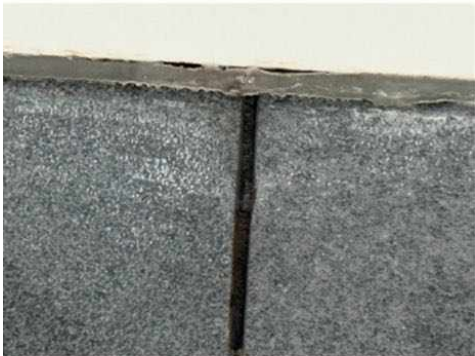
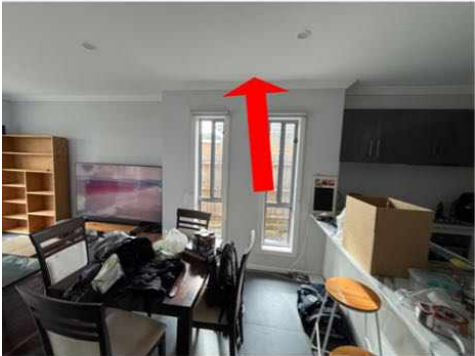
Defects 2.01

Building: Building 1
Location: Bathroom > All Areas
Finding: Suspected active moisture and water leak under the shower alcove floor tiles
Information: Active moisture and water leak was observed in and around the shower alcove. Moisture or water leaks are suspected to be entering where the grout between the tiles has been dislodged or missing. If left unmanaged water and moisture will certainly graduate further to cause secondary damage, corrosion and deterioration.

Where water damage is observed, the primary requirement is to identify and rectify the source of the leak immediately. A licensed builder should be appointed as soon as possible to remove the relevant shower floor tiles to identify any damage or deteriorated building elements and perform remedial works as deemed to be necessary to repair the leaks. Immediate action to rectify this problem will help ensuring the water damage is restricted and contained.

Once the shower floor tiles are repaired, consultation with relevant tradespeople, such as a cabinet maker is advised. Rectification works may include replacement of the basin cabinet and other building elements depending on the extent of the damage and how long the leak has been active.

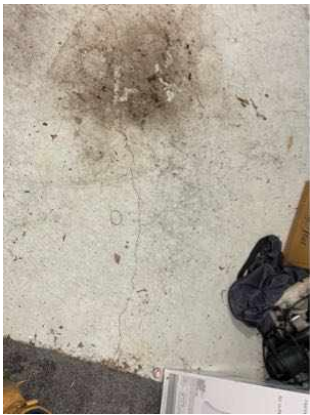
Defects 3.04

Building:	Building 1
Location:	Garage floor > All Areas
Finding:	Minor garage concrete cracks
Information:	The garage showed minor concrete cracks at the time of the inspection. Concrete cracks were considered to be minor are a common occurrence as a result of many primary defects. Such causes may include age, general wear and tear, expected building movement, general expansion/contraction of building materials in different weather conditions, and/or minor failings in the installation or application of building materials.

Monitoring of all cracking should be conducted annually. Contact a relevant tradespersons should cracks widen, lengthen, or become more numerous.

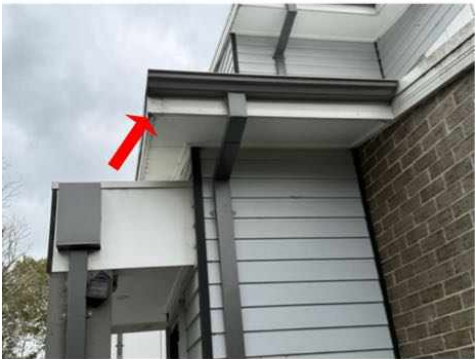
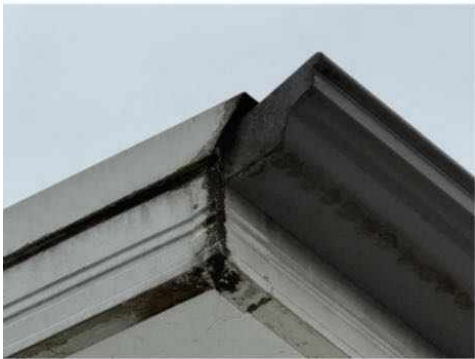
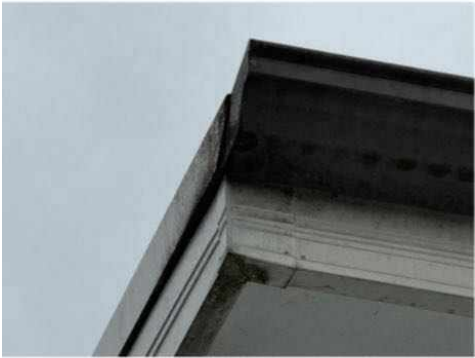
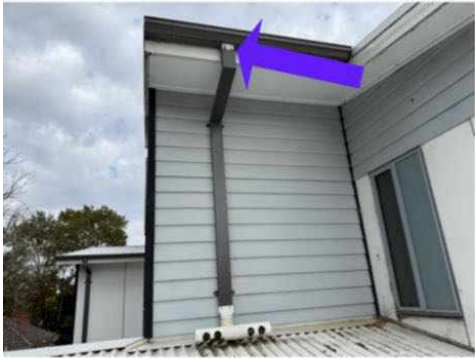
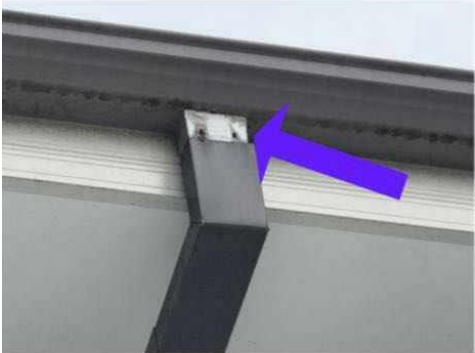
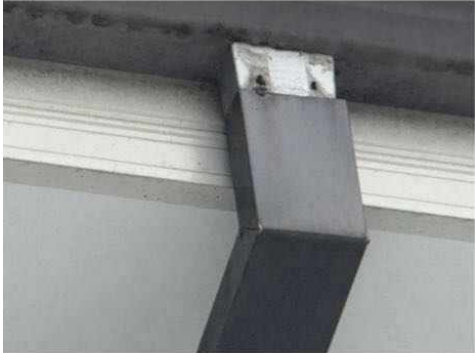
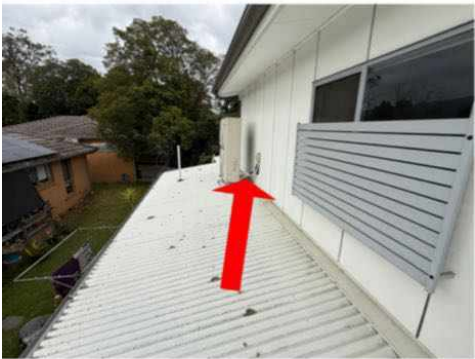
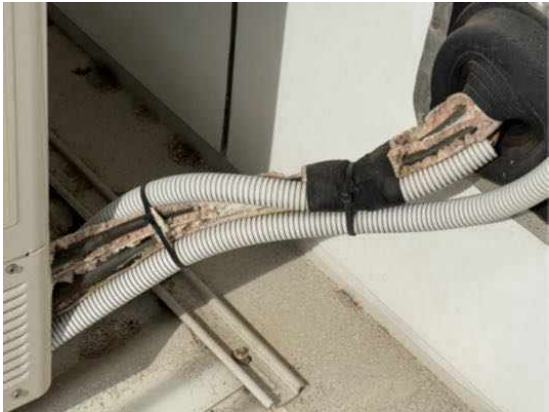
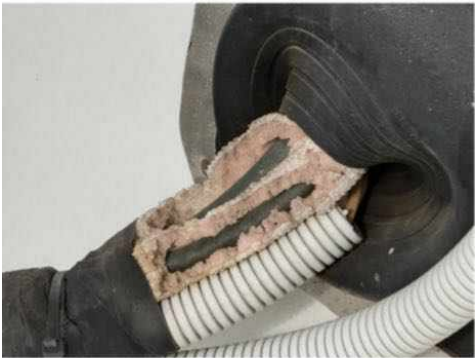
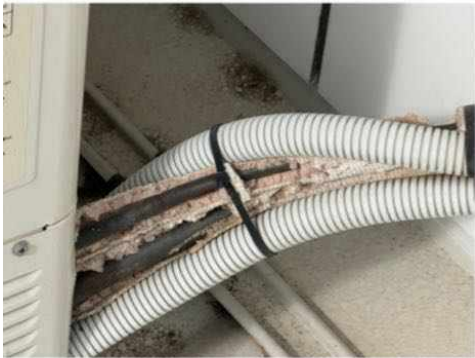
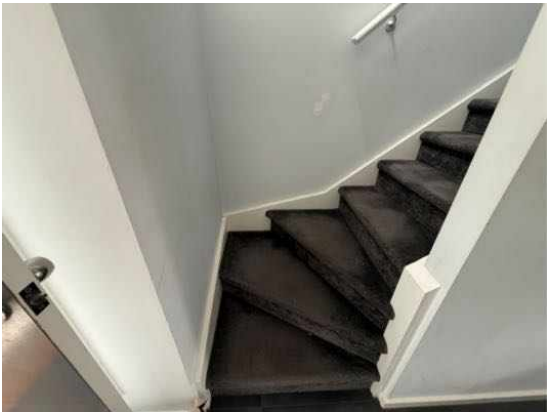
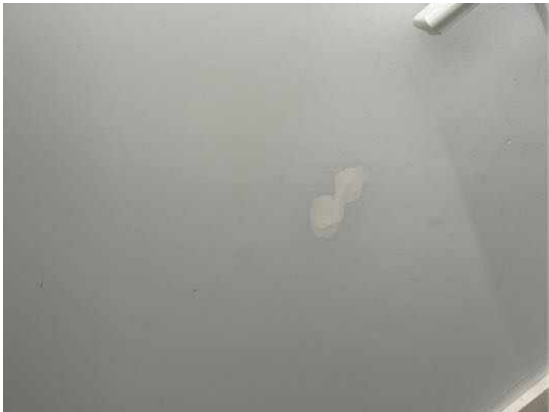
Noted Item

Building: Building 1
Location: All Areas > All Areas
Finding: Additional Photos
Information: Additional photos are provided for either future maintenance items for clients attention and or general reference. Arrows may have been included to highlight areas of importance. Please discuss these photos with your building consultant for clarification.

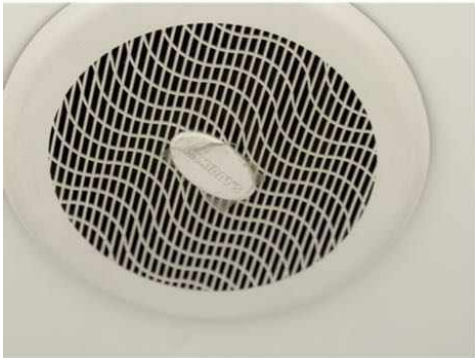
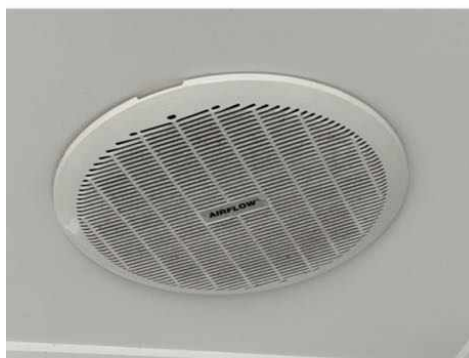
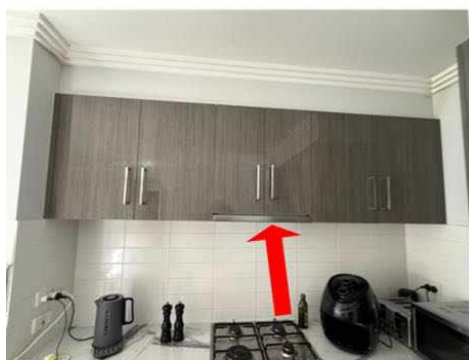
Noted Item

Building: Building 1
Location: All Areas > All Areas
Finding: Air filters, grilles and fans - require maintenance and cleaning
Information: Air grilles and fan covers need regular maintenance and cleaning. Dust, debris and dirt accumulated on the grill mesh will obstruct the normal air flow, these should be cleaned to prevent impairment of their intended functions. This includes such grilles and air filters from rangehoods, ducted heating / cooling units, ceiling and bathroom fans.

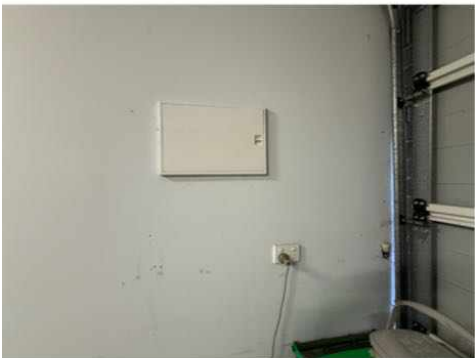
Noted Item

Building:	Building 1
Location:	All Areas > All Areas
Finding:	Termite Management System - out dated
Information:	At the time of the inspection, an old application of a chemical termite barrier was observed which is suspected to be from when the home was constructed. Such barriers are highly effective in preventing termite attack on any timber building elements throughout the property. A durable notice was observed to be placed in the in the meter box that indicated an old and out of date termite barrier, it appeared as though no termite management system has been installed recently, with no evidence to suggest preventative works taking place.

The client may consider gaining further advice from a pest controller as to the costs and procedures involved with this application. It is recommended that obtaining such advice be a short-term priority.
