Building and Timber Pest Inspection Report

Inspection Date: Fri, 6 Mar 2026

Property Address: 38 Graham St, Auburn NSW 2144, Australia

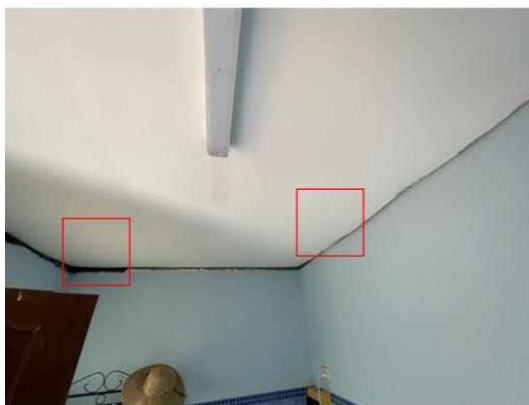
Finding 3.02

Building: Main Building
Location: Outbonding
Finding: Beads - Missing
Information: Beading acts (like cornice or skirtings) to cover the intersection or joins of building materials. It was noted at the time of inspection that beading in this area is missing.

Beading is important in weatherproofing the surrounding building elements and preventing pest ingress. Furthermore, beading works to protect the joins of building materials, which are more susceptible to deterioration and decay.

Replacement of the beading is advised to ensure the protection and longevity of any associated building elements. Such works may be performed by a general handyperson or qualified carpenter.

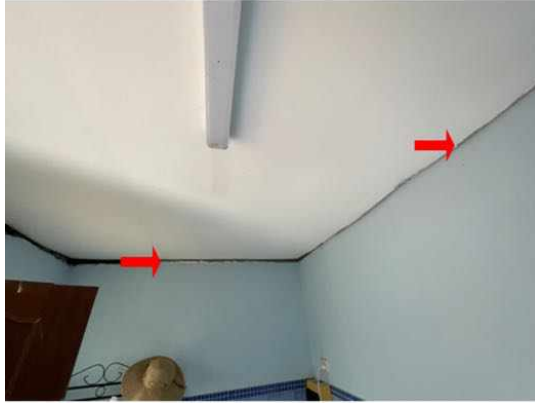
Finding 3.03

Finding: Eaves/Roof plumping -- water damages

Information: Water damage is generally an indication of excessive moisture being present, usually via a leak. It is suspected that gutter blockages causing stormwater to backflow into the eaves causing water damages. This is additionally conducive to termite activity due to the damp conditions.

Where water damage is evident, the primary requirement is to identify and rectify the source of the leak. Gutters must be kept clear of any blockages moving forward. A roofing plumber should be appointed for further assessment if the problem persists.

Once the leak is repaired, consultation with relevant tradespeople, including carpenters, plasterers and painters, is advised.

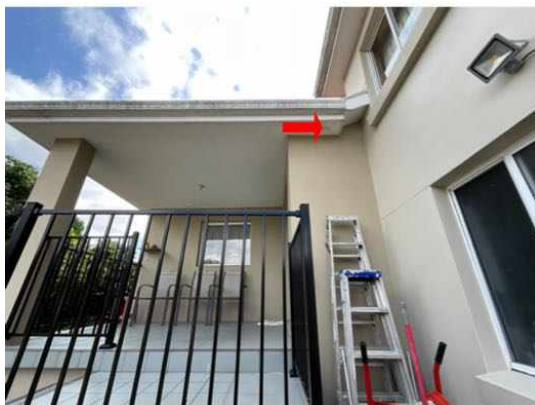
Finding 3.04

Finding: Site drainage— Inadequate

Information: The site drainage in this area was found to be inadequate at the time of inspection, creating potential for subsequent water damage to associated building elements. This is additionally conducive to termite activity.

It is important that water does not lie against the base of walls; surrounding paths and ground levels should be sloped to drain water away from walls. Downpipes should not discharge stormwater onto lower walls or plinths. Stormwater should be carried away by large, regularly cleaned drains. Ground levels may need to be lowered to expose a buried DPC.

Where site drainage is inadequate, installation of an Agricultural (Aggie) Drain may be required. A licensed plumber should be appointed to further inspect the property and perform any remedial works as necessary. Water damage and secondary defects are likely to occur if left unmanaged.

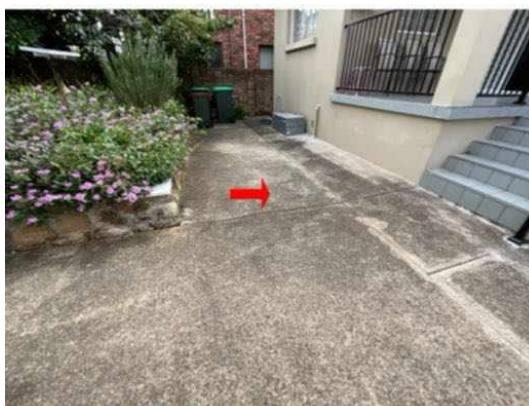
Finding 3.05

Building: Main Building
 Location: Rear left corner
 Finding: Water leak - External
 Information: Water leaks were found to be present to exterior plumbing work. Leaks are generally caused by deterioration of the plumbing elements over time, due to exposure to weather conditions, but may have also been caused by minor impact damage.

Such leaking creates damp conditions in the affected area, causing potential for water pooling and subsequent water damage if left unattended. These conditions may also attract termite attack, particularly if the area is subject to minimal levels of sun throughout daylight hours.

It is highly advised that a licensed plumber be appointed to rectify any water leaks that may be present. Areas of repair and replacement of plumbing fittings and fixtures may be required and, as such, a quotation should be sought.

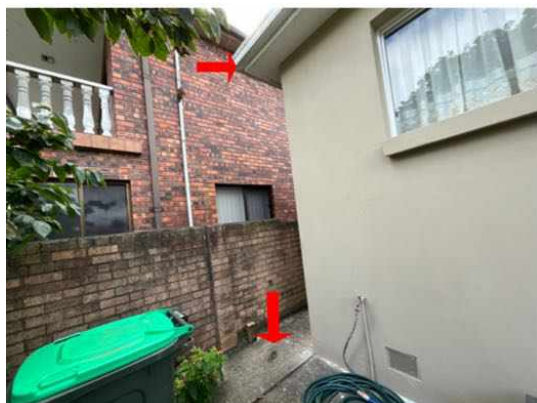
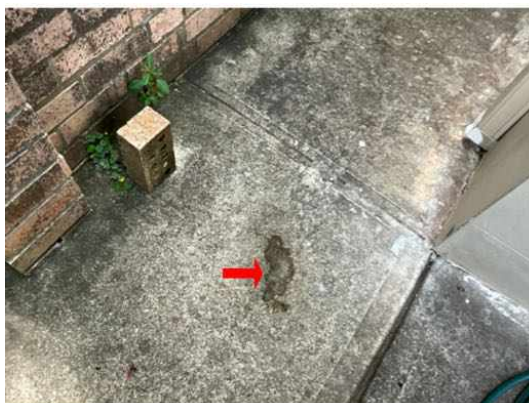
Finding 3.06

Building:	Main Building
Location:	Outbonding
Finding:	Stormwater drain - Not connected
Information:	The roof plumbing is not adequately connected to stormwater drainage on the site. This disconnection negatively impacts the functional capacity of the roof plumbing.

Where roof plumbing doesn't drain adequately, the area at the base perimeter can become excessively damp, potentially creating an environment that is susceptible to rust and corrosion of surrounding building elements, as well as attracting termites and other pests.

It is highly recommended that a plumber be appointed to further inspect the area and to install adequate drainage equipment where necessary.

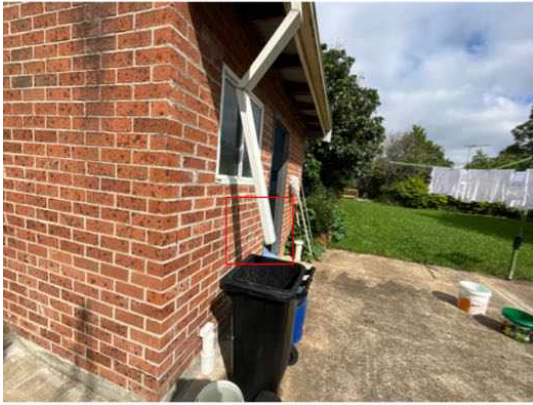
Finding 3.07

Building:	Main Building
Location:	Yard
Finding:	Untreated or non-durable timbers in a hazardous environment
Information:	To reduce the risk of timber pest attack it is essential that timber used in a hazardous environment (e.g. in direct contact with the ground or frequently exposed to damp conditions) is of sufficient durability and/or is adequately preservative treated.

Untreated timbers in direct contact with the ground are likely to develop severe wood rot and/or fungal decay if left unattended creating attraction for subterranean termites to infest the timbers from surrounding areas.

If untreated or non-durable timbers are found to be in a hazardous environment it is highly advised that replacement of these building elements be performed as soon as possible to aid the protection of the property against termite / timber pest attack.

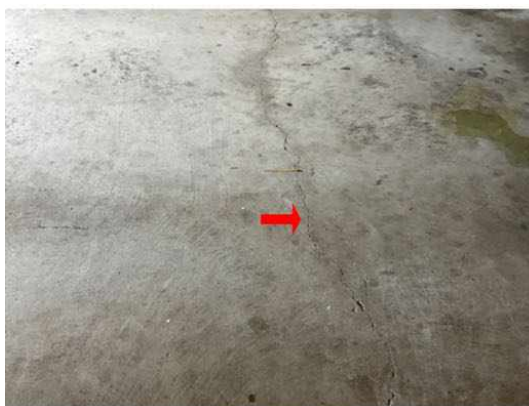
Finding 3.18

Building: Main Building
 Location: Multiple areas
 Finding: Crack in concrete slab - Category 2
 Information: A crack coded as Category 2 was identified in the slab. A Category 2 crack is described as a distinct crack, with the slab being noticeably curved or changed in level.

To be considered Category 2, the approximate width of the crack is less than 2.0mm, or a change in offset of less than 15mm when a 3m straight edge is placed over the defect.

Category 2 cracks to slabs should be monitored for a period of 12 months. At the end of the monitoring period, cracks rated greater than Category 2 are considered defects that require rectification.

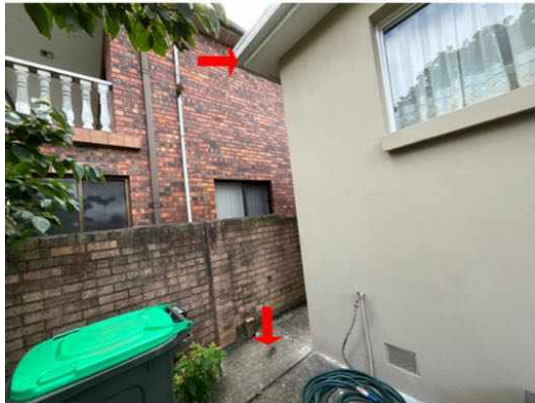
Finding 6.03

Where roof plumbing doesn't drain adequately, the area at the base perimeter can become excessively damp, potentially creating an environment that is susceptible to rust and corrosion of surrounding building elements, as well as attracting termites and other pests.

It is highly recommended that a plumber be appointed to further inspect the area and to install adequate drainage equipment where necessary.

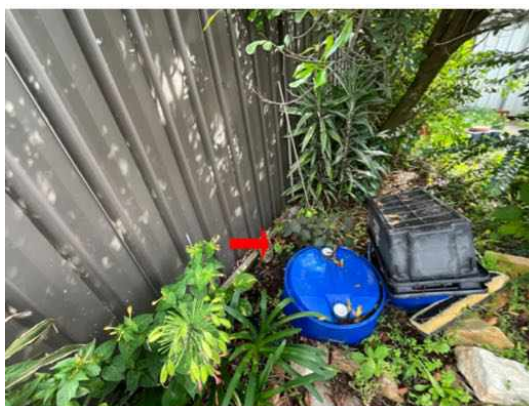
Finding 6.06

Building:	Main Building
Location:	Fencing & Landscaping
Finding:	Building materials in direct ground contact - conducive to termites
Information:	Where timber elements are in direct contact with the ground and consequently moisture or dampness they become conducive to termite activity. Whether timber is used as a building element part of a fencing structure or stored as an unused item they can provide an environment that is attractive to termite infestation.

When met with excessive moisture timber begins to decay and develop wood rot. Any timbers that are in direct contact with external grounds especially if left untreated or non-durable also provide ingress for subterranean termites into that particular element.

The removal of any such materials that may be conducive to termite activity should be removed as soon as possible to minimise the risk of termite attack.

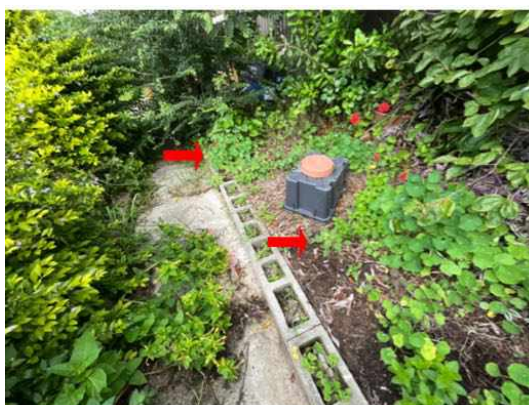
Finding 6.07

Building:	Main Building
Location:	Slab penetrations
Finding:	Service penetrations
Information:	Services into home can allow for concealed termite entry without additional or

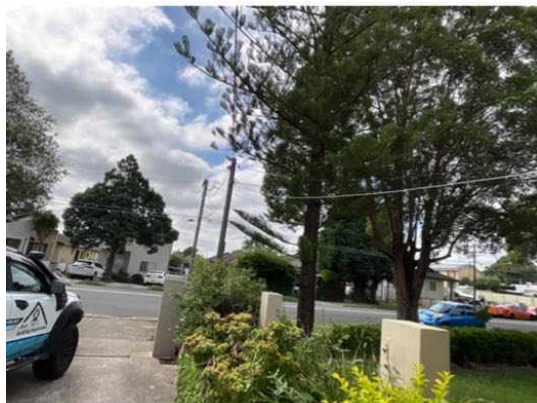
Finding 6.09

Building:	Main Building
Location:	Outbounding
Finding:	Bridging - Vegetation
Information:	Where vegetation obstructs inspection of building elements, also known as bridging as it provides a bridging point for the access of termites, full inspection can not be achieved. Consequently moisture or dampness may be present and the areas becomes conducive to termite activity. Plants against or very close to buildings provide cover, shade and can provide an environment that is attractive to termite infestation.

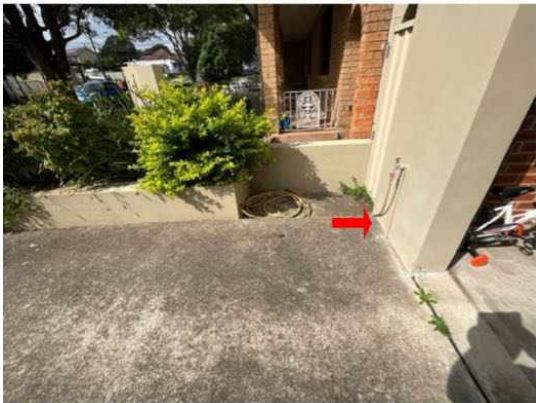
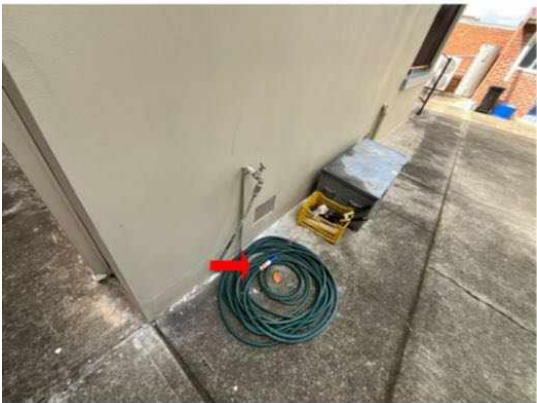
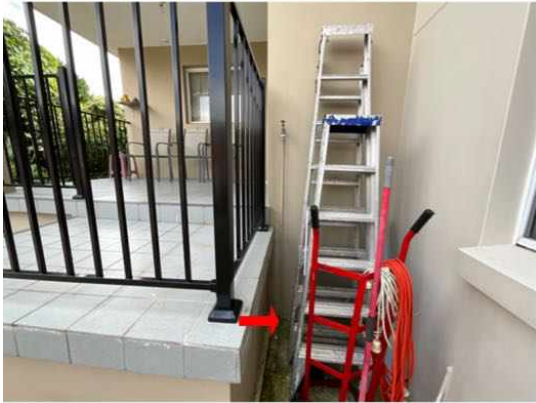
Finding 6.11

Building:	Main Building
Location:	Perimeter
Finding:	Slab Edge - Exposure
Information:	Slab Edge Exposure: Where external concrete slab edges are not exposed there is a high risk of concealed termite entry. In some buildings built since July 1995 the edge of the slab forms part of the termite shield system. In these buildings an inspection zone of at least 75mm should be maintained to permit detection of termite entry. The concrete edge should not be concealed by render, tiles, cladding, flashings, adjoining structures, paving, soil, turf or landscaping etc. Where this is the case you should arrange to have the slab edge exposed for inspection. Concealed termite entry may already be taking place but could not be detected at the time of the inspection. This may have resulted in concealed timber damage. Does the slab edge inspection zone fully comply?

Not able to comment. A very high proportion of termite attacks are over the edge of both Infill and other concrete slabs types. Covering the edge of a concrete slab makes concealed termite entry easy. Infill slab type construction has an even higher risk of concealed termite ingress as the slab edge is concealed due to the construction design and cannot be exposed. The type of slab may only be determined by assessment of the construction plans by a qualified person e.g. Builder, Architect. Construction Plans may be obtainable by your local Council or Builder. Termite activity and or damage may be present in concealed timbers of the building. We strongly recommend frequent regular inspections in accordance with AS 3660.2. Where the slab edge is not fully exposed or the slab is an infill slab or the slab type cannot be determined then we strongly recommend inspections every 3 to 6 months in accordance with AS 3660.2 or AS 4349.3.

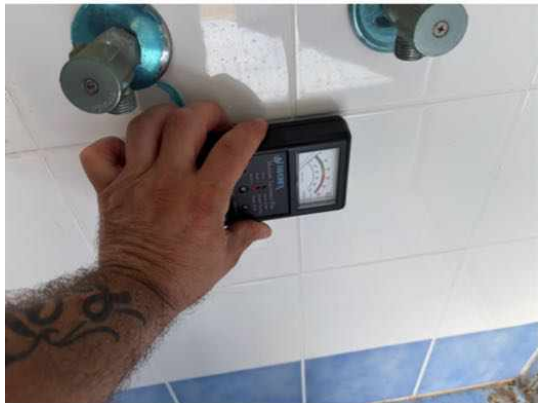
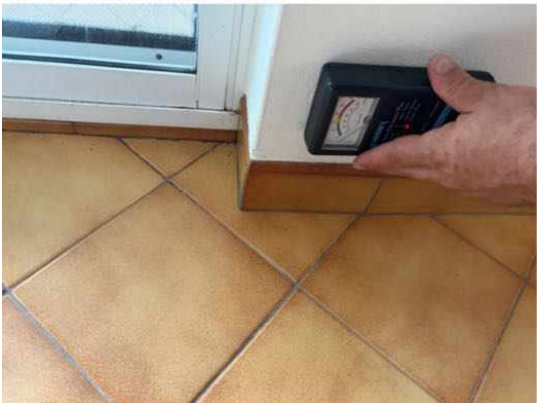
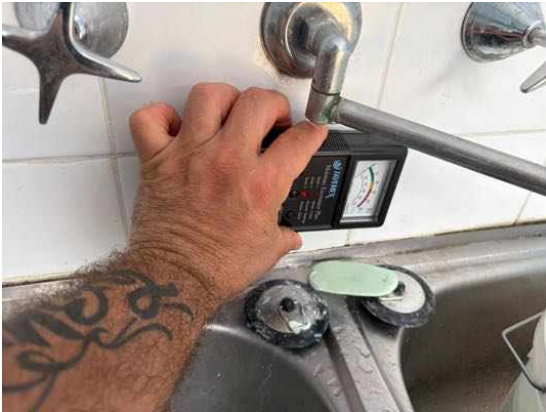
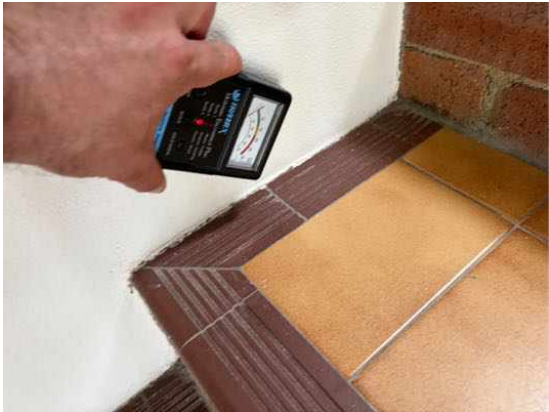
Noted Item

Building: Main Building
Location: All Areas
Finding: Moisture metre
Information: During the inspection the property was checked for moisture using a moisture metre.

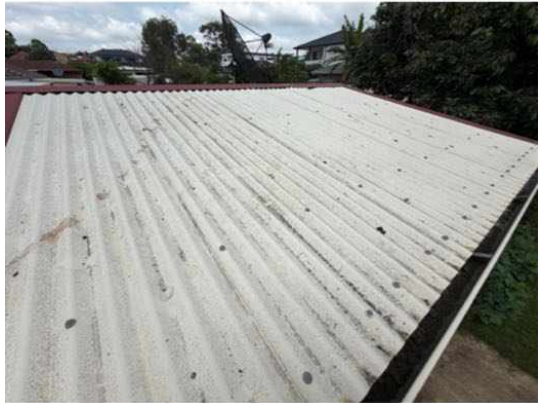
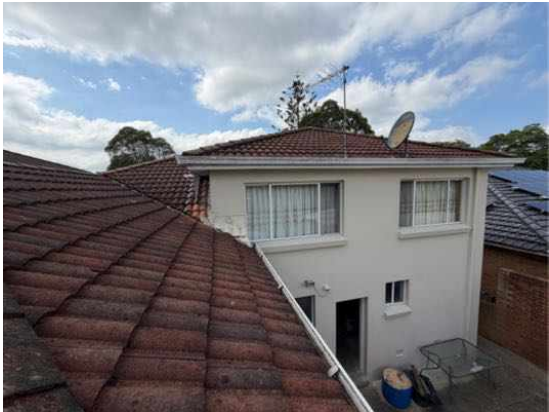
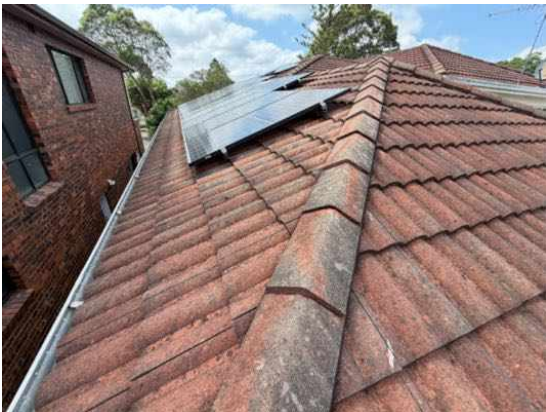
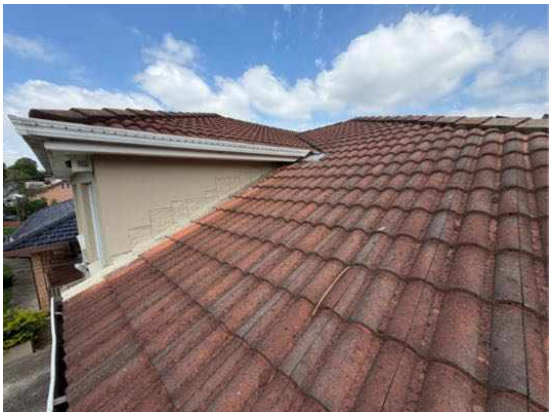
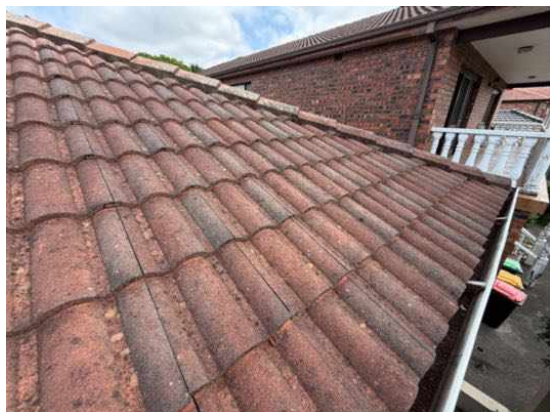
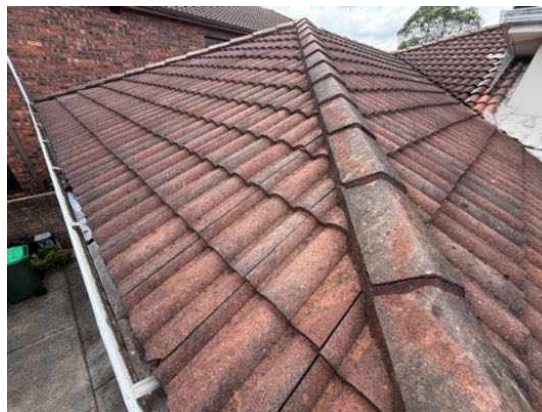
Noted Item

Building: Main Building
Location: Roof Exterior
Finding: Additional Photos
Information:

Additional photos are provided for your general reference.

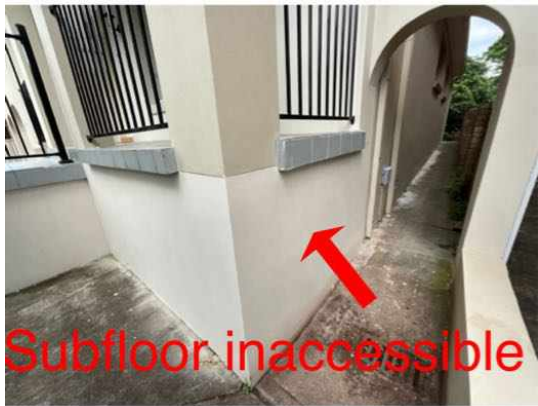
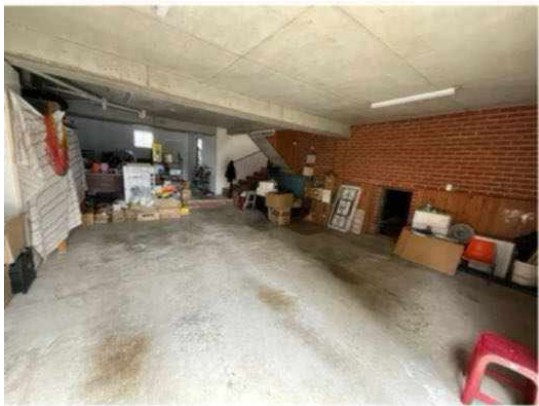
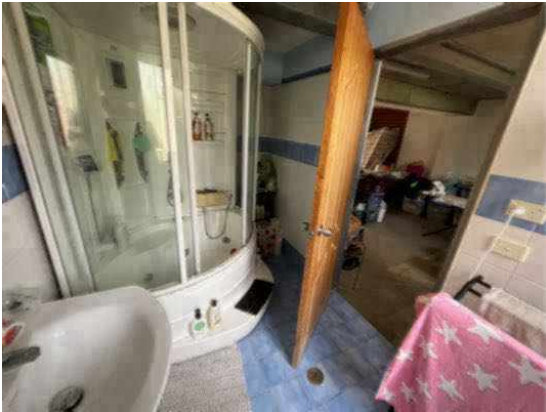
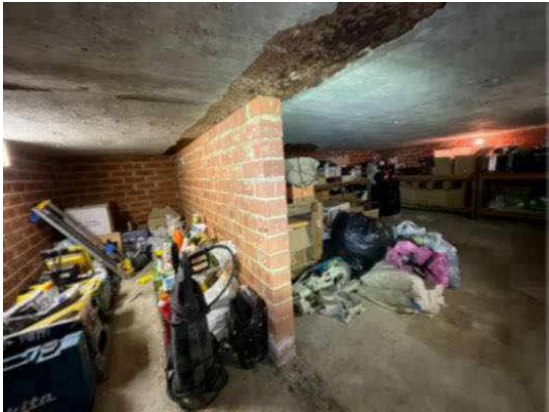
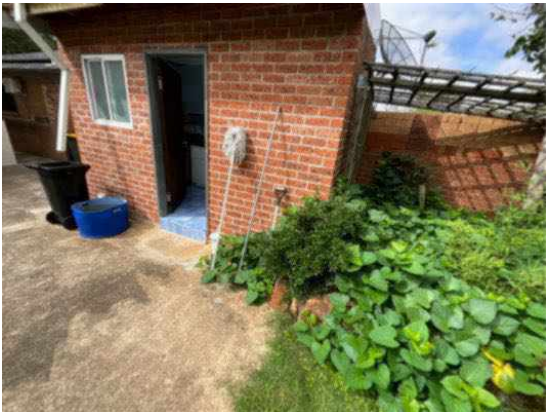
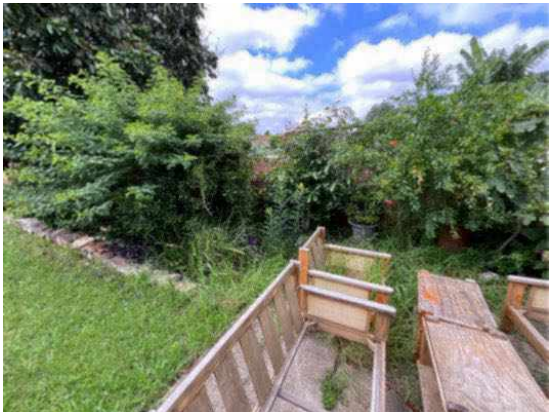
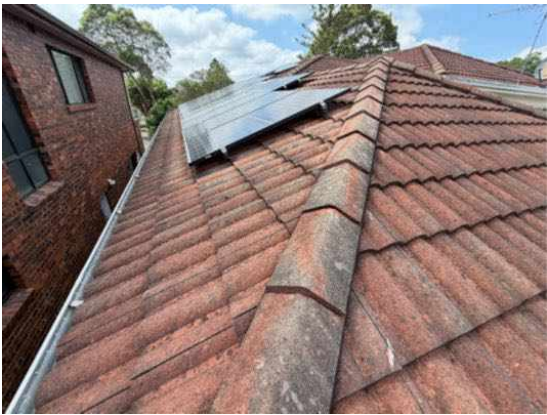
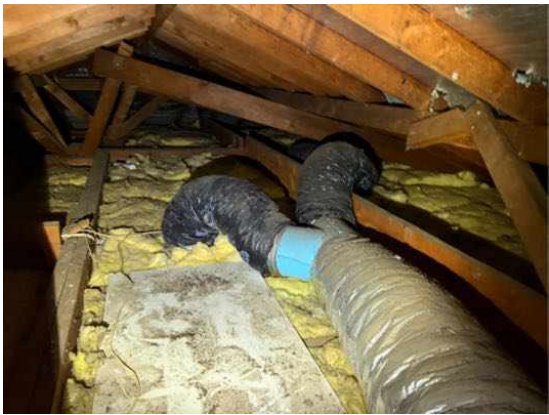
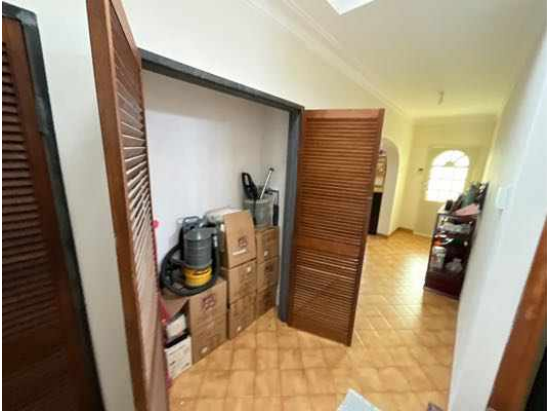
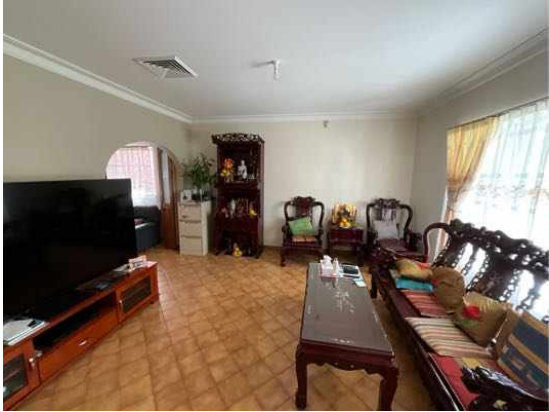
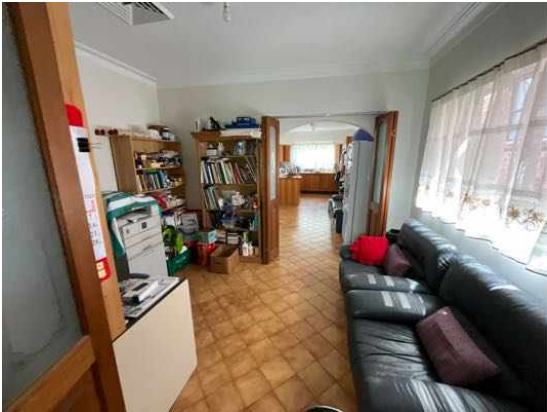
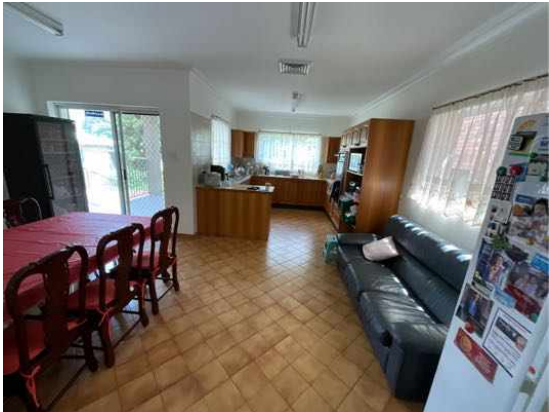
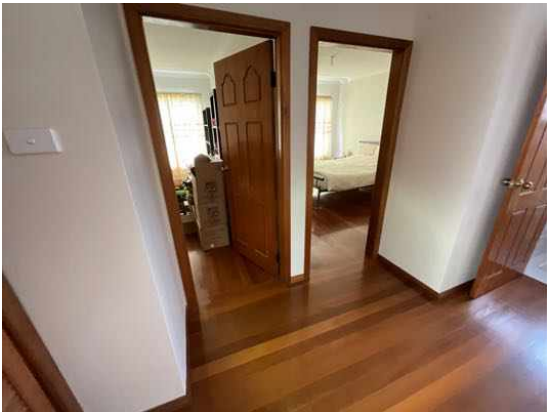
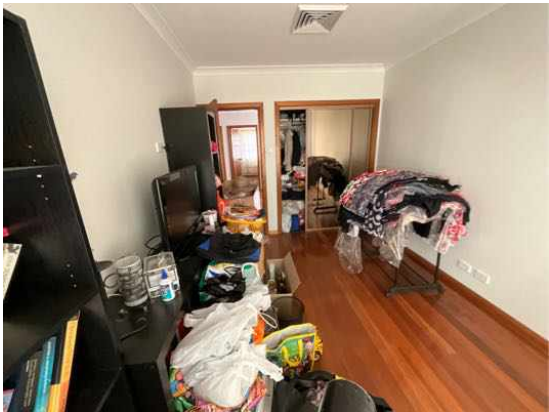
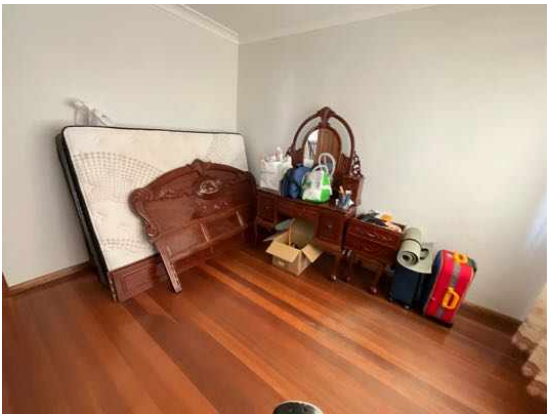
Noted Item

Building: Main Building
Location: All Areas
Finding: Additional Photos - Obstructions and Limitations
Information:

These photographs are an indication of the obstructions and limitations which impeded full inspection of the property at the time of inspection. These obstructions can hide an array of defects and should be removed to allow full inspection to be carried out. A re-inspection is recommended once the areas are made accessible.
