Building and Timber Pest Inspection Report

Inspection Date: Fri, 20 Feb 2026

Property Address: 56 Clara St, Tumbarumba NSW 2653,
Australia

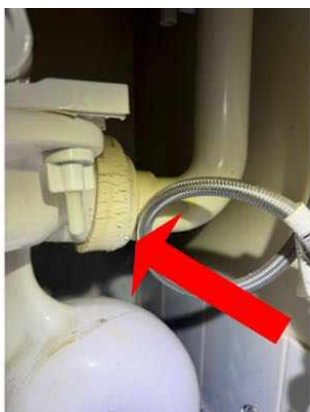
Finding 6.02

Building:	Main Building
Location:	Toilet Seal
Finding:	Toilet Seal - Leaking
Information:	The toilet seal was found to be leaking at the time of inspection. This creates an environment conducive to termite activity. Recommend engaging a licensed plumber in the short term, to provide minor maintenance works where necessary.

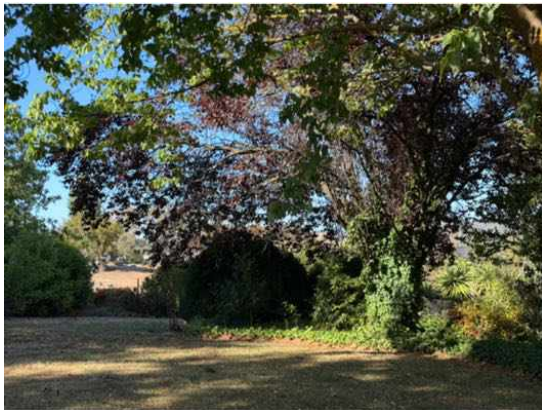
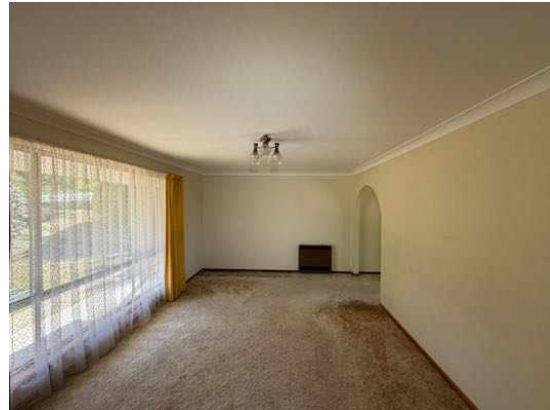
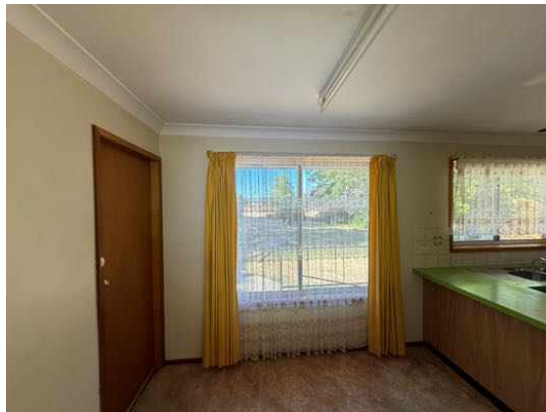
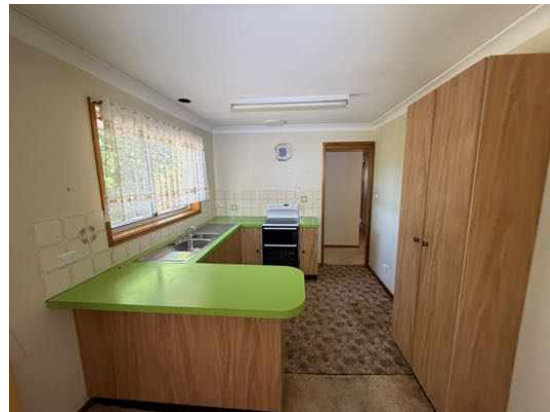
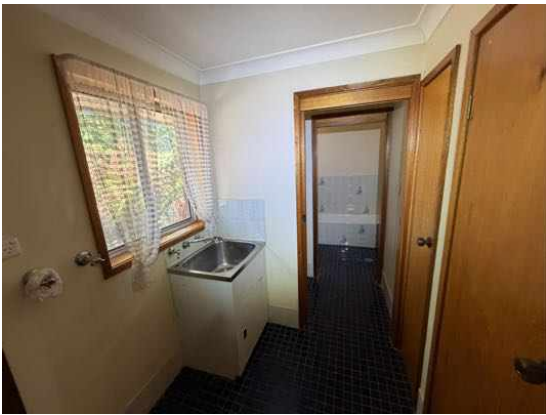
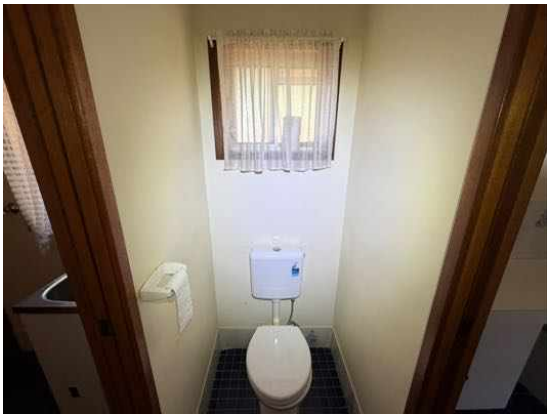
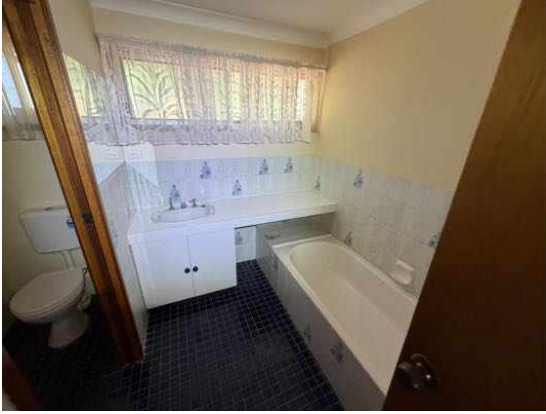
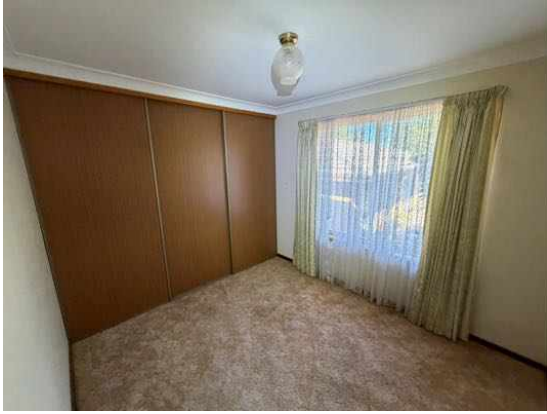
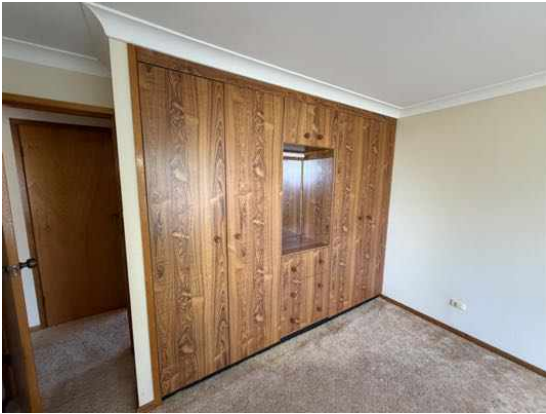
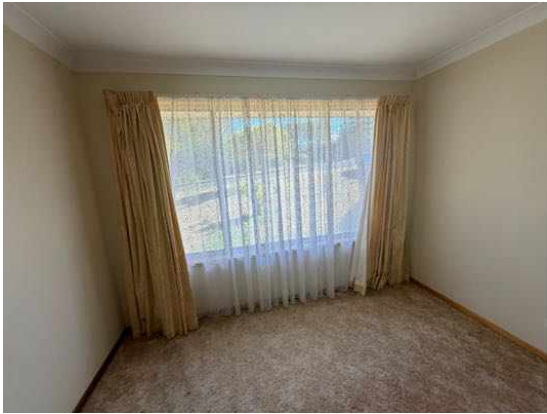
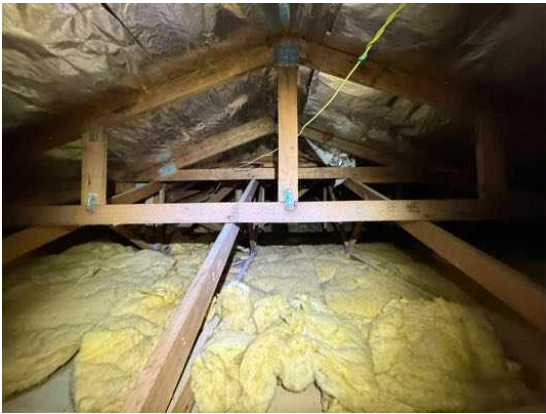
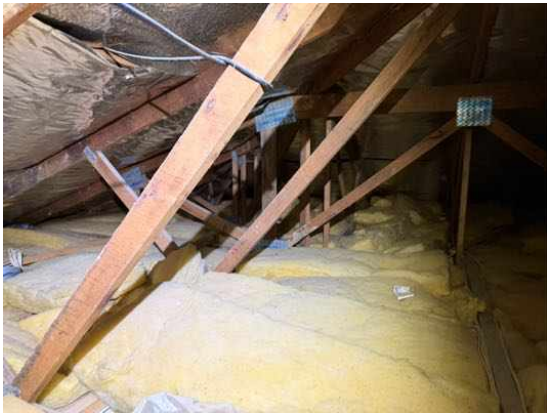
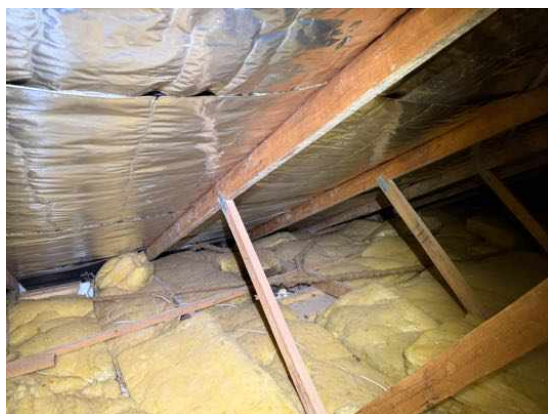
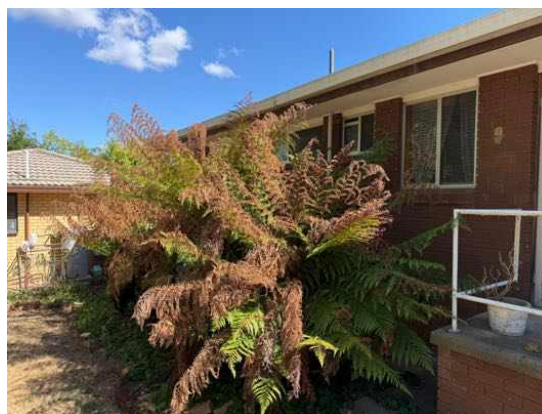
Building: Main Building
Location: All Areas
Finding: Additional Photos - Obstructions and Limitations
Information: These photographs are an indication of the obstructions and limitations which impeded full inspection of the property at the time of inspection. These obstructions can hide an array of defects and should be removed to allow full inspection to be carried out. A re-inspection is recommended once the areas are made accessible.

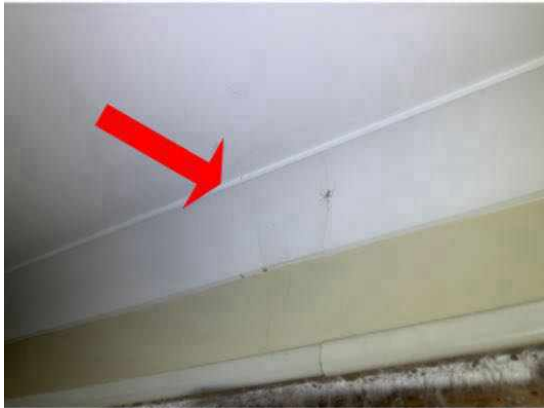
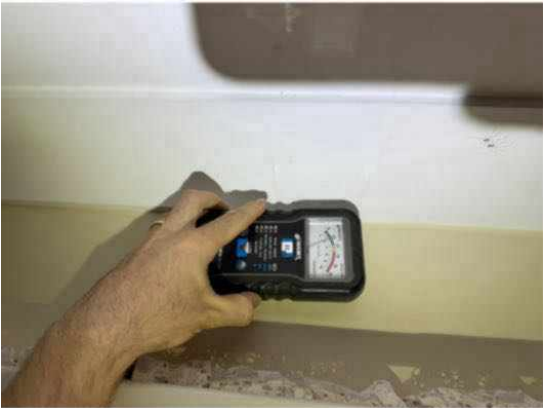
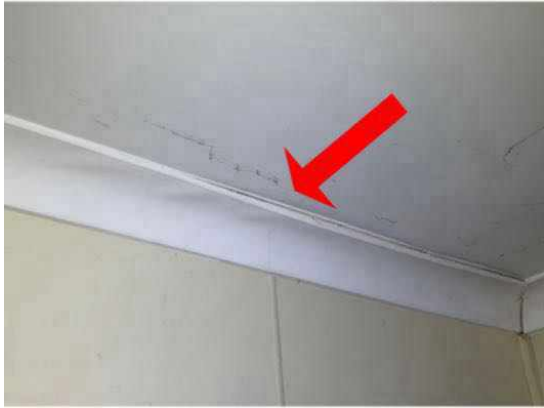
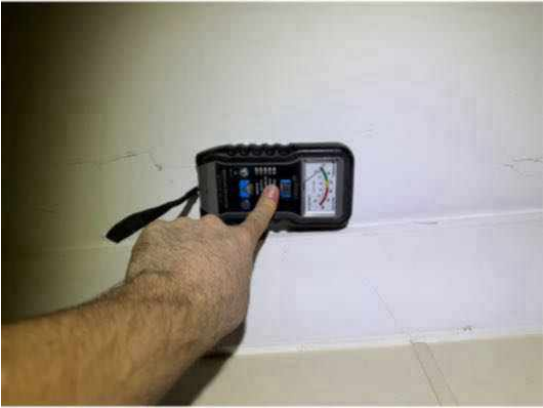
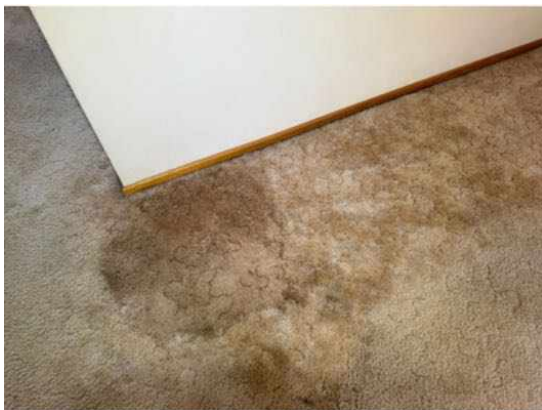
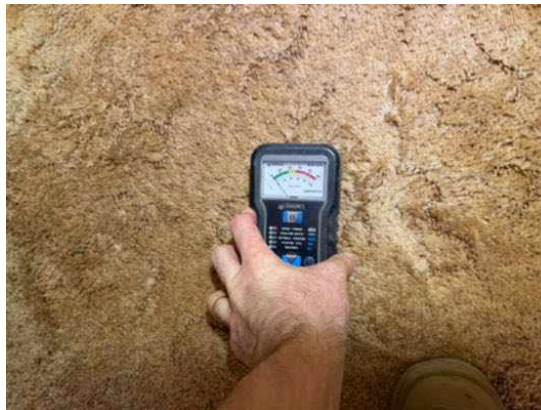
Recommend that the client monitor these areas and engage a licensed plumber, should the leak persist or return.
