Building and Timber Pest Inspection Report

Inspection Date: Wed, 18 Feb 2026

Property Address: 57/15 Beech Street Port Melbourne

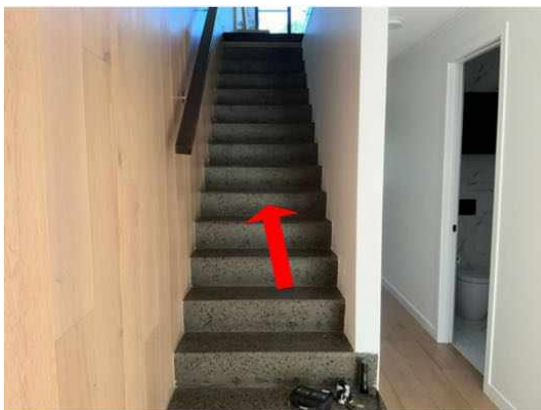
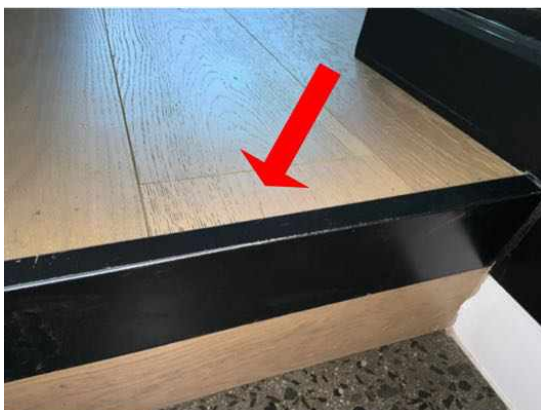
Building:	Main Building
Location:	Concrete stair treads and landing
Finding:	Stairs slippery finish
Information:	It was observed that the polished concrete stairs were finished in a coating that has no slip index rating and appears to be quite smooth

Polished stairs should be finished in an appropriate non-nonslip coating with a rough surface finish. Alternatively the stairs should be fitted with nonslip nosing to the treads or a non-slip tape to the stair treads

A general handyman or surface sealing contractor should review as soon as possible.

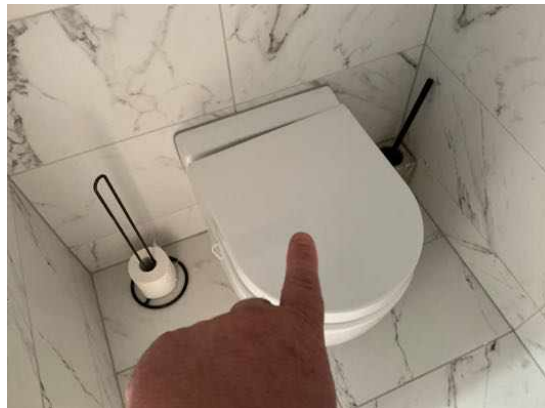
Finding 1.02

Building:	Main Building
Location:	All bathrooms
Finding:	Toilet seat loose

Information: It was observed that the toilet seats was loose and unstable.

Loose seats can cause fall injury to persons while in use and lead to serious injury

A licensed sanitary plumber should be engaged to review prior to use

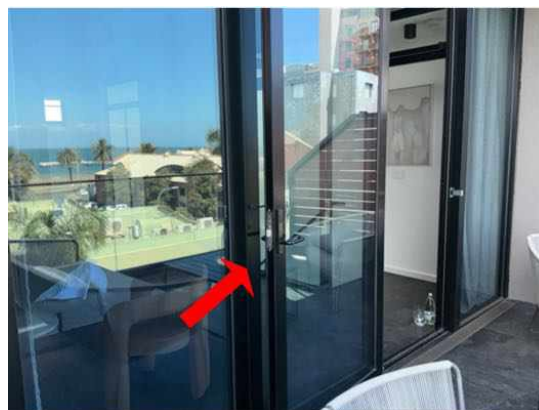
Information: It was observed at the time of the inspection that the French door to the master balcony does not have a door closing restraint mechanism four door cushion to stop the door and window colliding when operation. Unattended to the door and window could prematurely deteriorate.

If the door is opened. aggressively the glass could break.or shatter.

A window specialist or qualified carpenter should be engaged by the owner to review as soon as possible. Should the building still be under a builders warranty,The builder should make good immediately.

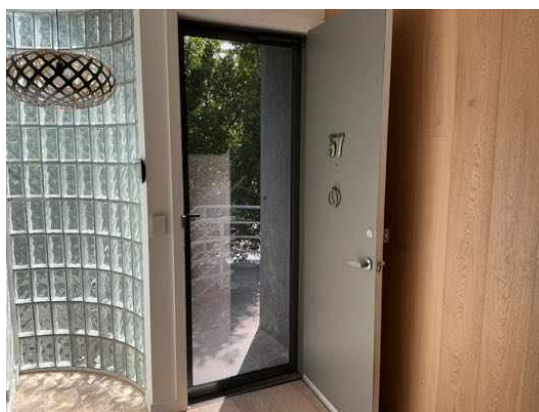
Finding: Security door closure defective

Information: It was observed that the door closure to the security door was not operating correctly and appears to require adjustment.

This is a minor defect and would be considered general wear and tear

A general handyman should be engaged to review at the clients discretion.

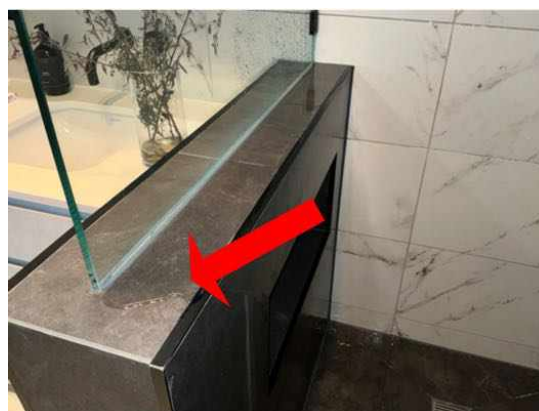
Building: Main Building
 Location: Bathroom 2
 Finding: Water pooling/shower closet
 Information: It was observed at the time of the inspection that there was water pooling on the top of the wall to the shower closet. It appeared that the top of the wall was constructed level and no consideration was made for water to run off back into the shower floor.

Given time the pooling water has a potential to cause premature deterioration to other building elements which could eventually cause water leaking.

A wall and floor tile should be engaged to review at the owners discretion

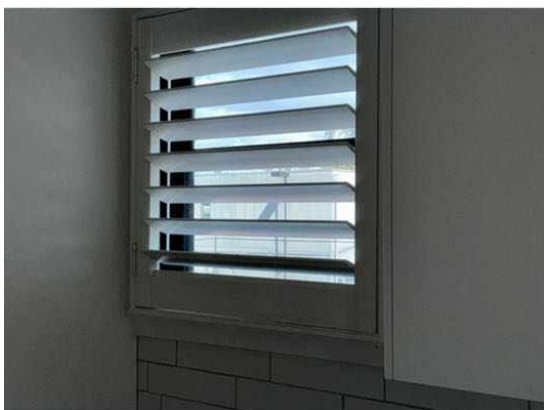
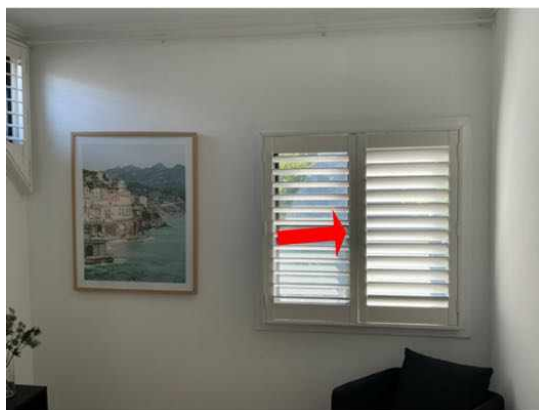
Building: Main Building
Location: All Internal Areas
Finding: Window shutters jamming
Information: It was observed at the time of the inspection that many window shutters throughout the property were binding and catching.

Unattended to the binding could cause premature deterioration to the shutter and other building elements

An experienced window installation contractor should be engaged to review at the owners discretion.

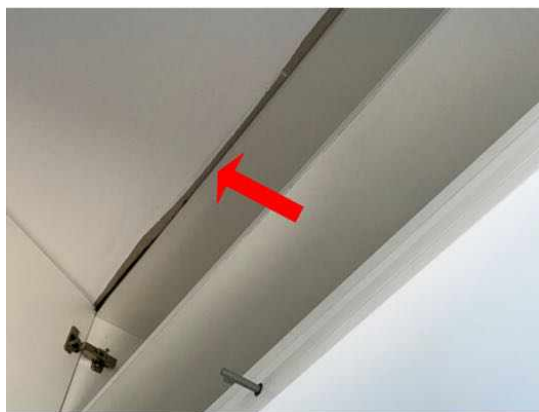
Finding 3.06

Building: Main Building
Location: Kitchen
Finding: Incomplete or substandard works
Information: The works to kitchen overhead cabinets appears to be incomplete or have been completed to a substandard level.

It is highly recommended that a general handyman be appointed to complete these works at the owner discretion.

Should the building still be subject to a builders warranty The builder should then make them as part of his warranty obligation. The purchaser should confirm with the vendor if the builders warranty is still active

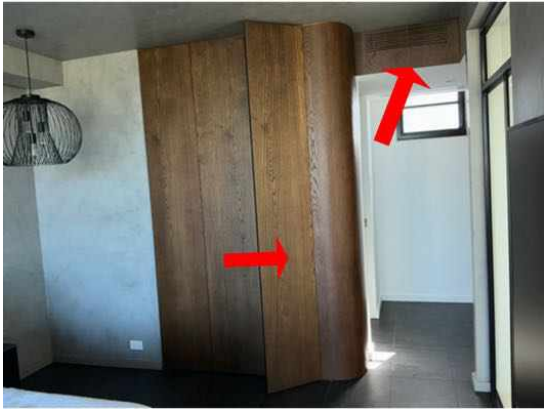
Finding 3.07

Building: Main Building
Location: Bedroom - Master
Finding: Cabinet veneer peeling and deteriorating
Information: It was noted at the time of the inspection that the veneer to the cabinet works in the master bedroom was peeling away from the chipboard substrate.

This is an aesthetic defect. However, it deteriorate from the overall appearance of the building. Unattended to the vineyard could further deteriorate.

A qualified cabinet maker should be engaged to review at the owners discretion.

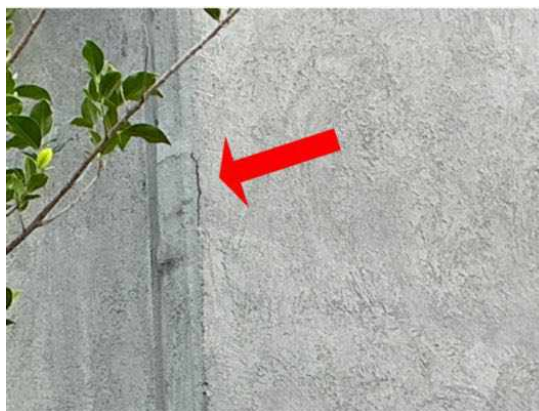
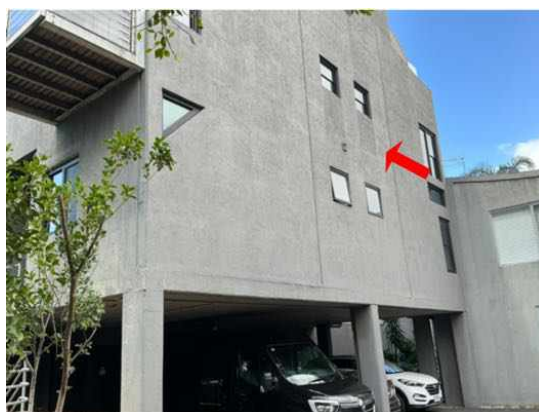
Building:	Main Building
Location:	Exterior walls - right side and front
Finding:	Minor cracking to rendering
Information:	At the time of the inspection, it was noted that there was some minor cracking and deterioration of the rendering coating to the building external walls.

Although this is a minor and aesthetic defect it detracts from the overall appeal of the building.

Unattended to the cracking could further deteriorate and eventually cause damage to other building elements

A qualified render should review at the owners discretionk

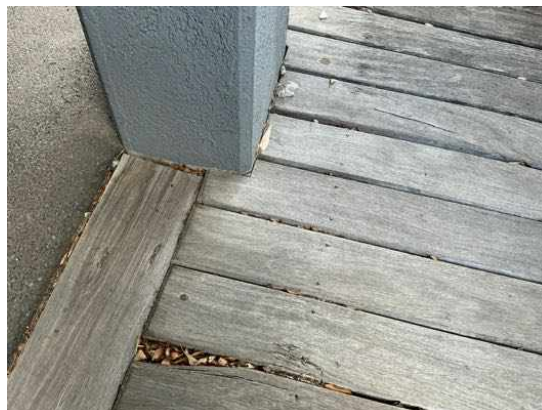
Untreated timbers in direct contact with the ground are likely to develop severe wood rot and/or fungal decay if left unattended creating attraction for subterranean termites to infest the timbers from surrounding areas.

If untreated or non-durable timbers are found to be in a hazardous environment it is highly advised that replacement of these building elements be performed as soon as possible to aid the protection of the property against termite / timber pest attack.

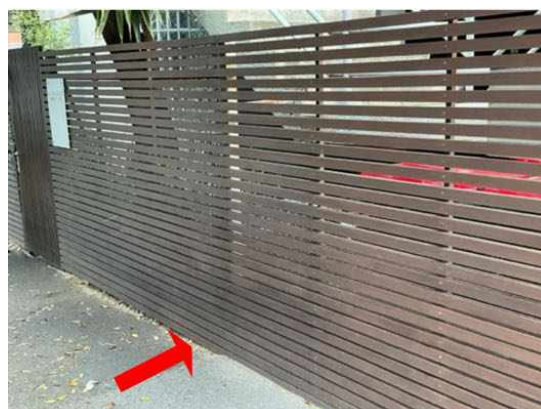
Finding 6.03

Building:	Main Building
Location:	Front Elevation
Finding:	Untreated or non-durable timbers / fence
Information:	To reduce the risk of timber pest attack it is essential that timber used in a hazardous environment (e.g. in direct contact with the ground or frequently exposed to damp conditions) is of sufficient durability and/or is adequately preservative treated. The timber for inground use should be rated H5 as stated in AS1604

Untreated timbers in direct contact with the ground are likely to develop severe wood rot and/or fungal decay if left unattended creating attraction for subterranean termites to infest the timbers from surrounding areas.

If untreated or non-durable timbers are found to be in a hazardous environment it is highly advised that replacement of these building elements be performed as soon as possible to aid the protection of the property against termite / timber pest attack.

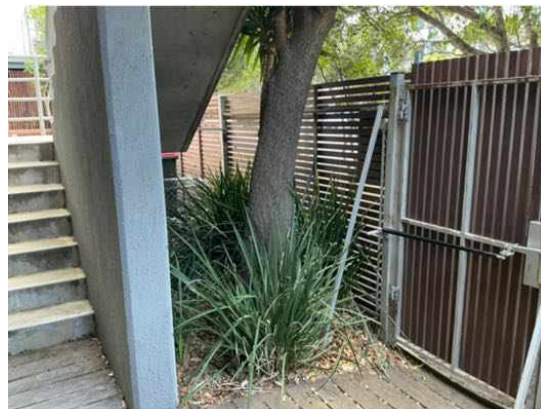
Finding 6.04

Building:	Main Building
Location:	All External Areas
Finding:	Trees/large/termite

The trees have the potential to provide conducive conditions for termite infestation

It is recommended that periodic 12 monthly inspections by a registered pest control contractor be undertaken and further reinstatement of outdated termite barriers as soon as possible.

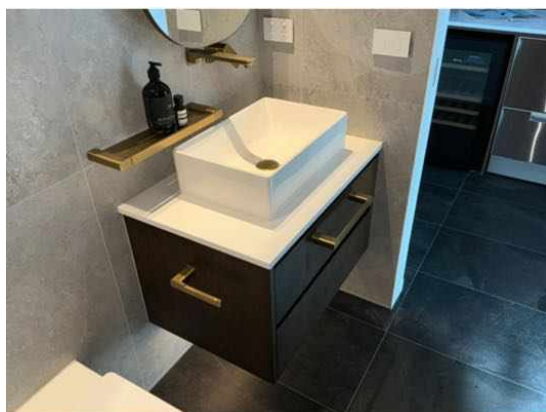
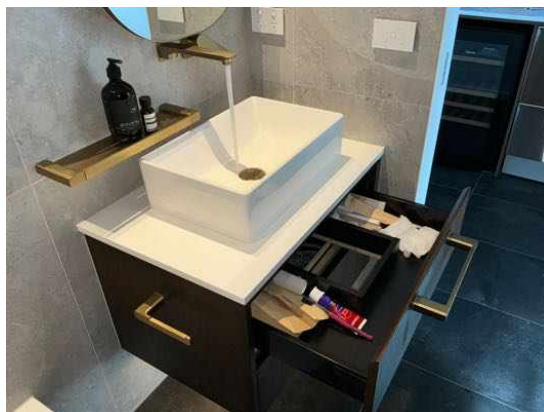
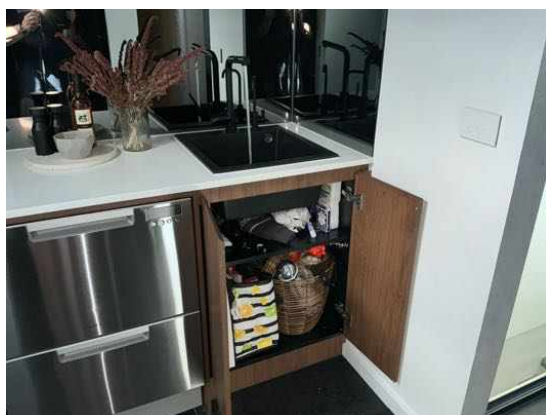
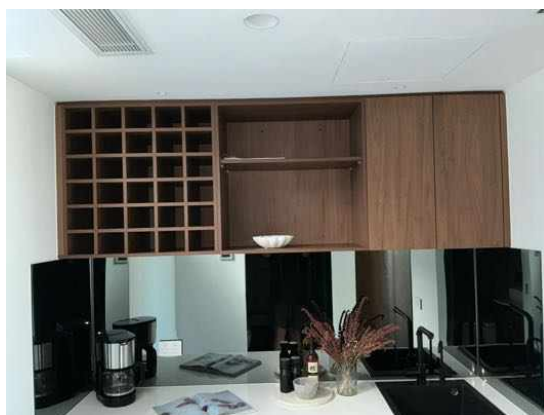
Building: Main Building
Location: All Areas
Finding: Additional Photos - Obstructions and Limitations
Information: These photographs are an indication of the obstructions and limitations which impeded full inspection of the property at the time of inspection. These obstructions can hide an array of defects and should be removed to allow full inspection to be carried out. A re-inspection is recommended once the areas are made accessible.
