# Building and Timber Pest Inspection Report

Inspection Date: Mon, 22 Dec 2025

Property Address: 7 Sotterra Walk Fraser rise

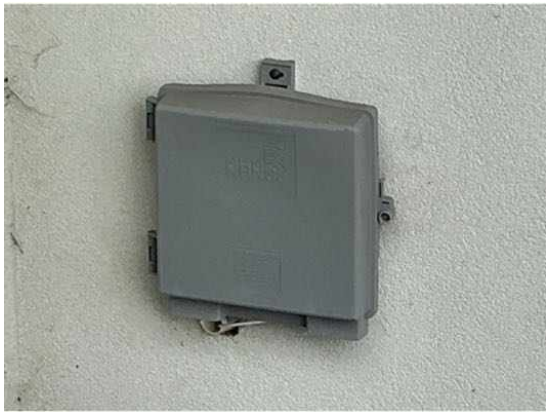
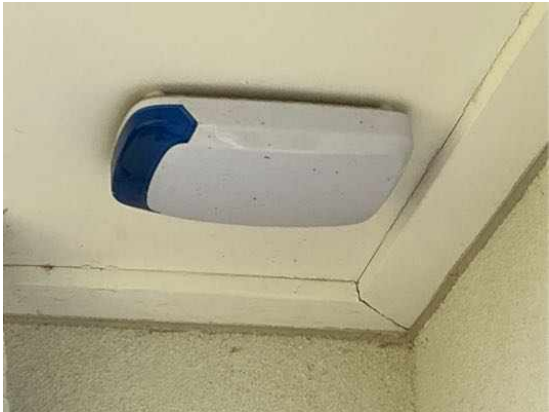
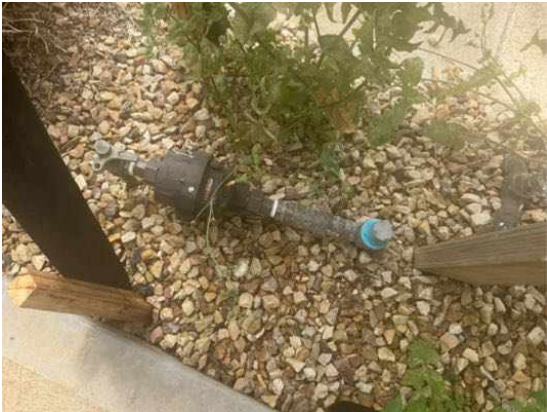
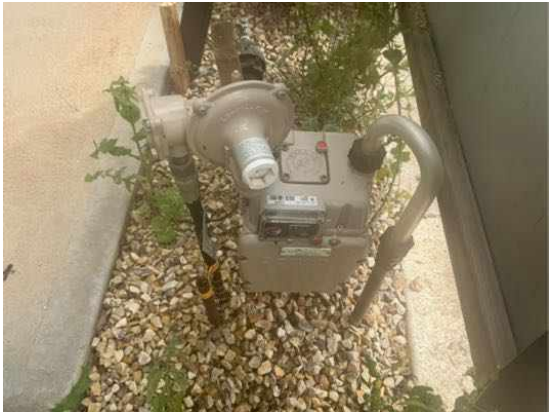
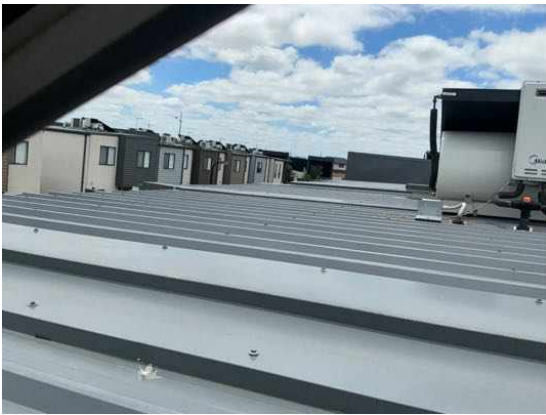
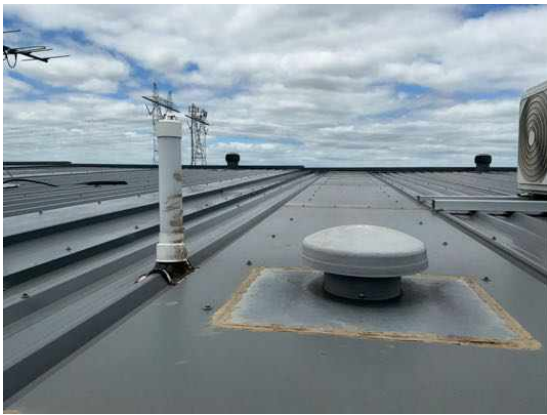
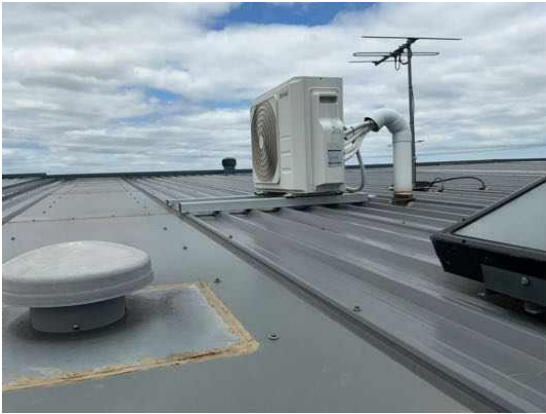
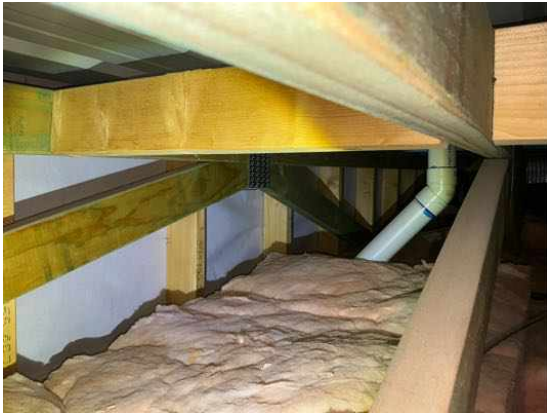
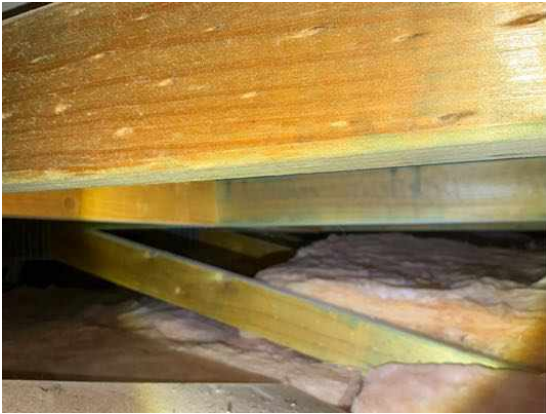
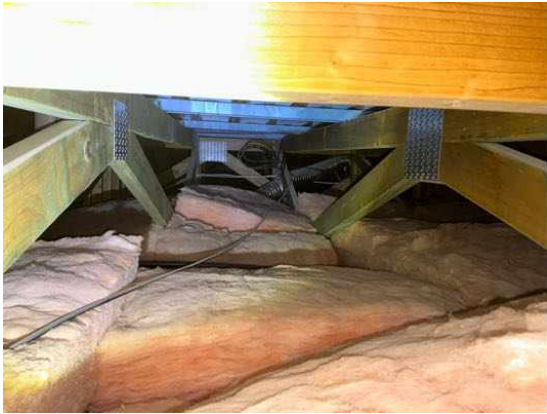
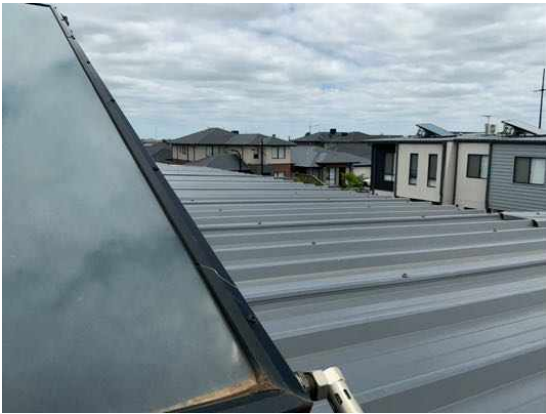
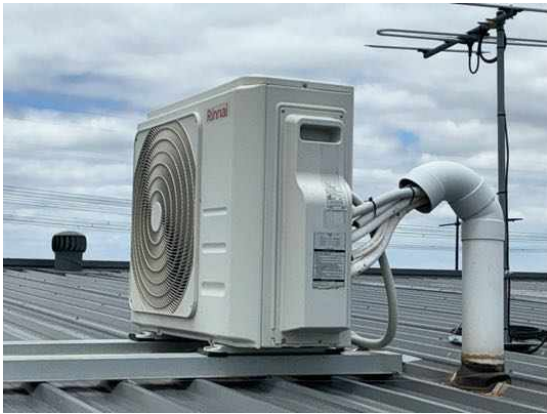
Building: Main Building  
Location: All Areas  
Finding: Additional Photos  
Information: Additional photos are provided for your general reference
