Building and Timber Pest Inspection Report

Inspection Date: Fri, 20 Mar 2026

Property Address: 232 Bourke St, Glen Innes NSW 2370,
Australia

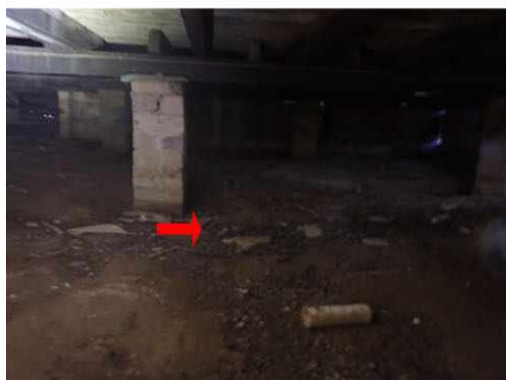
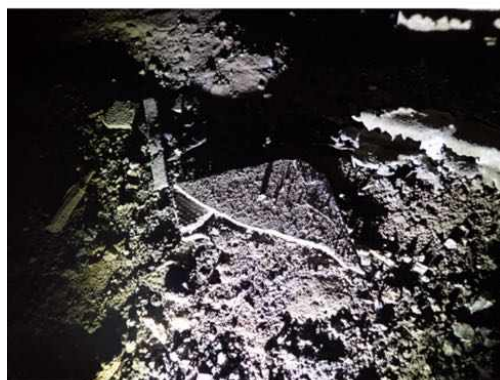
Finding 1.04

Building:	Main Building
Location:	Subfloor
Finding:	Suspected Asbestos Containing Materials Identified – Subfloor Area
Information:	Suspected asbestos containing building materials were identified at multiple locations within the subfloor area. These materials were commonly used in properties of this age and may pose a risk if disturbed or deteriorated. Possible causes relate to original construction materials and historical installations. It is recommended that a licensed asbestos professional carry out testing to confirm the presence of asbestos and provide advice on management, encapsulation, or removal as required. Preventative measures include avoiding disturbance of the materials until they have been properly assessed. Assessment and any required works should be carried out prior to any disturbance or works in the subfloor area.

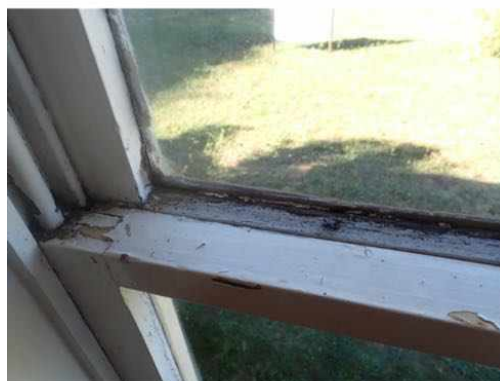
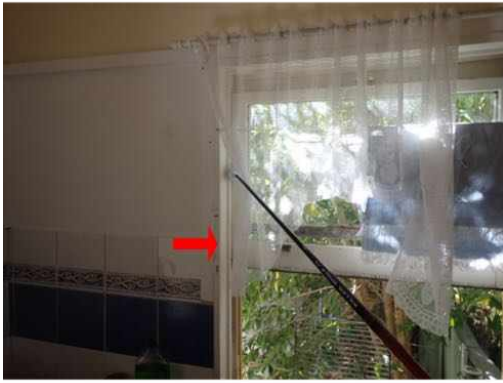
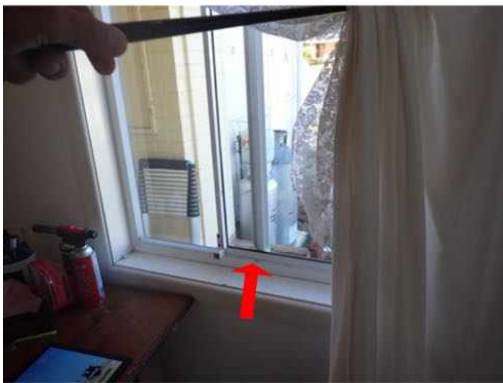
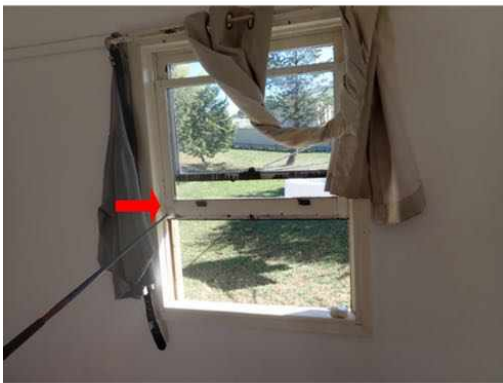
Finding 2.01

Building:	Main Building
Location:	Windows
Finding:	Windows Difficult to Operate and Deteriorated Condition
Information:	<p>The majority of the windows were either unable to be opened or were difficult to operate at the time of inspection. Some windows also showed signs of deterioration including wood rot. This condition may lead to reduced functionality and ongoing deterioration of associated building elements if left unaddressed. Possible causes include lack of maintenance, paint build-up, moisture ingress, structural movement, or general age-related wear and tear. This is a common defect in properties of this age. It is recommended that a licensed carpenter assess all affected windows, carry out repairs to ensure they are fully operational, and replace any components affected by wood rot as required. Preventative maintenance includes regular servicing, painting, and sealing of window frames to protect against moisture ingress. Repairs should be carried out as required.</p>

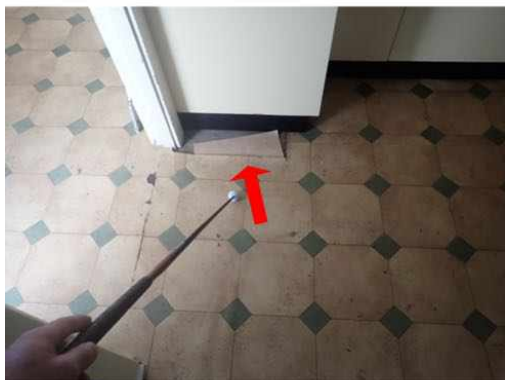
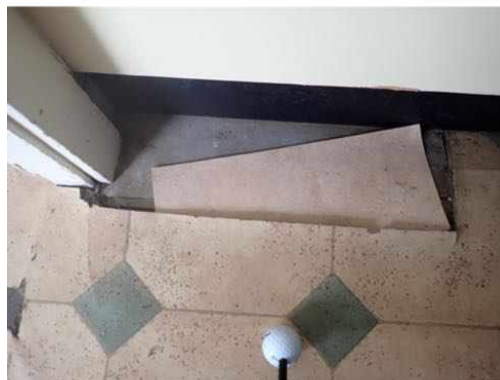
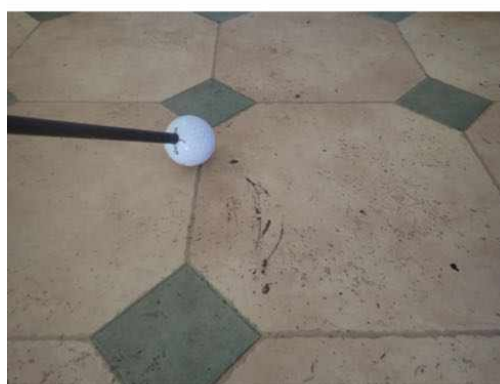
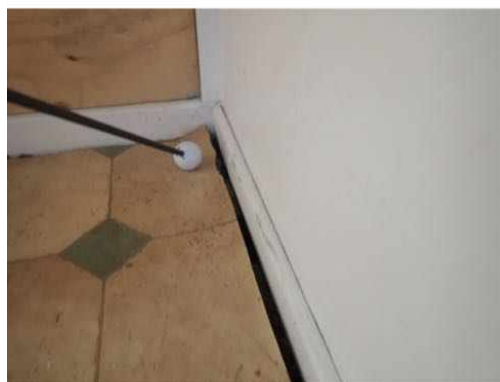
Finding 2.02

Building:	Main Building
Location:	Vinyl floored areas
Finding:	Vinyl Flooring in Poor Condition
Information:	The vinyl flooring was observed to be in poor condition with signs of wear and deterioration. This may lead to further degradation of the flooring surface and underlying materials if not addressed. Possible causes include general age-related wear and tear, moisture exposure, or inadequate maintenance. This is a common defect in properties of this age. It is recommended that a licensed flooring contractor assess the condition of the flooring and carry out repairs or replacement as required. Preventative maintenance includes regular cleaning and ensuring moisture is kept to a

minimum. Repairs should be carried out in the short term to prevent further deterioration.

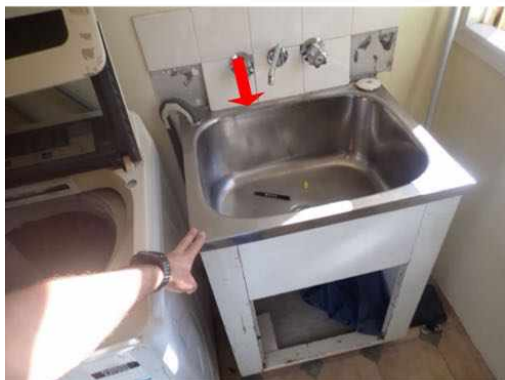
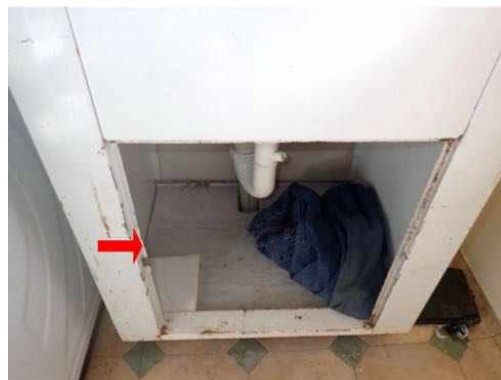
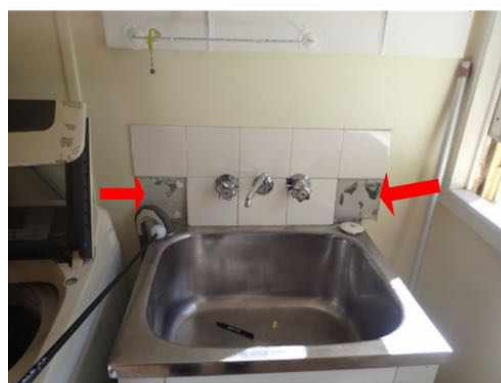
Finding 2.03

Building:	Main Building
Location:	Laundry
Finding:	Laundry Tub Cabinet Not Secured and Deteriorated Condition
Information:	The laundry tub cabinet was observed to be not secured to the wall, with surface rust present, a missing door, and damaged and missing tiles to the splashback. This condition may lead to instability of the cabinet and allow moisture ingress, resulting in further deterioration of the unit and surrounding building materials if not addressed.

Possible causes include poor installation, moisture exposure, and general age-related wear and tear. It is recommended that a licensed plumber or carpenter, in conjunction with a tiler, assess the cabinet, secure it appropriately to the wall, replace or repair the unit as required, and rectify the damaged splashback tiles with appropriate sealing. Preventative maintenance includes ensuring fixtures are properly fixed and limiting moisture exposure to cabinetry and wall linings. Repairs should be carried out in the short term to prevent further deterioration.

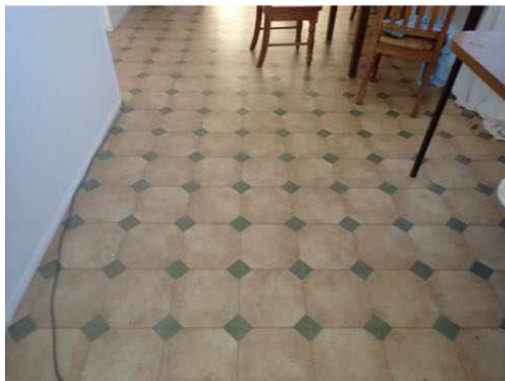
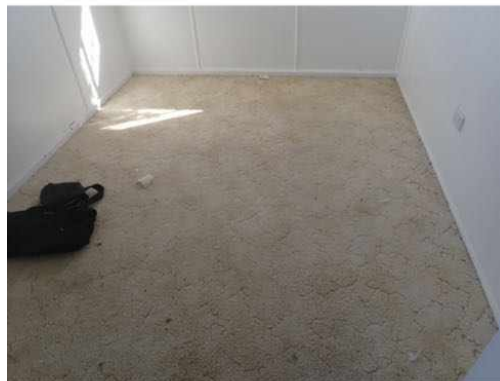
Finding 2.04

Building:	Main Building
Location:	Floor all areas
Finding:	Floor Uneven and Out of Level
Information:	The floor was observed to be generally wavy and out of level throughout the building. This condition may indicate movement or deterioration of the subfloor structure and can affect the performance of floor coverings and fixtures if not addressed. Possible causes include subfloor movement, settlement, inadequate support, moisture-related issues, or general age-related deterioration. This is a common defect in properties of this age. It is recommended that a licensed builder assess the subfloor and structural supports, and carry out further investigation and rectification works as required. Preventative maintenance includes maintaining adequate subfloor ventilation and ensuring moisture is controlled. Repairs should be carried out in the short term to prevent further deterioration.

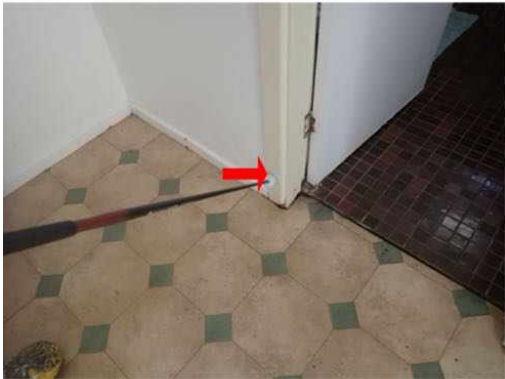
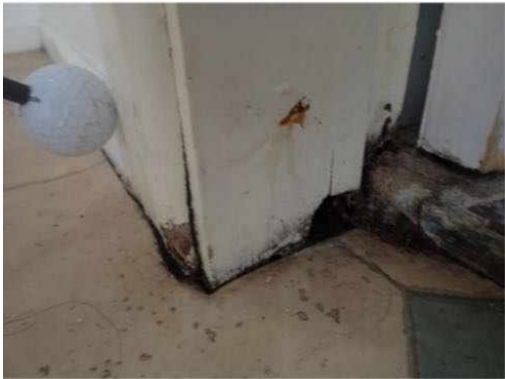
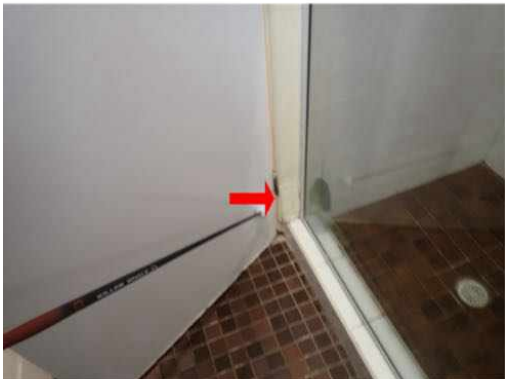
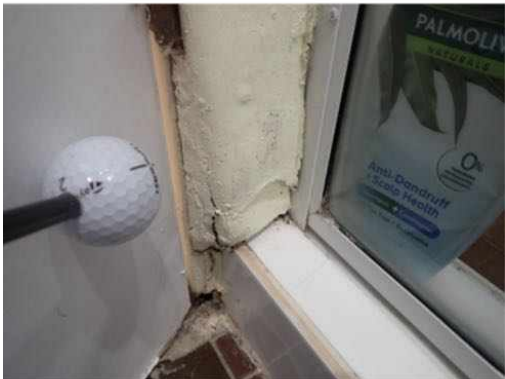
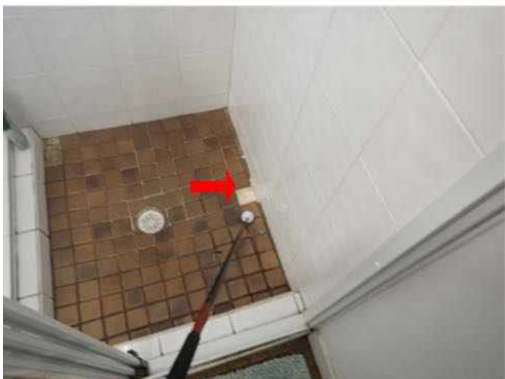
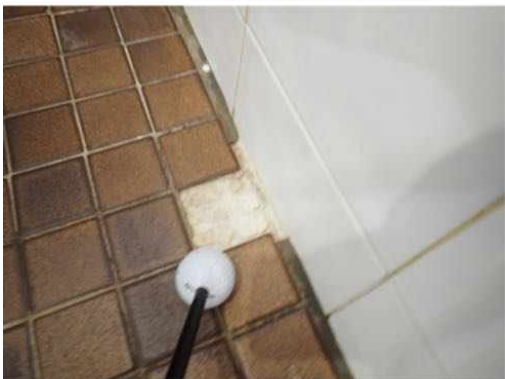
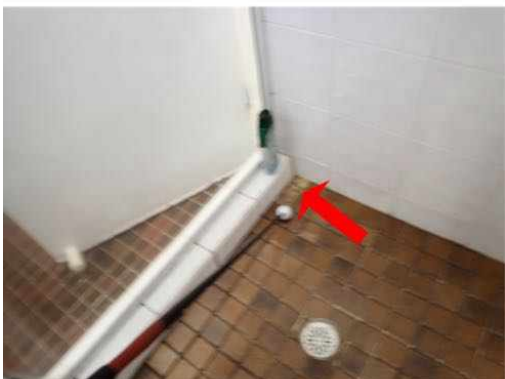
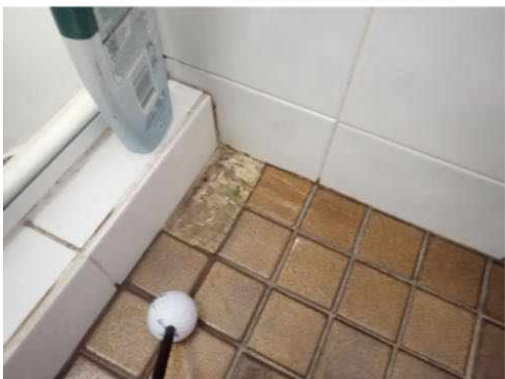
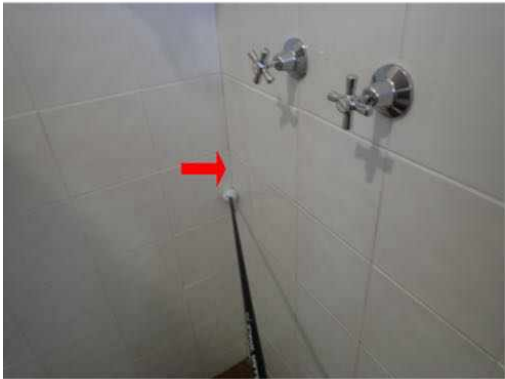
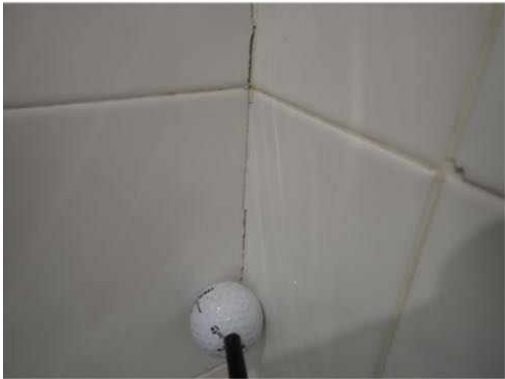
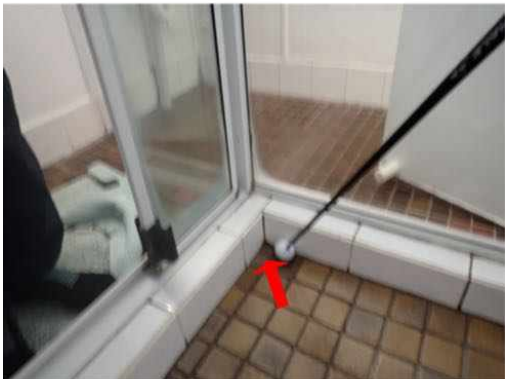
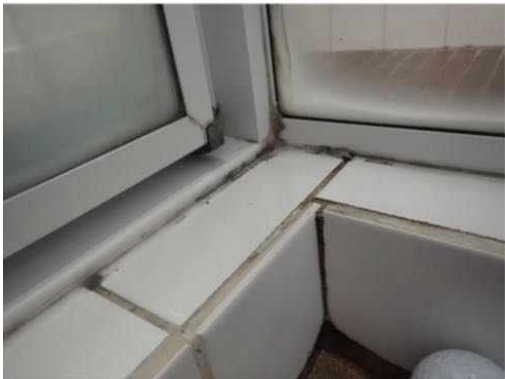
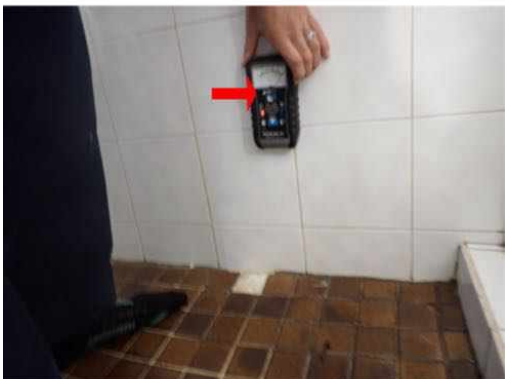
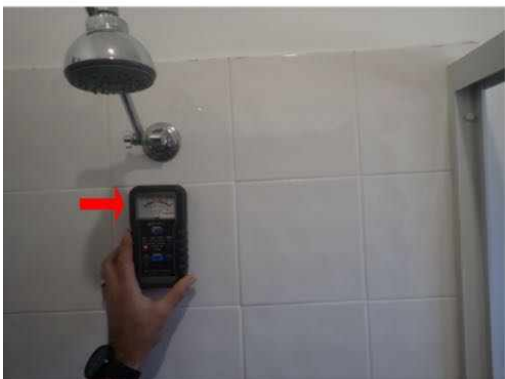
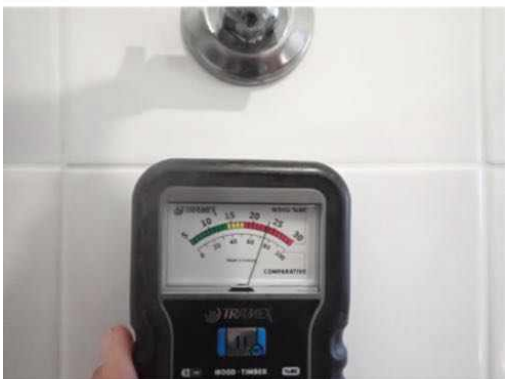
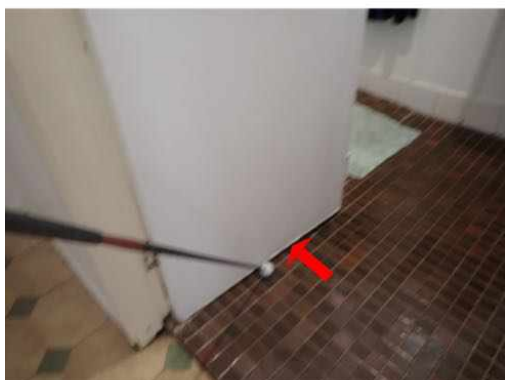
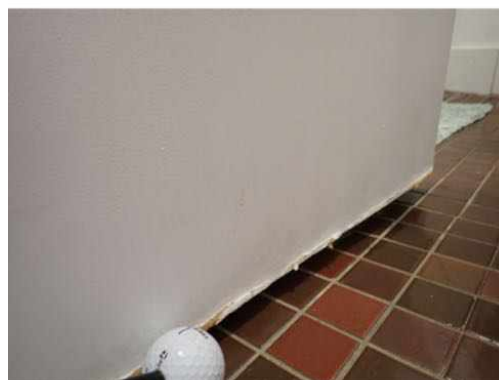
Finding 2.05

Building:	Main Building
Location:	Bathroom
Finding:	Bathroom Water Damage and Deteriorated Finishes
Information:	Water damage was identified to the bathroom, with missing tiles, deteriorated silicone and grout, and high moisture meter readings recorded to the walls. The bathroom entry door was also noted to be affected. This condition has led to deterioration of underlying building materials and may continue to deteriorate further if not addressed. Possible causes include failed waterproofing, deteriorated sealants and grout, and general age-related wear and tear. It is recommended that a licensed builder, in conjunction with a tiler and plumber, assess the extent of moisture damage, carry out further investigation to underlying materials, and complete repairs including replacement of tiles, re-grouting, and re-sealing as required. Preventative maintenance includes maintaining effective waterproofing, sealants, and grout to wet areas. Repairs should be carried out as soon as possible.

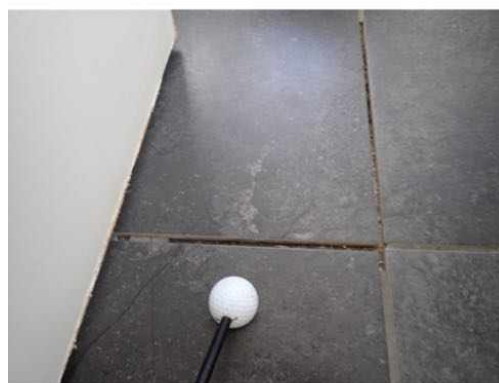
Finding 2.06

Building:	Main Building
Location:	Toilet (WC)
Finding:	Toilet Floor Tiles in Poor Condition and Poorly Laid
Information:	The toilet floor tiles were observed to be in poor condition and poorly laid. This may result in uneven surfaces, loose or drummy tiles, and potential moisture ingress if not addressed. Possible causes include poor workmanship, inadequate substrate preparation, or general wear and tear. It is recommended that a licensed tiler assess the area, remove and re-lay the tiles with appropriate preparation and sealing as required. Preventative maintenance includes ensuring tiles are properly installed and maintaining grout and sealants. Repairs should be carried out in the short term to prevent further deterioration.

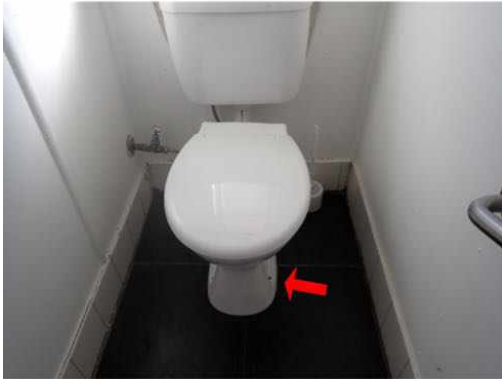
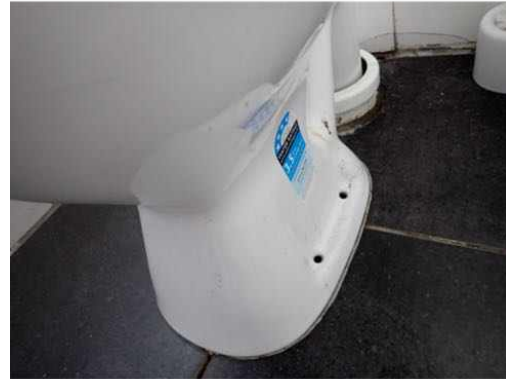
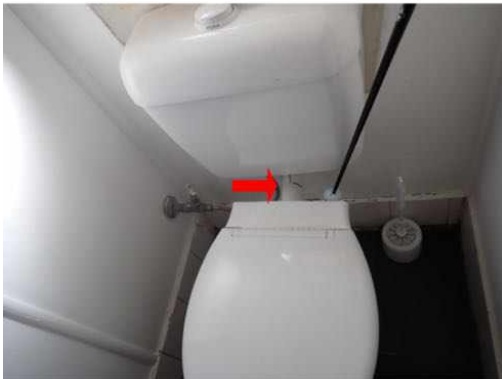
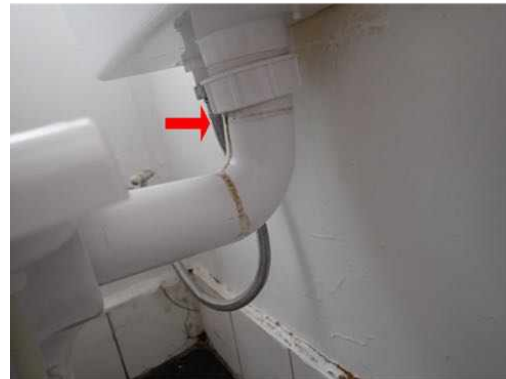
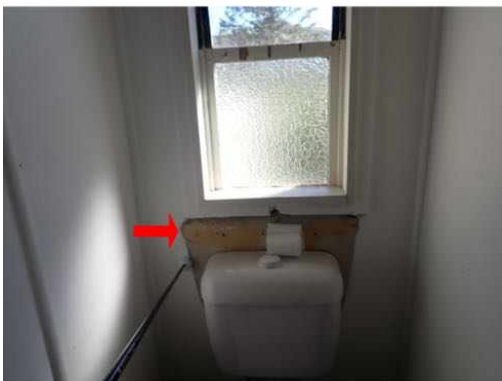
Finding 2.07

Building:	Main Building
Location:	Toilet (WC)
Finding:	Toilet Loose with Minor Leak and Wall Damage
Information:	The toilet was observed to be loose with a minor leak present, and damage was noted to the wall where a previous toilet installation had been carried out. This condition may lead to ongoing water leakage and further deterioration of surrounding building materials if not addressed. Possible causes include poor installation, failed seals, or

movement of the fixture over time. It is recommended that a licensed plumber assess the toilet, secure it correctly, repair the leak, and make good any associated wall damage as required. Preventative maintenance includes ensuring fixtures are properly installed and promptly addressing any leaks. Repairs should be carried out as soon as possible.

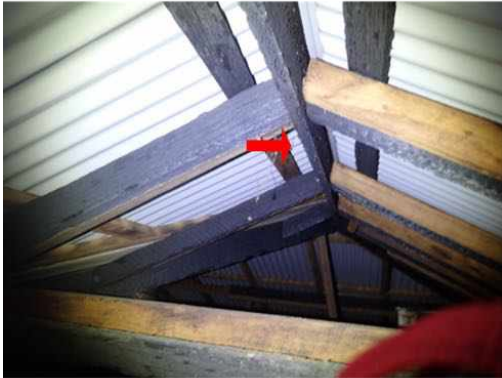
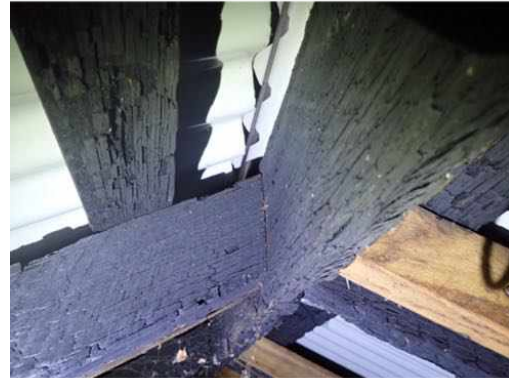
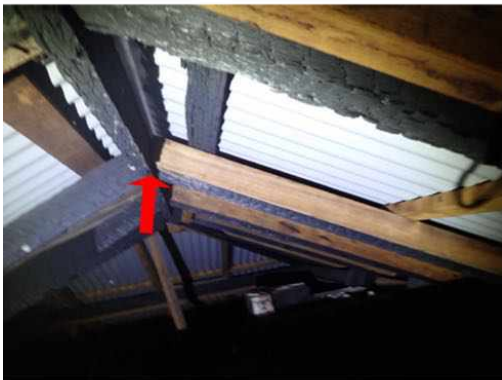
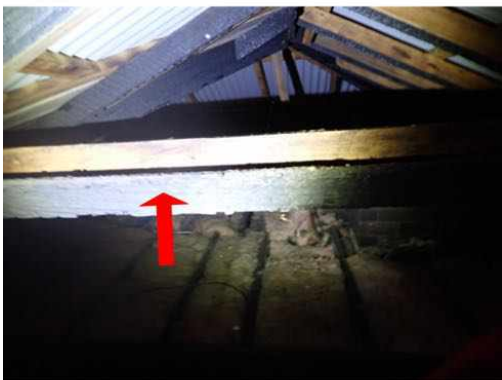
Finding 2.08

Building:	Main Building
Location:	Ceiling space
Finding:	Fire Damage to Roof Timbers (Partial Replacement Noted)
Information:	Evidence was observed that a fire has previously affected the roof timbers, with

sections having been replaced. This condition may indicate potential concealed damage to remaining structural elements and variations in the integrity of the roof framing if not fully assessed. Possible causes relate to a past fire event and subsequent partial rectification works. It is recommended that a licensed builder or structural engineer assess the roof structure to determine the extent of any remaining damage and confirm that repairs have been carried out appropriately. Preventative measures include ensuring all fire-affected materials have been fully removed and replaced where required. Further assessment should be carried out in the short term to confirm structural integrity.

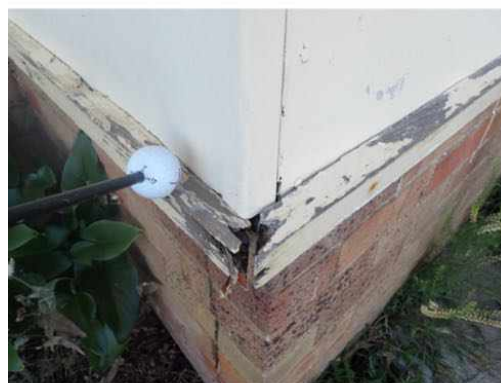
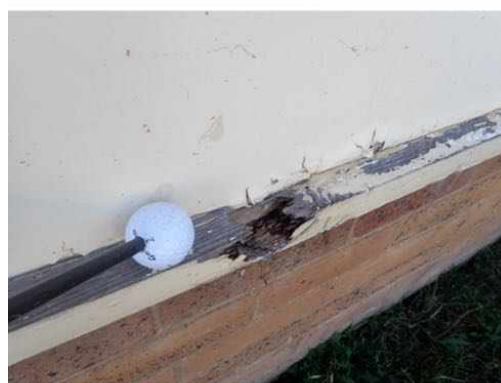
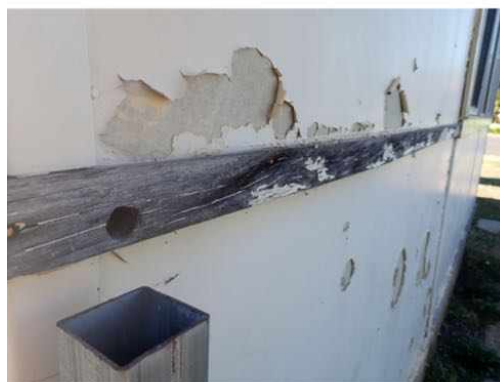
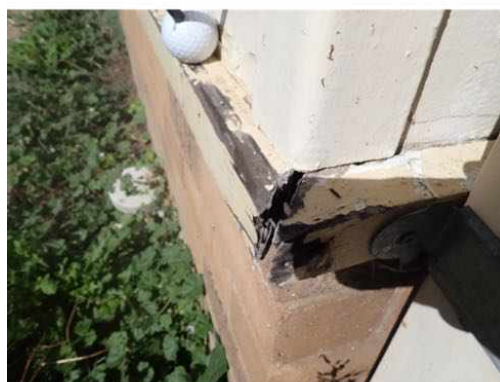
Finding 2.09

Building:	Main Building
Location:	External timber trims
Finding:	Wood Rot and Deteriorated Paintwork to External Timber Trims
Information:	Wood rot and deteriorated paintwork were identified to the external timber trims around the building. This condition may allow moisture ingress and lead to further deterioration of the timber elements if not addressed. Wood rot is also conducive to termite attack. Possible causes include prolonged exposure to weather, lack of maintenance, and general age-related wear and tear. This is a common defect in properties of this age. It is recommended that a licensed carpenter assess the affected timber trims, carry out repairs or replacement of any rotted sections, and repaint/seal the surfaces as required. Preventative maintenance includes regular painting and sealing of external timber elements to protect against moisture. Repairs should be carried out in the short term to prevent further deterioration.

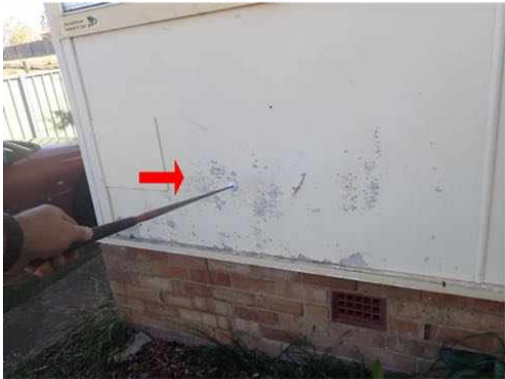
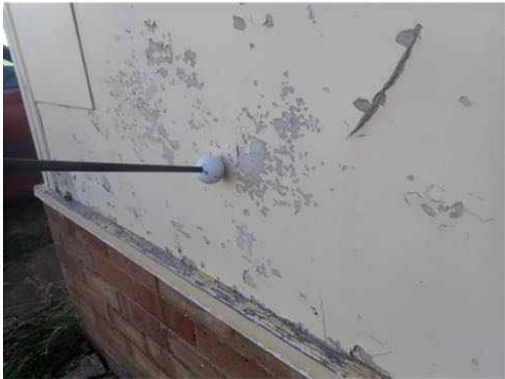
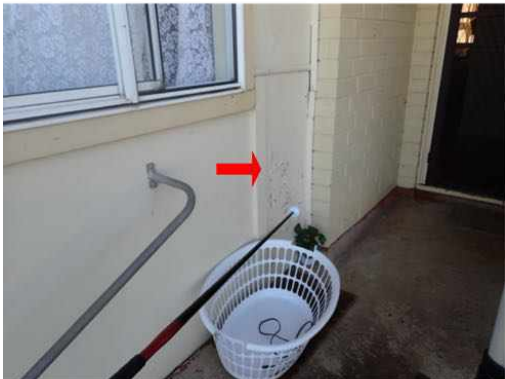
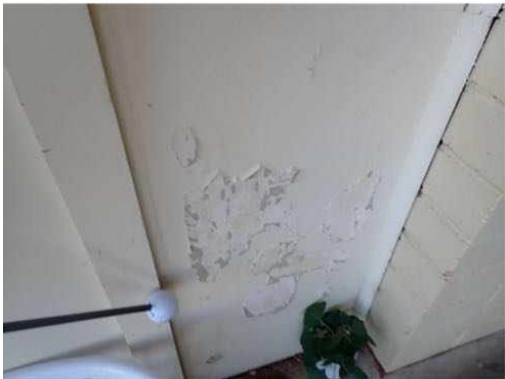
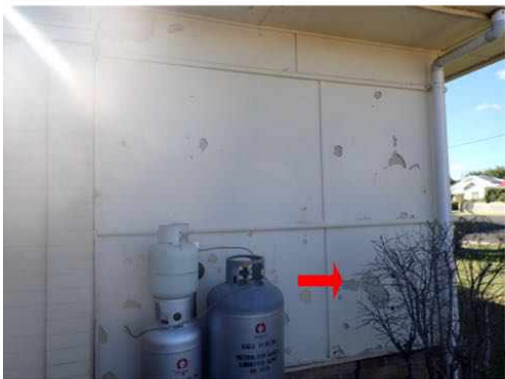
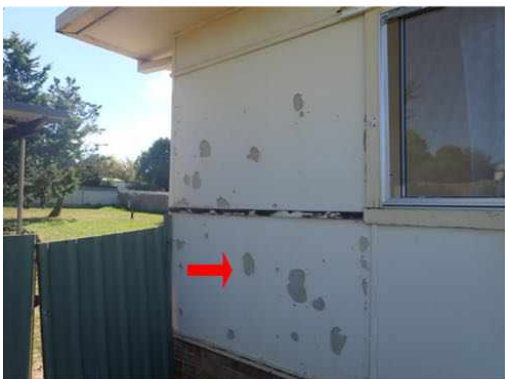
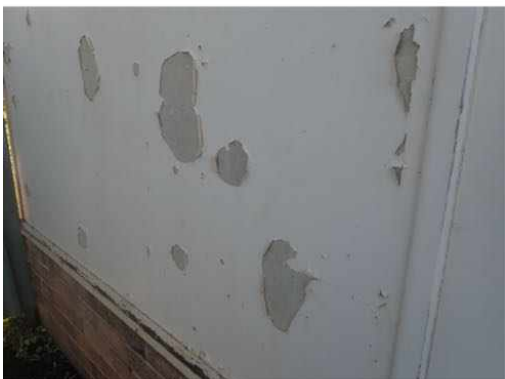
Finding 2.10

Building:	Main Building
Location:	External timber trims
Finding:	External Painting Required to Entire Dwelling
Information:	The external surfaces of the house, including timber windows and doors, were observed to be in need of painting. Deteriorated and unprotected surfaces may allow moisture ingress and lead to ongoing deterioration of timber elements if not addressed. Possible causes include weather exposure, lack of maintenance, and general age-related wear and tear. This is a common condition in properties of this age. It is recommended that a licensed painter assess all external surfaces, prepare the areas appropriately, and carry out full repainting including timber windows and doors. Preventative maintenance includes regular painting and sealing of external surfaces to protect against weathering. Works should be carried out in the short term to prevent further deterioration.

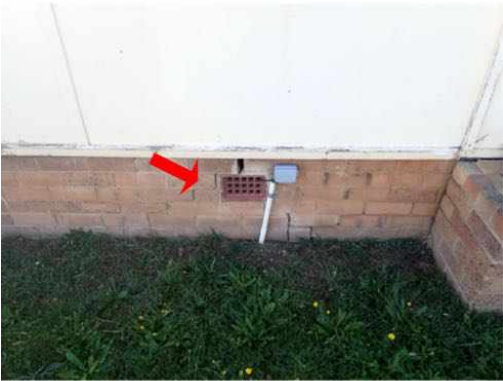
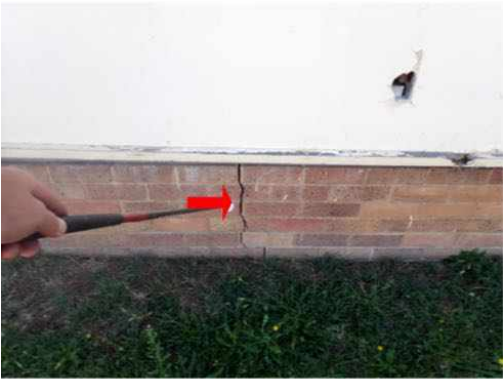
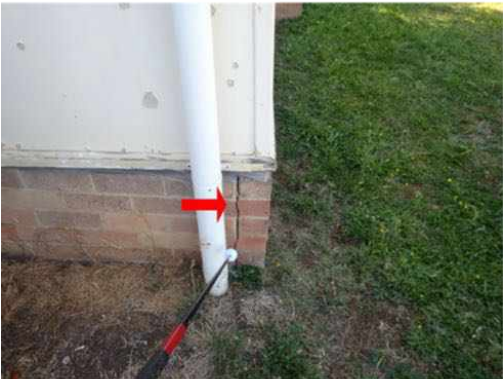
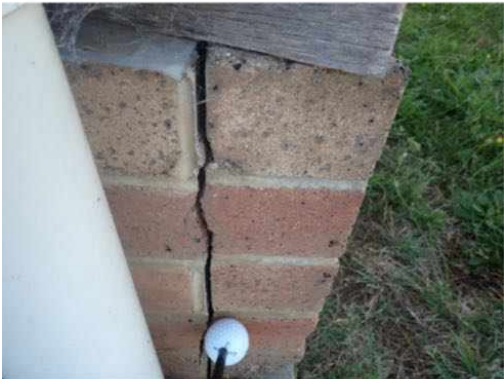
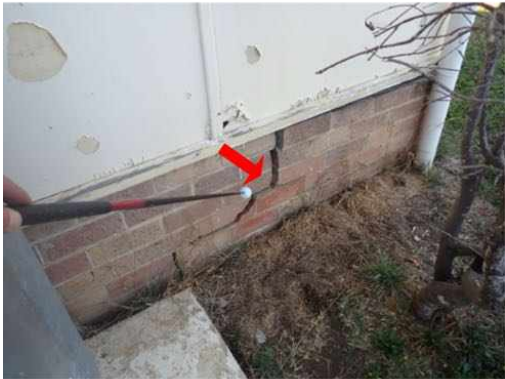
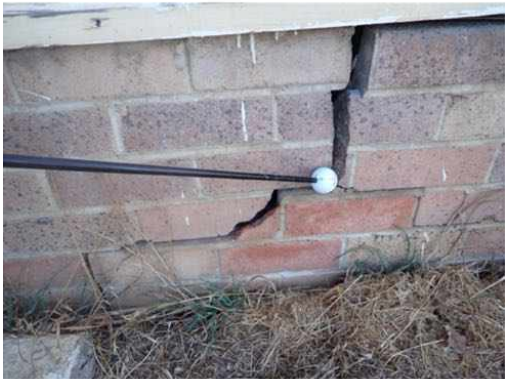
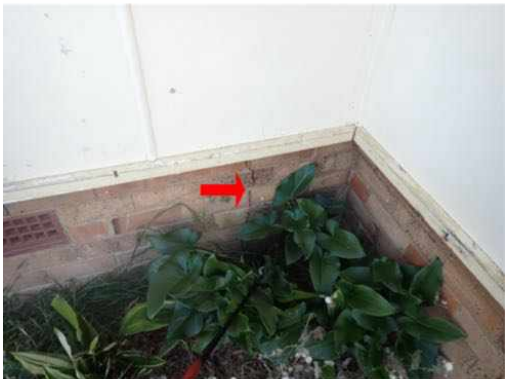
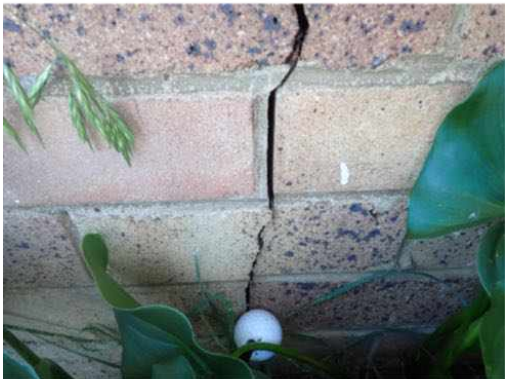
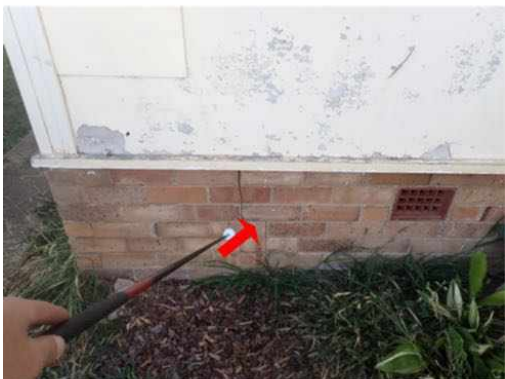
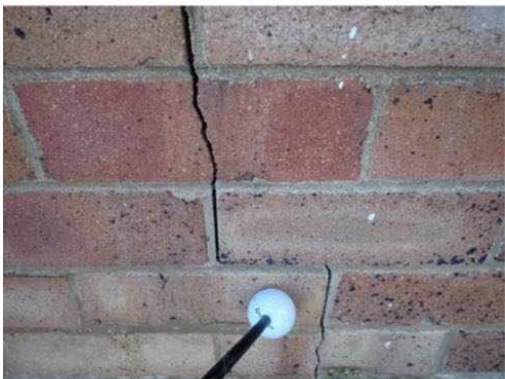
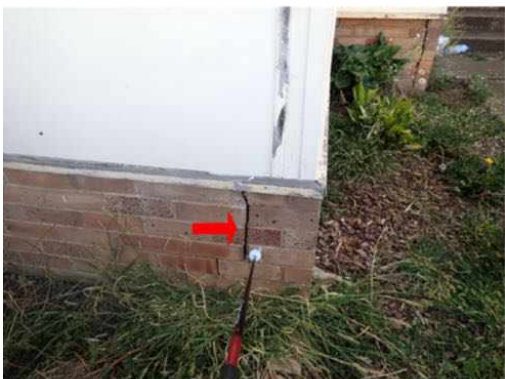
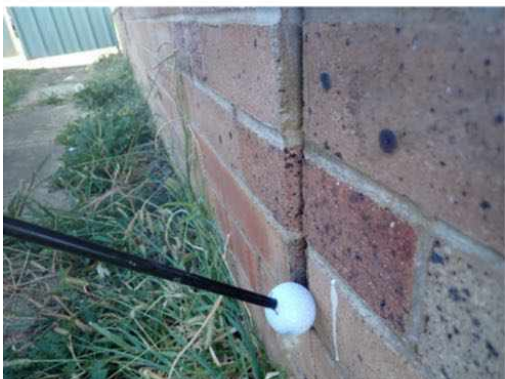
Finding 2.11

Building: Main Building
Location: Perimeter of building
Finding: Significant Cracking to Brick Base of Building
Information: Multiple significant cracks were identified to the brick base of the building. This condition indicates movement or possible structural issues and may lead to further structural deterioration if not addressed. Possible causes include foundation movement, reactive soils, moisture variation, or long-term settlement. It is recommended that a licensed structural engineer, in conjunction with a licensed builder, carry out a detailed assessment to determine the cause and extent of movement and specify appropriate rectification works. Preventative measures include

managing site drainage and controlling moisture levels around the building. Repairs and further assessment should be carried out as soon as possible.

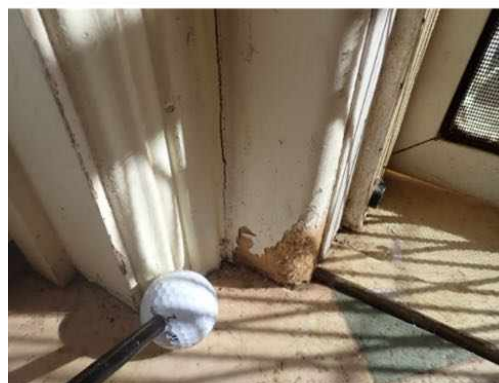
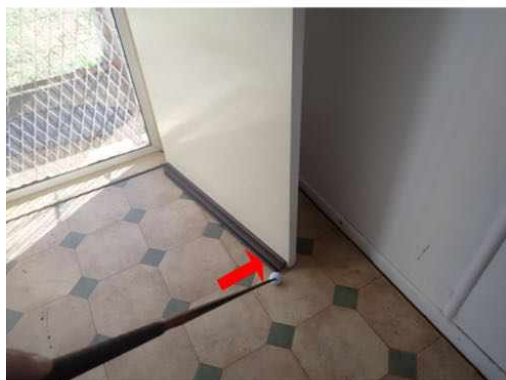
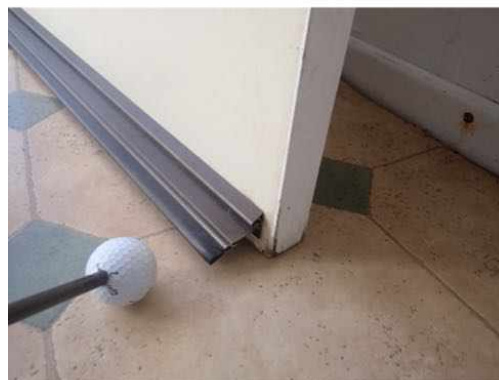
Finding 3.05

Building:	Main Building
Location:	Rear exit door
Finding:	Rear Exit Door Catching and Swollen Architrave
Information:	The rear exit door was observed to be catching on the floor covering, and the door architrave was noted to be swollen and made from MDF. This condition may lead to reduced functionality and ongoing deterioration, particularly where MDF has been affected by moisture. Possible causes include moisture ingress, material swelling, poor installation, or general wear and tear. It is recommended that a licensed carpenter assess the door and architrave, carry out adjustments to ensure proper clearance, and repair or replace the affected MDF components with more suitable materials as required. Preventative maintenance includes managing moisture levels and ensuring appropriate materials are used in areas prone to moisture. Repairs should be carried out in the short term to prevent further deterioration.

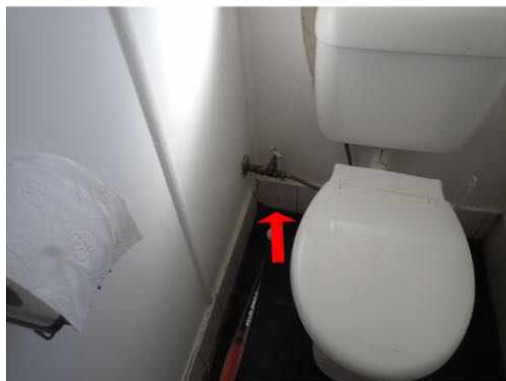
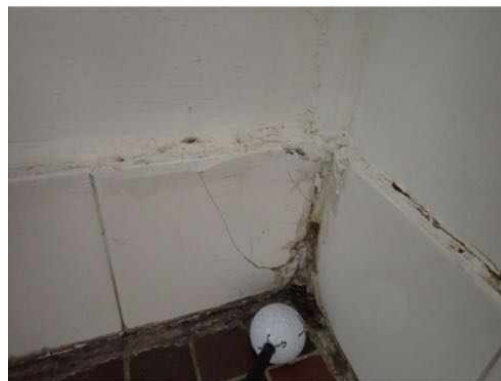
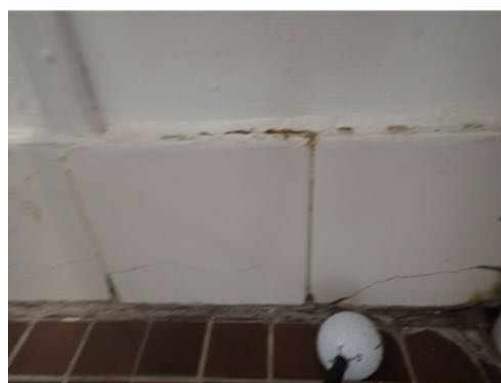
Finding 3.06

Building:	Main Building
Location:	Bathroom
Finding:	Cracked Tiles to Bathroom and Toilet Skirting
Information:	Cracked tiles were identified to the bathroom and toilet skirting. This condition may allow moisture ingress and lead to deterioration of adjacent building materials if not addressed. Possible causes include movement in the structure, impact damage, poor installation, or general age-related wear and tear. It is recommended that a licensed

tiler assess the affected area, replace the damaged tiles, and ensure appropriate sealing and waterproofing is in place. Preventative maintenance includes maintaining grout and sealants and addressing damaged tiles promptly. Repairs should be carried out in the short term to prevent further deterioration.

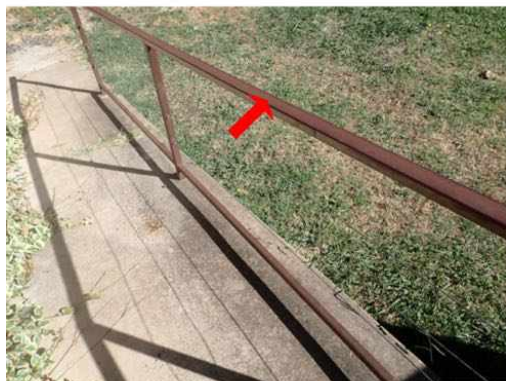
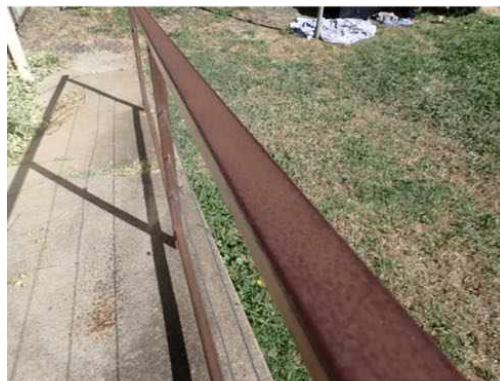
Finding 3.07

Building:	Main Building
Location:	Rear concrete ramp
Finding:	Surface Rust to Rear Ramp Handrail
Information:	Surface rust was identified to the rear ramp handrail. This condition may lead to further corrosion and deterioration of the metal if not addressed. Possible causes include

exposure to weather and lack of protective coating or maintenance. This is a common defect in external metal elements. It is recommended that a licensed painter or metal fabricator treat the affected areas, remove rust, and apply appropriate protective coatings to prevent further corrosion. Preventative maintenance includes regular inspection and repainting of exposed metalwork. Repairs should be carried out as part of routine maintenance.

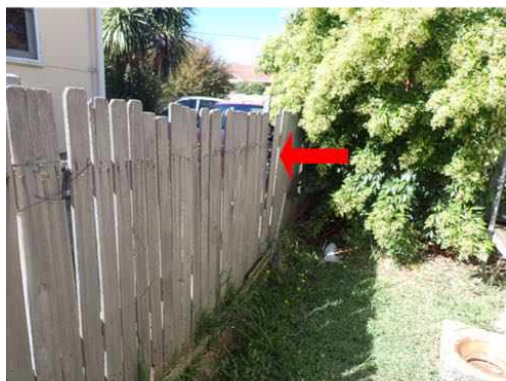
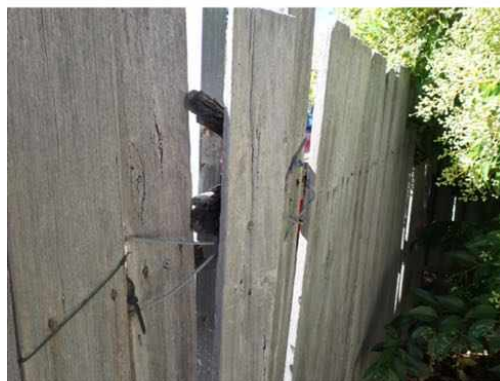
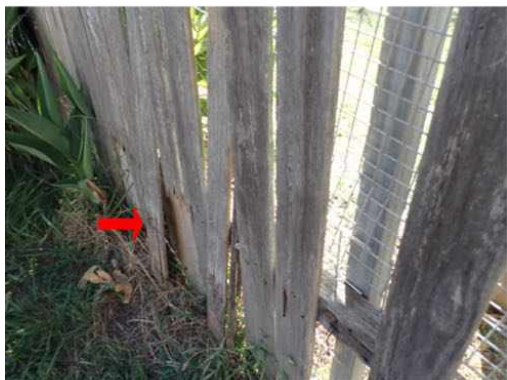
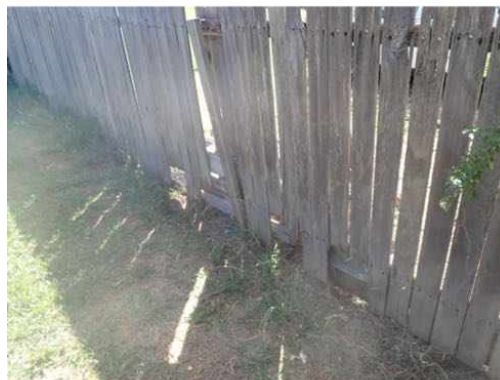
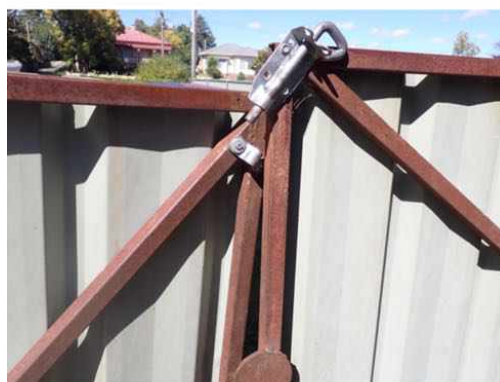
Finding 3.08

Building: Main Building
Location: Bounty fencing
Finding: Boundary Fencing in Deteriorated Condition
Information: The boundary fencing was observed to be in deteriorated condition overall, with signs of wear, weathering, and reduced structural integrity in sections. This condition may lead to further deterioration and potential failure of fencing components if not addressed. Possible causes include prolonged exposure to weather, age-related deterioration, and lack of maintenance. It is recommended that a licensed carpenter or fencing contractor assess the fencing and carry out repairs or replacement of affected sections as required. Preventative maintenance includes regular inspection and upkeep of fencing components. Repairs should be carried out in the short term to prevent further deterioration.

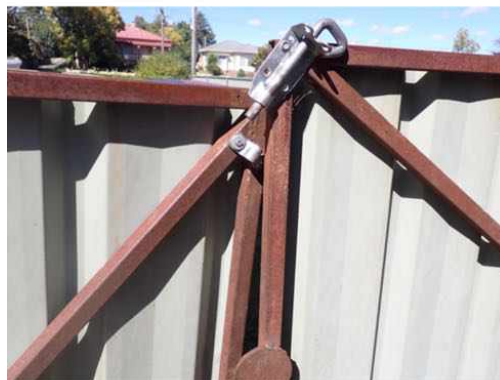
Finding 3.09

Building:	Main Building
Location:	Side gate
Finding:	Side Gate in Poor Condition
Information:	The side gate was observed to be in poor condition with signs of wear, damage, and deterioration. This condition may affect functionality and security and can lead to further deterioration if not addressed. Possible causes include general age-related wear and tear, weather exposure, and lack of maintenance. It is recommended that a licensed carpenter or fencing contractor assess the gate and carry out repairs or replacement as required. Preventative maintenance includes regular inspection and upkeep of gate components. Repairs should be carried out in the short term to prevent further deterioration.

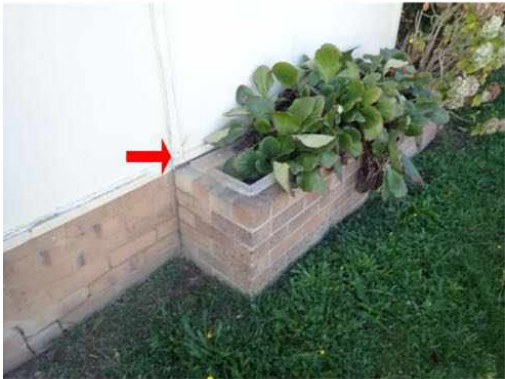
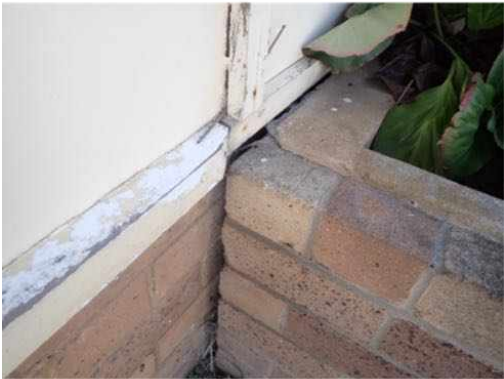
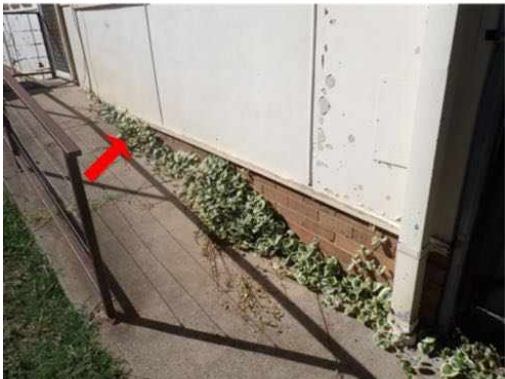
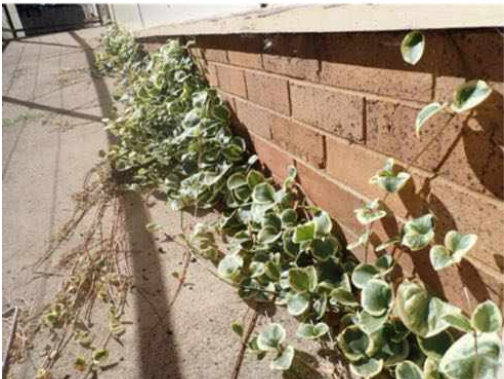
Finding 6.01

Building:	Main Building
Location:	Perimeter of building
Finding:	Conditions Conducive to Termite Attack – Concealed Entry Points
Information:	<p>Conditions conducive to termite attack were identified around the building and with in the subfloor, including areas that may allow concealed entry. Such conditions can increase the risk of termite activity and potential damage to timber elements if not addressed. Possible causes include timber in contact with the ground, inadequate clearance, poor maintenance, and obstructed inspection zones. This is a common issue in properties of this age. It is recommended that a licensed timber pest inspector assess the property, identify all risk areas, and implement appropriate termite management and protection measures. Preventative maintenance includes maintaining clear inspection zones, ensuring adequate clearances, and removing or isolating timber from ground contact. Works should be carried out in the short term to reduce the risk of termite attack.</p>

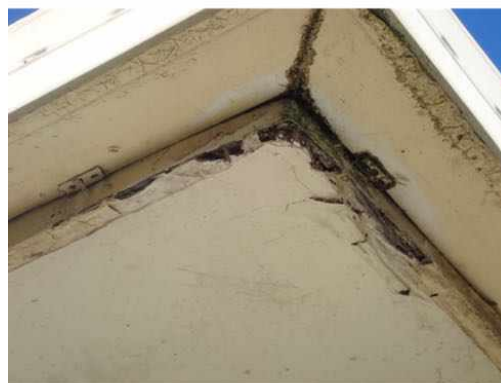
Finding 6.02

Building:	Main Building
Location:	Fascia boards
Finding:	Wood Rot to Fascia Board Ends
Information:	Wood rot was identified to the ends of the fascia boards. This condition may allow moisture ingress and lead to further deterioration of the timber elements if not addressed. Wood rot is also conducive to termite attack. Possible causes include prolonged exposure to weather, failed paint coatings, and general age-related wear and tear. This is a common defect in properties of this age. It is recommended that a licensed carpenter assess the affected fascia boards, carry out repairs or replacement of rotted sections, and repaint/seal the surfaces as required. Preventative maintenance includes regular painting and sealing of external timber elements to protect against moisture. Repairs should be carried out in the short term to prevent further deterioration.

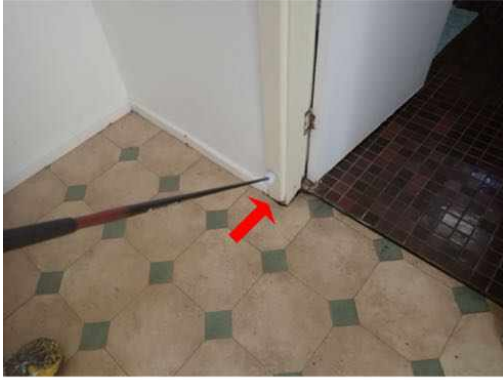
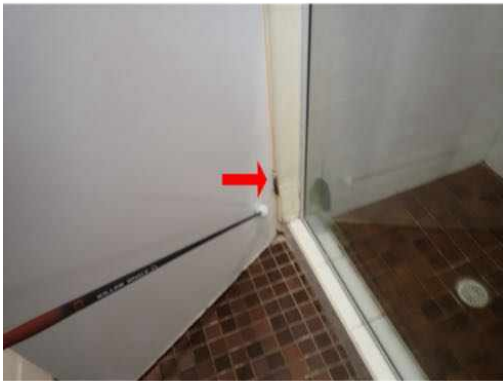
Finding 7.01

Building:	Main Building
Location:	Bathroom
Finding:	Wood Rot to Bathroom Door Jamb and Architraves
Information:	Wood rot was identified to the bathroom door jamb and architraves, likely resulting from moisture associated with a leaking shower. This condition indicates prolonged moisture exposure and may lead to further deterioration of surrounding building materials if not addressed. Possible causes include failed waterproofing, leaking shower components, and ongoing moisture ingress. It is recommended that a licensed builder, in conjunction with a plumber, assess the source of the leak, rectify the moisture issue, and repair or replace the affected timber elements as required. Preventative maintenance includes ensuring shower waterproofing and seals are maintained and promptly addressing any leaks. Repairs should be carried out as soon as possible.

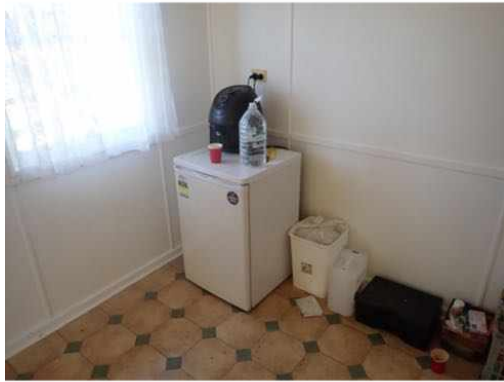
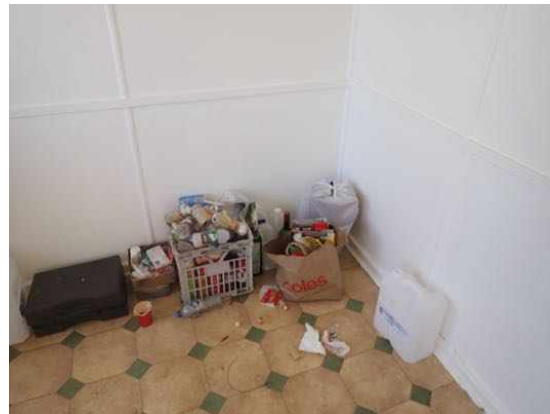
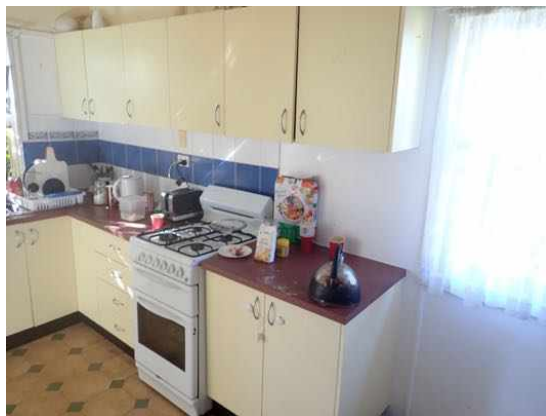
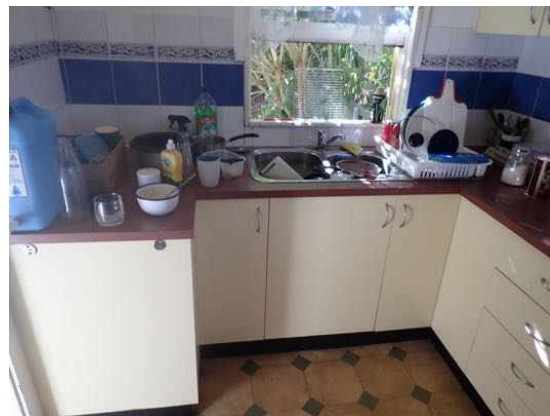
Noted Item

Building: Main Building
Location: All Areas
Finding: Additional Photos - Obstructions and Limitations
Information: These photographs are an indication of the obstructions and limitations which impeded full inspection of the area at the time of inspection. These obstructions can hide an array of defects and should be removed to allow full inspection to be carried out. A re-inspection is recommended once the areas are made accessible.
