Building and Timber Pest Inspection Report

Inspection Date: Fri, 6 Mar 2026

Property Address: 10 Glenairne St, Wodonga VIC 3690,
Australia

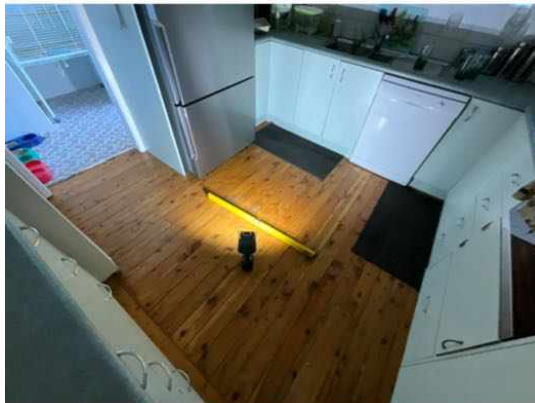
Information: The internal flooring in this area is out of level and uneven. Uneven flooring is likely to indicate minor defects such as expected movement of the foundations of the property, but may also indicate subsidence of the associated subfloor stumps.

It is advised that the flooring be closely monitored to identify any further movement. Where flooring remains relatively unchanged for an extended period of time (i.e. several months), it is likely that this defect has been caused by expected movement of the foundations of the property.

However, where flooring is uneven further, potentially invasive inspection of the subfloor structures and stumps in this area is required. In this case, works to repair are likely to be required, and would be carried out by a registered builder specialising in re-stumping.

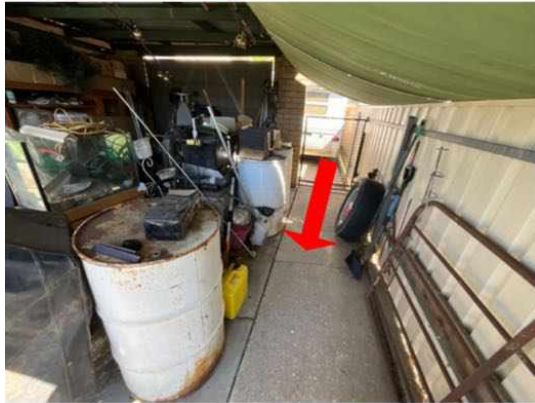
Building: Building 1
 Location: Yard - Back, driveway
 Finding: Cracking - External Concrete Paving Damage Category 4 - Gaps in Slab (4mm - 10mm +)
 Information: Gaps in the slab were identified in external concrete paving. Gaps in the slab are significant and are likely to lead to the development of safety hazards and secondary defects if left unmanaged, such as the creation of a trip hazard.

General age and expected deterioration of the paved areas is a common cause of this type of cracking. However, expansion and contraction of the slab may also have occurred due to environmental factors. Such factors include variable moisture and weather conditions, the presence of trees and their roots having a settling or lifting affect on the soil, or the effect of load bearing, e.g. heavy vehicles over a sustained period of time.

Cracking to this degree may also be due to poor original installation of the concrete. Factors such as poor compaction of the sub surface and/or inadequate reinforcing of the slab may create cracking and other secondary defects. Gaps in the concrete paving may also have a more significant structural cause, such as subsidence of soils.

Monitoring of all cracking should be conducted frequently. Always contact a building inspector should cracks widen, lengthen, or become more numerous.

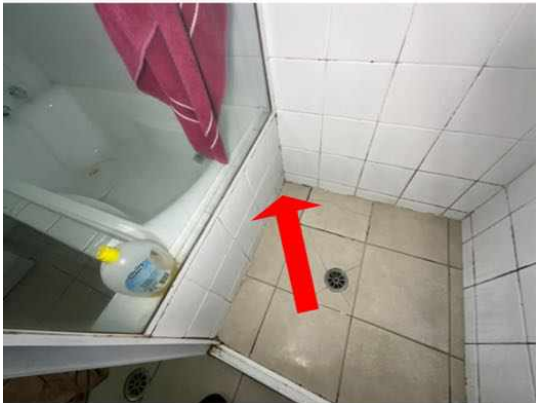
Finding 6.02

Building:	Building 1
Location:	Bathroom
Finding:	Cracked floor tiles
Information:	Cracking in the floor tiles was evident in this area at the time of inspection. It is suspected that this cracking has occurred as a result of minor settlement or impact damage.

Cracked tiles throughout the household detract from the overall appearance of the affected areas however it is unlikely to create or lead to any secondary defects.

While not considered a matter of urgency, replacement of cracked floor tiles is recommended at the clients discretion. A tiling contractor may be appointed to perform these works. Where cracks become more numerous, contact a licensed building inspector for further investigation.

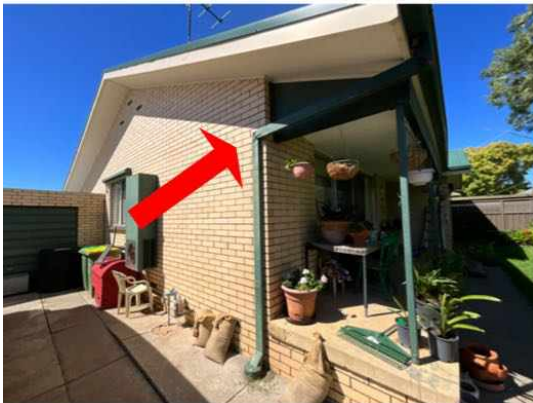
Downpipes ensure excess water is directed away from the structure to prevent damage. This damage includes Fungal timber decay, Termite attack and sinking of the stumps that support the floor. All of this type of damage may lead to costly repairs.

A Plumber should be contacted to make repairs as soon as possible to prevent deterioration of the Structure.

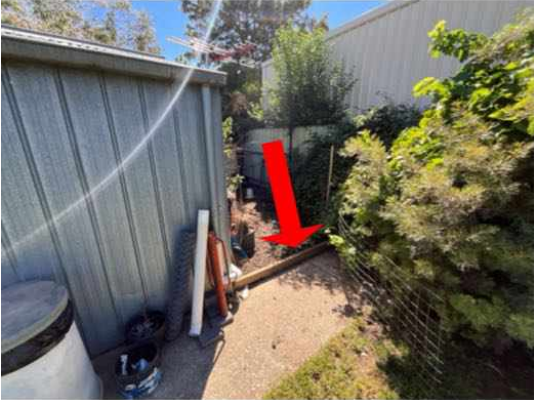
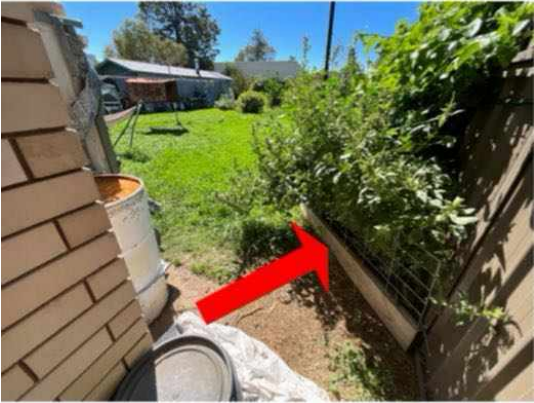
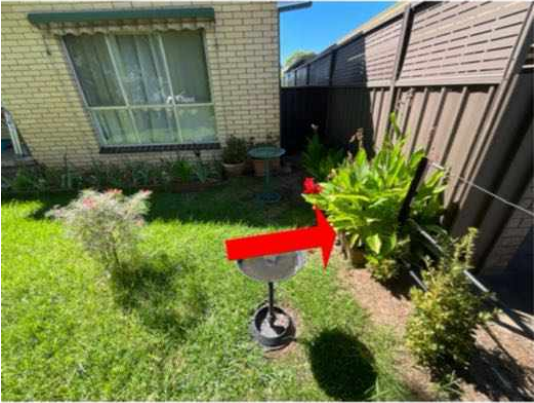
Finding 6.05

Building:	Building 1
Location:	Yard - Back, front
Finding:	Untreated or non-durable timbers in a hazardous environment
Information:	To reduce the risk of timber pest attack it is essential that timber used in a hazardous environment (e.g. in direct contact with the ground or frequently exposed to damp conditions) is of sufficient durability and/or is adequately preservative treated.

Untreated timbers in direct contact with the ground are likely to develop severe wood rot and/or fungal decay if left unattended creating attraction for subterranean termites to infest the timbers from surrounding areas.

If untreated or non-durable timbers are found to be in a hazardous environment it is highly advised that replacement of these building elements be performed as soon as possible to aid the protection of the property against termite / timber pest attack.

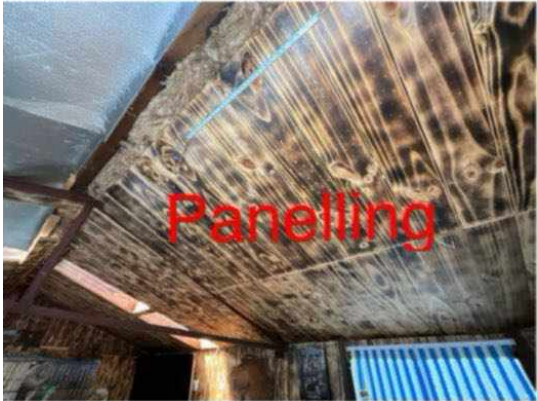
Building:	Building 1
Location:	All Areas
Finding:	Additional Photos - Obstructions and Limitations
Information:	These photographs are an indication of the obstructions and limitations which impeded full inspection of the property at the time of inspection. These obstructions can hide an array of defects and should be removed to allow full inspection to be carried out. A re-inspection is recommended once the areas are made accessible.
