Building Inspection Report

Inspection Date: Mon, 16 Mar 2026

Property Address: 37 Armstrong Way, Highland Park QLD
4211, Australia

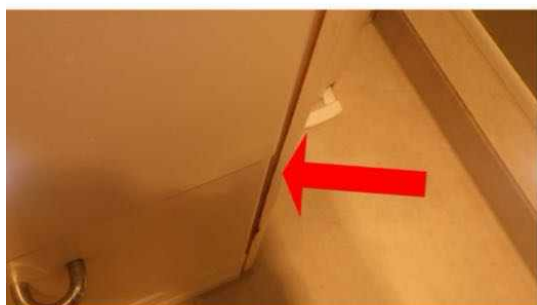
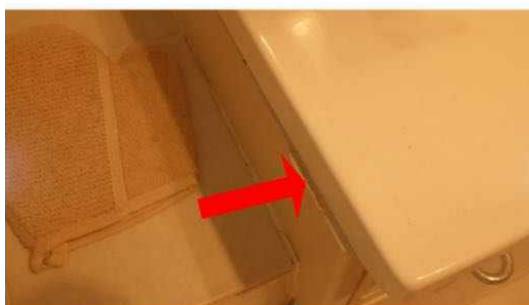
Defects 3.10

Building: Main Building
 Location: Bathroom > Centre Right

Finding: Cabinetry - Deterioration
 Information: At the time of inspection the bathroom cabinetry showed signs of minor deterioration. The level of damage appears consistent with exposure to moisture or general wear and tear.

A qualified cabinet maker or general handyman could be engaged to undertake repair works at the clients discretion.

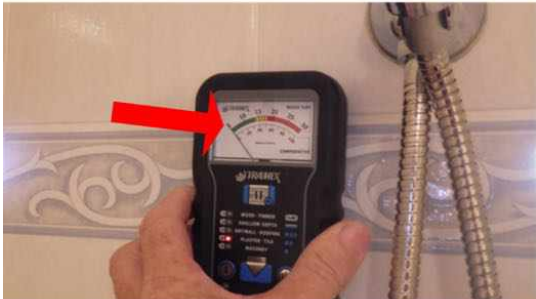
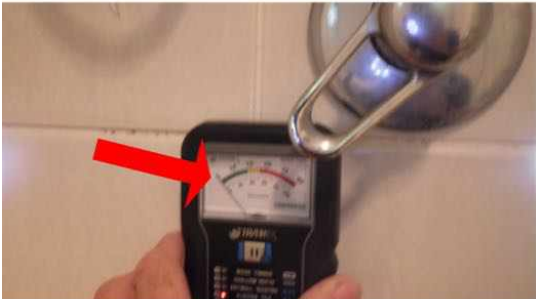
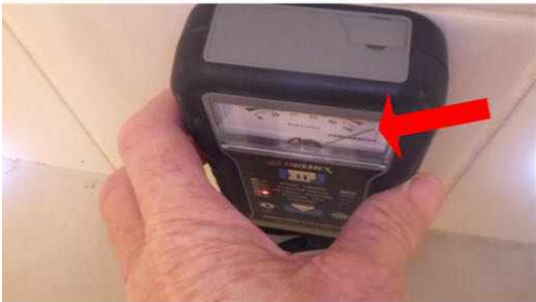
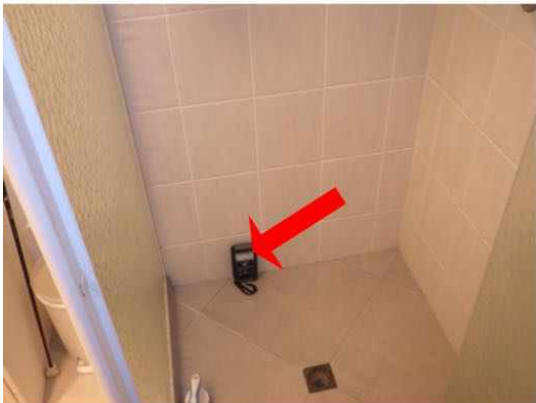
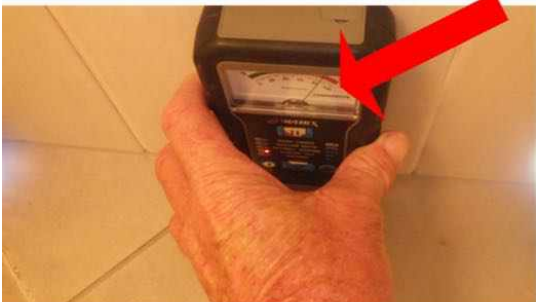
Defects 3.11

Building: Main Building
 Location: Bathroom > Front Right
 Finding: Shower - Monitor
 Information: Elevated moisture level readings were recorded to the lower 200mm of wall to the bathroom shower alcove at the time of inspection. There was no elevated moisture level readings around the tap area, and no elevated readings transferring outside the shower cubicle or to the other side of the wall in the areas where moisture readings were able to be obtained. Both sealant and grout appear in good condition at present.

This defect is quite common, and is suspected to have been caused by moisture permeating or leaching through the grouting and perhaps gaps in the sealant.

Monitoring the area is advised and if any visual signs of excessive moisture appear

(peeling paint, mould) then consultation with a bathroom specialist would be advised.

Always ensure that sealant and grout is in good condition to prevent any moisture issues occurring in the future.

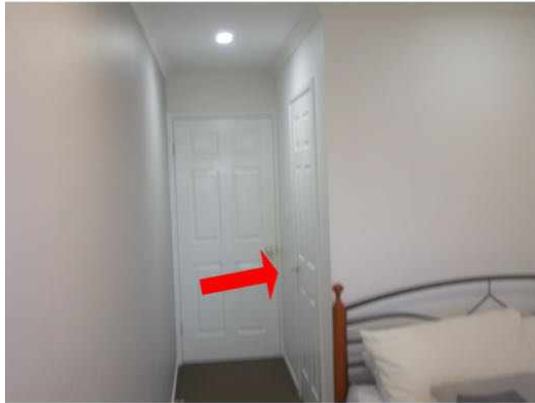
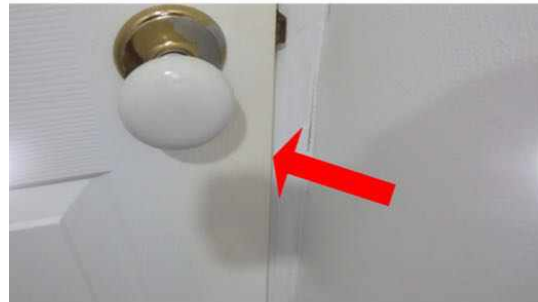
Defects 3.12

Building: Main Building
 Location: Bedroom 2 > Front
 Finding: Door - Binding/Jamming
 Information: Binding and/or jamming of the bedroom 2 door on the door frame was evident during standard operation. This defect inhibits the functionality of affected door as well as creating potential for secondary defects to associated building elements, such as damage to the door framing.

A door that binds to the associated door frame or sill may have several causes, such as poor installation of the door or deteriorated hinges.

A qualified carpenter or general handyperson could be appointed to perform minor rectification works at client discretion.

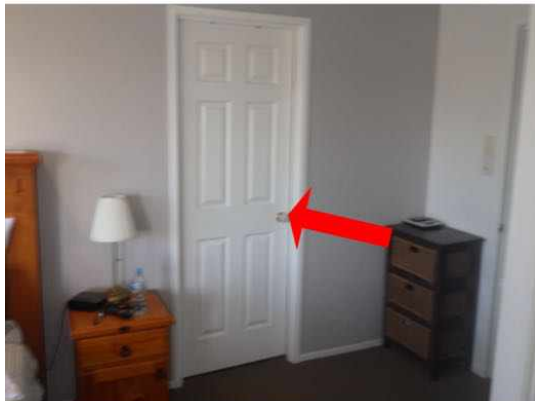
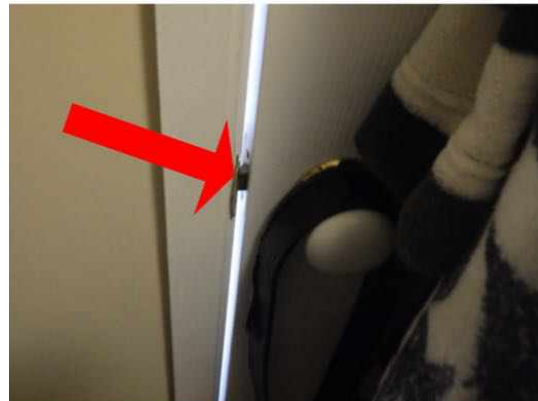
Defects 3.13

Building: Main Building
 Location: Walk In Robe > Front
 Finding: Door - Not latching
 Information: The door to the main bedroom walk in robe area was found to be not latching at the time of inspection. Breakage occurs generally when the building materials have aged and decayed.

A qualified carpenter or general handyman could be appointed to adjust the door handle striker plate at the client's discretion.

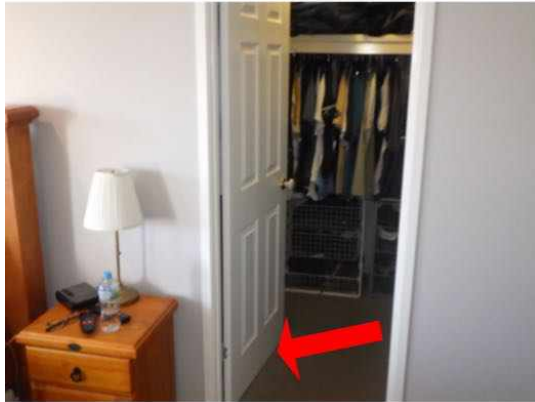
Defects 3.14

Building: Main Building
 Location: Walk In Robe > Front
 Finding: Door Rubbing
 Information: It was noted that the bottom edge of the walk in robe door is rubbing on the carpet making the door stiff to open and close at the time of inspection.

This is noted as a minor defect that you need to be aware of.

A licensed carpenter or general handyman could be engaged to ease the door at the clients discretion.

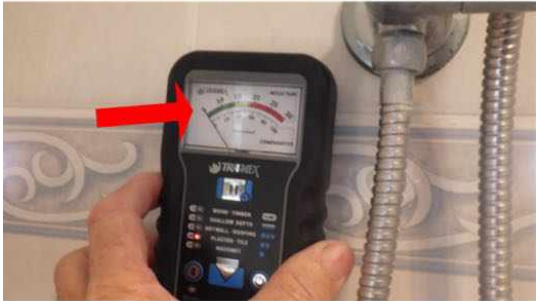
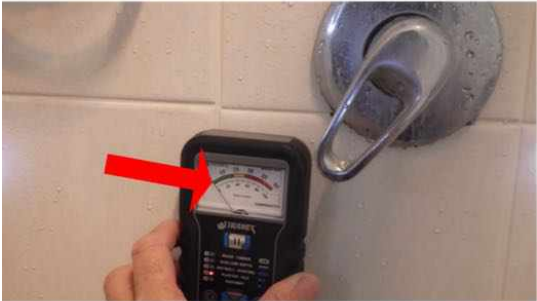
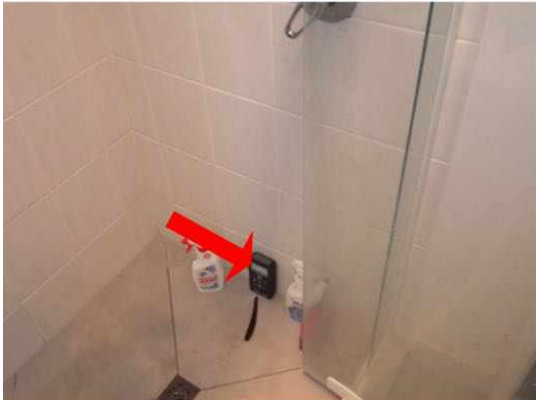
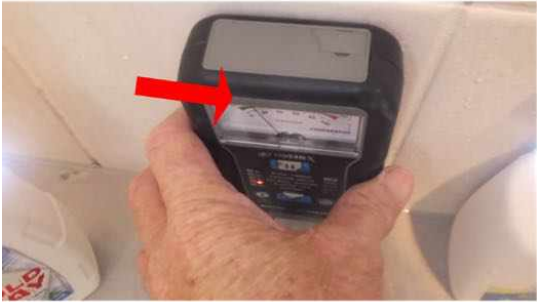
Defects 3.16

Building: Main Building
 Location: Ensuite > Front Right
 Finding: Shower - Monitor
 Information: Elevated moisture level readings were recorded to the rear lower 200mm of wall to the ensuite shower alcove at the time of inspection. There was no elevated moisture level

readings around the tap area, and no elevated readings transferring outside of the shower cubicle in the areas where moisture readings were able to be obtained. Both sealant and grout appear in good condition at present.

This defect is quite common, and is suspected to have been caused by moisture permeating or leaching through the grouting and perhaps gaps in the sealant.

Monitoring the area is advised and if any visual signs of excessive moisture appear (peeling paint, mould) then consultation with a bathroom specialist would be recommended.

Always ensure that sealant and grout is in good condition to prevent any moisture issues occurring in the future.

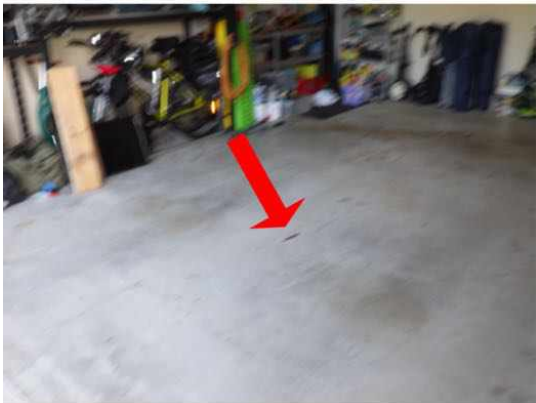
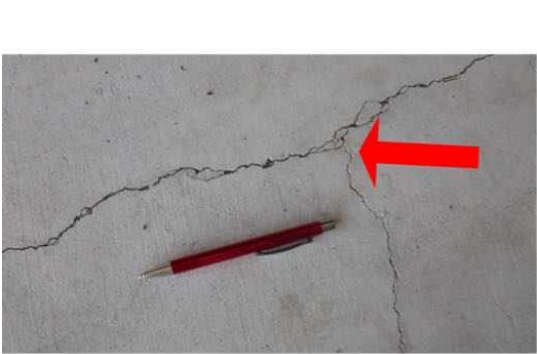
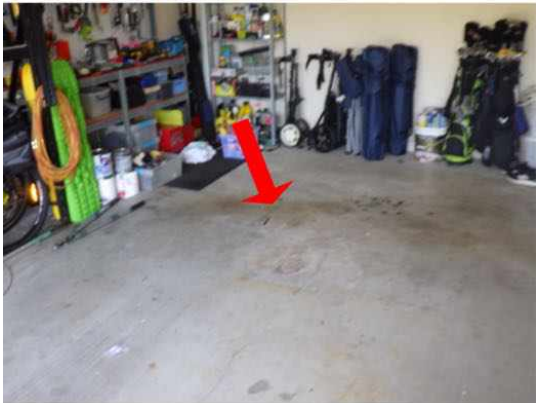
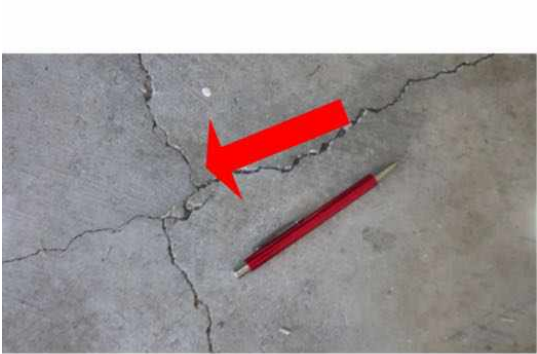
Defects 3.17

| Finding: | Cracking in concrete slab - Category 1 |
| Information: | Cracking coded as Category 1 was identified in the garage floor concrete slab (as per example photos). A Category 1 crack is described as a fine but noticeable crack, with the slab at an otherwise reasonable level. |

To be considered Category 1, the approximate width of the crack is 1.0mm, or a less than 10mm change in offset when a 3m straight edge is placed over the defect.

Category 1 cracks should be monitored for a period of 12 months. At the end of the monitoring period, identified cracks that are rated greater than Category 2 are considered defects, and require rectification.

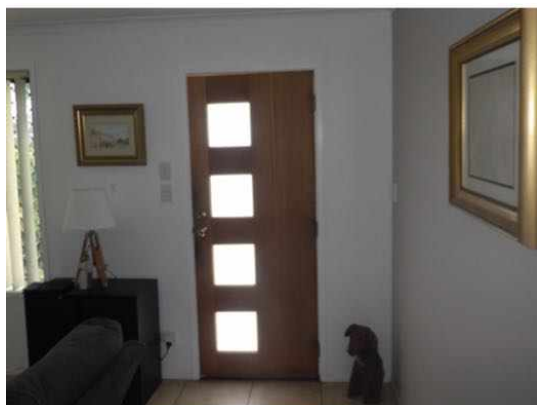
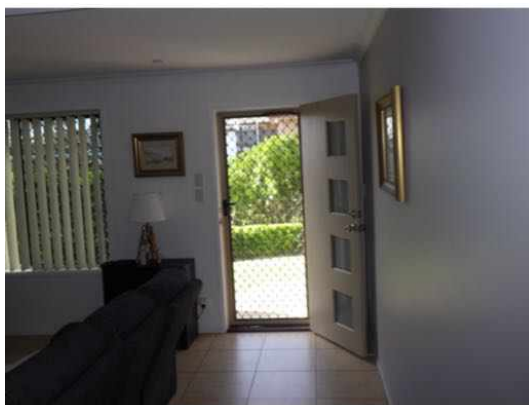
Noted Item

Building: Main Building
 Location: Entry > Existing
 Finding: No obvious defect
 Information: No obvious defects found at the time of inspection.

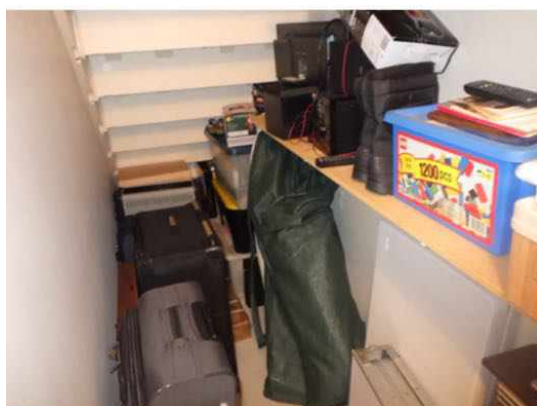
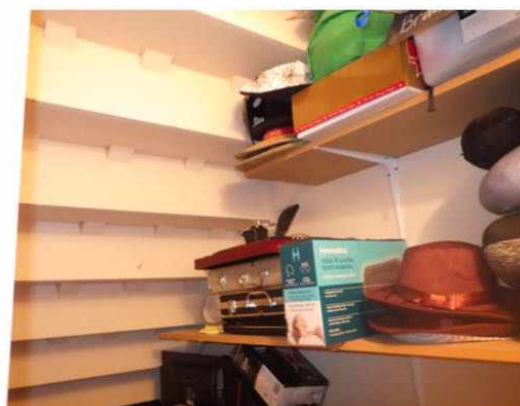
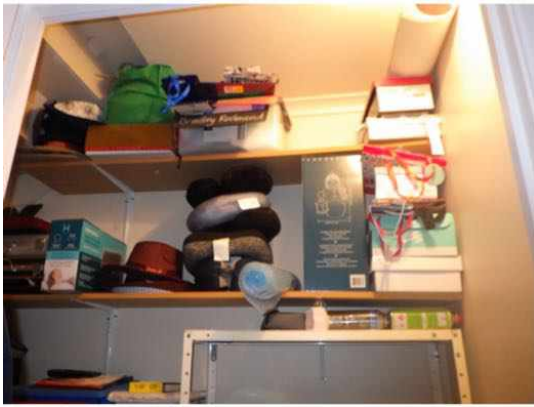
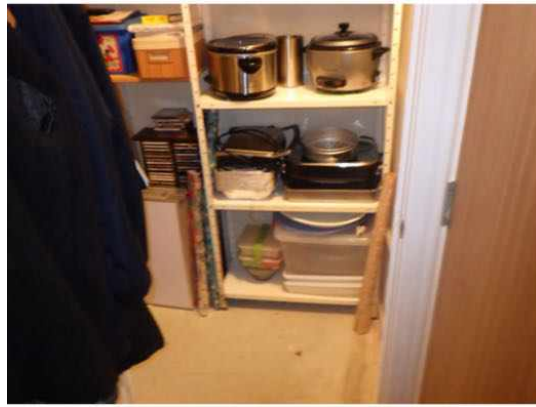
Building: Main Building
 Location: Under Stair Void or Storeroom > Existing
 Finding: Additional Photos - Obstructions and Limitations
 Information: These photographs are an indication of the obstructions and limitations which impeded full inspection of the under stair storage cupboard at the time of inspection. These obstructions can hide an array of defects and should be removed to allow full inspection to be carried out. A re-inspection is recommended once the areas are made accessible.

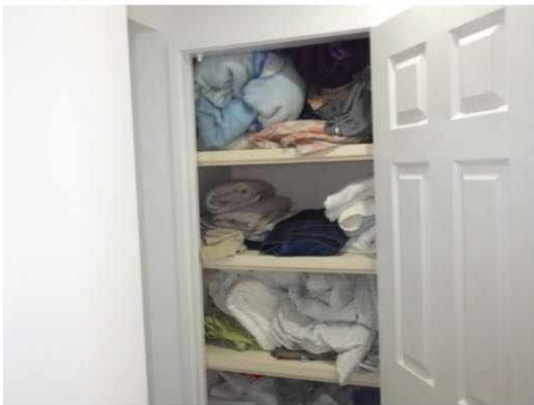
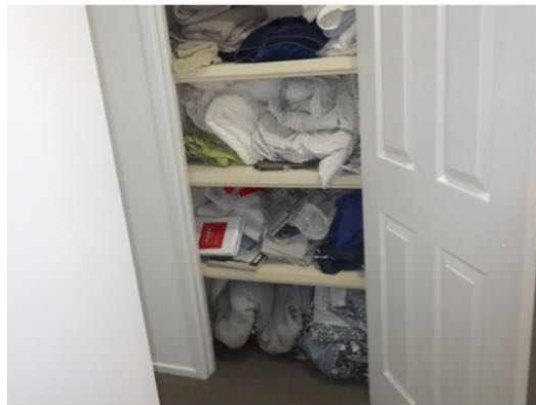
Building: Main Building
 Location: Linen Cupboard > Existing
 Finding: No obvious defect
 Information: No obvious defects found at the time of inspection.

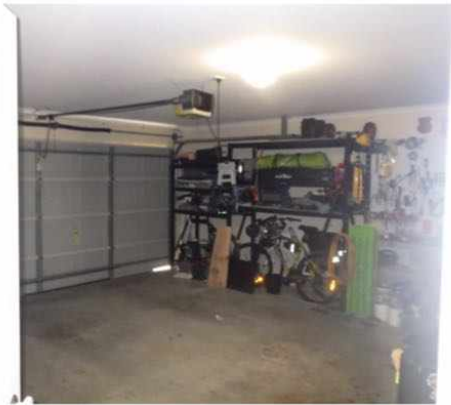
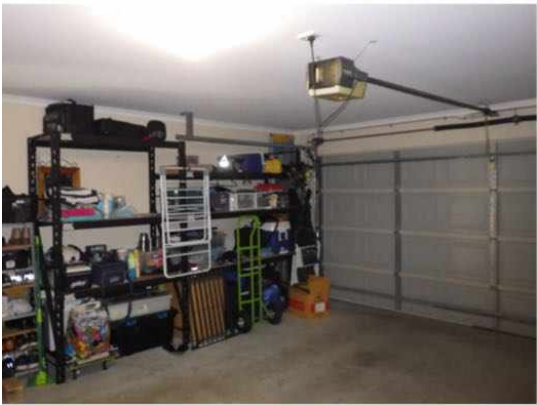
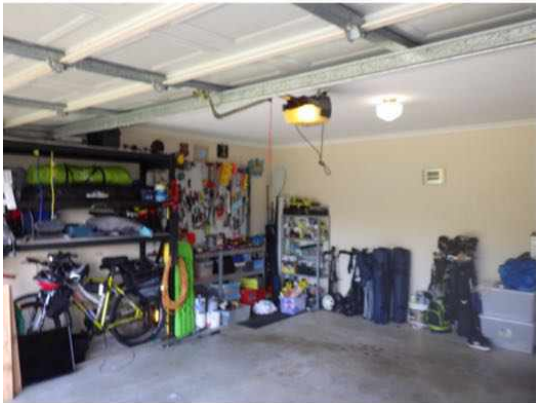
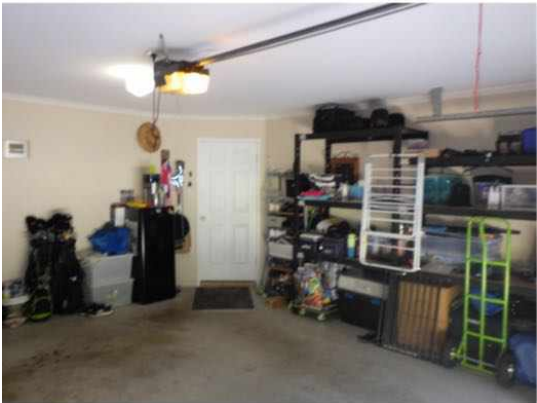
Building: Main Building
 Location: Garage > Existing
 Finding: Additional Photos - Obstructions and Limitations
 Information: These photographs are an indication of the obstructions and limitations which impeded full inspection of the garage area at the time of inspection. These obstructions can hide an array of defects and should be removed to allow full inspection to be carried out. A re-inspection is recommended once the areas are made accessible.

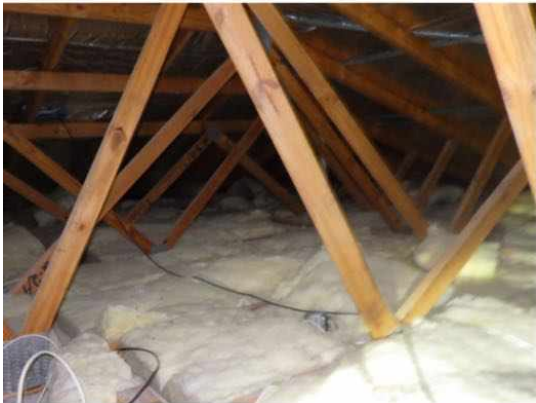
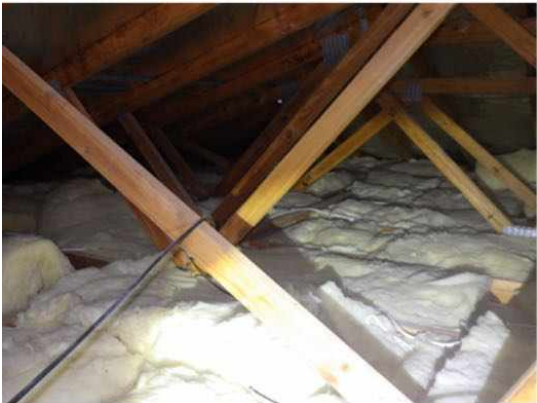
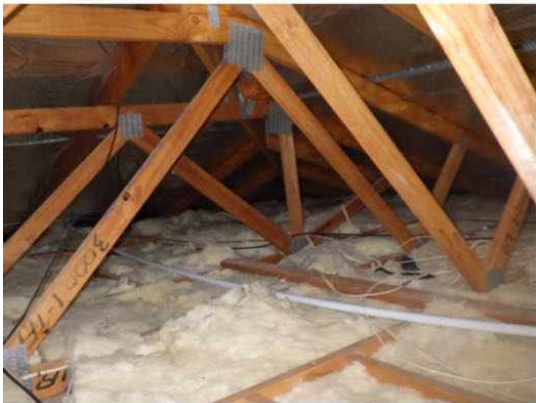
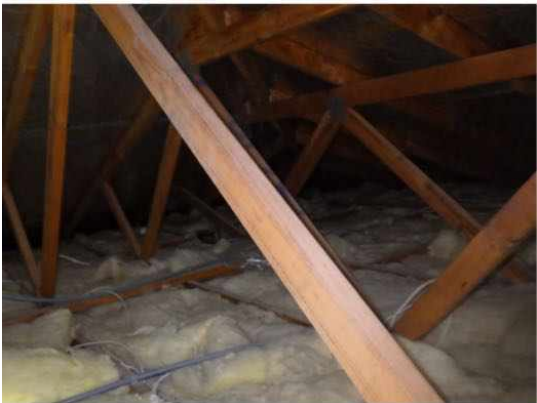
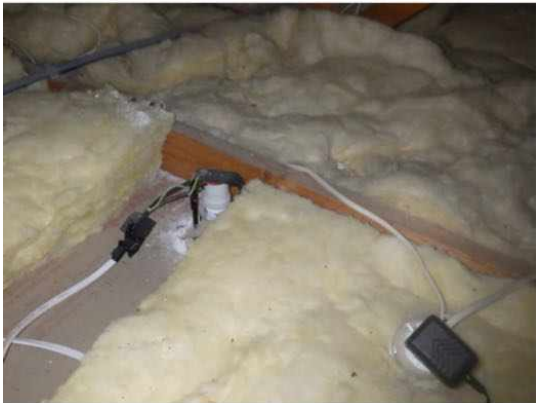
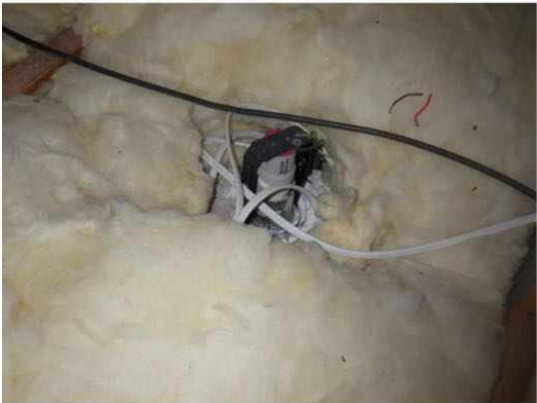
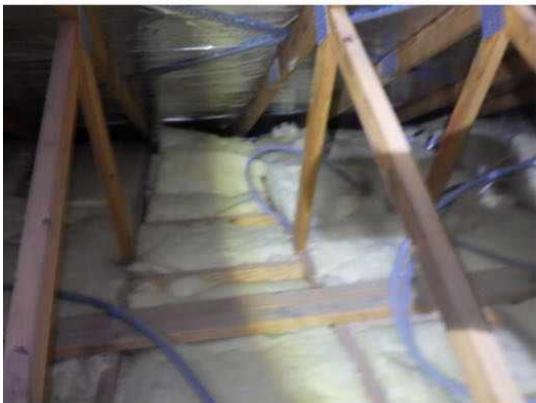
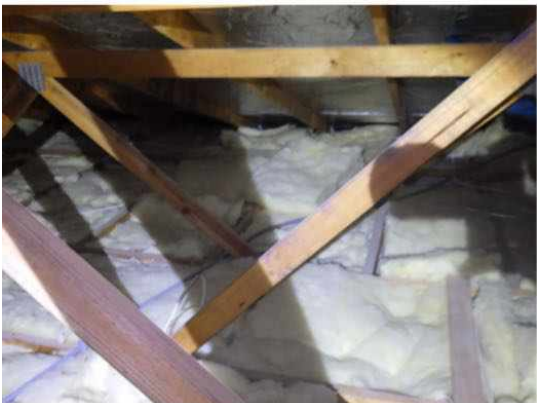
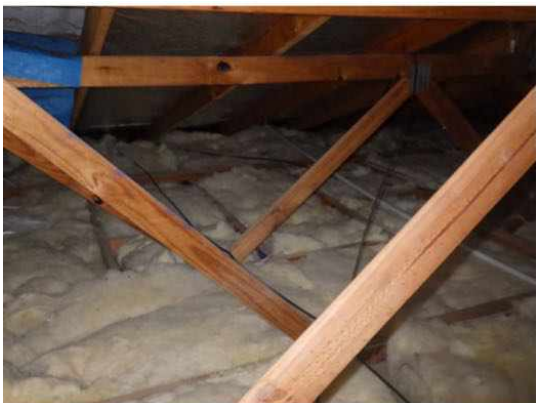
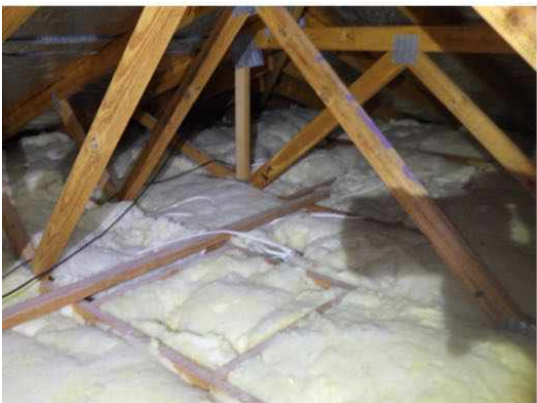
Building: Main Building
Location: Attic > Existing
Finding: Additional Photos
Information: Additional photos are provided for your general reference

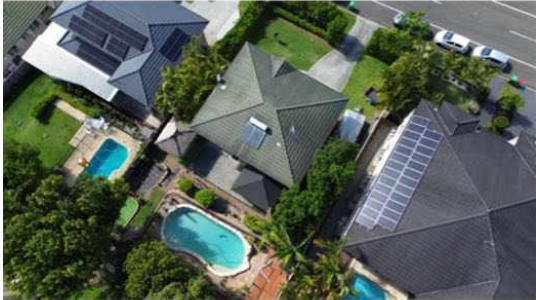
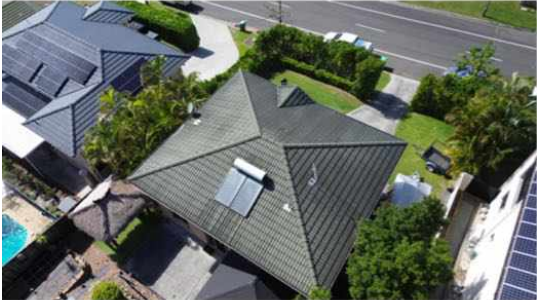
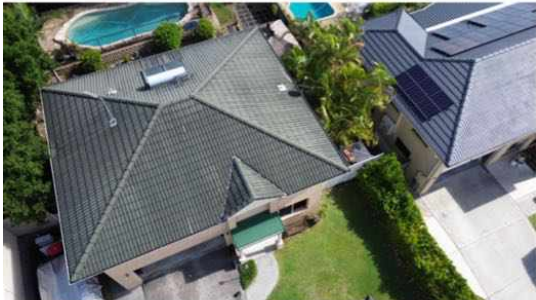
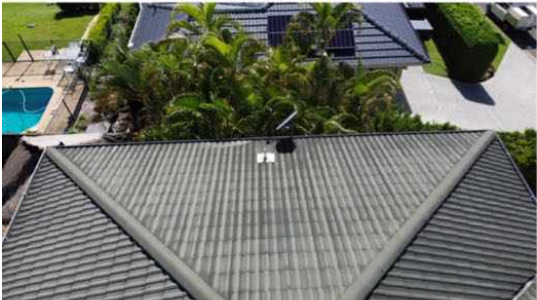
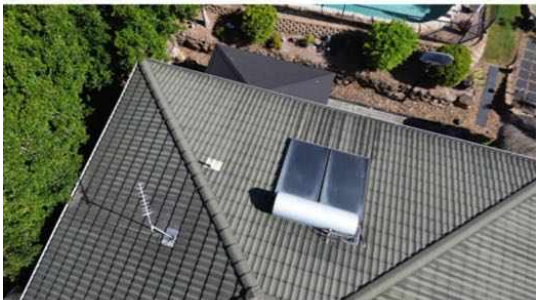
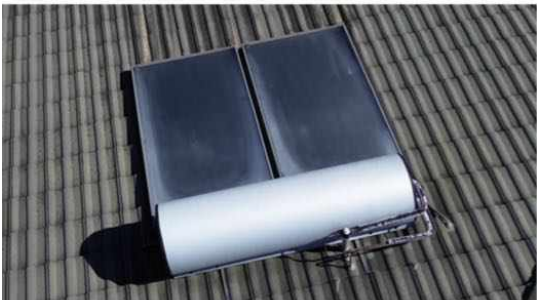
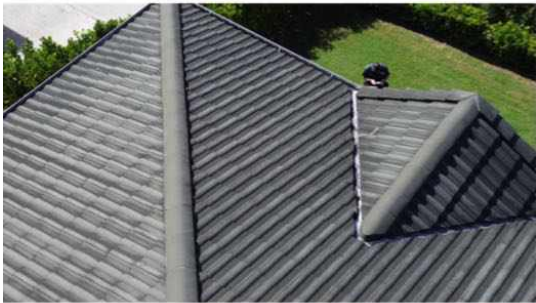
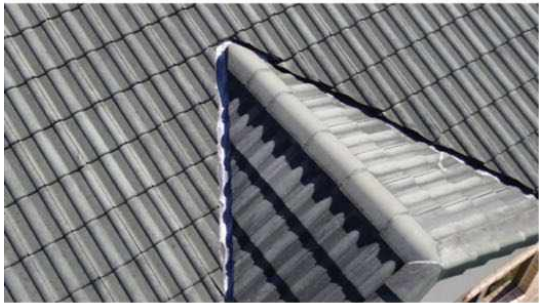
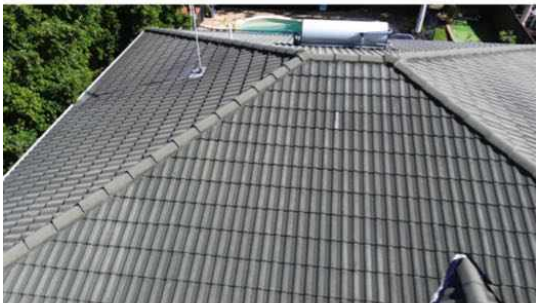
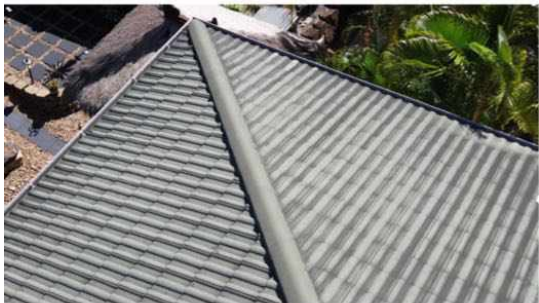
Building: Main Building
Location: Roof Exterior > Existing
Finding: Roof Photos
Information: Roof area photos were taken with the DJI Mini 3 Drone flown over the roof at the time of inspection.

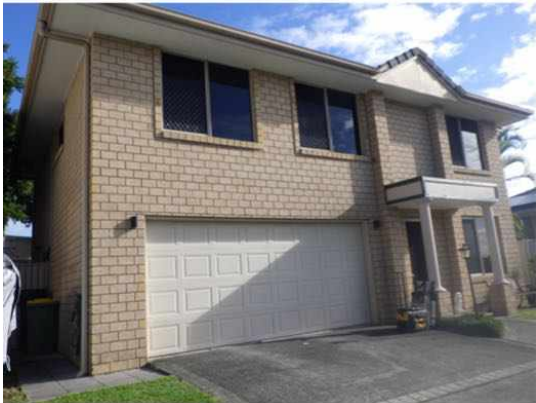
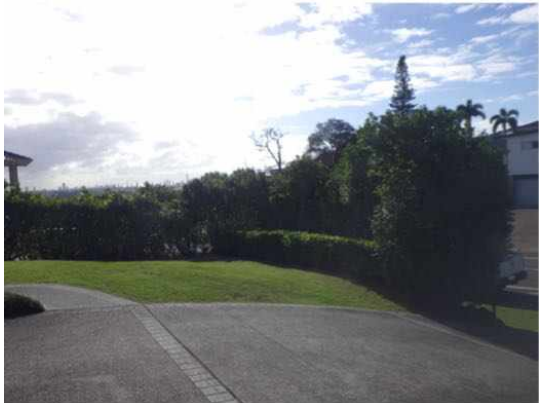
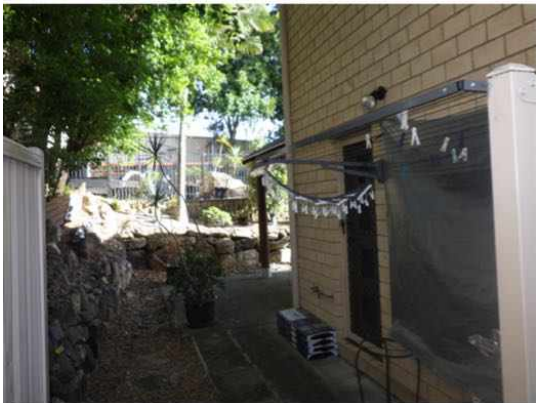
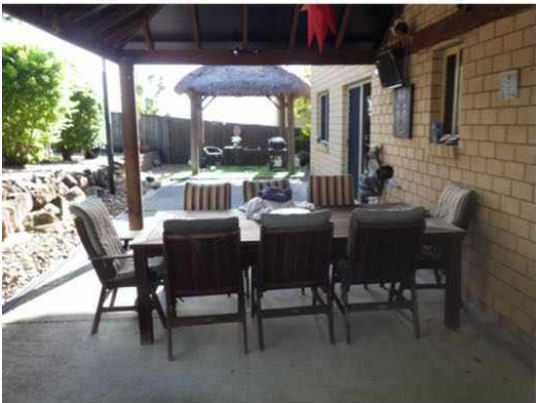
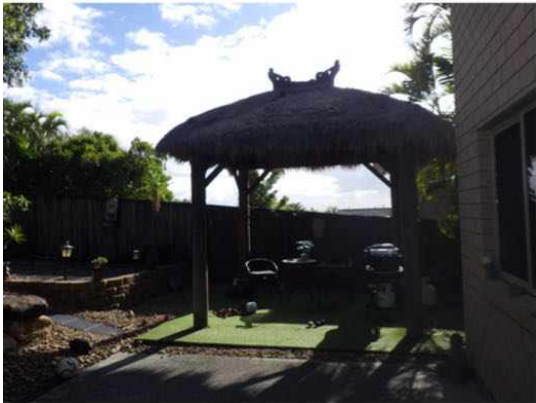
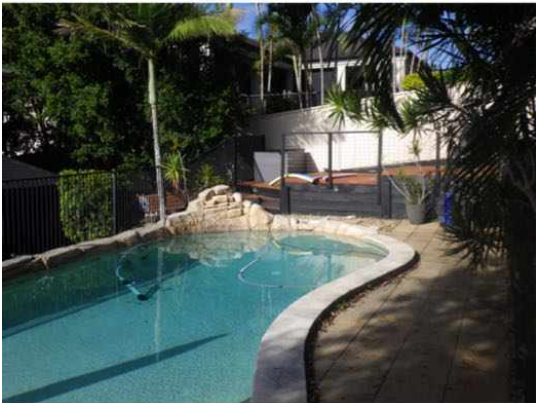
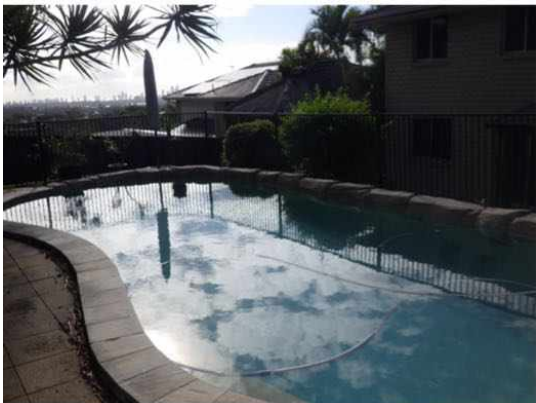
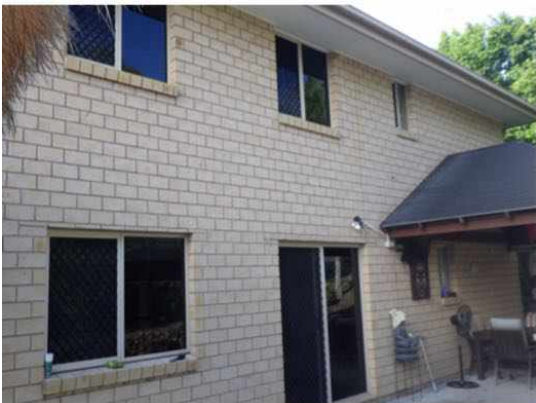
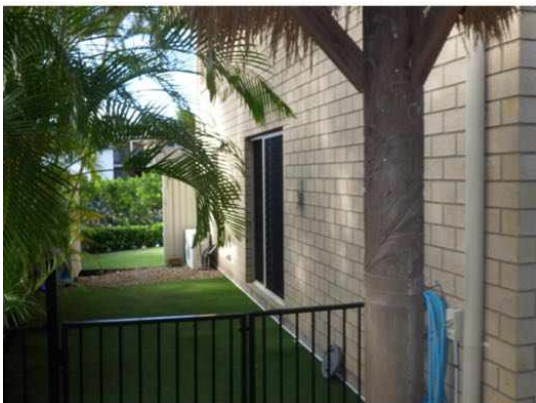
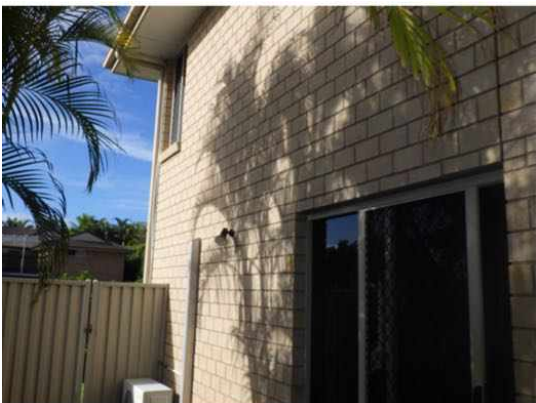
Building: Main Building
Location: External Areas > Existing
Finding: Additional Photos
Information: Additional photos are provided for your general reference

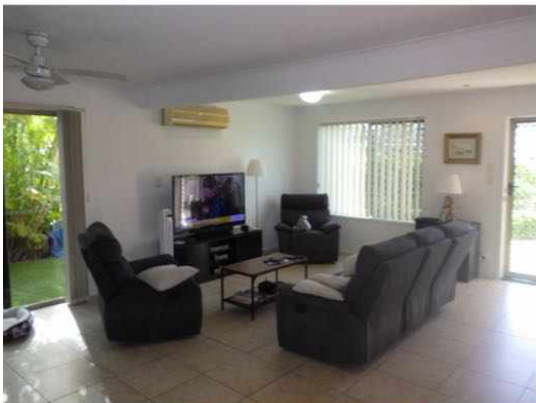
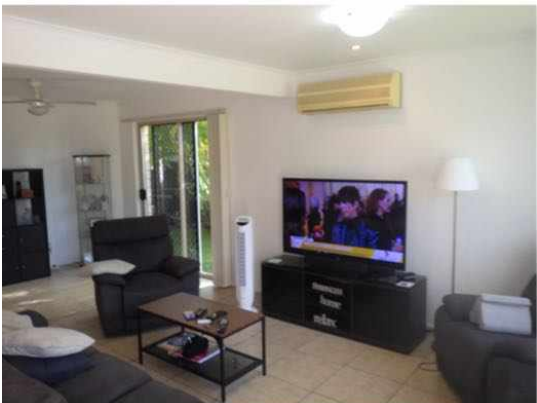
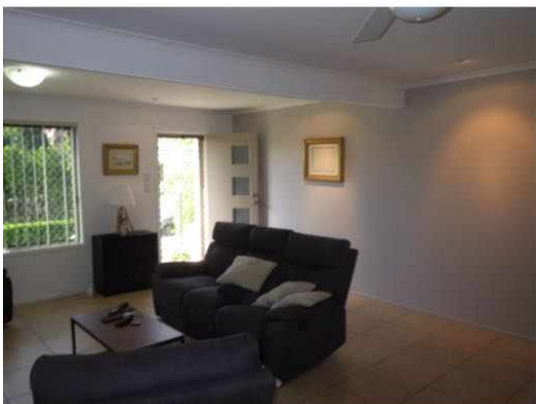
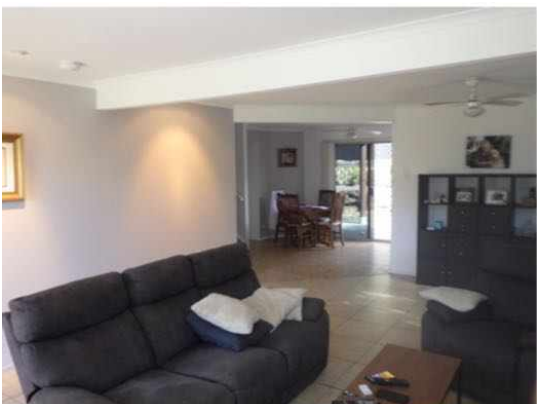
Building: Main Building
Location: Living Room > Existing
Finding: No obvious defect
Information: No obvious defects found at the time of inspection.

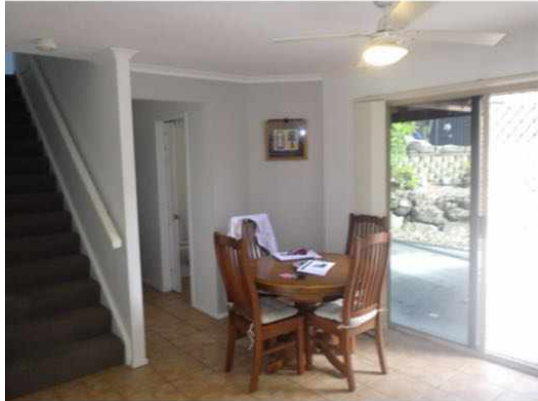
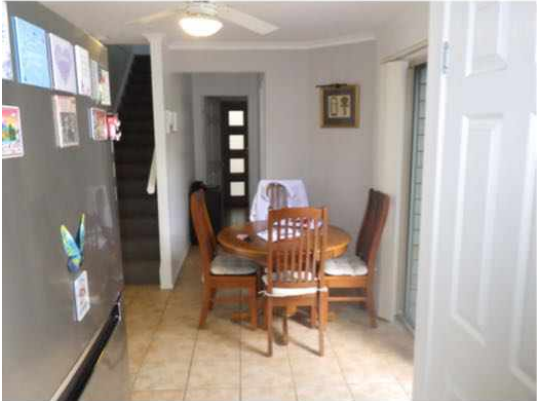
Building: Main Building
Location: Dining Room > Existing
Finding: No obvious defect
Information: No obvious defects found at the time of inspection.

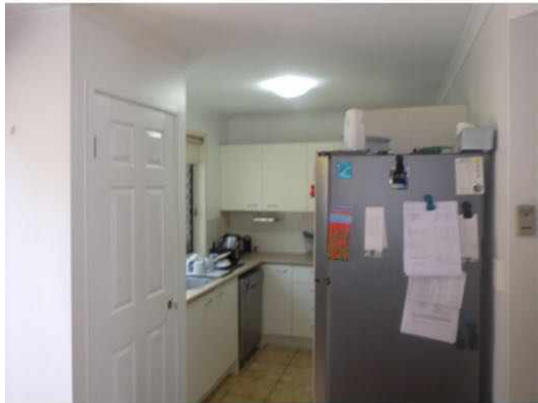
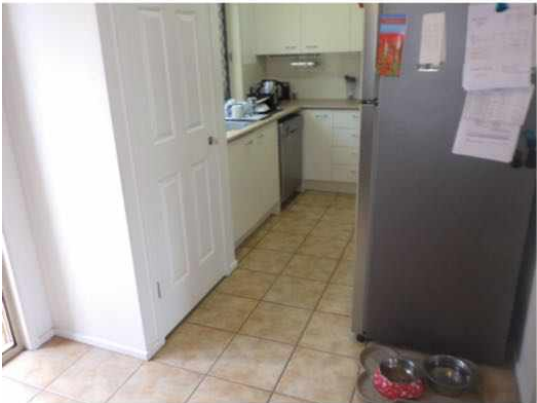
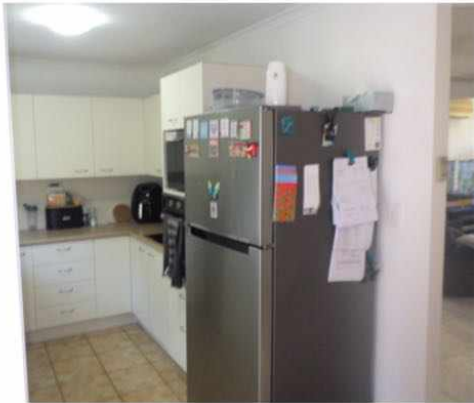
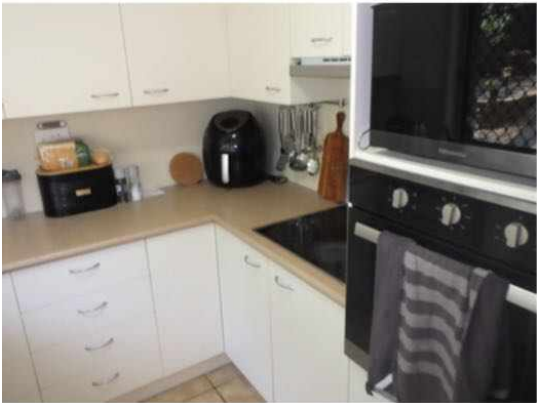
Building: Main Building
Location: Kitchen > Existing
Finding: No obvious defect
Information: No obvious defects found at the time of inspection.

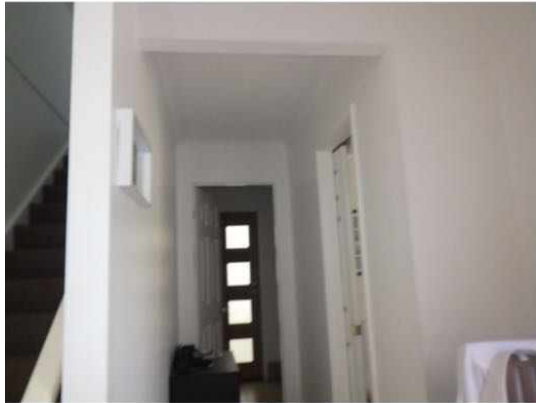
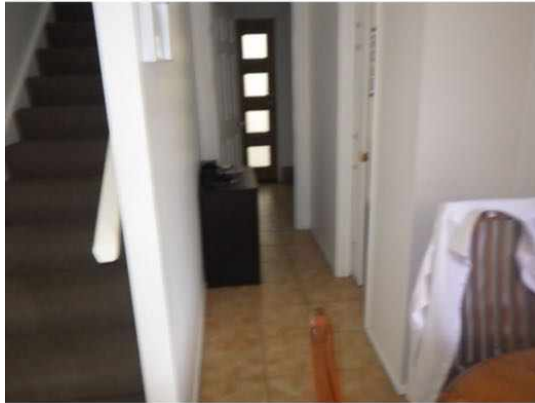
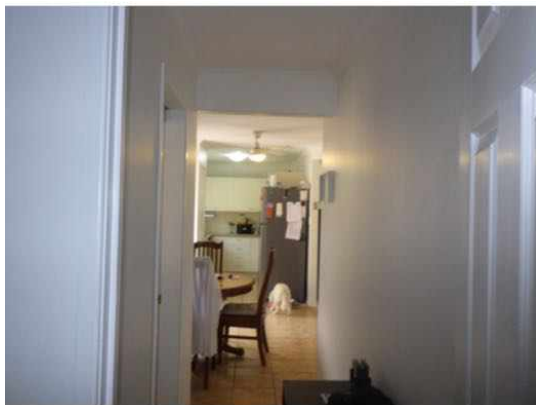
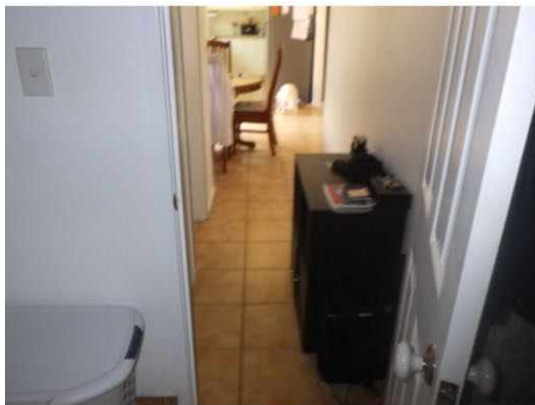
Building: Main Building
Location: Hallway > Existing
Finding: No obvious defect
Information: No obvious defects found at the time of inspection.

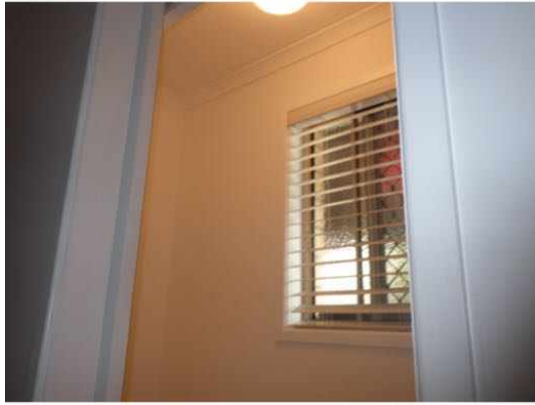
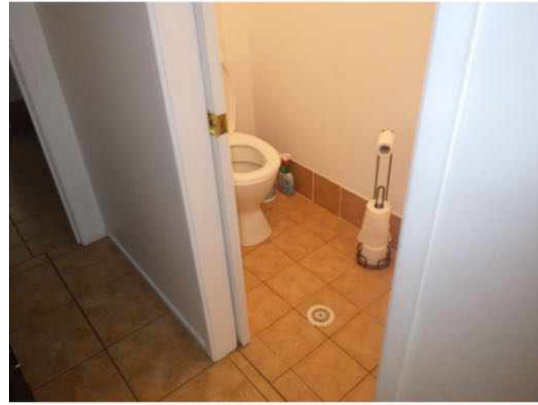
Building: Main Building
Location: Powder Room > Existing
Finding: No obvious defect
Information: No obvious defects found at the time of inspection.

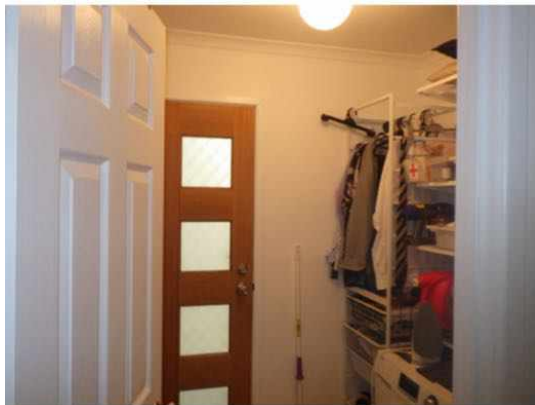
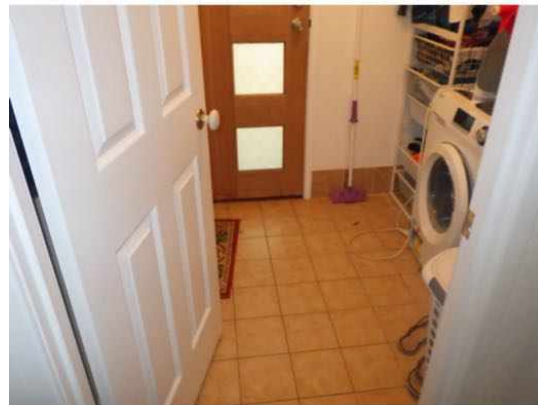
Building: Main Building
Location: Laundry > Existing
Finding: No obvious defect
Information: No obvious defects found at the time of inspection.

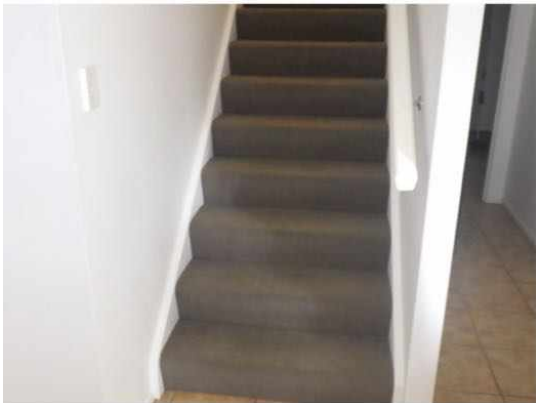
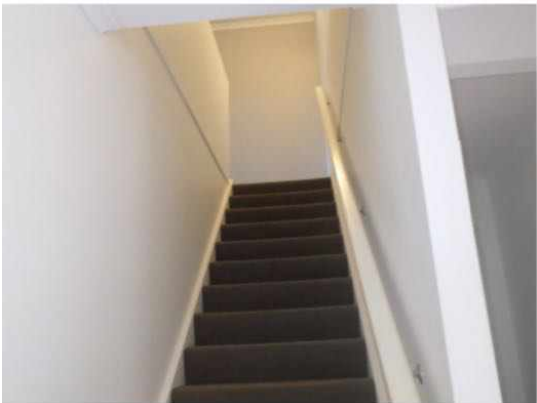
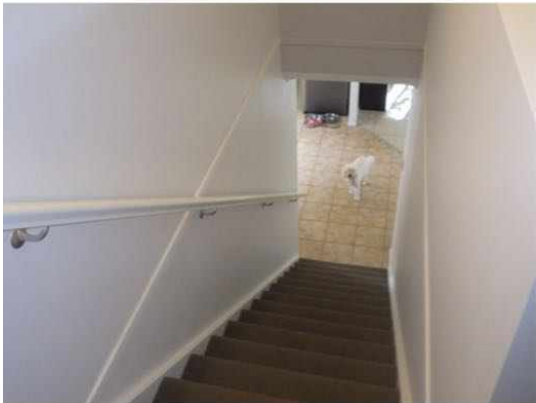
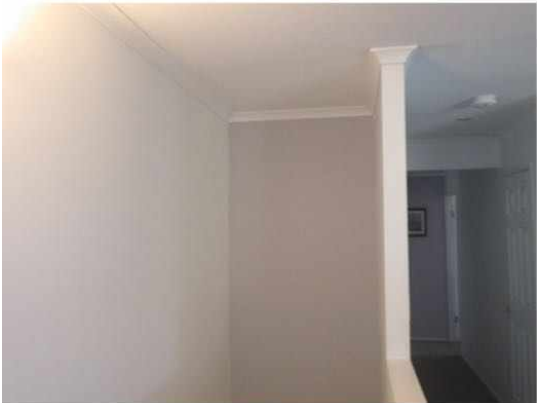
Building: Main Building
Location: Stairs - Internal > Existing
Finding: No obvious defect
Information: No obvious defects found at the time of inspection.

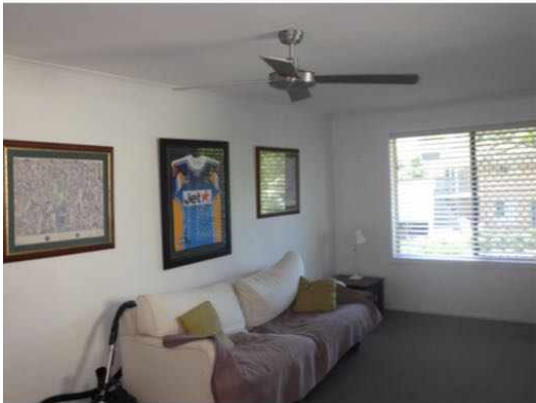
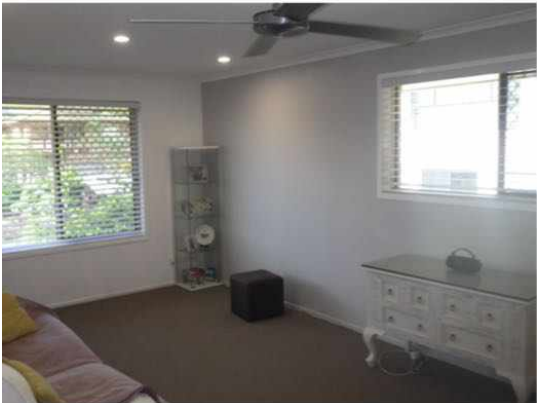
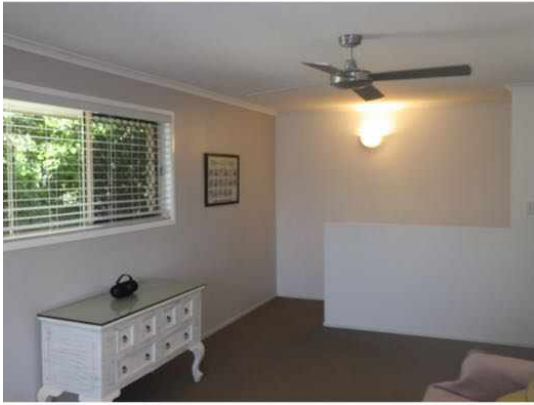
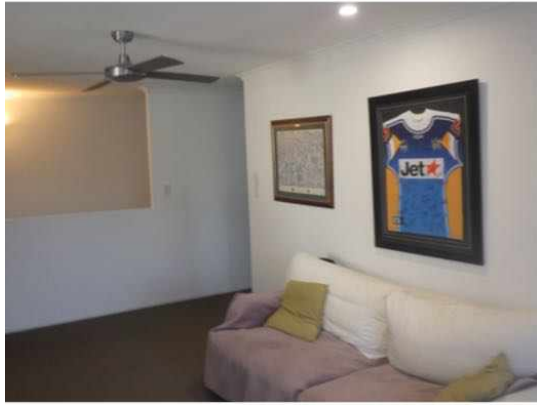
Building: Main Building
Location: Rumpus Room > Existing
Finding: No obvious defect
Information: No obvious defects found at the time of inspection.

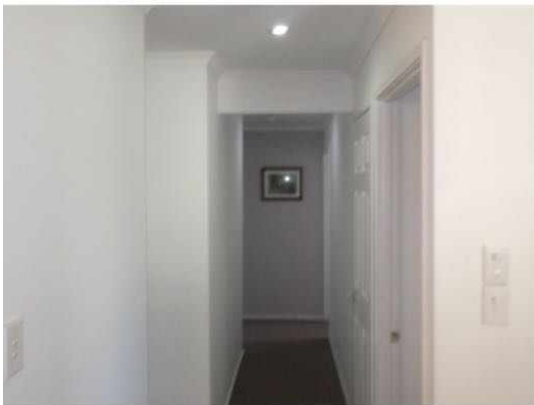
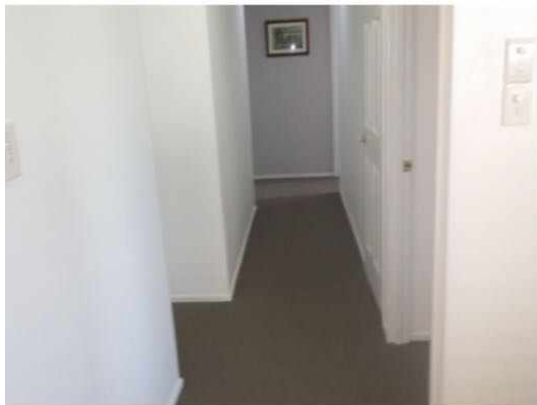
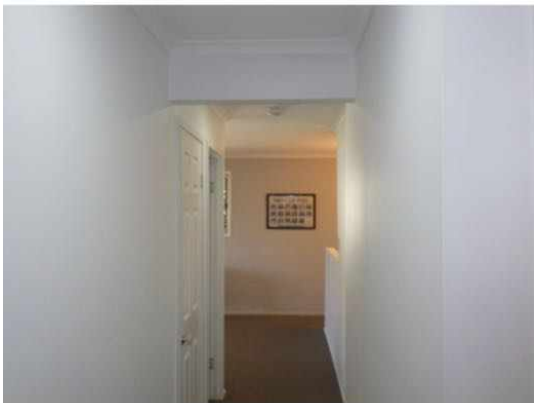
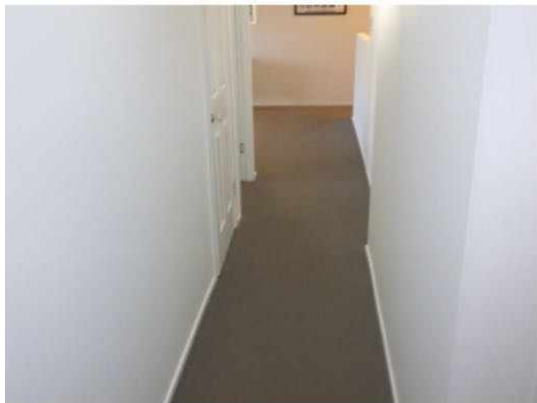
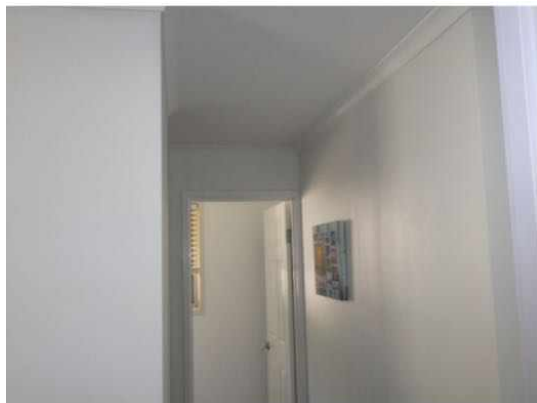
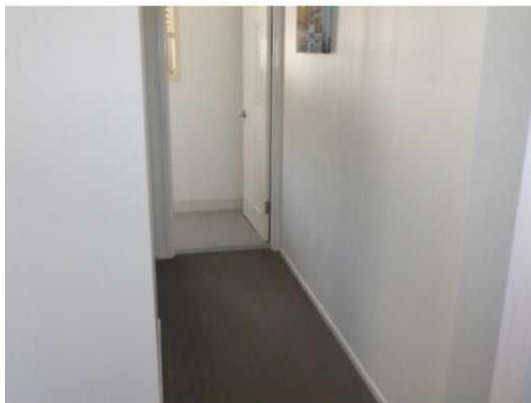
Building: Main Building
Location: Hallway 2 > Existing
Finding: No obvious defect
Information: No obvious defects found at the time of inspection.

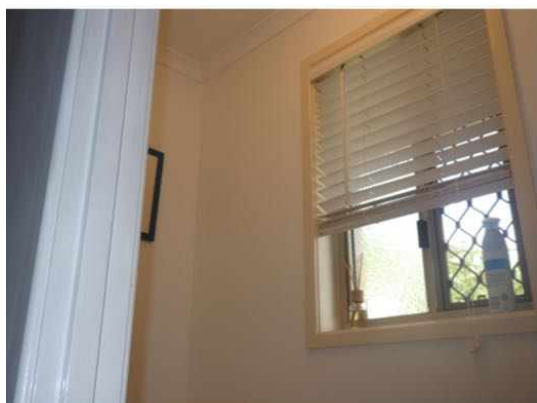
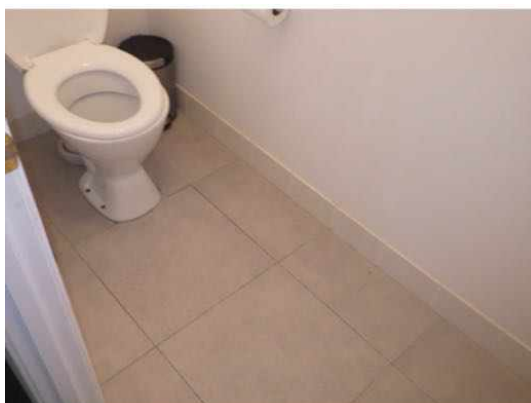
Building: Main Building
Location: Toilet (WC) > Existing
Finding: No obvious defect
Information: No obvious defects found at the time of inspection.

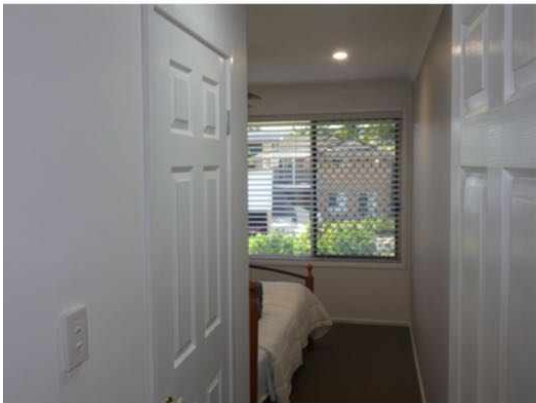
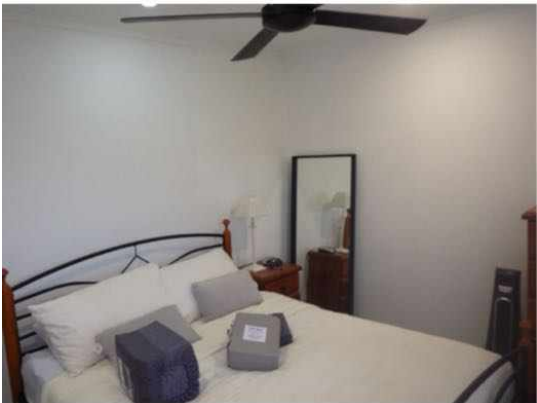
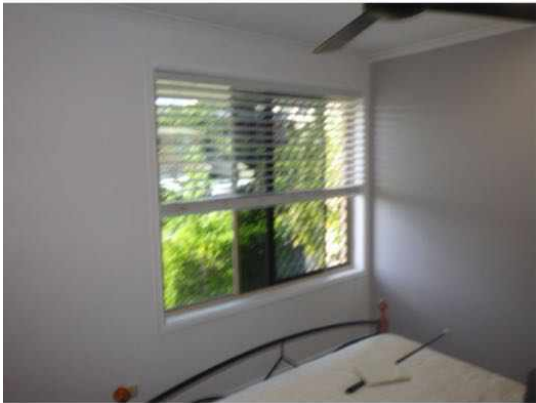
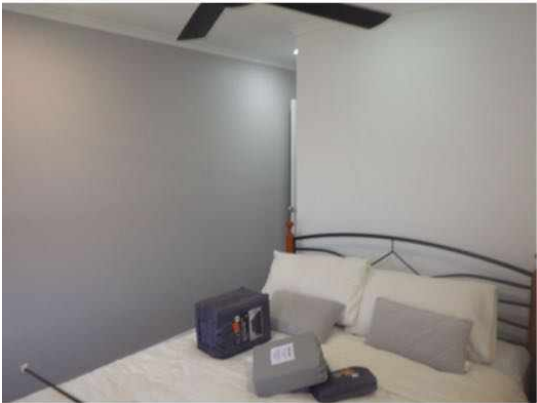
Building: Main Building
Location: Bedroom 2 > Existing
Finding: Additional Photos

Information: Additional photos are provided for your general reference
