Building Inspection Report

Inspection Date: Mon, 16 Mar 2026

Property Address: 37 Armstrong Way, Highland Park QLD
4211, Australia

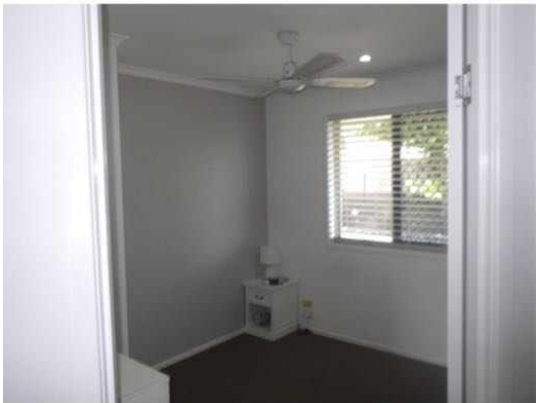
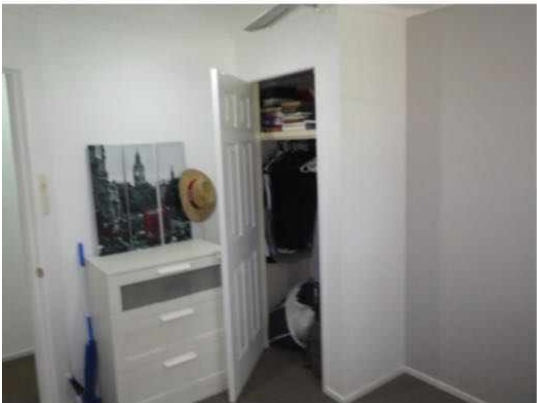
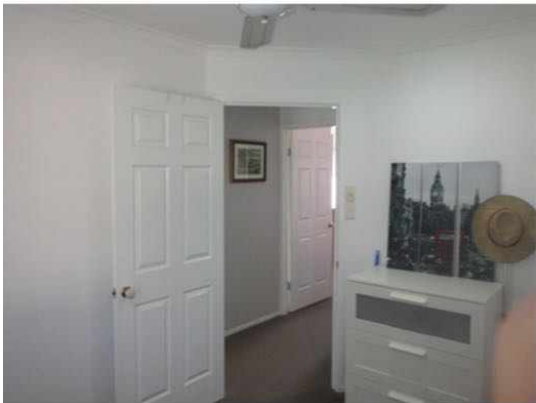
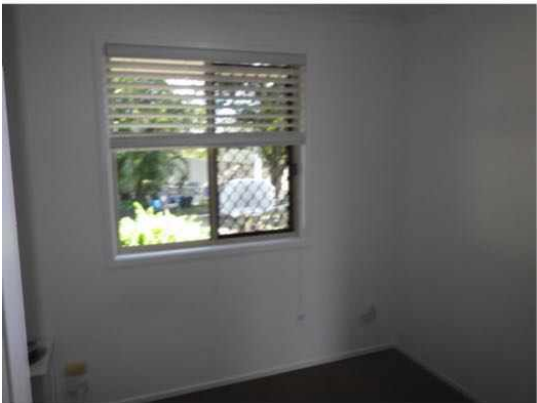
Building: Main Building
Location: Bedroom 3 > Existing
Finding: No obvious defect
Information: No obvious defects found at the time of inspection.

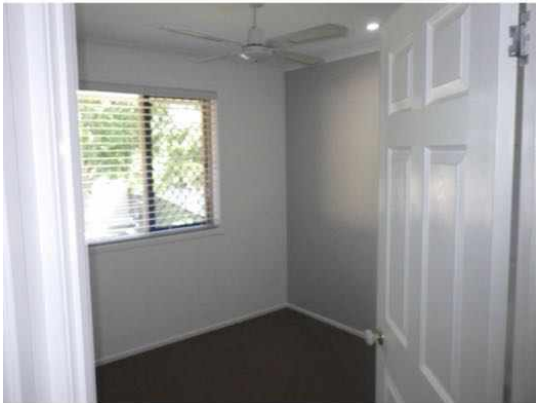
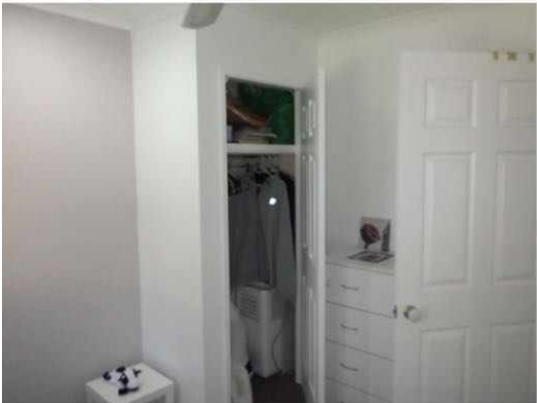
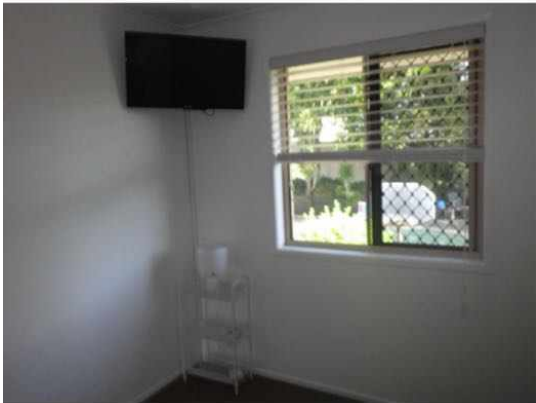
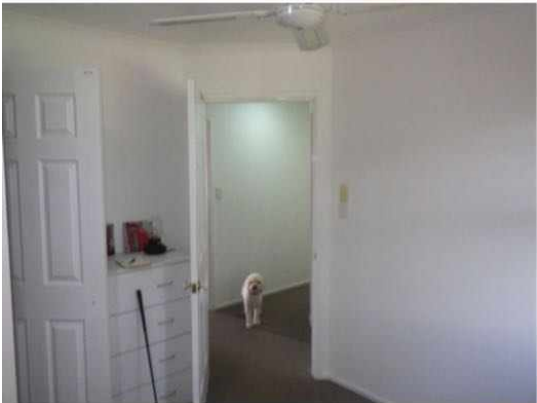
Building: Main Building
 Location: Bedroom 4 > Existing
 Finding: Additional Photos
 Information: Additional photos are provided for your general reference

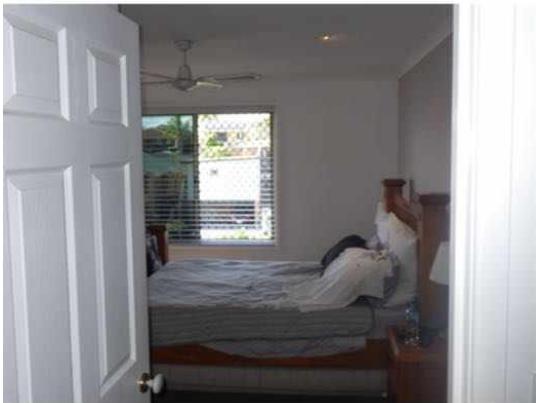
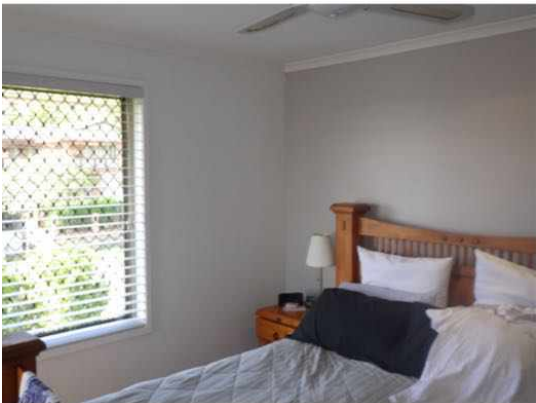
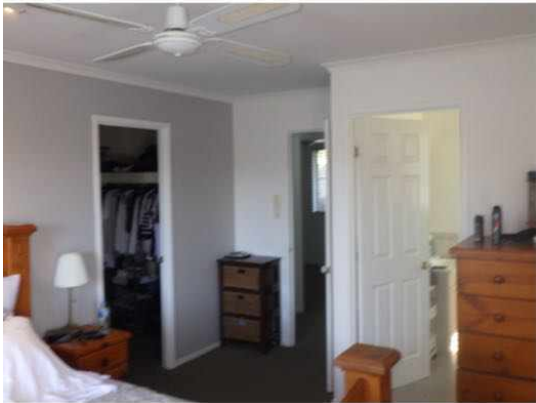
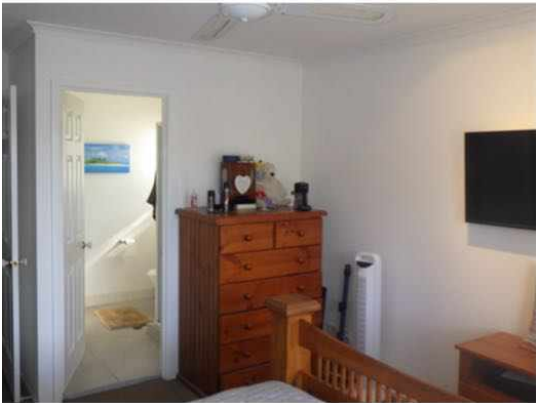
Building: Main Building
 Location: Bedroom - Master > Existing
 Finding: No obvious defect

Information: No obvious defects found at the time of inspection.
