Building and Timber Pest Inspection Report

Inspection Date: Tue, 31 Mar 2026

Property Address: 1/14 Milton Ave, Clayton South VIC 3169,
Australia

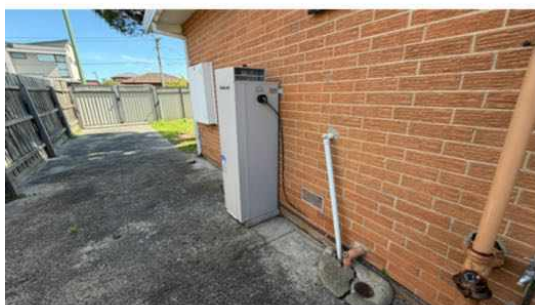
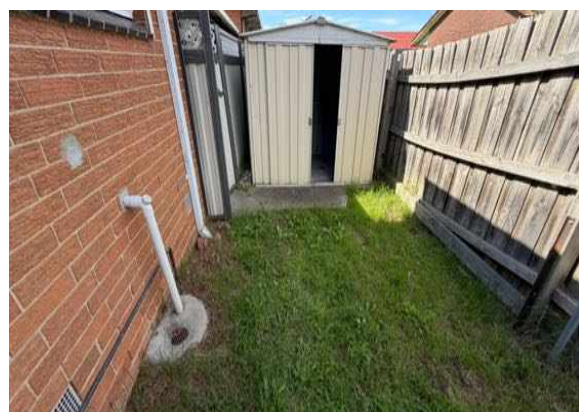
Finding 6.04

Where any part of an attachment to a building is not isolated and is not provided with a clear gap of not less than 25mm from the building, bridging occurs. Attachments to buildings such as hot water services, downpipes, verandahs, decks, steps, fences, service conduits are the like provide the opportunity for concealed entry.

Building: Main Building
 Location: All External Areas

Building attachments of this nature need to be frequently inspected for termite activity by a qualified inspector.

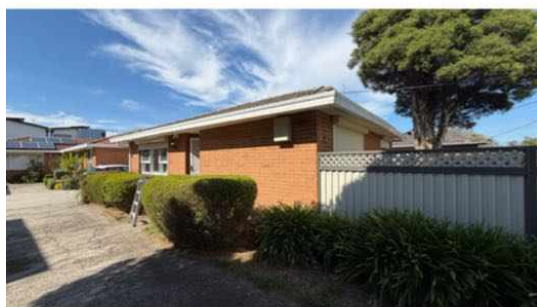
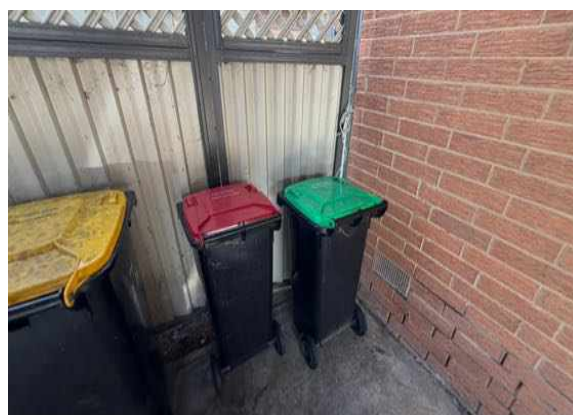
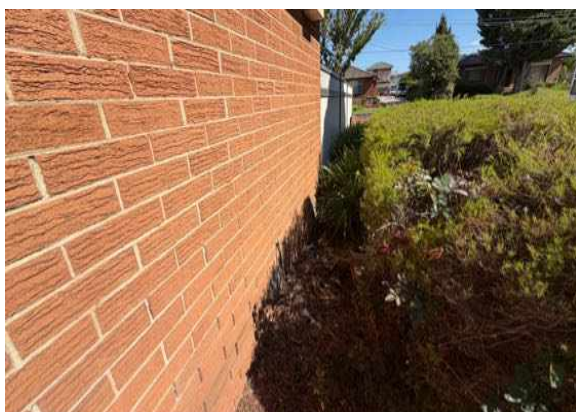
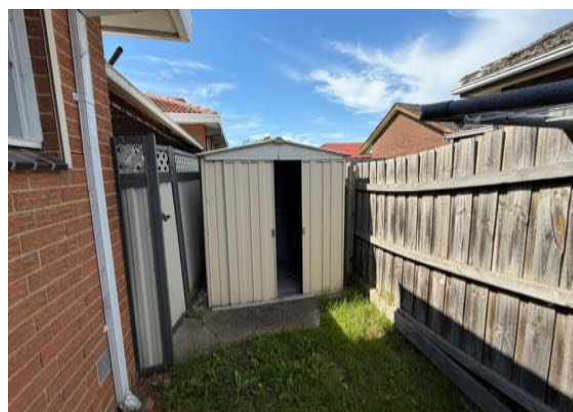
Noted Item

Building:	Main Building
Location:	All External Areas
Finding:	Obstructions and Limitations - External areas
Information:	These photographs are an indication of the obstructions and limitations which impeded full inspection of the external areas of the property at the time of inspection. These obstructions can hide an array of defects and should be removed to allow full inspection to be carried out. A re-inspection is recommended once the areas are made accessible.

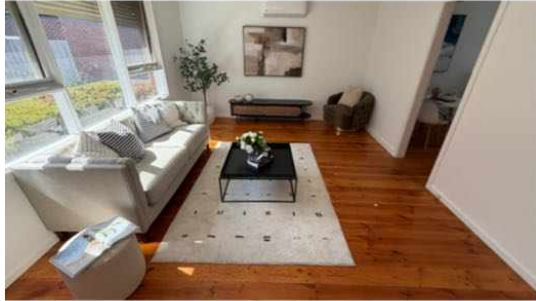
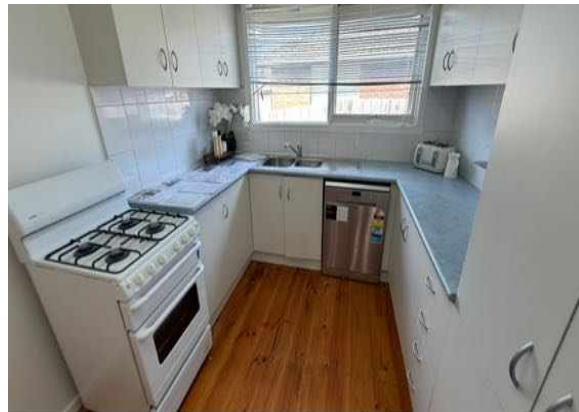
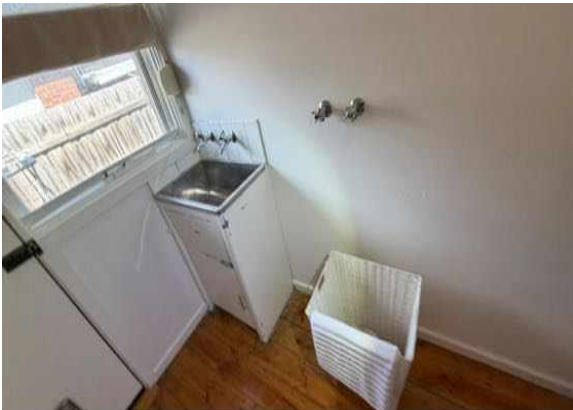
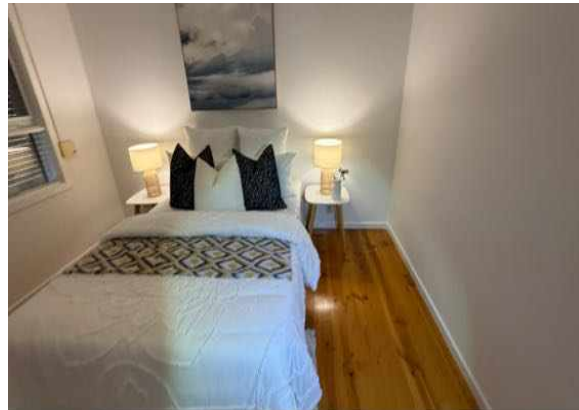
Noted Item

Building:	Main Building
Location:	All Internal Areas
Finding:	Obstructions and Limitations - Internal areas
Information:	These photographs are an indication of the obstructions and limitations which impeded full inspection of the internal areas of the property at the time of inspection.

These obstructions can hide an array of defects and should be removed to allow full inspection to be carried out. A re-inspection is recommended once the areas are made accessible.

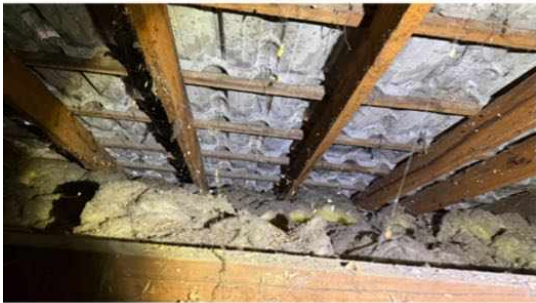
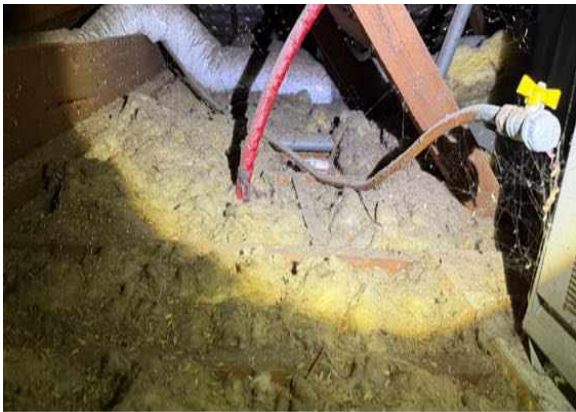
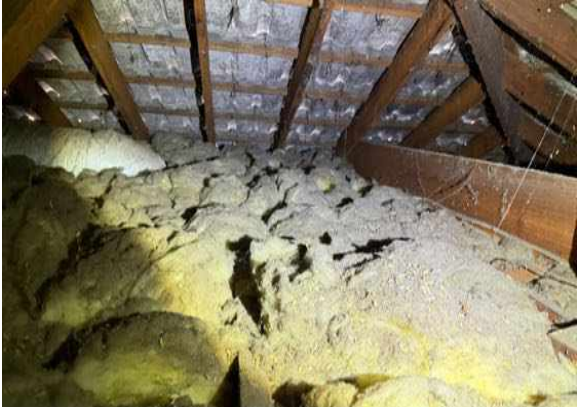
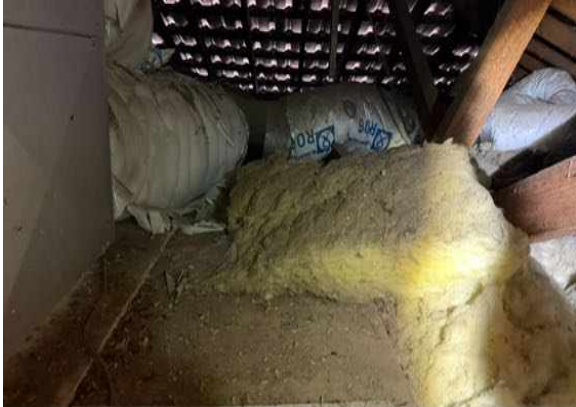
Noted Item

Building: Main Building
Location: Roof Void
Finding: Obstructions and Limitations - Roof Cavity
Information: These photographs are an indication of the obstructions and limitations which impeded full inspection of the roof cavity of the main building at the time of inspection. These obstructions can hide an array of defects and should be removed to allow full inspection to be carried out. A re-inspection is recommended once the areas are made accessible.
