# Building and Timber Pest Inspection Report

Inspection Date: Tue, 24 Feb 2026

Property Address: 25 Senna Ave, Denham Court NSW 2565,  
Australia

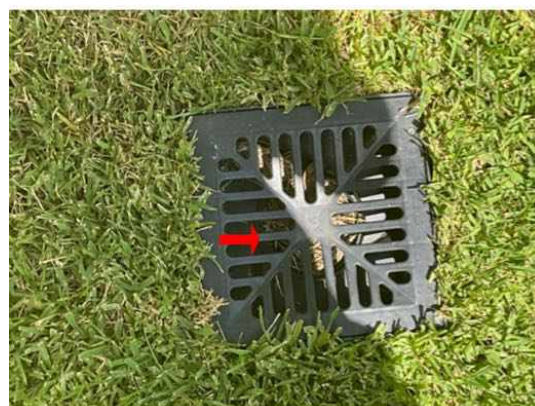
Building: Main Building  
 Location: All Areas  
 Finding: Blocked - Drains  
 Information: The drains are blocked, causing standing water and potential flooding during rain. This impedes proper drainage, posing a risk of property damage, waterlogging, and potential health hazards due to stagnant water.”

- Property damage from flooding.
- Waterlogging leading to potential structural damage.
- Health hazards due to stagnant water, such as breeding grounds for mosquitoes and other pests.

Solution:

A licensed plumber or drainage specialist can fix the blocked drains by inspecting and clearing the blockage, repairing any damaged pipes, and ensuring proper drainage functionality. Regular maintenance and inspection of the drainage system may also help prevent future blockages and associated risks.

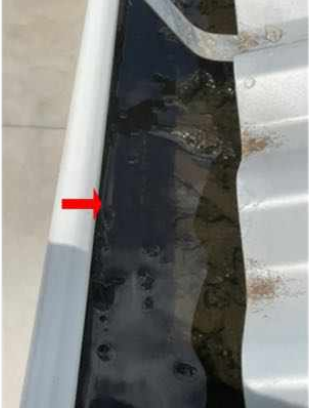
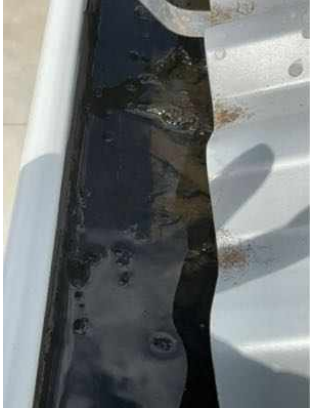
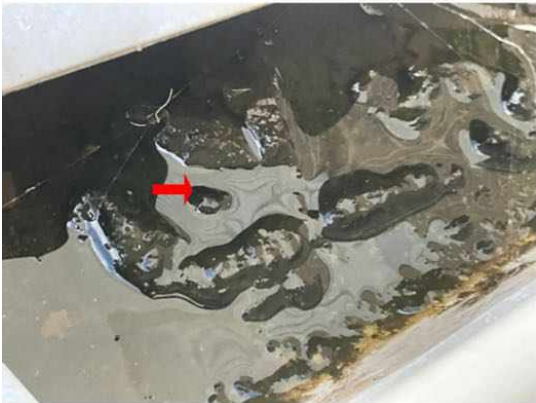
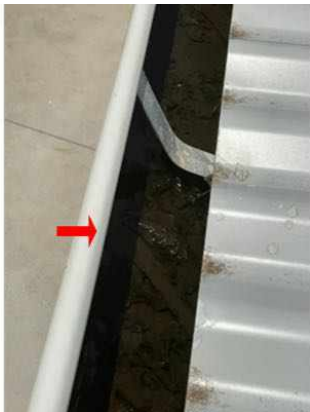
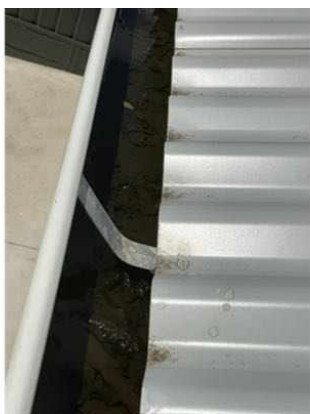
### Finding 3.03

Building:	Main Building
Location:	All Areas
Finding:	Gutters - Water pooling
Information:	Water was found to be pooling in sections of the roof guttering. This is generally a secondary defect caused by blocked or partially blocked gutters. Such blockages and subsequent water pooling are likely to lead to rust and water damage to associated structures if left unattended.

Any areas of guttering that shows evidence of water pooling should be checked for partial or full blockages and any secondary damage that may have occurred as a result. Depending on the extent of the damage, building elements may require repair and/or replacement to ensure adequate roof drainage and function of exterior

plumbing system.

A roofing plumber should be appointed as soon as possible to rectify this issue. It is highly advised that all gutters be maintained on a frequent basis to ensure the condition of roof plumbing.

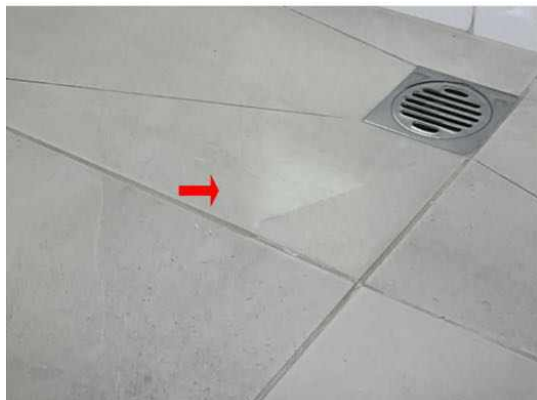
Building: Main Building  
 Location: Ensuite  
 Finding: Shower base - Water pooling  
 Information: Evidence of water pooling around the floor waste in the shower recess was noticed at the time of inspection. It is suspected that this excessive moisture is attributed to insufficient fall in the shower floor tiles.

grouting is also likely to occur, possibly necessitating further repair works.

Remedial works may involve some sections of tiling and flooring repair and replacement. A tiling contractor or bathroom specialist should be appointed to provide further advice on reparation options and to perform works as necessary.

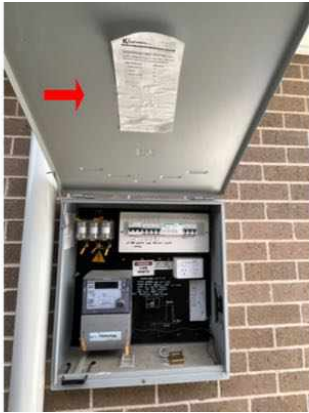
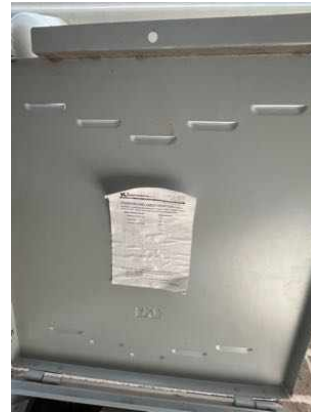
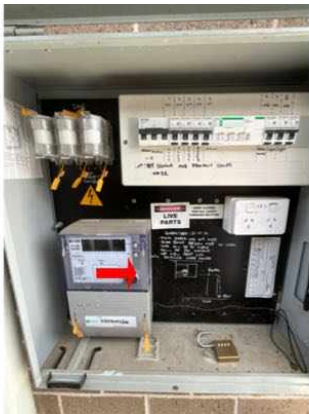
barriers is legible at the time of inspection.

Client must seek further information from the vendor or real estate agent if the conditions of termite management systems were maintained.

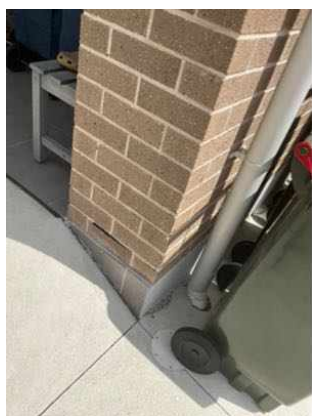
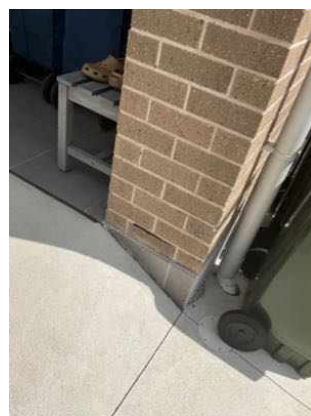
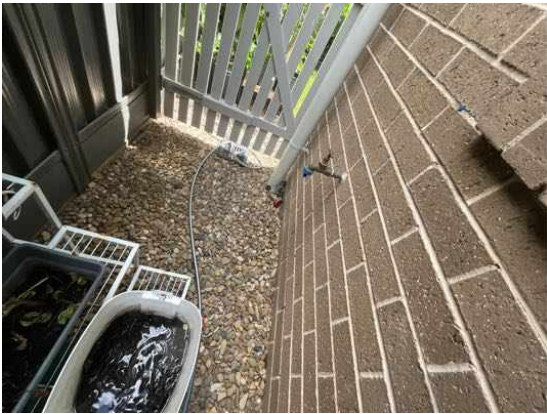
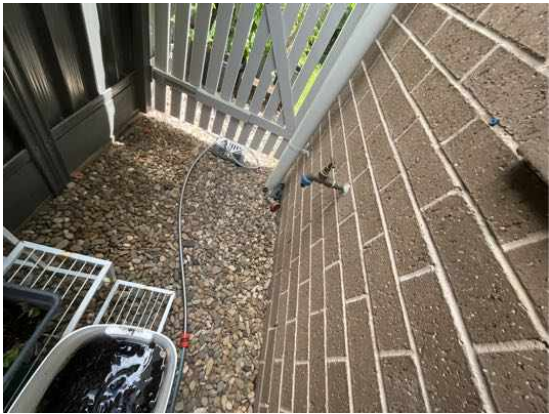
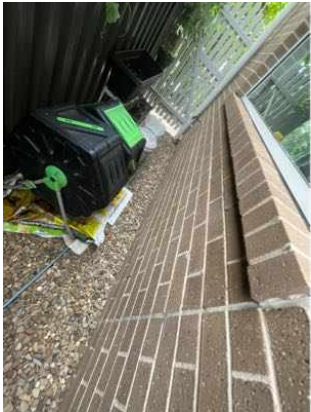
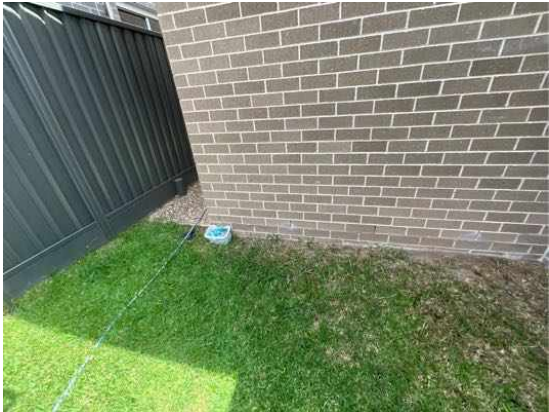
### Finding 6.02

Building:	Main Building
Location:	All Areas
Finding:	Slab Edge - Exposure
Information:	An inspection zone of at least 75mm in relation to the exposed slab edge, between the bottom brick and the perimeter pavement, is required. This inspection zone

If the slab edge is not properly exposed there is a high risk of termite attack. Sometimes, in order to determine the type of slab, a suitably qualified person such as an architect or builder may be required to consult the construction plans.

Where the slab edge cannot be properly inspected, it is highly recommended that termite or timber pest inspections be carried out every 6-12 months to aid protection of the property against infestation.

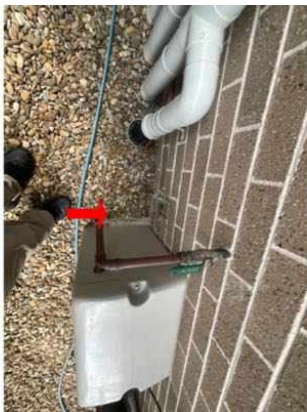
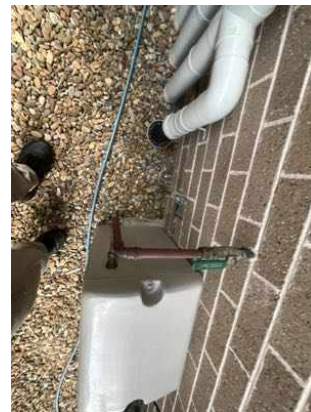
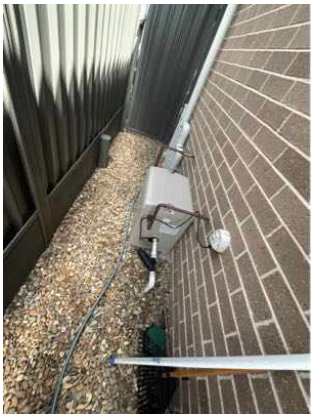
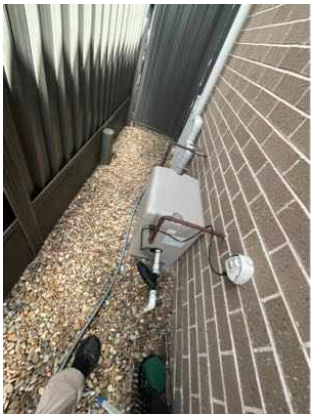
### Finding 6.03

Building:	Main Building
Location:	All Areas
Finding:	Bridging or Obstruction Conducive environment for Termites
Information:	Bridging of termite barriers occurs when termites bridge (usually by building a mud tunnel) a termite barrier or inspection inspection zone or where termites have a passage, allowing them to bridge the barrier.

Where bridging has occurred full inspection is prevented and termites may enter a property in a concealed or undetected manner.

Recommended moving obstructions away from the external walls for further and future inspections.

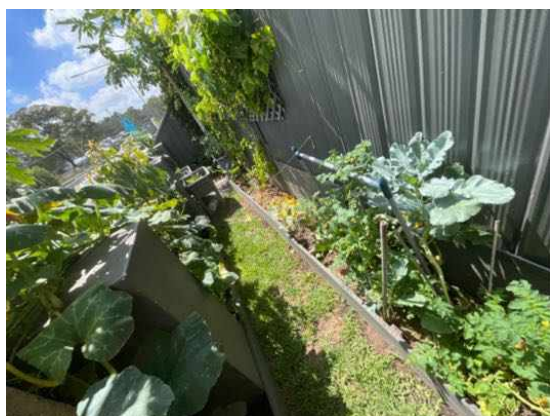
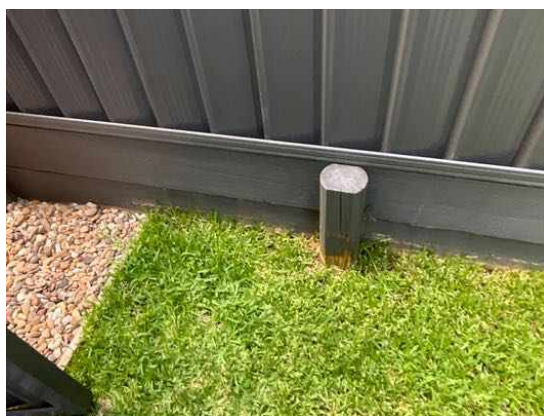
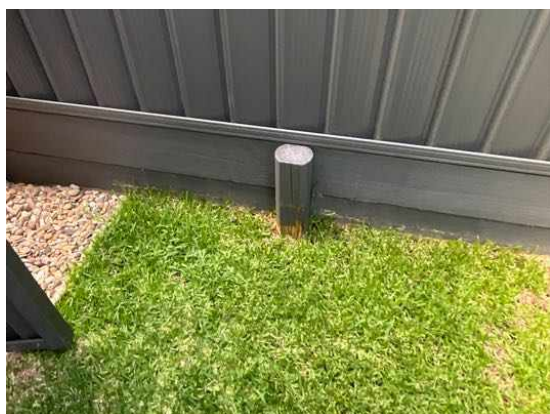
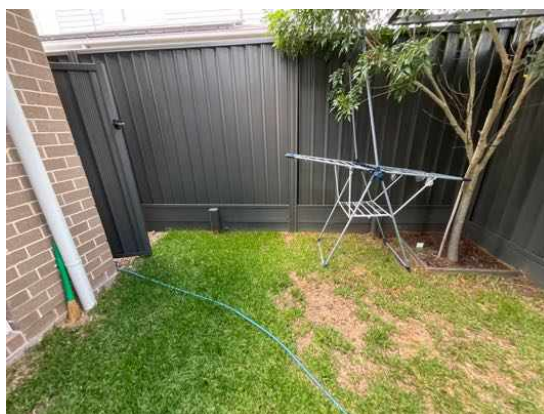
**Finding 6.04**

Building: Main Building  
 Location: All Areas  
 Finding: Timber on ground / conducive conditions to termite damage  
 Information: Timber on the ground is indeed conducive to termite damage. Termites are known to thrive in moist environments, and wood in contact with soil or moisture is more susceptible to infestation.

To prevent this, it's important to keep timber elevated and away from direct ground contact. Regular inspections and proper termite control measures are also essential to protect your wooden structures from termite damage.

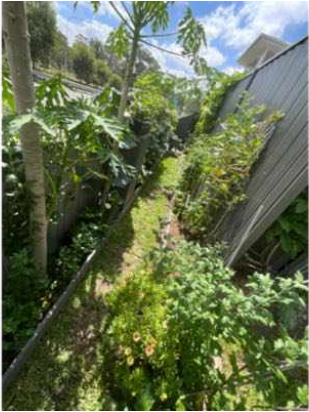
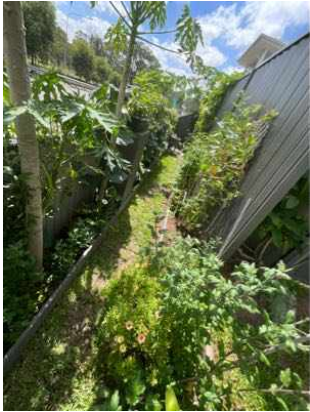
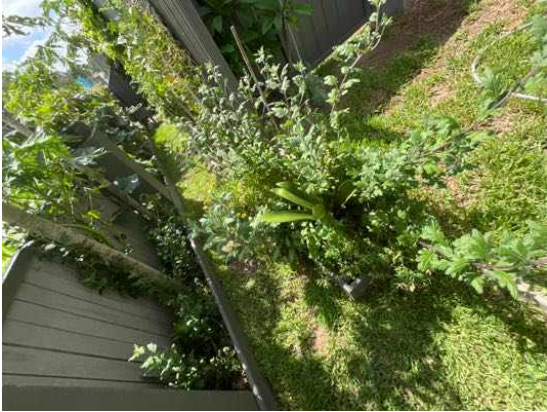
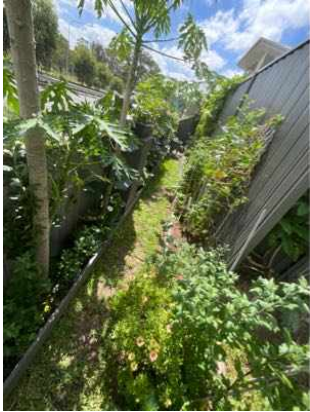
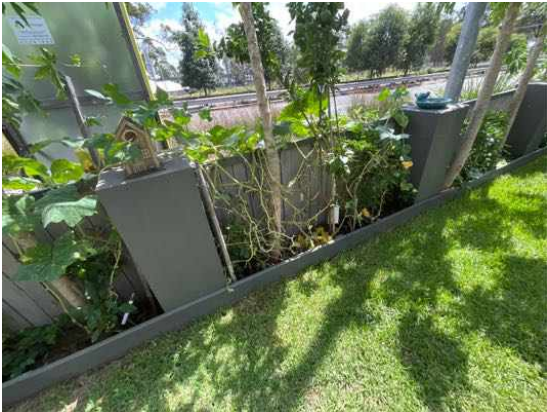
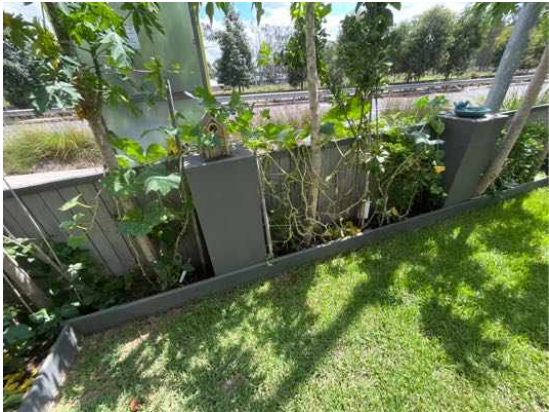
### Finding 6.05

Building:	Main Building
Location:	All Areas
Finding:	Dense vegetation around a property can increase the risk of termite infestation
Information:	The presence of dense vegetation around a property can increase the risk of termite infestation, as it provides a conducive environment for them. To address this, consider maintaining a clear space between the vegetation and your home. If you suspect a termite issue, it's advisable to consult with a licensed pest control professional for inspection and treatment.

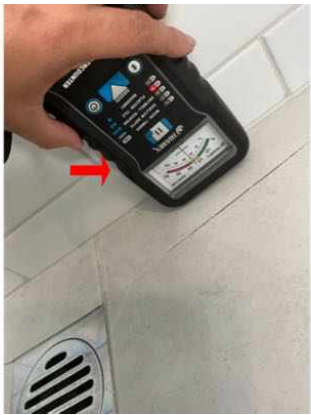
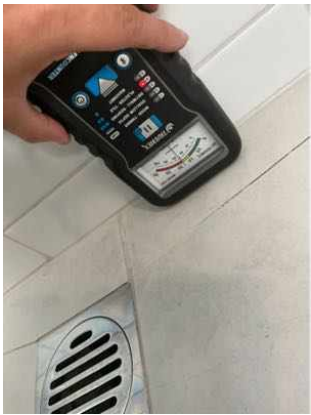
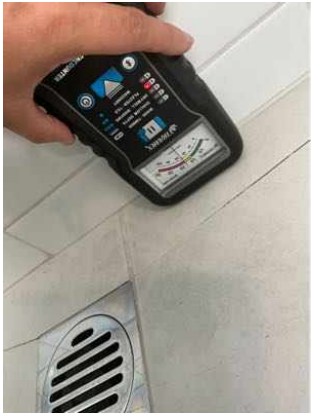
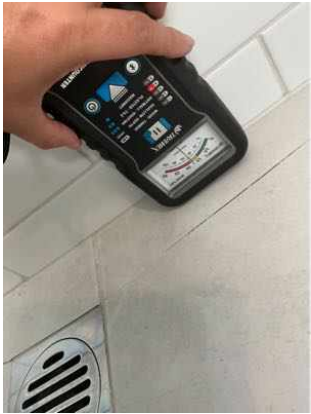
Building:	Main Building
Location:	Ensuite
Finding:	Excessive moisture - Conducive to Timber pest
Information:	Excessive moisture can attract termites and produce conditions that promote fungal growth and wood decay.

Excessive moisture is generally caused by deteriorated inadequate or missing roof drainage leaking plumbing pipes or fixtures poorly plumbed HWS overflows or condenser units and poor site drainage.

If mould growth has been found there may be environmental biological or health issues involved. In these cases an appropriately qualified inspector should also be contacted.

Prior to any remedial works being performed a qualified plumber should be appointed to further inspect the property and to identify the cause of the excessive moisture. Works to remove affected building elements may then be necessary and should be performed by an appropriate tradesperson.

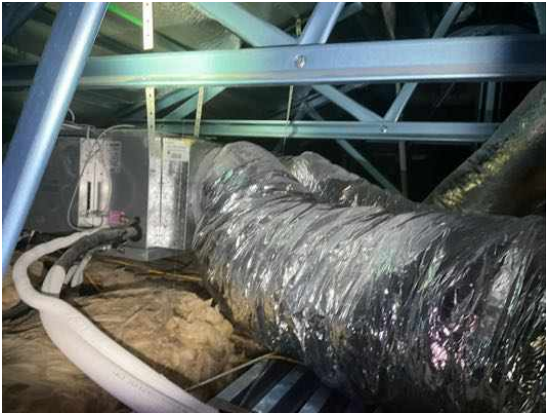
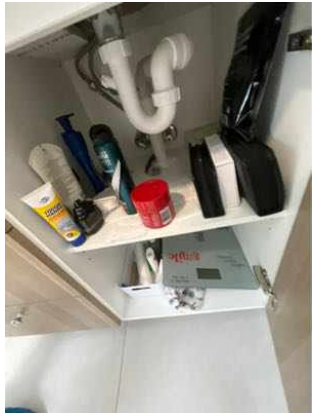
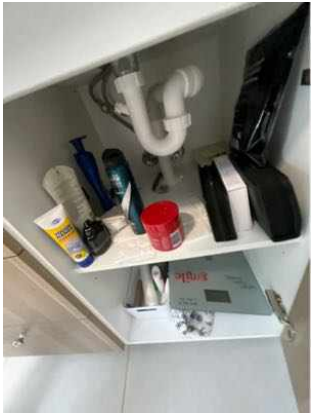
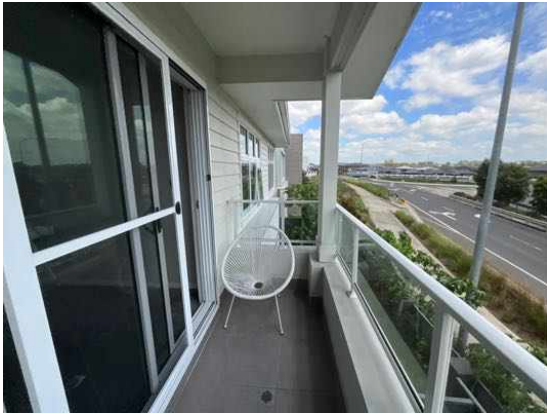
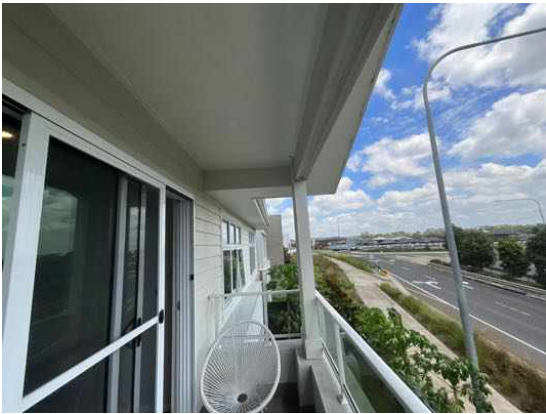
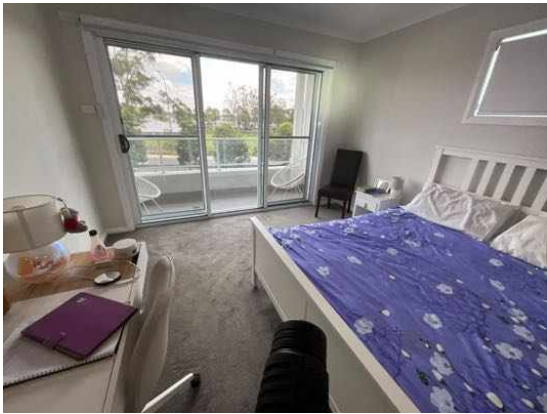
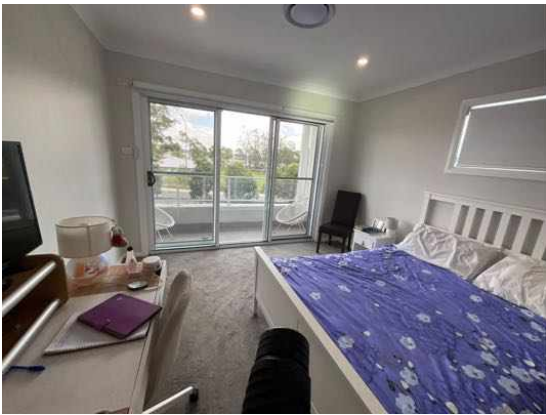
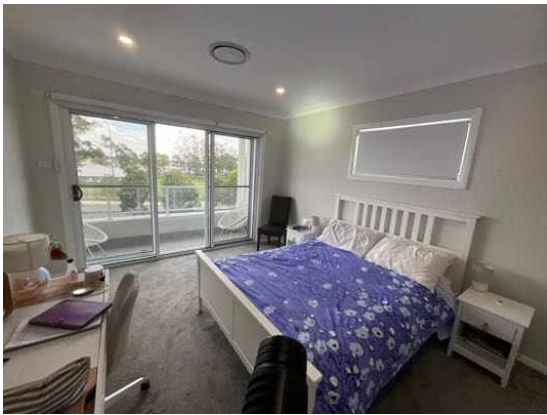
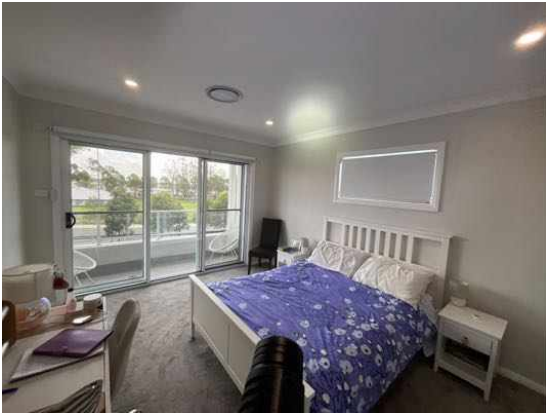
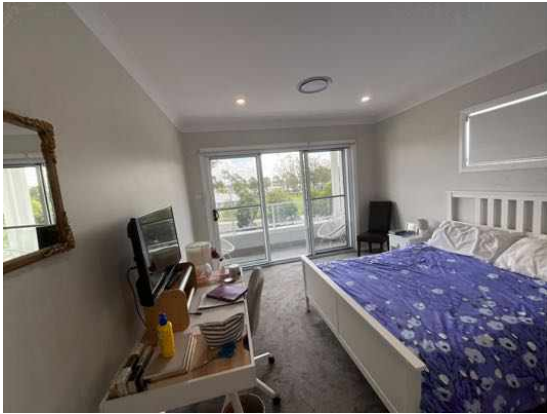
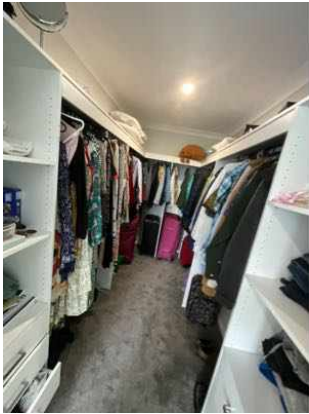
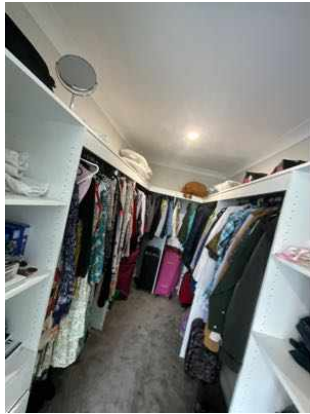
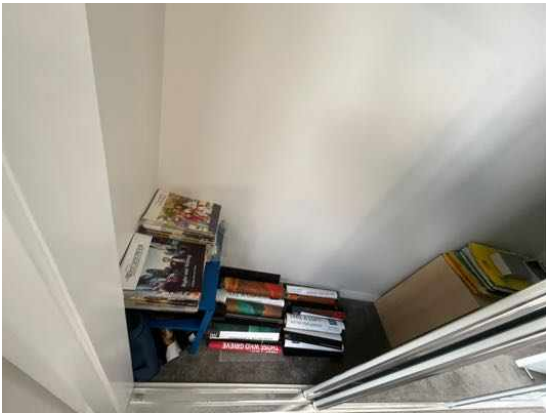
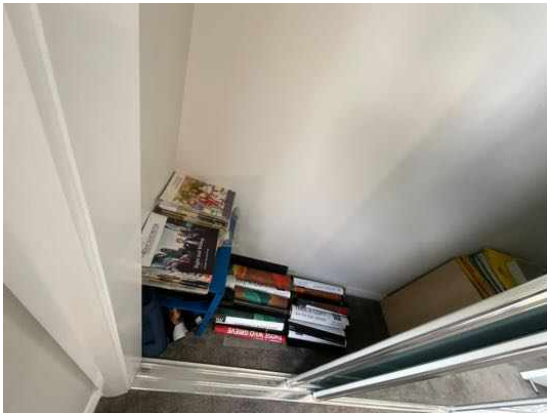
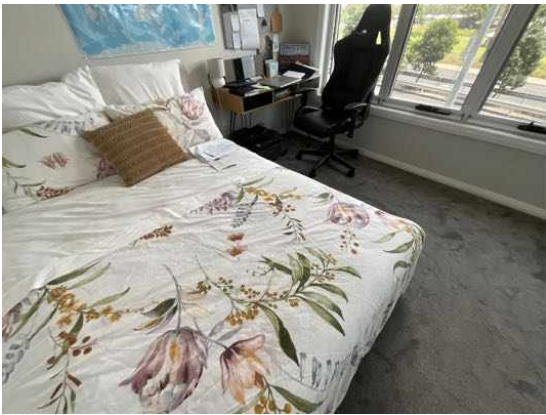
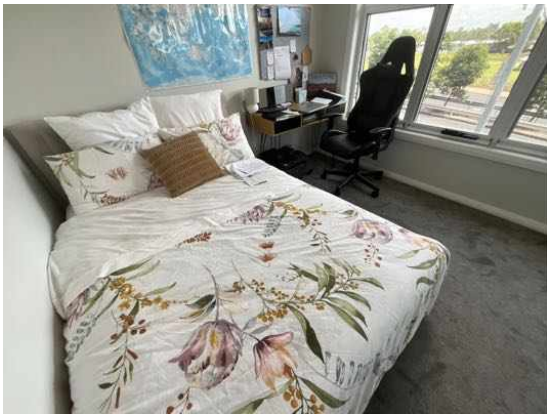
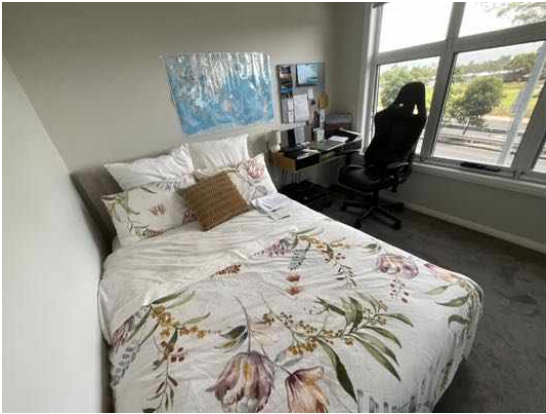
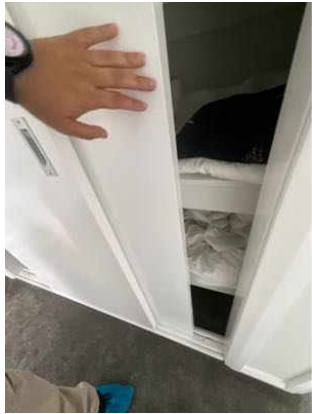
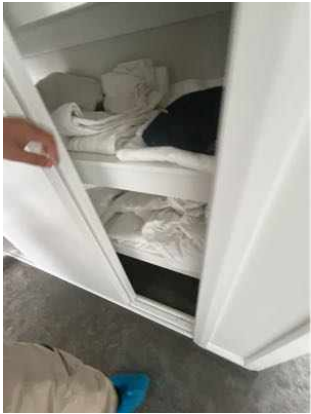
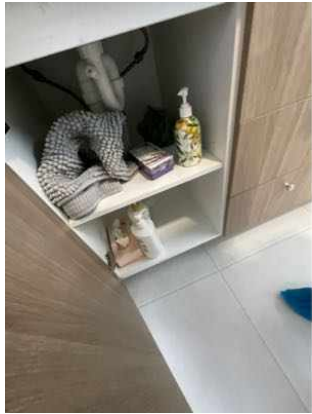
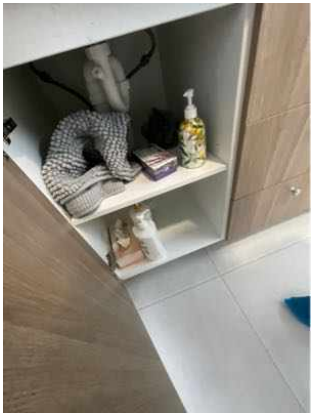
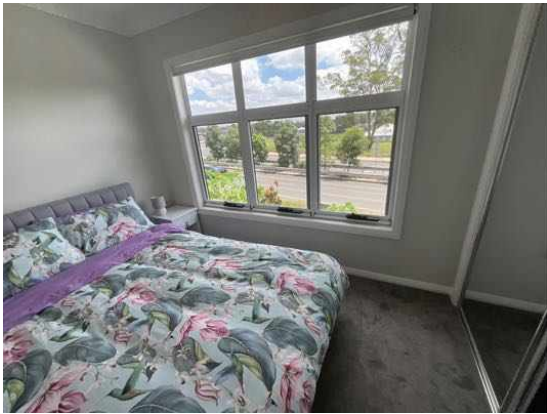
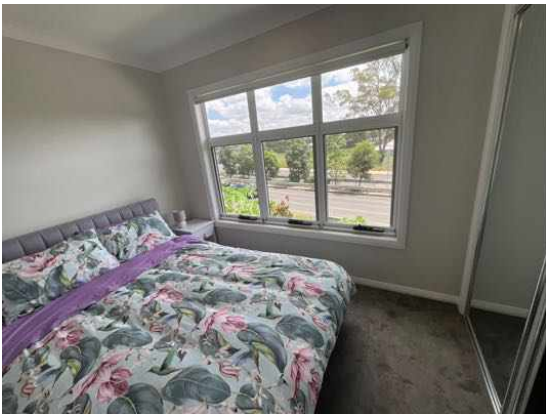
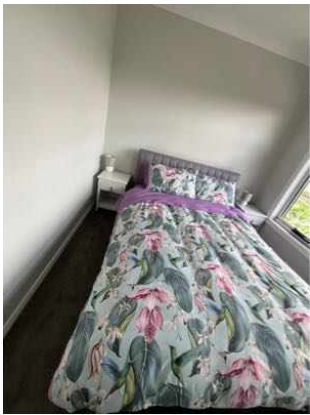
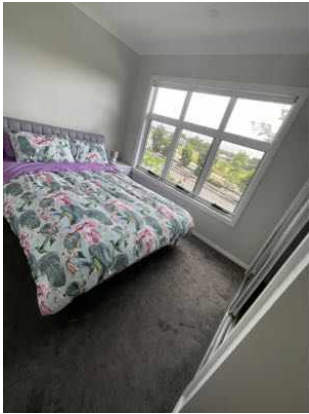
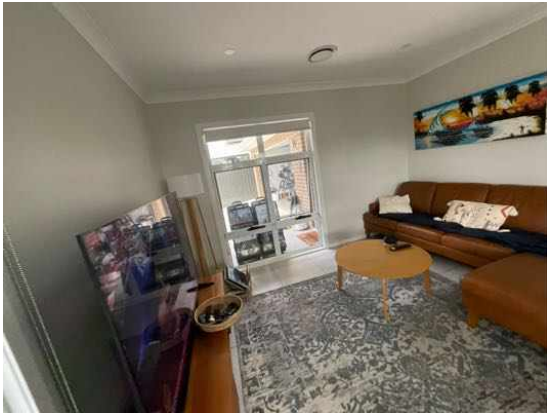
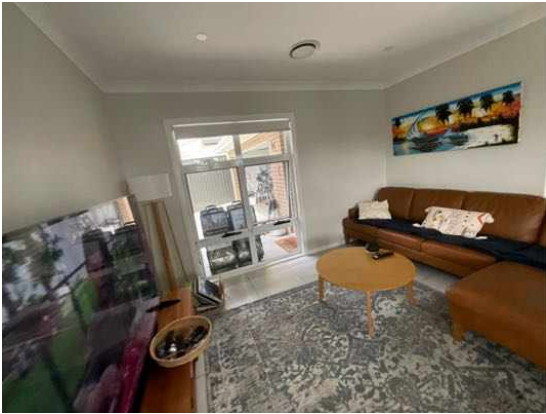
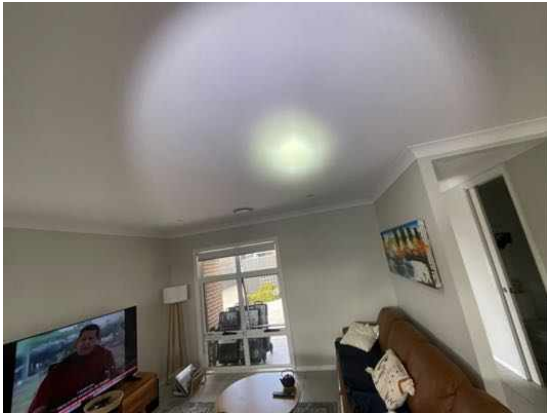
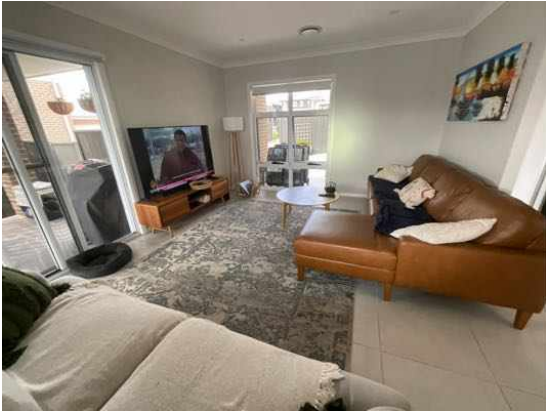
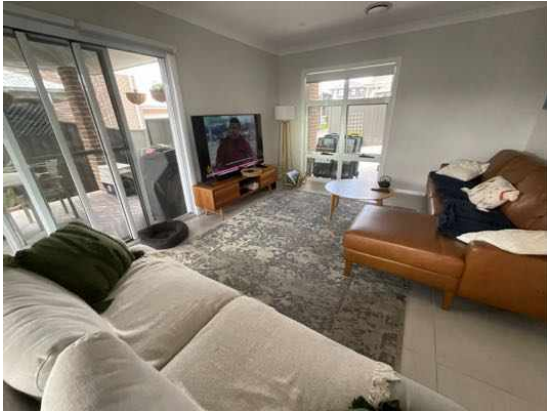
Building: Main Building  
Location: All Areas  
Finding: Additional Photos - Obstructions and Limitations  
Information: These photographs are an indication of the obstructions and limitations which impeded full inspection of the property at the time of inspection. These obstructions can hide an array of defects and should be removed to allow full inspection to be carried out. A re-inspection is recommended once the areas are made accessible.

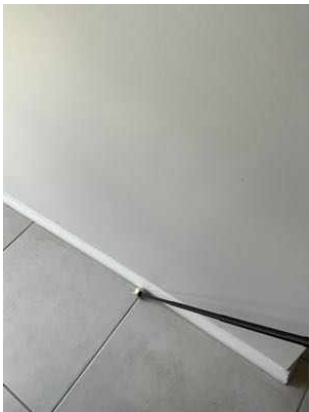
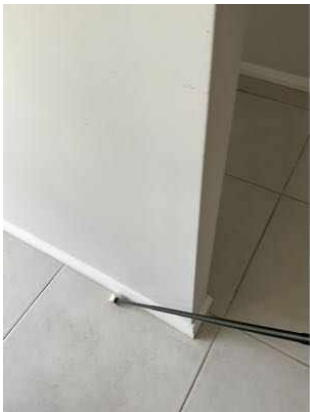
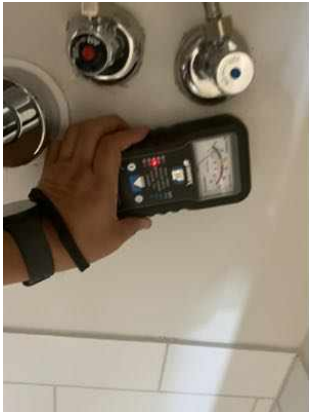
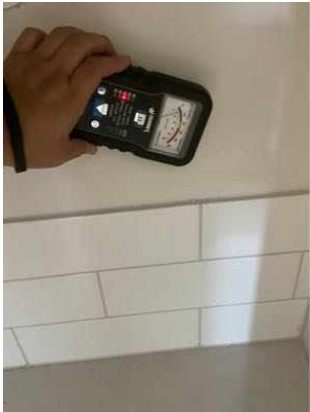
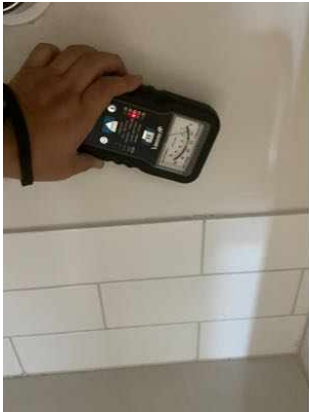
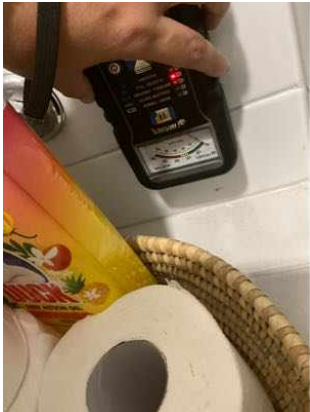
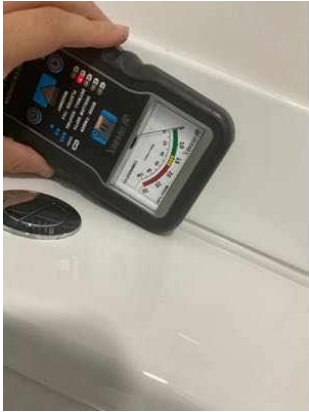
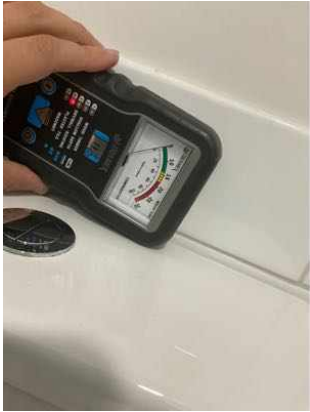
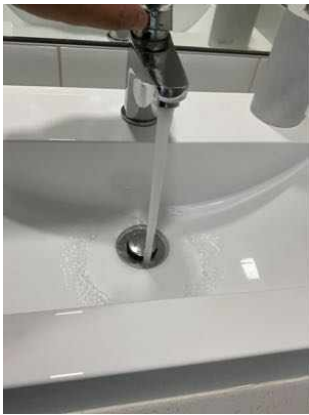
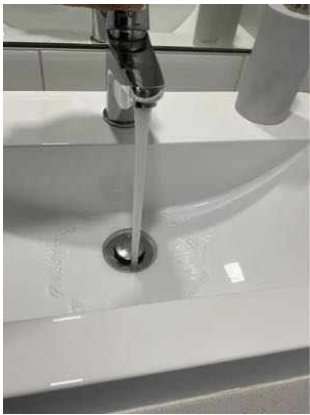
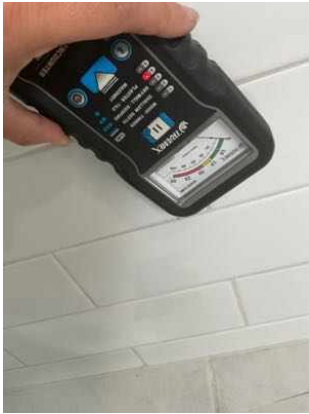
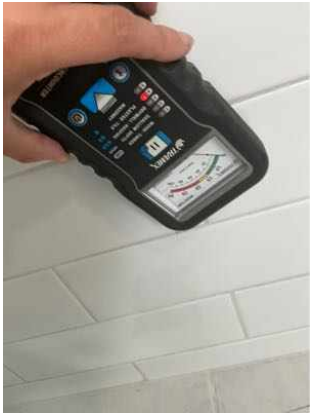
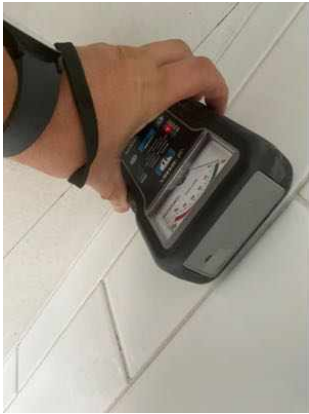
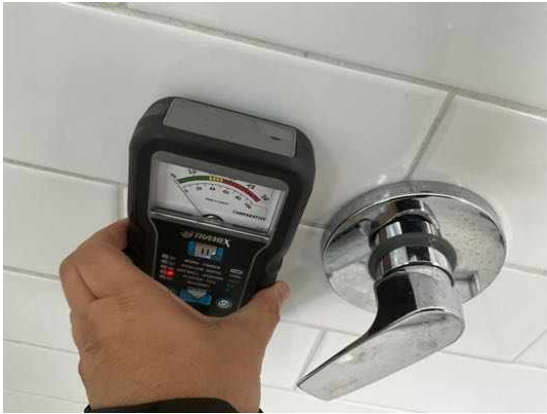
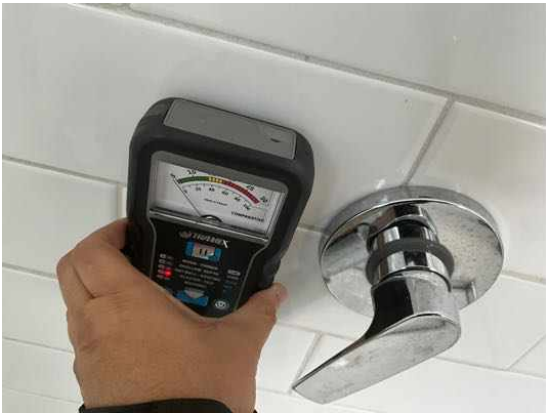
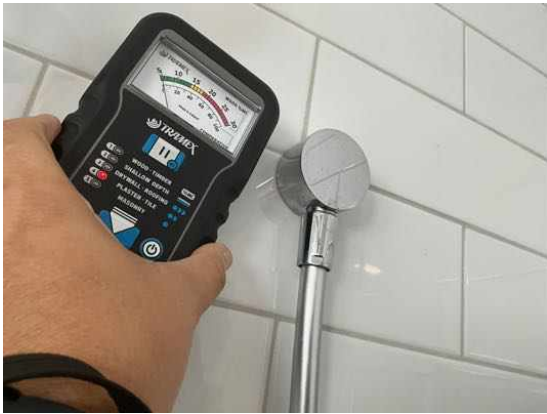
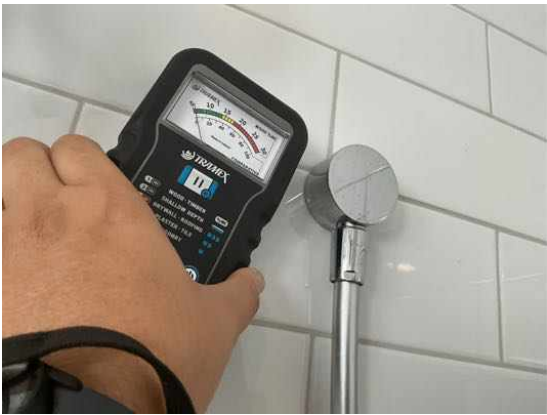
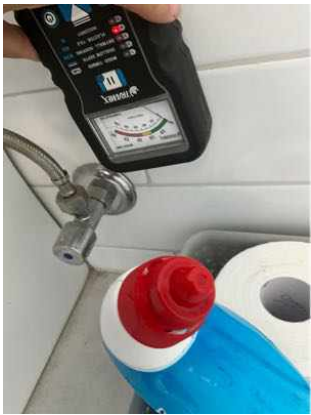
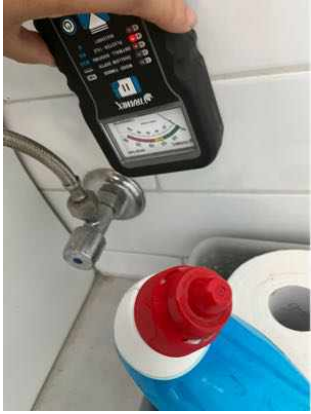
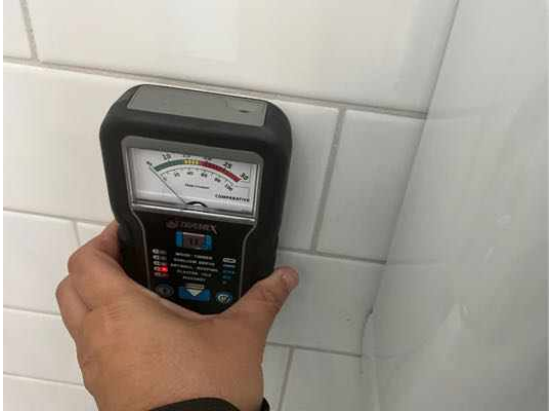
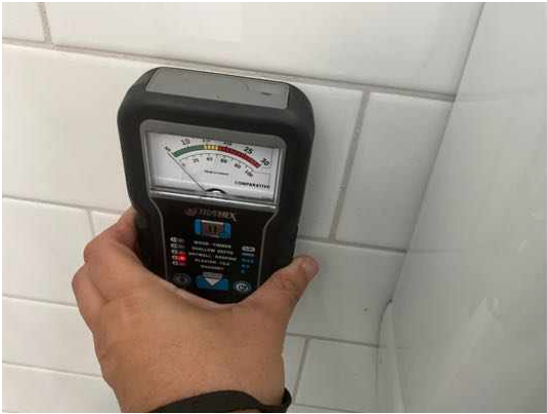
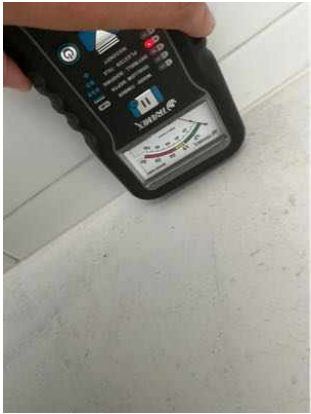
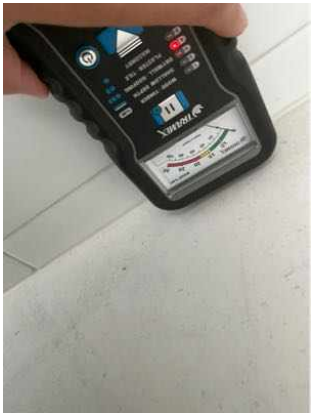
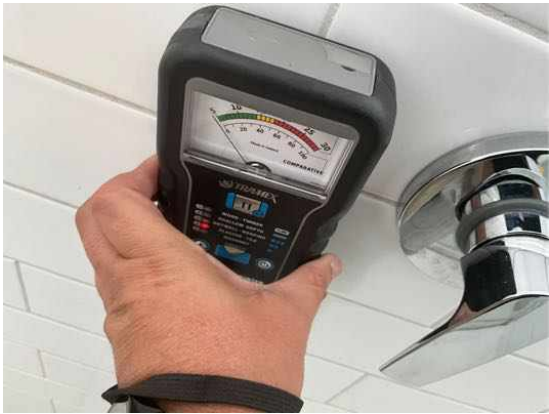
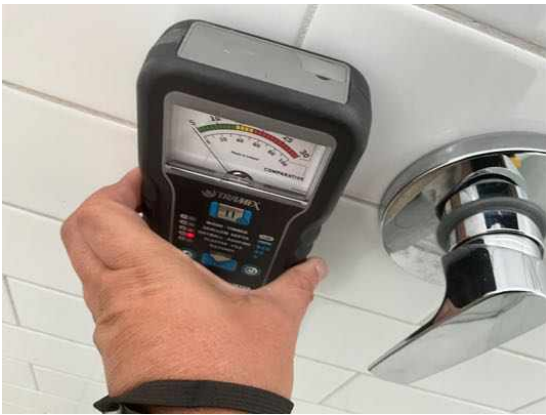
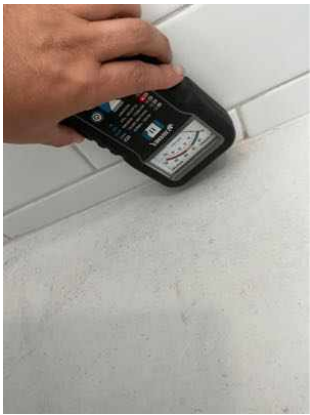
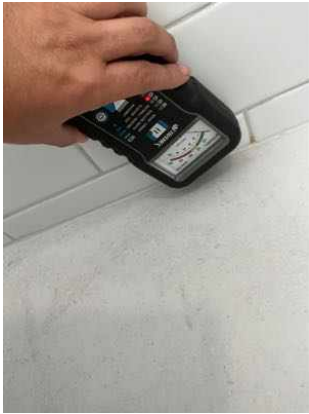
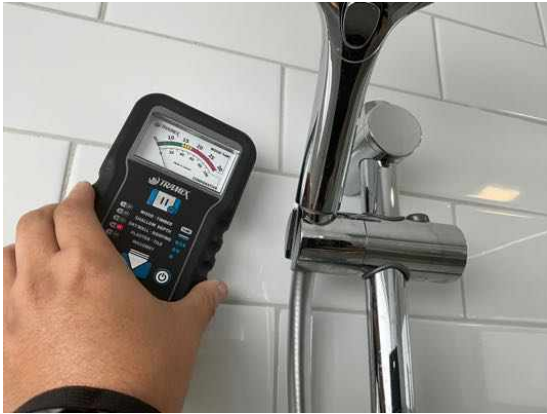
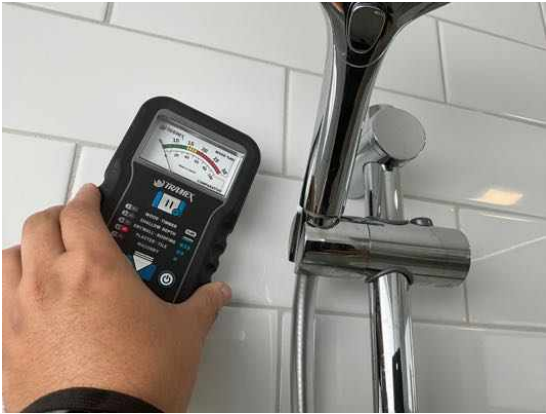
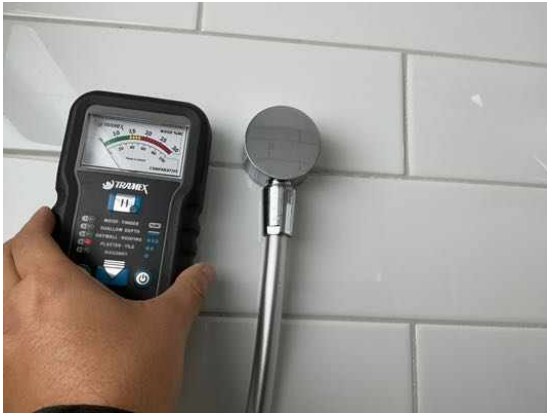
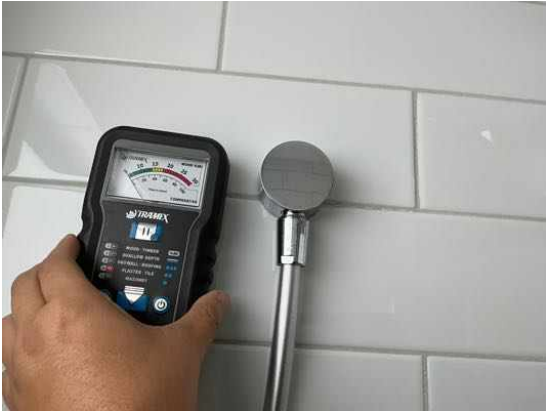
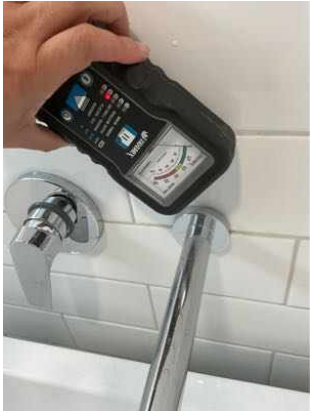
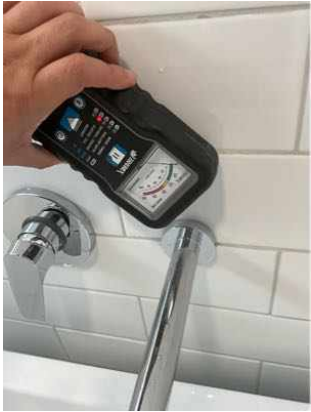
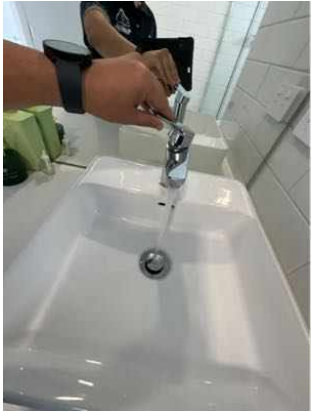
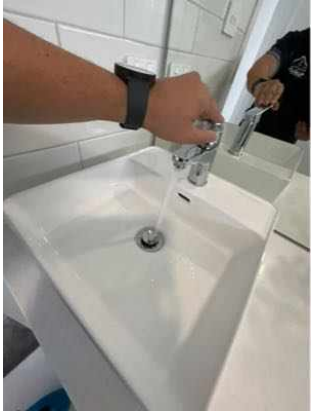
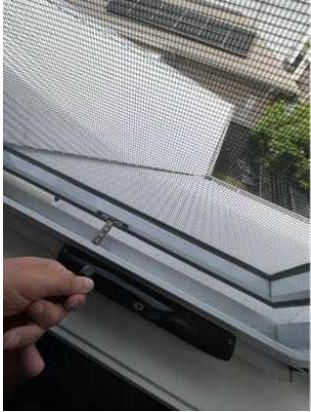
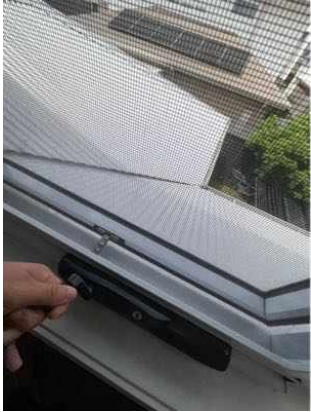
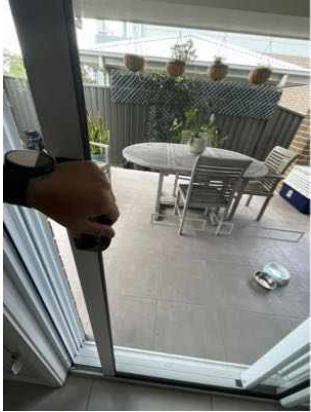
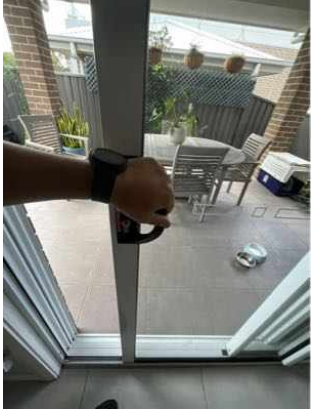
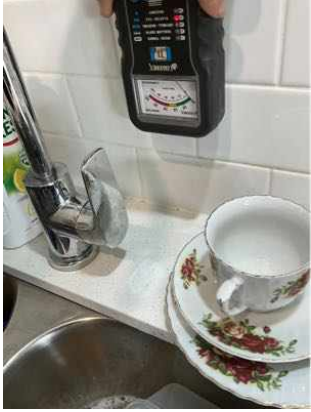
Building: Main Building  
Location: All Areas  
Finding: Additional Photos  
Information: Additional photos are provided for your general reference
