## Building Inspection Report

Inspection Date: Sat, 21 Feb 2026

Property Address: 4/48-50 Ann St, Dandenong VIC 3175,  
Australia

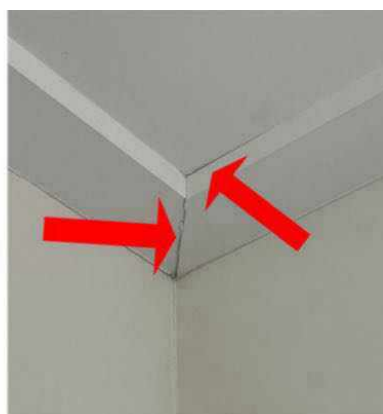
### Defects 3.11

Building:	Main Building
Location:	All Internal Areas
Finding:	Minor Gaps at Ceiling-to-Wall Junctions – Internal Areas
Information:

Such gaps are generally cosmetic in nature and are often attributable to normal structural movement, seasonal expansion and contraction, or minor settlement. No evidence was observed at the time of inspection to suggest structural failure associated with these junctions.

If considered unsightly, a qualified painter or handyman can undertake cosmetic rectification works including filling, re-sealing, sanding, and repainting to achieve a uniform and consistent finish. Ongoing monitoring is recommended to ensure the gaps do not progressively widen.

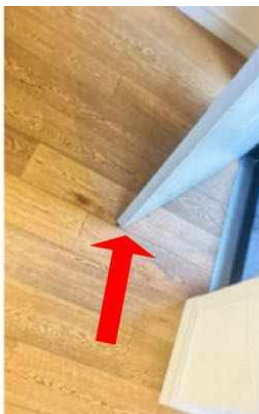
Continued friction may cause further damage to the floor finish and place unnecessary stress on the door hinges and hardware. The condition affects both functionality and presentation.

It is recommended that a qualified carpenter assess the door assembly. The weather strip may be temporarily removed to determine whether it is the cause of the interference. If friction persists, the door should be realigned, adjusted at the hinges, or carefully shaved at the bottom to provide adequate clearance without compromising weatherproofing performance.
