# Building and Timber Pest Inspection Report

Inspection Date: Wed, 4 Feb 2026

Property Address: 5/41 Hope Street, Penrith NSW 2750

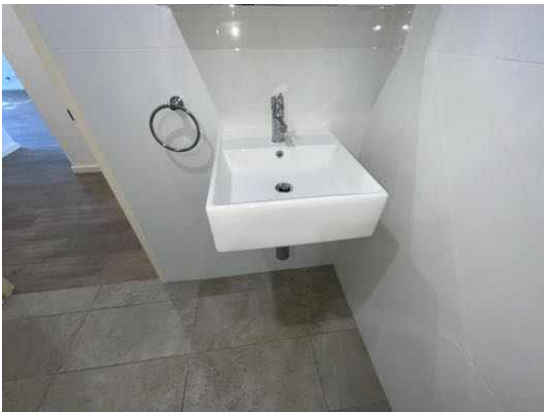
Building: Main Building  
Location: Ensuite  
Finding: Wet Areas - Bathroom(s) - Overall Condition & Recommendations.  
Information: Overall Condition & Recommendations

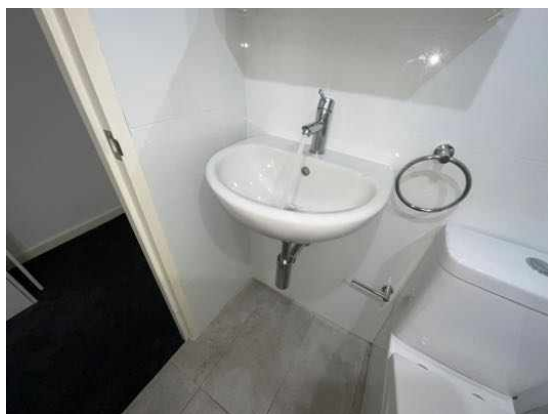
Building: Main Building  
 Location: All Areas  
 Finding: Water Pressure – Observation Only.  
 Information: During the inspection, water pressure appeared to be within a normal operating range based on a basic functional check. However, this observation was made without the use of pressure testing equipment and does not constitute an assessment by a licensed plumber.

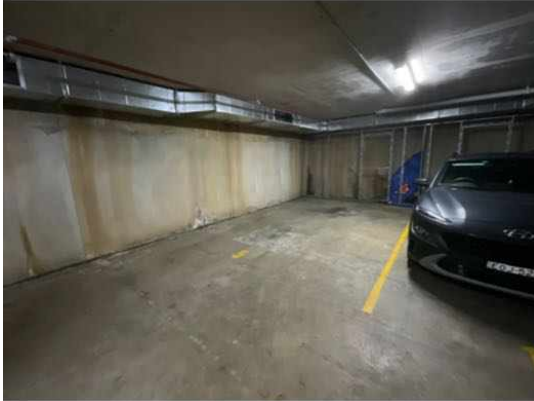
Location: Carpark  
Finding: Additional Photos  
Information: Additional photos are provided for your general reference
