Building Inspection Report

Inspection Date: Wed, 4 Feb 2026

Property Address: 23 Craighlands Ave, GORDON, NSW, 2072,
Australia

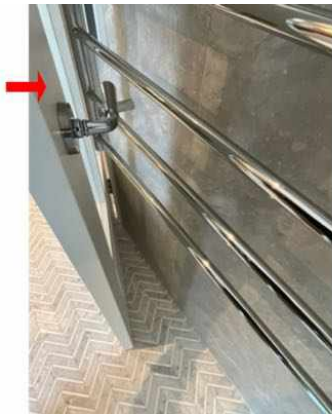
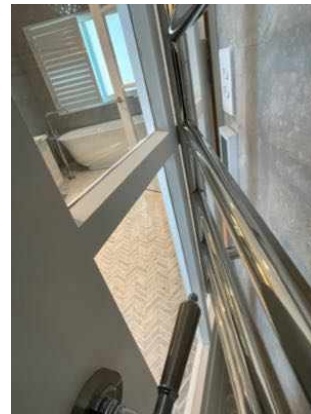
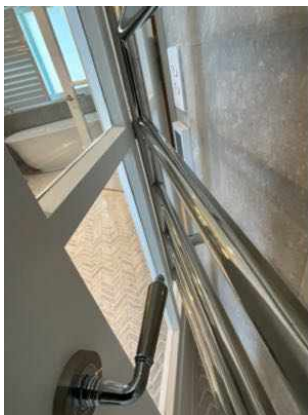
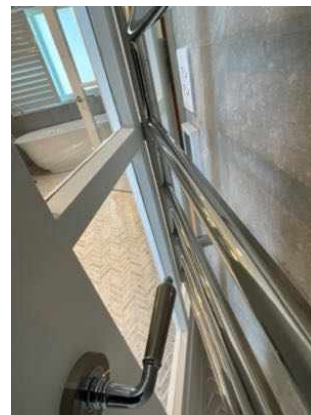
Defects 1.01

Building:	Main Building
Location:	Ensuite - Master
Finding:	Door Interference - Obstructive Towel Rail Installation
Information:	The towel rail has been installed in a position that restricts the door from fully opening. The door comes into direct contact with the rail, which may cause damage to both components over time and impairs normal use of the door.

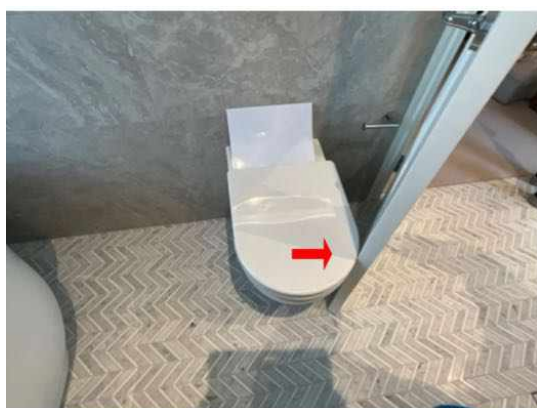
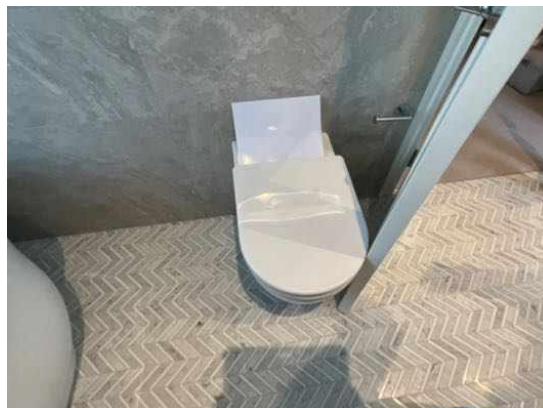
Defects 1.02

Building: Main Building
Location: Ensuite - Master
Finding: Door - Hitting toilet seat
Information: A safety hazard was identified in the bathroom of the property. The issue pertains to the door, which, when fully opened, makes contact with the adjacent toilet. This situation poses an immediate risk to the safety and well-being of occupants due to the potential for accidents and injuries.

Collision between the door and the toilet can cause injury to individuals using the bathroom.

The repeated contact between the door and the toilet can also result in damage to both fixtures, leading to costly repairs or replacements.

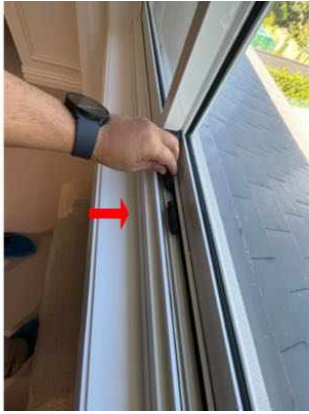
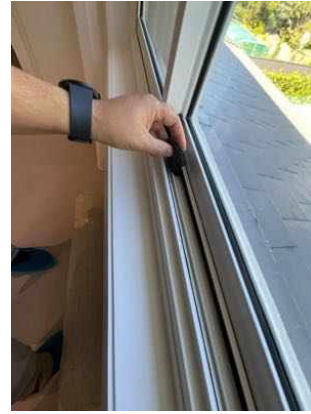
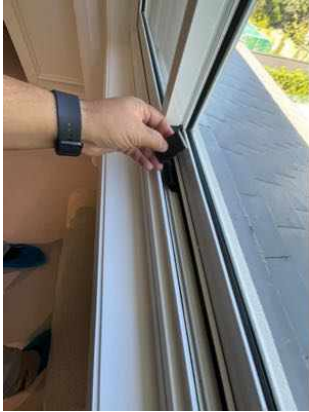
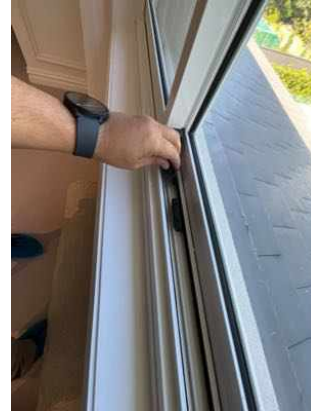
Defects 1.03

Building: Main Building
Location: All Areas
Finding: Window child lock missing
Information: The window in question lacks a child lock mechanism, which poses a potential safety risk to young occupants in the premises. As per Australian Standards windows accessible to children should be equipped with appropriate child safety locks to prevent accidental opening, reducing the risk of falls and ensuring compliance with safety regulations.

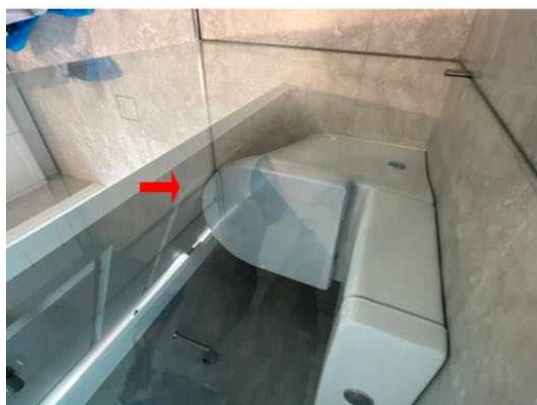
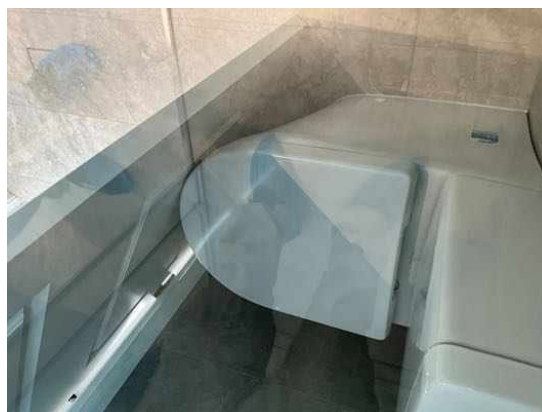
Defects 1.04

Information: A safety hazard was identified in the bathroom of the property. The issue pertains to the door, which, when fully opened, makes contact with the adjacent toilet. This situation poses an immediate risk to the safety and well-being of occupants due to the potential for accidents and injuries.

Collision between the door and the toilet can cause injury to individuals using the bathroom.

The repeated contact between the door and the toilet can also result in damage to both fixtures, leading to costly repairs or replacements.

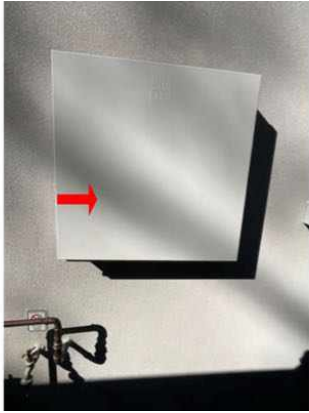
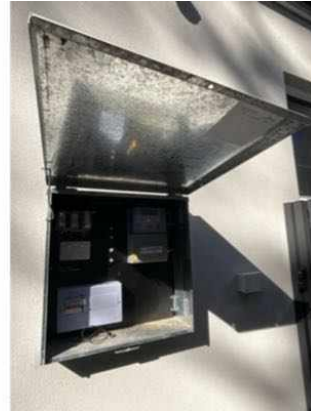
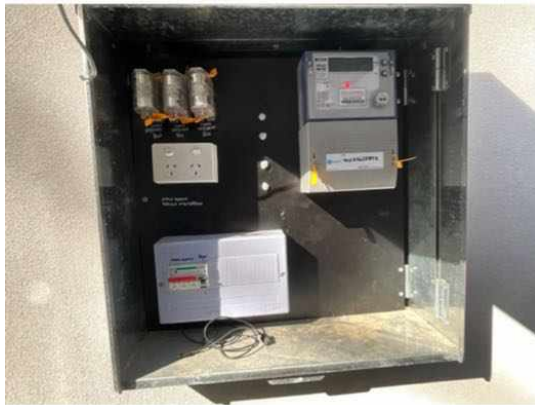
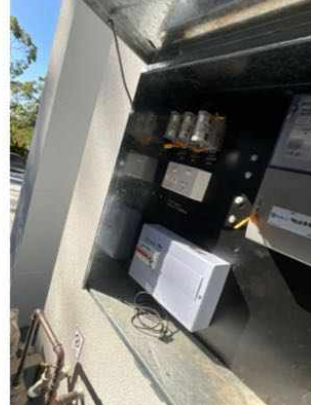
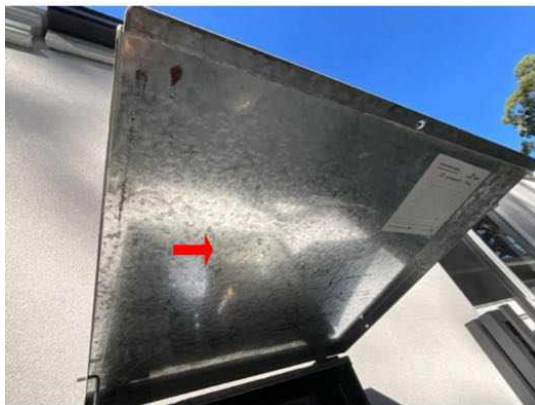
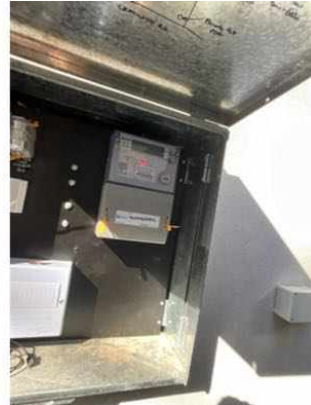
Defects 3.01

Building: Main Building
 Location: Exterior walls - right side
 Finding: Sticker - MISSING TERMITE MANAGEMENT SYSTEM NOTICE
 Information: The meter box does not display a termite management system sticker/notice. No information regarding the type of termite protection installed, installation date, installer details, or maintenance requirements is visible within the meter box or elsewhere on the property.

Mandates installation of a durable, legible notice after any termite management system is applied.

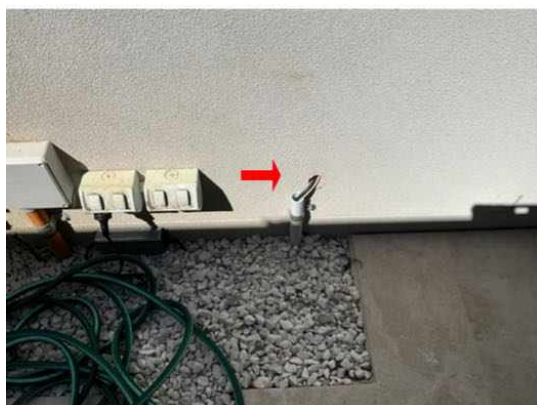
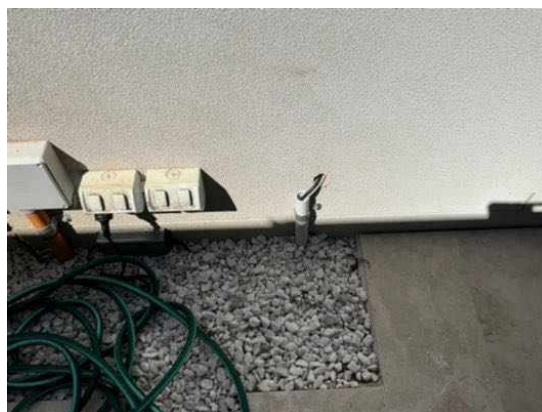
Defects 3.02

Building:	Main Building
Location:	Exterior walls - right side
Finding:	Pipe Penetrations - sealant required
Information:	It was noted that at the time of the inspection the pipe penetrations were defective as stated in the Australian Standards and Tolerances 7.3.

Plumbing holes are defective if they are not:

- a. properly grouted/sealed as appropriate
- b. fitted through neat minimal size penetrations (in the case of cabinetwork)
- c. fitted with tight fitting cover plates or collars with penetrations kept to the smallest size practicable.

This is to be rectified prior to handover.

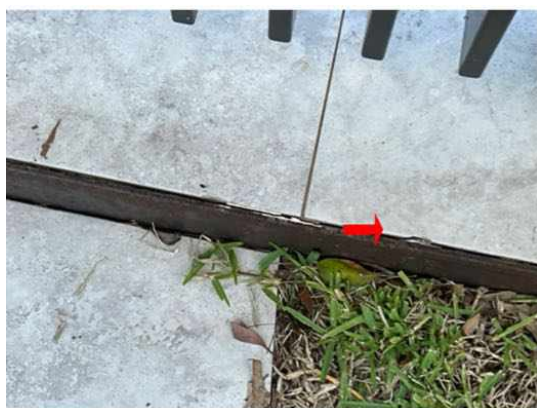
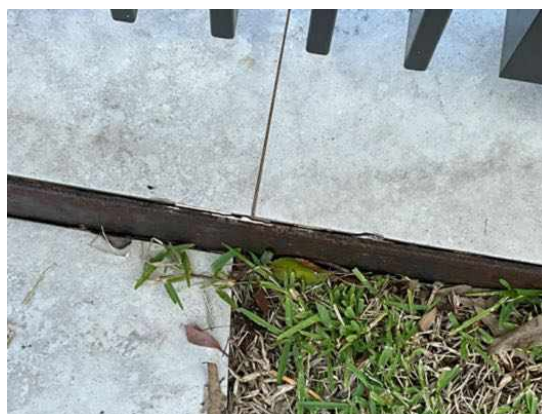
Defects 3.03

Building: Main Building
 Location: Yard - Front
 Finding: Tiles - Chipped
 Information: Cracked, pitted, chipped, scratched or loose tiles

Tiles are defective if they are cracked, pitted, chipped, scratched or loose at handover.

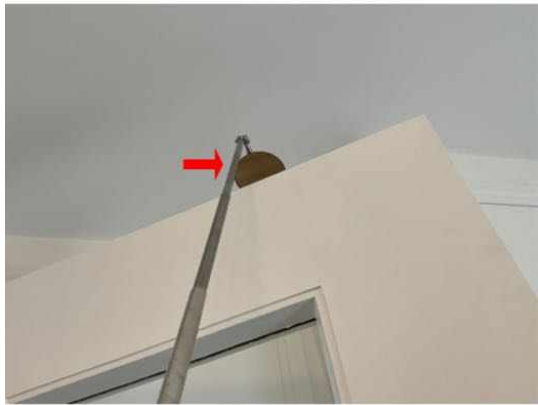
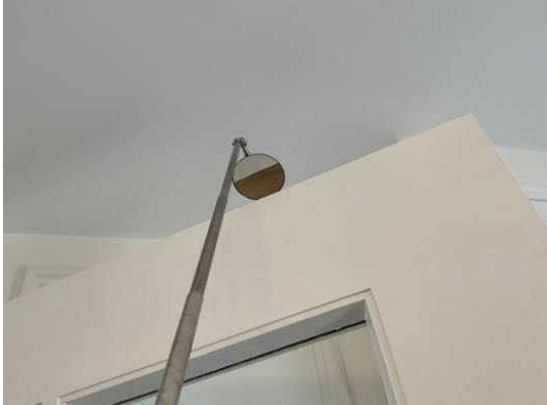
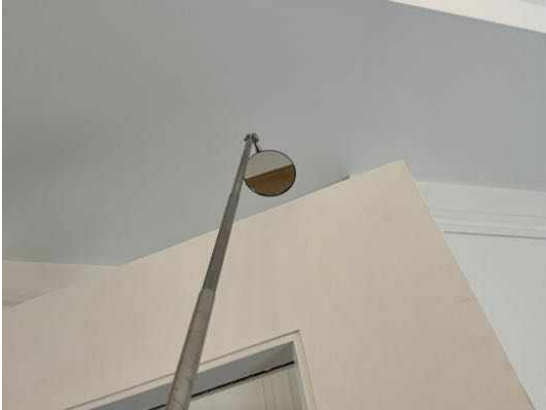
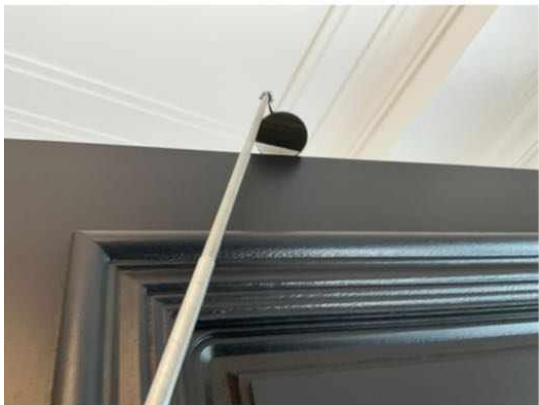
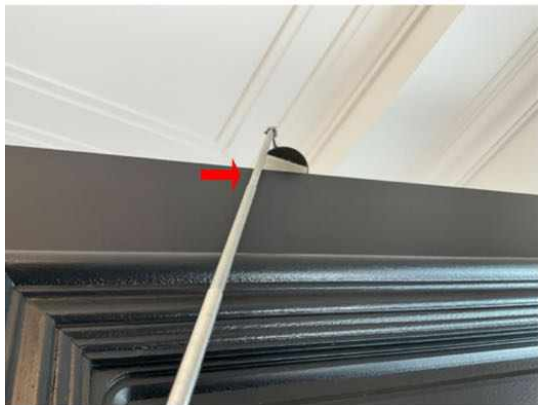
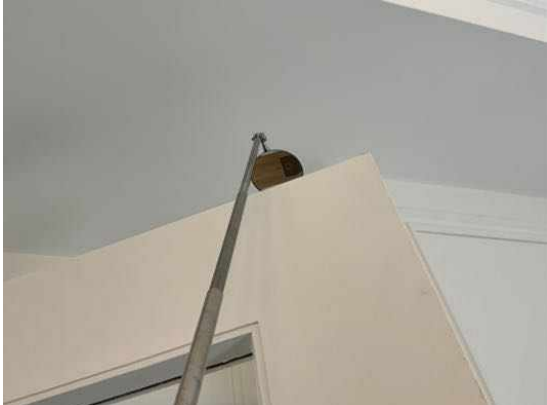
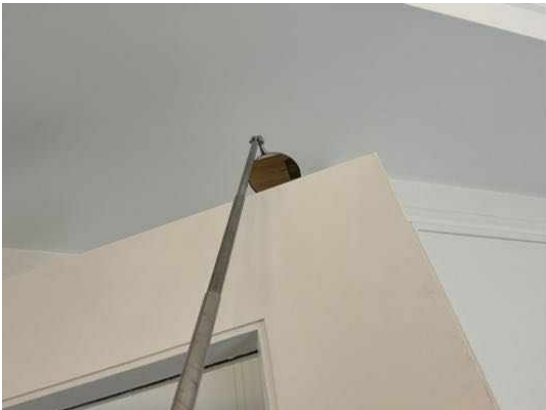
Defects 3.04

Building:	Main Building
Location:	All Areas
Finding:	Incomplete Painting of Doors
Information:	The paintwork on the doors throughout the building is incomplete, failing to meet the requirements specified by Australian Guides and Tolerances.

- ****Coverage:**** Incomplete paint coverage on the doors, with visible areas left unpainted or thinly coated.
- ****Edges and Corners:**** Edges and corners of the doors are inadequately painted, showing bare or poorly covered areas.

- Reduced durability and protection of the door surfaces against wear and environmental factors.
- Compromised aesthetic quality and overall visual appeal of the building.
- Increased maintenance costs due to the need for early repainting or repairs.

- Ensuring complete and consistent paint coverage on all surfaces of the doors.
- Achieving a smooth and even finish without visible defects such as brush marks, drips, or streaks.
- Proper surface preparation to ensure good paint adhesion and prevent peeling or flaking.
- Thoroughly painting edges and corners to achieve a uniform appearance.

A detailed inspection should be conducted post-repainting to confirm compliance with the required standards.

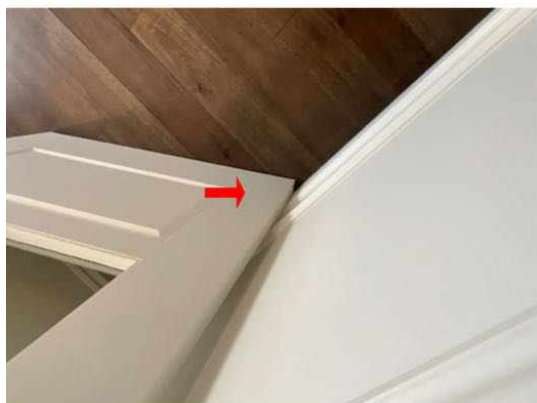
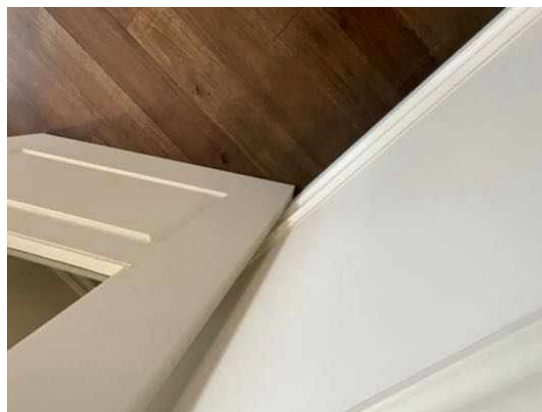
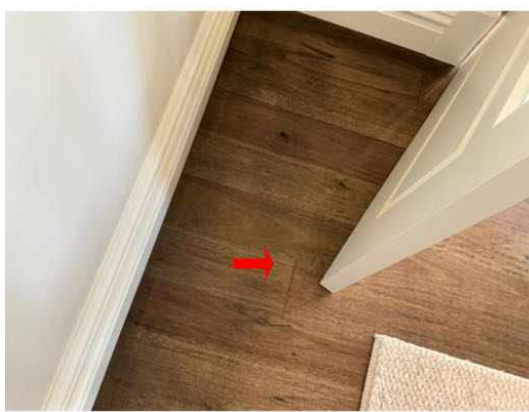
Defects 3.05

Building: Main Building
Location: Home office
Finding: Missing Door Stopper
Information: The door lacks a stopper, which is essential to prevent the door from swinging too far and potentially damaging the wall or the door handle. The absence of a door stopper increases the likelihood of impact damage to both the door and surrounding surfaces over time.

- **Damage Risk:** Moderate risk of damage to the door handle, wall, or door itself from repeated impacts when the door is opened forcefully or by a gust of wind.
- **Wear and Tear Risk:** Increased wear on door hardware and hinges due to the potential for abrupt stops without a dedicated stopper.

This issue is a minor defect but should be addressed to prevent potential damage and maintain the integrity of the door and surrounding areas.

- **Engage a Handyperson or Carpenter:** A handyperson or carpenter should install a suitable door stopper to prevent excessive door movement. This could be a floor-mounted or wall-mounted stopper depending on the space and door design.

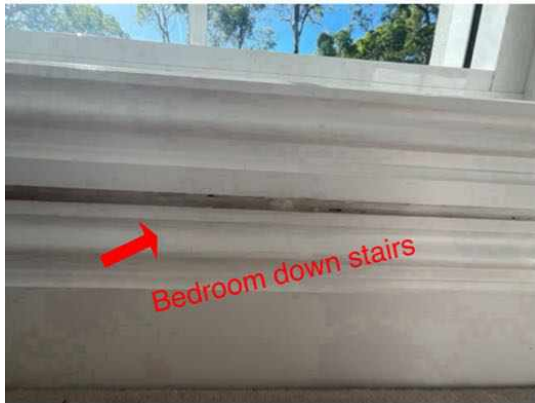
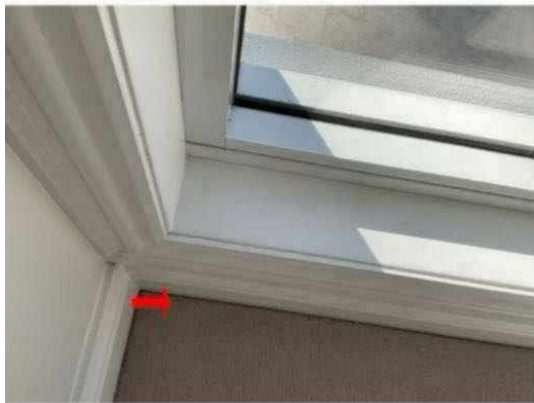
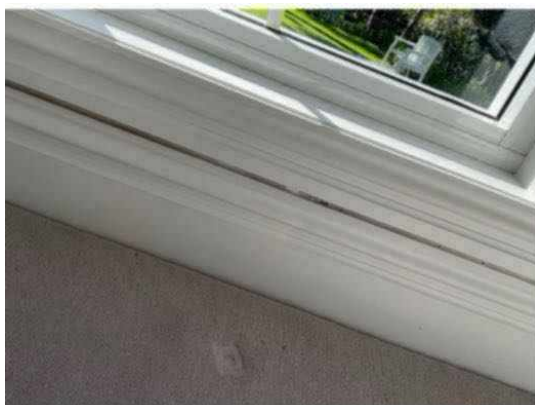
Defects 3.06

Building:	Main Building
Location:	All Areas
Finding:	Substandard Work- Various Areas of the Building
Information:	Substandard work has been identified in multiple areas throughout the building, failing to meet the requirements specified by Australian Guides and Tolerances.

- ****Paint Application:**** Inconsistent and incomplete paint coverage on walls, ceilings, and downpipes, with visible brush marks, drips, and streaks.
- ****Surface Preparation:**** Poor surface preparation resulting in inadequate paint adhesion and flaking..
- ****Plasterwork:**** Cracks in plaster exceeding the acceptable width as specified in the Guide to Standards and Tolerances.
- ****Fixtures and Fittings:**** Misaligned or improperly installed fixtures and fittings, not meeting the standard requirements for level and alignment.

- Accelerated deterioration and reduced durability of the affected elements.
- Compromised aesthetic quality and overall value of the property.
- Potential safety hazards and increased maintenance costs.

- Repainting surfaces with proper surface preparation and uniform application.
- Repairing or replacing cracked plaster to ensure compliance with acceptable standards.
- Realigning and properly installing fixtures and fittings.

A comprehensive inspection should be conducted post-repairs to ensure all rectifications comply with the required standards.

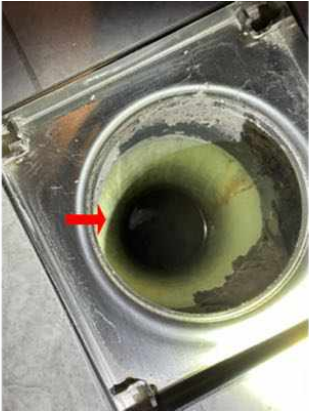
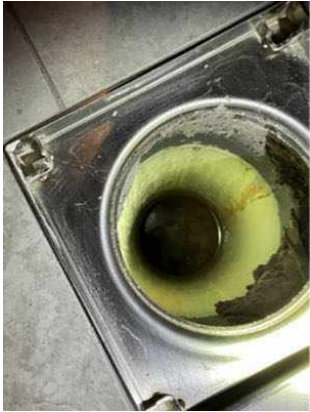
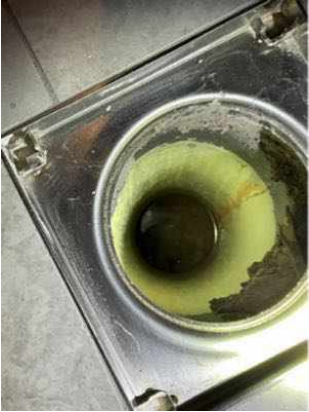
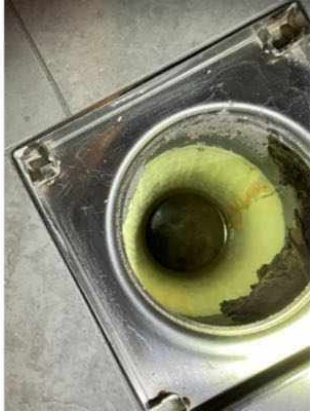
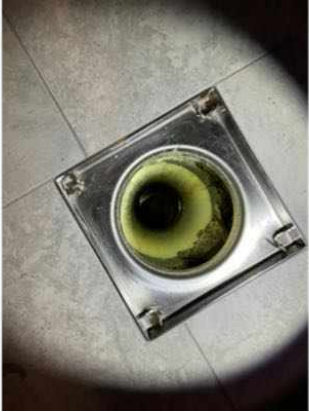
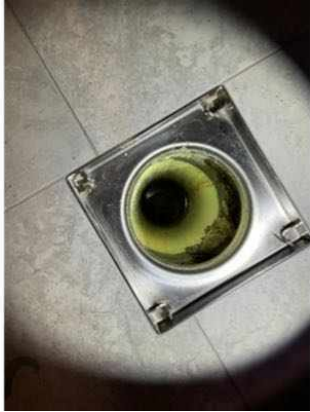
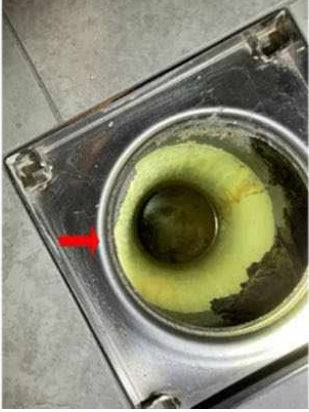
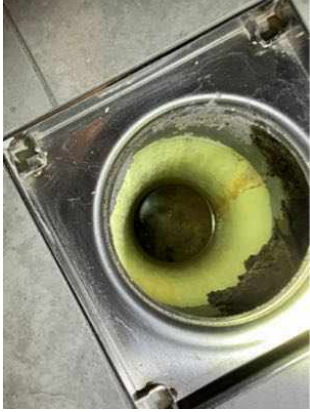
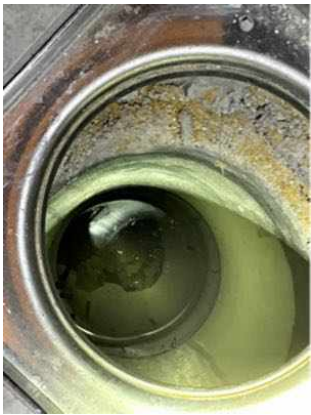
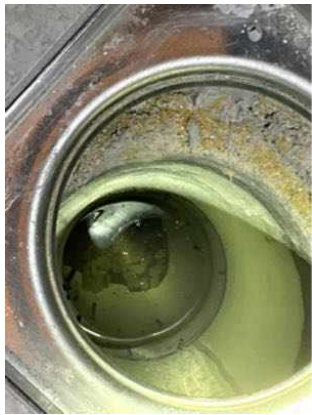
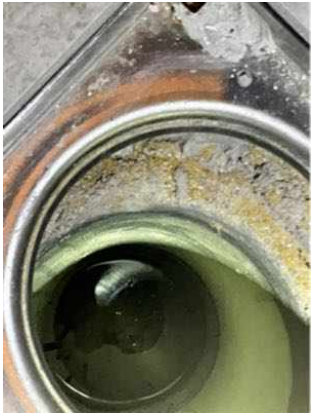
Defects 3.07

Building:	Main Building
Location:	All Areas
Finding:	Floor waste Debris
Information:	It was noted that there is builder debris in the floor waste drainage. Debris in the plumbing system may lead to blockages in the future.

This is referenced against the Australian Standards and Tolerances clause 19.8 Cleaning - Owners are entitled to expect that the building site and works are clean and tidy on completion.

Building sites are defective if they are not clear of building debris. All floor wastes need to be checked and cleared prior to handover.

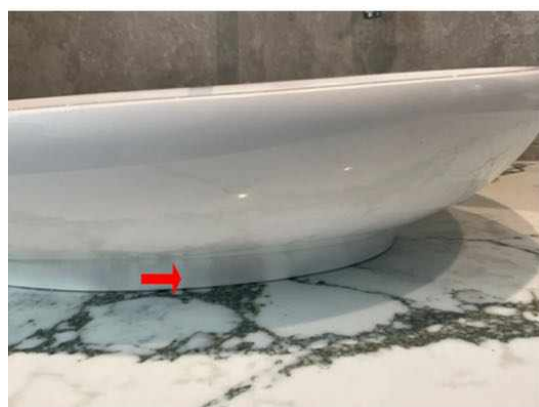
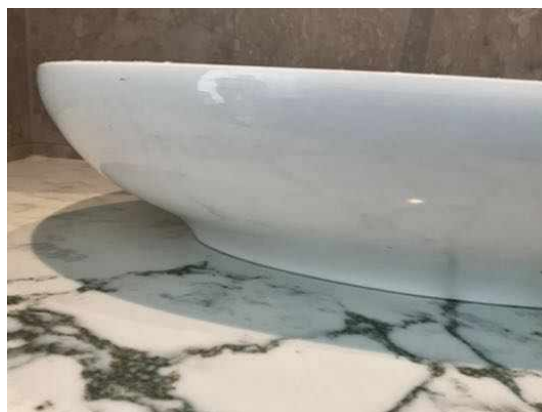
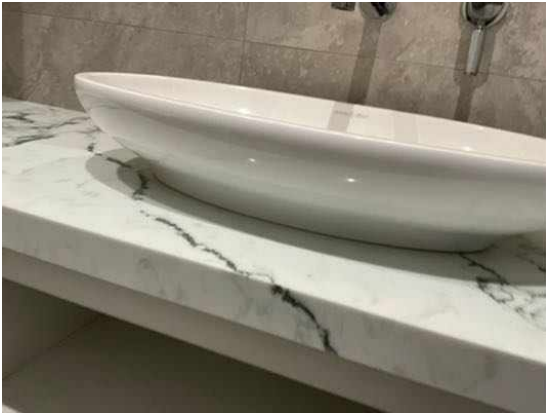
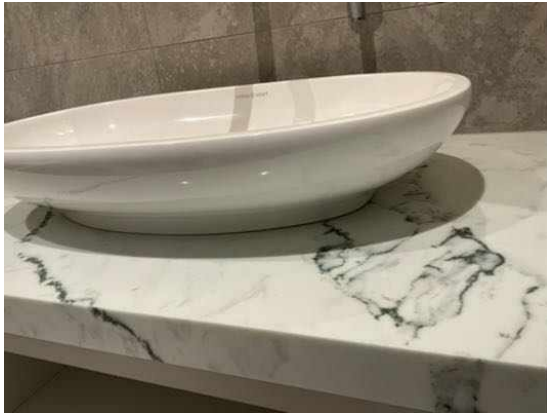
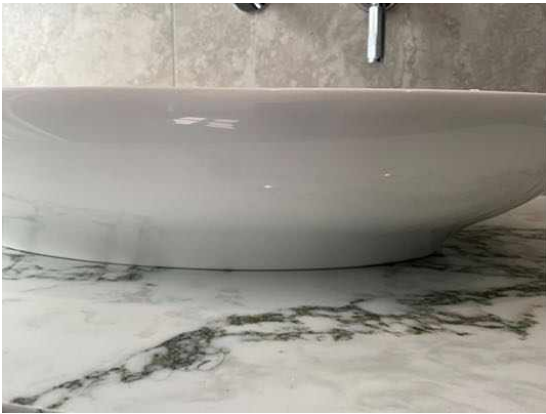
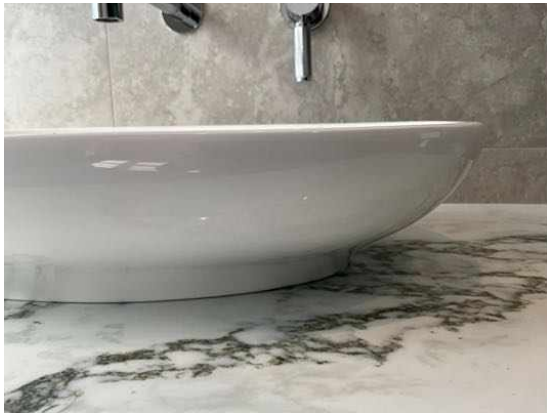
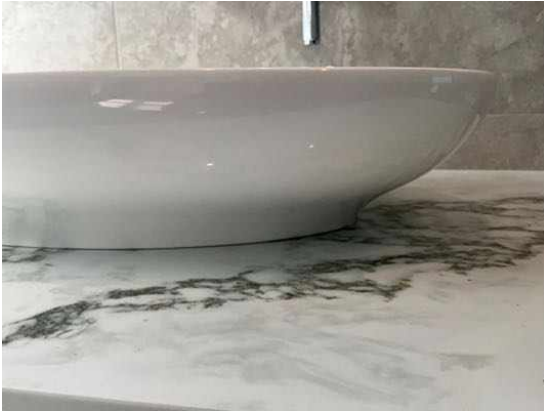
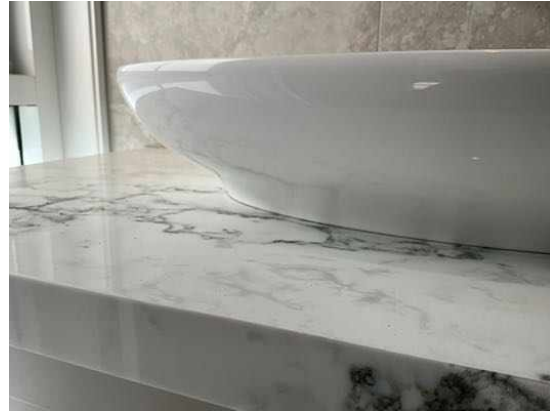
Defects 3.08

Building: Main Building
Location: All Areas
Finding: Silicone- Missing Sealant Around Basin
Information: No silicone sealant was observed around the perimeter of the vessel basin where it meets the benchtop surface. This is considered non-compliant with good building practice and may allow moisture ingress, leading to potential swelling, mould growth, and damage to cabinetry and surrounding finishes.

In accordance with the NCC and the Guide to Standards and Tolerances 2017, joints between sanitary fixtures (such as basins) and adjoining surfaces must be properly sealed with a flexible waterproof sealant to ensure water resistance and durability.

It is recommended that a qualified tradesperson apply a continuous bead of mould-resistant, sanitary-grade silicone sealant to all exposed joints to prevent future water damage and ensure compliance with standards.

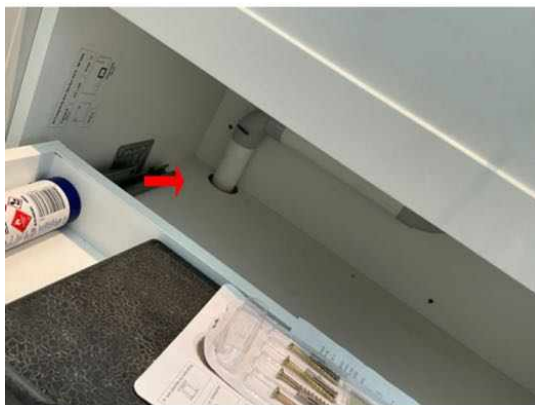
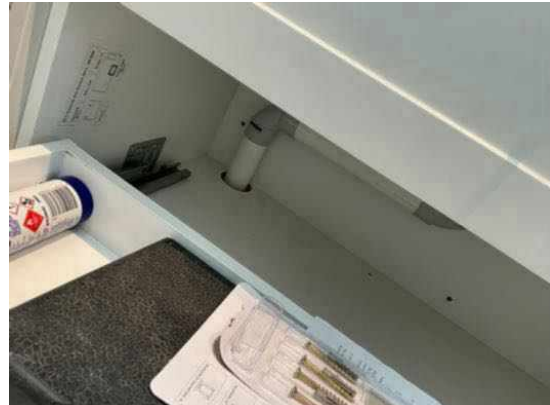
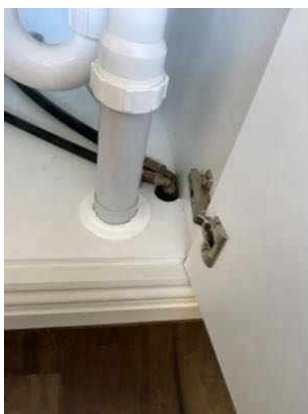
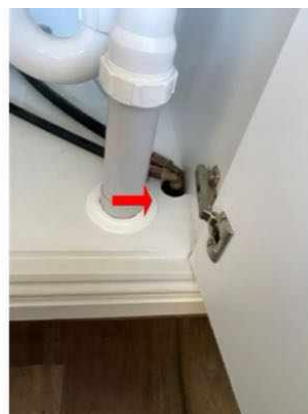
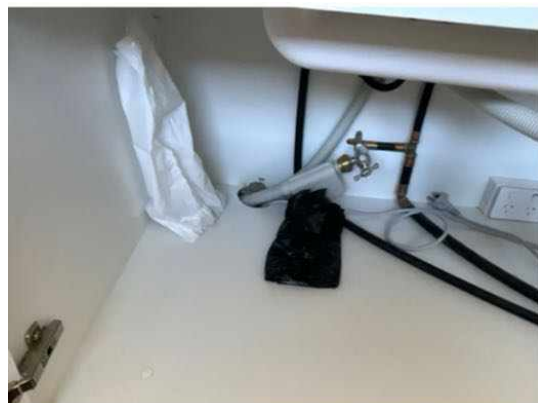
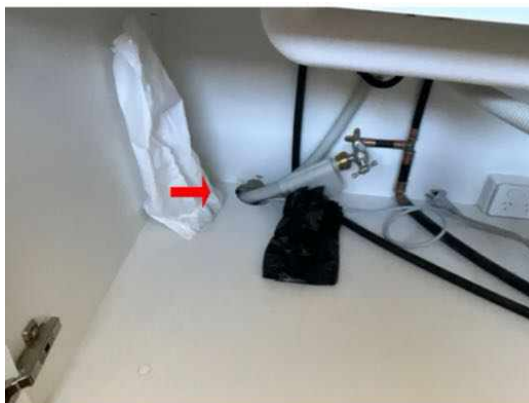
Defects 3.09

Building: Main Building
 Location: All Areas
 Finding: Pipe Penetrations not capped
 Information: There is an open hole around the pipes under the cabinetry that hasn't been sealed or capped.

- Pests like mice or cockroaches can enter through the gap.
- Water can get in and cause mould or damage to the cabinet.
- It looks untidy and is hard to keep clean.

A plumber or handyman can seal the hole using a cover plate, grommet, or suitable sealant.

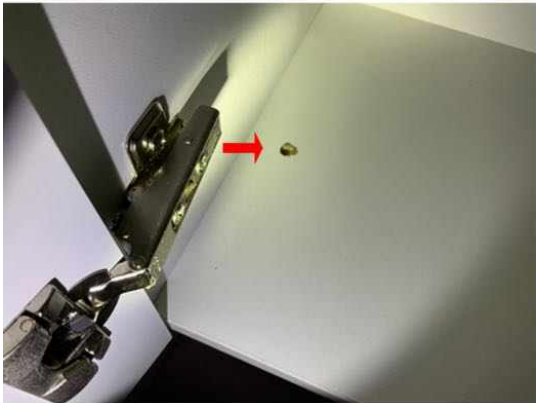
Defects 3.10

Building: Main Building
 Location: Bedroom downstairs
 Finding: Chipped cabinetry
 Information: A visible chip is present on the edge of the timber-finish cabinet door panel. The defect appears to have resulted from impact or mishandling during installation. The chip exposes the underlying substrate, making the area more prone to moisture absorption and further deterioration.

If unsealed, the exposed edge may swell or delaminate due to moisture ingress, affecting the door's appearance and alignment. Over time, this can lead to structural weakening or difficulty in closing the door properly.

A qualified cabinetmaker or joiner can repair the defect by sanding and filling the chipped area with colour-matched putty or veneer repair compound. If the damage is significant, replacement of the affected door panel may be necessary.

Repair and installation should comply with AS/NZS 4386.1 – Domestic Kitchen

Assemblies and AS 1859.2 – Reconstituted Wood-Based Panels, ensuring finish consistency and durability.

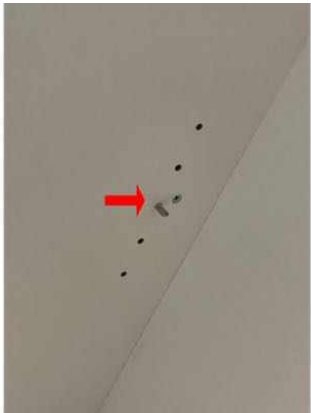
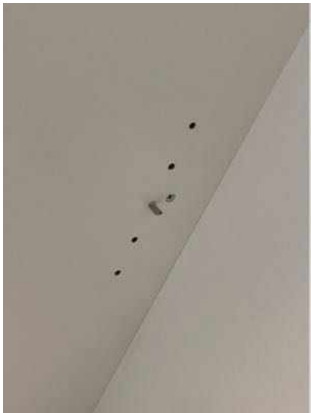
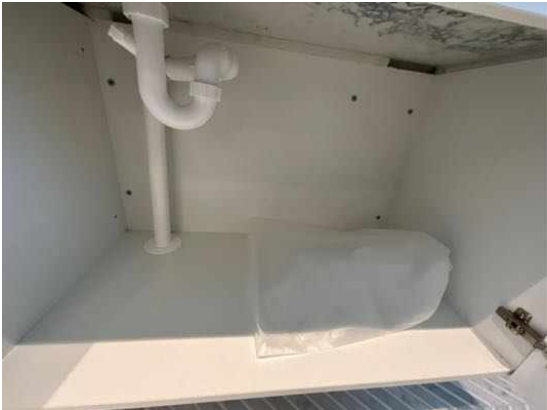
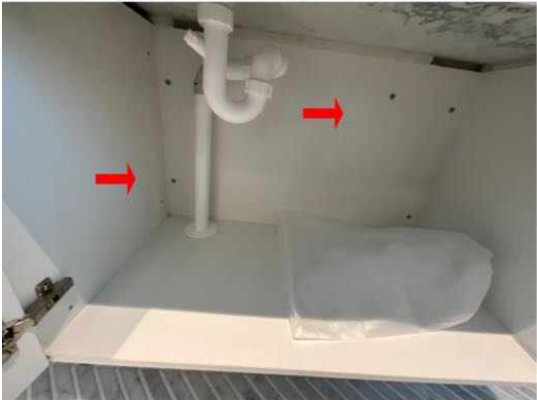
Defects 3.11

Building: Main Building
Location: All Areas
Finding: Joinery - screw caps/ stickers missing
Information: Screws inside cabinets, wardrobes, vanities and the like should be capped or covered. This is to be completed prior to handover.

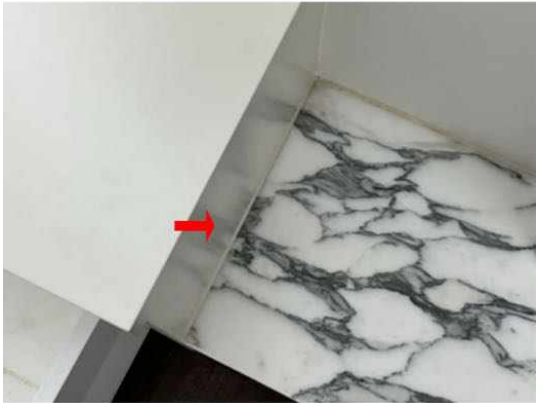
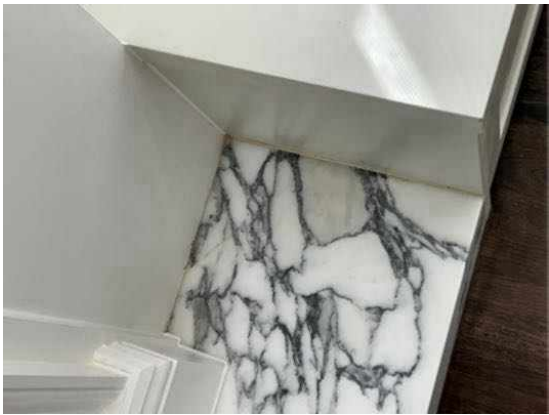
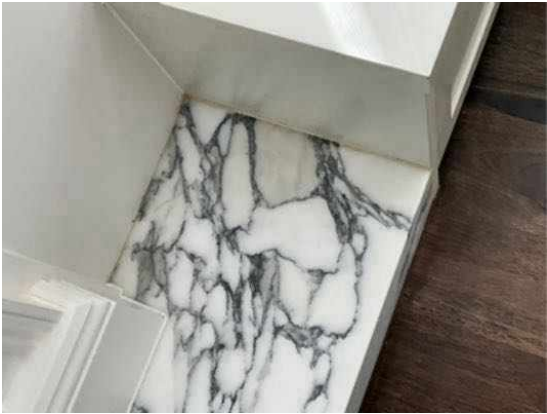
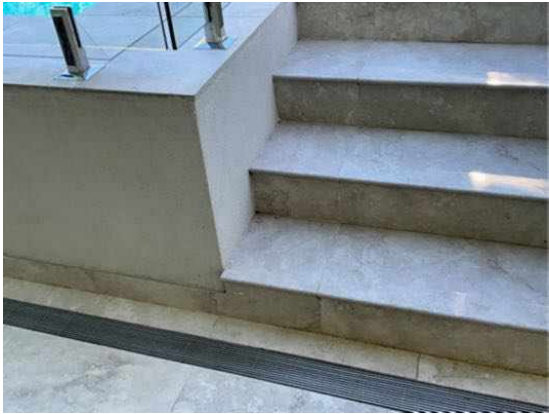
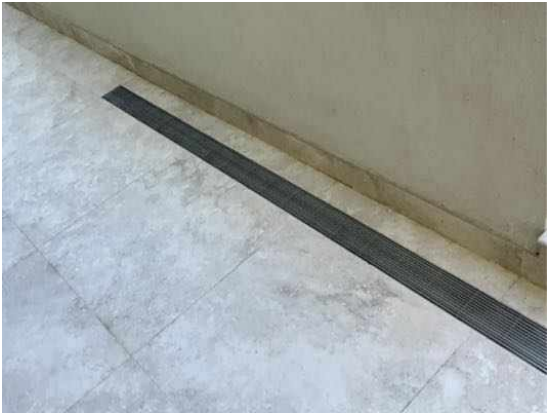
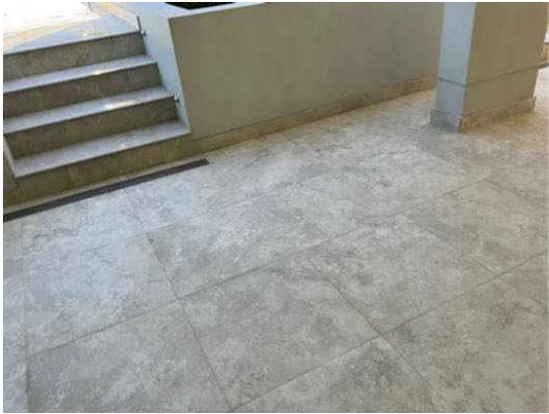
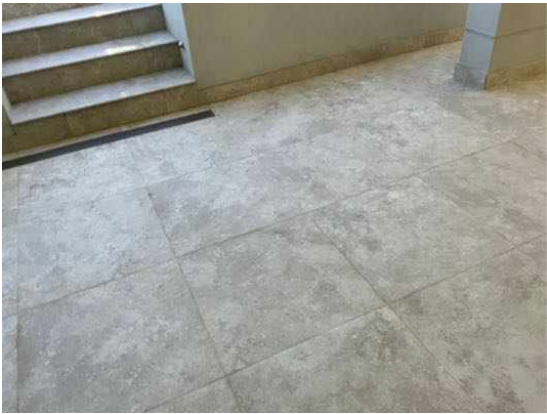
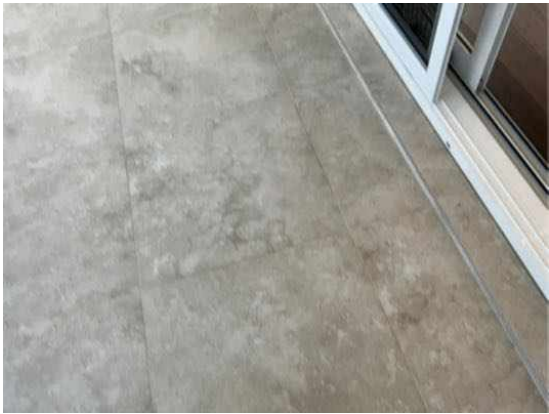
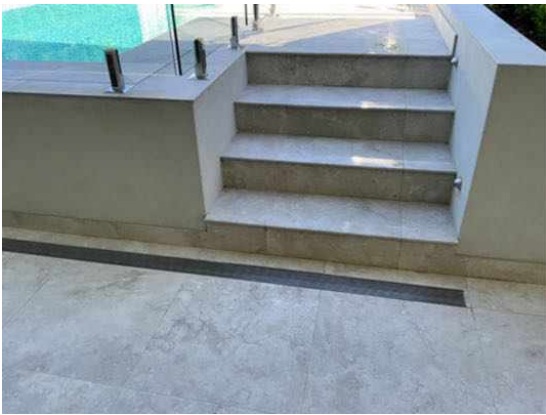
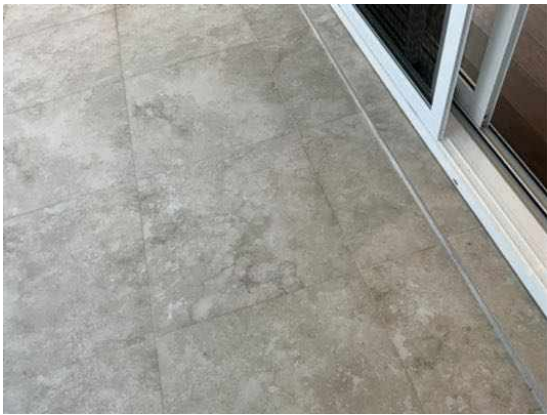
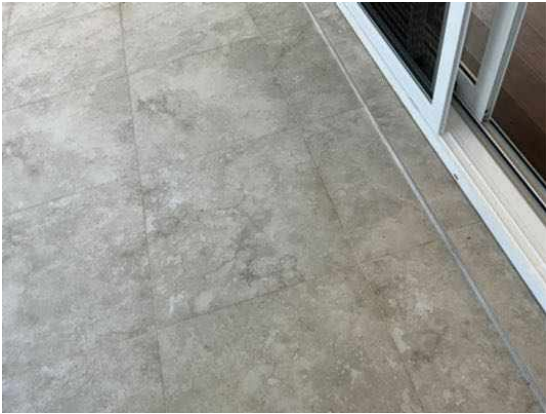
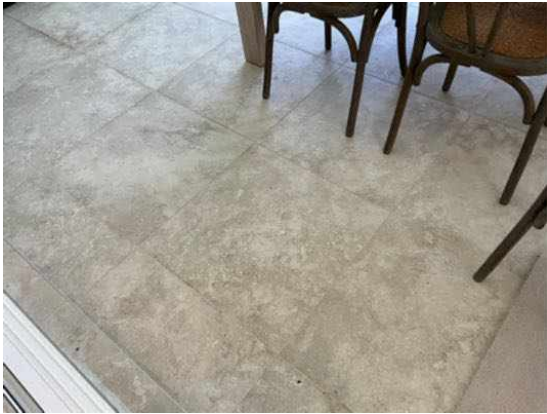
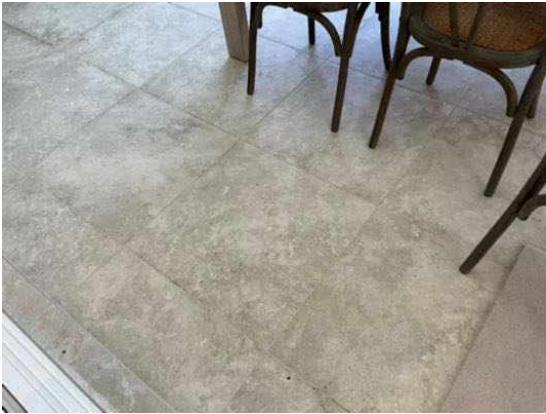
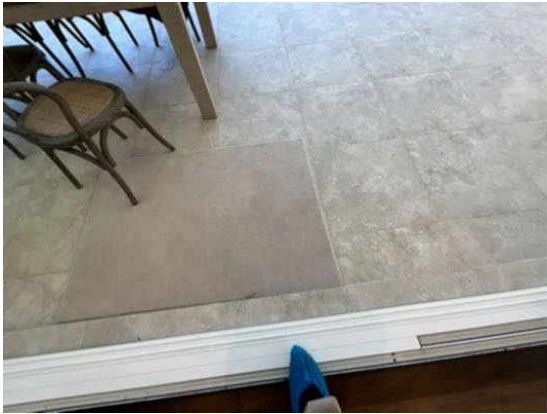
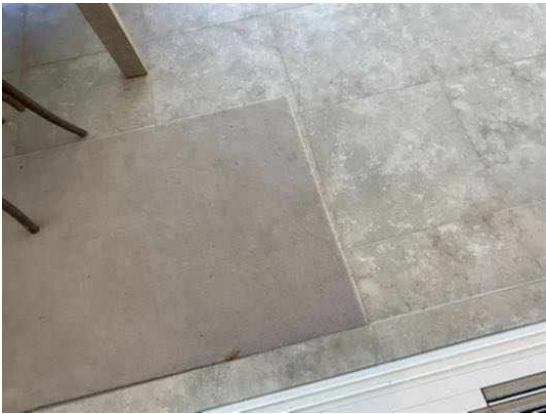
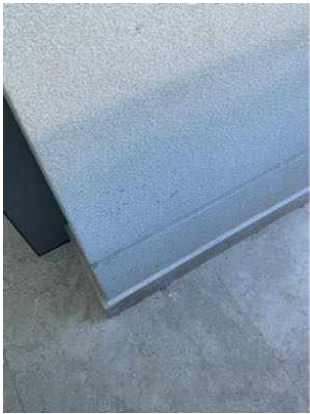
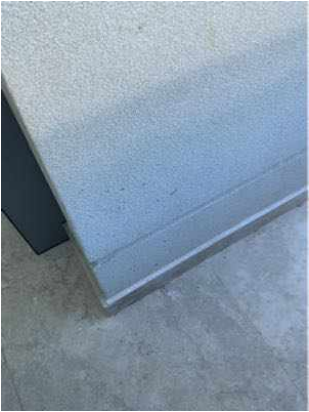
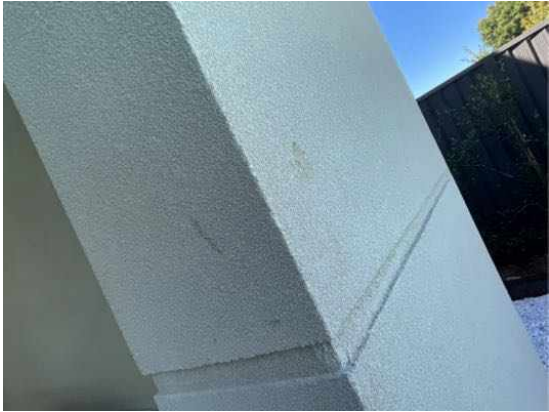
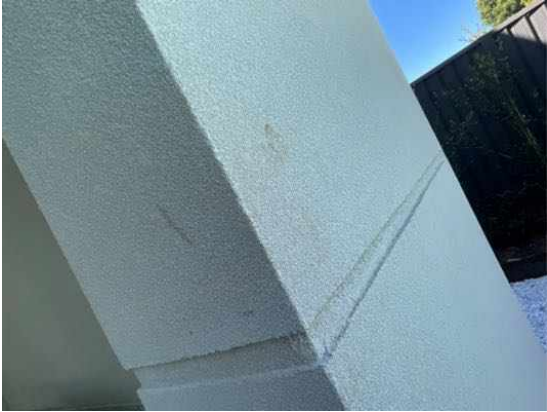
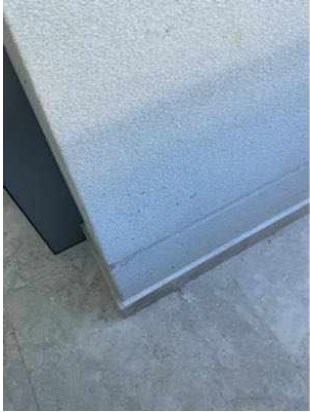
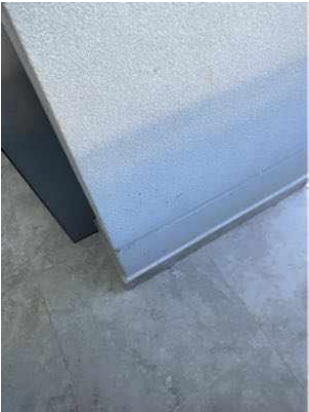
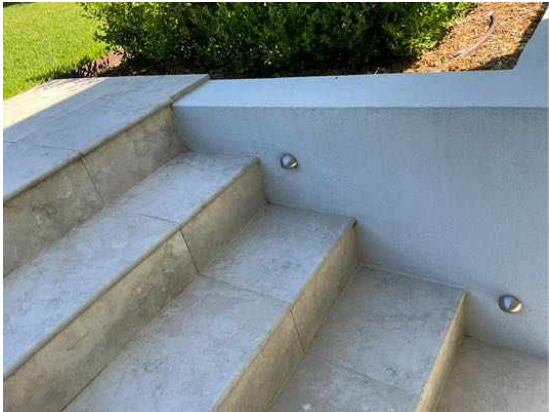
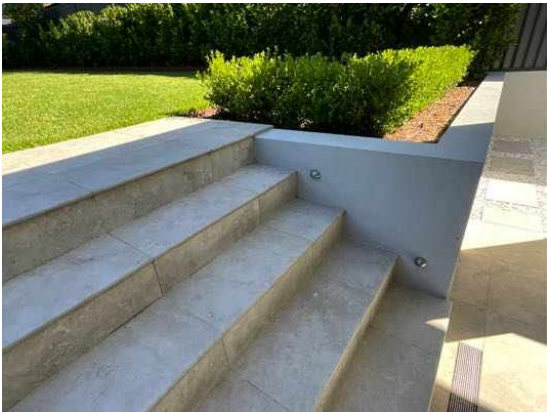
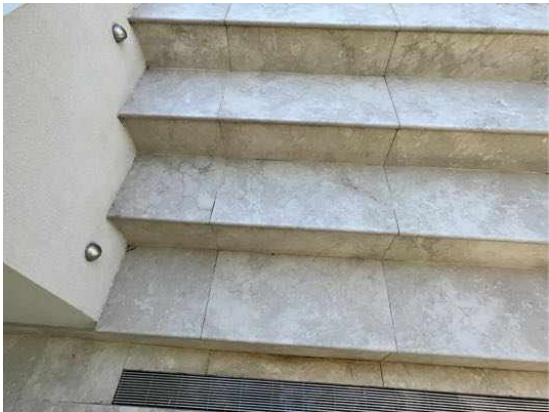
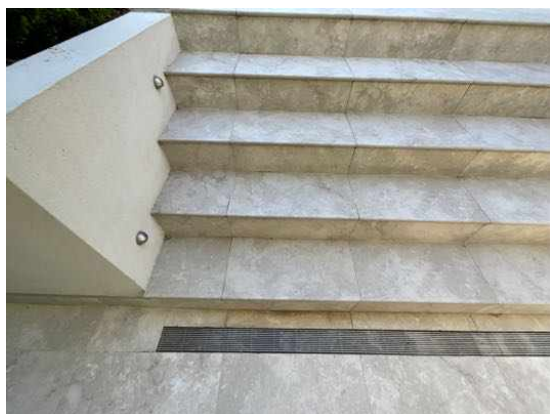
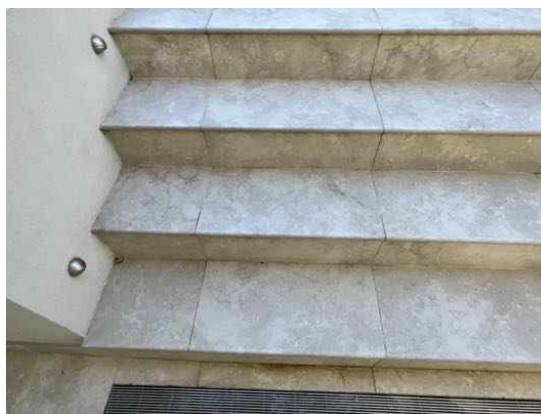
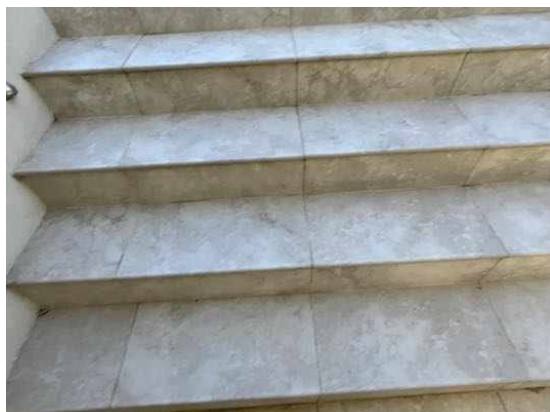
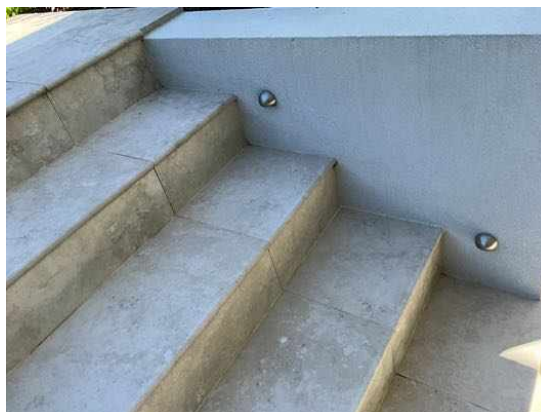
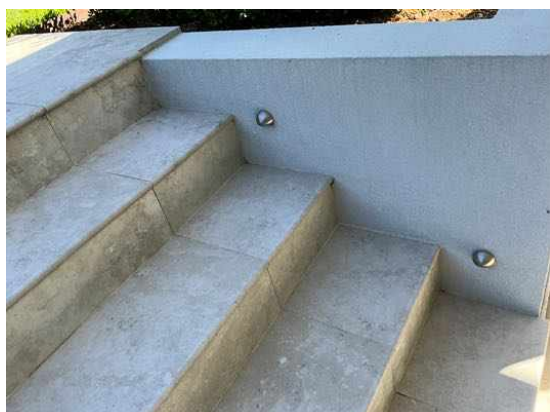
Defects 3.12

Building:	Main Building
Location:	All Areas
Finding:	Cleaning required
Information:	It was observed that the house requires cleaning.

Works are defective where windows are not clean, floors are not swept, mopped or vacuumed as appropriate, tiles, sinks, basins, baths, windows or any other area throughout the property are not cleaned, and shelving, drawers and cupboards are not ready for use not cleaned and ready for use at handover.

Building sites are defective if they are not clear of building debris.

This is to be addressed prior to handover.

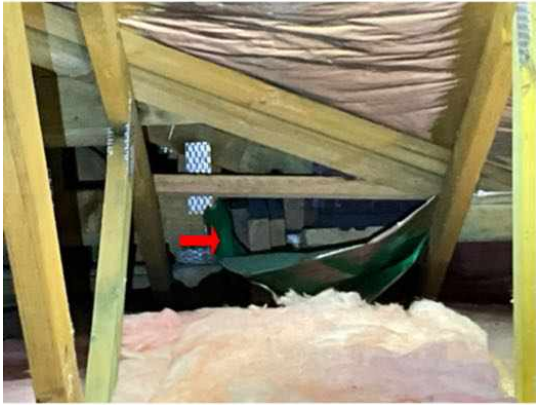
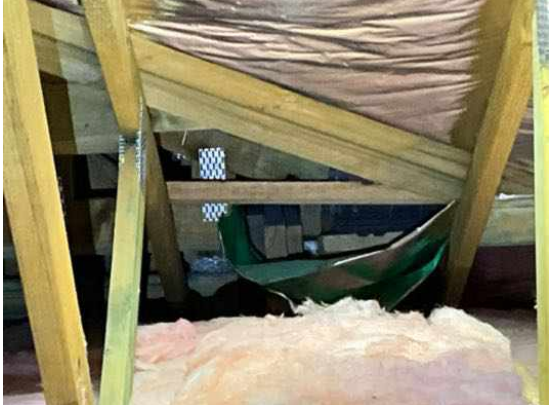
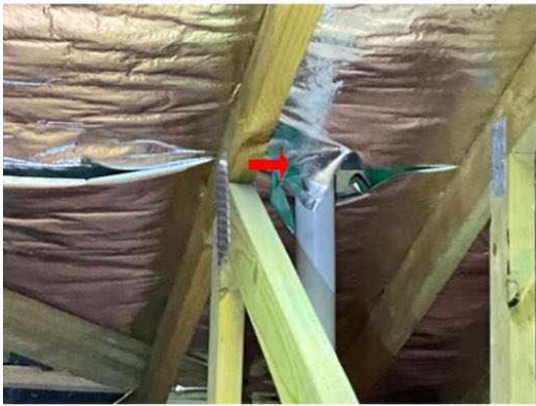
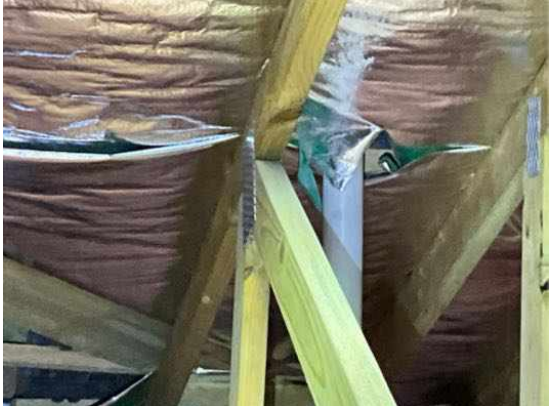
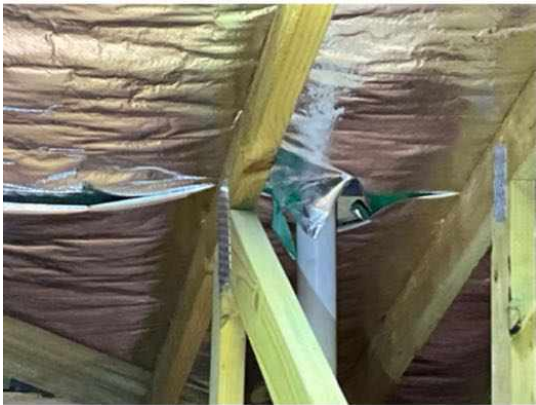
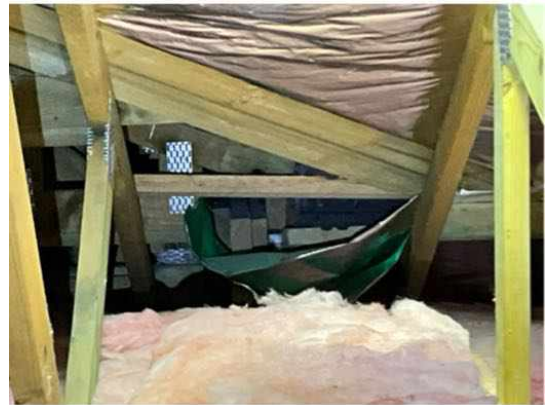
Defects 3.13

Building:	Main Building
Location:	Roof Void
Finding:	Sarking - substandard installation
Information:	The sarking in the roof cavity is not properly covering some joints and is not overlapping in other areas, indicating substandard installation.

****Risk:**** Improper sarking installation can lead to inadequate moisture and thermal protection, resulting in potential water damage, reduced energy efficiency, and increased susceptibility to mold growth.

****Recommended Action:**** A professional roofer should be engaged to re-install or

repair the sarking to ensure it is properly covering all joints and correctly installed, providing adequate protection for the roof structure.
