Building Inspection Report

Inspection Date: Wed, 4 Feb 2026

Property Address: 23 Craighlands Ave, GORDON, NSW, 2072,
Australia

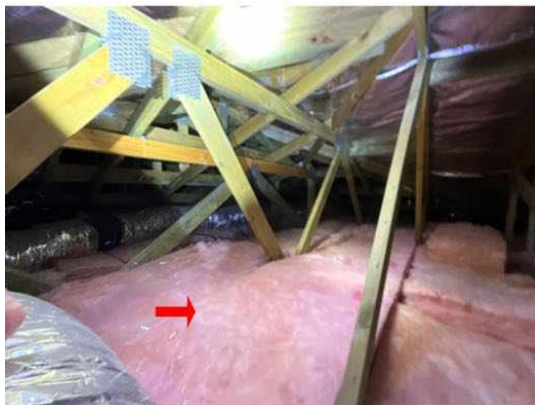
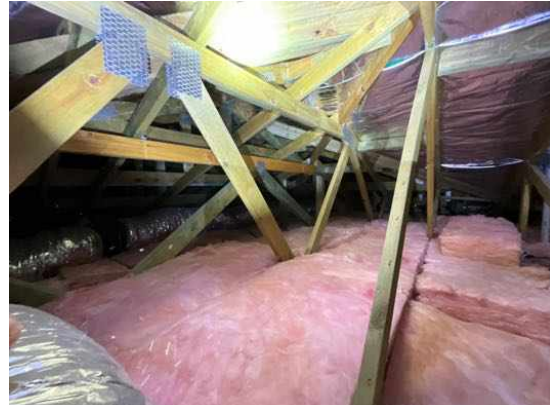
Defects 3.14

Information: Sections of insulation in the roof void have been poorly installed or moved from their original position and are covering down light fittings. While the down lights have been fitted with appropriate protective covers, the presence of this insulation creates a potential fire hazard.

Any insulation within the vicinity of down light fixtures should be moved and re-applied to more appropriate sections of the roof void, thus ensuring the area is fire-safe. An insulation contractor should be appointed as soon as possible to perform any necessary works as required.

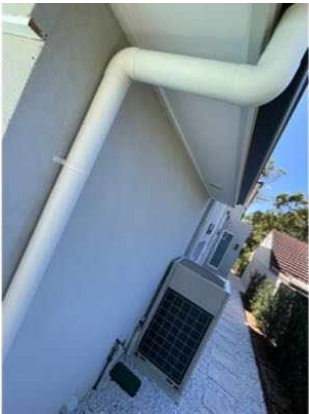
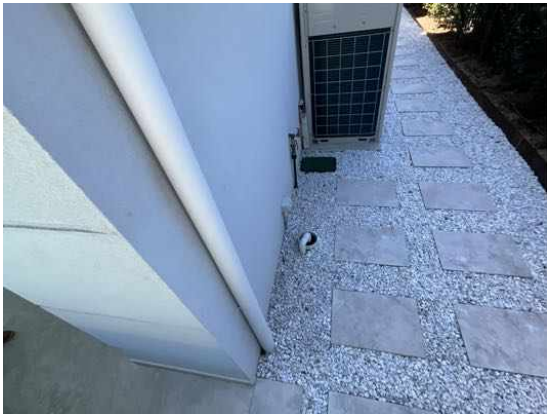
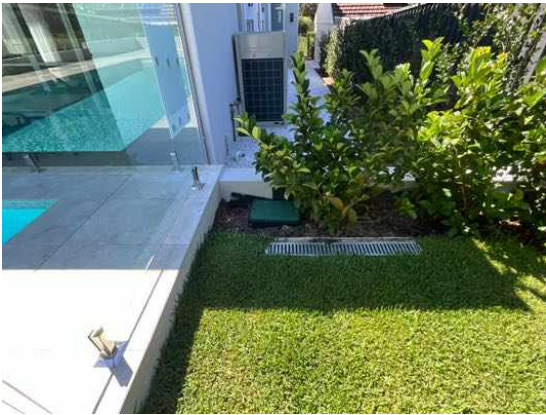
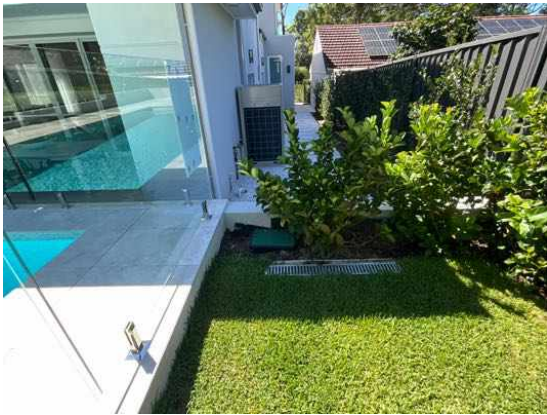
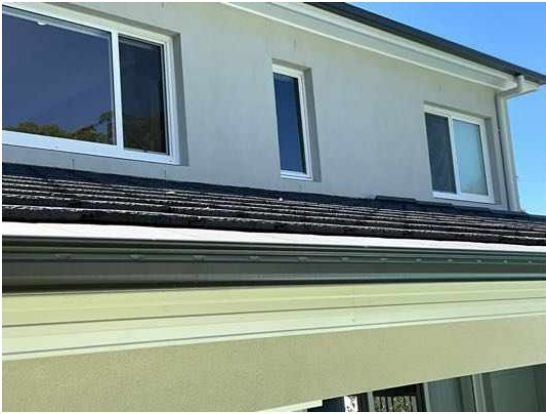
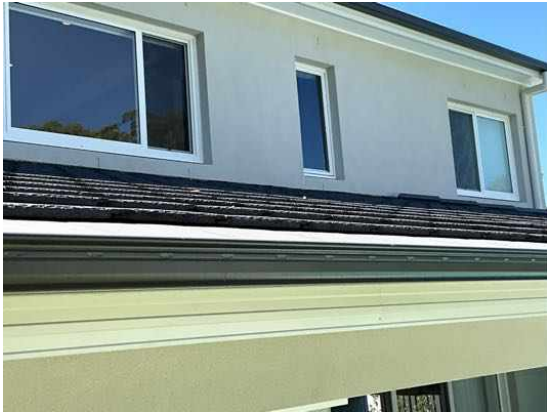
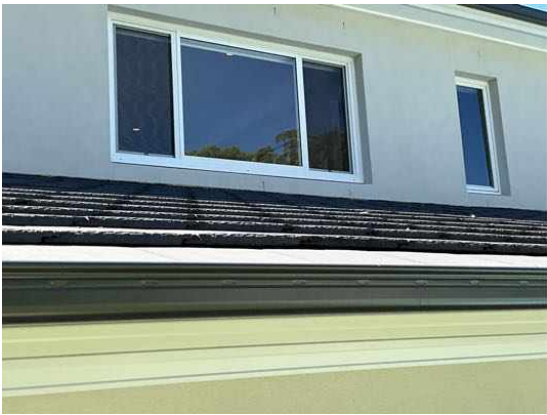
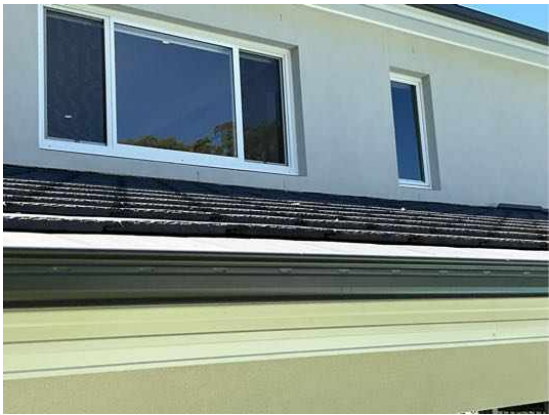
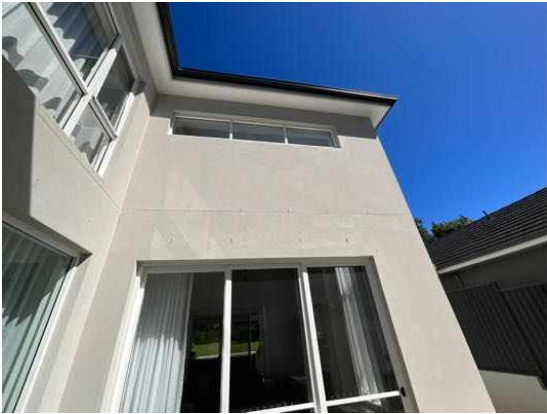
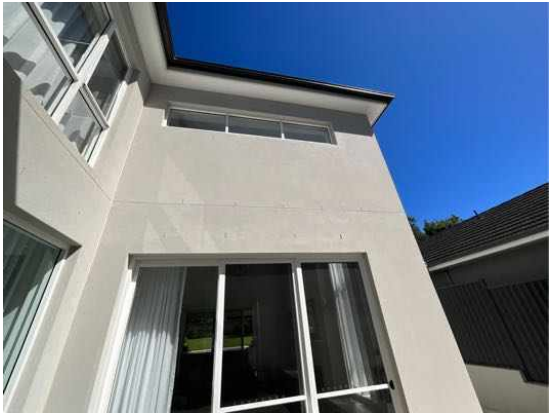
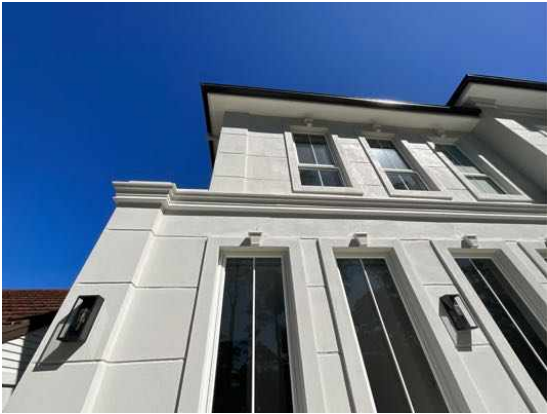
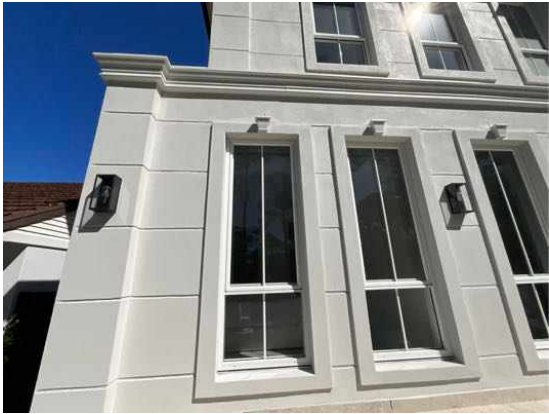
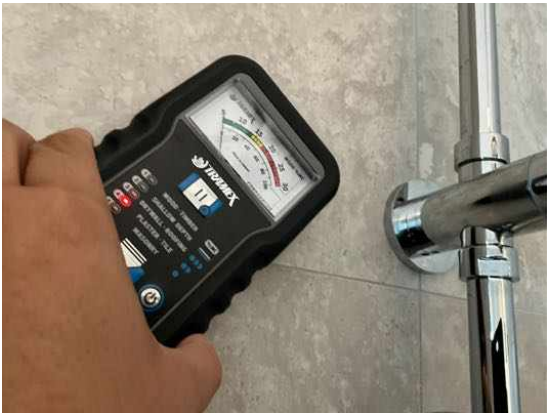
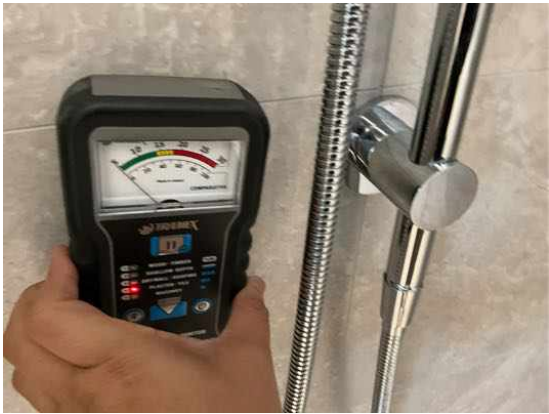
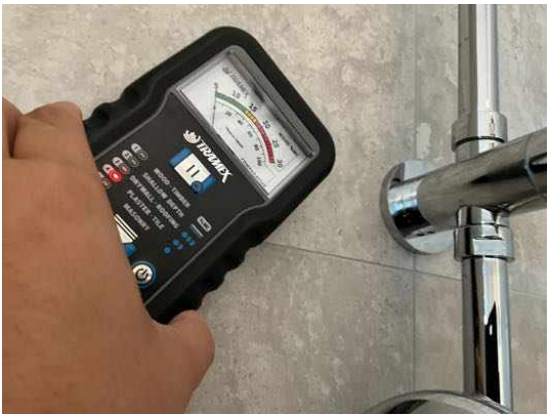
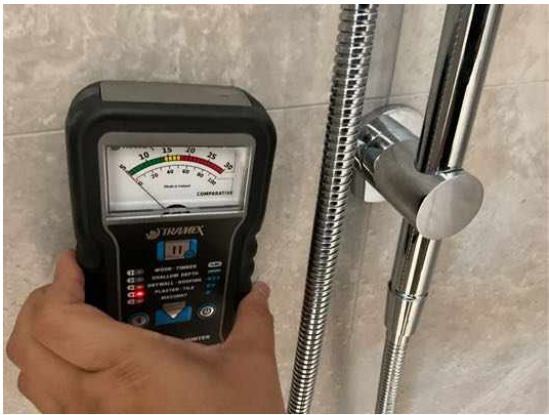
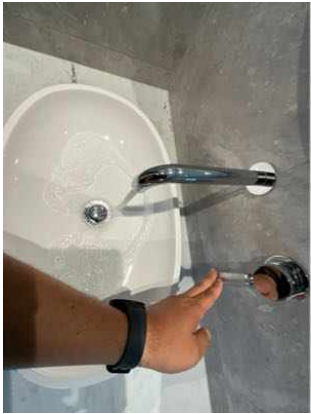
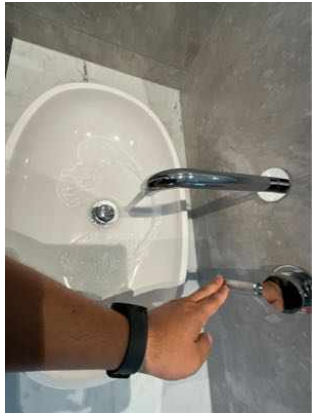
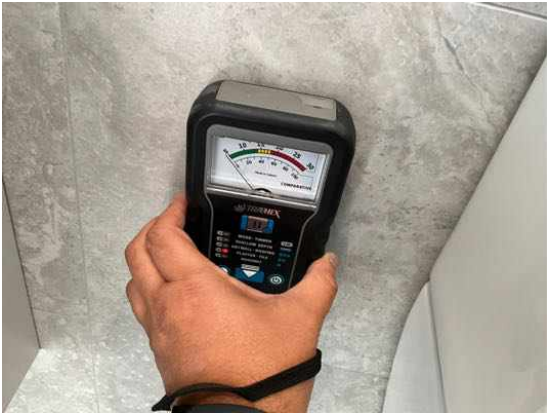
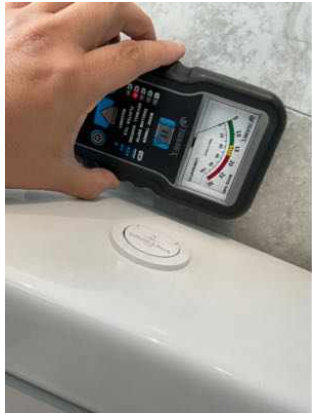
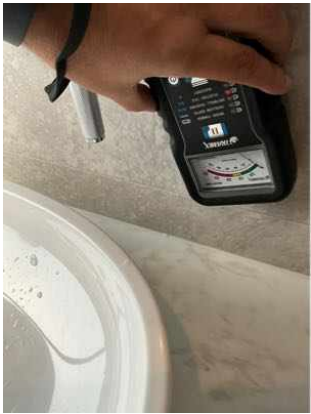
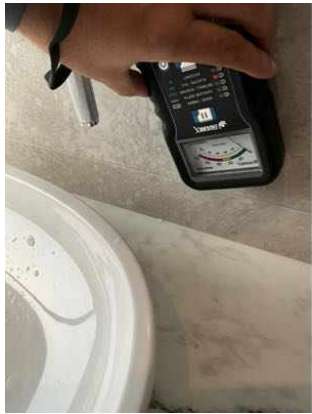
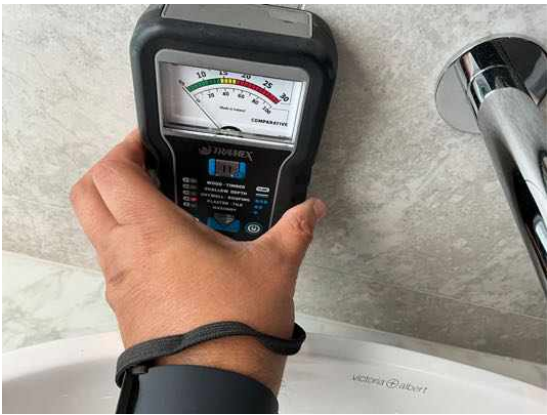
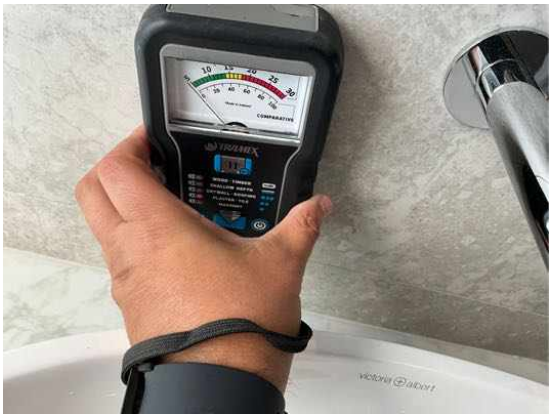
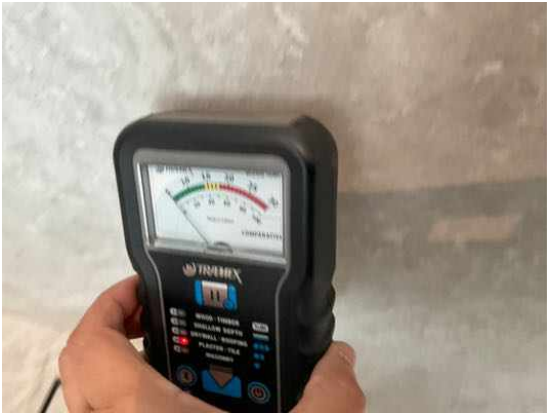
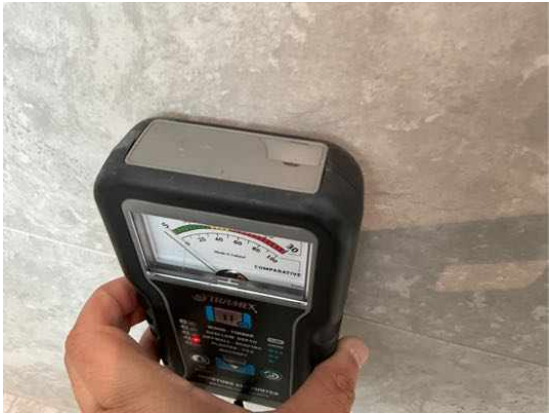
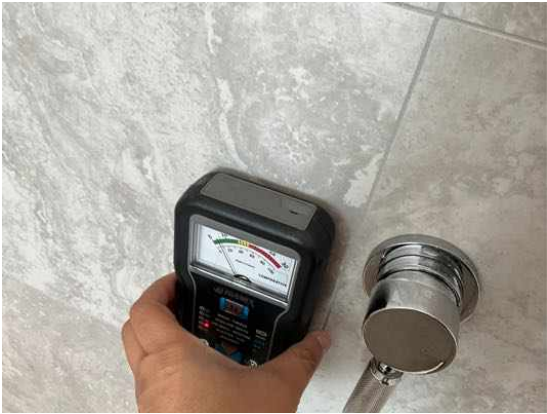
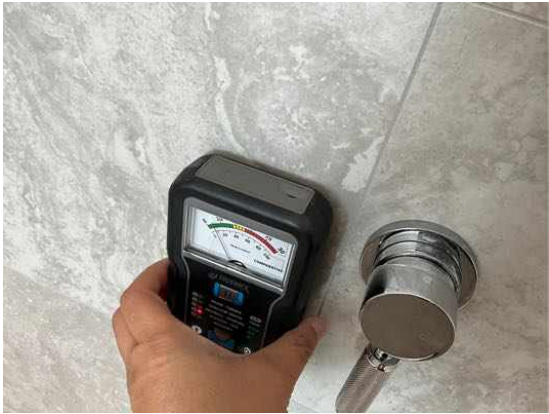
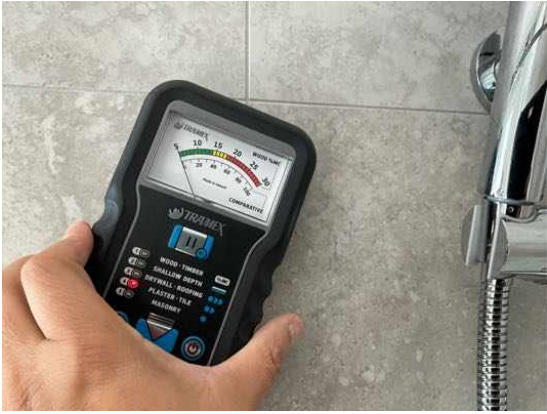
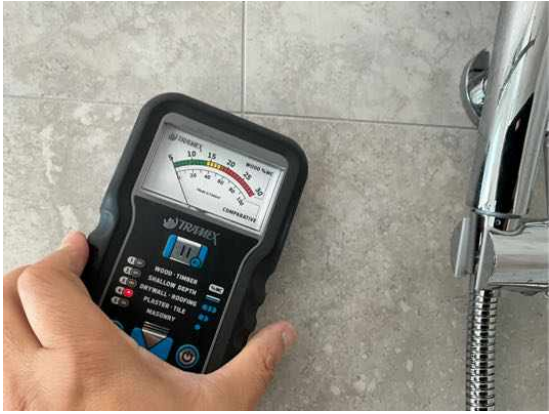
Building: Main Building
Location: All Areas
Finding: Additional Photos
Information: Additional photos are provided for your general reference

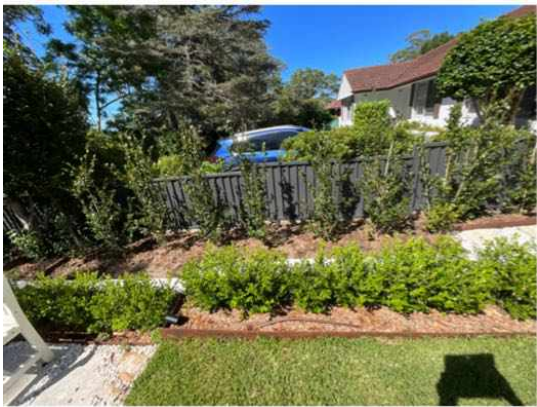
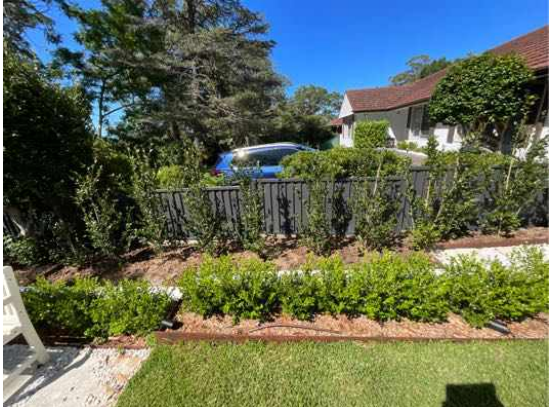
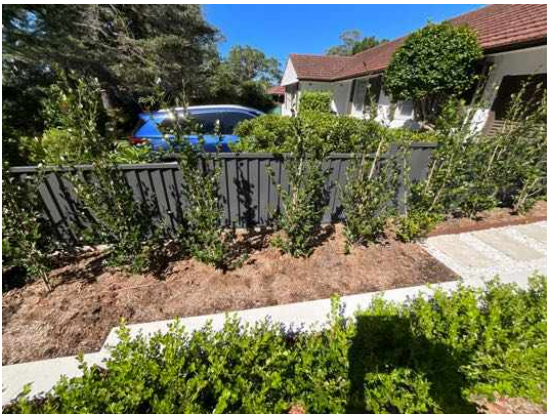
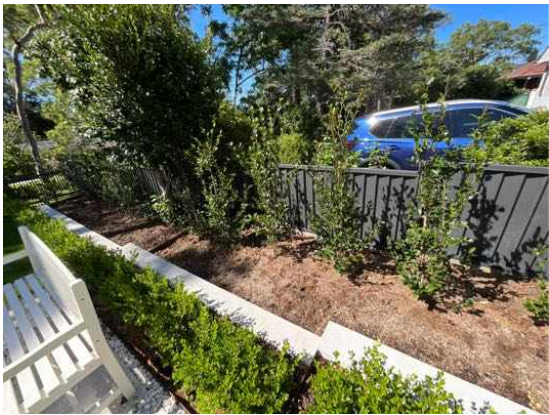
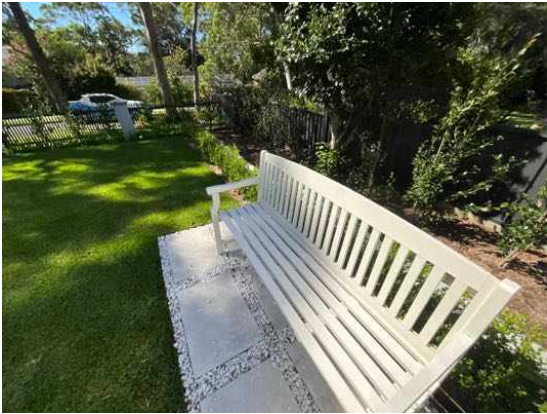
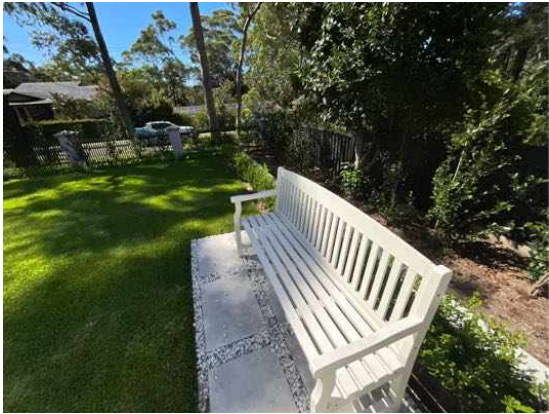
Building: Main Building
Location: All Areas
Finding: Additional Photos - Obstructions and Limitations
Information: These photographs are an indication of the obstructions and limitations which impeded full inspection of the property at the time of inspection. These obstructions can hide an array of defects and should be removed to allow full inspection to be carried out. A re-inspection is recommended once the areas are made accessible.
