## Building Inspection Report

Inspection Date: Tue, 17 Feb 2026

Property Address: 6 Avenza St, Mentone VIC 3194, Australia

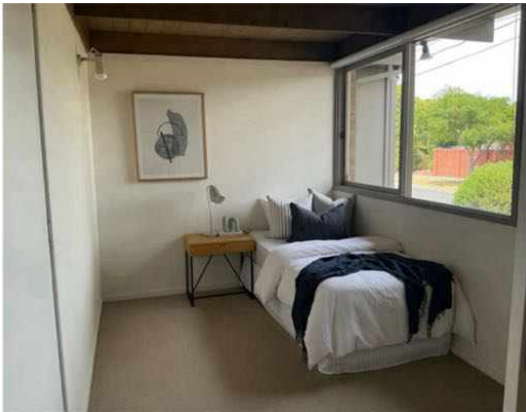
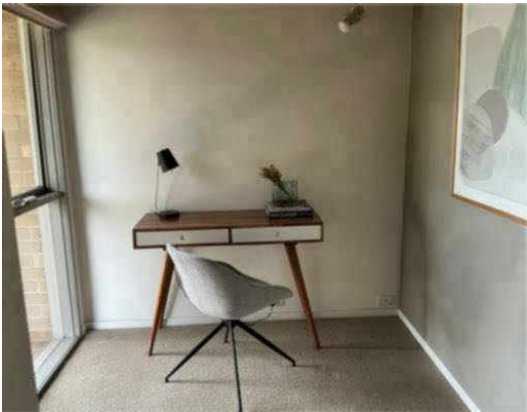
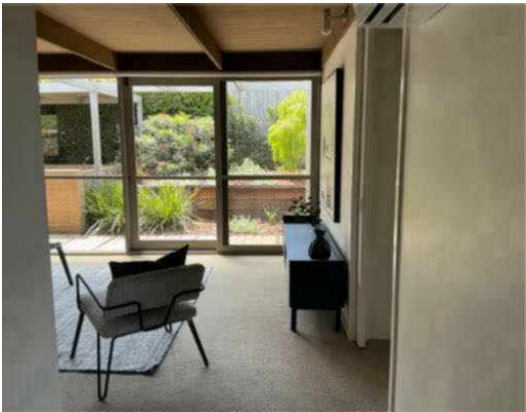
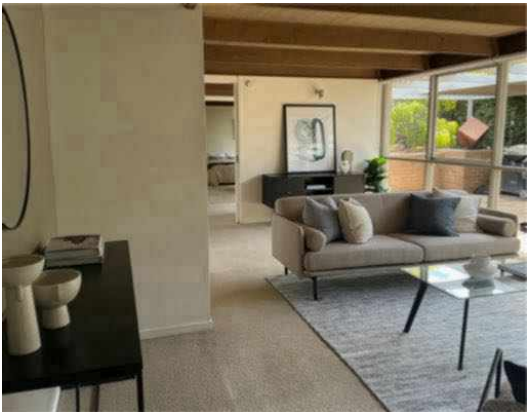
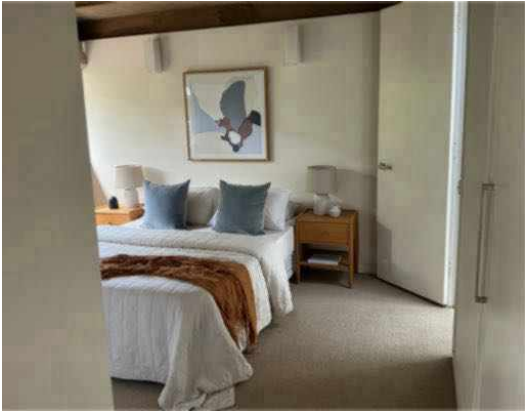
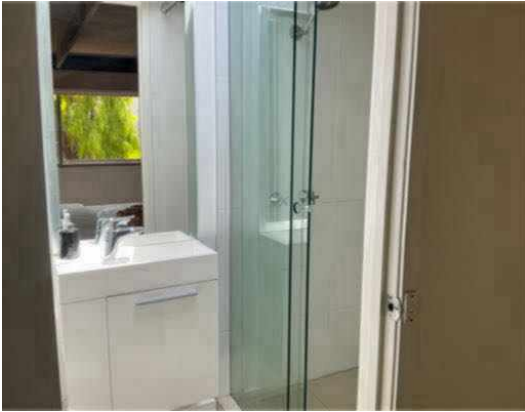
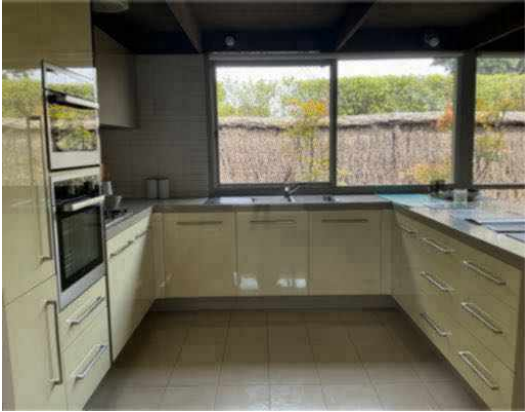
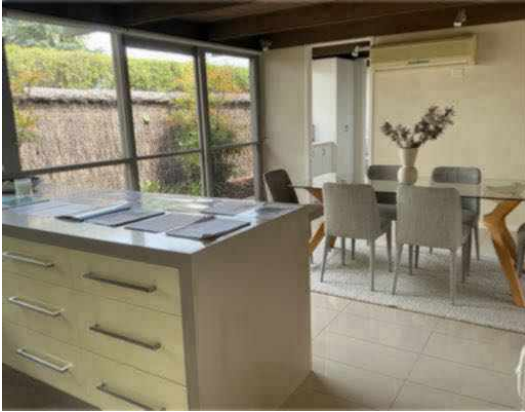
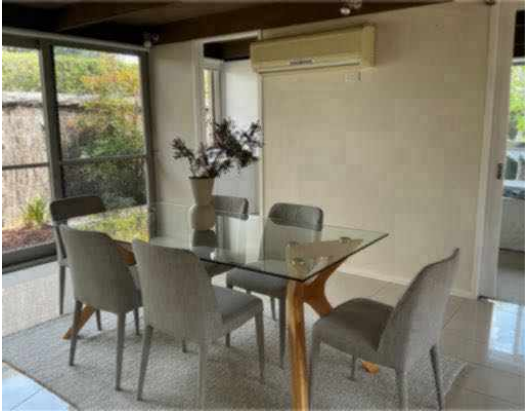
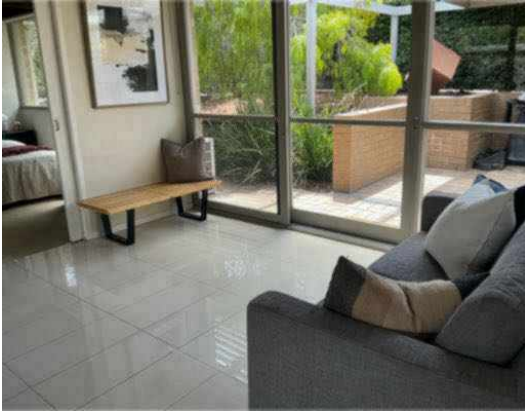
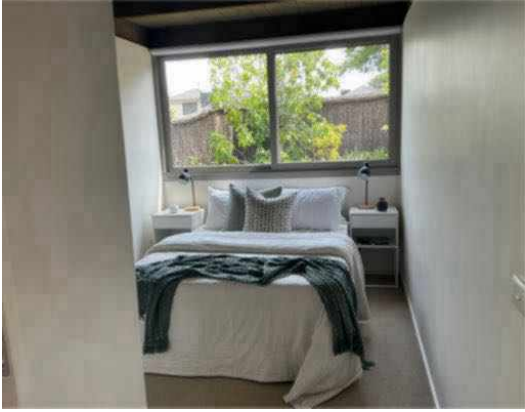
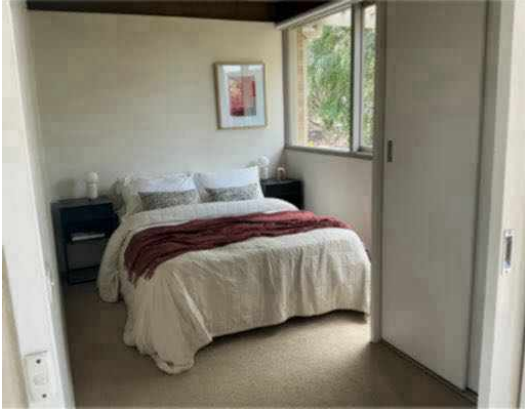
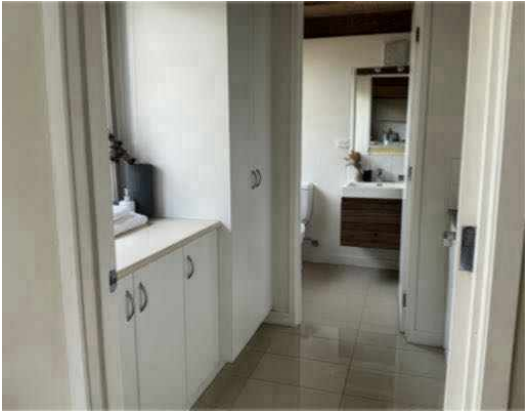
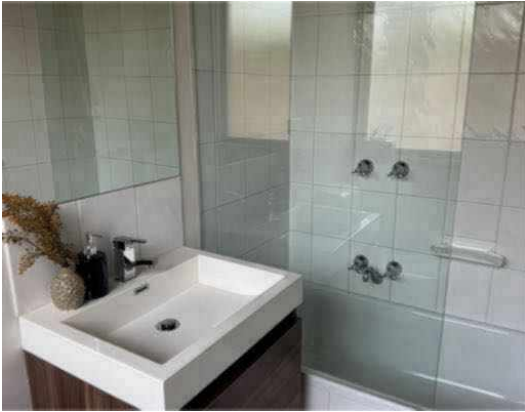
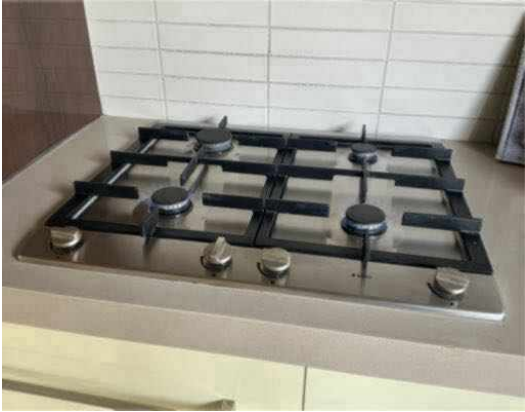
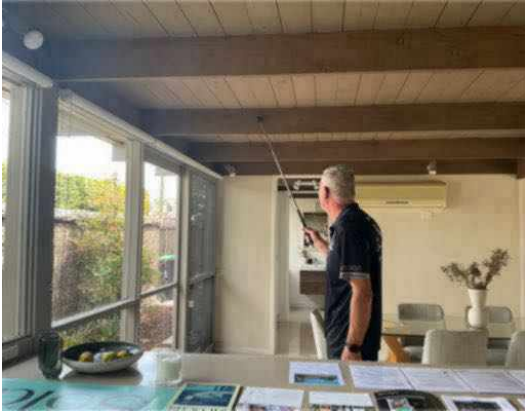
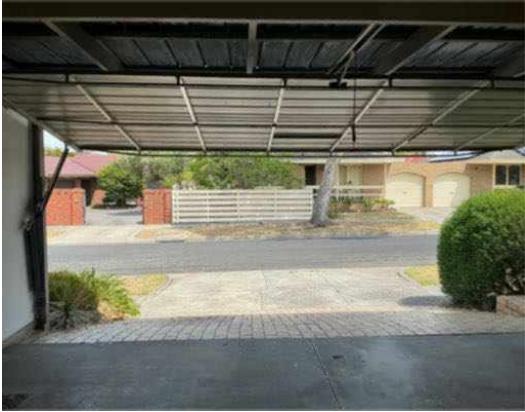
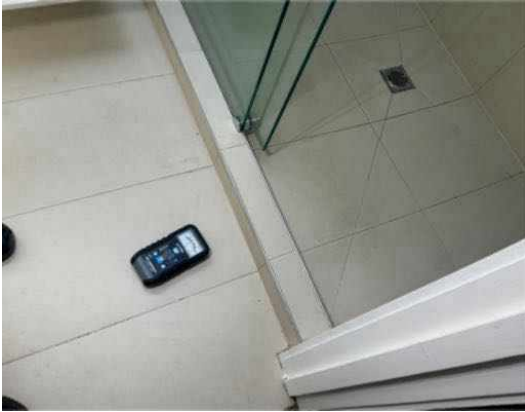
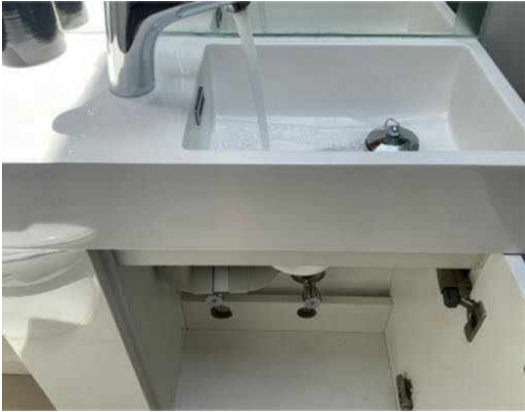
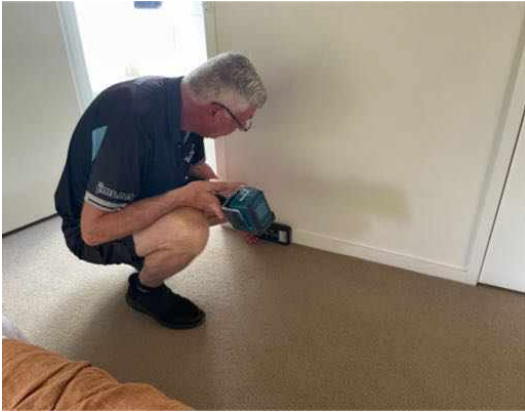
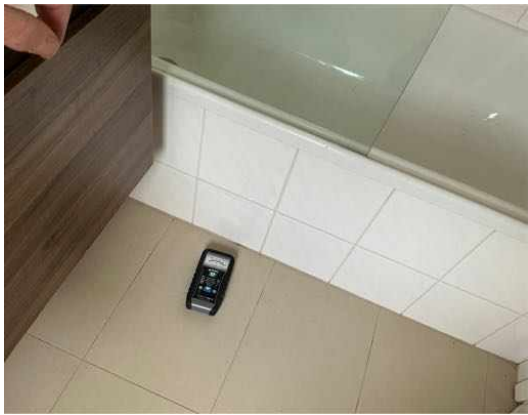
Building: Main Building  
Location: All Areas  
Finding: Additional Photos and Obstructions and Limitations  
Information: These are additional photographs and photographs of the obstructions and limitations inside and outside (furniture, landscaping etc) which may impede full inspection of the property at the time of inspection. These obstructions can hide an array of defects and may be removed to allow full inspection to be carried out. A re-inspection may be made if clients require once the areas are made accessible.

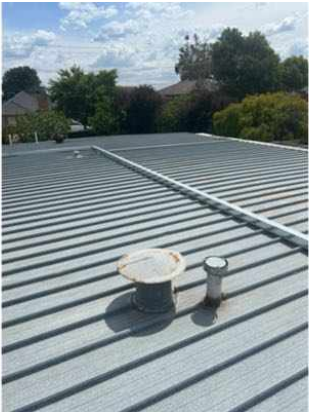
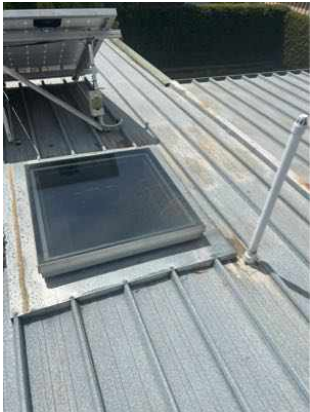
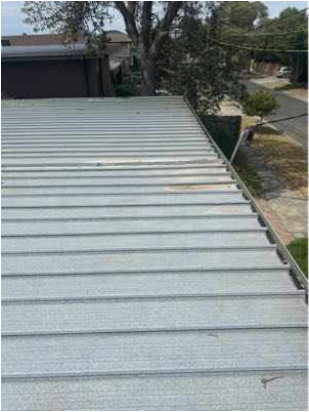
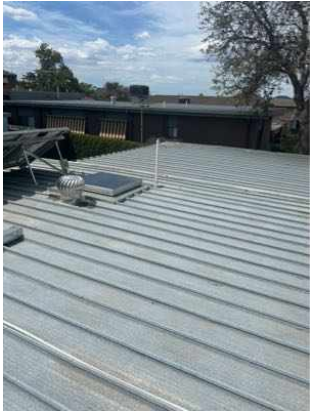
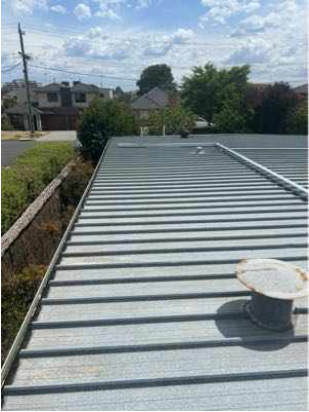
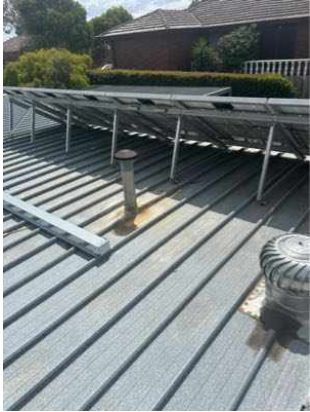
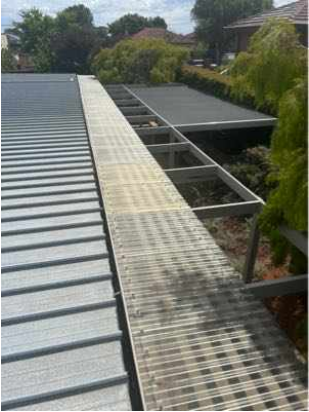
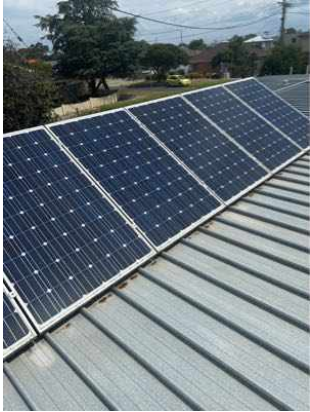
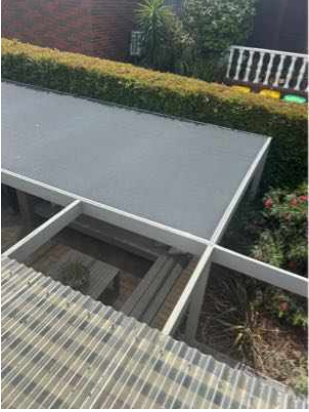
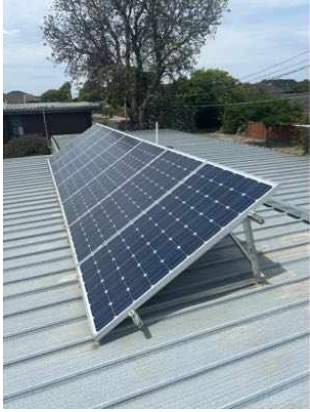
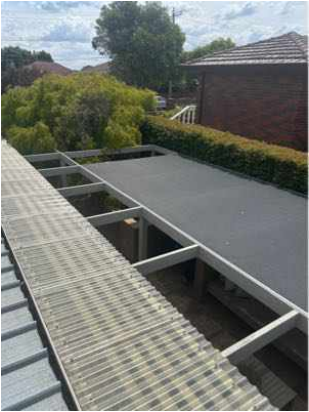
Building: Main Building  
Location: All Areas  
Finding: Additional Photos  
Information: Additional photos are provided for your general reference
