# Building and Timber Pest Inspection Report

Inspection Date: Wed, 1 Apr 2026

Property Address: 9 Myall Ct, Golden Grove SA 5125,  
Australia

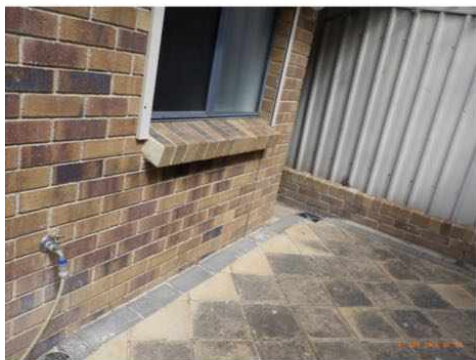
#### Finding 2.01

This bridges the required inspection zone and compromises the intended moisture management system. The minimum clearance of approximately 75 mm between the finished paving level and the slab edge / DPC has not been maintained, restricting visual inspection and allowing moisture to track across the DPC into the structure.

In addition, obstruction of weep holes prevents adequate drainage and ventilation of the wall cavity, increasing the likelihood of moisture build-up, damp ingress, and subsequent deterioration of masonry, internal linings, and adjacent building elements.

This condition also presents a heightened risk of concealed termite ingress.

Rectification is required to reinstate an inspection zone by lowering or removing the paving to achieve a minimum 75 mm clearance below the DPC and ensuring all weep holes are fully exposed and operational. Ongoing maintenance of this clearance is essential, and a licensed builder should be engaged to assess and carry out the required remedial works.

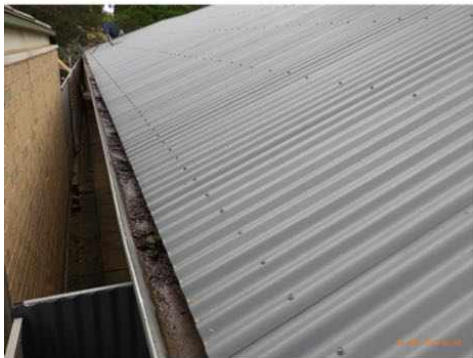
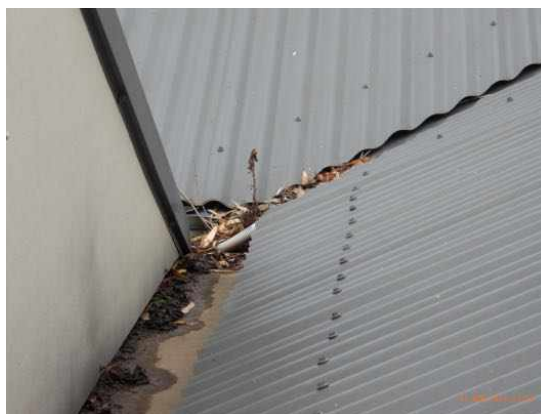
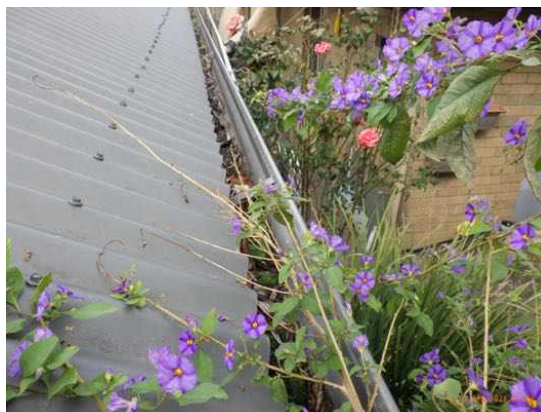
## Finding 2.02

Building:	Building 1
Location:	Roof Exterior
Finding:	Gutters - Blocked

Blocked gutters are likely to lead to high levels of moisture in the affected areas. Such moisture will not only cause rust and decay of the associated building materials, but can also provide conditions that are conducive to termite and timber pest activity. Blockages in gutters should therefore be removed immediately to ensure dry conditions are maintained.

Consult a Licensed Plumber for further specific advice on remedial works that may be required. In the interim, it is highly advised that blocked gutters be removed by the homeowner or a general handyperson as a matter of urgency.

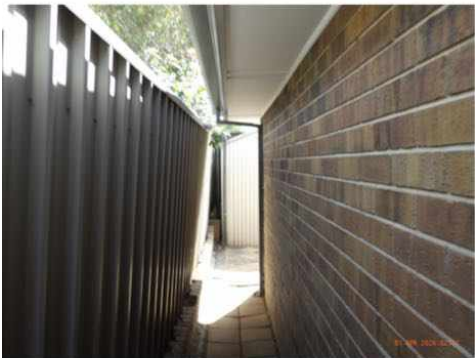
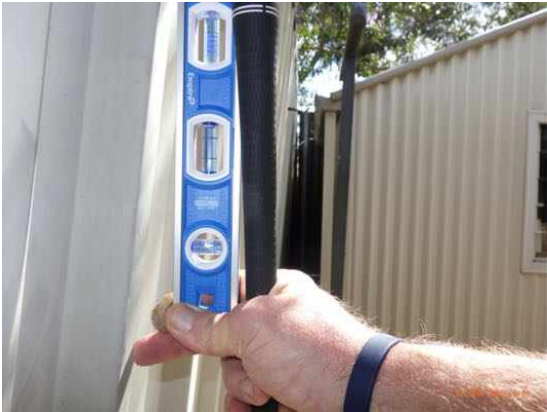
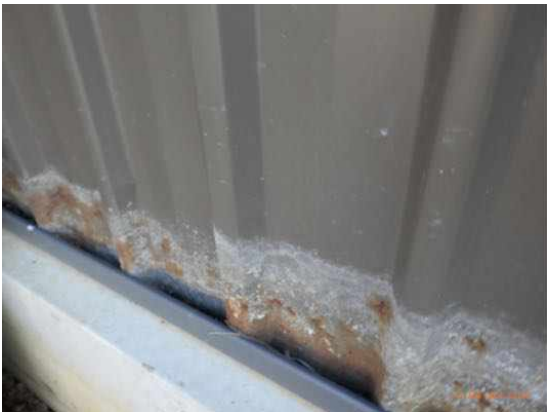
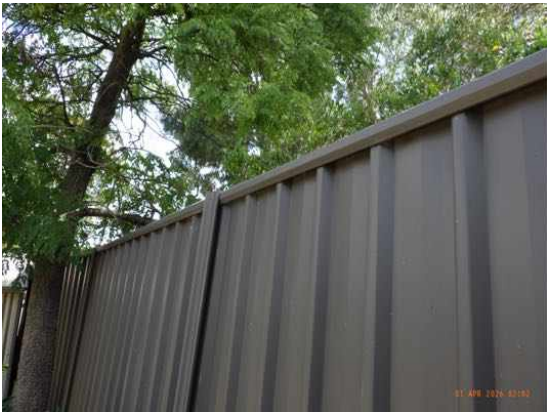
### Finding 3.01

Building:	Building 1
Location:	Yard - Back
Finding:	Fencing - Deteriorated
Information:	It was noted at the time of inspection that sections of the fencing throughout the property have deteriorated. Typically fencing deteriorates due to age and or wear, rot and or rust which is generally expected for a structure of this age, due to prolonged exposure to weather conditions. Sometimes inadequate installation or maintenance can be to blame.

If left unattended, it is likely that further damage will occur. It is suspected that repair of several elements of the fencing may be required however replacement may be a consideration of the client also.

A licensed fencing contractor should be appointed to provide further advice and perform rectification works as necessary.

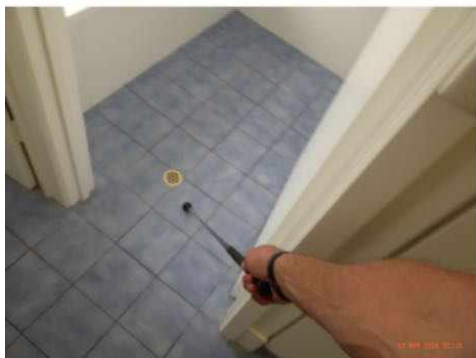
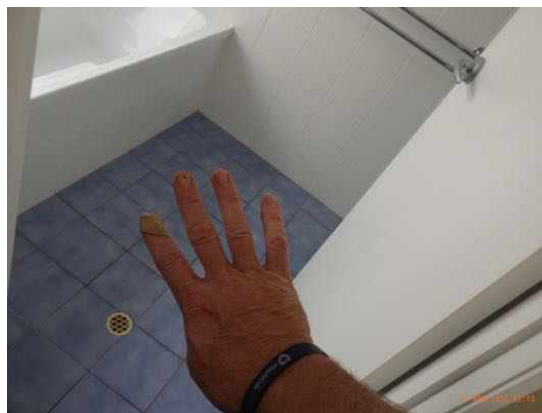
### Finding 3.03

Building:	Building 1
Location:	Bathroom
Finding:	Tiles - Drummy sealant and grout ok.
Information:	Drummy tiles were identified to approximately 40% of the floor tiles to the bathroom at the time of inspection.

The term 'drummy' refers to tiles that have become detached from their fixing, despite otherwise being in relatively good condition, or sometimes they get laid onto dust during the building process and never really form a good bond. Such defects are generally caused by physical or moisture damage to the area or poor workmanship during the building process.

As no damage to tiles or grout was evident at the time of inspection further monitoring is recommended and should deterioration to the tiles become evident a licensed tiling contractor should be appointed to required repairs at the discretion of the client.

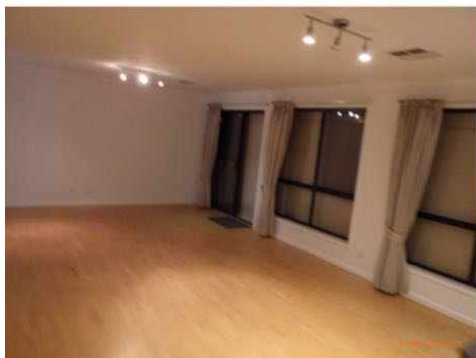
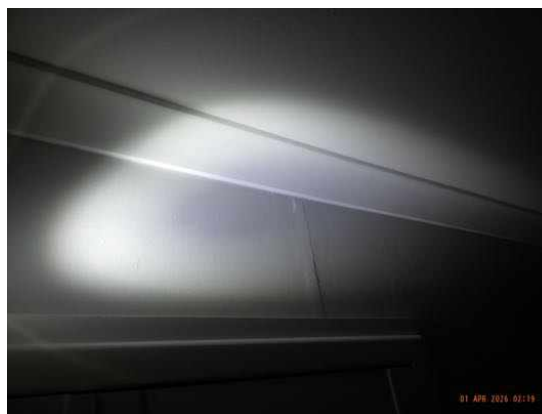
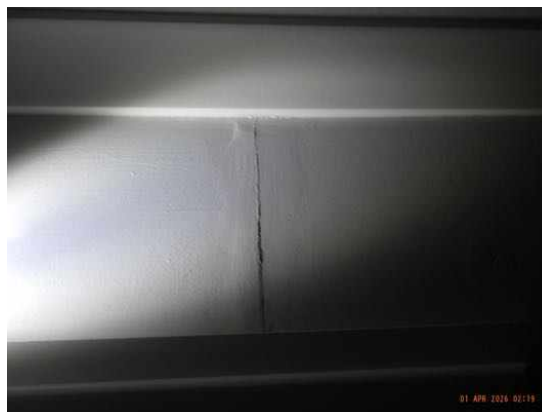
### Finding 3.04

Building:	Building 1
Location:	All Internal Areas
Finding:	Cracking - Damage Category 1 - Fine (up to 1mm)
Information:	There were fine cracks evident to the walls and ceilings throughout the dwelling at the time of inspection.

Although fine cracks are quite noticeable, they are often only considered to be an appearance defect, and usually do not indicate any structural damage. Generally, the cause of a fine crack is indicative of a separation between building materials and finishes (e.g. paint, plaster, etc.) along joints.

Cracking of this nature can generally be repaired with minor sanding, filling and/or repainting. Such works should be performed by a qualified painter or a general handyman.

Monitoring of all cracking should be conducted frequently. Always contact a building inspector should cracks widen, lengthen, or become more numerous.

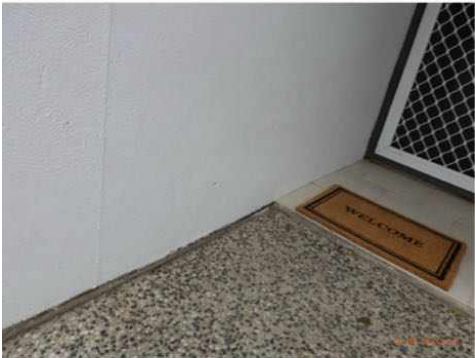
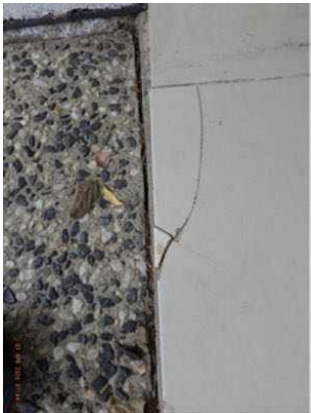
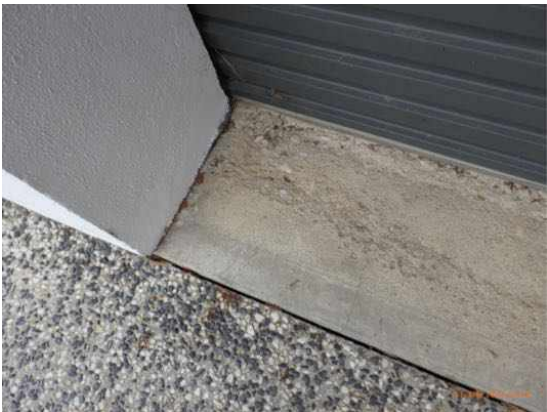
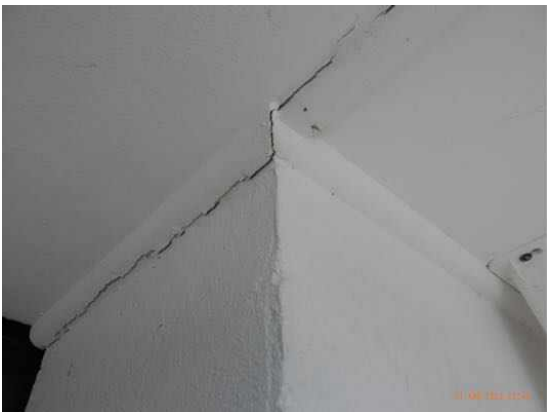
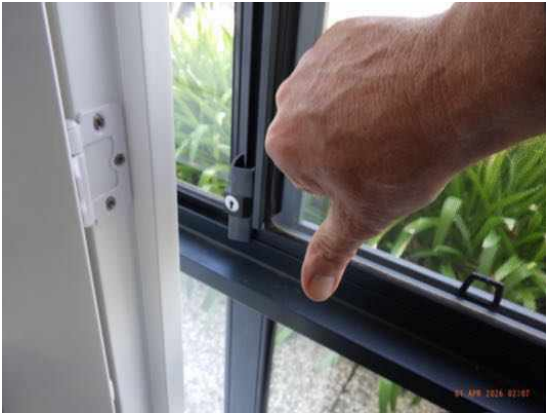
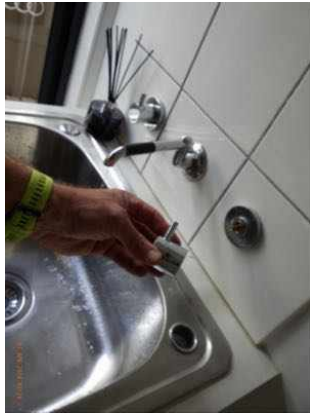
### Finding 3.05

Building:	Building 1
Location:	All Areas
Finding:	Minor defects present
Information:	Minor defects were evident throughout the dwelling at the time of inspection, which are consistent with normal wear and tear and considered appropriate for a property of this age.

- Eaves shows signs of minor movement and sag.
- Concrete deteriorating to garage entry
- Crack to front porch tile
- Laundry tap loose
- Window lock not operating - spring gone
- Several doors rubbing throughout home

be addressed as part of routine and ongoing property maintenance to prevent further deterioration. Repairs and maintenance works should be carried out by appropriately licensed and qualified tradespeople to ensure the continued serviceability and longevity of the dwelling.

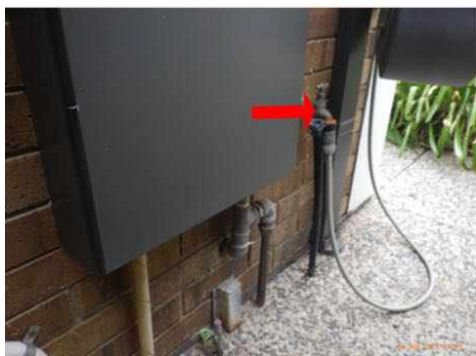
### Finding 6.02

Building:	Building 1
Location:	Front Elevation
Finding:	Air conditioner and or external tap - No drainage
Information:	Moisture around the perimeter of the building should be minimised to ensure that the area is kept dry and stable which in turn reduces the risk of water damage and termite infestation.

There appears to be no drainage points set up to the air conditioning unit, and or the external tap. While this is not a legal requirement it is recommended to reduce the risk of moisture related issues and the creation of an environment conducive to termite activity.

It is recommended that a licensed plumber be appointed to set up drainage in order to prevent such an environment from being created.

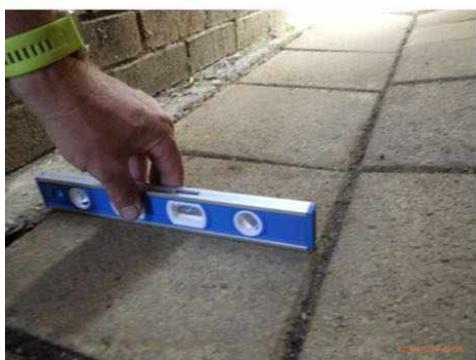
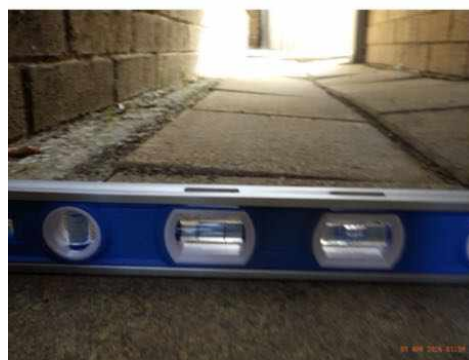
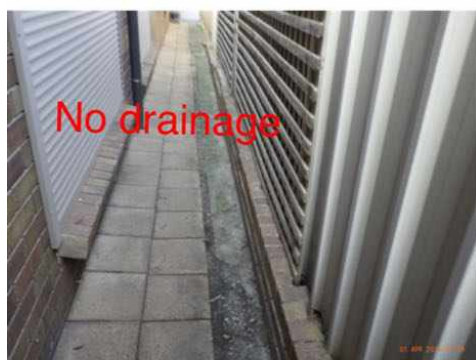
### Finding 6.03

Information: The perimeter paving or ground levels were found to have an inadequate slope away from the adjoining building structure, creating potential for water pooling in this area.

This standard ensures that excessive moisture does not pool around the base of building structures, which creates potential for water and structural damage, as well as making the area susceptible to termite and timber pest activity.

Where paving or ground levels do not have adequate fall, a licensed paving contractor should be appointed to install or remove and re-level pavement.

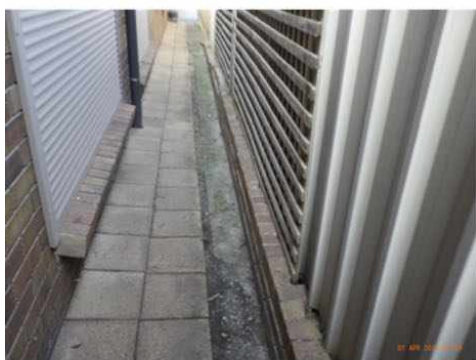
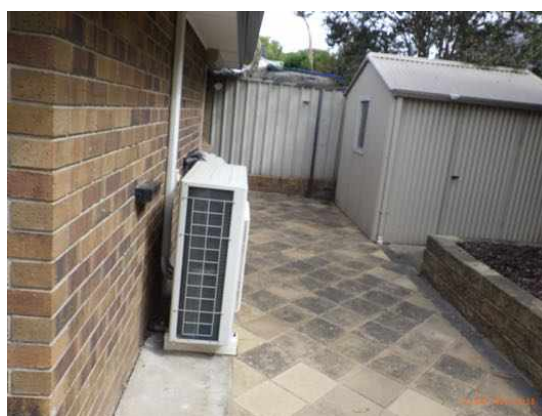
### Finding 6.04

Building:	Building 1
Location:	Yard - Side
Finding:	Site drainage - Inadequate
Information:	The site drainage in this area was found to be inadequate at the time of inspection, creating potential for subsequent water damage to associated building elements.

It is important that water does not lie against the base of walls; surrounding paths and ground levels should be sloped to drain water away from walls. Downpipes should not discharge stormwater onto lower walls or plinths. Stormwater should be carried away by large, regularly cleaned drains. Ground levels may need to be lowered to expose a buried DPC.

Where site drainage is inadequate, installation of an additional drainage may be required. A qualified plumber should be appointed to further inspect the property and perform any remedial works as necessary. Water damage and secondary defects are likely to occur if left unmanaged.

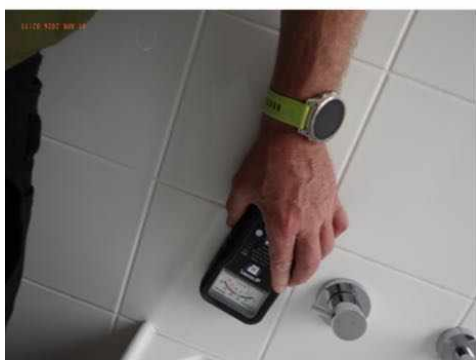
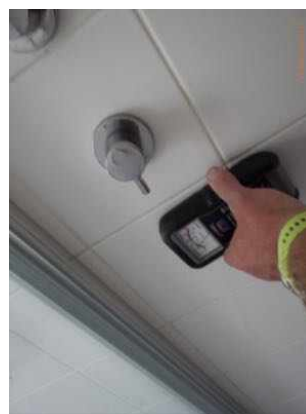
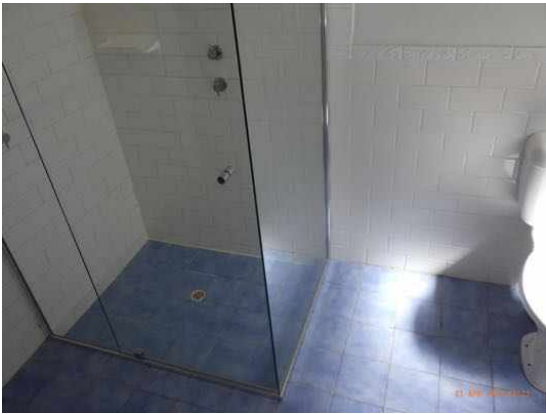
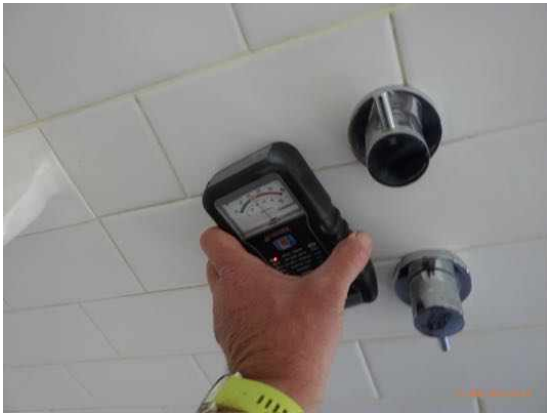
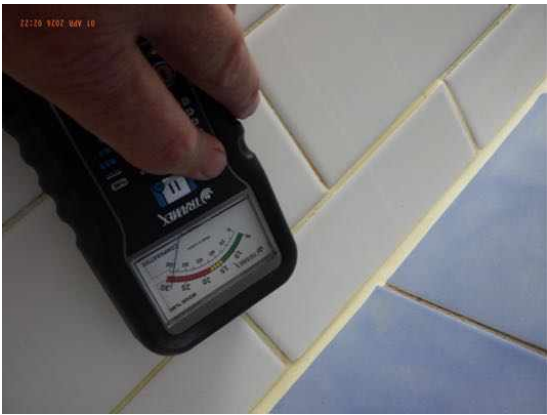
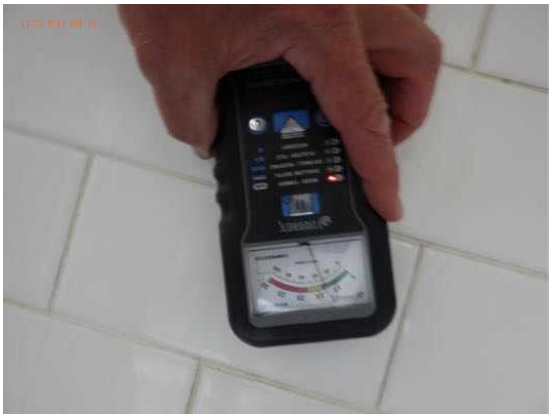
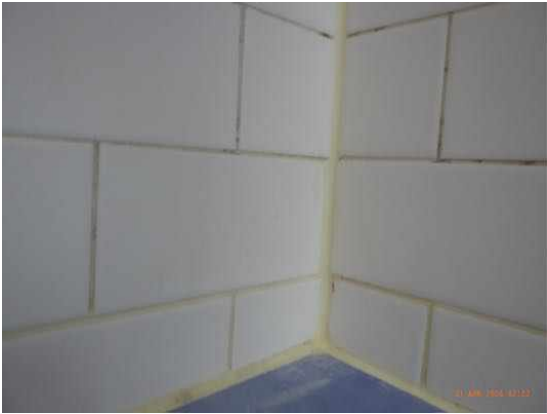
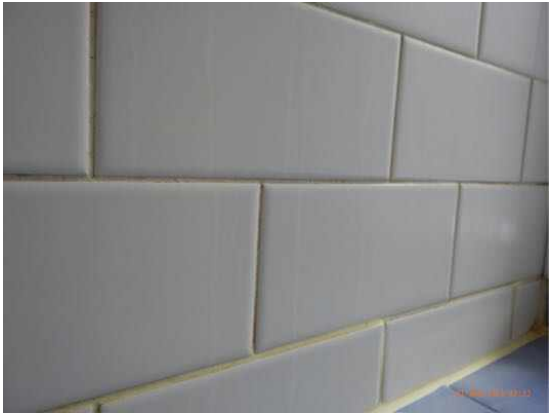
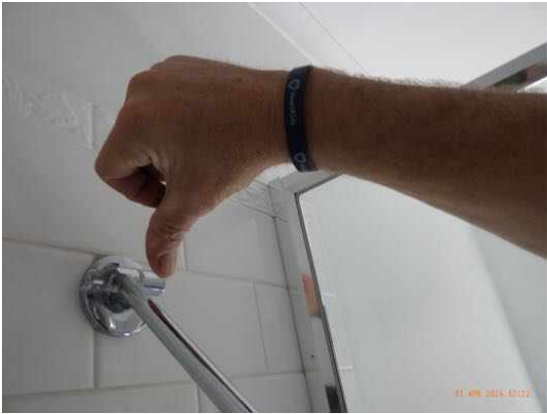
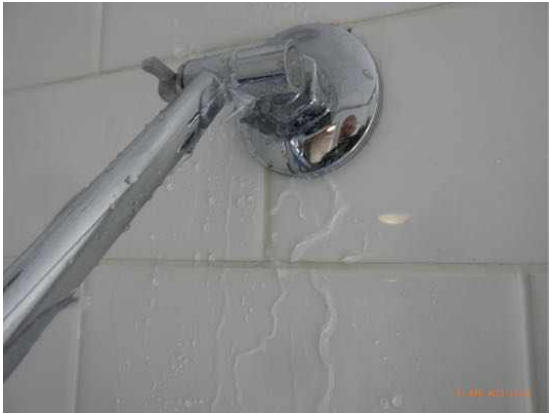
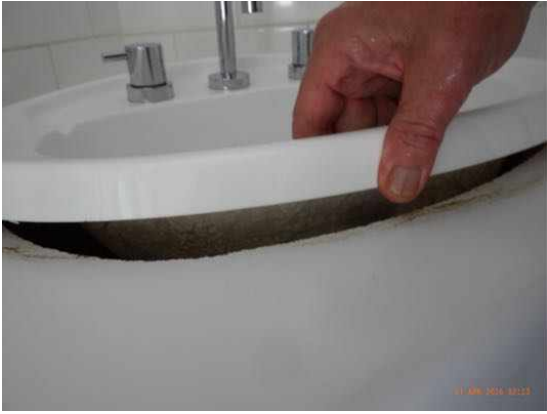
Finding: Shower damp and other minor issues  
Information: Multiple defects were identified to both bathrooms at the time of inspection, including deteriorated and missing grout to tiled surfaces, leaking showerheads, a loose and inadequately secured vanity unit, and an exhaust fan that was not operational.

There was a small area of localised high moisture reading evident to the ensuite bathroom. High moisture around timber building elements creates a perfect environment for termite activity and as such further investigation could uncover currently concealed defects.

Deteriorated grout allows water to penetrate behind tiled surfaces, increasing the risk of moisture ingress and concealed damage to wall and floor substrates, while leaking plumbing fixtures contribute to unnecessary water exposure and potential long-term deterioration.

The loose vanity unit presents a functional and durability concern, and the non-operational exhaust fan reduces ventilation, contributing to elevated moisture levels, condensation, and potential mould growth within the wet areas.

Repairs and replacement of defective components are required, including re-grouting of affected areas, rectification or replacement of leaking fixtures, secure fixing of the vanity unit, and repair or replacement of the exhaust fan to restore adequate ventilation.

A licensed plumber, electrician, and/or builder should be engaged as appropriate to complete these works, ensuring the wet areas perform as intended and to support the long-term durability and serviceability of the bathrooms.

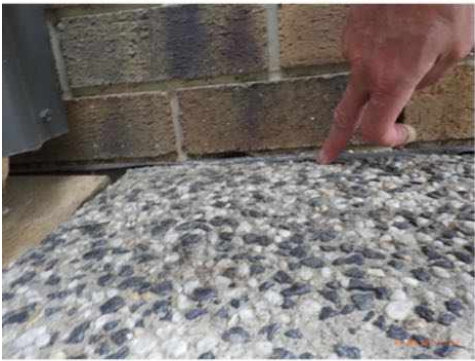
Building: Building 1  
 Location: All Areas  
 Finding: Additional Photos - Obstructions and Limitations  
 Information:

These photographs are an indication of the obstructions and limitations which impeded full inspection of the property at the time of inspection. These obstructions can hide an array of defects and should be removed to allow full inspection to be carried out.

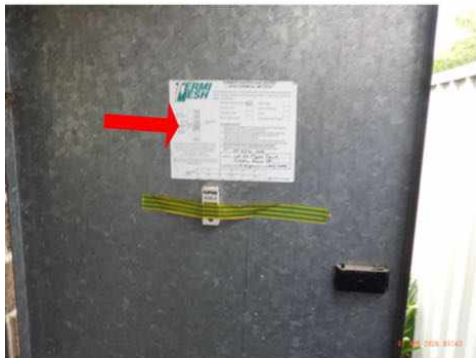
This building has been constructed with a stainless steel mesh barrier which restricts termites from accessing timbers in accordance with AS 3650.1 as follows:
