## Building Inspection Report

Inspection Date: Fri, 27 Feb 2026

Property Address: 17 Buttercup St, Macquarie Fields NSW  
2564, Australia

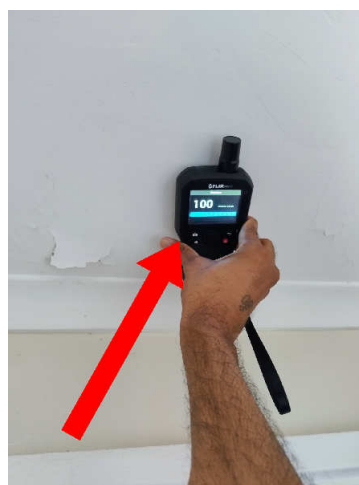
#### Defects 2.01

Finding: Evidence of Excessive moisture - identified - Major Defect

Information: Evidence of excessive moisture recorded by moisture meter in the dining room ceiling.

Excessive moisture can attract termites and produce conditions that promote fungal growth and wood decay.

Excessive moisture is generally caused by deteriorated, inadequate or missing roof drainage, leaking plumbing pipes or fixtures, poorly plumbed HWS overflows or condenser units and poor site drainage.

Prior to any remedial works being performed a qualified plumber should be appointed to further inspect the property and to identify the cause of the excessive moisture. Works to remove affected building elements may then be necessary and should be performed by an appropriate tradesperson.

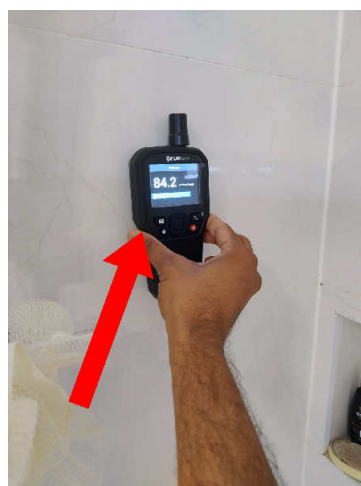
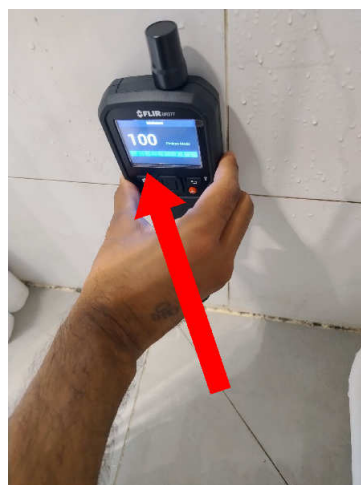
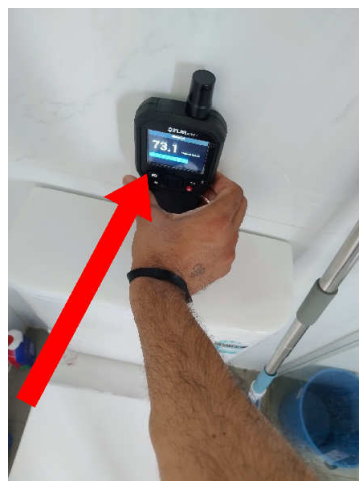
### Defects 2.02

Building: Main Building  
Location: Both Main and Granny unit Bathroom walls  
Finding: Evidence of Excessive moisture - identified in both bathroom

Evidence of excessive moisture recorded by moisture meter in both Bathroom walls ( Main builds and Granny Flat ) and shower area walls at the time of inspection. Excessive moisture can attract termites and produce conditions that promote fungal growth and wood decay.

Excessive moisture is generally caused by deteriorated, inadequate or missing roof drainage, leaking plumbing pipes or fixtures, poorly plumbed HWS overflows or condenser units and poor site drainage.

Prior to any remedial works being performed a qualified plumber should be appointed to further inspect the property and to identify the cause of the excessive moisture. Works to remove affected building elements may then be necessary and should be performed by an appropriate tradesperson as soon as possible.

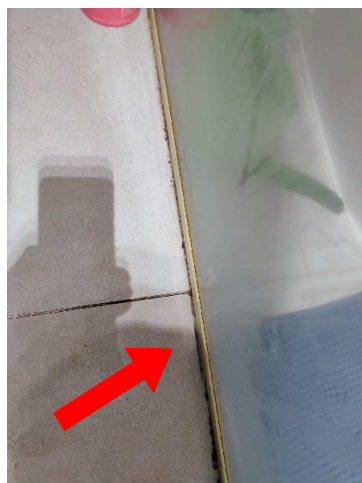
### Defects 2.03

Information: Mould were observed at the time of inspection in bathroom area. Where evidence of mould growth was noted, there may be environmental, biological or health issues associated with the report. A specialist inspection by a suitably qualified environmental health inspector is warranted, where mould is extensive or where any queries regarding air quality spores or other related issues apply.

Generally, the client is advised to ensure that the general environment is free of moisture and humidity to aid in the prevention of mould formation and development. Any mould found during the inspection should be cleaned immediately by a cleaning contractor or the homeowner as applicable.

Please note that severely affected building elements may require replacement by a registered builder or qualified carpenter.

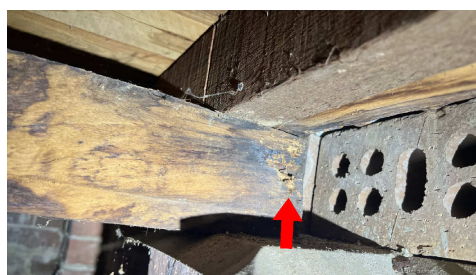
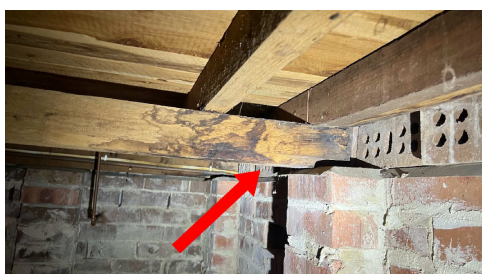
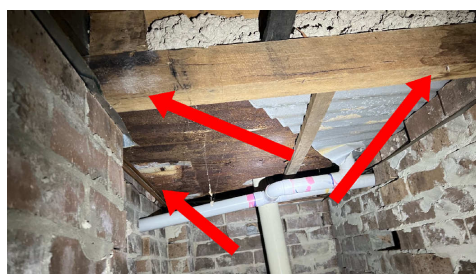
### Defects 2.04

Building: Main Building  
Location: Subfloor  
Finding: Water leak - Active - Detoriation to timber flooring

Water ponding was observed near the pipe in subfloor at the time of inspection near toilet and bathroom area. And Tiber structure below floor is deteriorated due to water leak at the time of inspection.

Generally, water leaks occur when a particular area of the property is not weather or water tight. As the surrounding area was found to be very damp at the time of inspection, the leak is considered ongoing and hence requires urgent action.

It is highly advised that the cause of the leak be identified and resolved immediately by a licensed plumber to prevent any further damage. Depending on the extent of the damage previously sustained, repair and/or replacement of any affected building materials may be required.

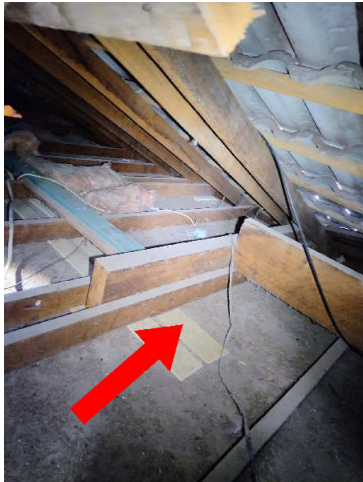
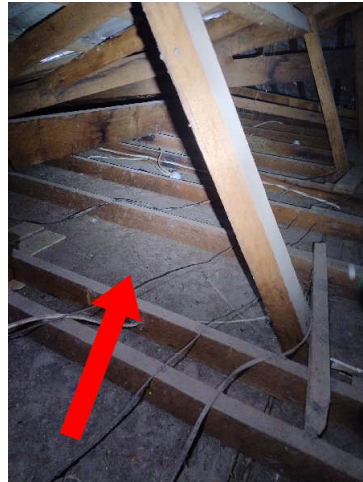
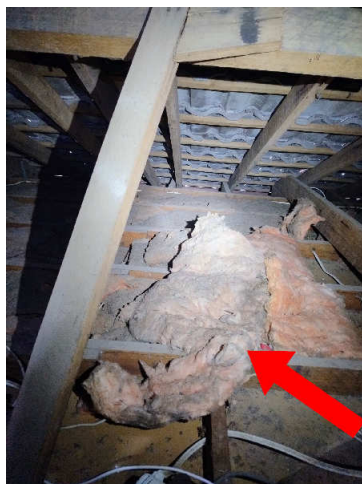
### Defects 3.01

Finding: Insulation - Missing and misplaced

Information: Upon inspection of the roof void it was noted that insulation is not properly placed and missing at some location.

Insufficient insulation will result in a comparatively higher cost to heat and cool a property as there is a lack of Insulation (or uneven coverage of insulation) which works as a barrier to heat transfer. This helps to keep out unwanted heat in summer and preserves warmth inside your home in winter. It can also help soundproof your home from unwanted airborne noise transfer.

Where insulation is absent, the area does not meet current Australian Standards. Installation of adequate insulation is required and should be conducted as soon as possible.

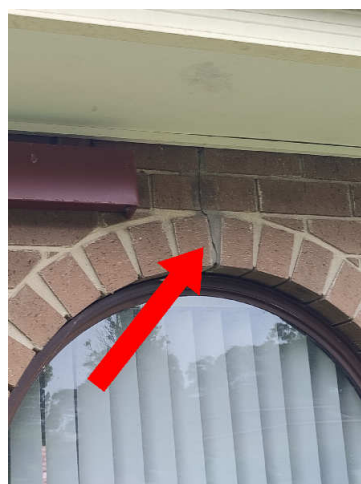
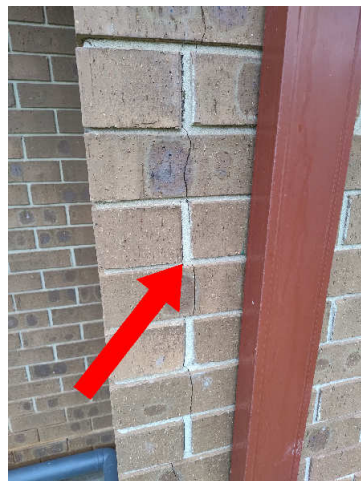
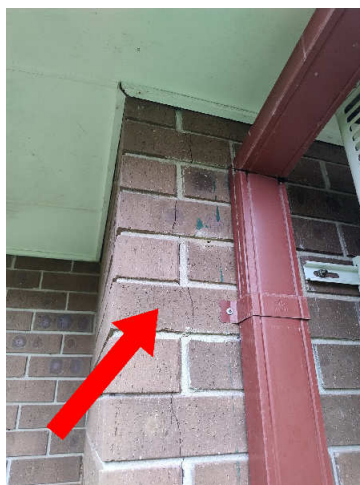
**Defects 3.02**

Finding: Brickwork - Cracking [Fine] - external wall

Information: Several cracks were observed in the side wall under patio and the exterior rear walls rear elevation.  
Generally, the cause of a fine crack is indicative of a separation between brickwork and mortar throughout the structure, but single bricks may also show cracks of this nature.

Cracking of this nature can generally be repaired with minor filling and should be conducted by a qualified bricklayer.

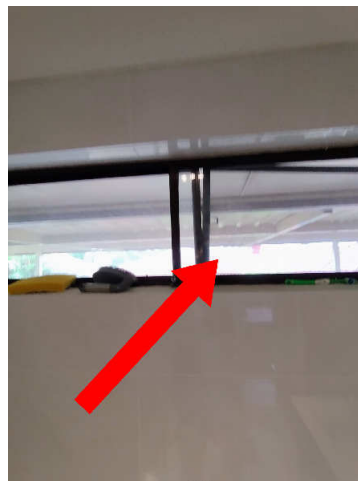
### Defects 3.03

Finding: Outer screen - Damaged

Information: Outer partition screen were found to be Damaged in right side elevation area at the time of inspection.

A general handyperson may be appointed to replace flyscreens at the discretion of the client.

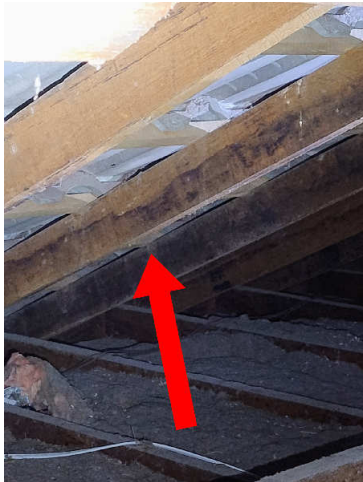
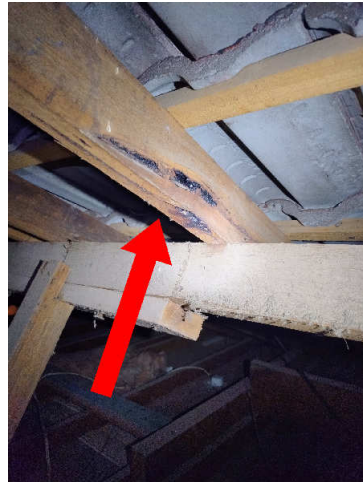
### Defects 3.04

Finding: Stained timbers

Information: At the time of the inspection, water staining was observed in Roof void areas. The staining was visually evident, with discoloration and marks present on the surface.

This suggests that the staining is likely a result of a previous water intrusion event that has since dried. It is recommended that the cause of the water staining be further investigated by means of an invasive inspection, to ensure that there are no underlying issues that could lead to a MAJOR defect and future moisture problems.

The vendor or the real estate agent might be able to provide further information on the cause of the staining and potential rectification at the time. Otherwise, a roofing contractor is recommended to investigate the roof flashings for any areas of water ingress as soon as possible.

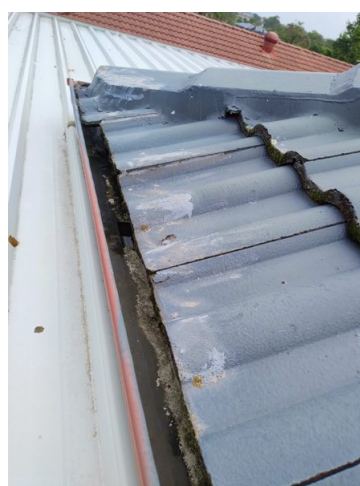
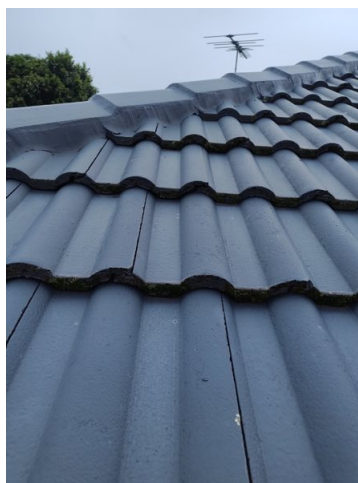
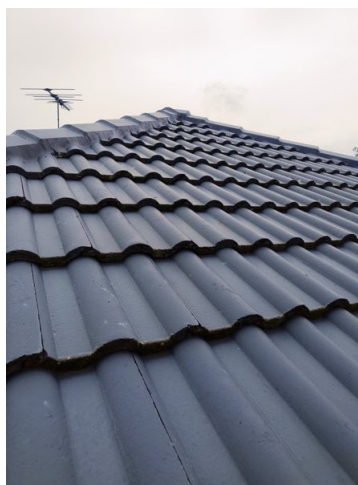
### Defects 3.05

Building: Main Building  
Location: Roof Exterior  
Finding: Roof tiles - Weathered

Upon inspection of the exterior roofing, the majority of roof tiles were considered to be in a fair condition. While weathering of the tiles is consistent with the age of the property, maintenance works are required.

Isolated areas of mortar have come loose in the valleys and minor cracking is also present. Re-pointing and re-sealing the may be considered as an interim solution by the client to help preserve and extend the life span of the tiles.

Consultation with a roofing contractor is highly advised to gain advice on cost of remedial works that may be required in the short to medium term. Remedial works are likely to increase the longevity of the exterior roofing structure.

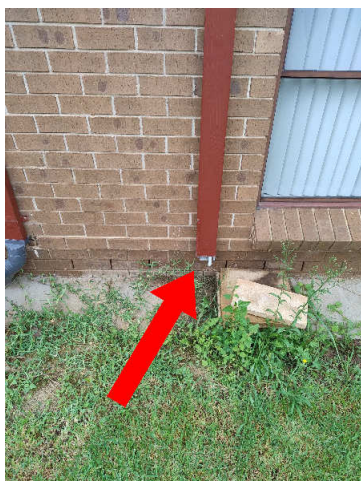
### Defects 3.06

Finding: Air conditioner unit - Not connected overflow

Information: The Air Conditioner (A/C) overflow was found to be not connected to storm water drainage and is creating excessive moisture in the surrounding area.

It is highly recommended that a licensed plumber be appointed to connect the A/C overflow in order to prevent such an environment from being created. These minor works should be carried out as soon as possible.

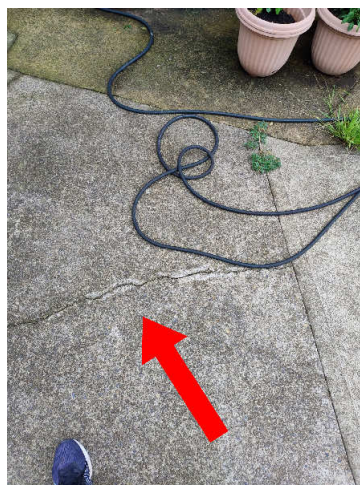
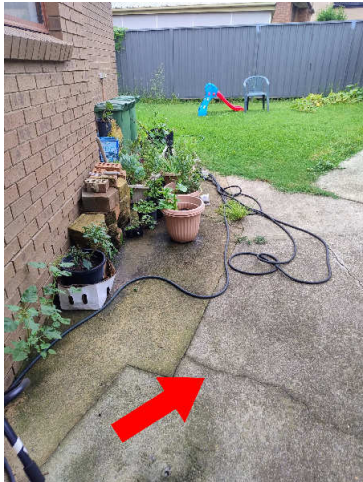
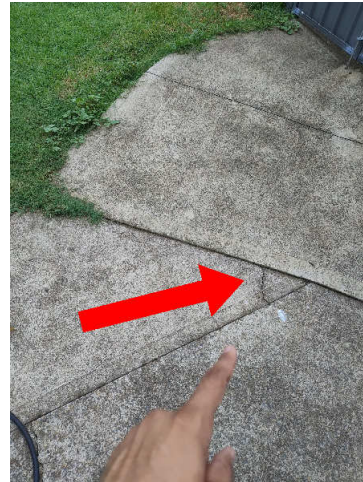
### Defects 3.08

Finding: Crack in concrete slab - Category 2

Information: A crack coded as Category 2 was identified in the slab in carport area at the time of inspection. A Category 2 crack is described as a distinct crack, with the slab being noticeably curved or changed in level.

To be considered Category 2, the approximate width of the crack is less than 2.0mm, or a change in offset of less than 15mm when a 3m straight edge is placed over the defect.

Category 2 cracks to slabs should be monitored for a period of 12 months. At the end of the monitoring period, cracks rated greater than Category 2 are considered defects that require rectification.

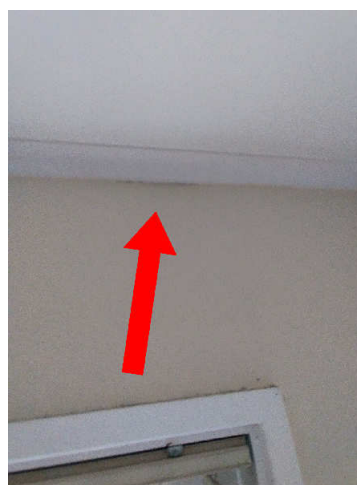
**Defects 3.10**

Finding: Cracking - Damage Category 2 - Noticeable (up to 5mm)

Information: Several cracks in all internal areas were observed at the time of inspection. Noticeable cracks are a common occurrence as a result of many primary defects. Such causes may include age, general wear and tear, expected building movement, general expansion/contraction of building materials in different weather conditions, and/or minor failings in the installation or application of building materials.

Relevant tradespeople, such as carpenters, painters and plasterers, should be appointed to perform remedial works, as deemed necessary.

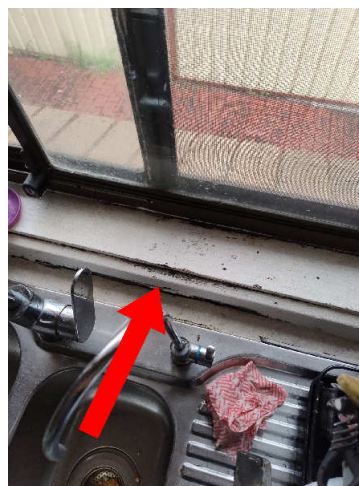
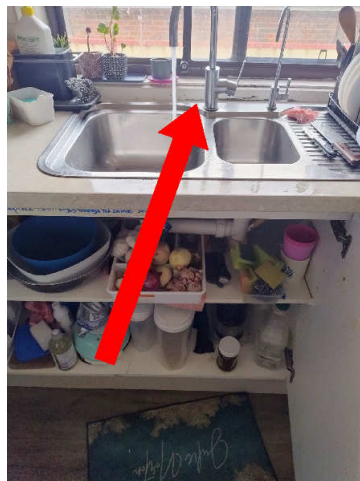
**Defects 3.11**

Information: Window timber near kitchen wash basin area was observed to be swollen at the time of inspection. Swollen building elements generally indicate that the building materials have been affected by excessive moisture over a prolonged period of time, and have swollen as a result. The formation and development of mould/fungi or mildew is also a likely consequence of excessive moisture, which may pose major respiratory issues for occupants, particularly the elderly, the very young and those with existing illnesses and could be potential health safety hazards. In these cases an appropriately qualified inspector/tester should also be contacted for advice and/or technical assistance.

The structural integrity of swollen building elements can not be guaranteed, and further damage is likely to develop if left unmanaged. Excessive moisture is likely to lead to the development of secondary damage to any associated building elements, which may necessitate major reparation works if prolonged.

Rectification of the cause of the water leak should be addressed prior to any remedial works to the swollen building elements. A licensed plumber should be appointed immediately to identify the cause of the leak and provide advice on remedial works as necessary, Repair and/or replacement of swollen building elements should be conducted as a matter of urgency by a registered builder or qualified carpenter.

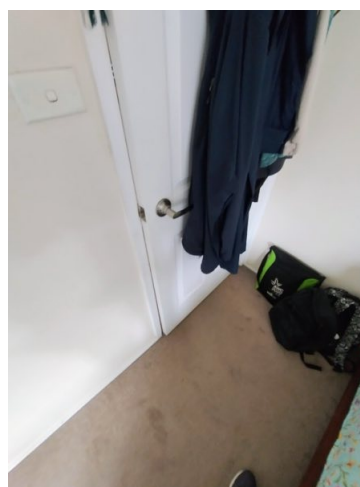
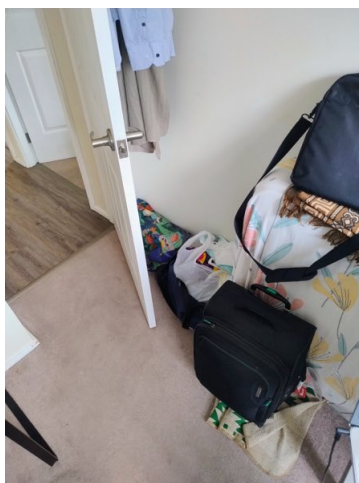
### Defects 3.12

Finding: Door stop - Missing

Information: The door stop was missing and was inadequate to stop the door handle from damaging the wall in all bedrooms at the time of inspection. Although some building elements may seem irrelevant or unnecessary, all building elements play a key role in the operation and function of the overall structure and its performance.

Re-installation or replacement of the door stop is advised as soon as possible to prevent any subsequent damage to the door or associated structures. A general handyman may be appointed to perform these works at client discretion.

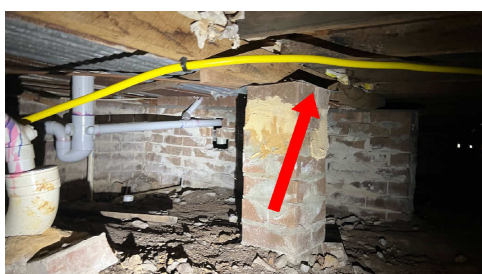
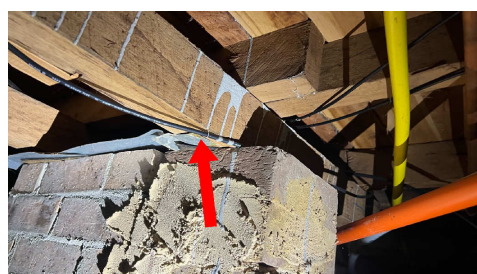
### Defects 3.13

Installed during the construction process, ant caps are designed to easily identify termite or pest ingress from stumps to the adjoining bearers.

Where ant caps have not been installed properly, frequent monitoring of these areas should be carried out in order to identify any signs of termite or timber pest workings.

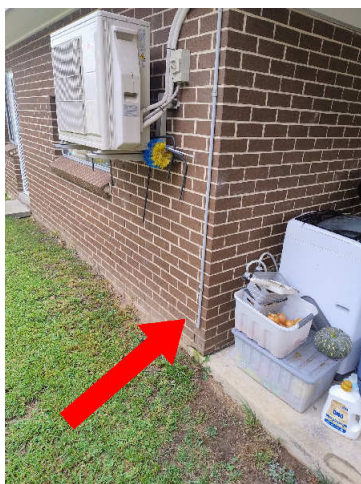
### Defects 3.14

Building:	Granny-Flat
Location:	Airconditioning Vent or Intake
Finding:	Air conditioner - Disconnected overflow
Information:	The Air Conditioner (A/C) overflow was found to be disconnected from storm water drainage and is creating excessive moisture in the surrounding area at the time of inspection.

It is highly recommended that a licensed plumber be appointed to connect the A/C overflow in order to prevent such an environment from being created. These minor works should be carried out as soon as possible.

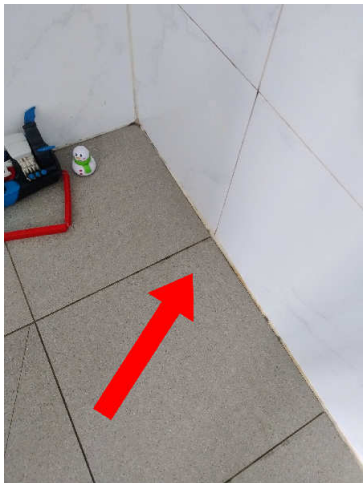
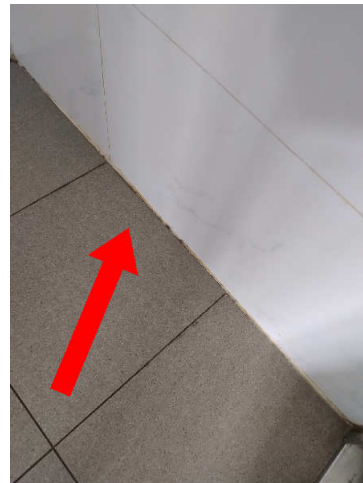
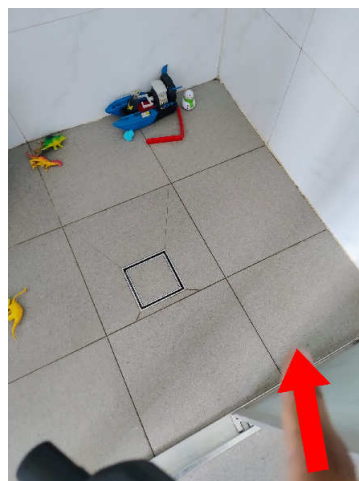
### Defects 3.15

Building:	Granny-Flat
Location:	Bathroom
Finding:	Sealant and Grouting - Damaged or Detoriorated

It was noted on inspection that sealant or grout is degraded to the tiled shower alcove and or other areas of the bathroom in Granny flat.

There mould to the sealant and grout which will likely require scraping out and replacement.

This can lead to water ingress into the shower base and creates conducive condition to termite activity. If left unmanaged can cause further deterioration to building elements.

Qualified trade person or plumber must be appointed for rectification on priority.

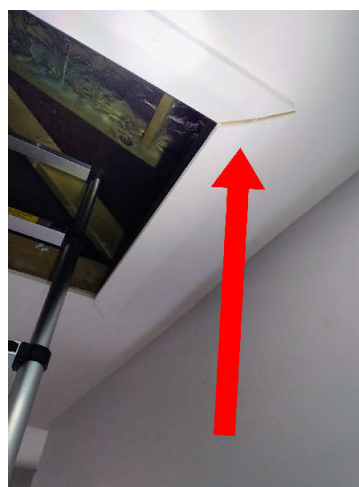
### Defects 3.16

Building:	Granny-Flat
Location:	Roof Void
Finding:	Roof void entrance side timber - Damaged
Information:	<p>Timber at the rood void entrance was observed to be damaged at the time of inspection.</p> <p>Breakage occurs generally when the building materials have either aged and decayed, or as a result of damage (accidental or deliberate).</p>

Repair and/or replacement of broken elements is advised to ensure that additional secondary defects do not arise as a consequence. Such works are necessary, as all building elements play a key role in the operation and function of the overall structure and its performance.

A relevant tradesperson should be appointed to repair or replace the affected building element prior to any subsequent damage being caused.

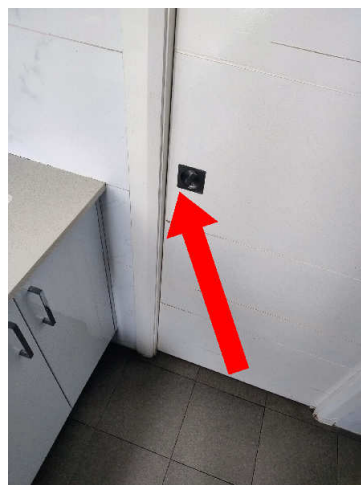
### Defects 3.17

It is suspected that this defect has occurred due to minor issues with the associated hinges. Such damage is identified as general wear and tear, which is expected for building elements of this age.

A qualified carpenter or general handyperson may be appointed to perform rectification works as necessary, at client discretion. If left unattended, further functional impairment is likely to occur.
