Building and Timber Pest Inspection Report

Inspection Date: Sat, 7 Feb 2026

Property Address: 25 Hester Ave, Claymore NSW 2559,
Australia

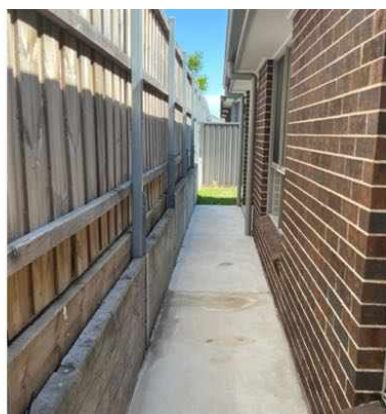
Building: Main Building
Location: All External Areas
Finding: Site drainage - Inadequate
Information: The site drainage in this area was found to be inadequate at the time of inspection, creating potential for subsequent water damage to associated building elements.

It is important that water does not lie against the base of walls; surrounding paths and ground levels should be sloped to drain water away from walls. Downpipes should not discharge stormwater onto lower walls or plinths. Stormwater should be carried away by large, regularly cleaned drains. Ground levels may need to be lowered to expose a buried DPC.

Where site drainage is inadequate, installation of an Agricultural (Aggie) Drain may be required. A qualified plumber should be appointed to further inspect the property and perform any remedial works as necessary. Water damage and secondary defects are likely to occur if left unmanaged.

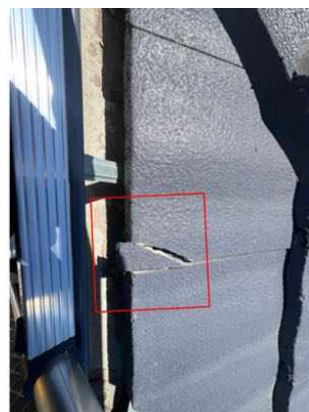
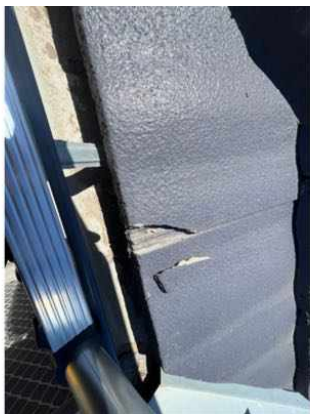
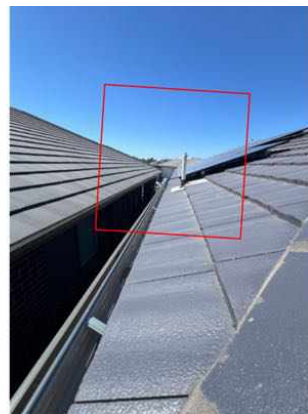
Finding 3.02

Building:	Main Building
Location:	Roof Exterior
Finding:	Roof tiles - Broken and lifting to some areas
Information:	Upon inspection of the exterior roof covering, broken roofing tiles were identified. Broken and friable roof tiles are generally the result of ageing and weathering of what is essentially a porous material.

If left to further deteriorate, broken and brittle roof tiles are likely to lead to water penetration via the roof into the ceiling space, causing secondary damage to ceiling linings, insulation and roof structures. Broken roof tiles are also likely to detract from the effectiveness of the roof drainage system, creating potential for secondary damage to the exterior roof covering and roof plumbing.

Replacement of broken tiles is required and should be performed by a roofing contractor as soon as possible.

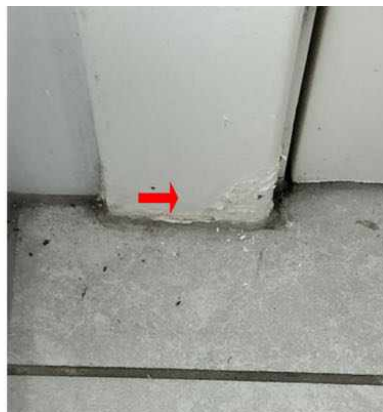
Finding 3.03

Building:	Main Building
Location:	Bathroom
Finding:	Wet-Area Door Jambs – Moisture Staining / Decay
Information:	Minor moisture staining and early signs of deterioration were observed at the base of the wet-area door jamb and architraves. This is commonly due to water splashing or moisture tracking from the bathroom floor into adjacent joinery. At the time of inspection.

It is recommended that the door junctions be resealed with a suitable moisture-resistant sealant and that ventilation and drainage within the bathroom be maintained to reduce further dampness. Where timber swelling or decay has progressed, localised repair or replacement using moisture-resistant materials (H3-treated or equivalent) should be undertaken.

Further inspection by a licensed carpenter or waterproofing contractor is recommended to confirm the extent of deterioration and verify whether any remedial sealing or minor replacement works are warranted.

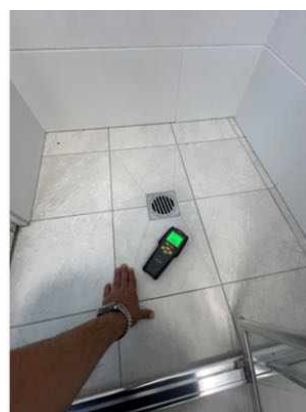
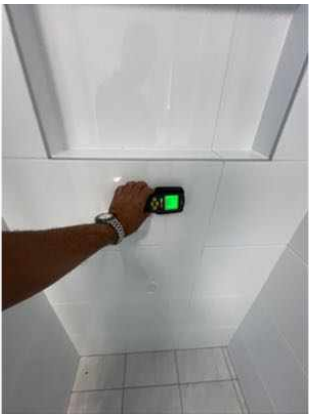
Finding 3.04

Building:	Main Building
Location:	Bathroom, Ensuite
Finding:	Elevated Moisture Bathroom (No visible deterioration noted)
Information:	Elevated moisture levels were detected to tiled surfaces in bathroom/shower areas. Persistent moisture ingress can lead to concealed damage, including timber rot and mould growth.

Elevated moisture readings in tiled wet areas can occur from normal shower use, age/deterioration of waterproofing membranes, plumbing leaks or moisture absorption through grout lines. While no damage was visible, elevated readings may indicate moisture retention behind tiles, which can be a conducive condition for future deterioration if not monitored.

No immediate action required. Monitor the area over time for signs of drumming, efflorescence, tile movement, or grout deterioration. If concerns arise, a licensed waterproofing specialist can perform further investigation (e.g., pressure testing, membrane assessment).

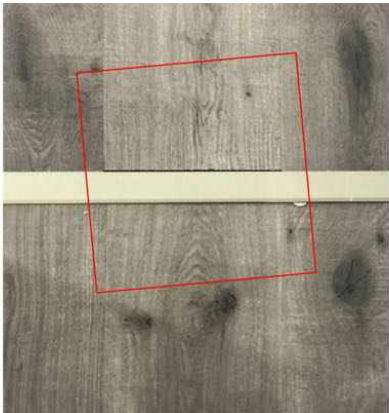
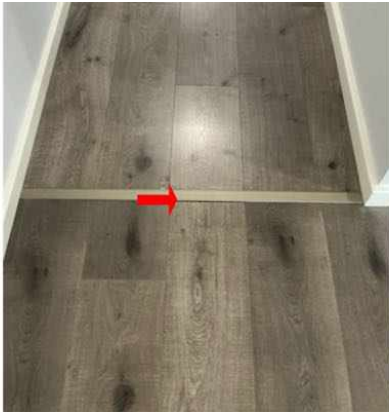
Finding 3.05

Building: Main Building
Location: All Internal Areas
Finding: Internal Flooring
Information:

The internal laminate/engineered timber flooring displays inconsistent installation quality, including visible gaps at board joints, uneven end-joint alignment, poor staggering, and/or unevenness to some areas. While the flooring remains serviceable, the defects detract from appearance and may lead to increased wear over time, rectification by a qualified flooring contractor is recommended to improve finish and long-term performance.

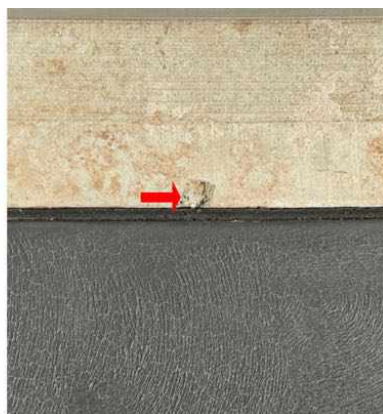
Finding 3.06

Building:	Main Building
Location:	Garage
Finding:	Building element - Damaged - Concrete damage/chipped
Information:	Breakage occurs generally when the building materials have either aged and decayed, or as a result of damage (accidental or deliberate).

Repair and/or replacement of broken elements is advised to ensure that additional secondary defects do not arise as a consequence. Such works are necessary, as all building elements play a key role in the operation and function of the overall structure and its performance.

A relevant tradesperson should be appointed to repair or replace the affected building element prior to any subsequent damage being caused.

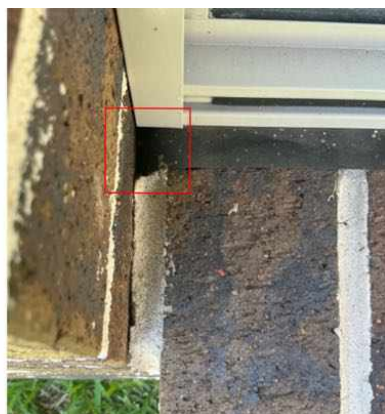
Finding 3.07

Building:	Main Building
Location:	All External Areas
Finding:	Gap Between Window Frame and Masonry
Information:	A visible gap is present between the external window frame and the adjacent masonry wall. This gap may allow water ingress, air infiltration, and potential pest entry if not adequately sealed. Over time, such exposure can contribute to frame deterioration, internal water damage, or reduced thermal performance. Sealing or filling the gap with a suitable weatherproof compound is recommended to maintain the integrity of the building envelope, in accordance with good building practice and AS 4349.1

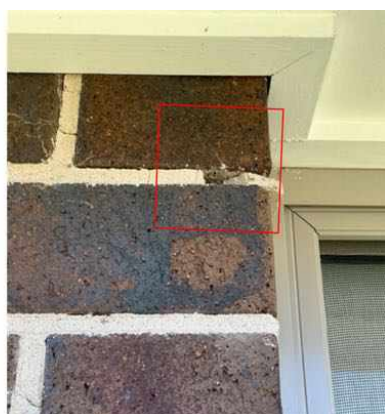
Finding 3.08

Building:	Main Building
Location:	All External Areas
Finding:	Brickwork - Deteriorated mortar to some areas
Information:	Mortar, or 'bedding', is the material which fills joints and intersections between bricks in masonry walls and structures. Sections of mortar in this brickwork were identified as having deteriorated, which is generally expected for a property of this age and condition.

Mortar may deteriorate as a result of age of building materials, minor movement of bricks, or frequent exposure to weathering. Mortar should be replaced to ensure that bricks remain in their intended location and to prevent gaps, which would allow water or moisture ingress and secondary damage as a result.

Mortar deterioration can be addressed by a bricklayer where areas of deterioration are localised and easily accessible. Alternatively, appointment of a registered builder is advised, to repoint large areas of decaying mortar. Where secondary structural defects have become evident, consultation with a structural engineer may be required.

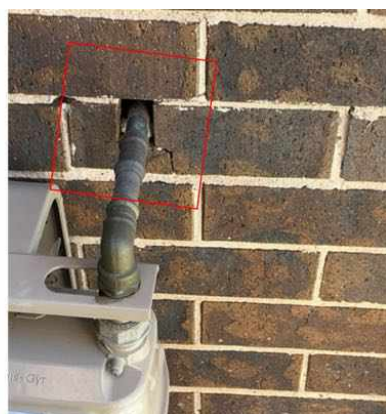
Finding 3.09

Building:	Main Building
Location:	All External Areas

Works that have not been completed to a satisfactory level create potential for the development of building defects and may impede on the safety and integrity of the overall structure.

It is highly recommended that the relevant trades be appointed to complete these works and ensure the safety of the area and the longevity of all associated building elements.

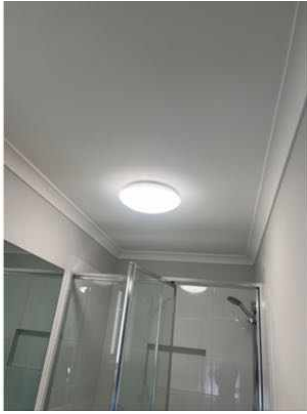
Finding 3.10

Building: Main Building
 Location: Ensuite
 Finding: Exhaust fan - Missing
 Information: An exhaust fan has not been installed in this area. Missing exhaust fans may lead to the development of more significant defects such as moisture damage to surrounding building materials from inadequate ventilation. Inadequate ventilation in internal areas creates an environment that is conducive to the formation and development of mould and other respiratory hazards. It is highly advised that a licensed electrician be appointed to retrospectively install an exhaust fan. Failure to perform works to aid the ventilation of the area may lead to the development of these secondary defects.

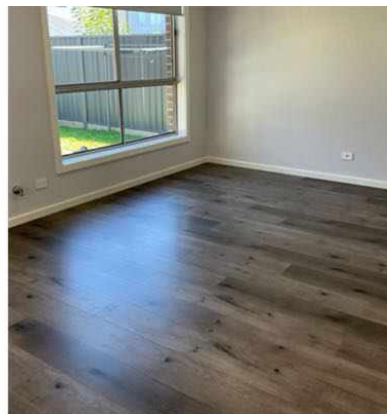
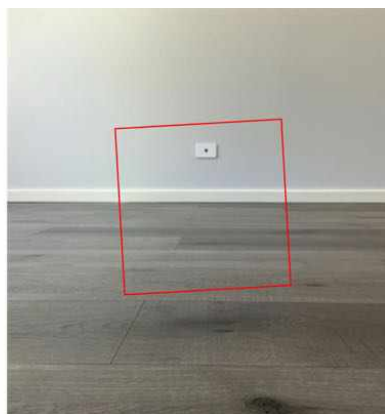
Finding 3.11

Finding: Gap Between Skirting and Timber flooring

Information: Visible gaps between the skirting board and the timber flooring was noted, commonly associated with natural shrinkage, seasonal movement of timber flooring, or installation tolerances. While no signs of moisture damage, distortion, or structural concern are evident at the time of inspection, the gap may detract from the finish and could allow minor moisture ingress or debris accumulation, and is therefore considered a minor defect. Rectification, if desired, typically involves adjustment or refixing of skirting boards or installation of appropriate flexible sealant or trim by a qualified carpenter, particularly where moisture exposure is likely.

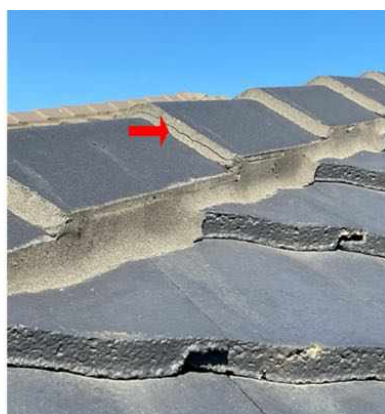
Finding 3.12

Building:	Main Building
Location:	Roof Exterior
Finding:	Mortar - Deterioration to some areas
Information:	Mortar, or 'bedding', is the material which fills joints and intersections between tiles and other building elements on the exterior roof covering, such as gable ends, hip capping and valleys. Upon inspection of the exterior roof, it was noted that sections of the mortar show varying levels of deterioration.

Mortar generally deteriorates as a result of frequent exposure to weather conditions over a prolonged period of time. Mortar that is deteriorating may allow water ingress into the roof void, putting associated building elements and roofing structures at risk of water damage. Deteriorated mortar also detracts from the functionality of roof tiles and other roofing elements, potentially decreasing weather tightness and roof drainage.

Mortar deterioration can be attended to by a handyperson where areas of deterioration are localised and easily accessible. Otherwise, consultation with a roofing contractor is advised where greater works are required.

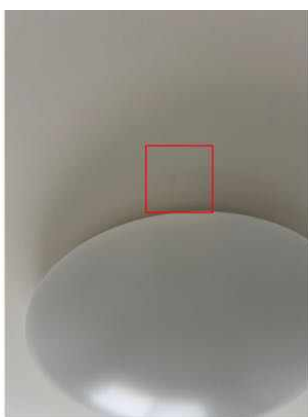
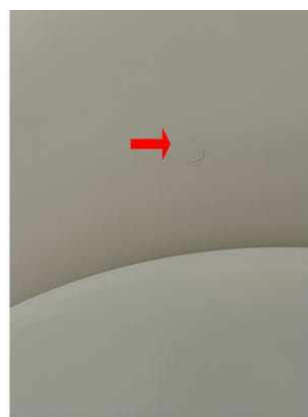
Finding 3.13

Finding: Ceiling nails - Popping To some areas
Information: Numerous popped nails were identified in the internal ceiling at the time of inspection. Nails and screws hold simply by the friction between them and the surface they are applied to. Over time, the nails and screws can back out, which is often a result of general ageing and deterioration of the building structure.

If left unmanaged, the ceiling sheets may become loose and unstable, increasing the rate of deterioration of the internal ceiling and creating potential for the development of secondary defects.

Re-fastening of popped nails will help to maintain the stability of the internal ceiling and associated building elements. Such minor works will also help to improve the appearance of the affected area and secure the ceiling sheets, so as to prevent the onset of ceiling sagging. These works should be performed by a qualified carpenter or plasterer at client discretion.

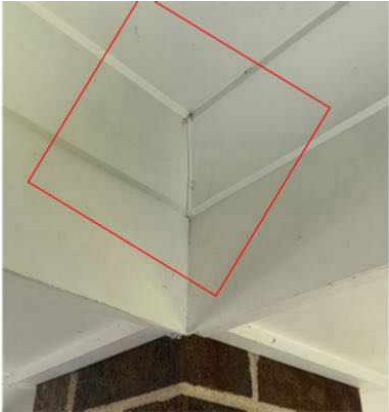
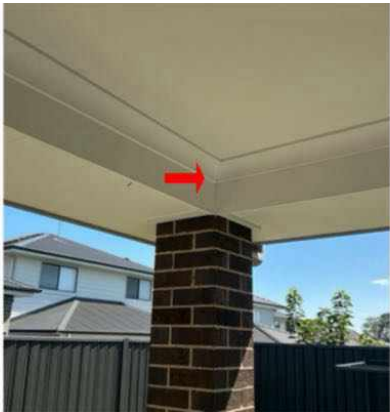
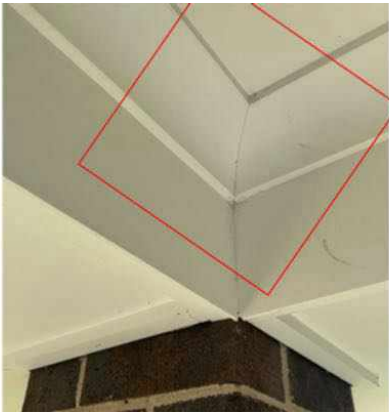
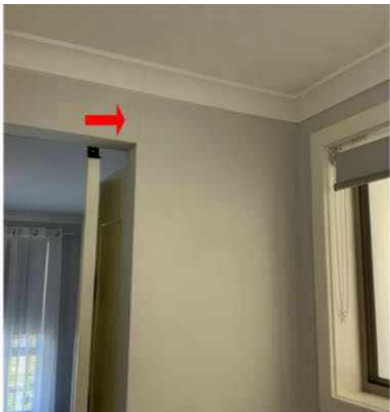
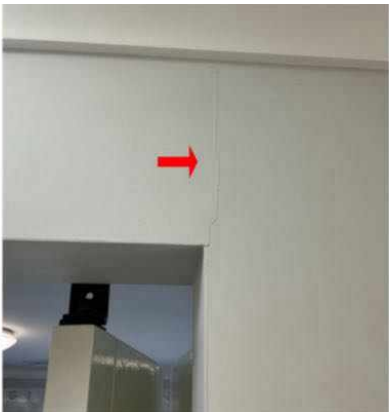
Finding 3.14

Building: Main Building
Location: All Internal Areas
Finding: Paint Finish & Hairline Cracking - To some areas
Information: The paint finish in this area was identified as being incomplete or substandard at the time of inspection including some hairline minor cracking/separation. Monitoring is recommended where cracking and separation is evident.

Whilst incomplete or missing paint finish is generally an appearance defect, it can also lead to the development of secondary building defects over time. Incomplete areas of paint finish expose the area to moisture, potentially accelerating the deterioration of underlying building materials.

Incomplete paint finishes should be sanded back, filled, leveled and painted, as applicable. Where inadequate or missing paint protection has led to the deterioration of the associated building element, repair and/or replacement of this building element may be required.

A painting contractor should be appointed as soon as possible to perform necessary works to aid the appearance of the affected area and to ensure the area is protected against further deterioration. Alternatively, the homeowner following manufacturer instructions may perform these works.

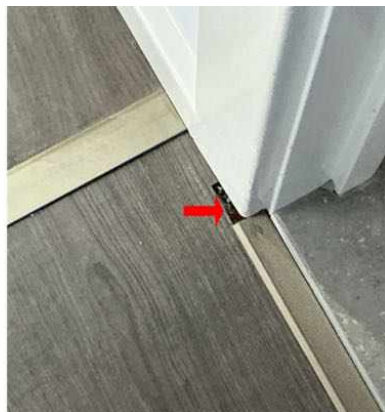
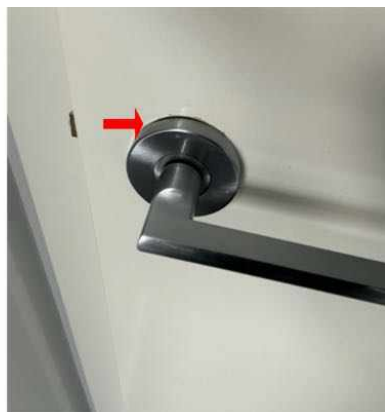
Finding 3.16

Building:	Main Building
Location:	Bedroom, hallway
Finding:	Building element - Damaged - Door handle loose
Information:	Breakage occurs generally when the building materials have either aged and decayed, or as a result of damage (accidental or deliberate).

Repair and/or replacement of broken elements is advised to ensure that additional secondary defects do not arise as a consequence. Such works are necessary, as all building elements play a key role in the operation and function of the overall structure and its performance.

A relevant tradesperson should be appointed to repair or replace the affected building element prior to any subsequent damage being caused.

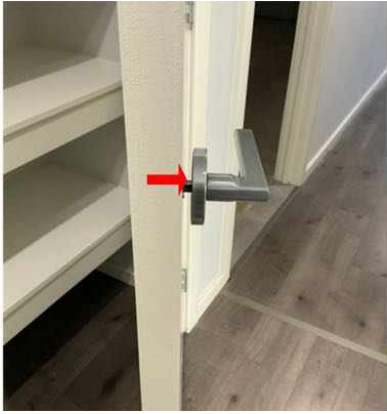
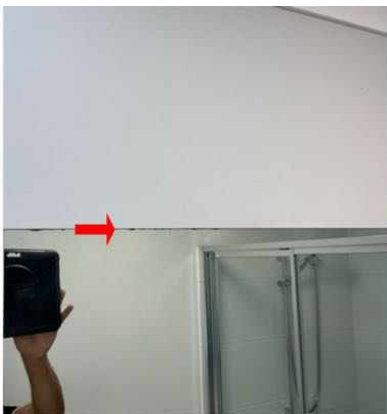
Finding 3.17

Building:	Main Building
Location:	Ensuite, main bath
Finding:	Mirror Desilvering at Bathroom Vanity
Information:	Desilvering is evident along the bottom edge of the bathroom mirror above the vanity unit. This defect is located in the main bathroom and presents as brown-black deterioration of the reflective backing of the mirror. The desilvering is likely caused by prolonged exposure to moisture or water splashes from the basin below. This issue is considered a minor defect under AS 4349.1, affecting aesthetic appearance rather than function, and may worsen over time if left unaddressed. A licensed bathroom contractor or glazier should replace the mirror, and adequate sealing or ventilation should be ensured to prevent recurrence.

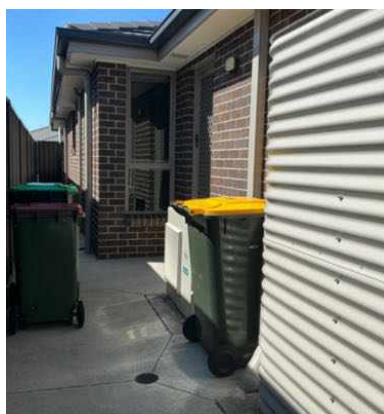
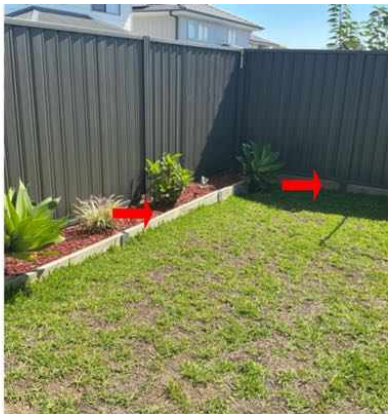
Finding 6.02

Building:	Main Building
Location:	All External Areas
Finding:	In ground contact - Timber
Information:	Any timbers in direct ground contact provide opportunity for concealed termite entry and are likely to be subject to premature rot and decay as the soil retains moisture or damp conditions against the timbers.

Remove untreated timber that is in direct contact with external grounds. Consider replacement with more durable materials i.e. treated timber or non timber elements. Frequent pest inspections are advised to readily identify any termite activity in these areas.

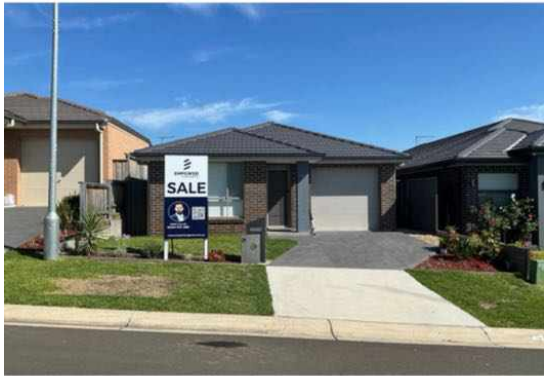
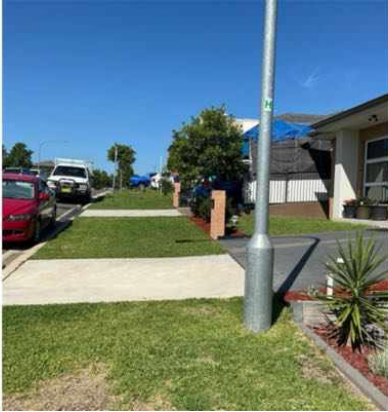
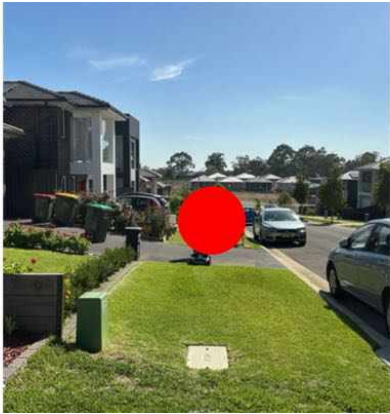
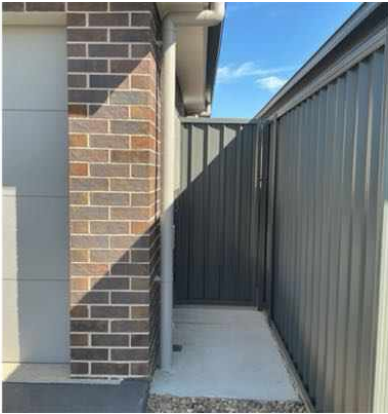
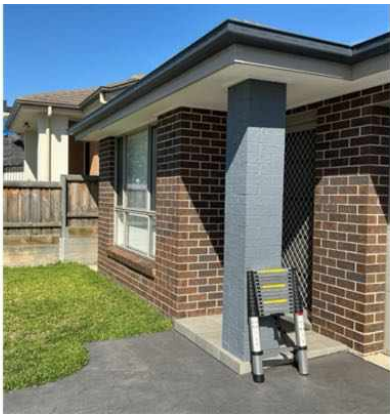
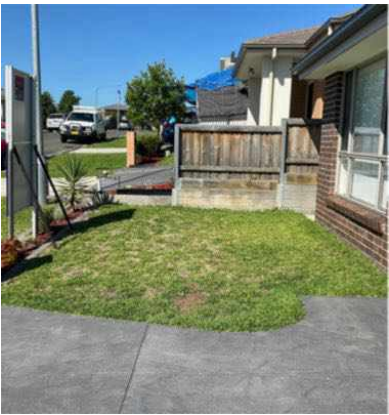
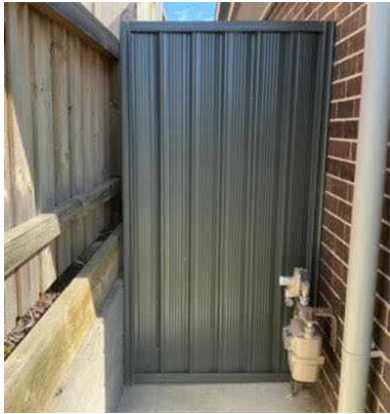
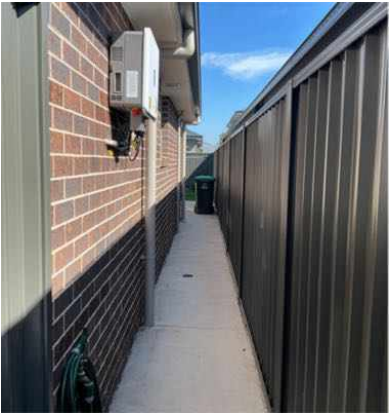
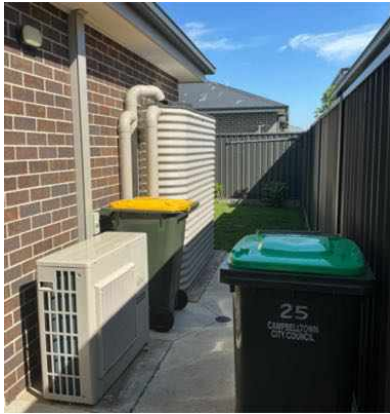
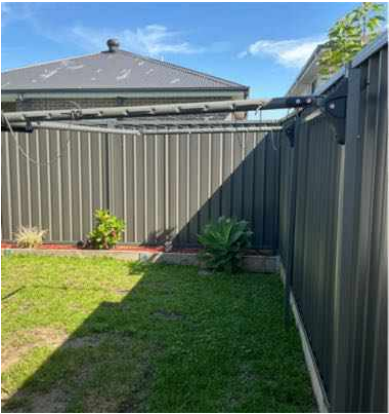
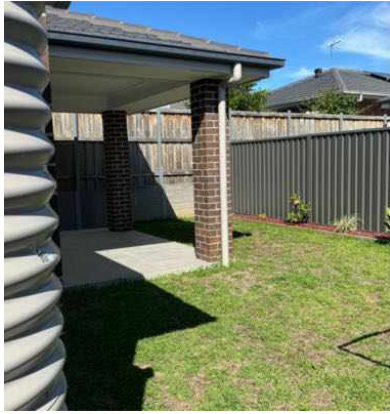
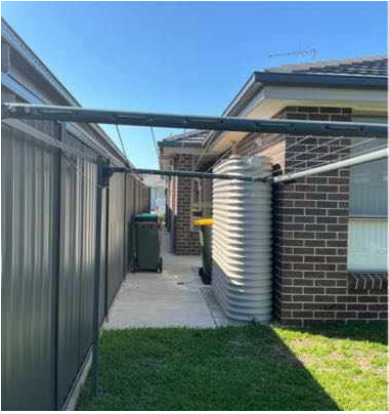
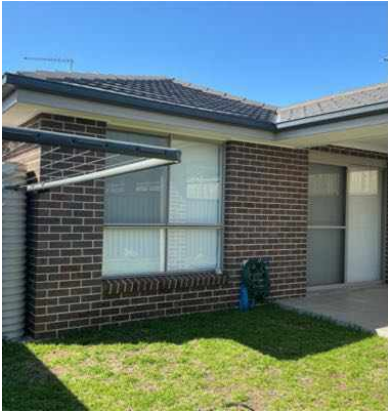
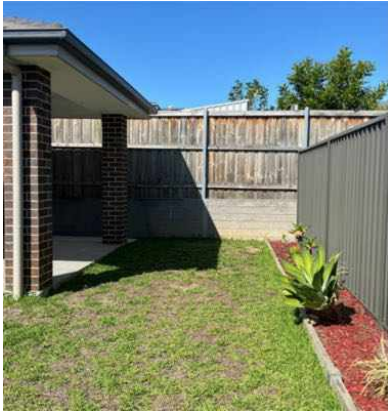
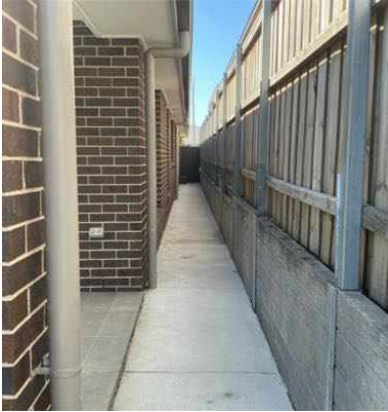
Noted Item

Building: Main Building
Location: All External Areas
Finding: Additional Photos - Obstructions and Limitations
Information: These photographs are an indication of the obstructions and limitations which impeded full inspection of the property at the time of inspection. These obstructions can hide an array of defects and should be removed to allow full inspection to be carried out. A re-inspection is recommended once the areas are made accessible.

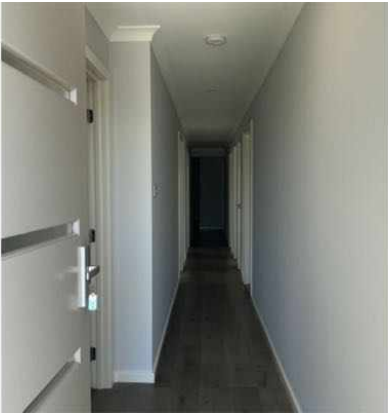
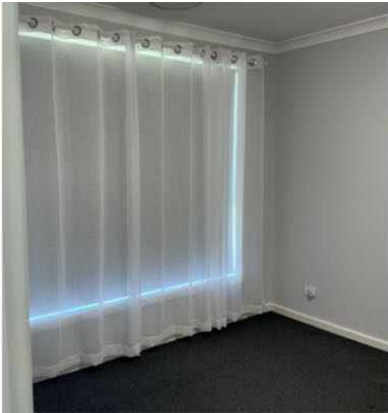
Noted Item

Building: Main Building
Location: All Internal Areas
Finding: Additional Photos - Obstructions and Limitations
Information: These photographs are an indication of the obstructions and limitations which impeded full inspection of the property at the time of inspection. These obstructions can hide an array of defects and should be removed to allow full inspection to be carried out. A re-inspection is recommended once the areas are made accessible.

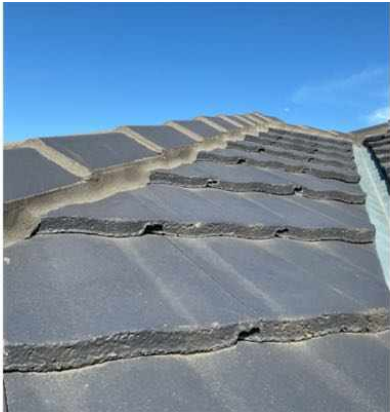
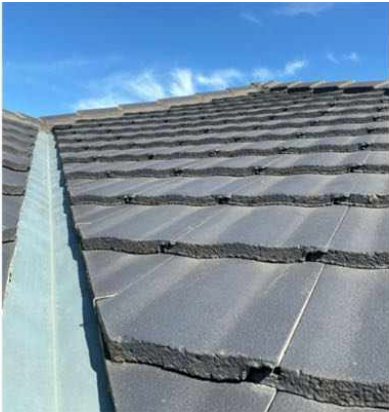
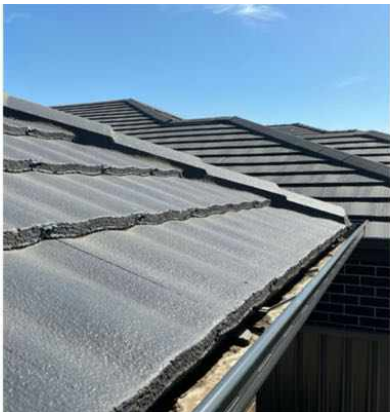
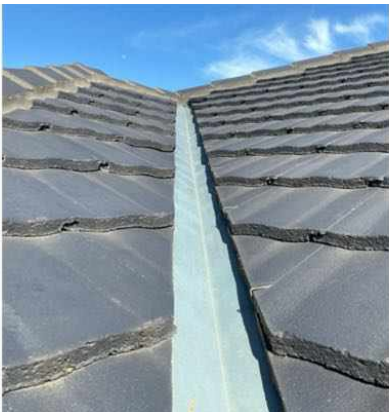
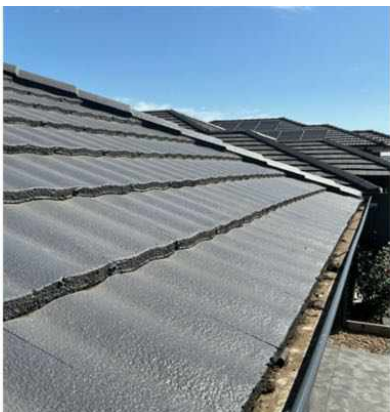
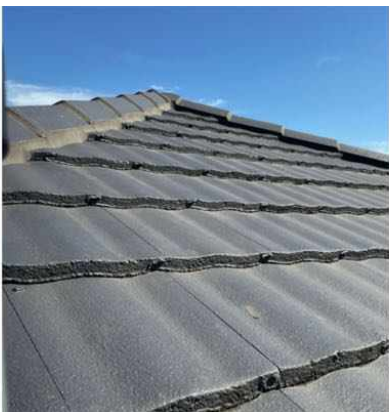
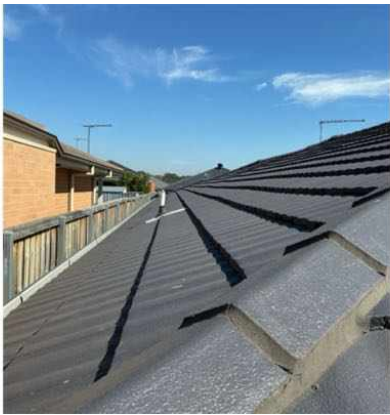
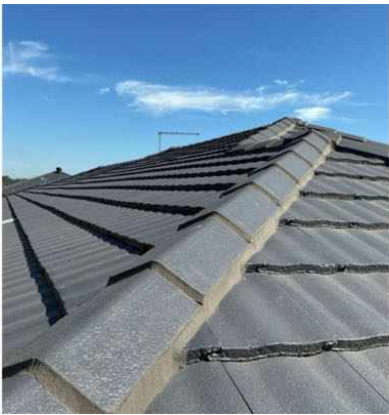
Building: Main Building
Location: Roof Exterior
Finding: Additional Photos - Obstructions and Limitations
Information: These photographs are an indication of the obstructions and limitations which impeded full inspection of the property at the time of inspection. These obstructions can hide an array of defects and should be removed to allow full inspection to be carried out. A re-inspection is recommended once the areas are made accessible.

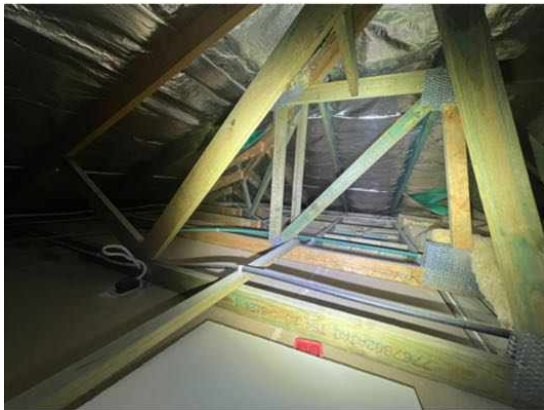
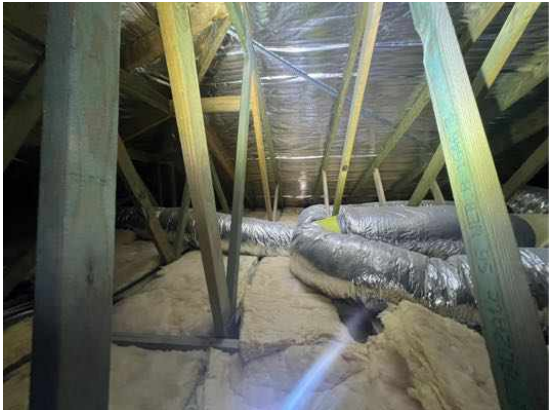
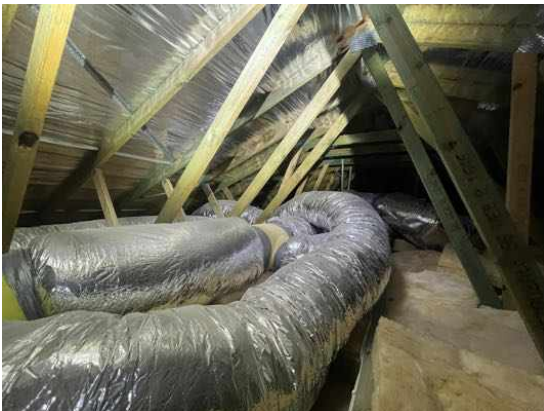
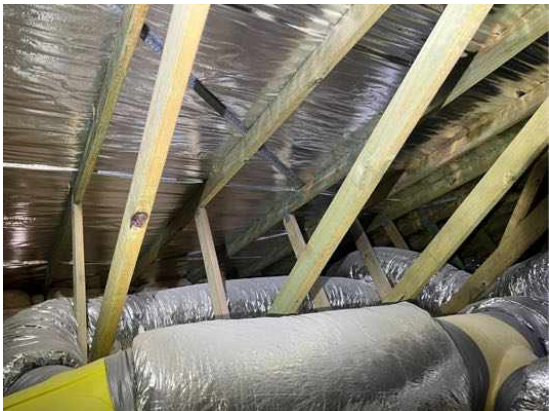
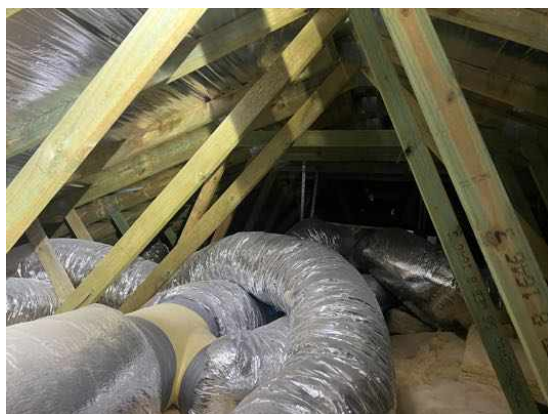
Building: Main Building
Location: Roof Void
Finding: Additional Photos - Obstructions and Limitations
Information: These photographs are an indication of the obstructions and limitations which impeded full inspection of the property at the time of inspection. These obstructions can hide an array of defects and should be removed to allow full inspection to be carried out. A re-inspection is recommended once the areas are made accessible.

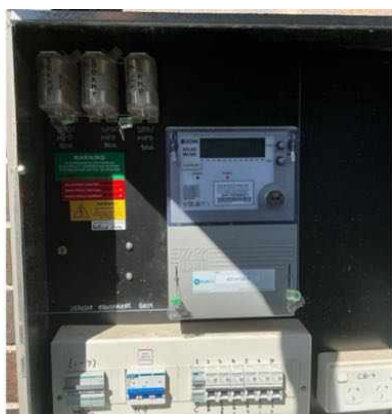
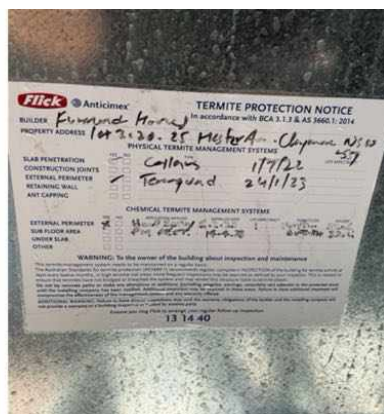
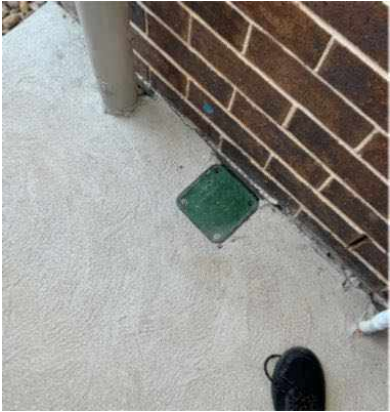
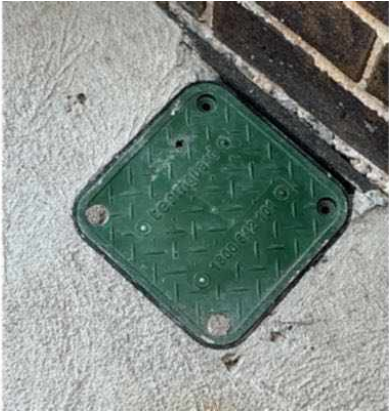
The following items were noted as - Evidence of a previous termite management program

Where a Termite Management System has been identified you should refer to the type of barrier date of installation warranty conditions and any documentation provided by a builder or past owner. Consult the company who installed the barrier to confirm whether the system is still under warranty.

Most chemical termite management systems expire and require replenishment and all physical systems are primarily designed to prevent concealed entry.
