Building and Timber Pest Inspection Report

Inspection Date: Thu, 29 Jan 2026

Property Address: 43 Richard Ave, Earlwood NSW 2206,
Australia

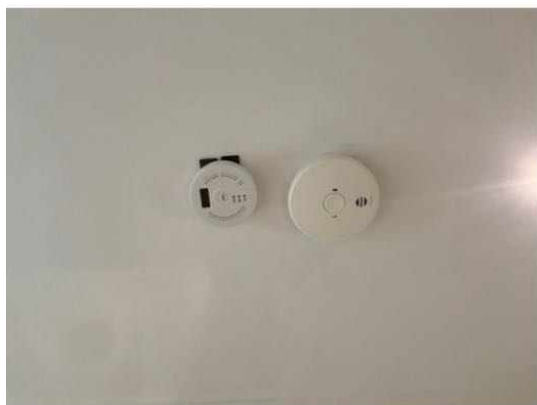
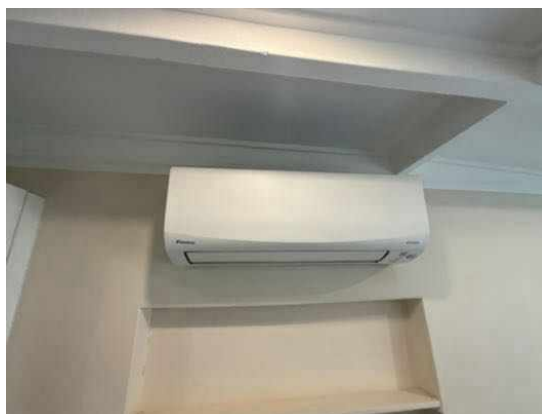
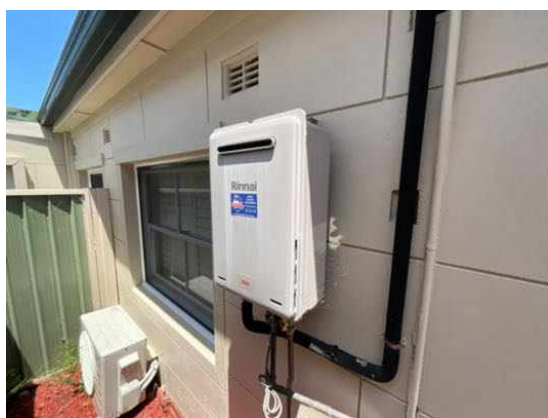
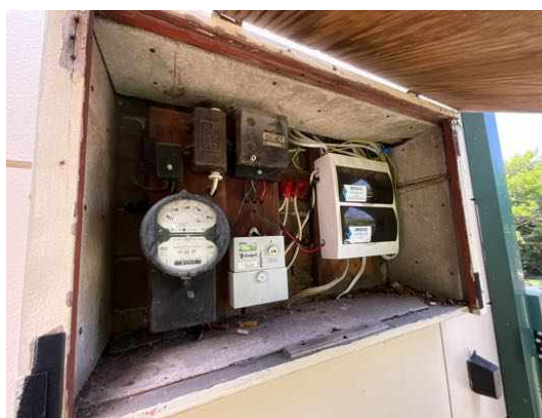
Building: Main Building
Location: All Areas
Finding: Photos Added
Information: Additional photos are provided for your general reference.

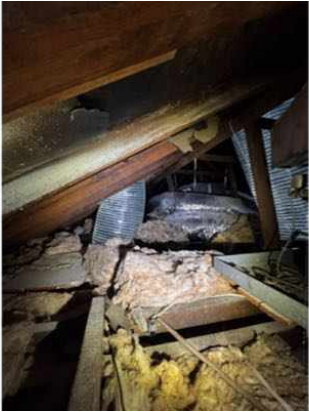
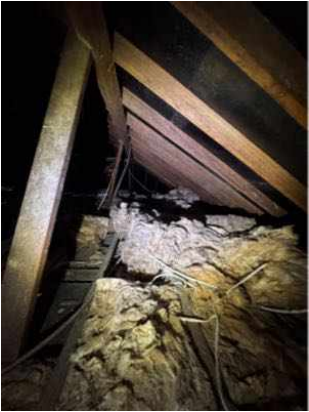
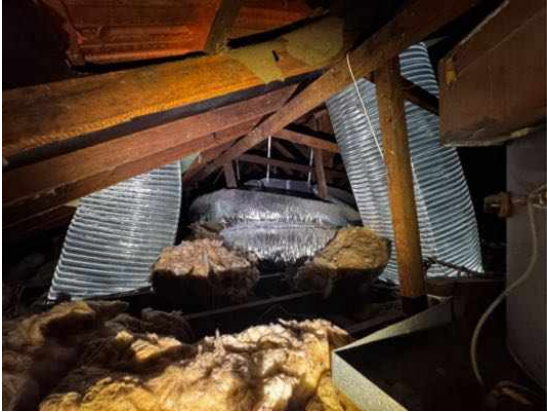
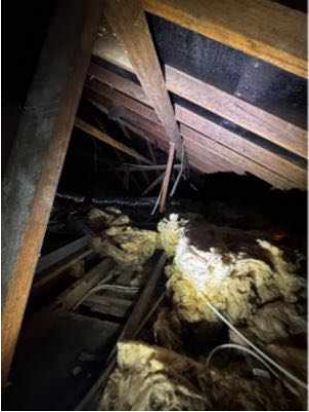
Building: Main Building
Location: Roof Void
Finding: Photos Added
Information: Additional photos are provided for your general reference.
