# Building and Timber Pest Inspection Report

Inspection Date: Fri, 6 Feb 2026

Property Address: 1/792 Nepean Hwy, Mornington VIC 3931,  
Australia

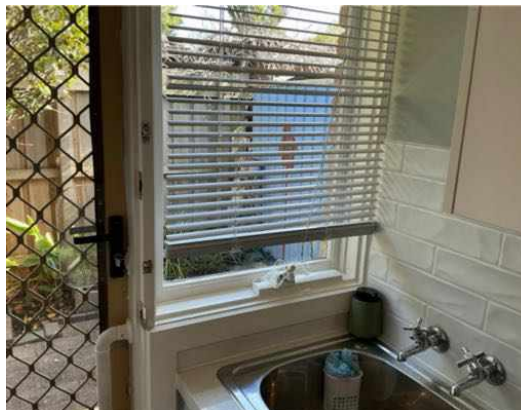
Building: Main Building  
 Location: Various parts of the building  
 Finding: Doors and windows required maintenance  
 Information: Some of the doors and windows to the building require some maintenance or repair to make them operate more smoothly. This can happen overtime with deterioration or lack of maintenance. Recommend engaging a carpenter to repair/maintain windows and doors at the owners discretion.

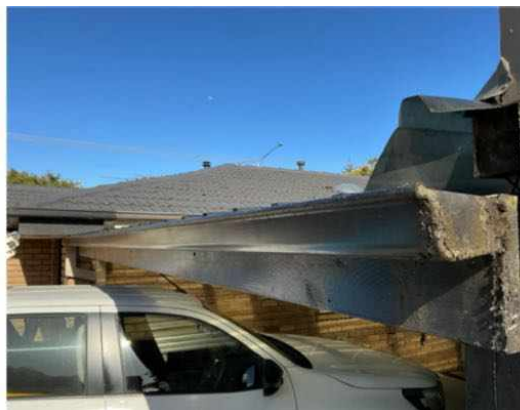
Any areas of guttering that shows evidence of water pooling should be checked for partial or full blockages and any secondary damage that may have occurred as a result. Depending on the extent of the damage, building elements may require repair and/or replacement to ensure adequate roof drainage and function of exterior plumbing system.

A roofing plumber should be appointed as soon as possible to rectify this issue. It is highly advised that all gutters be maintained on a frequent basis to ensure the condition of roof plumbing.

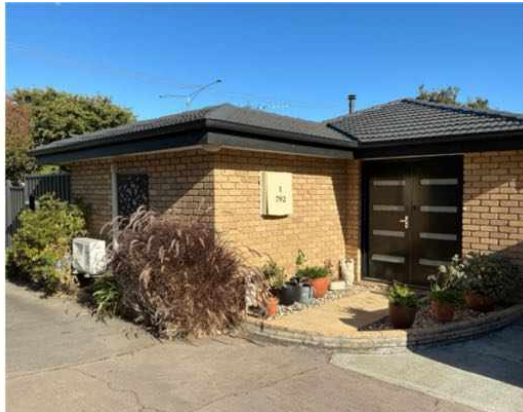
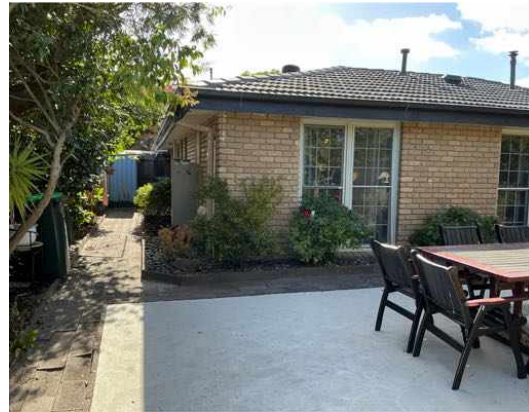
Building: Main Building  
Location: All External Areas  
Finding: Additional Photos - Obstructions and Limitations  
Information: These photographs are an indication of the obstructions and limitations which impeded full inspection of the property at the time of inspection. These obstructions can hide an array of defects and should be removed to allow full inspection to be carried out. A re-inspection is recommended once the areas are made accessible.

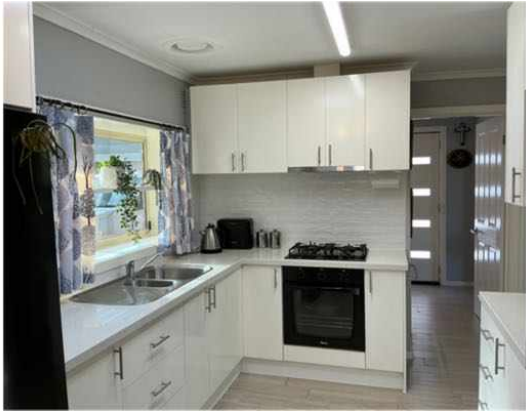
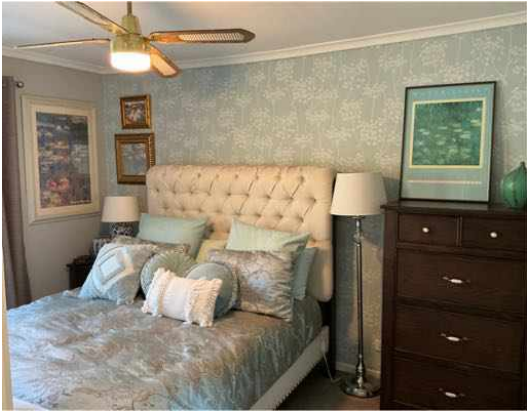
Building: Main Building  
Location: All Internal Areas  
Finding: Additional Photos - Obstructions and Limitations  
Information: These photographs are an indication of the obstructions and limitations which impeded full inspection of the property at the time of inspection. These obstructions can hide an array of defects and should be removed to allow full inspection to be carried out. A re-inspection is recommended once the areas are made accessible.

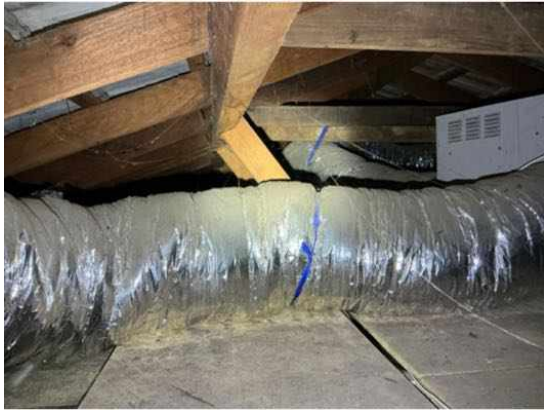
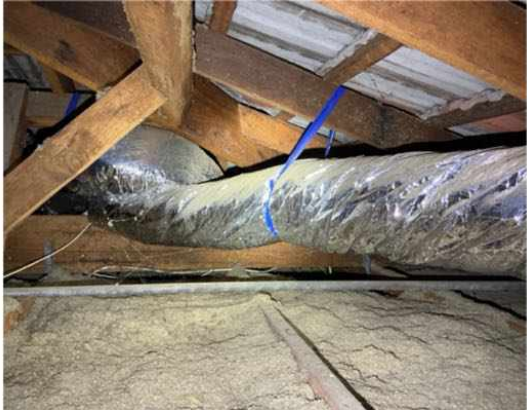
Building: Main Building  
Location: Roof Void  
Finding: Obstructions and Limitations -roof cavity  
Information: These photographs are an indication of the obstructions and limitations which impeded full inspection of the roof cavity at the time of inspection. These obstructions can hide an array of defects and should be removed to allow full inspection to be carried out. A re-inspection is recommended once the areas are made accessible.
