Building and Timber Pest Inspection Report

Inspection Date: Fri, 20 Feb 2026

Property Address: 34 Fantail Cres, Erskine Park NSW 2759,
Australia

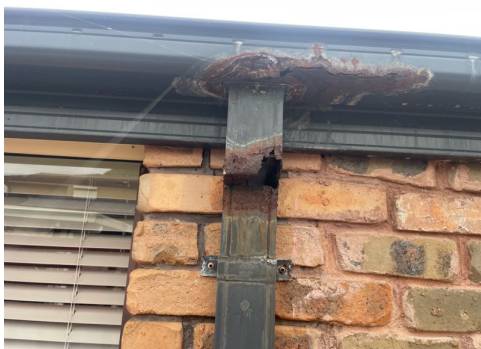
Corrosion at the gutter base reduces the material's structural integrity and can lead to leaks, water overflow, and potential damage to fascias, eaves, and adjoining wall surfaces. It also increases the risk of water ingress into the roof cavity during heavy rainfall.

It is recommended that the affected gutters be inspected and replaced by a licensed roof plumber or qualified trade as a short-term priority to restore effective roof drainage and prevent further water-related damage.

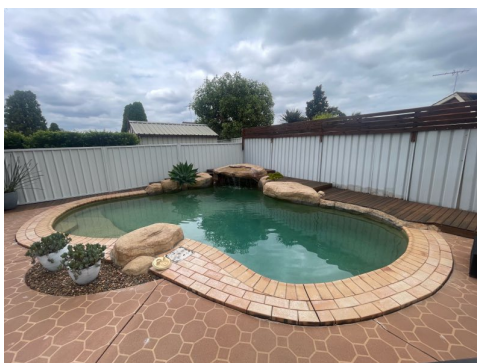
Building:	Main Building
Location:	Swimming Pool
Finding:	Pool fencing/area
Information:	This inspection specifically excludes any inspection of the pool, associated pool equipment and pool surrounds. An inspection should be made by a specialist pool inspector to determine the condition of the pool, pool equipment and surrounds. A pool safety inspection is not included as part of a standard building inspection and must be commissioned separately as a specialist report.

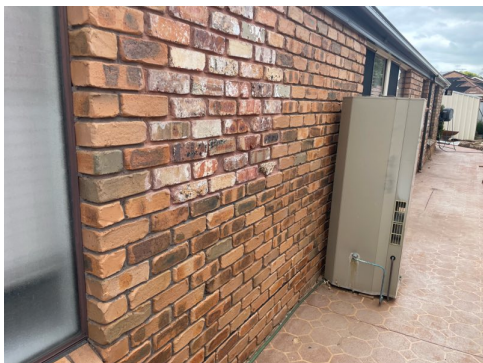
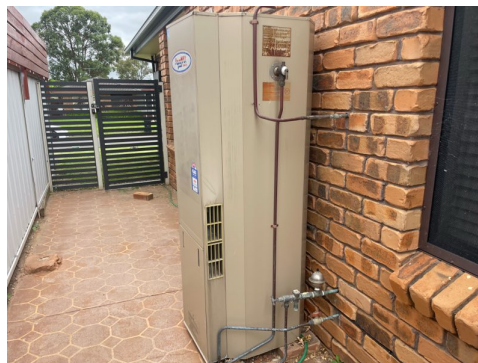
Information: The HWS appeared to be in good condition at the time of inspection. For the date of manufacture - (see attached photo)

Water pressure appears to be normal, however, this is not an opinion of a licensed plumber. No water hammer was noted when taps are turned off fast.
