# Building and Timber Pest Inspection Report

Inspection Date: Tue, 10 Mar 2026

Property Address: 119 Glenmore Ridge Drive, Glenmore Park  
NSW 2745

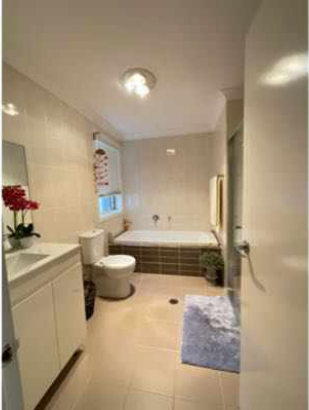
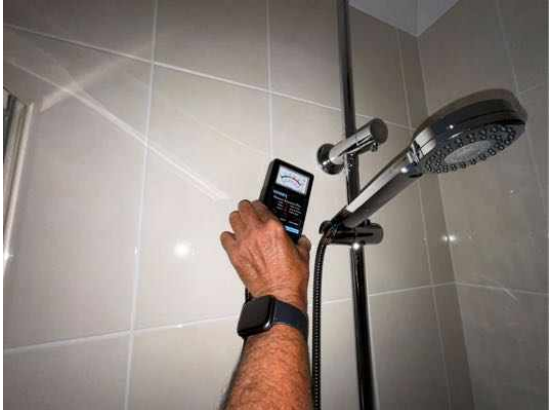
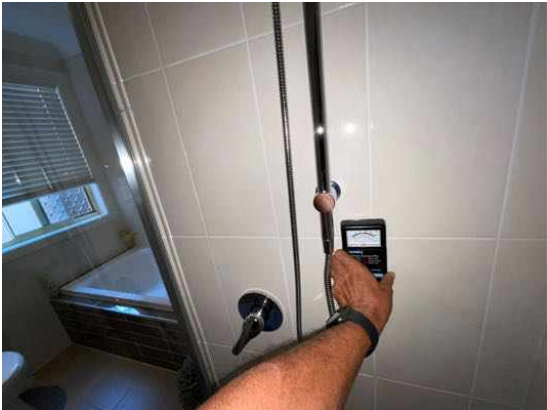
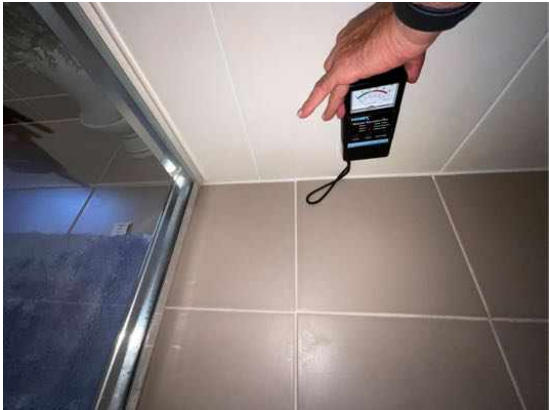
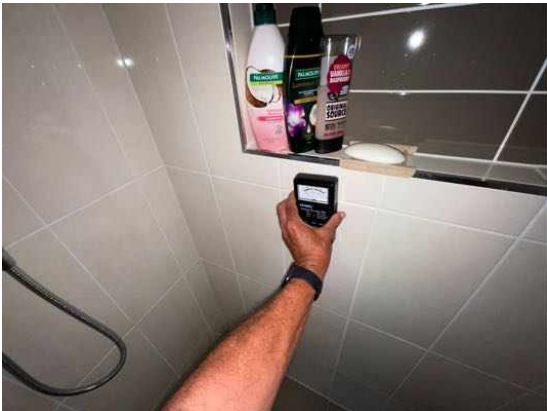
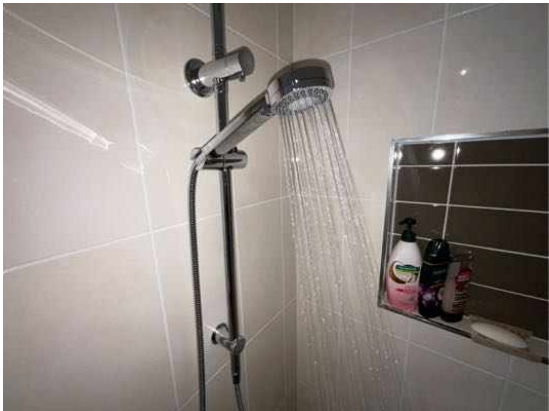
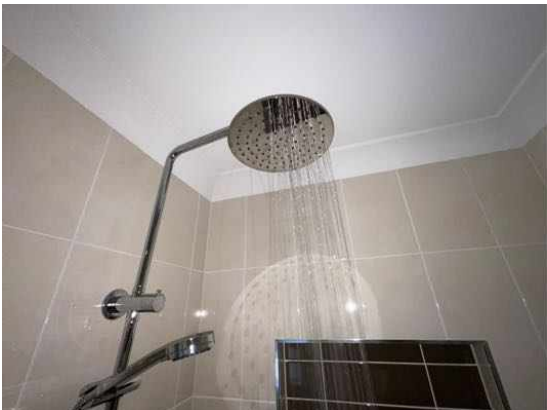
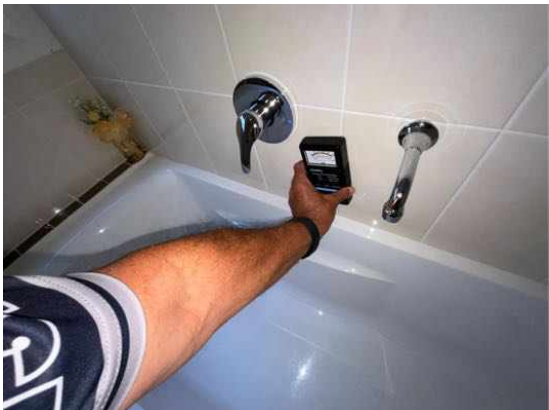
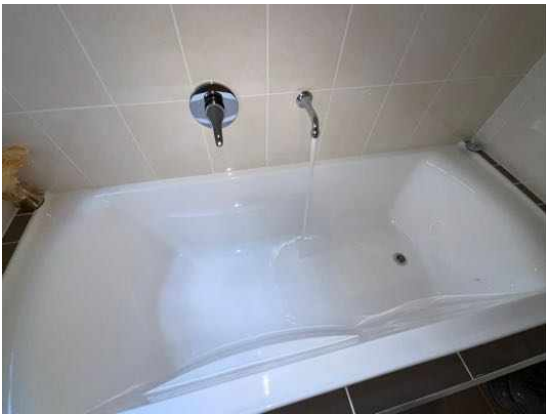
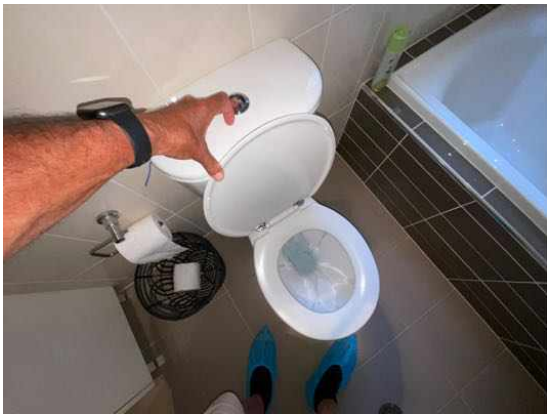
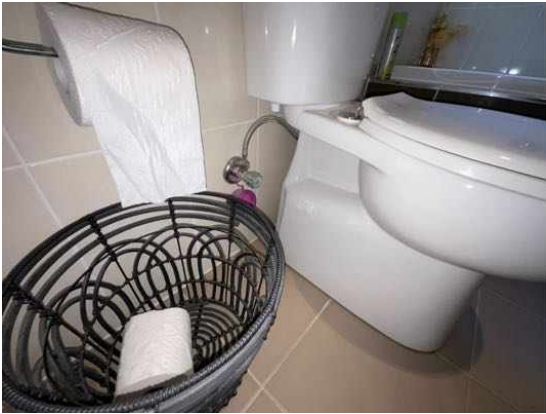
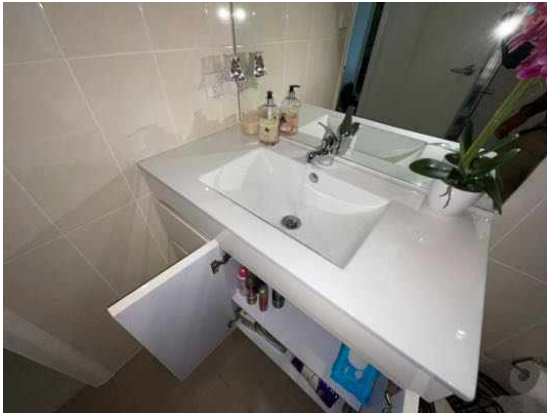
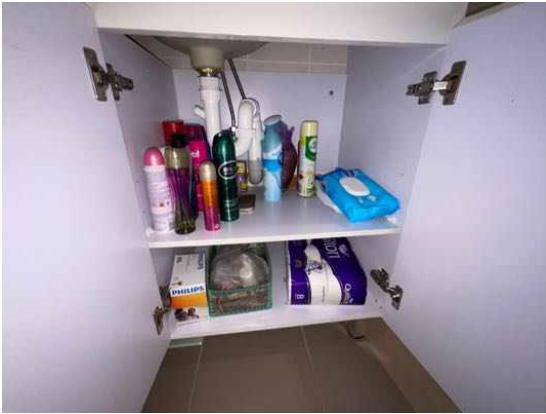
Building: Main Building  
Location: Ensuite  
Finding: Wet Areas - Bathroom(s) - Overall Condition & Recommendations.  
Information: Overall Condition & Recommendations

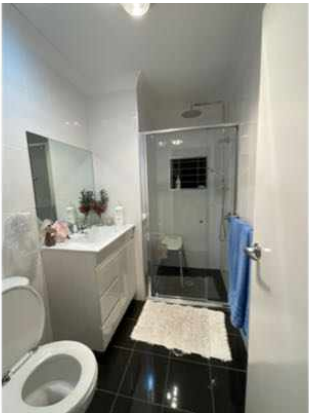
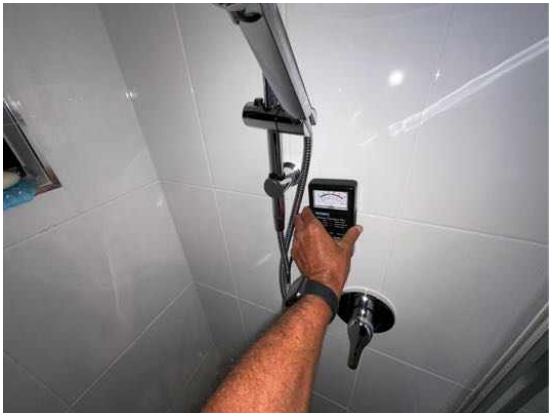
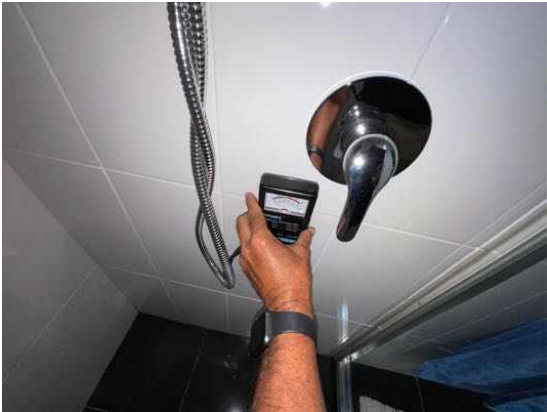
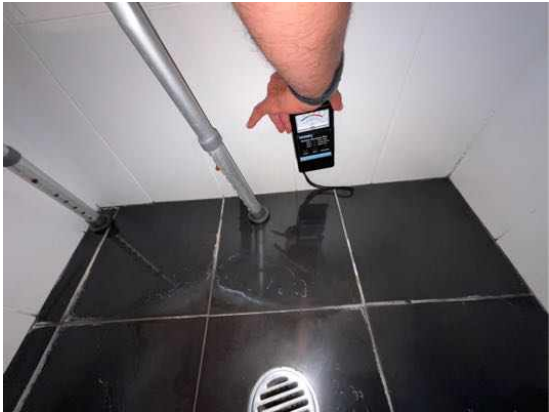
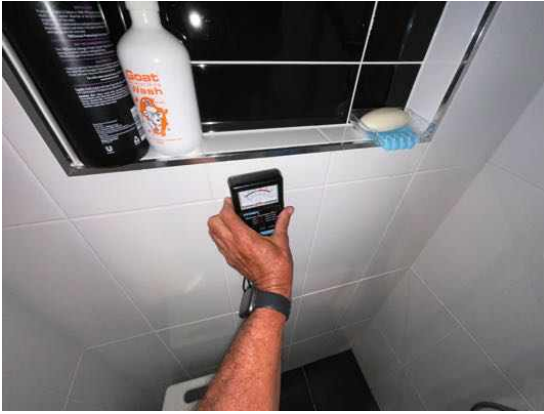
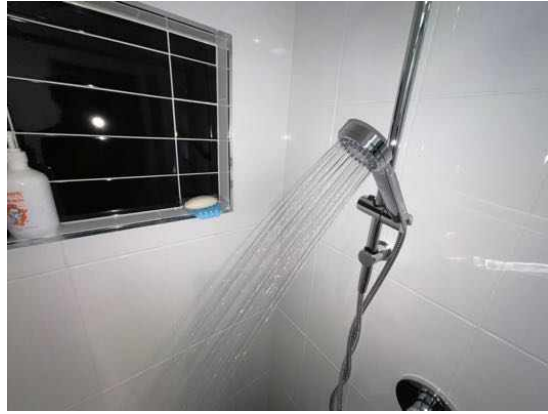
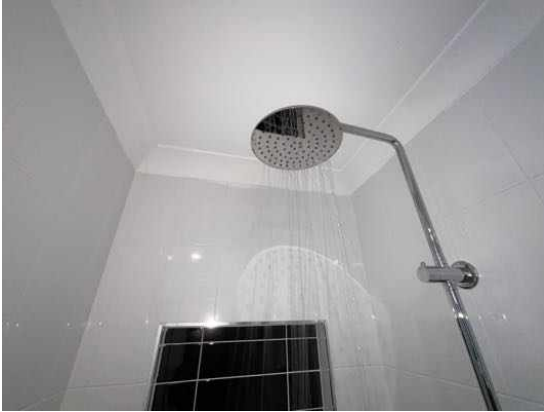
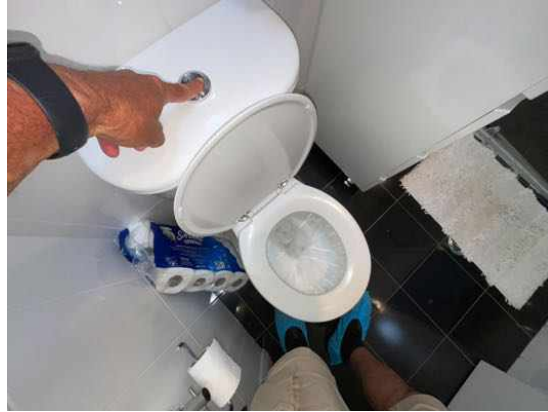
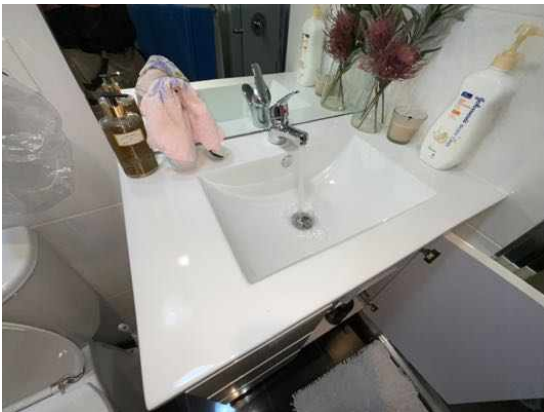
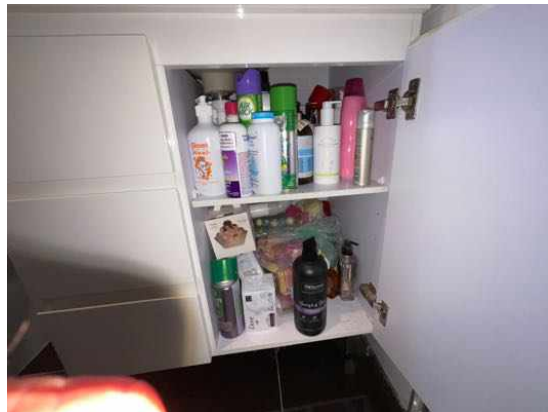
Building: Main Building  
 Location: All Areas  
 Finding: Water Pressure – Observation Only.  
 Information: During the inspection, water pressure appeared to be within a normal operating range based on a basic functional check. However, this observation was made without the use of pressure testing equipment and does not constitute an assessment by a licensed plumber.

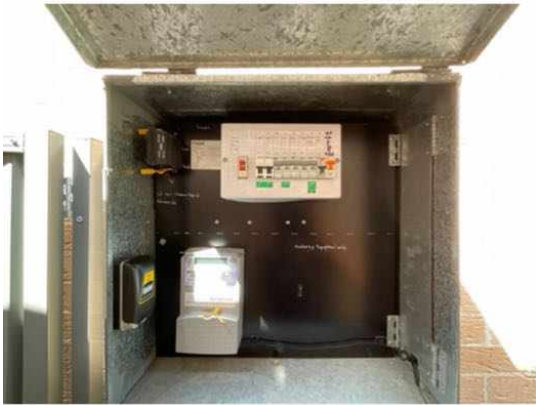
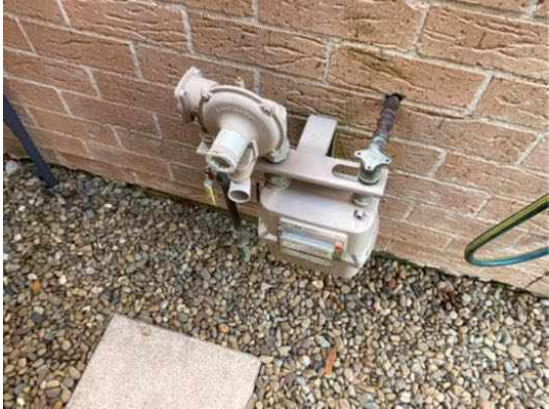
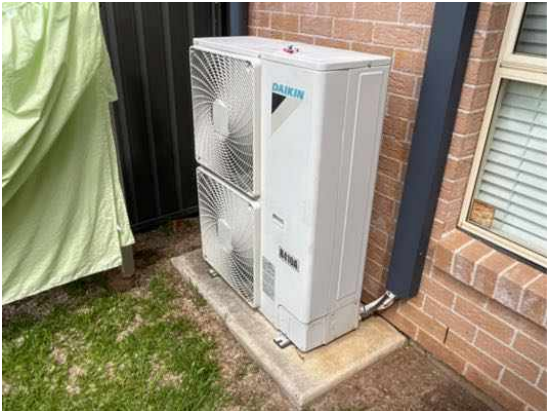
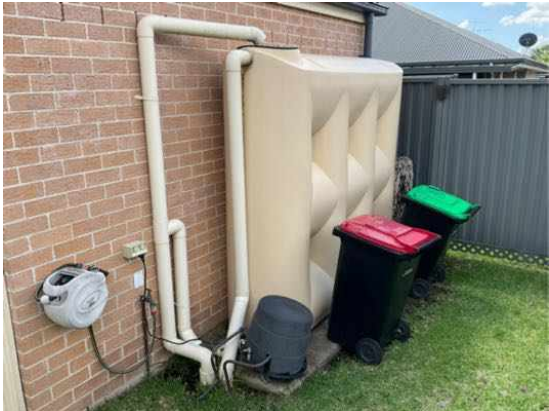
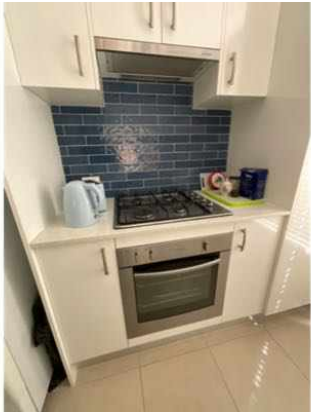
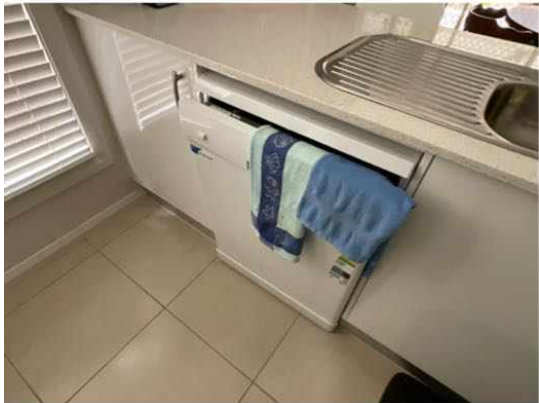
Building: Main Building  
 Location: All Areas  
 Finding: Plumbing, Electrical & Gas Installations – Scope and Recommendations.  
 Information: Plumbing and electrical inspections fall outside the scope of this building inspection and must be carried out by appropriately licensed and registered tradespersons.

- Any gas appliances (if applicable) must be inspected by a licensed gas plumber to confirm they are operating safely and efficiently.
- We also recommend that all other plumbing and electrical installations be thoroughly checked by qualified professionals to ensure they are functioning correctly and meet current safety and compliance standards.

While this inspection includes observations of visually apparent defects relating to plumbing and electrical elements, it does not assess compliance with current regulations. Legislation requires that any such assessment be undertaken and documented by licensed electricians and plumbers.

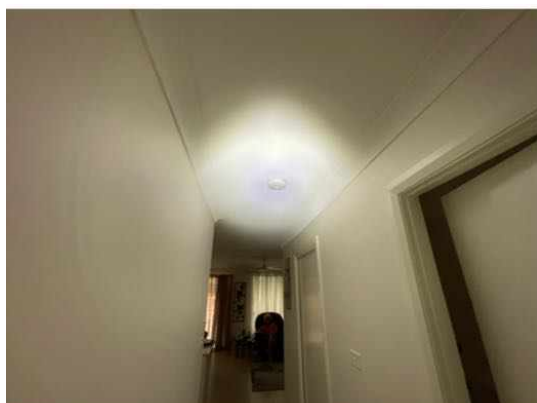
Building: Main Building  
Location: All Areas  
Finding: Smoke Detectors / Alarms.

Failure to comply with these requirements may pose a serious risk to occupant safety.

To ensure compliance and safety, further inspection and/or advisory services from a qualified specialist are recommended. These services can confirm the sufficiency, type, location, and functionality of all smoke detection devices within the property.

- All smoke detectors be tested monthly by the homeowner.
- All systems comply with the requirements of AS 3786 and any applicable state-based legislation.
