Building and Timber Pest Inspection Report

Inspection Date: Wed, 18 Mar 2026

Property Address: 6 Wirreanda Cl, WARRAWEE, NSW, 2074,
Australia

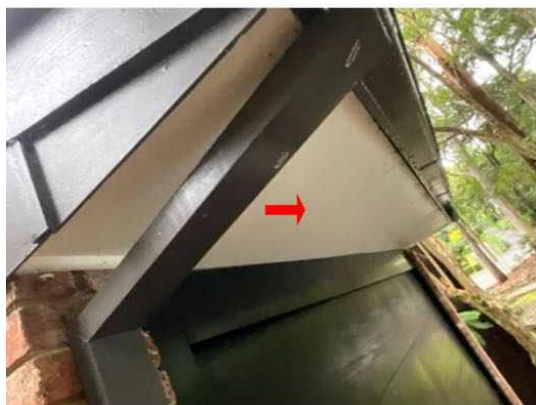
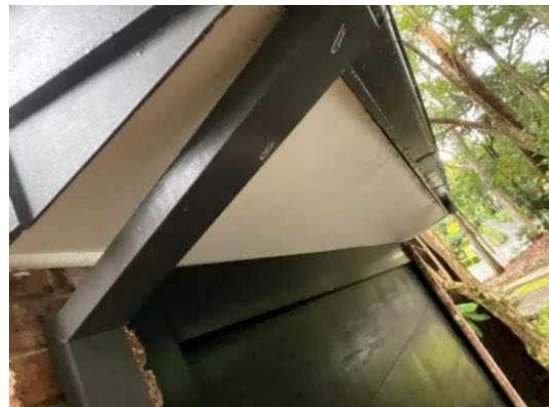
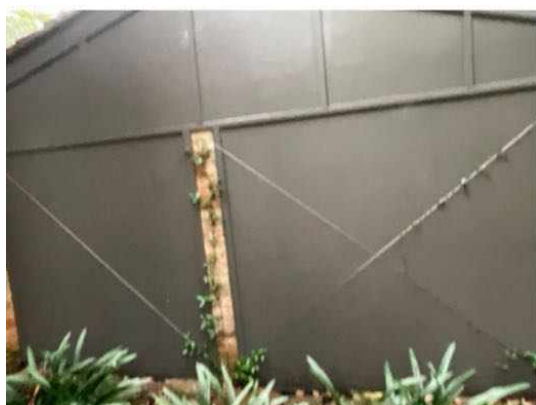
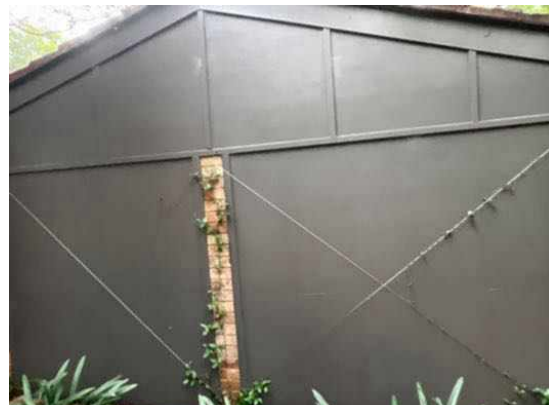
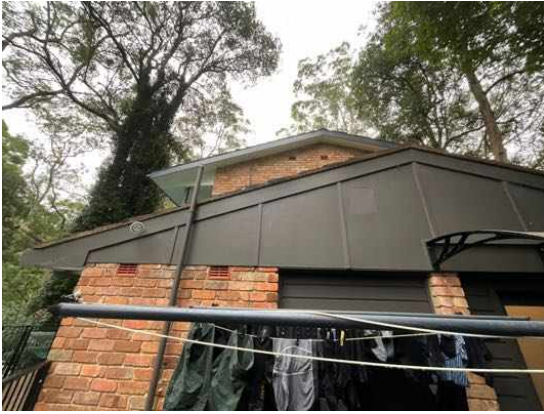
Building:	Main Building
Location:	All Areas
Finding:	Asbestos - Suspected ACM Identified on Site
Information:	Reporting on Asbestos is outside the Scope of this Report. This suspected defect is highlighted as a caution only. We suspect, based on our experience in the building industry, that there is a higher risk of the identified building element containing asbestos.

As Asbestos Reporting is outside the scope of this report, we advise that you consider a separate Asbestos Inspection and Condition Audit, which can include the taking of samples for definitive confirmation of the presence of Asbestos.

In the interim, the client is advised to act with caution, especially when considering any damage to building materials general wear and tear renovations extensions demolition and general maintenance activities due to the suspected presence of Asbestos.

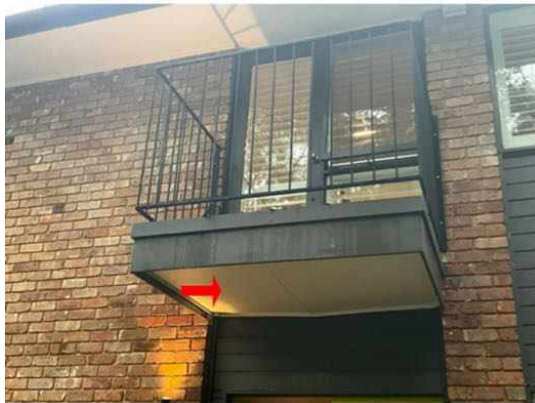
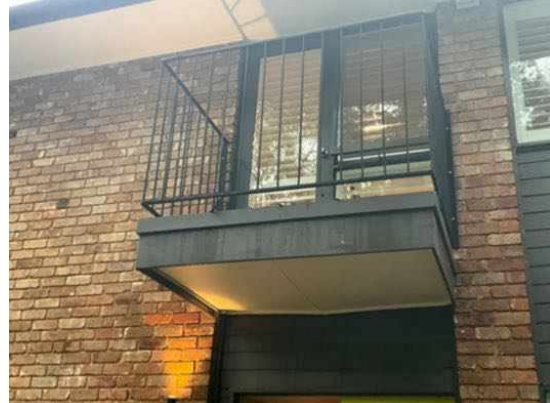
Finding 1.02

Building: Main Building
 Location: All Areas
 Finding: External timber balcony or deck-structural stability
 Information: The load capacity of the external balcony or deck could not be verified during the inspection.

External timber structures are also constantly exposed to weather deteriorates in an exhilarate manner, ongoing assessments are required.

It is highly recommended that a structural engineer further, assess the external timber balcony or a deck to inform the client of its load capacity.

Regular maintenance inspections by competent practitioners is needed.

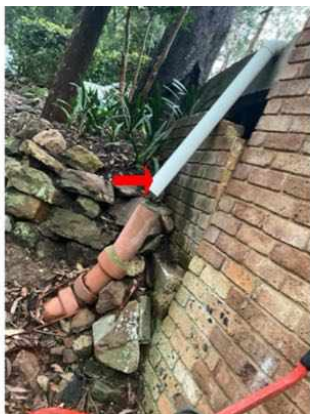
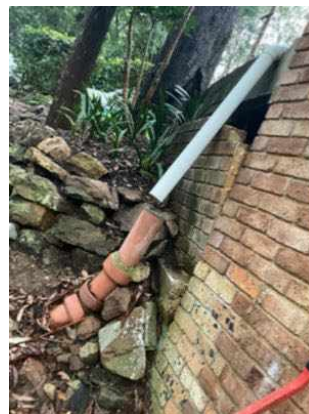
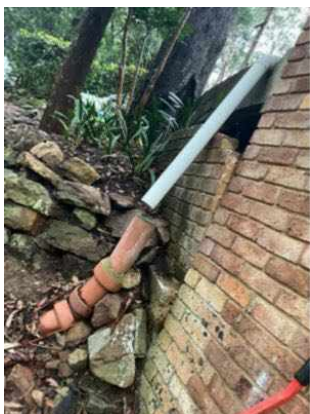
Finding 2.04

Building:	Main Building
Location:	All Areas
Finding:	Soil Erosion Under Structure
Information:	Soil erosion is evident around and beneath the structure's support post, exposing the base and potentially undermining its stability. This erosion appears to be caused by poor drainage and surface runoff.

1. Structural Instability – Continued erosion may weaken the support footing, leading to settlement or movement.
2. Moisture-Related Damage – Water pooling in the eroded area can contribute to rusting of steel components or rotting of timber elements.
3. Trip Hazard – The uneven surface around the post creates a safety risk for occupants and maintenance personnel.
4. Drainage Issues – Erosion can redirect water flow, potentially leading to further issues in the surrounding area.

- Structural Engineer – If significant movement has occurred, an engineer should assess the integrity of the post.
- Landscaper or Drainage Specialist – To improve site drainage and prevent further erosion.
- Builder – To backfill and compact the soil, install protective measures, or reinforce the footing.

Immediate attention is advised to prevent further structural issues and safety risks.

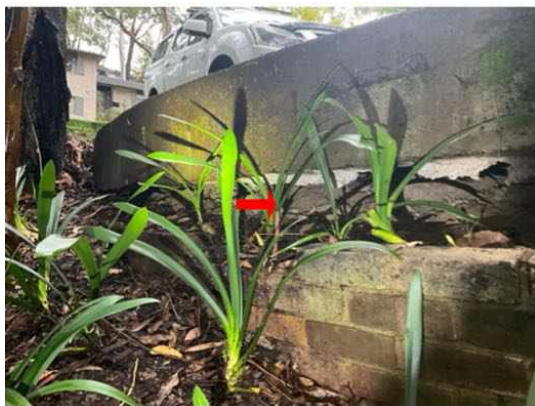
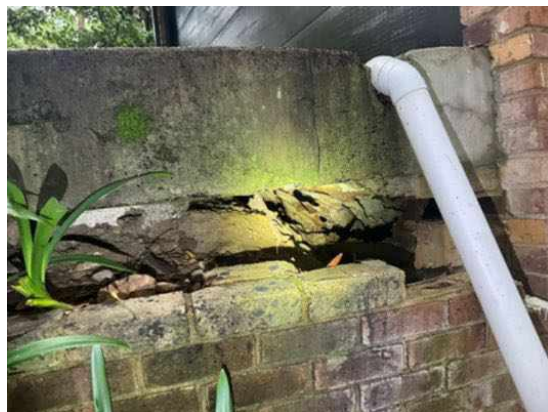
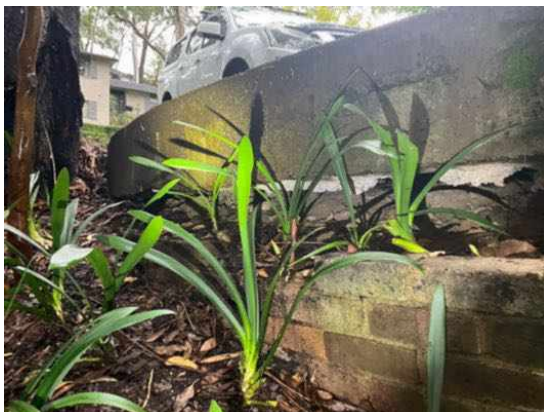
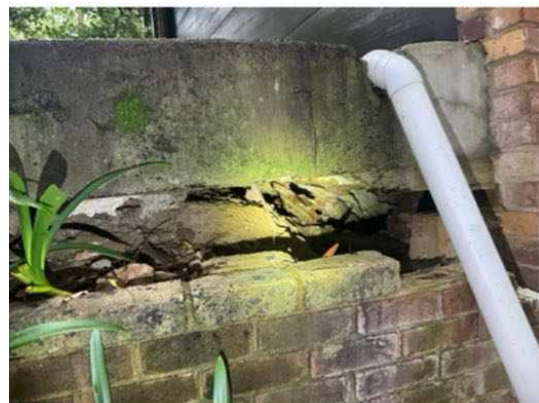
Finding 2.05

Finding: Subfloor- Wood Rot in Bearer and Joist

Information: The bearer and joist in the subfloor show significant wood rot, which has compromised the structural integrity of the timber. Wood rot typically occurs due to prolonged exposure to moisture, and in this case, it has led to severe decay, weakening the timber and reducing its load-bearing capacity. This deterioration poses a critical risk to the overall stability of the floor structure.

- **Structural Risk:** High risk of structural failure in the affected area due to compromised load-bearing capacity. If left unaddressed, this could lead to sagging, uneven floors, or even collapse in extreme cases.
- **Safety Risk:** Elevated safety risk for occupants, as a weakened subfloor could fail under load, posing a potential hazard.
- **Moisture and Decay Propagation Risk:** The presence of rot in the timber can spread if the source of moisture is not addressed, potentially affecting adjacent timbers and leading to widespread damage.

repair or replace faulty fittings, and confirm watertight integrity. A builder may also be required to assess and rectify any structural damage.

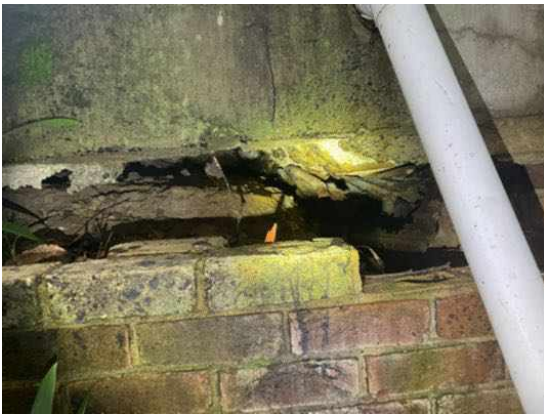
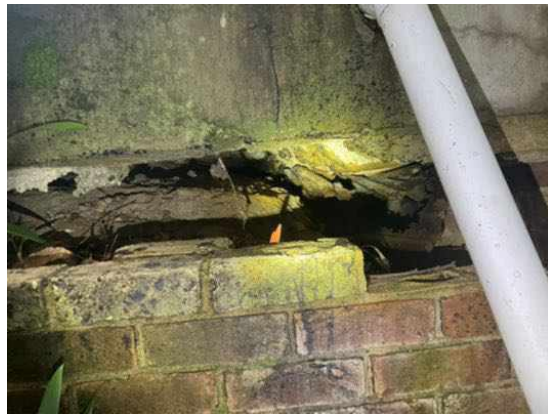
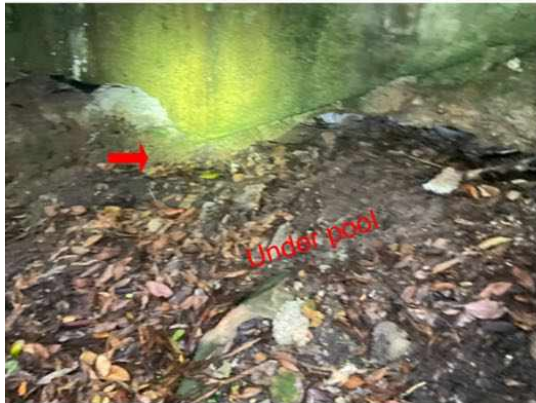
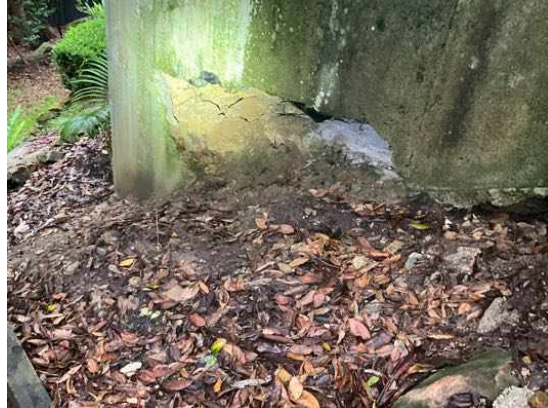
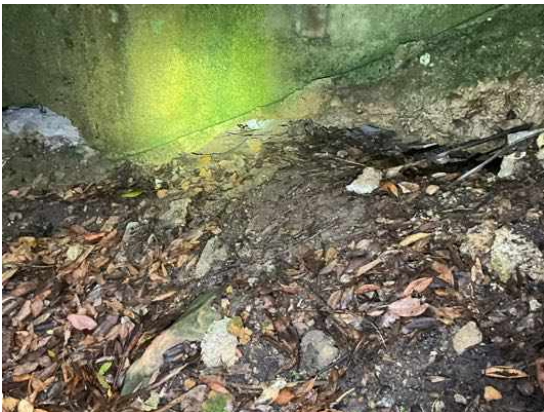
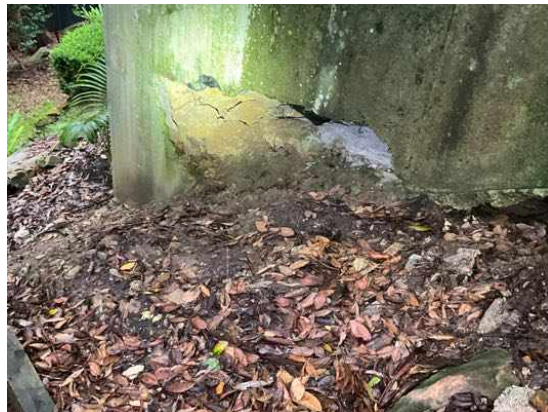
This defect should be classified as a major defect due to the severe impact on structural integrity and safety. Immediate action is required to rectify the issue and maintain the building's stability.

- **Engage a Licensed Carpenter or Structural Engineer:** A qualified carpenter or structural engineer should assess the extent of the damage and replace the affected bearer and joist. They will ensure the replacement timbers are adequately treated and installed to meet structural standards.
- **Address Moisture Source:** It is critical to identify and eliminate the moisture source contributing to the wood rot. Improving subfloor ventilation, repairing leaks, or installing a moisture barrier may be necessary to prevent future decay.

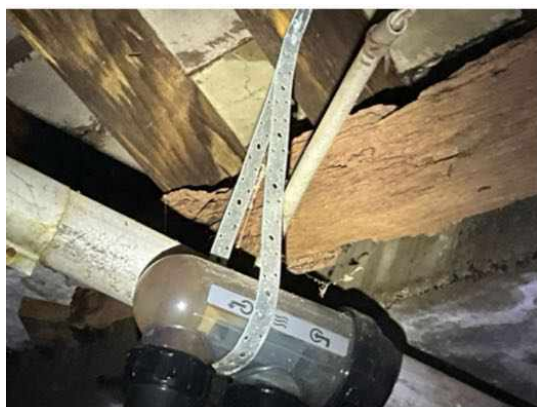
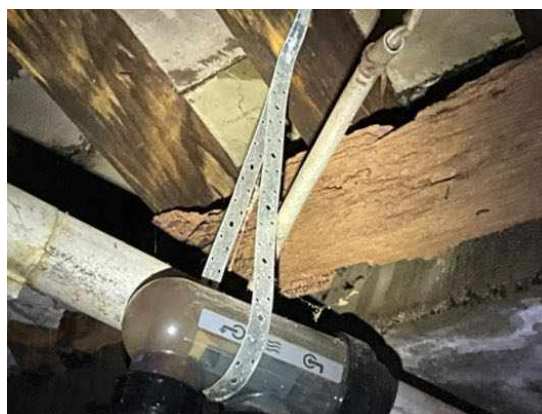
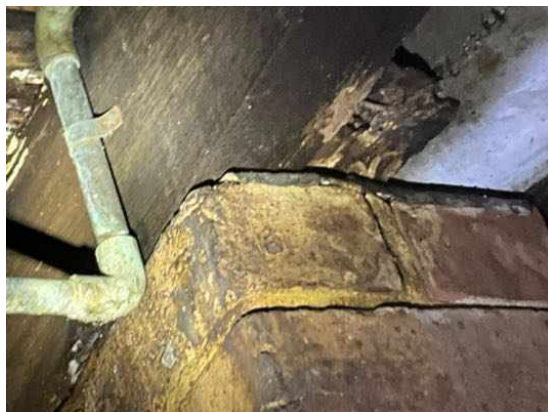
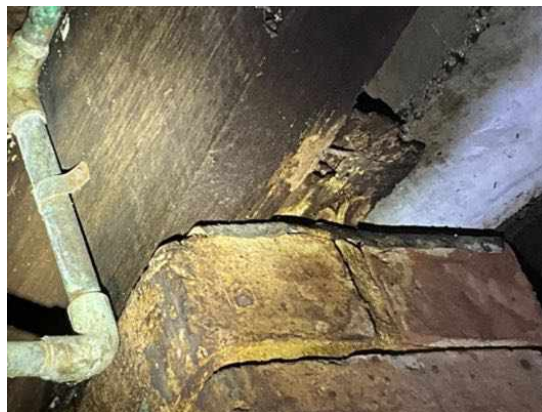
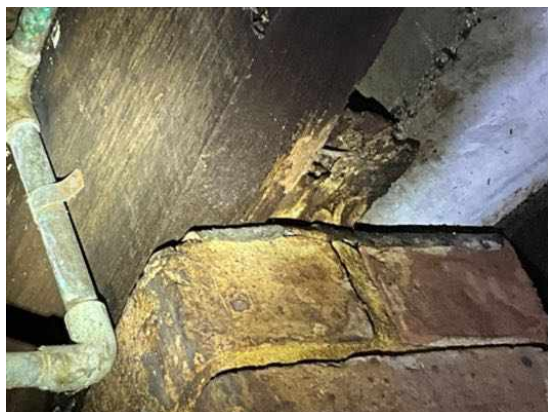
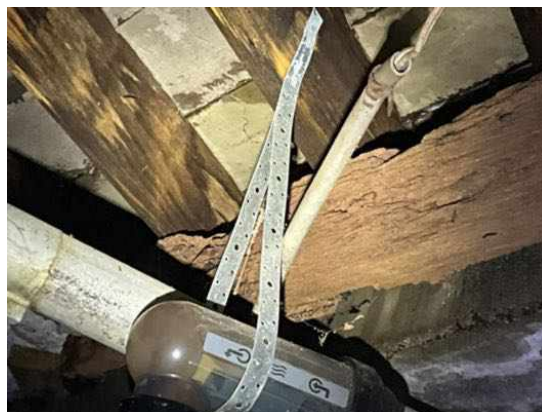
Finding 2.06

Building:	Main Building
Location:	Subfloor
Finding:	Subfloor- leaking plumbing fittings
Information:	Evidence of leaking plumbing fittings was observed within the subfloor area. Moisture staining and timber deterioration suggest prolonged water exposure from faulty pipe joints or fixtures.
Risk:	<ul style="list-style-type: none"> • Structural damage to timber framing and flooring due to continuous moisture exposure. • Mould growth and decay, posing potential health risks and further degradation of building materials. • Pest attraction, as damp environments are conducive to termites and other pests. • Non-compliance with plumbing standards and risk of escalation if not addressed promptly.
Who Can Fix It:	<ul style="list-style-type: none"> • A licensed plumber should be engaged to identify the exact source of leakage,

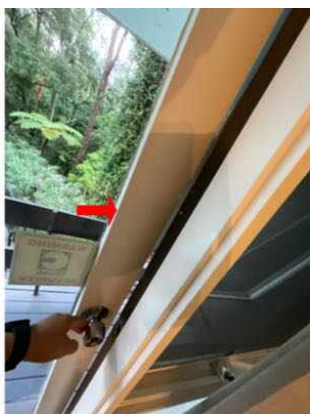
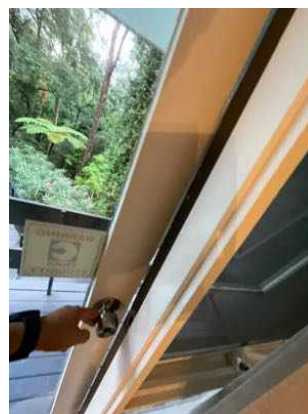
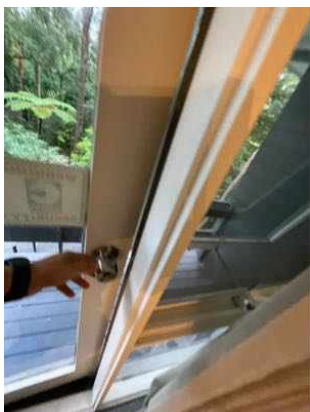
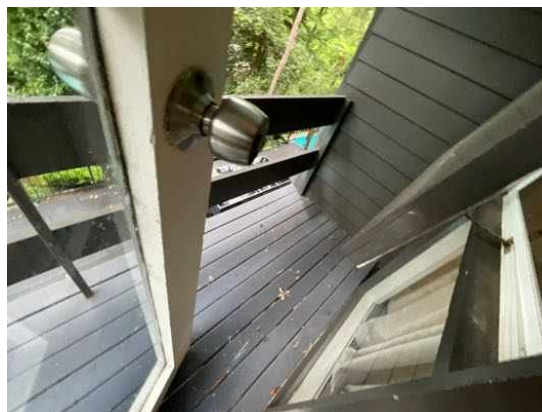
Finding 3.07

Building:	Main Building
Location:	Balcony 2
Finding:	Door - Binding/jamming
Information:	Binding and/or jamming of this door is evident during standard operation. This defect inhibits the functionality of the affected door as well as creating potential for secondary defects to associated building elements.

A door that binds to flooring or to the associated door frame may have several causes, ranging from minor defects, such as poor installation of the door or deteriorated hinges, through to major structural issues. For minor causes, a qualified carpenter or general handyman should be appointed to perform minor rectification works at client discretion.

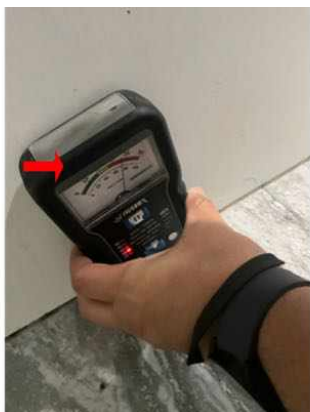
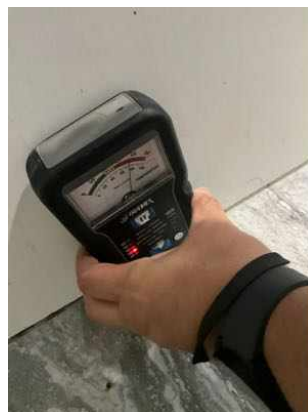
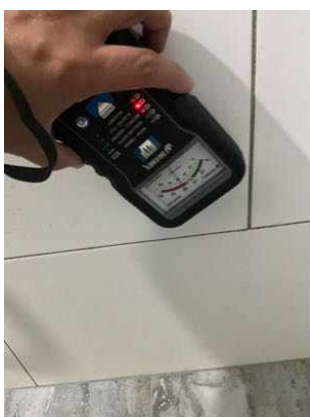
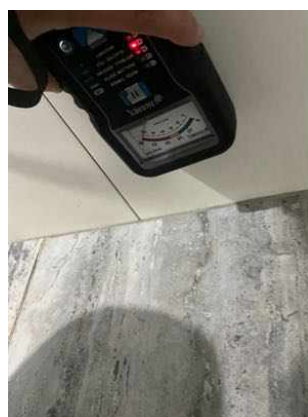
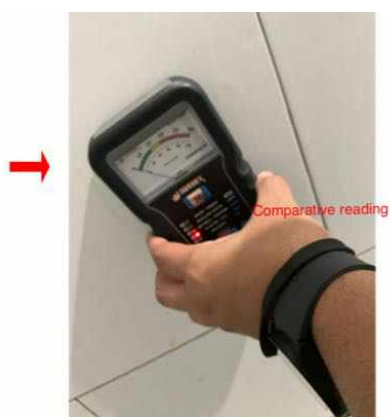
Finding 3.08

Building:	Main Building
Location:	Ensuite
Finding:	Shower - Damp
Information:	Damp is evident to the lower 300mm of wall to the shower alcove. This defect is quite common, and is suspected to have been caused by moisture permeating through the grouting in this area, which shows evidence of deterioration. Leaking pipes within the adjoining wall is also a possible cause.

Damp (or structural damp) refers to the presence of unwanted moisture in the structure of a building, either as the result of intrusion from outside, or condensation from within the structure. In the shower area, internal water leaks or other sources of excessive moisture are generally the cause of damp.

Unmanaged damp in the shower recess is likely to facilitate the formation and development of mould and fungi growth, decaying associated building materials and compromising their structural integrity. It is important to address damp conditions, as the World Health Organisation notes that excess moisture leads - on almost all indoor materials - to growth of microbes such as moulds, fungi and bacteria, which subsequently emit spores and other matter into the indoor air. Exposure to these contaminants is associated with a wide range of respiratory and other health-related problems.

Consultation with a qualified plumber or bathroom specialist is advised immediately to identify the cause of damp and to perform remedial works as required. Where excessive mould growth is present, further inspection by a specialist environmental health inspector should also be considered.

Always ensure that sealant and grout is in good condition to prevent any moisture issues occurring in the future.

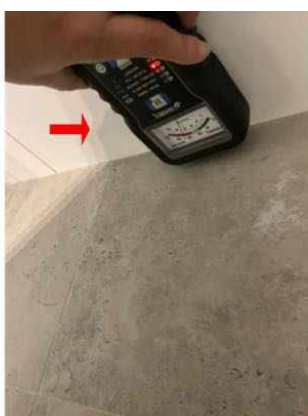
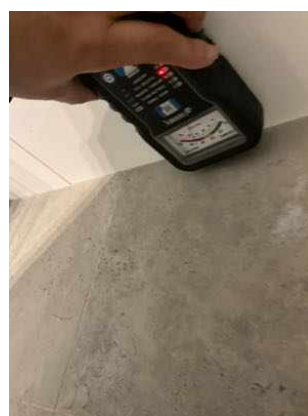
Finding 3.09

Building: Main Building
Location: Bathroom upstairs

Information: Damp is evident to the lower 300mm of wall to the shower alcove. This defect is quite common, and is suspected to have been caused by moisture permeating through the grouting in this area, which shows evidence of deterioration. Leaking pipes within the adjoining wall is also a possible cause.

Damp (or structural damp) refers to the presence of unwanted moisture in the structure of a building, either as the result of intrusion from outside, or condensation from within the structure. In the shower area, internal water leaks or other sources of excessive moisture are generally the cause of damp.

Unmanaged damp in the shower recess is likely to facilitate the formation and development of mould and fungi growth, decaying associated building materials and compromising their structural integrity. It is important to address damp conditions, as the World Health Organisation notes that excess moisture leads - on almost all indoor materials - to growth of microbes such as moulds, fungi and bacteria, which subsequently emit spores and other matter into the indoor air. Exposure to these contaminants is associated with a wide range of respiratory and other health-related problems.

Consultation with a qualified plumber or bathroom specialist is advised immediately to identify the cause of damp and to perform remedial works as required. Where excessive mould growth is present, further inspection by a specialist environmental health inspector should also be considered.

Always ensure that sealant and grout is in good condition to prevent any moisture issues occurring in the future.

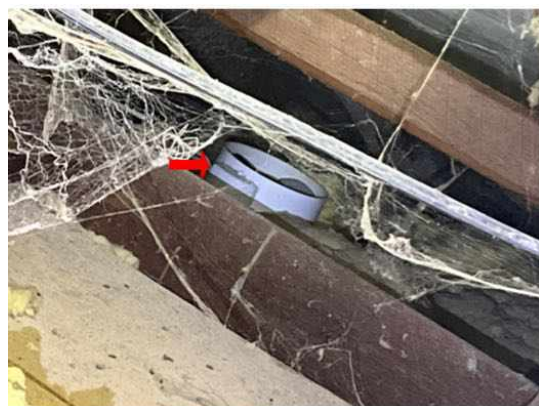
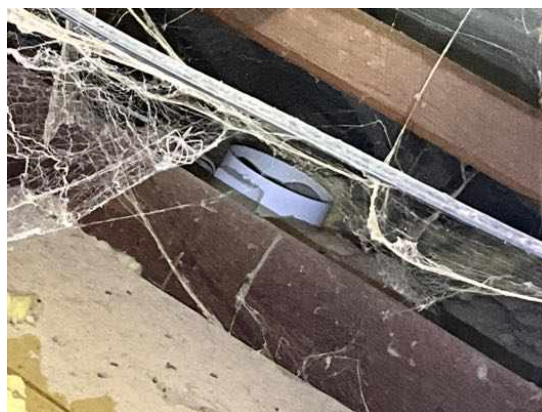
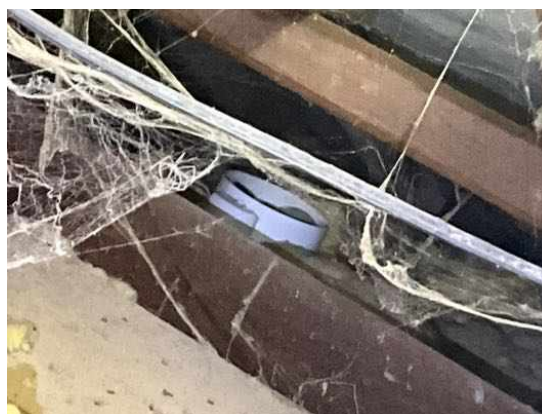
Finding 3.10

Building:	Main Building
Location:	Roof Void
Finding:	Exhaust fan not vented out
Information:	The exhaust fan located within the roof void is not appropriately ducted to the external atmosphere and is currently discharging moist air directly into the roof space. This is considered a defect under AS 4349.1, as it does not meet the minimum standard of residential building performance expected under normal residential building practices.

This condition may lead to excessive condensation within the roof void, increasing the risk of mould growth, deterioration of insulation, timber decay, and overall reduced durability of building elements. It may also result in poor indoor air quality, potentially affecting occupant health.

It is recommended that the exhaust fan be modified by a licensed HVAC contractor or qualified builder, ensuring it is properly ducted to discharge externally in accordance with manufacturer specifications, the National Construction Code (NCC), and applicable Australian Standards.

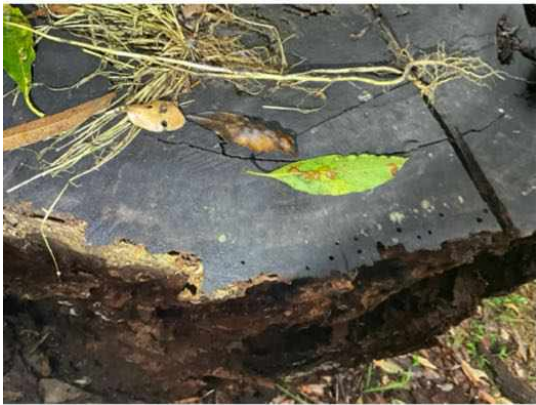
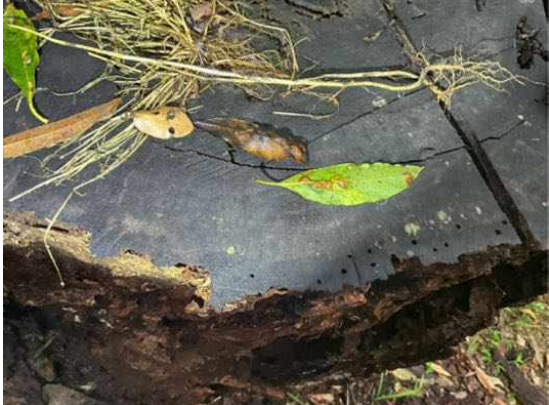
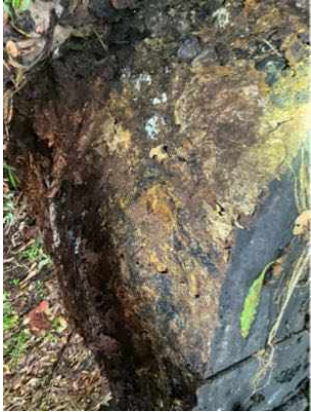
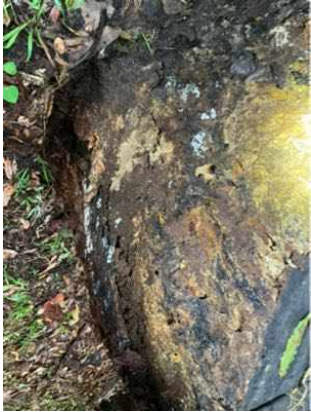
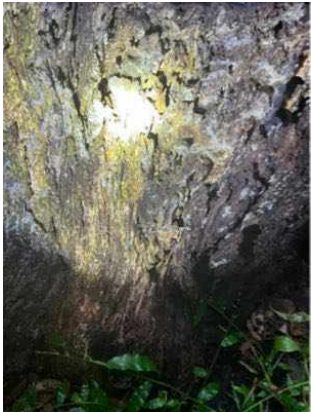
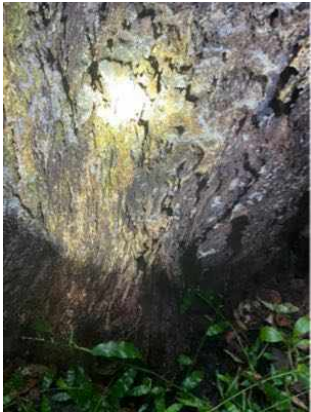
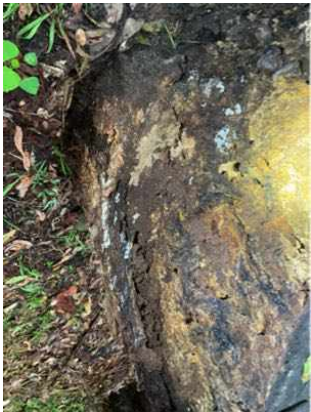
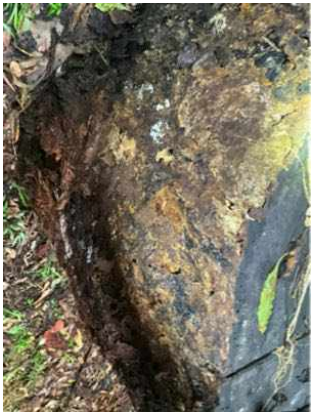
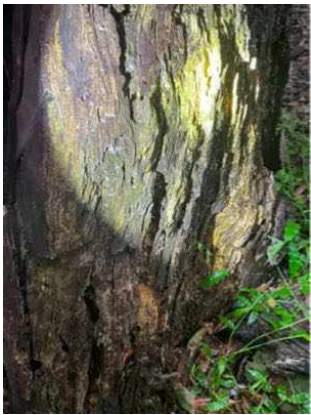
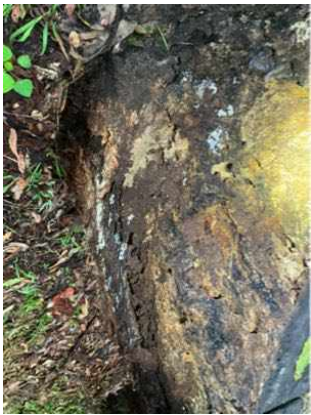
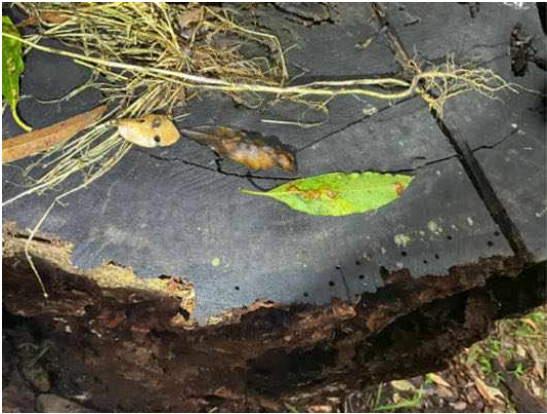
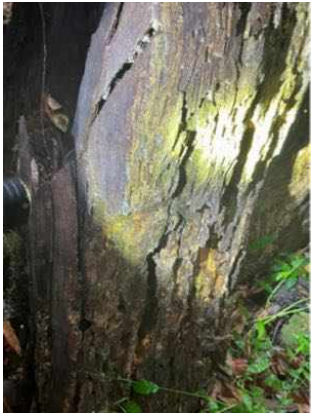
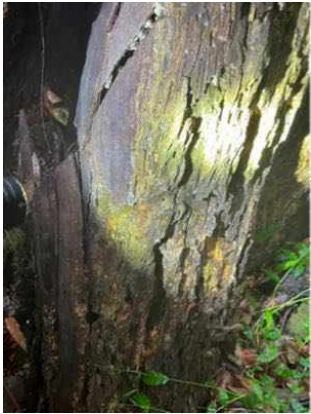
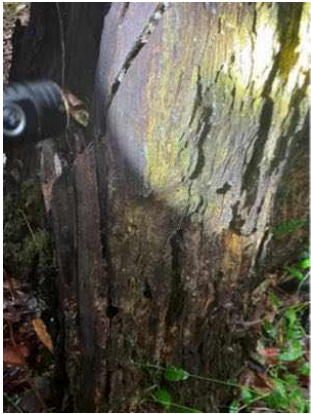
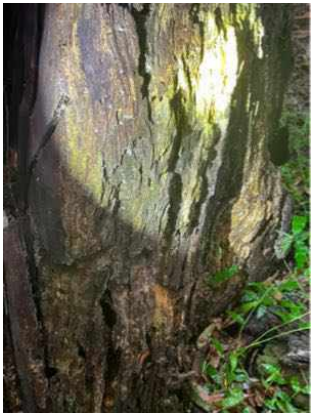
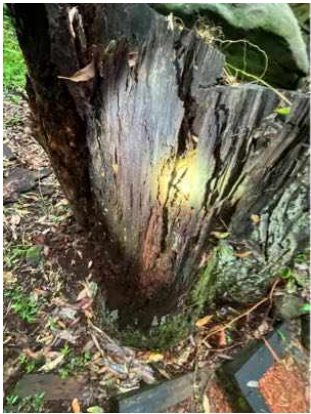
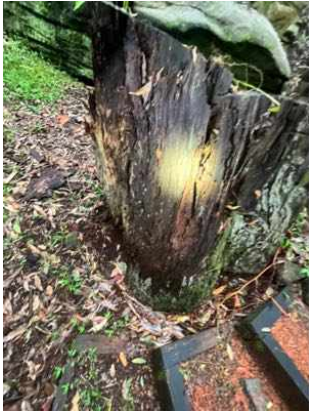
Building: Main Building
 Location: Yard - Back
 Finding: Suspected - Timber pest damage
 Information: Despite no live termite or timber pest activity being indicated, suspected previous timber pest damage was found to have affected this area. This damage is considered to be inactive at the time of inspection.

It is advised that the area be visually inspected frequently to ensure that the condition of affected building materials does not worsen.

A licensed pest controller must be appointed to provide a further invasive inspection.

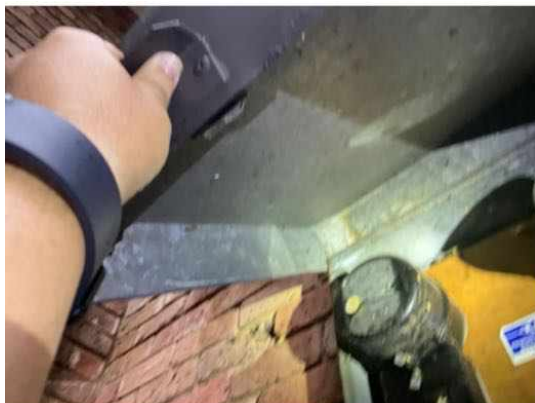
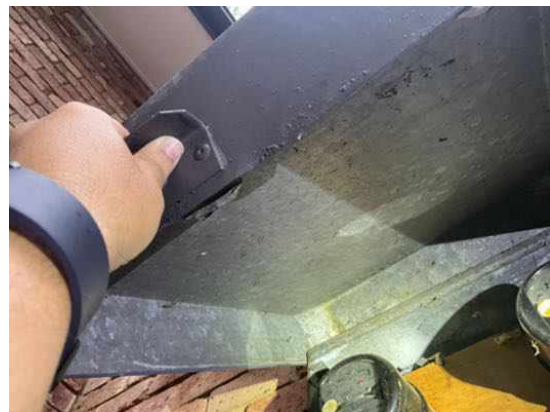
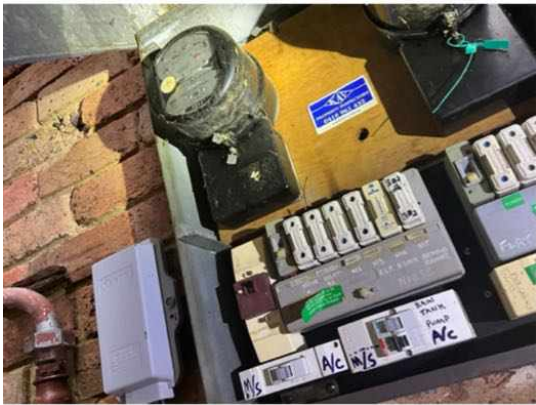
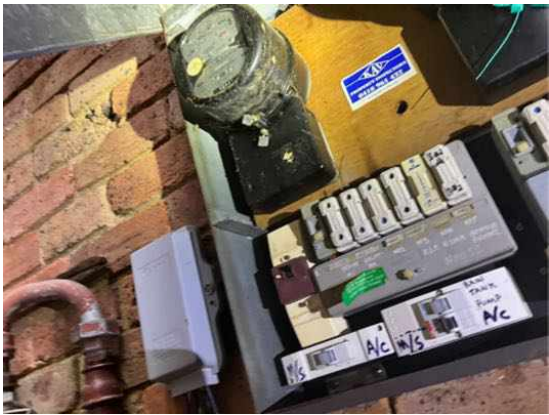
Finding 6.01

Building:	Main Building
Location:	Exterior walls - rear
Finding:	No Evidence of Termite Management System - Durable notice / Legible Sticker
Information:	The application of a pre & post-construction chemical termite barrier is highly recommended for all properties. Such barriers are highly effective in preventing termite attack on any timber building elements throughout the property.

A durable notice was not placed in the switchboard unit to indicate current termite barriers is legible at the time of inspection.

Client must seek further information from the vendor or real estate agent if the conditions of termite management systems were maintained.

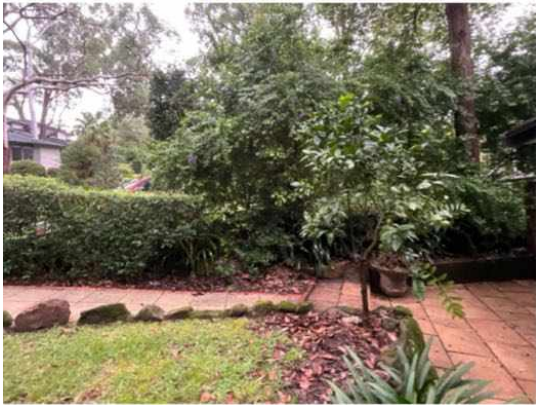
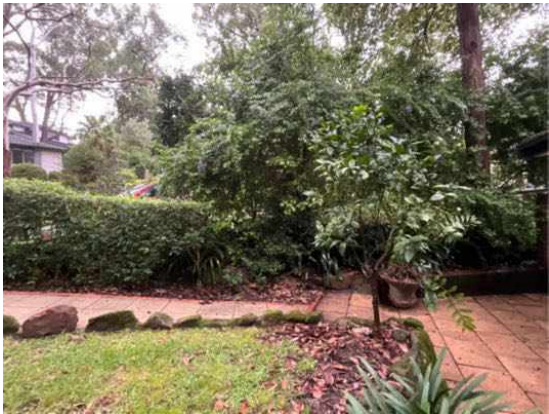
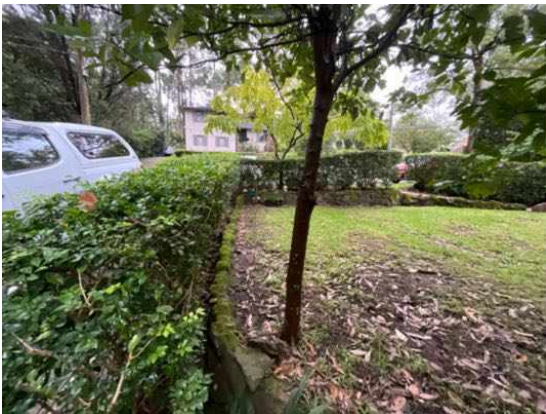
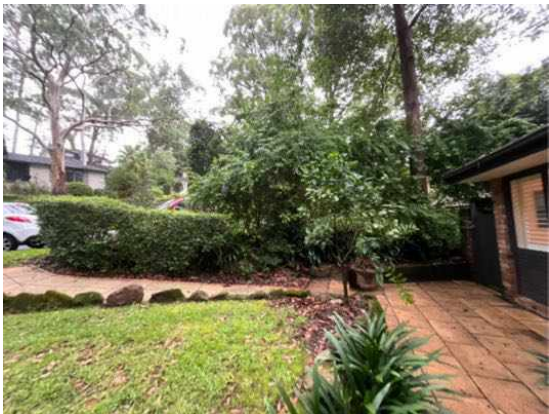
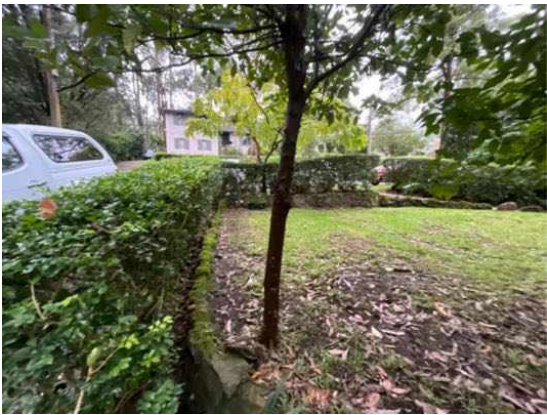
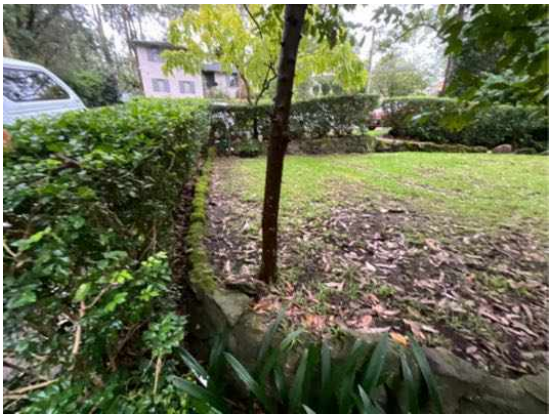
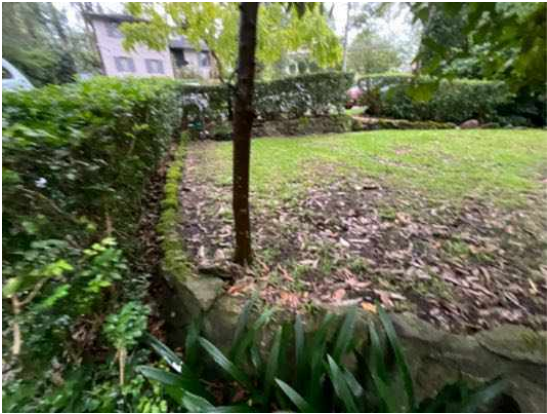
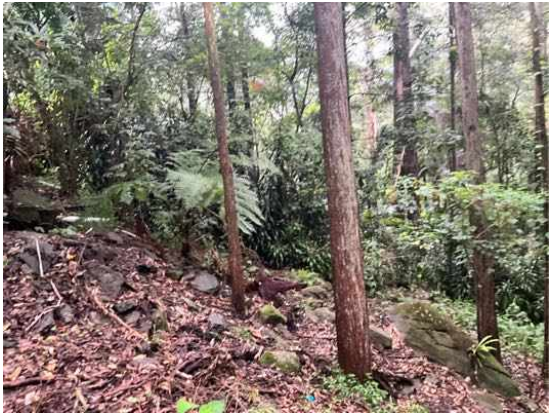
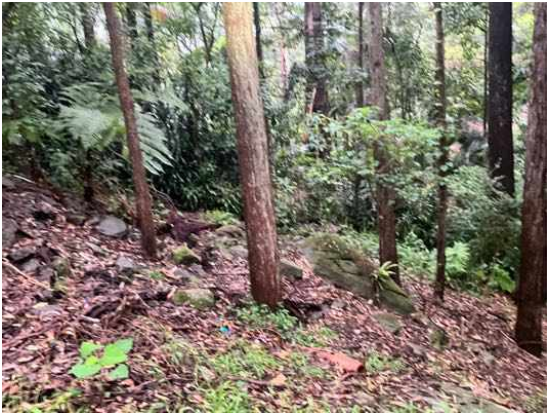
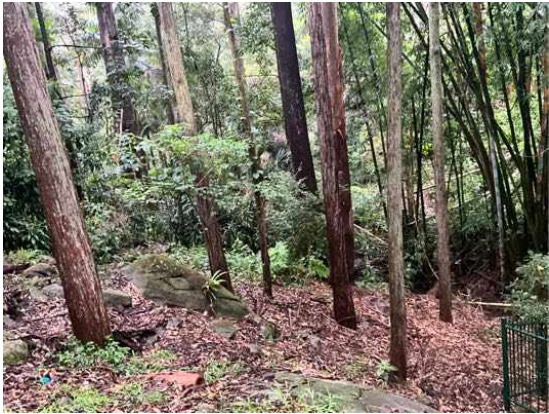
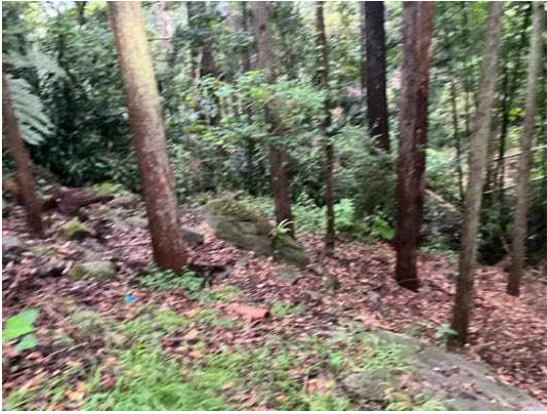
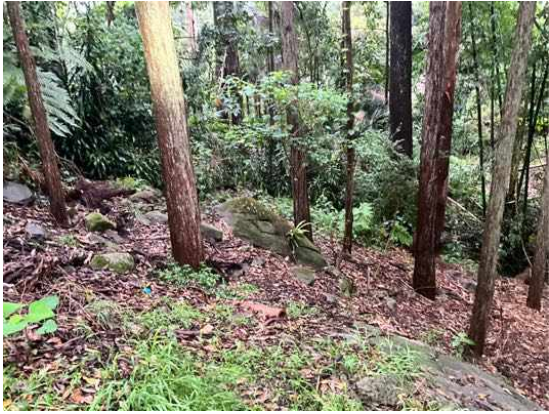
Finding 6.02

Building: Main Building
Location: All Areas
Finding: Dense vegetation around a property can increase the risk of termite infestation
Information: The presence of dense vegetation around a property can increase the risk of termite infestation, as it provides a conducive environment for them. To address this, consider maintaining a clear space between the vegetation and your home. If you suspect a termite issue, it's advisable to consult with a licensed pest control professional for inspection and treatment.

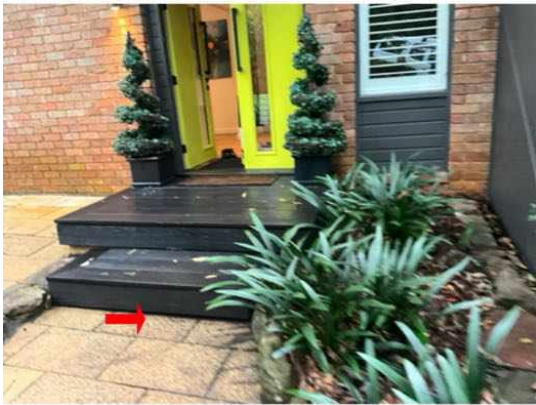
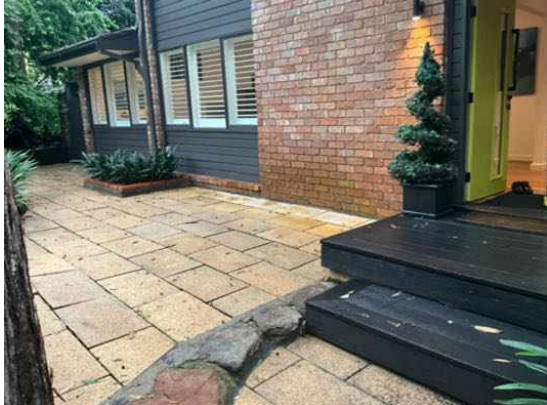
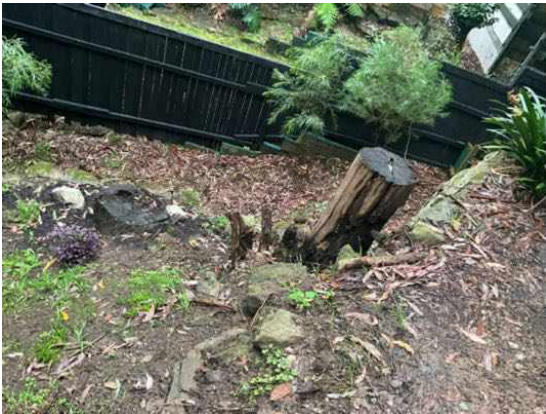
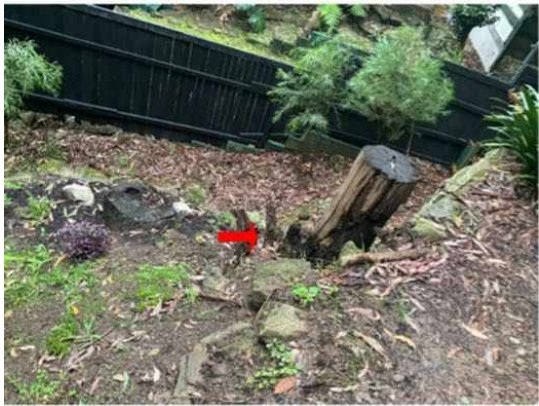
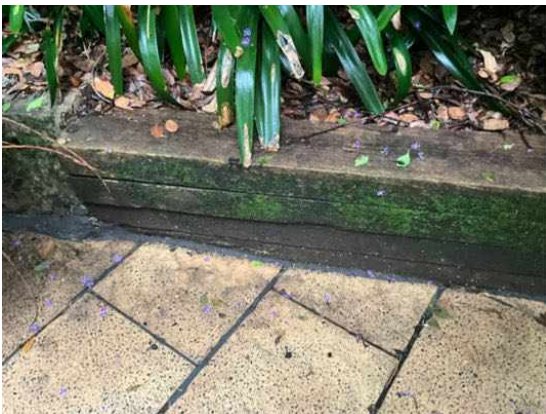
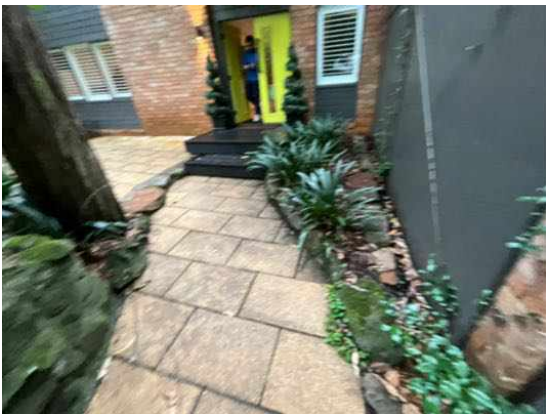
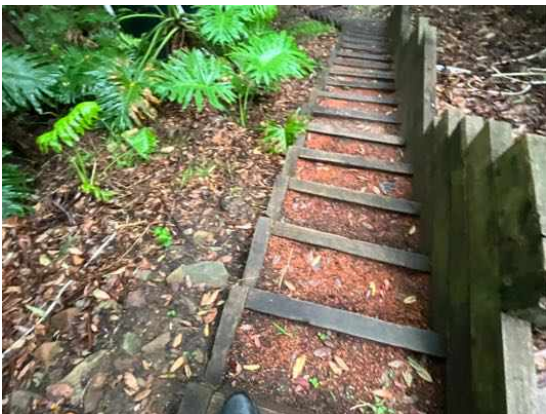
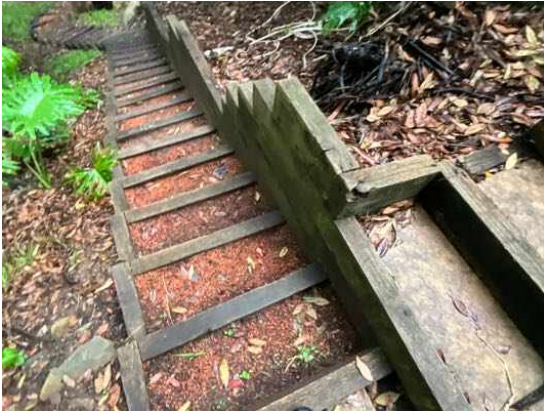
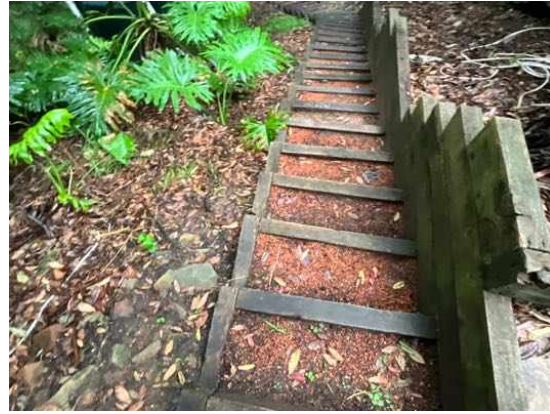
Finding 6.03

Building: Main Building
 Location: All Areas
 Finding: Timber on ground / conducive conditions to termite damage
 Information: Timber on the ground is indeed conducive to termite damage. Termites are known to thrive in moist environments, and wood in contact with soil or moisture is more susceptible to infestation.

To prevent this, it's important to keep timber elevated and away from direct ground contact. Regular inspections and proper termite control measures are also essential to protect your wooden structures from termite damage.

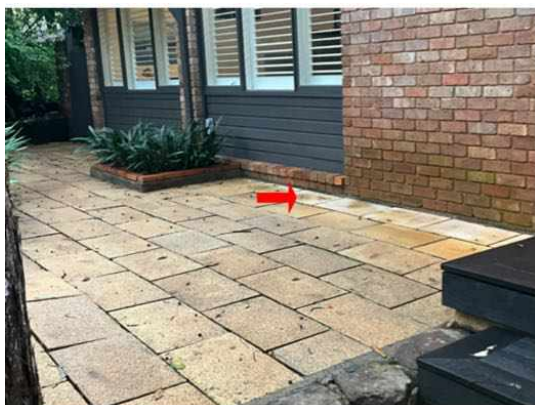
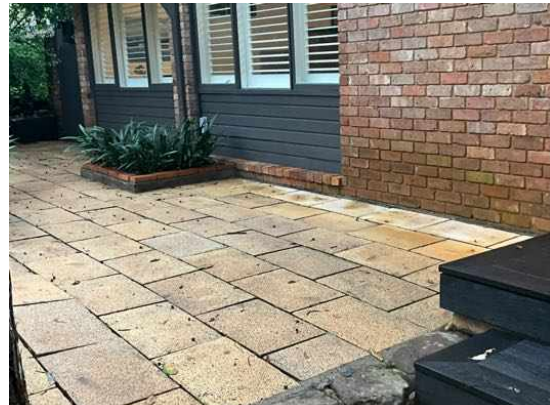
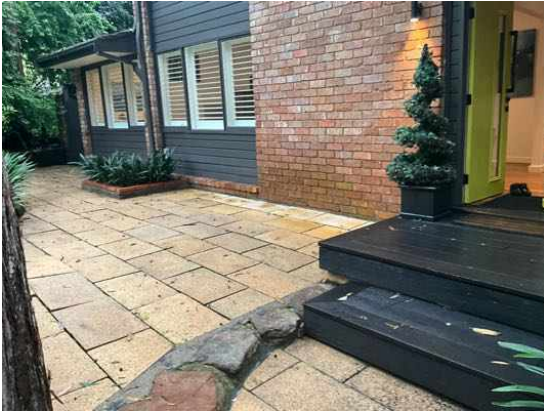
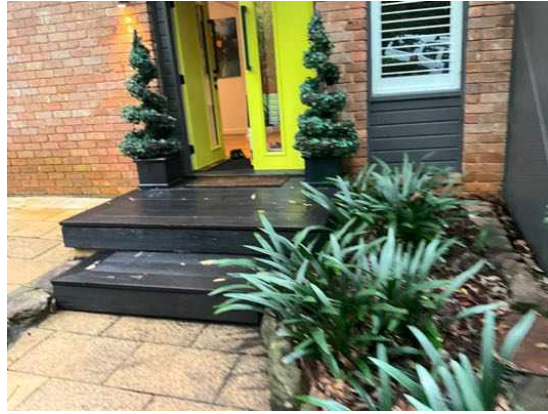
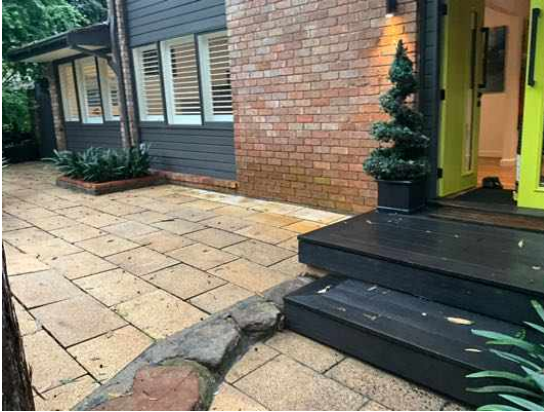
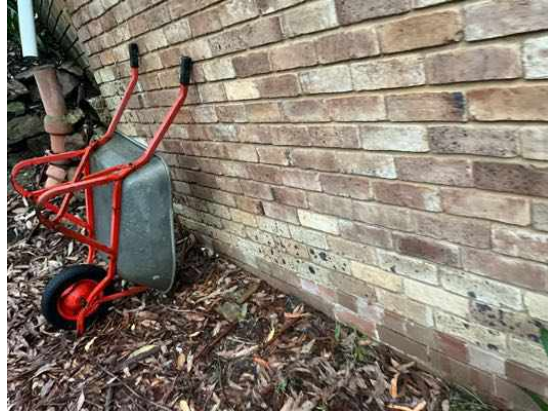
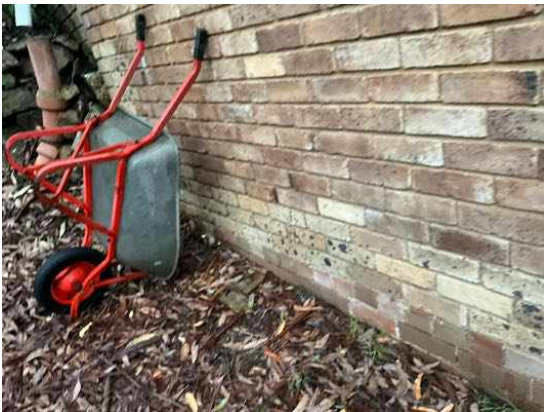
Finding 6.04

Building: Main Building

If the slab edge is not properly exposed there is a high risk of termite attack. Sometimes, in order to determine the type of slab, a suitably qualified person such as an architect or builder may be required to consult the construction plans.

Where the slab edge cannot be properly inspected, it is highly recommended that termite or timber pest inspections be carried out every 6-12 months to aid protection of the property against infestation.

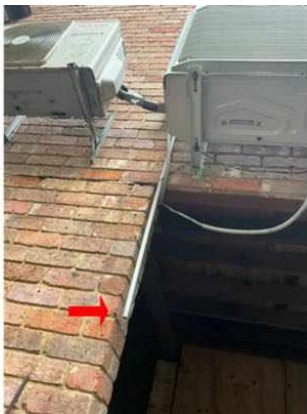
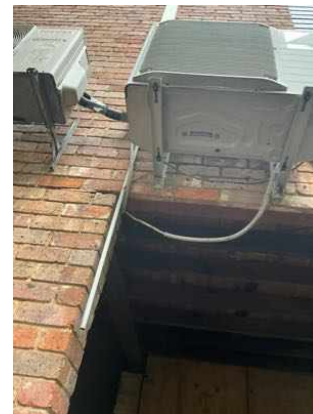
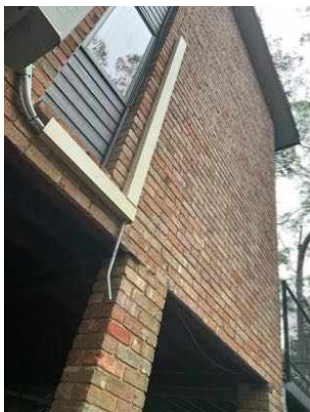
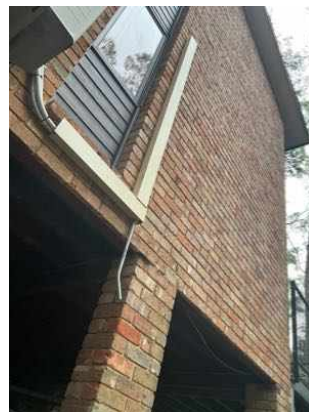
Finding 6.05

Building:	Main Building
Location:	All Areas
Finding:	Aircon - Excessive moisture conducive condition near Air-conditioner
Information:	<p>Excessive moisture near an air conditioner can indeed create conducive conditions for termites. Termites are attracted to damp and decaying wood, which can be found in areas with high moisture levels. To fix this issue:</p> <ol style="list-style-type: none"> 1. Fix Leaks: Check for any leaks or condensation around your air conditioning unit. Repair any damaged pipes, drains, or insulation that may be causing moisture buildup.

2. Proper Drainage: Ensure that your air conditioner has proper drainage. Make sure the condensate drain line is clear and directed

away from your home's foundation.

3. Ventilation: Improve ventilation around the unit. Ensure that the area is well-ventilated to reduce humidity levels.

4. Regular Maintenance: Schedule regular maintenance for your air conditioning system. This can help prevent leaks and ensure

it's working efficiently, reducing the chance of moisture.

5. Please consult a HVAC Technician: HVAC (Heating, Ventilation, and Air Conditioning) technicians are trained to diagnose and

repair a wide range of air conditioning problems. They can handle issues with the cooling system, refrigerant, electrical components, and more.

6. Consult an appropriate and Qualified Professional: For severe moisture issues or persistent termite problems, consult with a

pest control professional who can provide targeted solutions.
