Building and Timber Pest Inspection Report

Inspection Date: Wed, 18 Mar 2026

Property Address: 6 Wirreanda Cl, WARRAWEE, NSW, 2074,
Australia

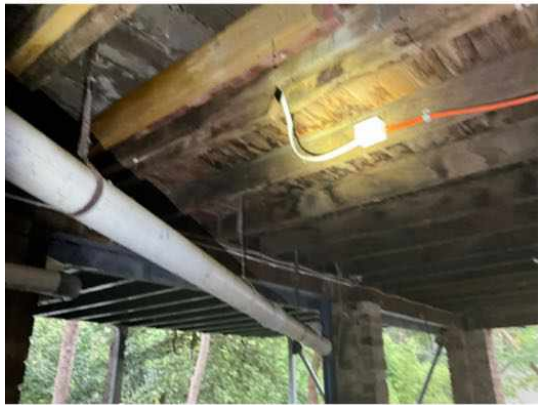
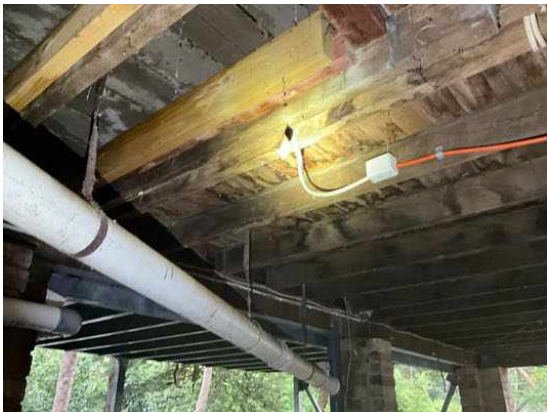
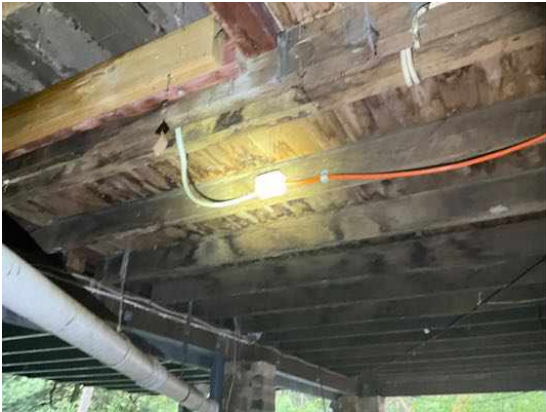
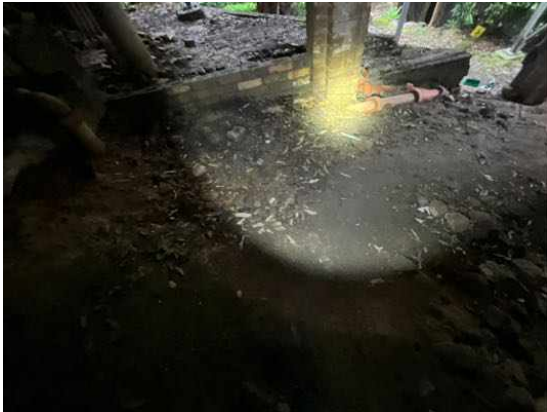
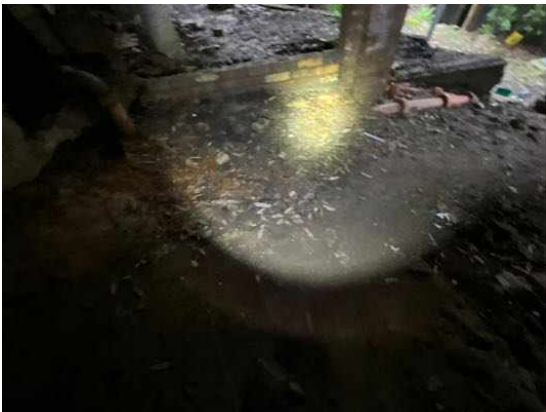
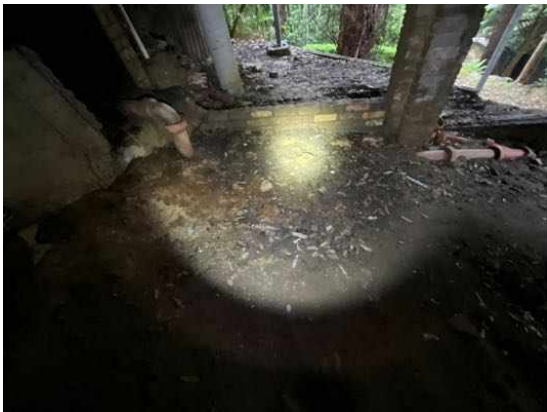
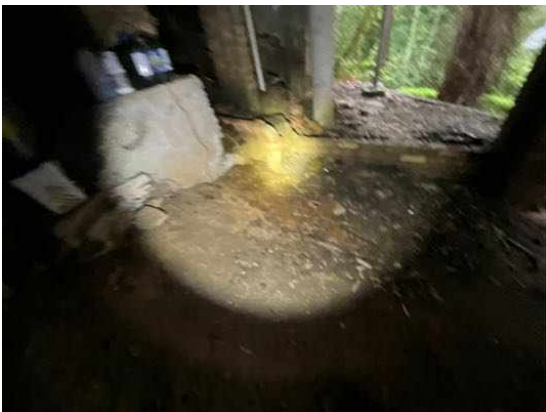
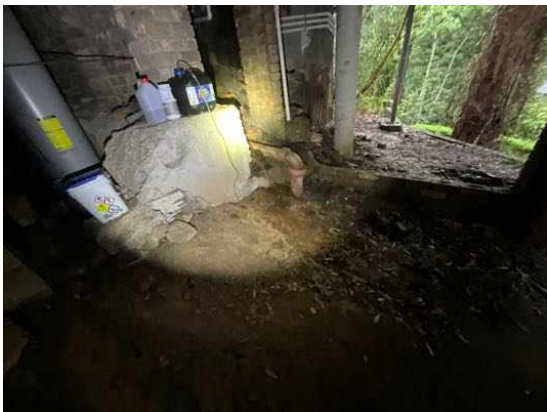
Finding 6.06

Building:	Main Building
Location:	Subfloor
Finding:	Subfloor - poor ventilation, inadequate site drainage, water stains
Information:	The subfloor lacks adequate ventilation, suffers from inadequate site drainage, exhibits water stains, creating conducive conditions for timber pests such as termites.

Risk: The combination of poor ventilation, inadequate drainage, water stains significantly increases the risk of timber pest infestations. Termites are attracted to moist environments and can thrive in subfloors with high humidity levels and water damage. The lack of proper ventilation and drainage exacerbates moisture retention, providing an ideal habitat for timber pests to establish colonies and cause extensive damage to the subfloor structure. Additionally, water stains indicate previous or ongoing moisture issues, which further attract timber pests and contribute to the deterioration of timber materials.

A licensed pest control professional specializing in timber pest management should be consulted to assess the extent of the infestation and develop a comprehensive treatment plan. They can implement strategies to eliminate existing timber pests, such as termites and prevent future infestations by addressing underlying moisture issues. Additionally, a qualified plumber or builder may be needed to improve subfloor ventilation, enhance site drainage, repair water-damaged areas. Regular inspections and maintenance are essential to ensure ongoing protection against timber pests and maintain the structural integrity of the subfloor.

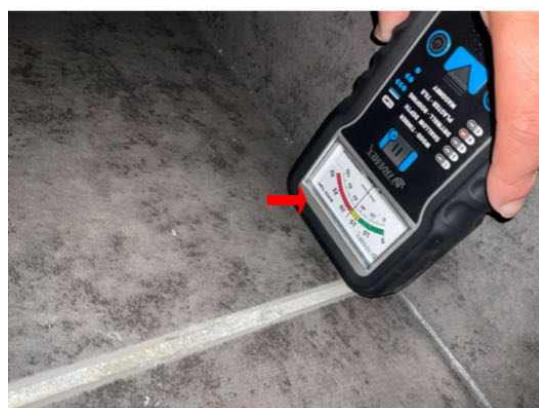
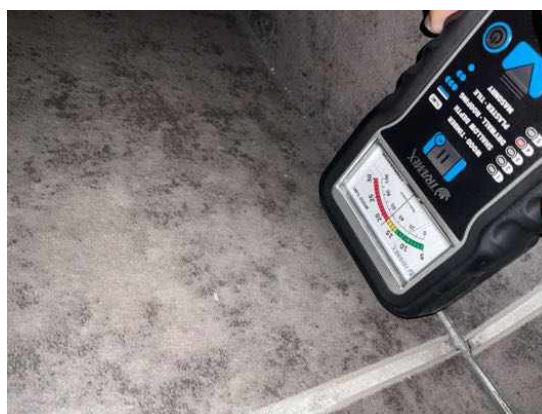
Finding 6.07

Building:	Main Building
Location:	Bathroom studio
Finding:	Excessive moisture - Conducive to Timber pest
Information:	Excessive moisture can attract termites and produce conditions that promote fungal growth and wood decay.

Excessive moisture is generally caused by deteriorated inadequate or missing roof drainage leaking plumbing pipes or fixtures poorly plumbed HWS overflows or condenser units and poor site drainage.

Prior to any remedial works being performed a qualified plumber should be appointed to further inspect the property and to identify the cause of the excessive moisture. Works to remove affected building elements may then be necessary and should be performed by an appropriate tradesperson.

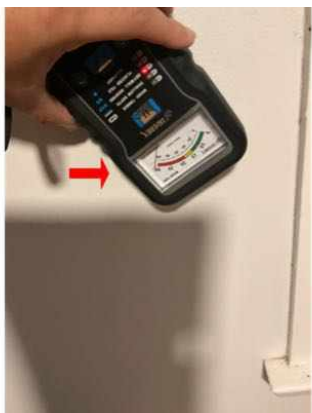
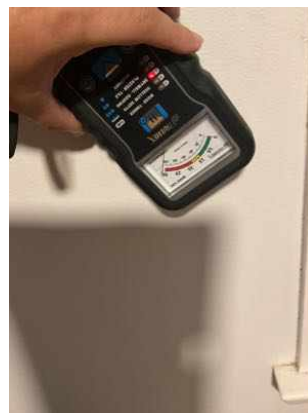
Finding 6.08

Building:	Main Building
Location:	Living Room
Finding:	Excessive moisture - Conducive to Timber pest
Information:	Excessive moisture can attract termites and produce conditions that promote fungal growth and wood decay.

Excessive moisture is generally caused by deteriorated inadequate or missing roof drainage leaking plumbing pipes or fixtures poorly plumbed HWS overflows or condenser units and poor site drainage.

Prior to any remedial works being performed a qualified plumber should be appointed to further inspect the property and to identify the cause of the excessive moisture. Works to remove affected building elements may then be necessary and should be performed by an appropriate tradesperson.

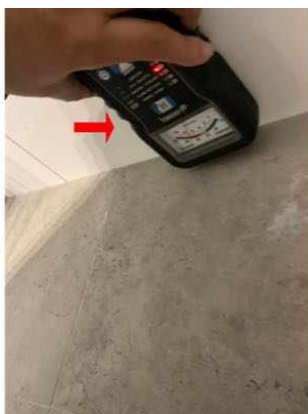
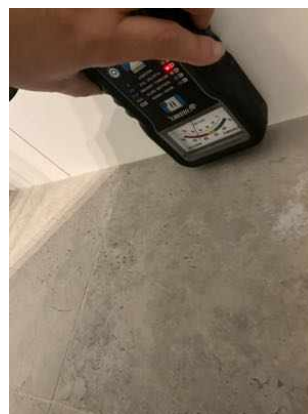
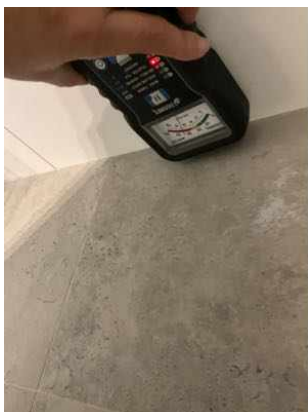
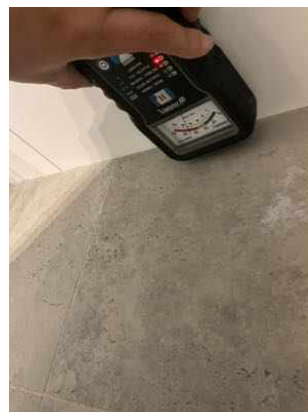
Building:	Main Building
Location:	Bathroom upstairs
Finding:	Excessive moisture - Conducive to Timber pest
Information:	Excessive moisture can attract termites and produce conditions that promote fungal growth and wood decay.

Excessive moisture is generally caused by deteriorated inadequate or missing roof drainage leaking plumbing pipes or fixtures poorly plumbed HWS overflows or condenser units and poor site drainage.

Prior to any remedial works being performed a qualified plumber should be appointed to further inspect the property and to identify the cause of the excessive moisture. Works to remove affected building elements may then be necessary and should be performed by an appropriate tradesperson.

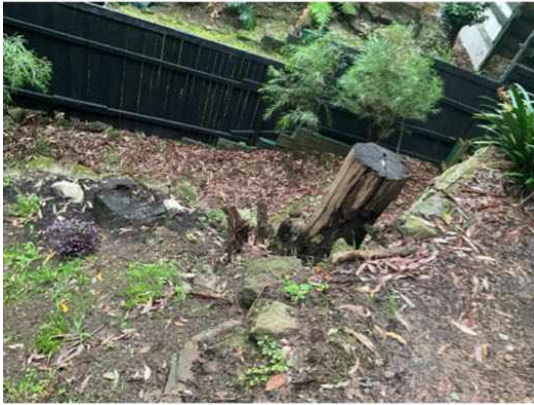
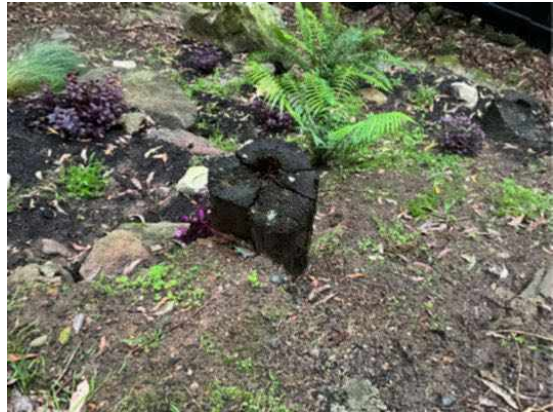
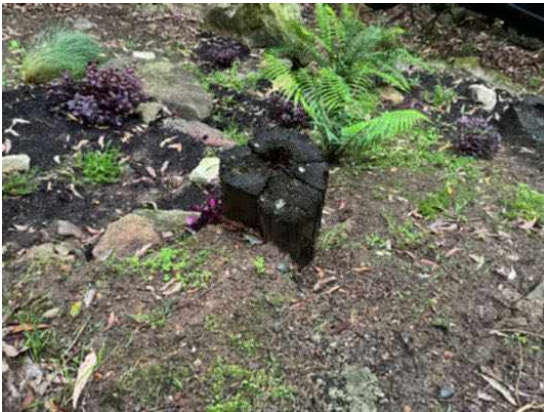
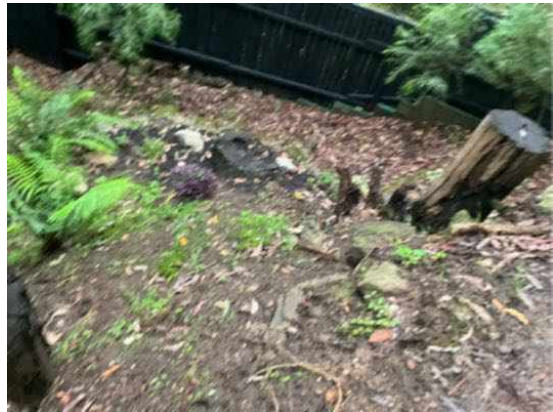
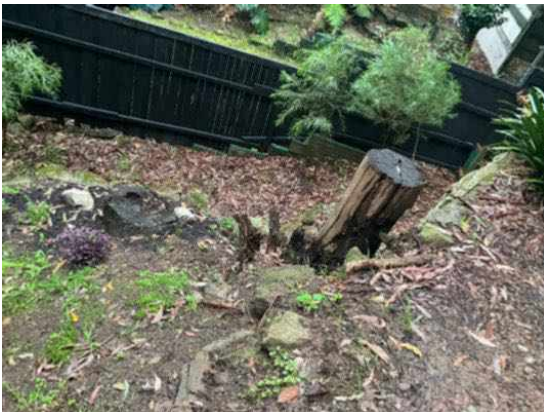
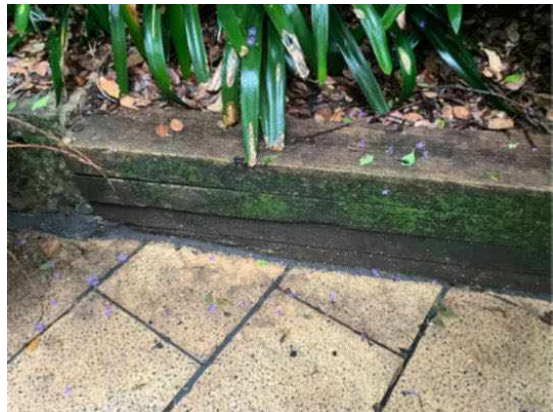
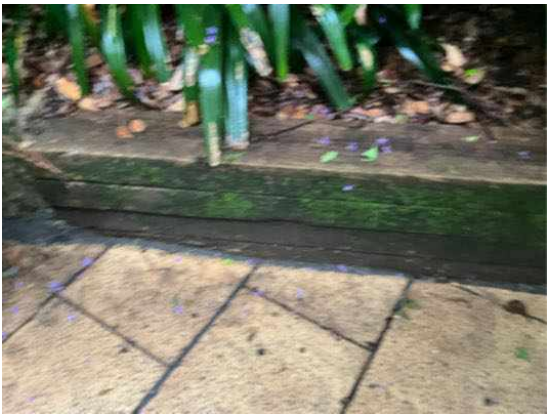
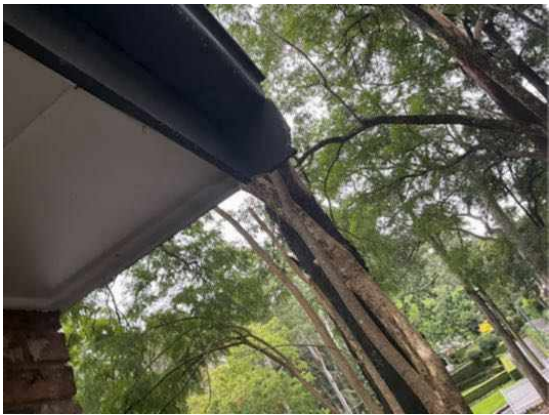
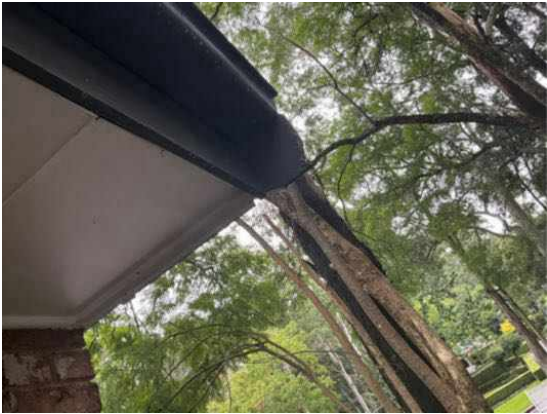
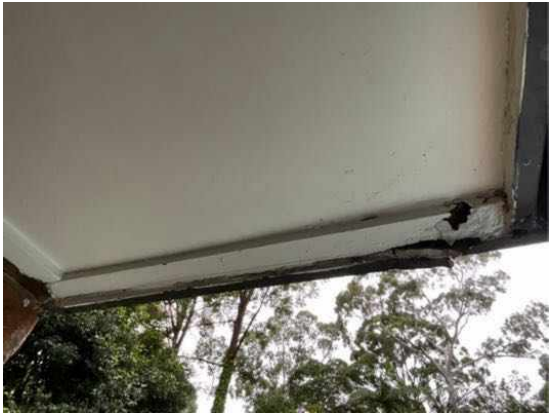
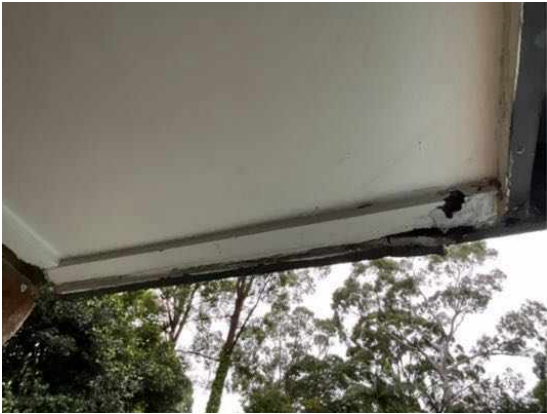
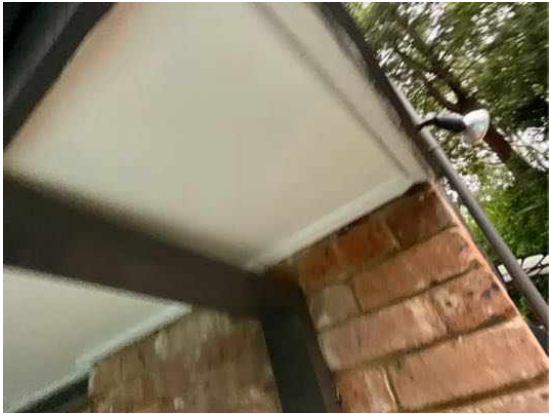
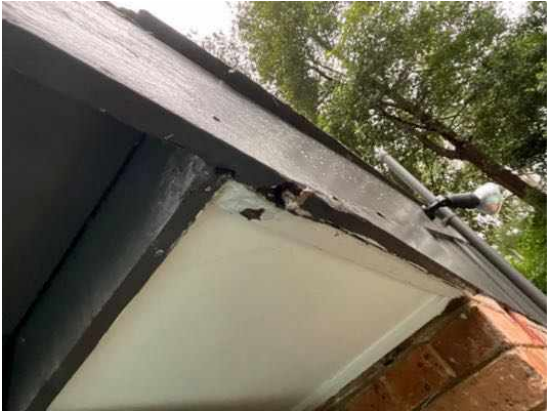
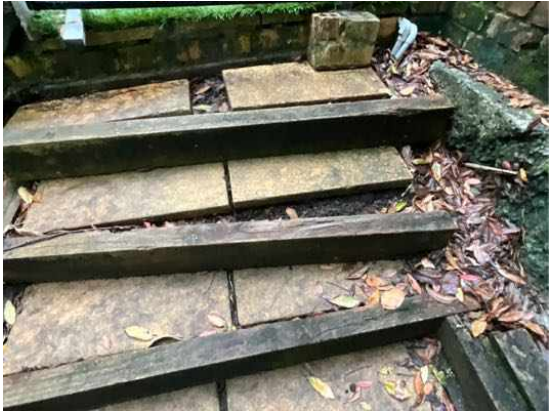
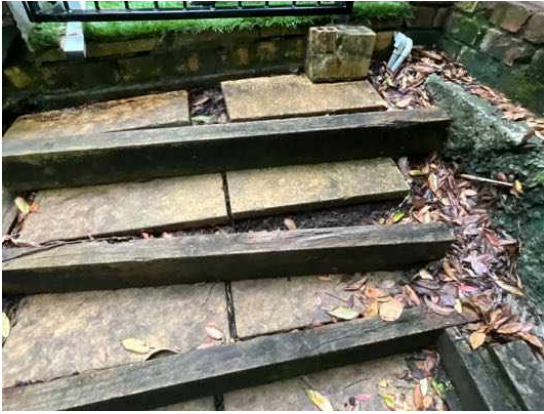
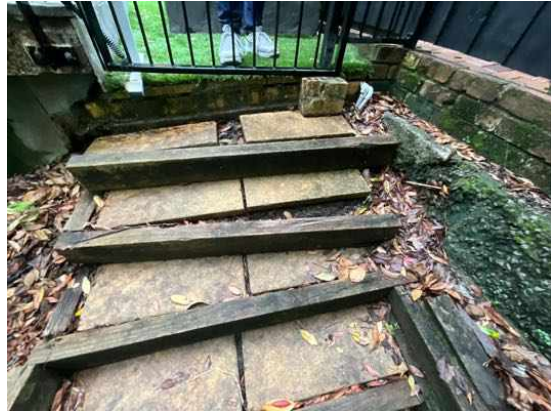
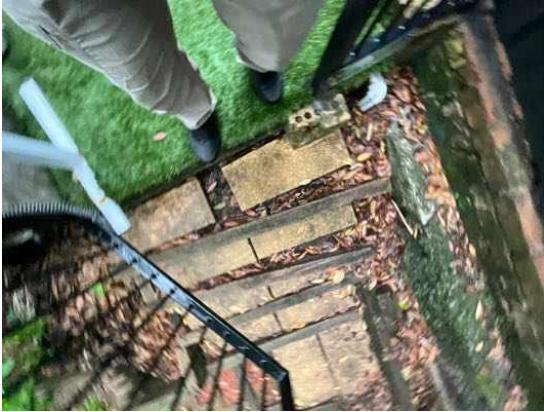
Finding 7.01

Finding: Wood rot

Information: This building element shows evidence of wood rot. Wood rot, also known as Fungal Decay, occurs when timbers and other cellulose building materials are exposed to damp conditions on an ongoing basis. This could be the result of exposure to weathering over a prolonged period of time, or the attraction of excessive moisture from other abutting building materials. Contributing factors also include poor air ventilation in the area.

Wood rot is often associated with general damp problems and is evidenced by a 'musty' smell or mould and mildew occurring on surfaces. If left unmanaged, damp conditions can lead to further health problems and the decay of timbers will continue.

Early intervention and regular maintenance, particularly of exterior timbers, will prolong the useful life of these building elements. Prior to any works being performed, the cause of the moisture that has created the visible wood rot should be identified and addressed in a suitable manner. Replacement of affected timbers may then be a necessary step in protecting surrounding building elements from such deterioration.

A qualified plumber may be appointed to assess the cause of excessive moisture and to provide advice on any remedial works as required. A qualified carpenter or registered builder may also be required to replace affected building materials.

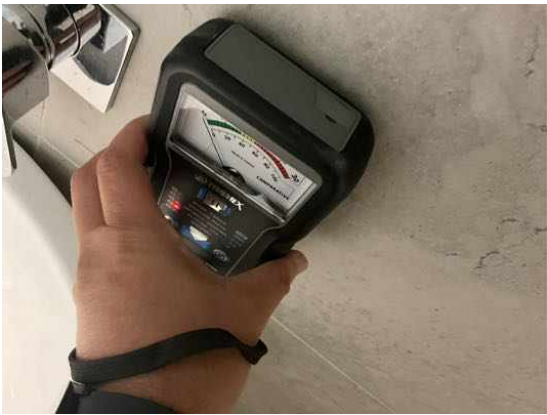
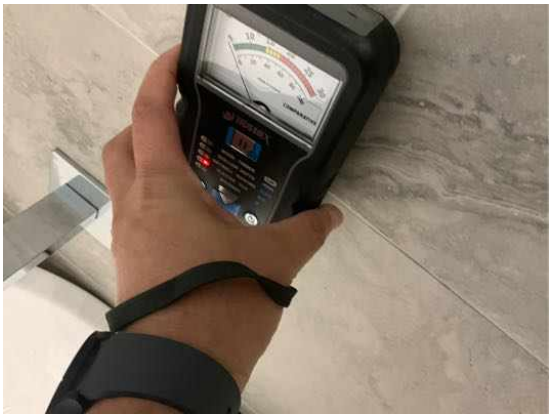
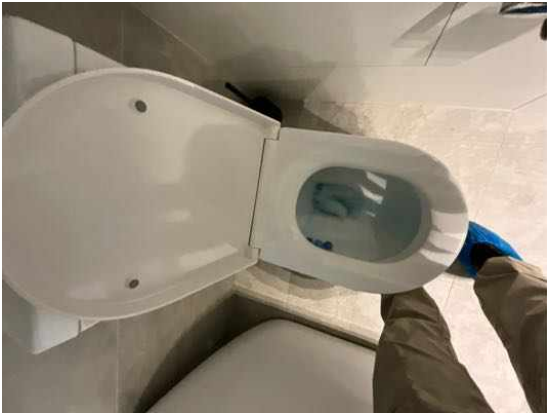
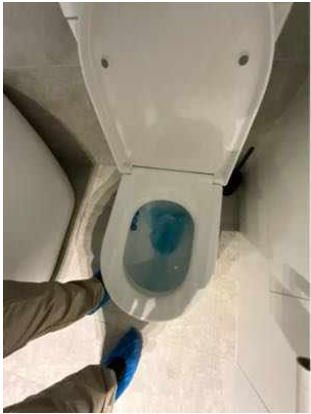
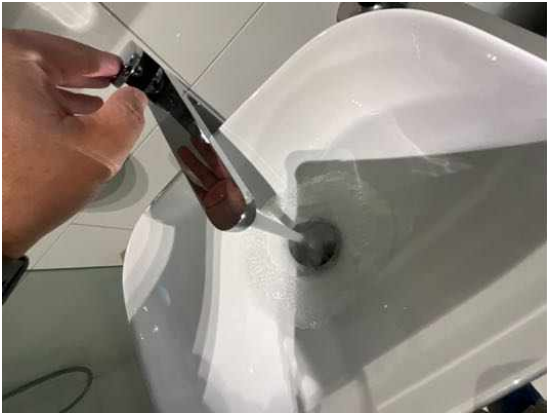
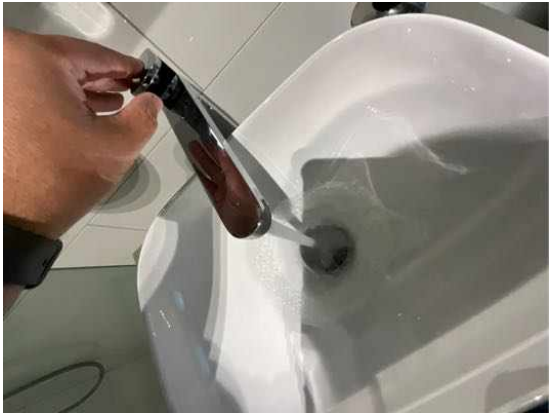
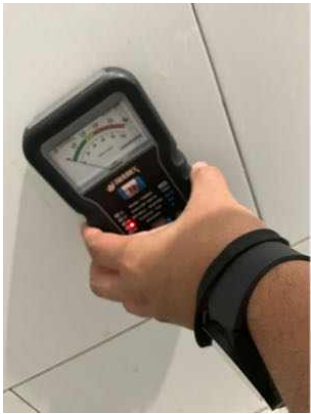
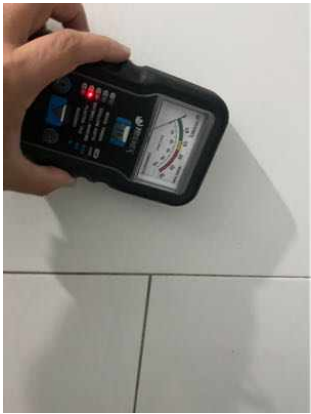
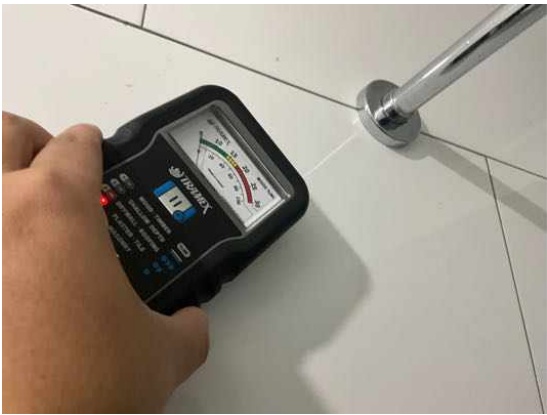
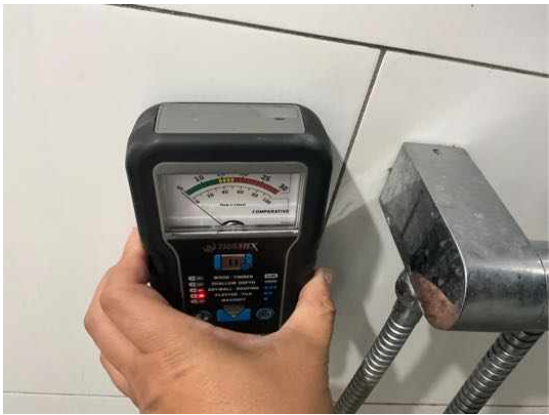
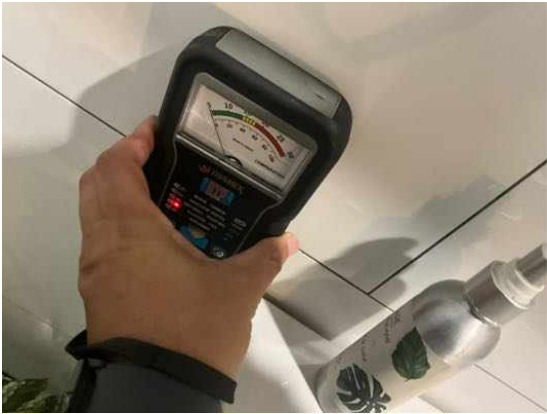
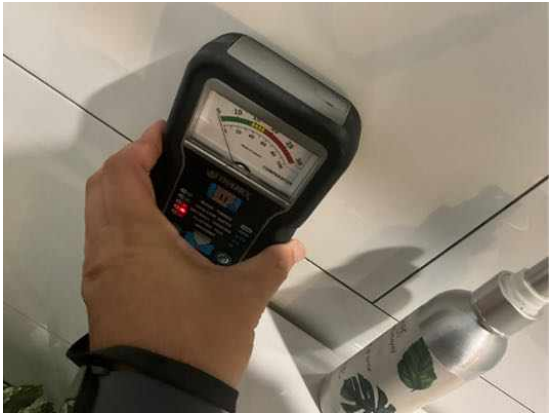
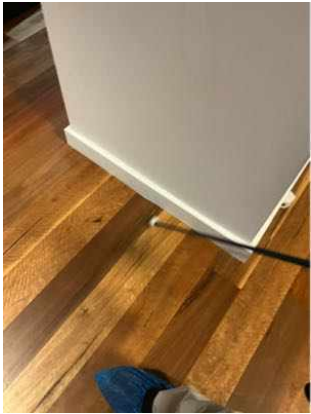
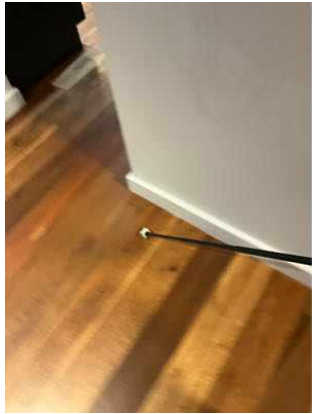
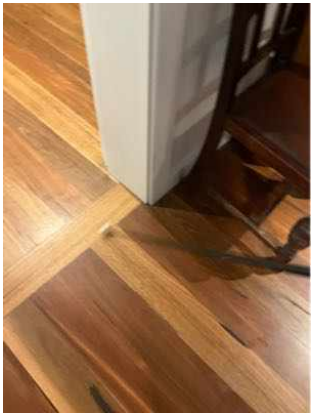
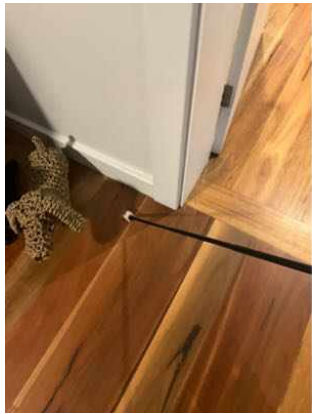
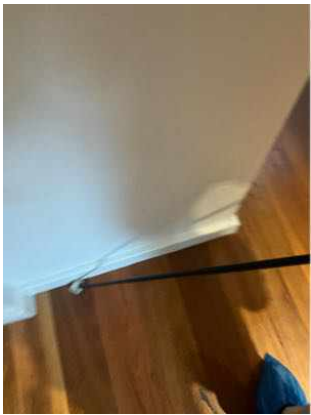
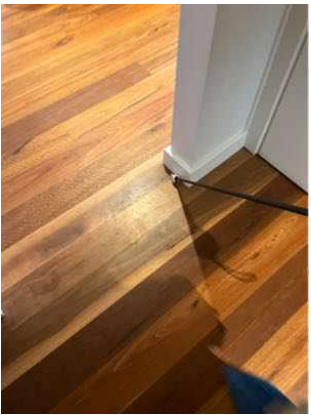
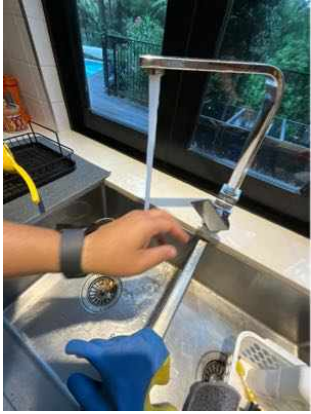
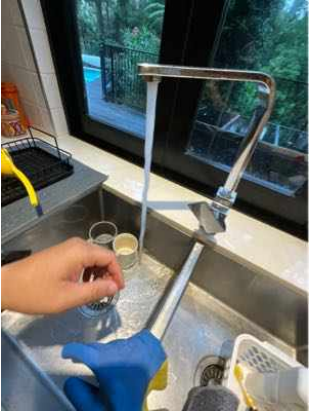
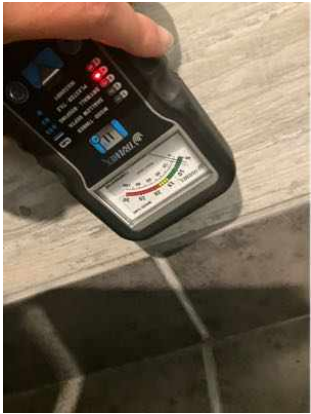
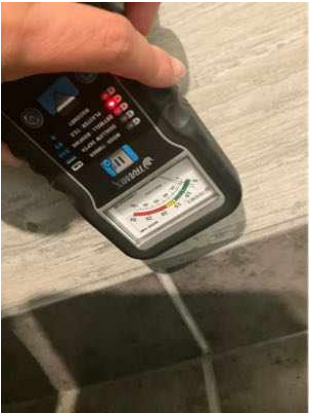
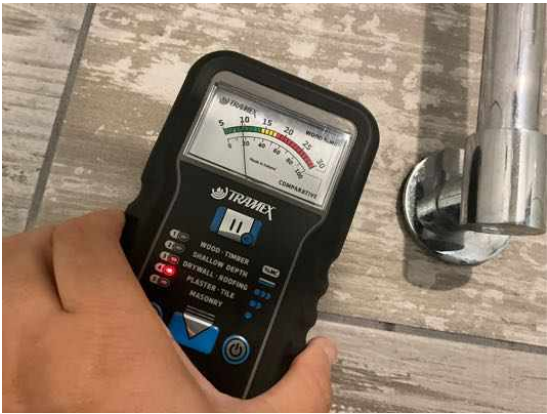
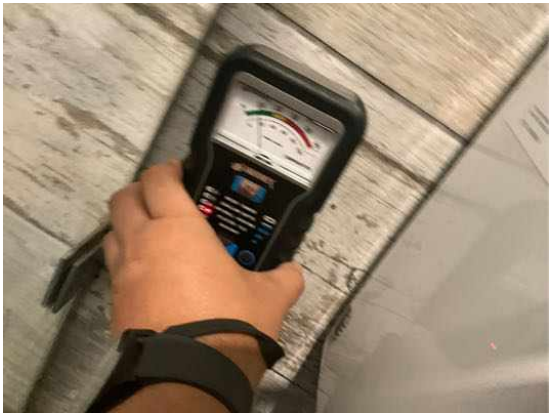
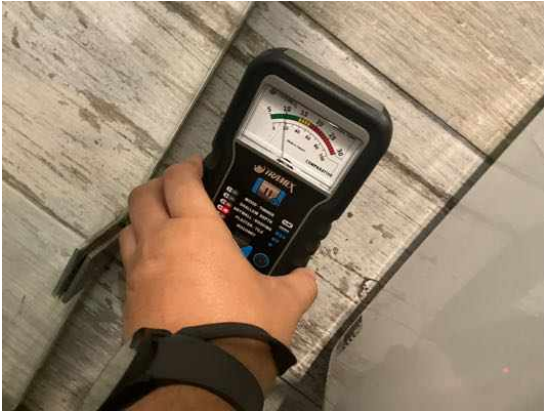
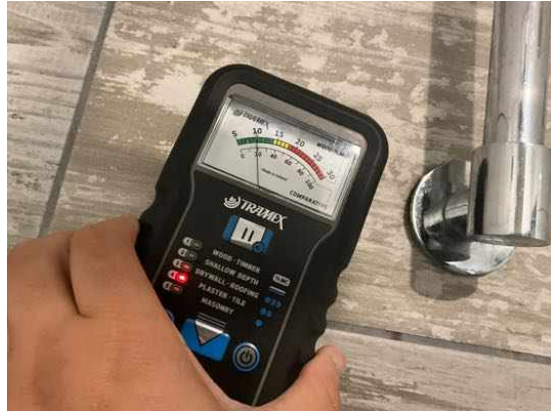
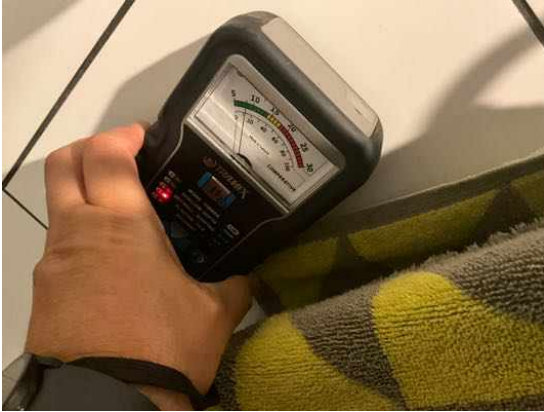
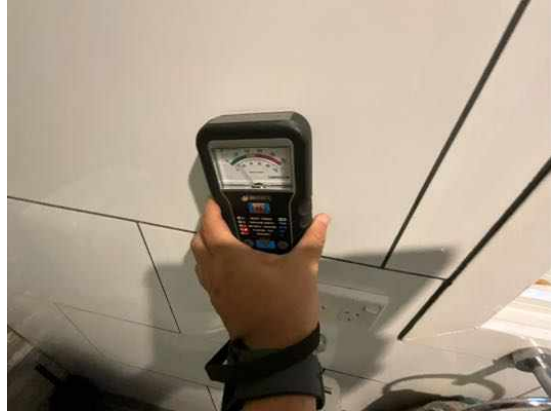
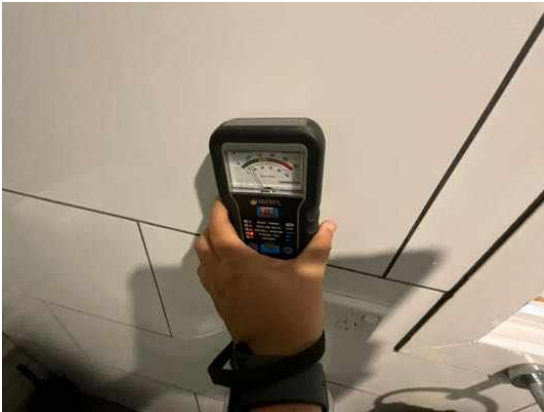
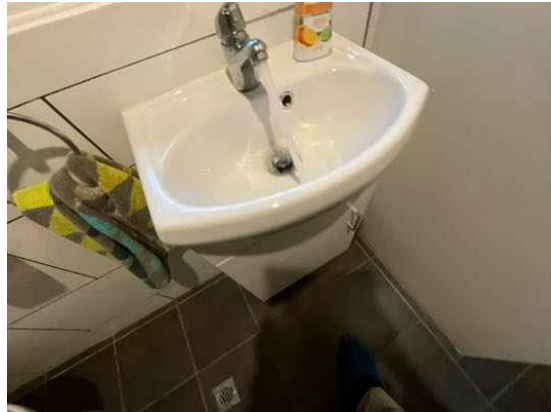
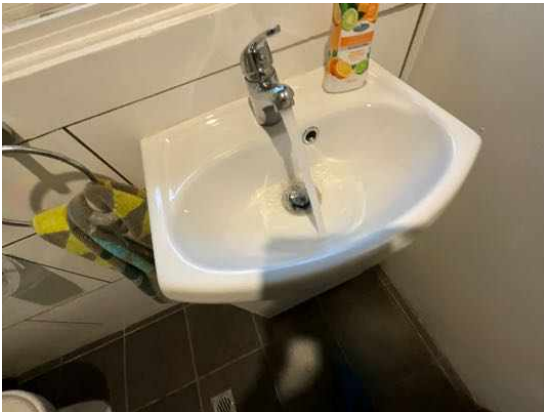
Building: Main Building
Location: All Areas
Finding: Additional Photos
Information: Additional photos are provided for your general reference

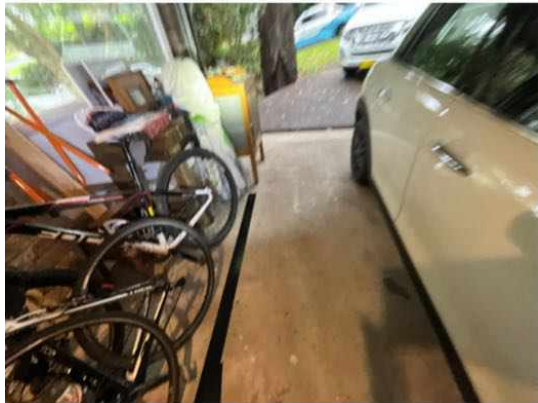
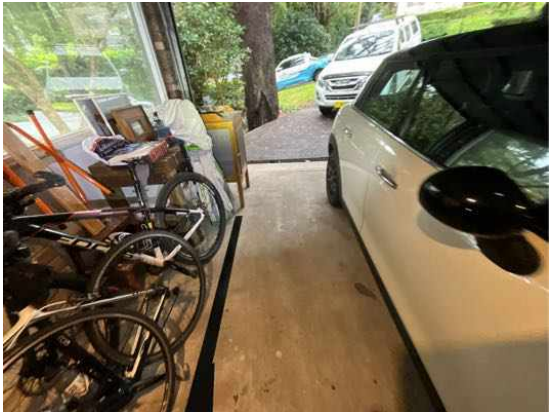
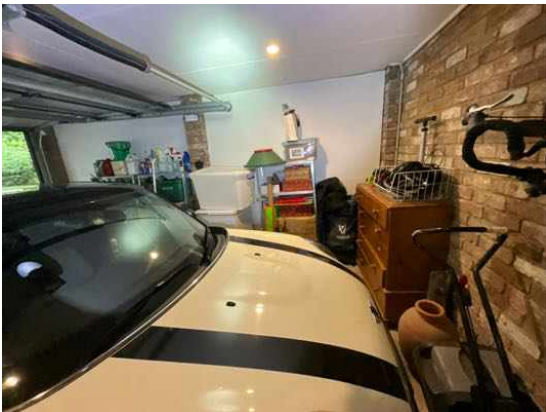
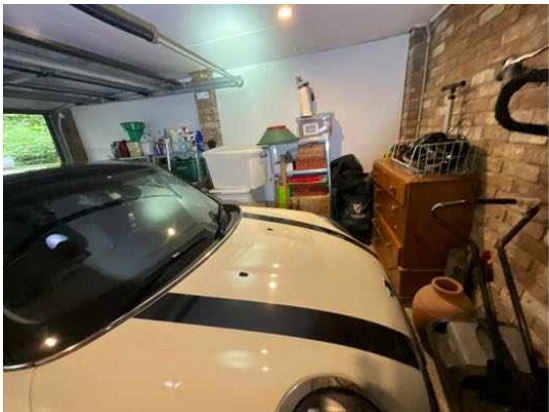
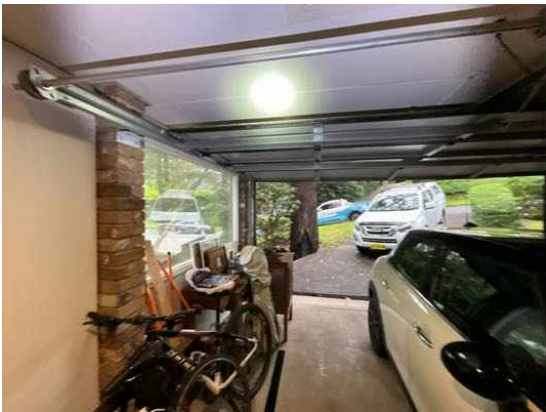
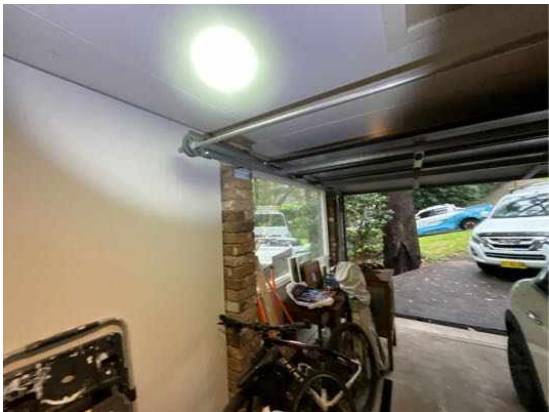
Building: Main Building
Location: All Areas
Finding: Additional Photos - Obstructions and Limitations
Information: These photographs are an indication of the obstructions and limitations which impeded full inspection of the property at the time of inspection. These obstructions can hide an array of defects and should be removed to allow full inspection to be carried out. A re-inspection is recommended once the areas are made accessible.
