# Building and Timber Pest Inspection Report

Inspection Date: Wed, 28 Jan 2026

Property Address: 1 Stanton Ct, Glen Waverley VIC 3150,  
Australia

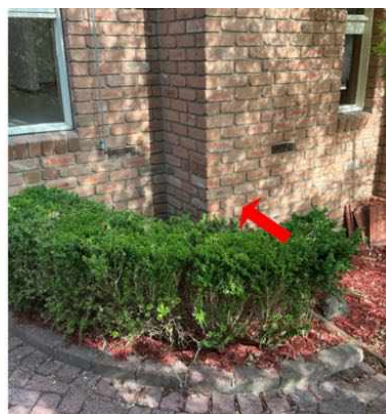
### Finding 3.03

Building:	Main Building
Location:	Walls
Finding:	Brickwork - Cracking noticeable
Information:	Noticeable cracks are a common occurrence in external brickwork and are a likely result of age expected building movement, general expansion, and/or contraction of building materials in different weather conditions. Noticeable cracks in brickwork may develop if left unattended, with potential for necessitating major remedial works or replacement of the brickwork.

It is highly advised that a qualified bricklayer be appointed to provide necessary works to cracked brickwork to prevent any further damage.

Always monitor these cracks and contact a building inspector should cracks widen, lengthen, or become more numerous.

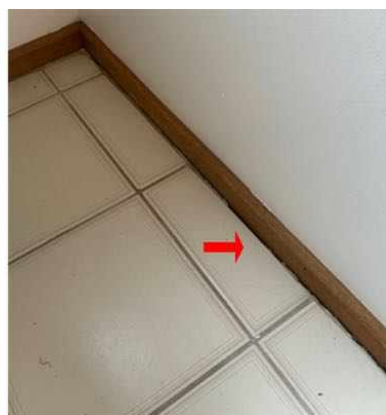
**Finding 3.04**

Building: Main Building  
 Location: Toilet (WC)  
 Finding: Sealant deteriorate  
 Information: The compromised sealant may allow water to penetrate into the substrate beneath the tiles. Over time, this can lead to deterioration of the underlying waterproofing membrane, increasing the risk of moisture ingress and potential structural damage.

A licensed waterproofing contractor should be engaged to remove the degraded sealant and reapply suitable waterproof-grade sealant.

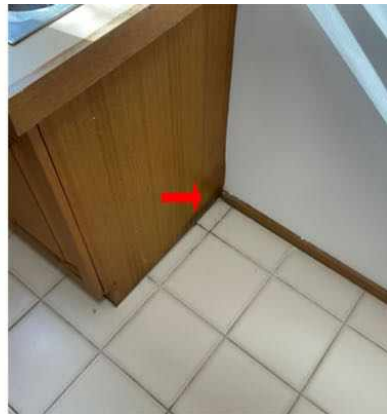
**Finding 3.05**

Building: Main Building  
 Location: Laundry  
 Finding: Timber swelling- minor  
 Information: The swelling observed at the base of the cabinet appears to be caused by moisture exposure, likely due to inadequate sealing or water ingress from nearby wet areas. It may also result from water splashing onto the floor after showering and not being wiped up promptly. Typically, the base of cabinetry should be sealed with a waterproof coating or raised slightly above the floor surface to prevent direct contact with moisture. It is recommended to engage a qualified carpenter to repair or replace

the affected timber and ensure appropriate sealing or clearance is provided to prevent future water-related damage.

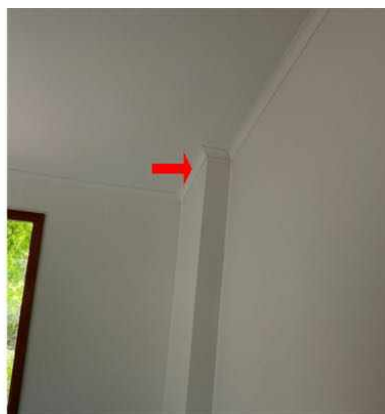
### Finding 3.06

Finding: Plaster cracks

Information: Interior plaster cracks can result from factors such as normal settling, temperature and humidity changes, structural movement, or poor application.

Please continue to monitor these cracks. If they worsen or raise concerns, consider consulting a professional structural engineer to assess potential underlying issues

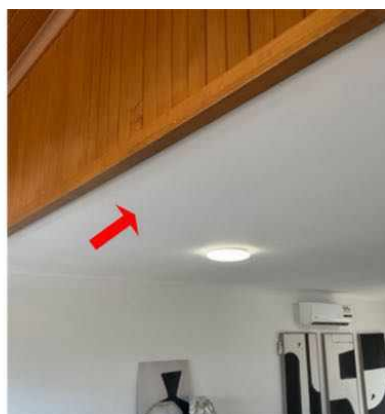
### Finding 3.07

Building:	Main Building
Location:	Living Room
Finding:	Ceiling plaster crack
Information:	Ceiling plaster cracks are a common occurrence in homes. It's important to monitor them over time, as they can affect both the appearance and structural integrity of the property. If the cracks worsen, it's advisable to consult structural engineer. They can assess the situation and recommend appropriate repairs based on the specific conditions of your home.

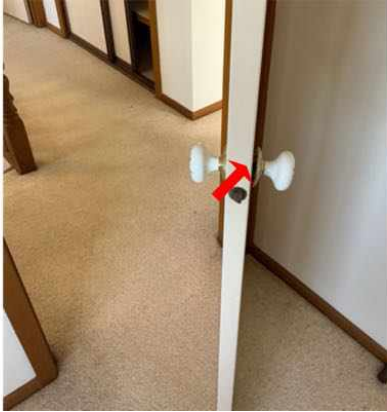
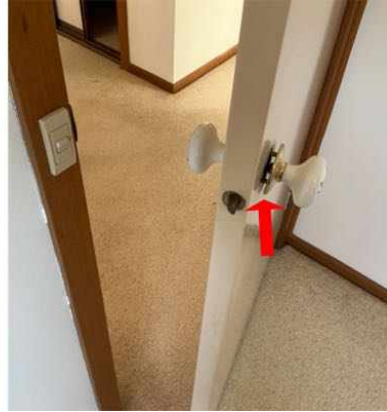
### Finding 3.08

Building:	Main Building
Location:	Bedroom
Finding:	Fitting or fixture - Loose
Information:	The fitting in this area is loose and requires adjustment to tighten.

If left unmanaged, the fitting may further deteriorate, causing potential for the development of other minor secondary defects.

A relevant tradesperson should be appointed to perform these rectification works at discretion of the client.

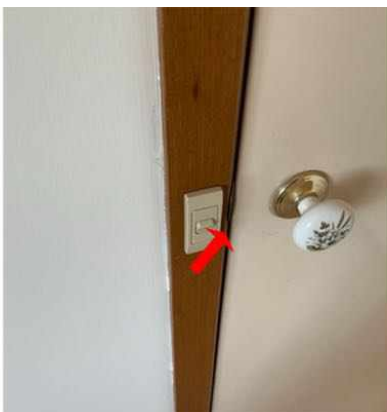
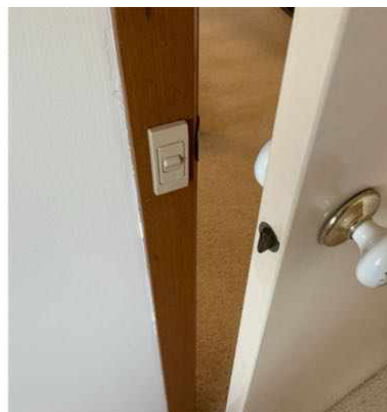
### Finding 3.09

Information: It was noted that the door in this area was not latching during operation at the time of inspection. Whilst detracting from the functionality of this building element, this minor defect may also be a security risk, and may therefore have serious implications if left unattended.

It is suspected that this defect has occurred due to minor issues with the associated hinges. Such damage is identified as general wear and tear, which is expected for building elements of this age.

A qualified carpenter or general handyperson may be appointed to perform rectification works as necessary, at client discretion. If left unattended, further functional impairment is likely to occur.

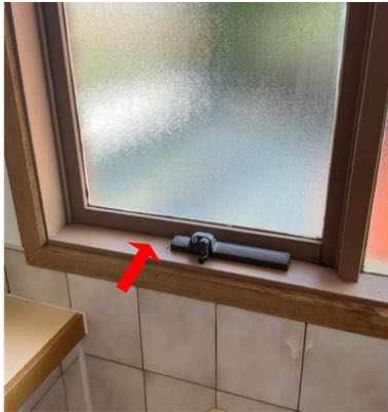
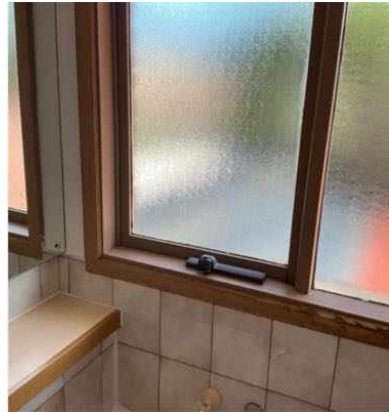
### Finding 3.10

Finding: Window Unable to Operate  
 Information: At the time of inspection, the window could not be opened using the designed operating mechanism. The mechanism appears faulty and is not functioning as intended.

Client is advised to engage a qualified window contractor or competent handyman to replace the window mechanism and restore normal operation.

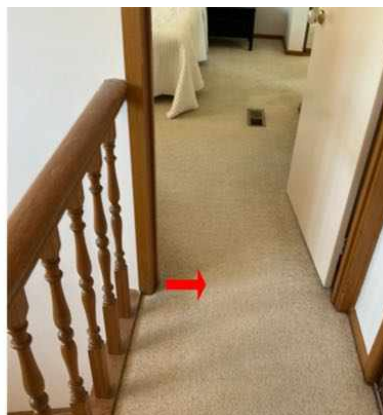
Information: Localised “squeaky/squishy” sound and slight movement is noted when pressure is applied to the floor surface in the affected area. This is typically consistent with minor flooring movement, loose fixings, or subfloor friction/movement.

Ongoing movement may lead to worsening noise, loosening of floor finishes, and potential damage to joints/edges over time.

Engage a licensed carpenter/builder (or flooring contractor) to investigate the flooring fixings and rectify as required (e.g., re-fix, pack/level, add adhesive, or address subfloor movement).

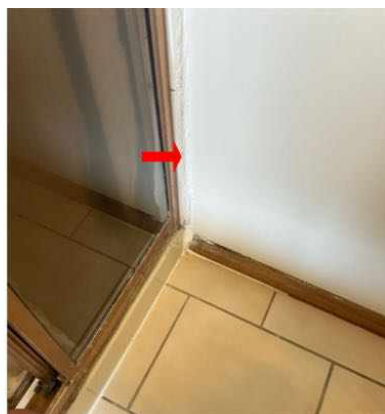
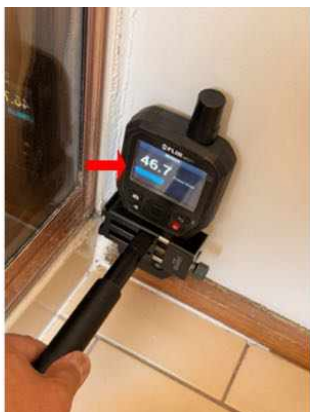
### Finding 3.13

Building: Main Building  
 Location: Ensuite - Master  
 Finding: Wood decay— skirting  
 Information: Rot/decay to the skirting at the outside corner of the shower was observed, with an elevated moisture meter reading (~46.7 in pinless mode) recorded at the affected area (higher than adjacent sections, indicating a localised moisture issue).

Ongoing moisture exposure can cause further timber deterioration and concealed damage to wall lining/framing, and may contribute to mould/odour and finish failure.

Engage a licensed plumber (and builder if required) to investigate the moisture source (e.g., shower waterproofing failure, leaking plumbing, failed silicone/tiles/grout), and carry out invasive investigation if needed; complete rectification and drying before replacing the skirting and repainting.

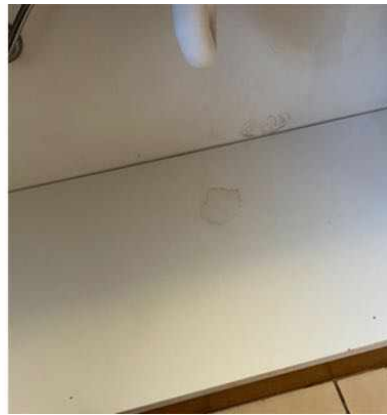
### Finding 3.14

Building: Main Building  
 Location: Ensuite - Master  
 Finding: Water staining  
 Information:

Water staining was evident in this area at the time of inspection. Water staining indicates that surfaces have been exposed to excessive moisture over time. The minerals and other elements in the water lead to staining, which may graduate to corrosion and deterioration if left unmanaged.

While mostly an appearance defect, water staining can be indicative of more serious defects, which may be currently concealed by other building elements.

At time of inspection, water staining is old and inactive, affected building materials may be repaired or replaced at client discretion. A qualified carpenter or registered builder may be appointed to perform these works.

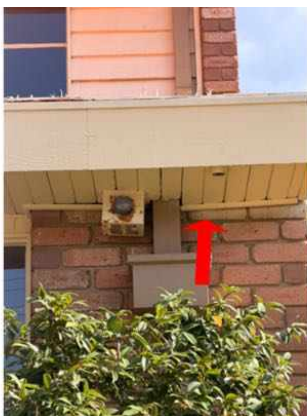
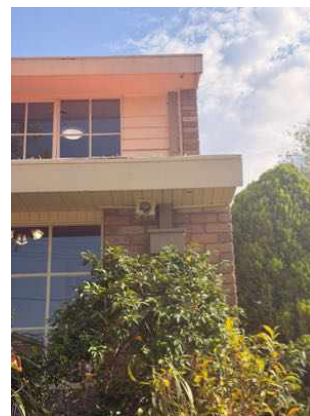
### Finding 3.15

Information: Sagging to the eaves was evident in this area at the time of inspection. This type of defect is generally consistent with older properties, where the eave sheeting has worn over time.

Eaves are important in preventing water ingress to associated walls by promoting adequate water run-off from roofing structures. Their secondary function is to prevent shelter to adjoining structures from excessive moisture and hence prevent water damage to these areas.

Sagging eaves are susceptible to the attraction of excessive moisture, and are therefore considered non-functional. This defect also detracts from the overall appearance and condition of the roofing structure and any associated structures.

A roofing plumbing or general handyman is recommended to perform rectification works as soon as possible. Subsequent water damage is likely to result over time if left unattended.

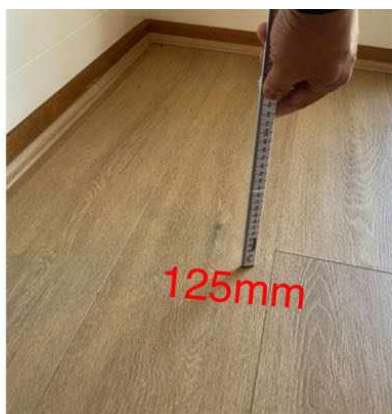
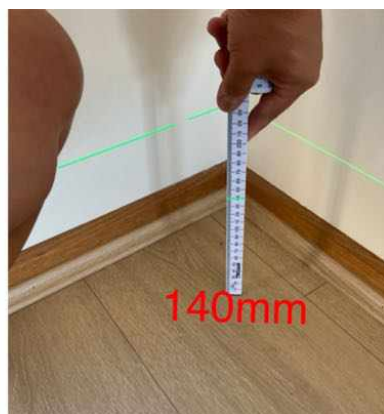
### Finding 3.16

Building: Main Building  
Location: All Areas  
Finding: floor unevenness - v4  
Information: The standard laser level was positioned 125 mm above the floor, as shown in the photo. The measured floor deviation across the room ranges from the lowest point to the highest point by approximately 15mm

Considering the age of the property and no visible significant cracks were observed at time of inspection. This degree of settlement is generally within an acceptable range for a building of its era. However, for buyers who have higher expectations regarding floor levelness or sensitivity to uneven floors, it should be noted that restumping or re-leveling can involve a considerable cost. This should be taken into account when planning the overall purchase budget.

For further information or investigation, contact a licensed builder for cost estimation and a structural engineer to assess the extent of settlement and the condition of the stumps.

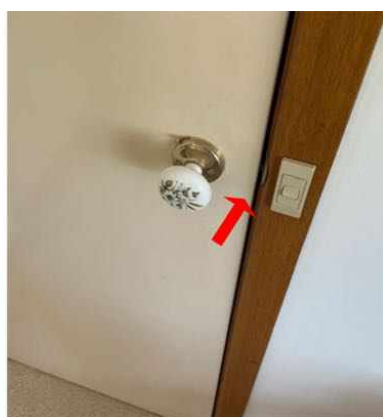
Finding 3.17

Building: Main Building  
 Location: Bedroom - Master  
 Finding: Door handle - Not latching  
 Information: It was noted that the door in this area was not latching during operation at the time of inspection. Whilst detracting from the functionality of this building element, this minor defect may also be a security risk, and may therefore have serious implications if left unattended.

It is suspected that this defect has occurred due to minor issues with the associated hinges. Such damage is identified as general wear and tear, which is expected for building elements of this age.

A qualified carpenter or general handyperson may be appointed to perform rectification works as necessary, at client discretion. If left unattended, further functional impairment is likely to occur.

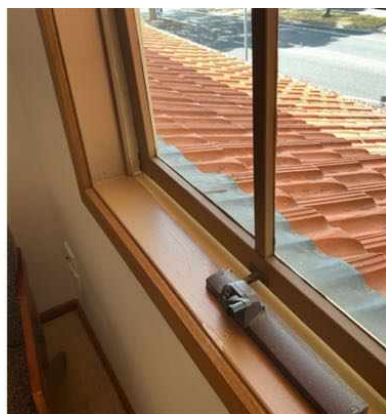
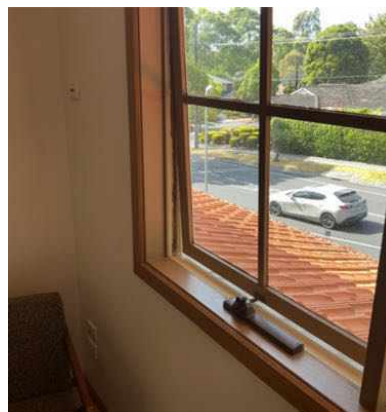
### Finding 3.18

Building: Main Building  
 Location: Bedroom - Master  
 Finding: Window - Stiff to operate  
 Information: The window in this area was jammed and difficult to operate at the time of the inspection. Windows provide ventilation to the adjoining area and should be at a fully operational level to ensure user comfort. Restricted function of the window may also pose as a potential safety hazard if required for emergency egress from the building.

Generally, factors such as general age of the building element and a lack of maintenance are the usual causes for this type of defect.

Replacement of window hardware or frame may be required, as well as minor repairs and cleaning. A registered builder or general handy person will be required to repair the window.

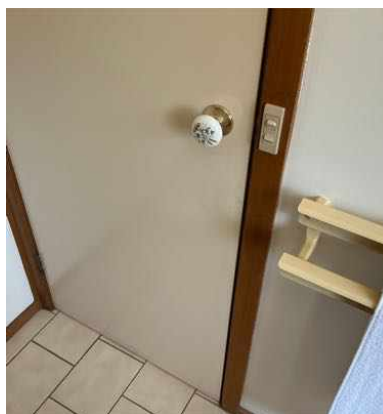
### Finding 3.19

Building:	Main Building
Location:	Ensuite - Master
Finding:	Door handle - Not latching
Information:	It was noted that the door in this area was not latching during operation at the time of inspection. Whilst detracting from the functionality of this building element, this minor defect may also be a security risk, and may therefore have serious implications if left unattended.

It is suspected that this defect has occurred due to minor issues with the associated hinges. Such damage is identified as general wear and tear, which is expected for building elements of this age.

A qualified carpenter or general handyperson may be appointed to perform rectification works as necessary, at client discretion. If left unattended, further functional impairment is likely to occur.

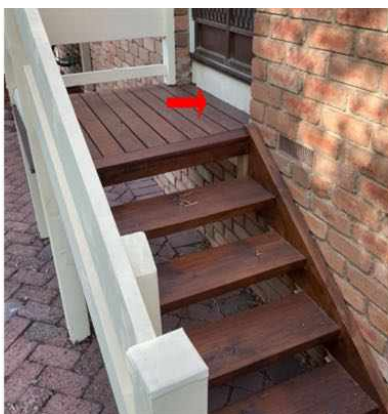
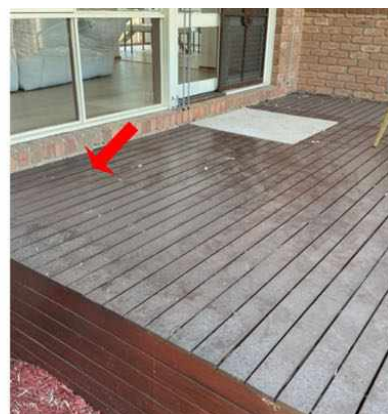
If any attachment to the building—such as a hot water unit, downpipe, deck, verandah, fence, steps, or service conduit—is not properly isolated and lacks a minimum 25mm inspection gap from the building, it is considered a potential bridging point.

These attachments can provide concealed termite entry and should be regularly inspected for signs of termite activity by a qualified pest inspector.

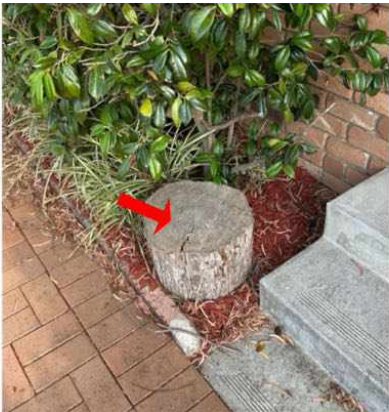
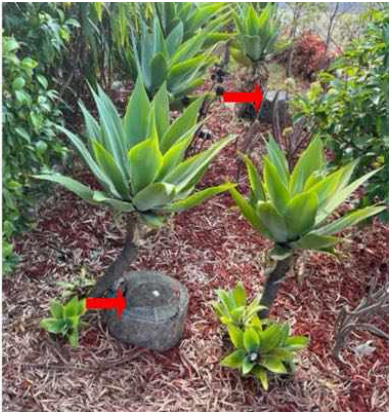
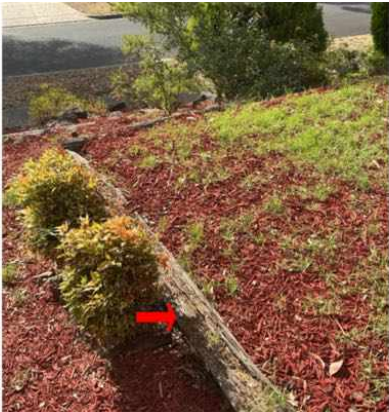
## Finding 6.03

Building:	Main Building
Location:	All Areas
Finding:	Stored timbers - subfloor space or external area
Information:	The storing of timbers in the subfloor space or around the external property (including

bark mulch) increases the risk of termite activity being present. As they are likely to come into contact with weather conditions or excessive moisture wood rot is likely to develop on timbers that are not treated.

It is highly recommended that any stored timbers be immediately removed from areas in which they may attract any termite / timber pest attack. Minimisation of risk / prevention of termite attack is far more adequate than dealing with the presence of termite activity.

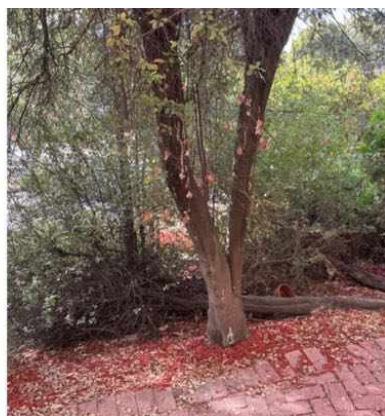
Regular inspections are recommended. Consider test drilling any large trees.

A pest controller can be contacted to carry out such testing at the owners discretion.

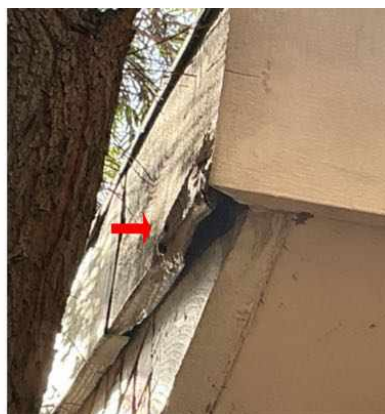
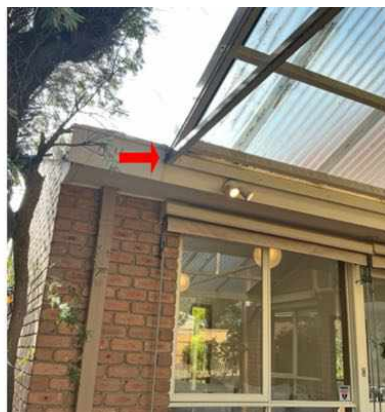
### Finding 7.01

Finding: Fascias - Wood rot

Information: Wood rot was found to be affecting fascias and barges in this area, evidenced by the presence of mould on the surface in some areas. Wood rot, also known as Fungal Decay, occurs when timbers and other cellulose building materials are exposed to damp conditions on an ongoing basis.

It is likely that this wood rot has developed as a result of faults in the roof plumbing, creating excessive moisture in this areas. Frequent exposure to rain and other weather conditions also make fascias and barges susceptible to accelerated deterioration.

Early intervention and regular maintenance will prolong the useful life of these building elements. Prior to any works being performed, the cause of the moisture that has created the visible wood rot should be identified and addressed in a suitable manner.

It is advised that a roof plumber be appointed to inspect all roof plumbing and subsequently identify the cause of the wood rot. Replacement of affected fascias and barges may then be a necessary step in protecting surrounding building elements from such deterioration.

A qualified plumber may be appointed to assess the cause of excessive moisture and to provide advice on any remedial works as required. A qualified carpenter or registered builder may also be required to replace affected building materials.

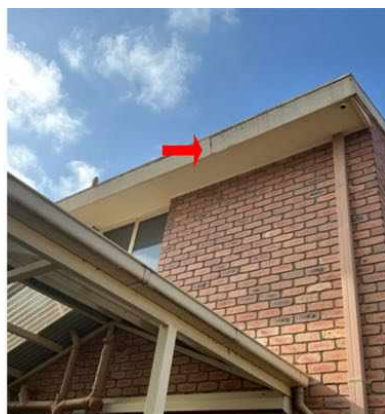
### Finding 7.03

Finding: Fascias - Wood rot

Information: Wood rot was found to be affecting fascias and barges in this area, evidenced by the presence of mould on the surface in some areas. Wood rot, also known as Fungal Decay, occurs when timbers and other cellulose building materials are exposed to damp conditions on an ongoing basis.

It is likely that this wood rot has developed as a result of faults in the roof plumbing, creating excessive moisture in this areas. Frequent exposure to rain and other weather conditions also make fascias and barges susceptible to accelerated deterioration.

Early intervention and regular maintenance will prolong the useful life of these building elements. Prior to any works being performed, the cause of the moisture that has created the visible wood rot should be identified and addressed in a suitable manner.

It is advised that a roof plumber be appointed to inspect all roof plumbing and subsequently identify the cause of the wood rot. Replacement of affected fascias and barges may then be a necessary step in protecting surrounding building elements from such deterioration.

A qualified plumber may be appointed to assess the cause of excessive moisture and to provide advice on any remedial works as required. A qualified carpenter or registered builder may also be required to replace affected building materials.

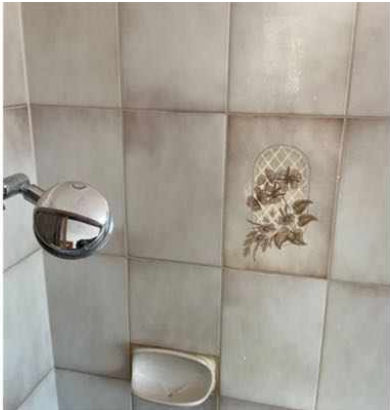
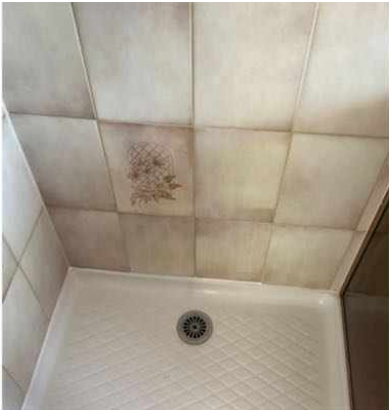
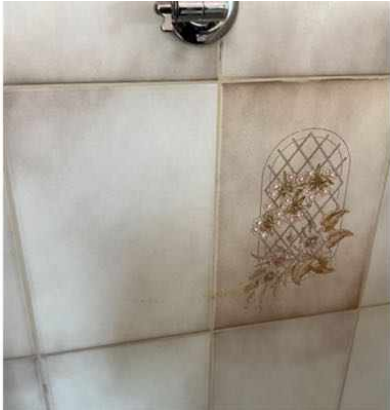
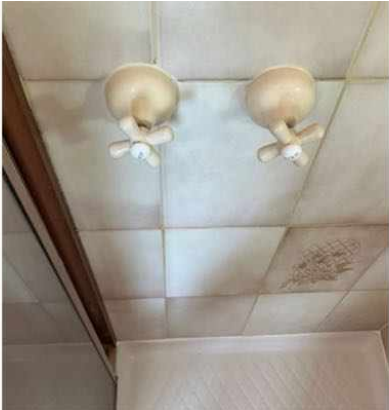
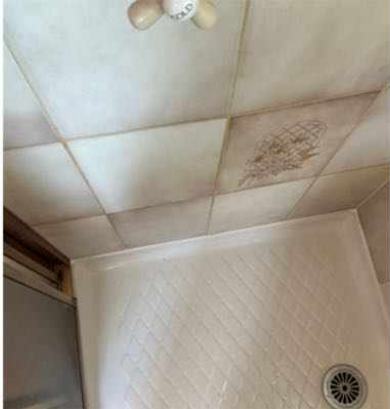
Building: Main Building  
Location: Bathroom  
Finding: For your information  
Information: This is provided for your information only. No immediate action is required at the time of inspection.

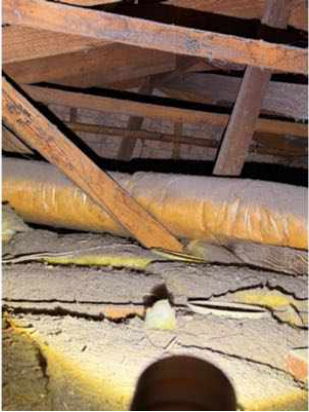
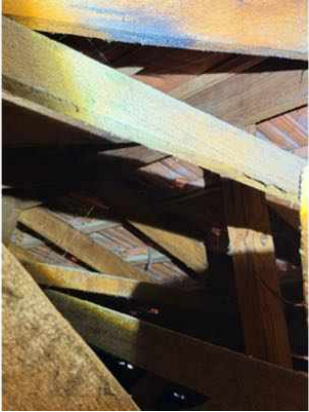
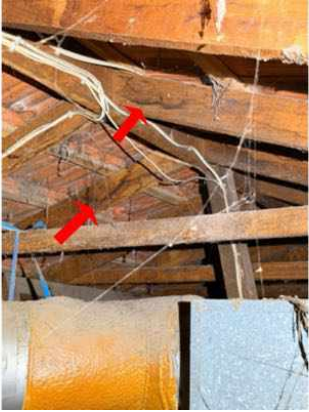
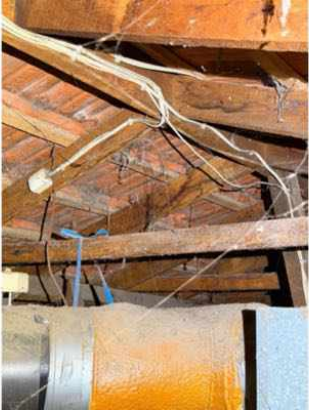
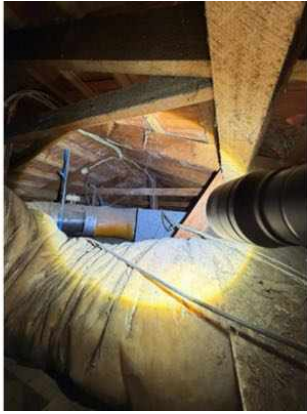
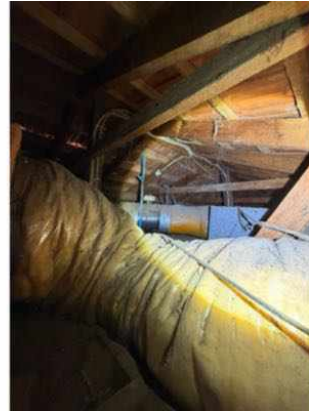
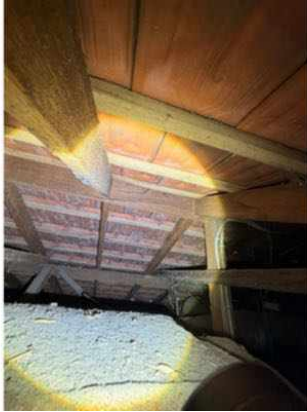
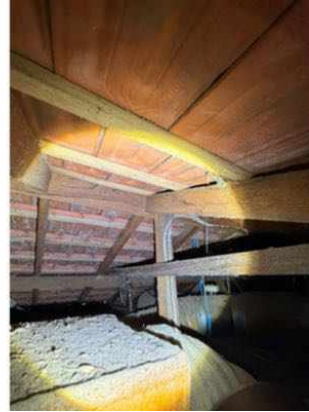
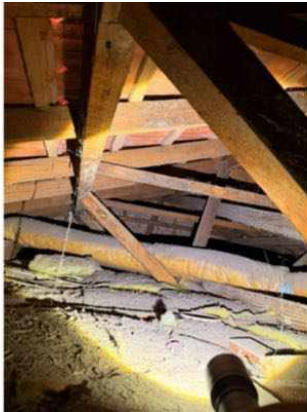
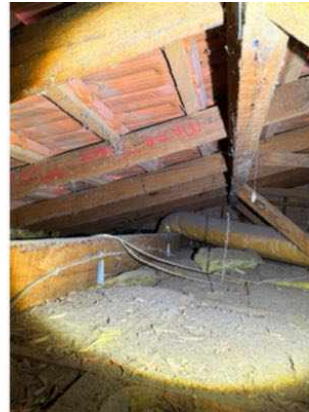
Building: Main Building  
Location: Roof Void  
Finding: Roof void timber condition.  
Information: At the time of inspection, the majority of roof void timbers were observed to be in generally acceptable condition when considered against the age of the property. Isolated timbers exhibited darker staining/discolouration, which may indicate past or active moisture ingress. No significant timber decay, softening, or wood rot was identified within the accessible roof void areas at the time of inspection. It is recommended that the client monitor the stained timbers during and after periods of heavy rainfall to confirm there is no ongoing moisture ingress and to help maintain the roof structure in a sound condition.

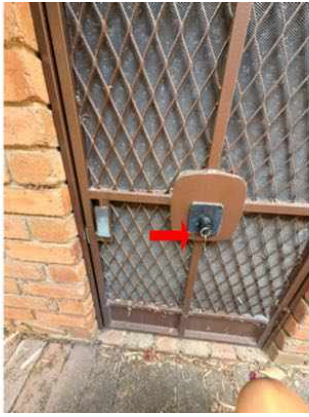
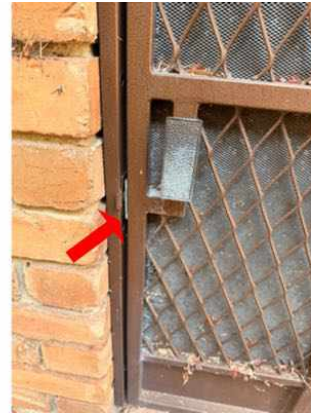
Building: Main Building  
 Location: Subfloor  
 Finding: Additional Photos - Obstructions and Limitations  
 Information: At time of inspection, the subfloor gate was unable to open even with the key in place.

These photographs are an indication of the obstructions and limitations which impeded full inspection of the property at the time of inspection. These obstructions can hide an array of defects and should be removed to allow full inspection to be carried out. A re-inspection is recommended once the areas are made accessible.

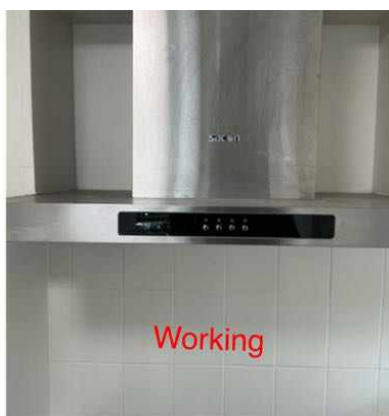
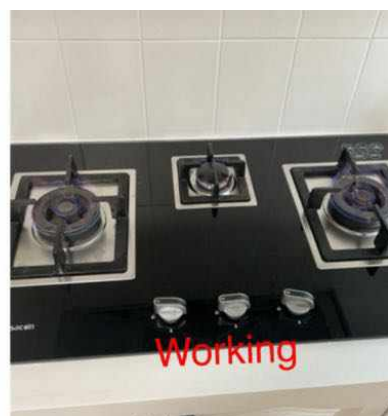
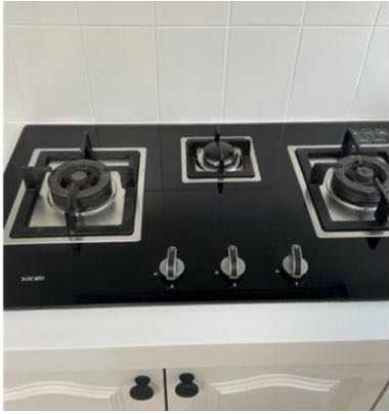
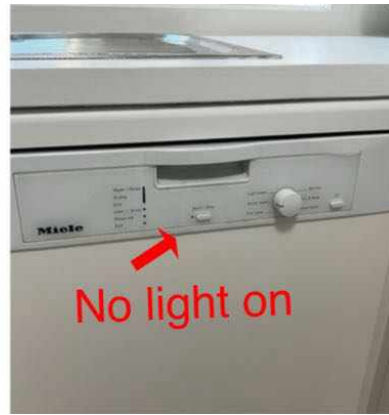
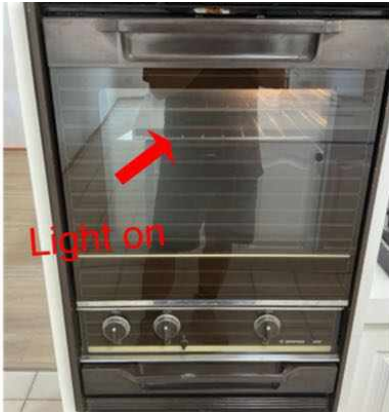
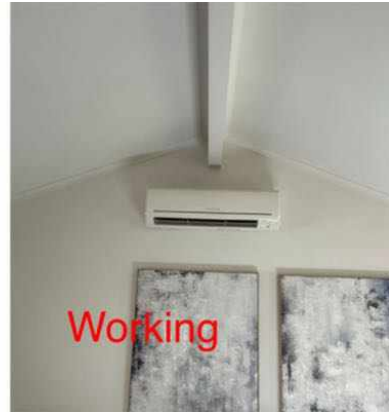
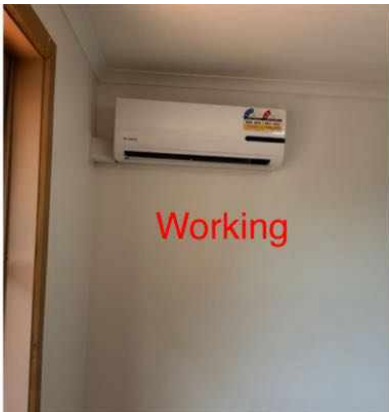
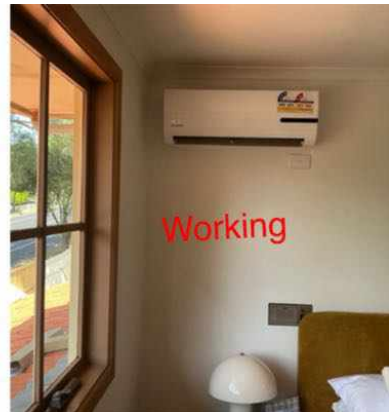
Building:	Main Building
Location:	Plumbing/electrical/gas/aircon/appliances/pool equipment/fire safety etc
Finding:	For your information
Information:	Plumbing and electrical inspections are outside the scope of the building inspection and must be conducted by a Licensed and registered Trades person.

It is highly recommended that the client makes immediate arrangements to have the gas appliances checked by a licensed gas plumber to ensure that the appliances are working safely and efficiently.

We recommend all other installations be checked also.

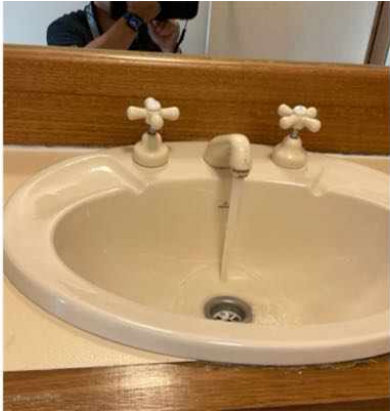
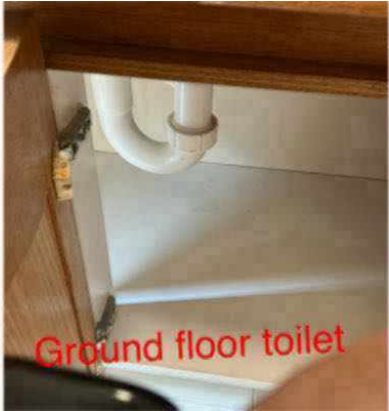
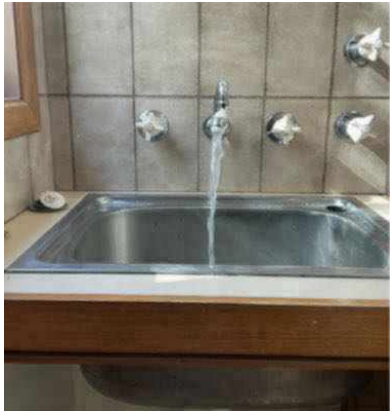
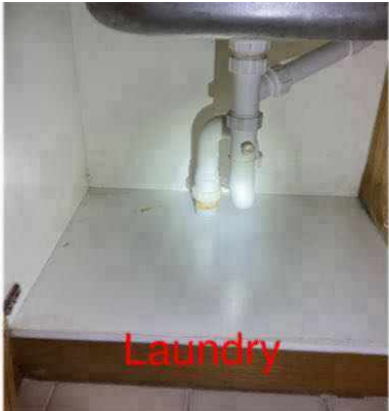
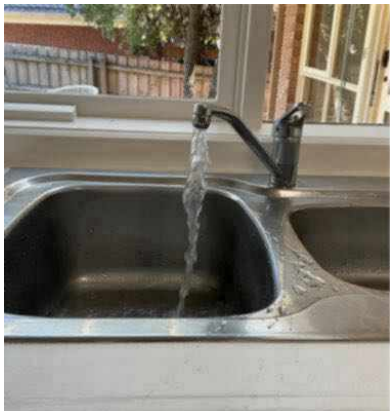
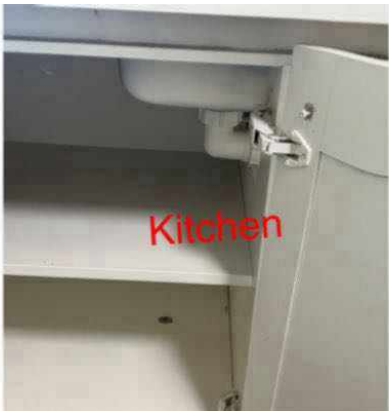
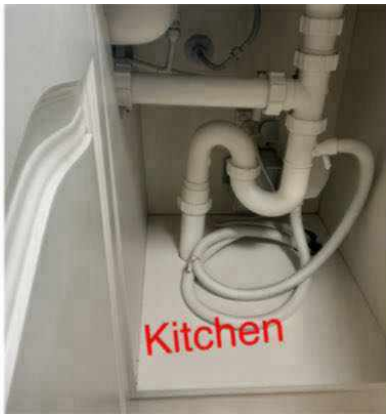
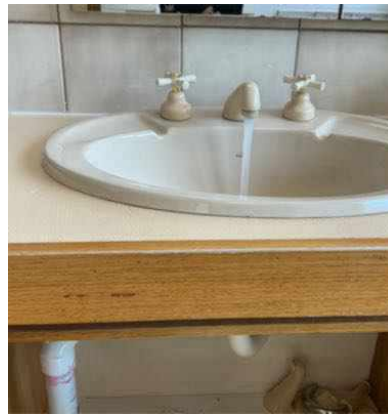
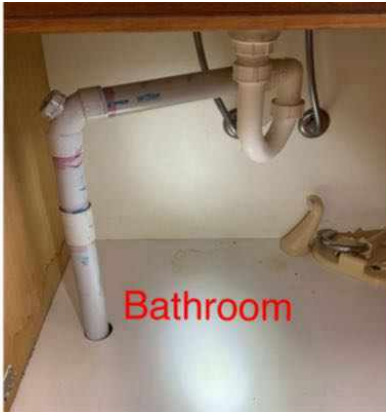
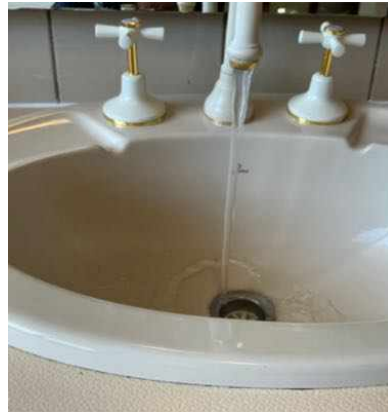
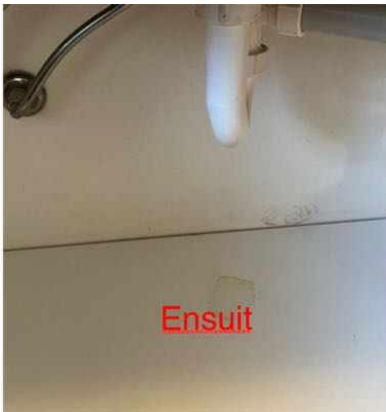
Building: Main Building  
 Location: Cabinetry plumbing  
 Finding: For your information  
 Information: Cabinetry plumbing - No leaks evident

NOTE: Please be aware that although cupboards have had a thorough inspection, obstructions in cupboards may conceal potential water damage, prevent a full inspection and conditions can change after the initial inspection was carried out, therefore damage may be found after obstructions are removed.

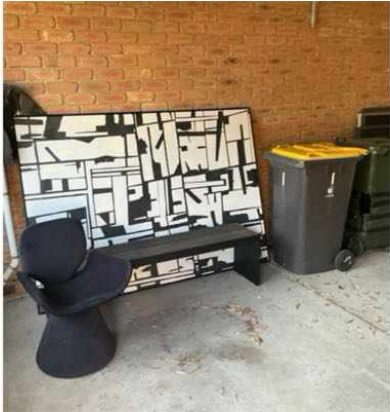
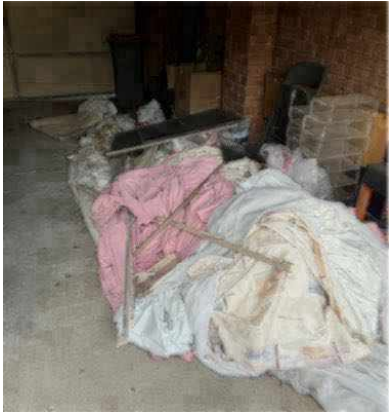
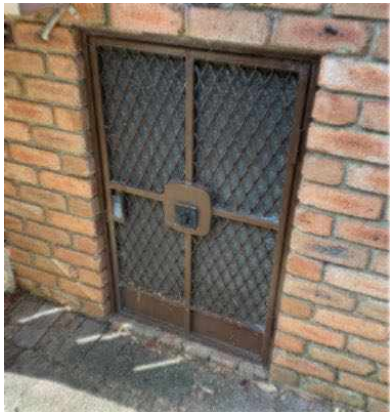
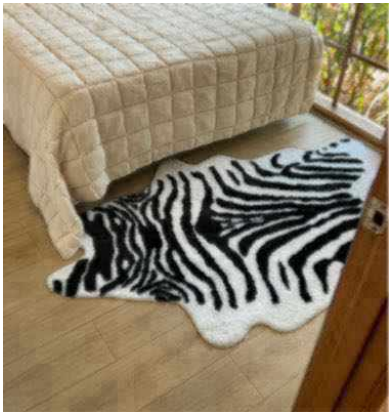
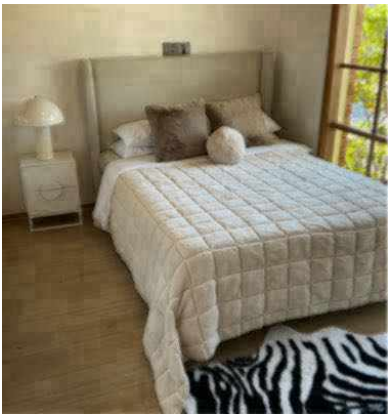
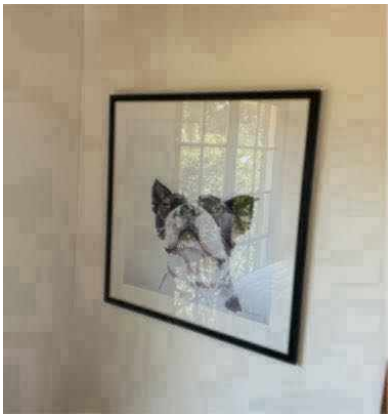
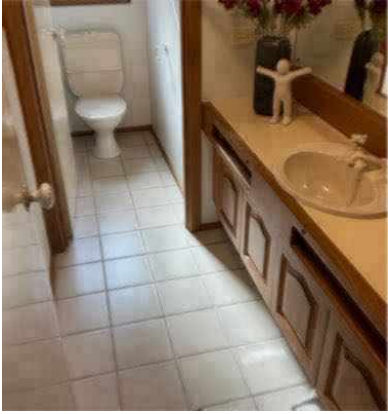
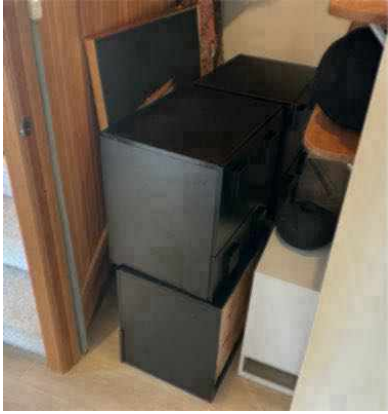
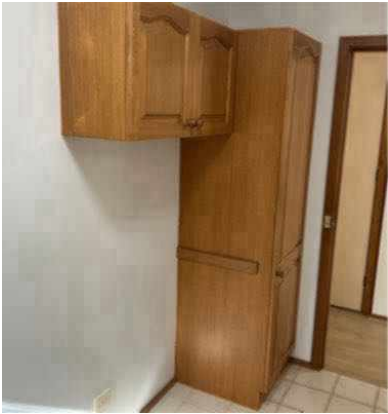
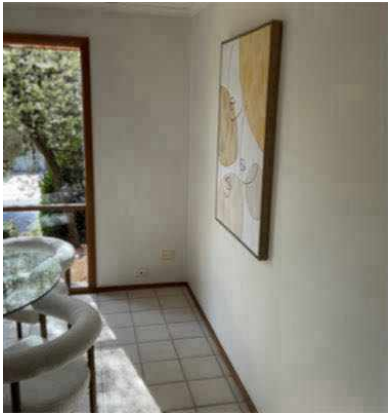
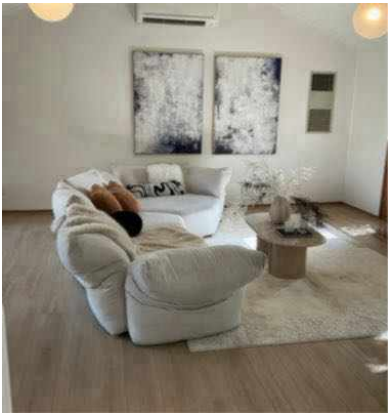
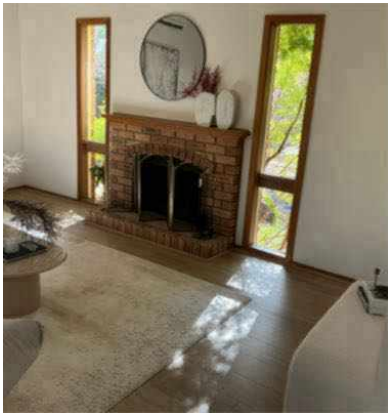
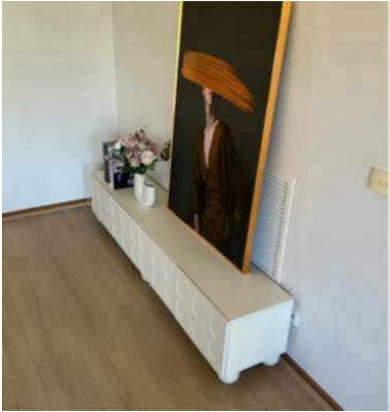
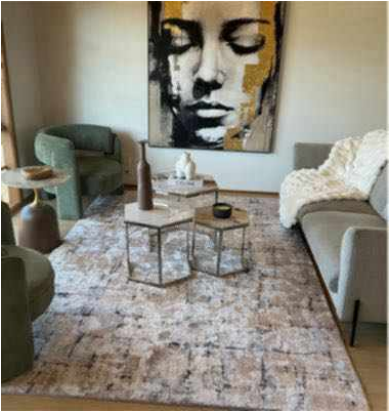
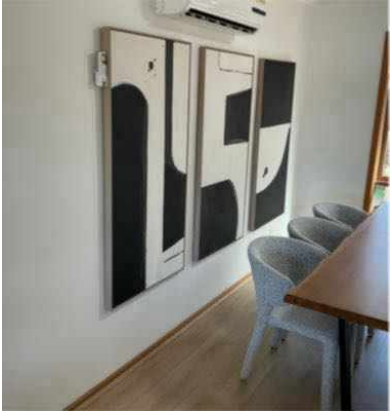
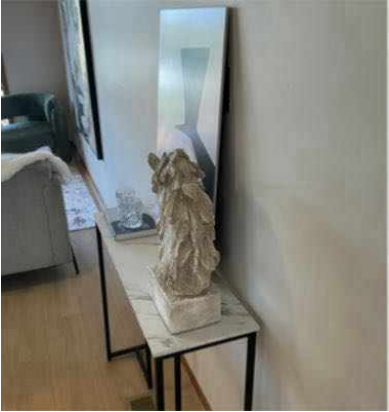
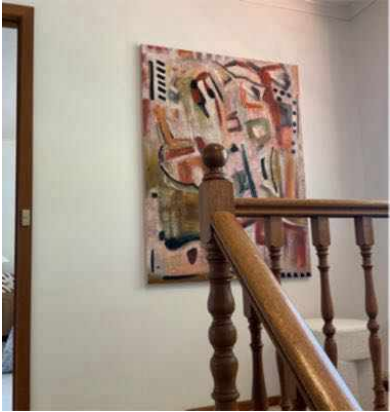
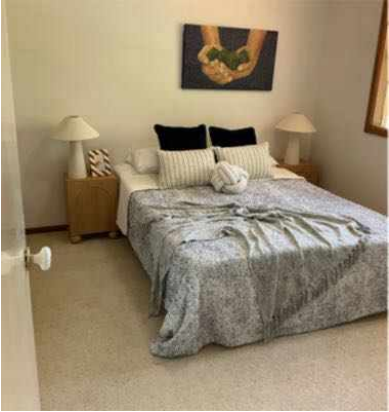
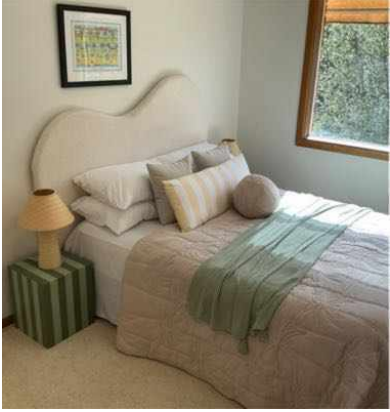
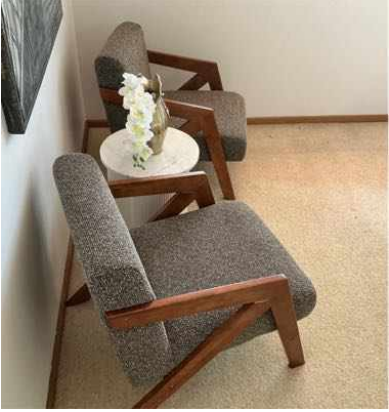
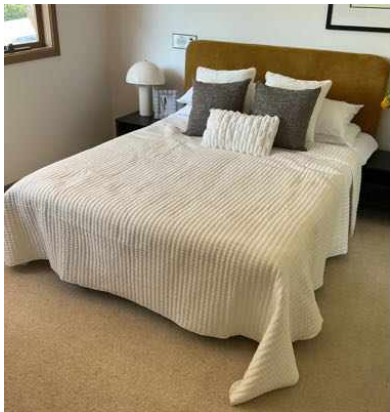
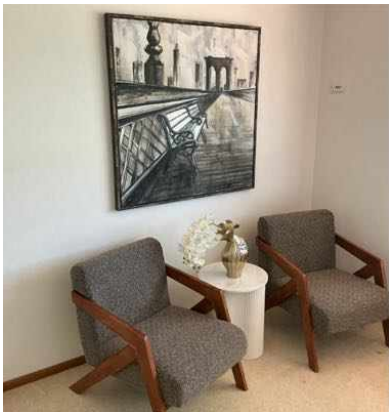
Building: Main Building  
Location: All Areas  
Finding: Additional Photos - Obstructions and Limitations  
Information: These photographs are an indication of the obstructions and limitations which impeded full inspection of the property at the time of inspection. These obstructions can hide an array of defects and should be removed to allow full inspection to be carried out. A re-inspection is recommended once the areas are made accessible. Arrows and highlights have been included to identify minor defects. The purchaser can discuss further with the building inspector.
