Building and Timber Pest Inspection Report

Inspection Date: Fri, 13 Feb 2026

Property Address: 9/93 Duncan St, Maroubra NSW 2035,
Australia

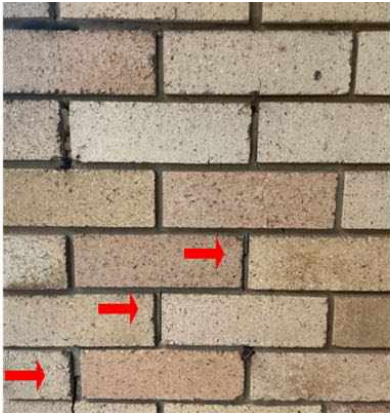
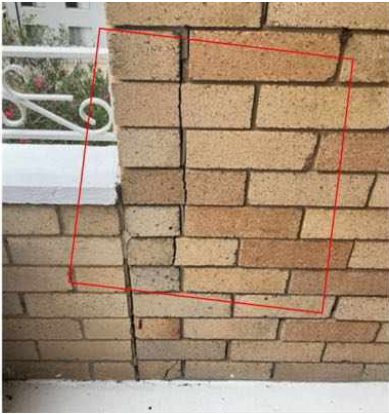
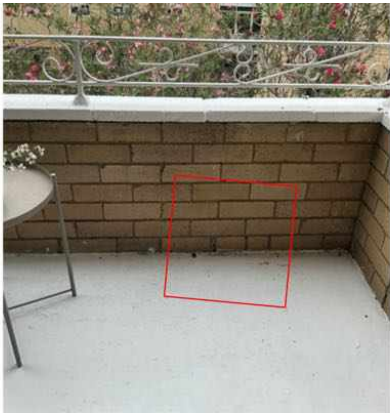
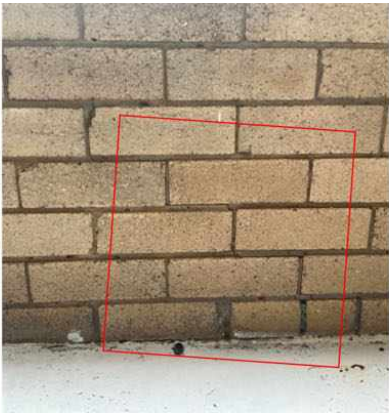
Building: Main Building
Location: Balcony
Finding: Brickwork - Step cracking (Further investigation by a Structural Engineer Required) - Also refer to 3.1
Information: Step cracking was identified to the brickwork in this area at the time of inspection. Step cracking, which is similar to other forms of cracking, has a variety of possible causes. However, the most common is the subsidence of adjacent footings.

Step cracking is a relatively common defect, and is most likely to occur adjacent to windows, doors and other openings. Mortar failure in the gaps between affected bricks indicates the stresses and tensions affecting the wall.

Where step cracking is extensive or severe, the client is advised to consult a structural engineer. Minor step cracking can be used as a warning sign to address factors causing stress to the wall, which can include the effect of surrounding trees, water leaks, soil erosion, or even the presence of reactive soils in the surrounding area.

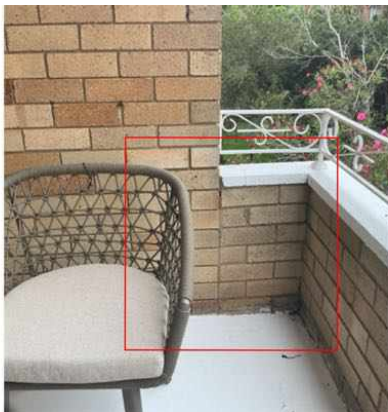
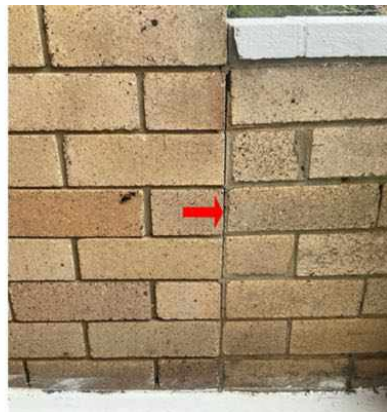
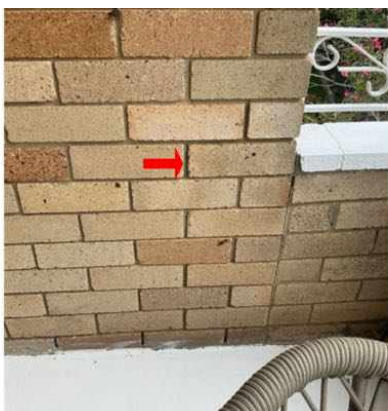
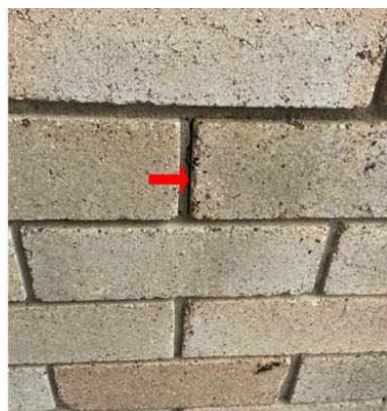
Finding 3.01

| Finding: | Brickwork - Cracking noticeable |
| Information: | There were several cracks and or crack repairs evident to external brickwork. |

Noticeable cracks are a common occurrence in external brickwork and are a likely result of age expected building movement, general expansion, and/or contraction of building materials in different weather conditions. Noticeable cracks in brickwork may develop if left unattended, with potential for necessitating major remedial works or replacement of the brickwork.

It is highly advised that a qualified bricklayer be appointed to provide necessary works to cracked brickwork to prevent any further damage. Such works should be conducted as soon as possible.

Always monitor these cracks and contact a building inspector should cracks widen, lengthen, or become more numerous.

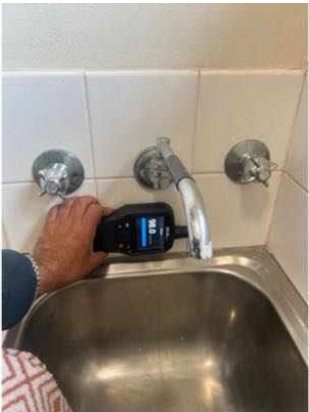
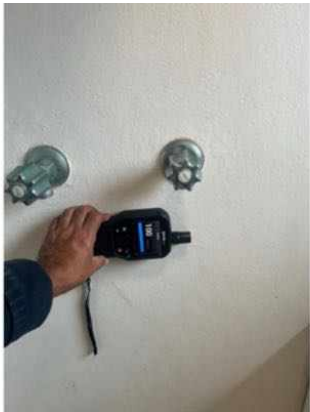
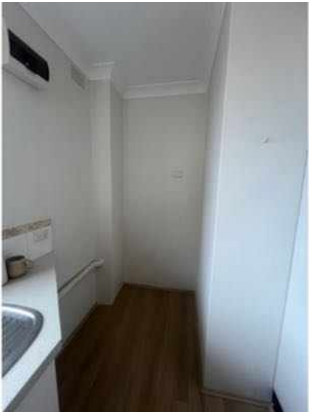
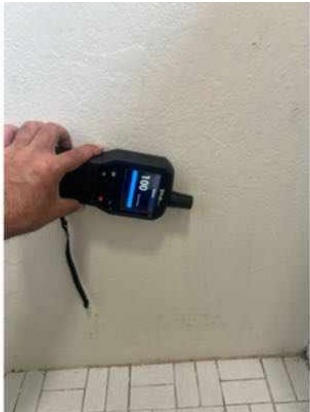
Finding 3.02

Building: Main Building
Location: Laundry , Kitchen
Finding: Elevated Moisture – Further Investigation Recommended
Information: Elevated moisture readings were detected in several locations, with some areas also showing signs of dampness or past repairs while others did not present visible surface issues, although no significant structural damage was evident at the time of inspection, dampness can contribute to deterioration if left unaddressed. A further investigation by a licensed plumber or waterproofing specialist is recommended to confirm the source and ensure no concealed issues are developing.

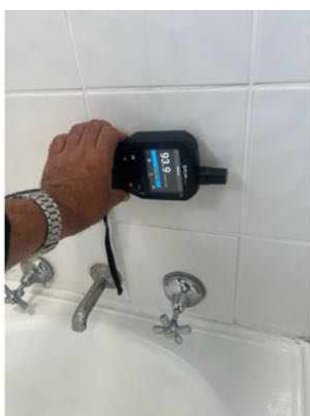
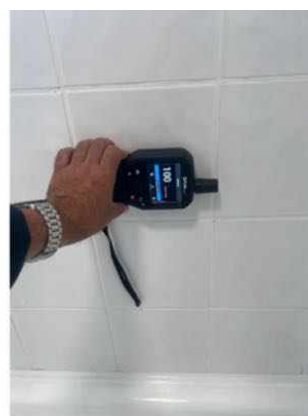
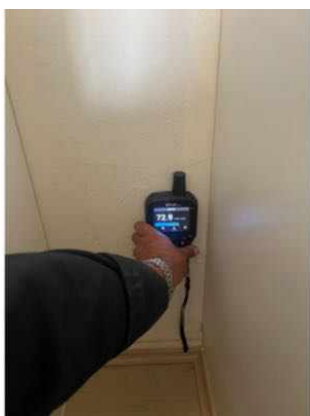
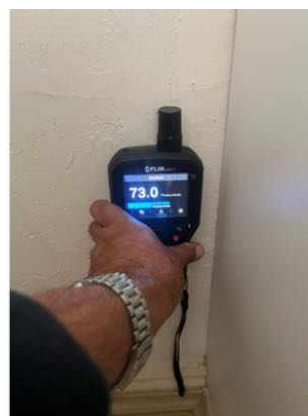
Finding 3.03

| Finding: | Elevated Moisture Bathroom & Back of shower |
| Information: | Elevated moisture levels were detected to tiled surfaces in bathroom/shower areas. This may be due to porous or missing grout, cracked tiles or recent use, however the possibility of waterproofing membrane failure or plumbing leaks cannot be excluded. Persistent moisture ingress can lead to concealed damage, including timber rot and mould growth. Further investigation by a licensed plumber and/or waterproofing contractor is recommended as soon as possible. The back of shower area also showed elevated moisture but no visible deterioration was evident at the time of inspection. |

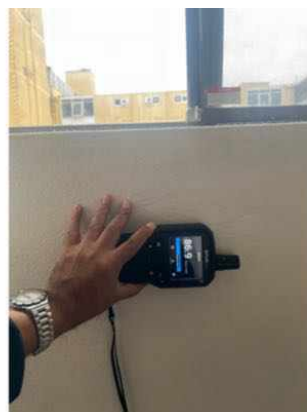
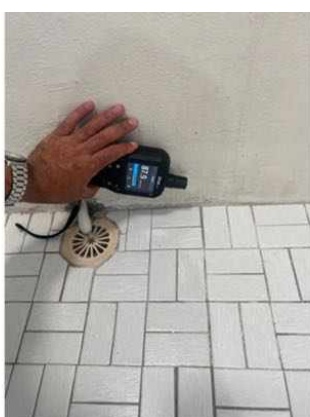
Finding 3.04

| Finding: | Elevated Moisture Detected - Strata |
| Information: | Elevated moisture levels were detected on external walls in rear bedroom and lounge. The areas should be monitored for and changes to existing conditions e.g damp , paint bubbling of staining. Further invasive investigation by a licensed plumber or waterproofing specialist is recommended to confirm the source and extent of water ingress. As this relates to a multi-residential building, the source of water ingress may |

involve common property, a suitably qualified waterproofing contractor is recommended to determine cause, responsibility, and scope if required.

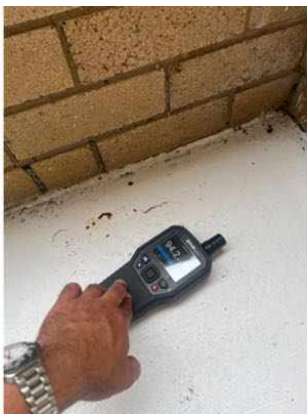
Finding 3.05

| Finding: | Balcony Elevated Moisture - Strata |
| Information: | Elevated moisture was recorded in balcony flooring. While no internal damage was visible at the time of inspection, balconies in multi-unit dwellings are high-risk areas for waterproofing failure, which can lead to leaks into adjoining units and significant rectification costs. Further investigation by a licensed waterproofing contractor is strongly recommended. |

Depending on the strata plan, this area may form part of the common property, in which case remedial responsibility may rest with the owners corporation (strata). Purchasers should seek clarification from the strata manager and legal adviser prior to purchase.

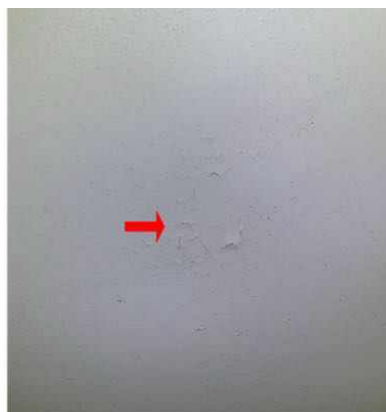
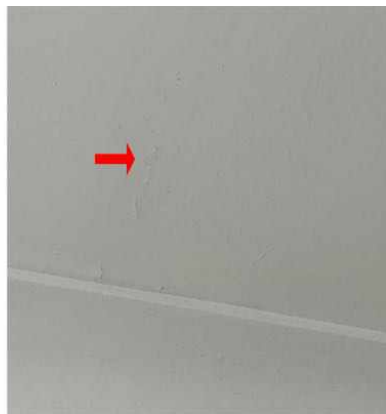
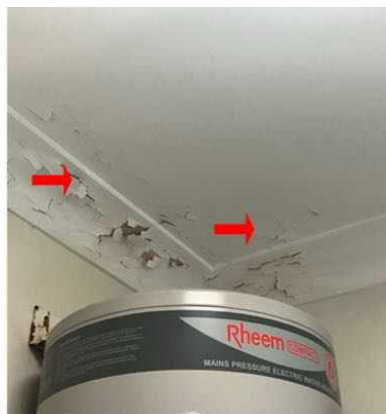
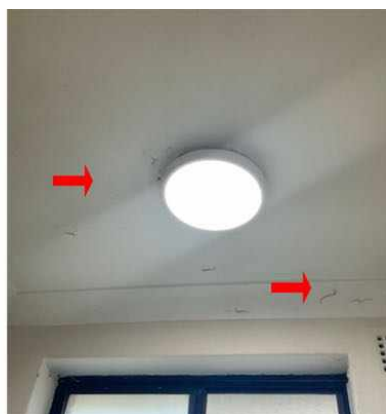
Finding 3.06

| Information: | Sections of paint in this area was found to have bubbled and deteriorated. Paint bubbling is generally an indication of excessive moisture in the area, that is currently hidden by the painted surface. |

The presence of excessive moisture can have major implications on associated building elements if left unattended. While only seemingly minor at this stage, the damage cannot be determined due to the paint obstructing any further inspection of the damage.

It is highly advised that the affected paint be cleaned to allow a further, more invasive inspection by a licensed plumber. Failure to act on this defect may necessitate major works in the future.

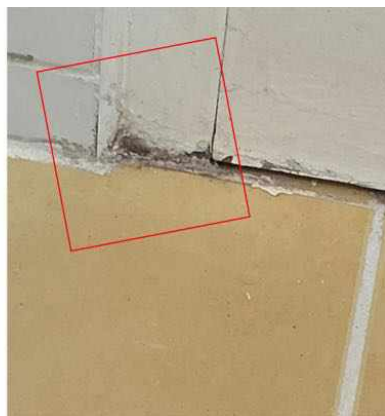
Finding 3.07

| Finding: | Wet-Area Door Jambs – Moisture Staining / Decay |
| Information: | moisture staining and deterioration were observed at the base of the wet-area door jamb. This is commonly due to water splashing or moisture tracking from the bathroom floor into adjacent joinery or inadequate waterproof transition at the bathroom threshold. |

Further inspection by a licensed waterproofing contractor is recommended to verify exact cause and remedial measures

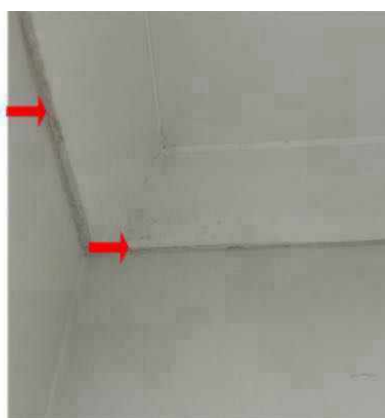
Finding 3.08

| Finding: | Water staining |
| Information: | Water staining was evident in this area at the time of inspection. Water staining indicates that surfaces have been exposed to excessive moisture over time. The minerals and other elements in the water lead to staining, which may graduate to corrosion and deterioration if left unmanaged. |

While mostly an appearance defect, water staining can be indicative of more serious defects, which may be currently concealed by other building elements.

Where water staining is active, a licensed plumber must be consulted to identify the cause of the staining and to provide advice on any reparation works that may be required. Replacement of any broken or damaged structures is advised.

Conversely, where water staining is old and inactive, affected building materials may be repaired or replaced at client discretion. A qualified carpenter or registered builder may be appointed to perform these works.

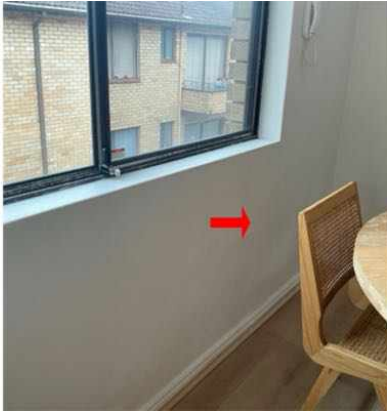
Finding 3.09

Building: Main Building
 Location: Lounge Room
 Finding: Walls - Water stained
 Information:

Water staining to sections of the walls in this area was evident at the time of inspection. Water staining indicates that surfaces have been exposed to excessive moisture over time. The minerals and other elements in the water lead to staining, which may graduate to corrosion and deterioration if left unmanaged. Given the proximity to the window, the condition may be associated with past water ingress, condensation, or inadequate sealing to external elements.

While mostly an appearance defect, water staining can be indicative of more serious defects, which may be currently concealed by wall linings.

Where water staining is active, a licensed plumber must be consulted to identify the cause of the staining and to provide advice on any repair work that may be required. Replacement of any broken or damaged structures is advised.

Conversely, where water staining is old and inactive, affected building materials may be repaired or replaced at client discretion.

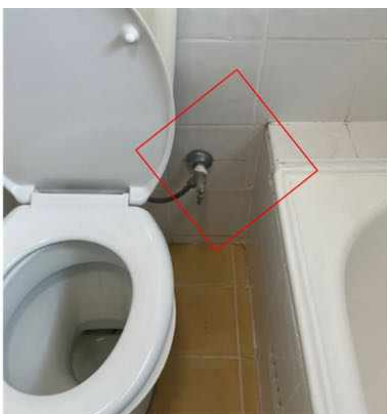
Finding 3.10

Finding: Tiles - Cracked or damaged to some areas

Information: Cracking was evident to the tiling in this area at the time of inspection. While the cracking appears to be minor, this area is frequently exposed to water, allowing potential for water penetration into adjoining sections of walls or flooring.

If left unmanaged, water penetration to these areas may lead to subsequent water damage, which is likely necessitate repair work to affected building elements.

A tiling contractor should be appointed to ensure that no further water damage occurs. The re-application of silicone and grouting throughout remaining tile work is also advised, to further protect the area against water penetration.

Where water penetration has led to water damage, appointment of a relevant tradesperson may be required to repair damaged building elements.

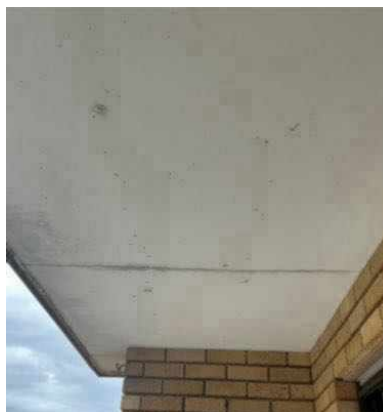
Finding 3.11

Building: Main Building
Location: Balcony
Finding: Water staining
Information:

Where water staining is active, a licensed plumber must be consulted to identify the cause of the staining and to provide advice on any reparation works that may be required. Replacement of any broken or damaged structures is advised.

Conversely, where water staining is old and inactive, affected building materials may be repaired or replaced at client discretion. A qualified carpenter or registered builder may be appointed to perform these works.

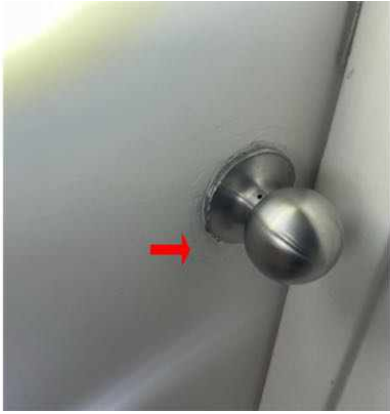
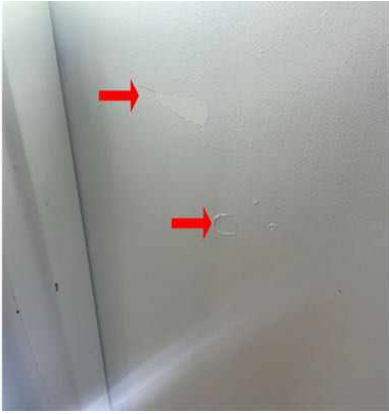
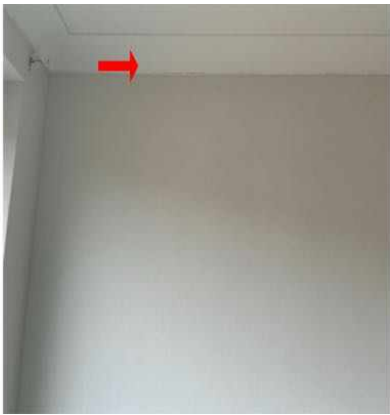
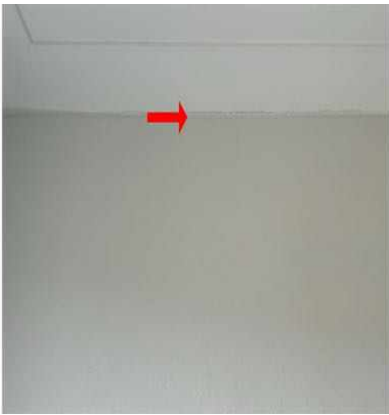
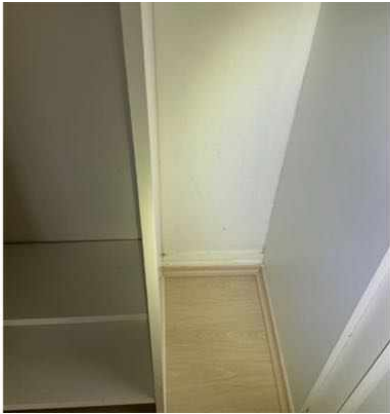
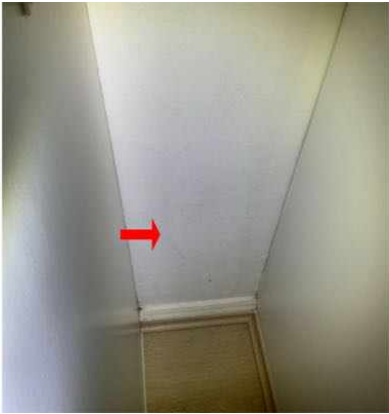
Finding 3.12

| Finding: | Paint finish and hairline cracking |

Incomplete paint finishes should be sanded back, filled, leveled and painted, as applicable. Where inadequate or missing paint protection has led to the deterioration of the associated building element, repair and/or replacement of this building element may be required.

A painting contractor should be appointed as soon as possible to perform necessary works to aid the appearance of the affected area and to ensure the area is protected against further deterioration. Alternatively, the homeowner following manufacturer instructions may perform these works.

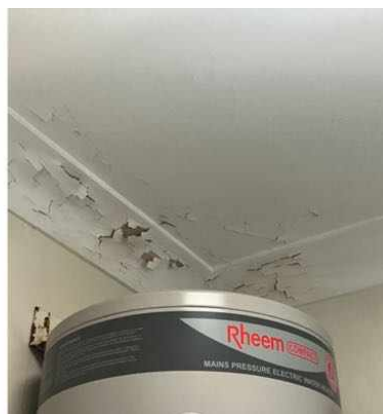
Finding 3.17

| Information: | Delamination is one means by which composite materials (e.g. layered timber composites) may fail over time. In laminated materials, repeated cyclic stresses may lead to the formation of mini-structures of separate layers, with significant loss of mechanical toughness. Water penetration or the presence of excessive moisture also generally contributes to delamination. |

Where building materials have become delaminated, they lose their structural strength, and are likely to have a variety of appearance and serviceability defects as a result.

Delamination of timbers may be repaired where the area affected is minor and/or easily accessible, by gluing and screwing layers back together. However, this is an interim repair, and where delamination has occurred, the client should plan for the replacement of affected timbers sooner than would otherwise be expected.

All timber structures affected by delamination should be replaced as soon as possible to avoid any further damage. Repair and replacement estimates should be sought

from a registered builder or qualified carpenter.

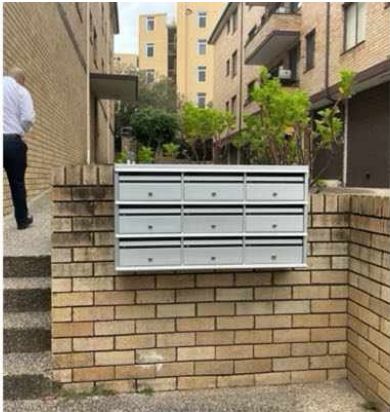
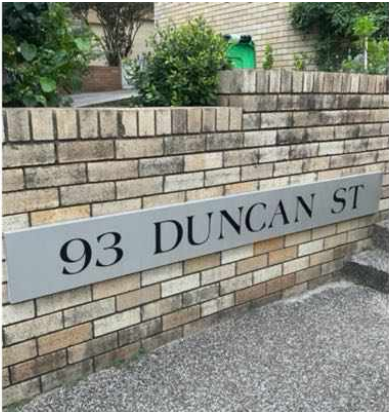
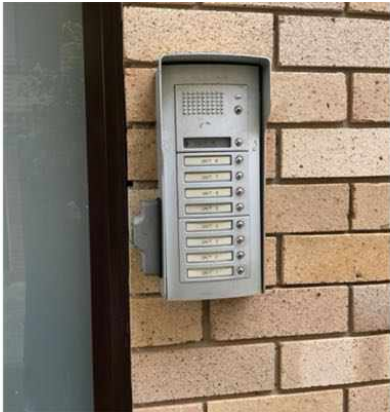
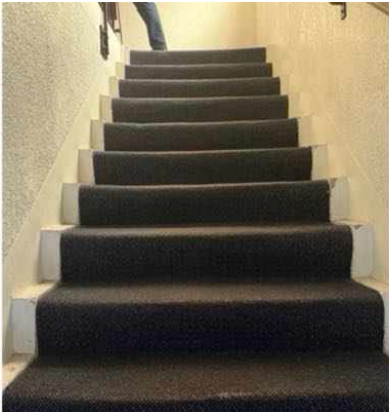
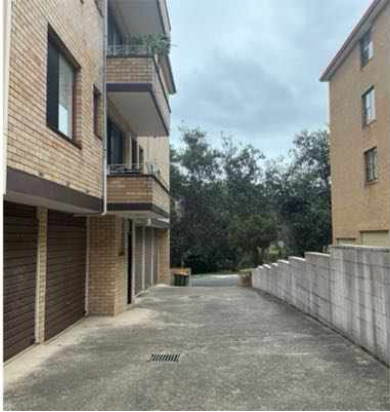
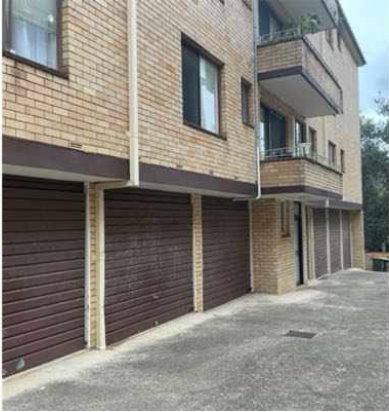
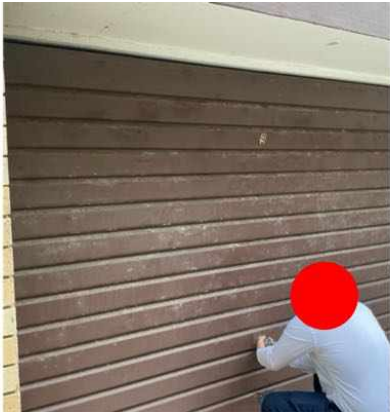
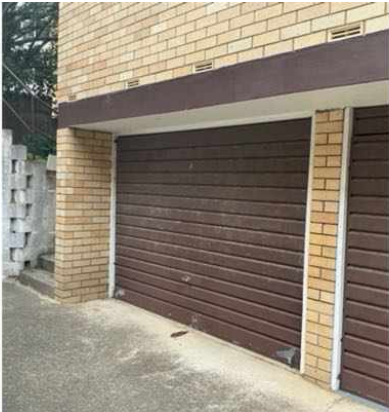
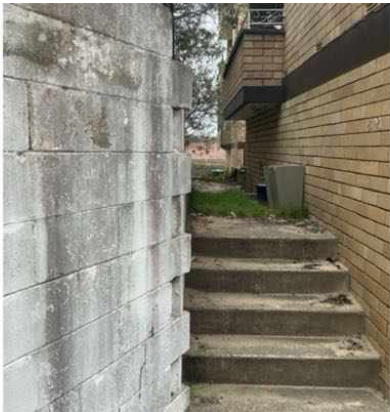
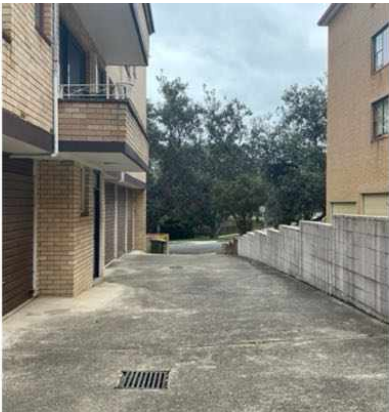
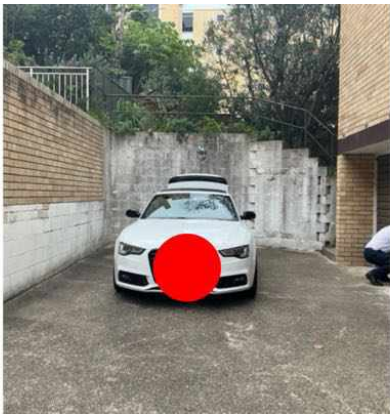
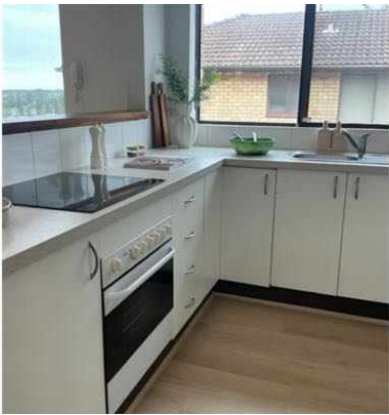
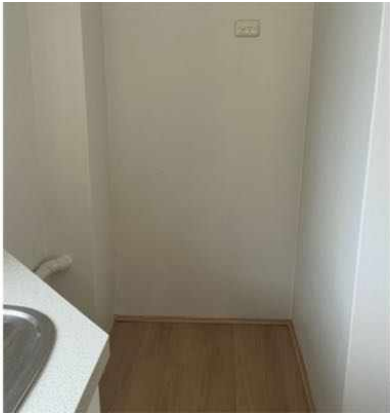
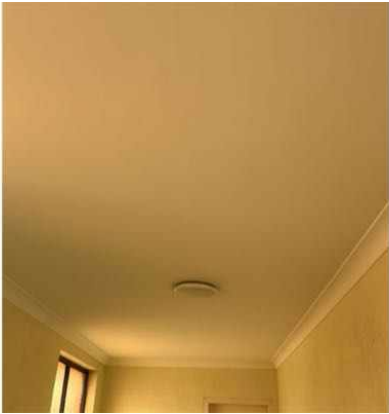
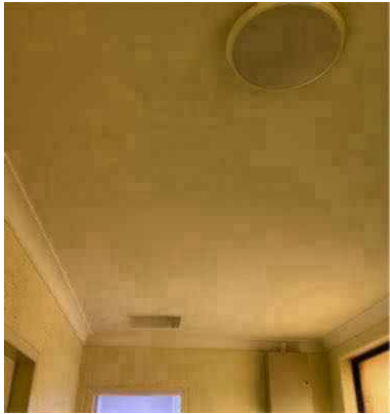
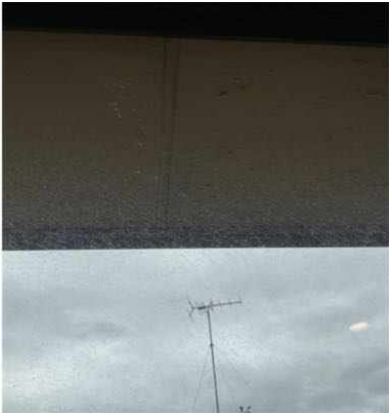
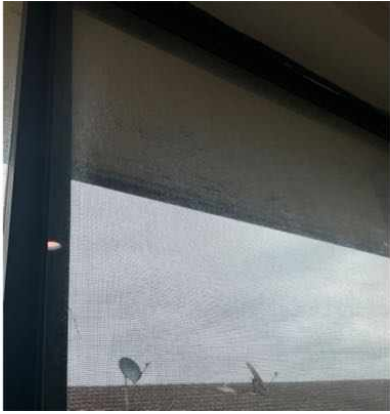
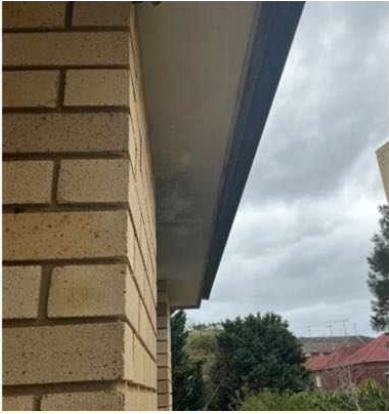
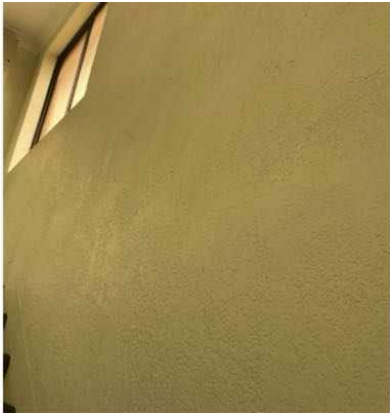
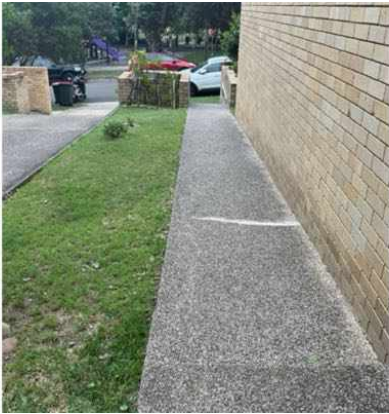
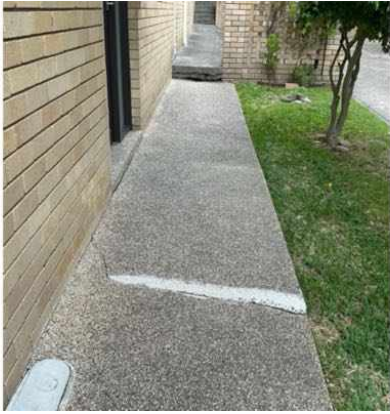
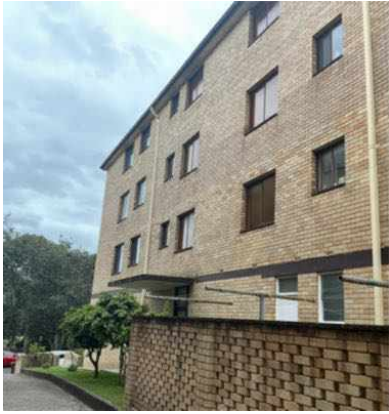
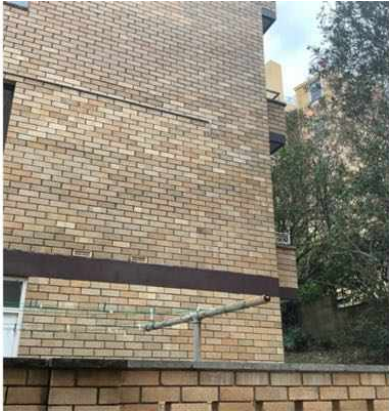
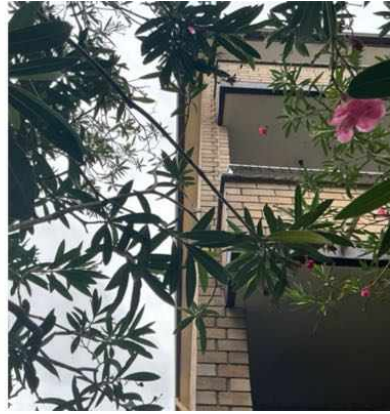
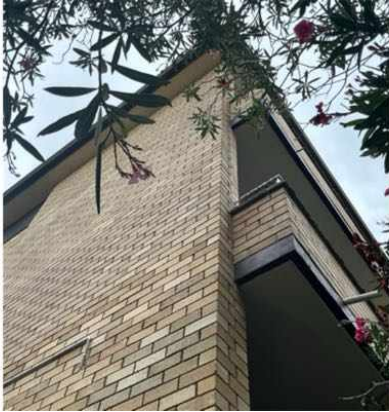
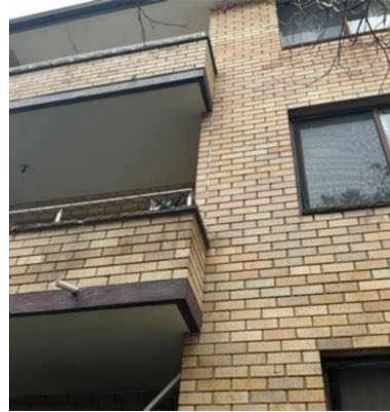
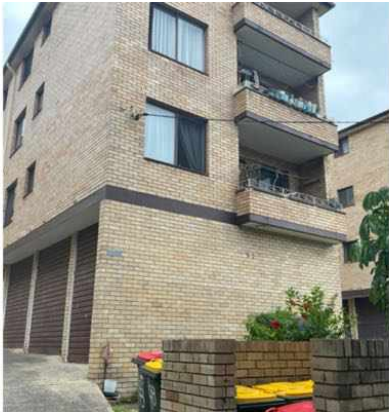
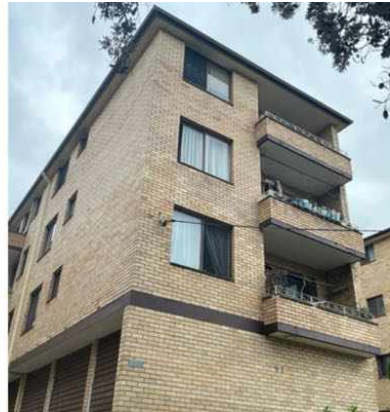
Building: Main Building
Location: All External Areas
Finding: Additional Photos - Obstructions and Limitations
Information: These photographs are an indication of the obstructions and limitations which impeded full inspection of the property at the time of inspection. These obstructions can hide an array of defects and should be removed to allow full inspection to be carried out. A re-inspection is recommended once the areas are made accessible.

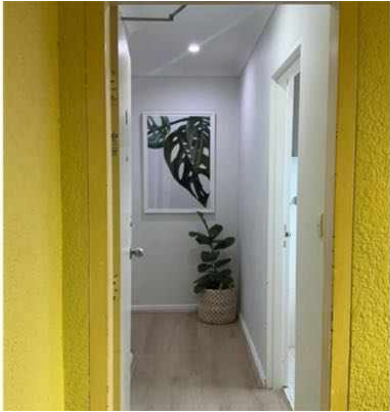
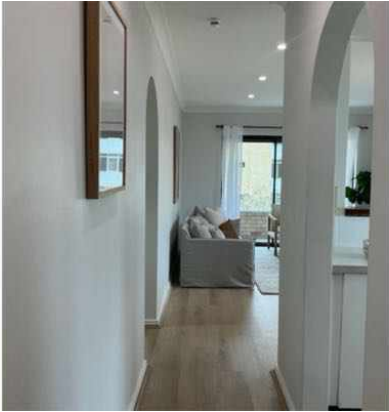
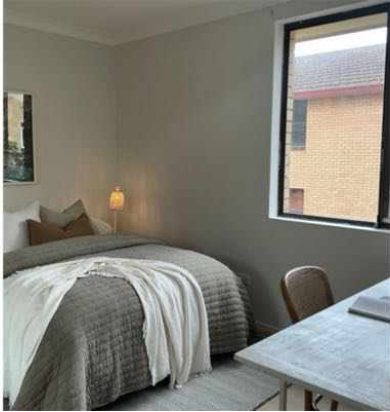
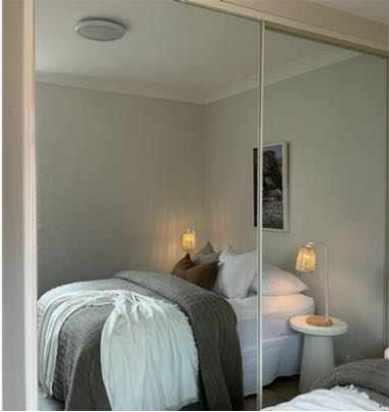
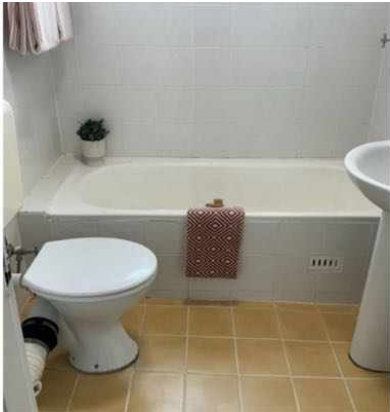
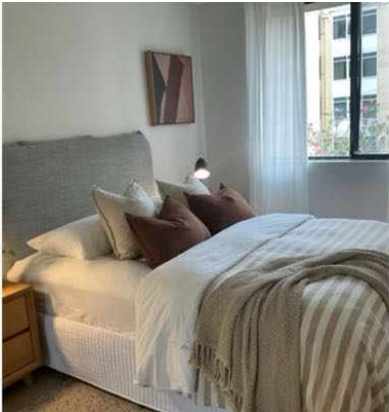
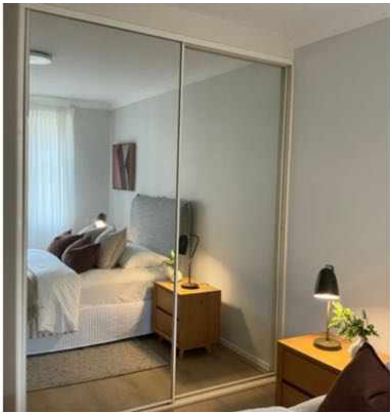
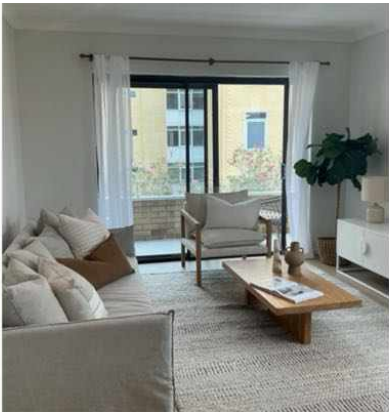
| Finding: | Additional Photos - Obstructions and Limitations |
| Information: | These photographs are an indication of the obstructions and limitations which impeded full inspection of the property at the time of inspection. These obstructions can hide an array of defects and should be removed to allow full inspection to be carried out. A re-inspection is recommended once the areas are made accessible. |
