Building Inspection Report

Inspection Date: Thu, 18 Dec 2025

Property Address: 411/240 Barkly St, Footscray VIC 3011,
Australia

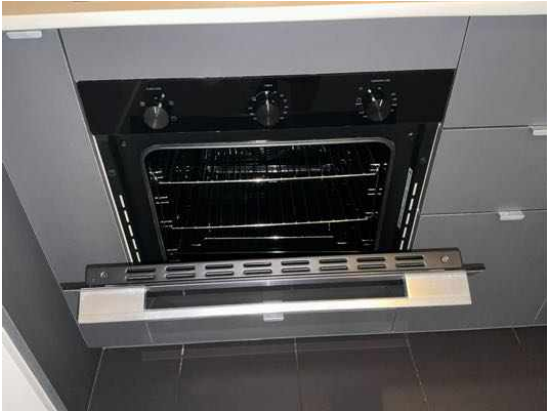
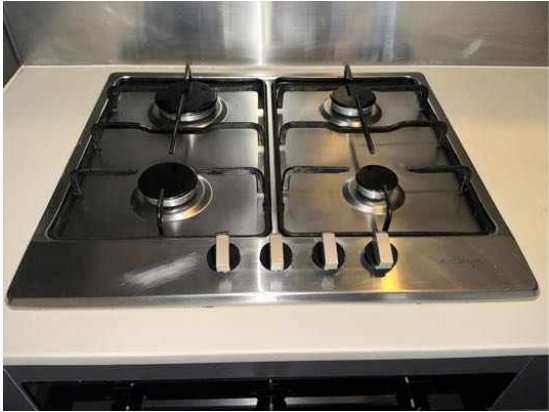
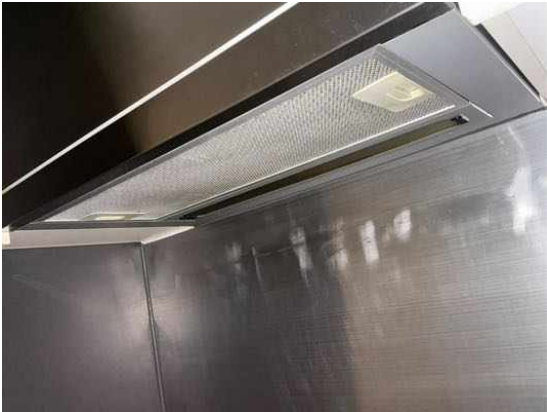
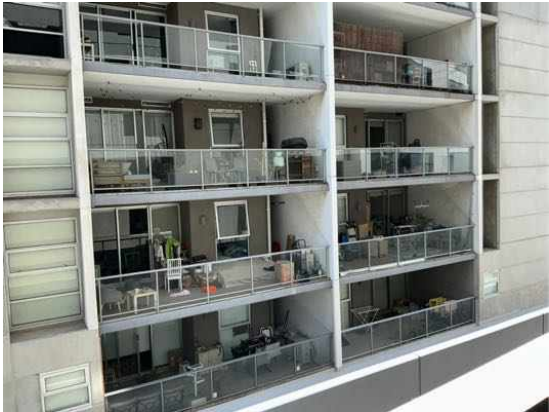
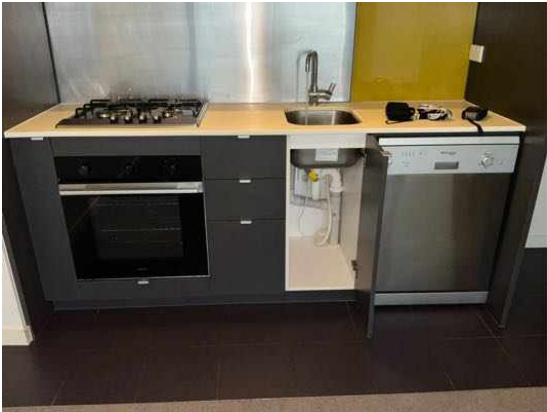
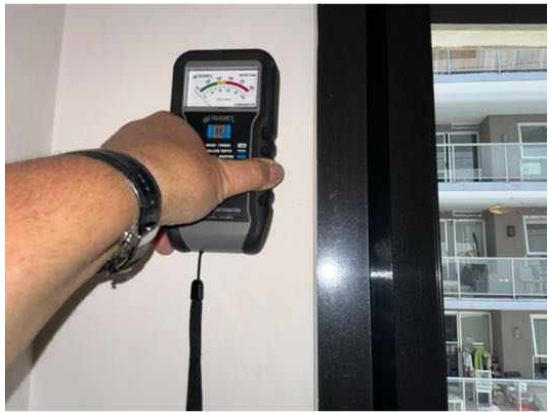
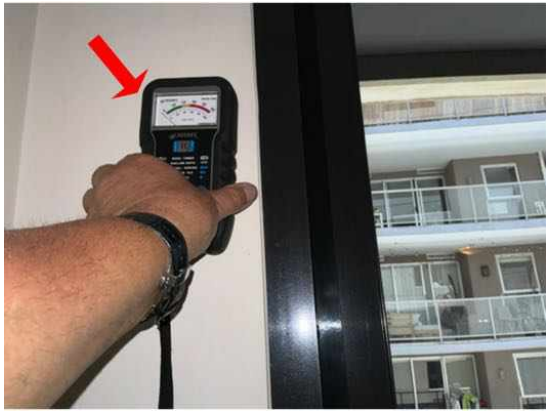
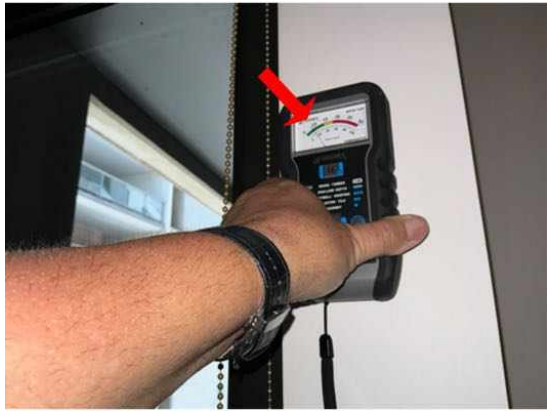
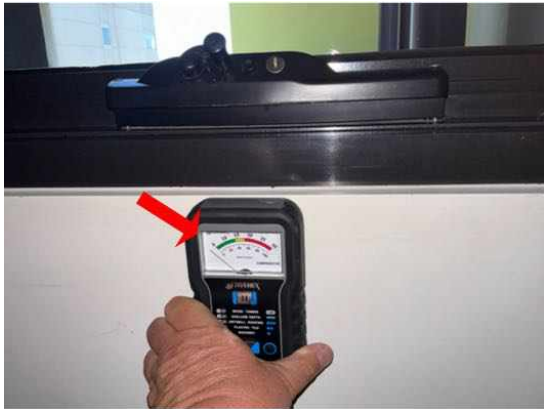
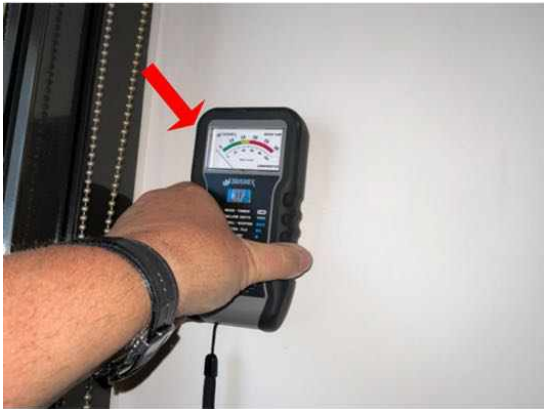
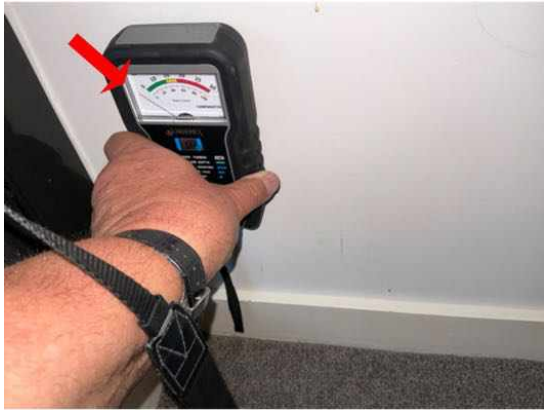
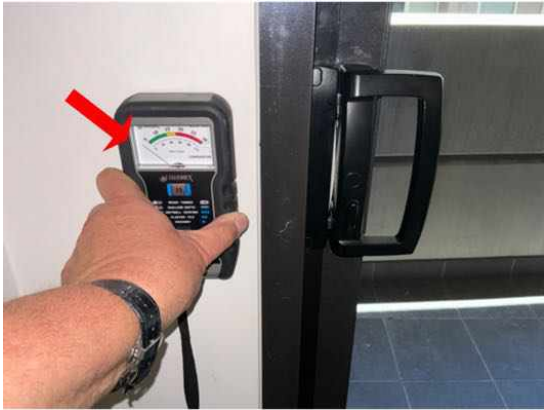
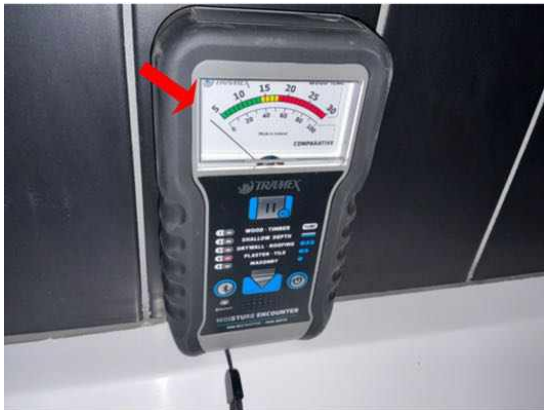
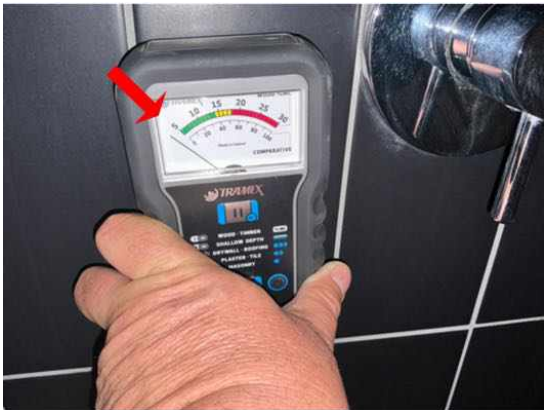
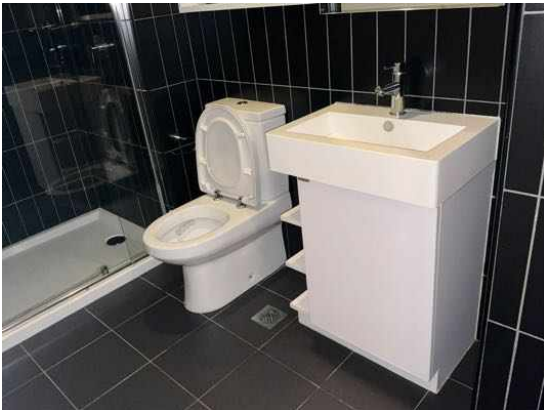
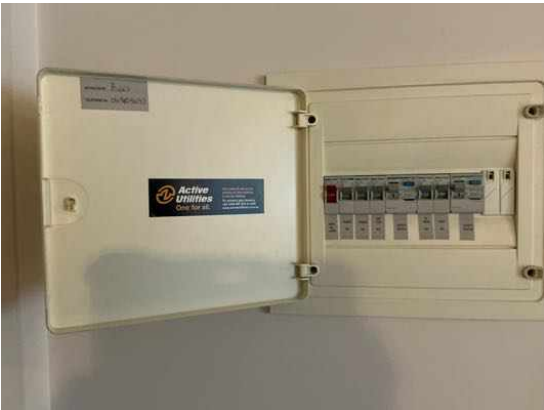
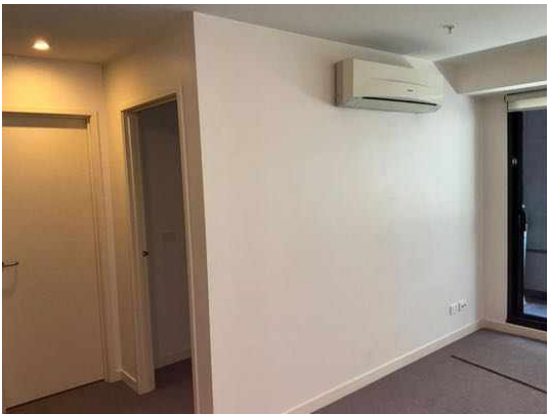
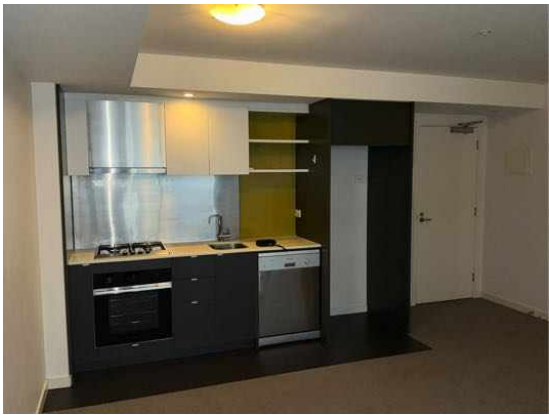
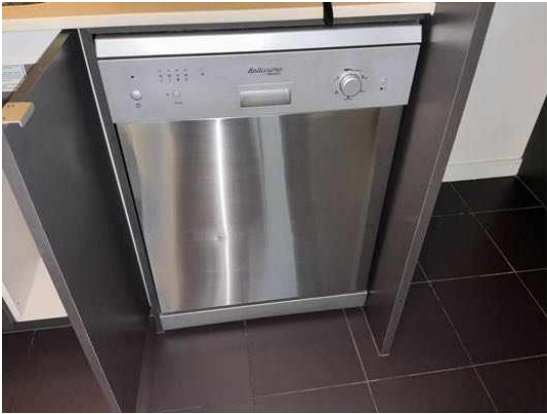
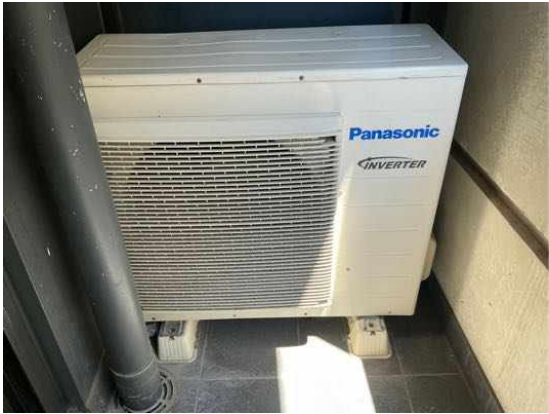
Building: Main Building
 Location: All Areas
 Finding: Additional Photos
 Information: Additional photos are provided for your general reference
