Building Inspection Report

Inspection Date: Fri, 20 Mar 2026

Property Address: 15 Manna Gum Dr, Pakenham VIC 3810,
Australia

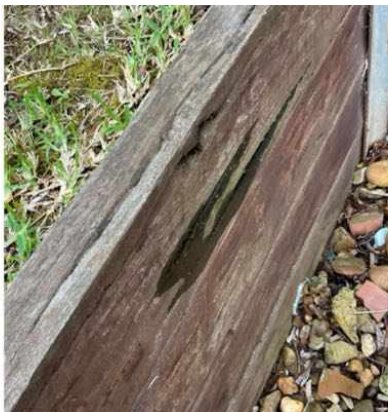
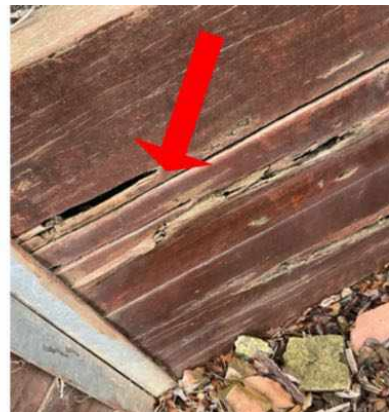
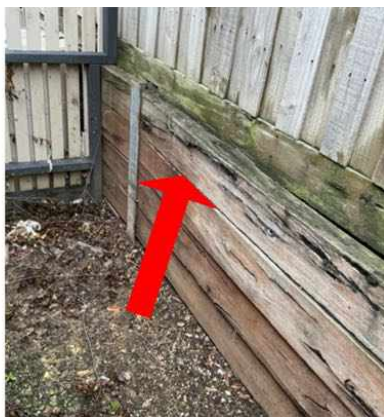
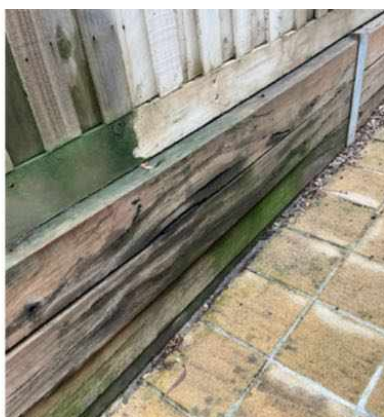
Defects 3.01

Building: Main Building
Location: All External Areas
Finding: Defective Retaining Wall Timber – Deterioration and Decay
Information:

The timber retaining wall elements surrounding the dwelling were observed to be deteriorated, with visible signs of decay and weathering to multiple sections. The affected components exhibit loss of material integrity and are no longer in sound condition.

Deterioration of retaining wall timbers can compromise their structural performance, potentially leading to soil movement, reduced lateral support, and eventual failure of the retaining system. This may also contribute to ground instability in adjacent areas of the property if not addressed.

A qualified carpenter or suitably experienced retaining wall specialist should be engaged to assess the full extent of the deterioration. The affected timber elements should be removed and replaced, with all new materials properly treated for external in-ground use. Associated works, including reinstatement of structural support and drainage provisions where required, should be completed to ensure the retaining wall performs as intended.

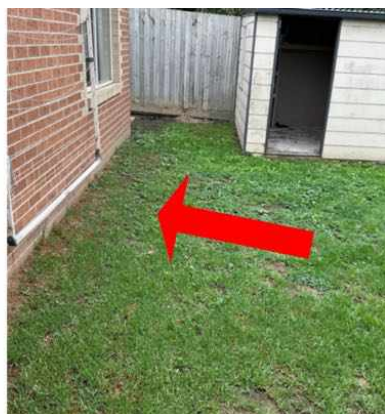
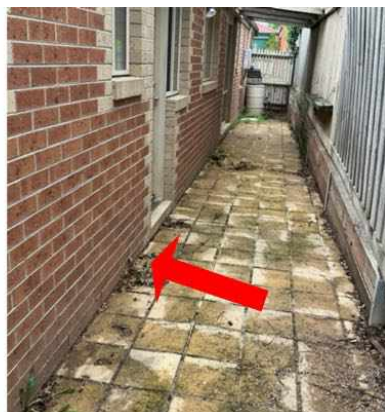
Defects 3.02

| Finding: | Site drainage - Inadequate |
| Information: | The site drainage in the yards was found to be inadequate at the time of inspection, creating potential for subsequent water damage to associated building elements. |

It is important that water does not lie against the base of walls; surrounding paths and ground levels should be sloped to drain water away from walls. Downpipes should not discharge stormwater onto lower walls or plinths. Stormwater should be carried away by large, regularly cleaned drains. Ground levels may need to be lowered to expose a buried DPC.

Where site drainage is inadequate, installation of an Agricultural (Aggie) Drain may be required. A qualified plumber should be appointed to further inspect the property and perform any remedial works as necessary. Water damage and secondary defects are likely to occur if left unmanaged.

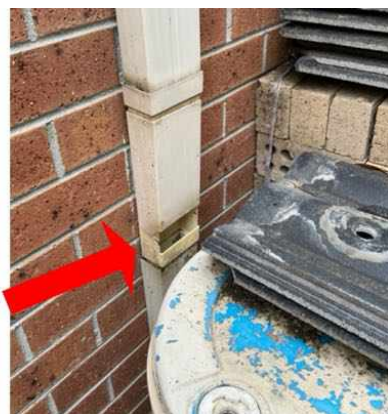
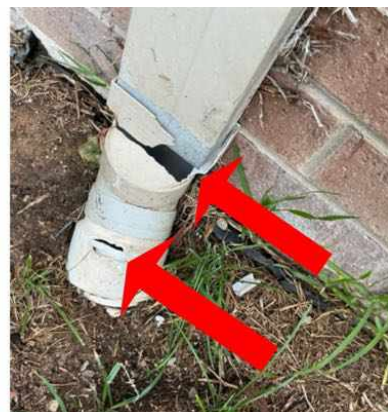
Defects 3.03

| Finding: | Defective Downpipes – Detachment and Damage |
| Information: | A number of downpipes around the dwelling, including within the side yard, were observed to be in defective condition. One downpipe is partially detached from its joint connection point, while another shows damage at the lower section near the stormwater connection. These conditions indicate compromised integrity of the rainwater disposal system. |

Defective or damaged downpipes can lead to uncontrolled discharge of roof water, which may result in water pooling around the base of the structure, increased risk of moisture ingress, and potential foundation movement or deterioration over time.

A licensed plumber should be engaged to resecure the partially detached downpipe and repair or replace the damaged section of piping at the stormwater connection. All works should ensure proper alignment, secure fixing, and effective discharge of stormwater away from the structure.

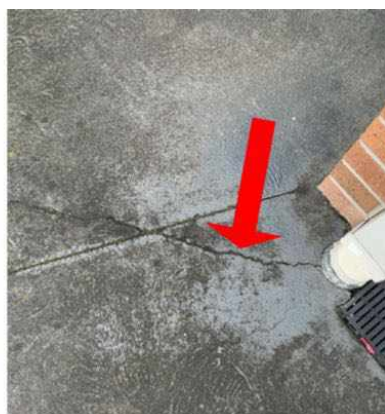
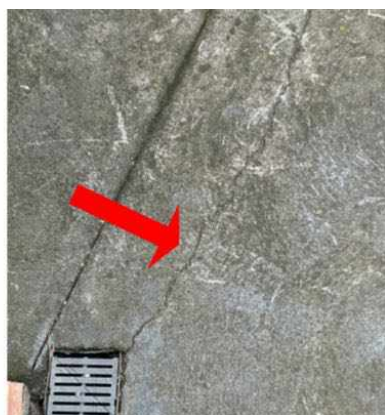
Defects 3.04

| Finding: | Cracking - External Concrete Paving Damage Category 2 - Distinct (less than 3mm) |
| Information: | Distinct cracks were identified in external concrete paving. Distinct cracks are generally found in older concrete paving, and may also present as a trip hazard as consequence of an uneven or curved surface. |

General age and expected deterioration of the paved areas is a common cause of this type of cracking. However, expansion and contraction of the slab may also have occurred due to environmental factors. Such factors include variable moisture and weather conditions, the presence of trees and their roots having a settling or lifting affect on the soil, or the effect of load bearing, e.g. heavy vehicles over a sustained period of time.

Cracking to this degree may also be due to poor original installation of the concrete. Factors such as poor compaction of the sub surface and/or inadequate reinforcing of the slab may create cracking and other secondary defects.

Repairs are likely to be required to prevent further cracking and to reduce hazards associated with cracking, such as tripping. Monitoring of all cracking should be conducted frequently. Always contact a building inspector should cracks widen, lengthen, or become more numerous.

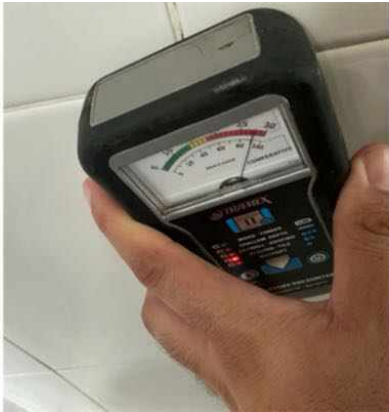
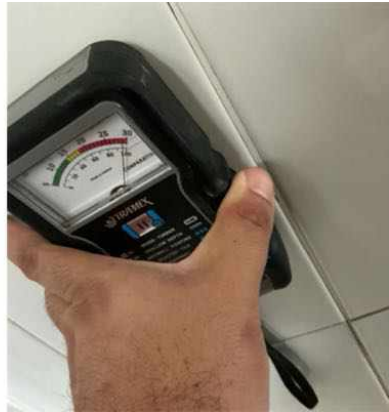
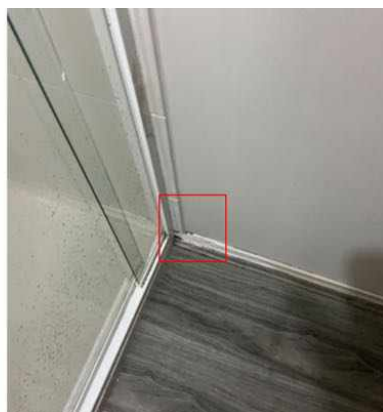
Defects 3.05

| Finding: | Excessive Moisture Detected to Shower Area and Adjacent Elements |
| Information: | Elevated moisture readings were recorded to the shower wall tiles, the plasterboard walls behind the shower from both sides, and the adjacent skirting boards using a non-invasive moisture meter. The skirting boards show signs of prior water damage that appears to have been painted over; however, high moisture levels remain present. The shower was operated continuously for approximately 45–60 minutes, and thermal imaging was undertaken, which did not identify any active moisture migration beyond the immediate area at the time of inspection. No visible surface damage was noted to the wall linings behind the shower from both sides; however, the assessment is limited to a visual, non-invasive inspection. |

Excessive moisture in wet areas may indicate underlying defects such as leaking plumbing components, failed or deteriorated waterproofing, or water ingress through grout lines or junctions. If not addressed, this condition can lead to concealed damage to wall framing, linings, and finishes, and may contribute to mould growth and long-term structural deterioration.

A licensed plumber should be engaged as a matter of urgency to undertake further

investigation to determine the exact source of the moisture ingress. This may include invasive inspection where required. All identified defects should be rectified accordingly, and any damaged materials (including skirting boards and wall linings) should be repaired or replaced following устранation of the moisture source.

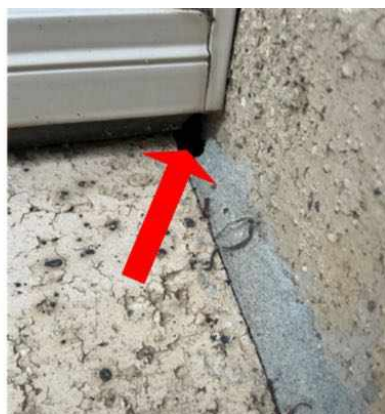
Defects 3.06

| Finding: | Window seals - deteriorated |
| Information: | The window seals have deteriorated and are in a generally poor condition. Due to frequent exposure to weather conditions and subsequent moisture, deterioration of window seals is expected in a property of this condition and age. |

Where window seals have deteriorated, the window is no longer weather-tight; rain penetration and subsequent water damage is therefore likely to ensue. Insulation of the area against external weather conditions will also be compromised.

It is recommended that all deteriorated window seals be replaced by a general handyman or sealant expert to prevent any further damage and to restore the window to a fully functional level.

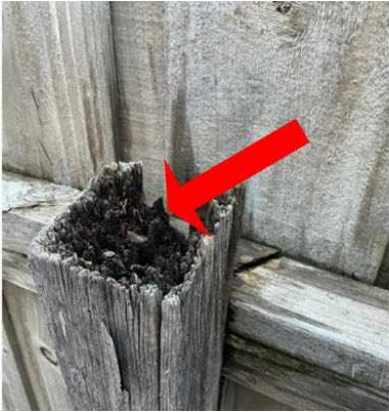
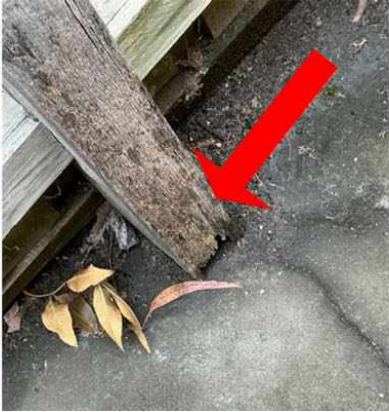
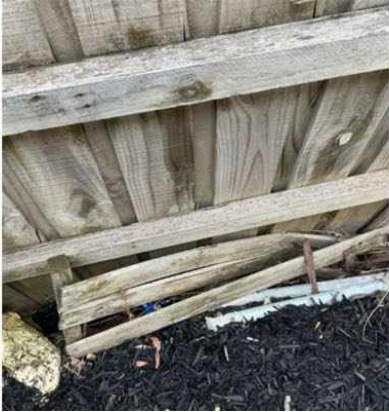
Defects 3.07

| Finding: | Fencing - Deteriorated |
| Information: | It was noted at the time of inspection that sections of the fencing throughout the property have deteriorated. Typically fencing deteriorates due to age and or wear, rot and or rust which is generally expected for a structure of this age, due to prolonged exposure to weather conditions. Sometimes inadequate installation or maintenance can be to blame. |

If left unattended, it is likely that further damage will occur. It is suspected that repair of several elements of the fencing may be required however replacement may be a consideration of the client also.

A licensed fencing contractor should be appointed to provide further advice and perform rectification works as necessary.

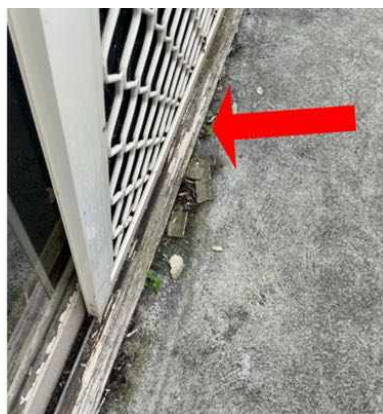
Defects 3.08

Building: Main Building
Location: Yard - Side
Finding: Rotten Timber Trim Below Sliding Door
Information:

The timber trim located beneath the sliding door in the side yard was observed to be deteriorated and affected by rot. The timber shows loss of integrity consistent with prolonged exposure to moisture and weathering.

Deteriorated and rotten timber elements can continue to degrade over time, potentially allowing moisture ingress into adjacent building components and compromising the durability of the door framing and surrounding finishes.

A qualified carpenter should be engaged to remove and replace the affected timber trim with suitably treated material designed for external exposure. All works should ensure proper sealing and protection to prevent future moisture-related deterioration.

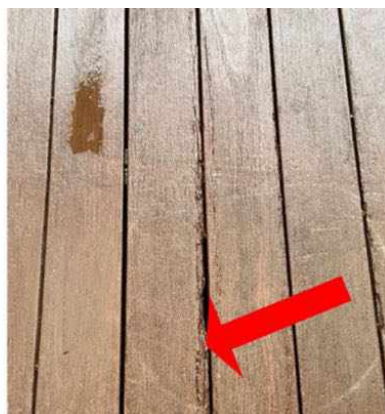
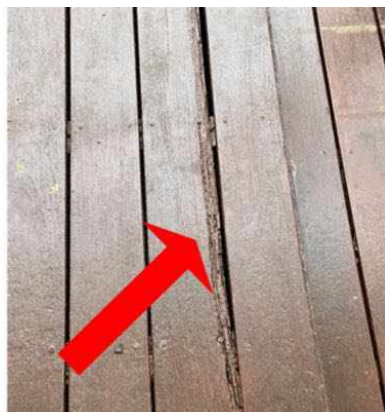
Defects 3.09

Finding: Minor Deterioration to Timber Decking Boards

A section of the timber decking in the backyard was observed to exhibit early signs of deterioration to the decking boards, likely associated with weathering and possible moisture exposure over time. The affected area appears to have been previously painted, and the boards were found to be firm underfoot at the time of inspection, with no significant structural movement noted.

While currently minor and largely cosmetic in nature, continued exposure to moisture and environmental conditions may result in progressive timber decay if not maintained, potentially leading to future loss of durability and performance of the decking surface.

A qualified carpenter or decking specialist may be consulted to assess the affected boards. Maintenance works such as sanding, sealing, or localised replacement of deteriorated boards can be undertaken at the client's discretion to preserve the condition and longevity of the deck.

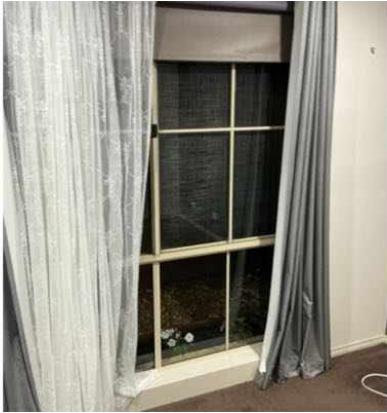
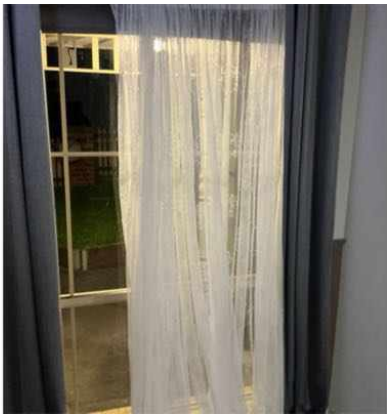
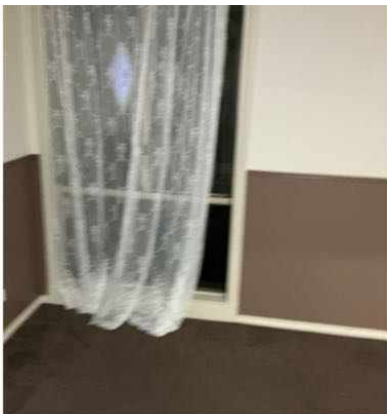
Defects 3.10

| Information: | Several windows throughout the property were jammed and difficult to operate at the time of the inspection. Windows provide ventilation to the adjoining area and should be at a fully operational level to ensure user comfort. Restricted function of the window may also pose as a potential safety hazard if required for emergency egress from the building. |

Generally, factors such as general age of the building element and a lack of maintenance are the usual causes for this type of defect.

Replacement of window hardware or frame may be required, as well as minor repairs and cleaning. A registered builder or general handy person will be required to repair the affected windows.

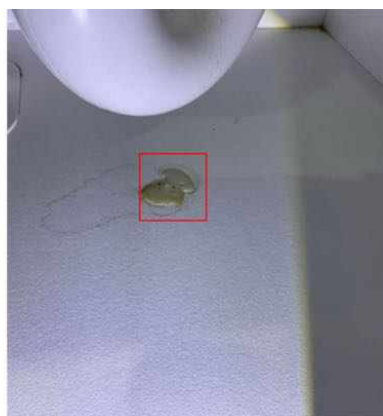
Defects 3.11

| Finding: | Kitchen plumbing pipes - Leaking |
| Information: | The plumbing pipes in the kitchen were found to be leaking at the time of inspection. |

This is a common defect that is consistent with general ageing of the building element. However, it may be indicative of substandard plumbing workmanship if the tap is relatively new.

While this defect only seems minor, if left unmanaged, it is likely to result in the development of rust, water damage and/or extensive water usage.

It is advised that a handyman or licensed plumber be appointed to perform remedial works on the affected tap. Such works should be performed prior to the development of secondary defects to ensure adequate functionality of all associated building elements

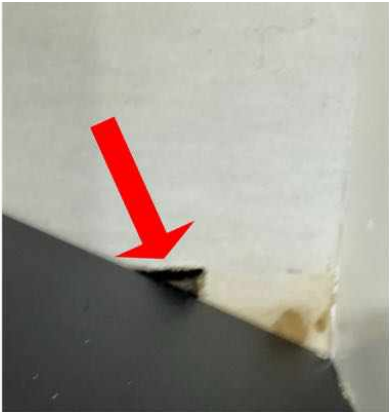
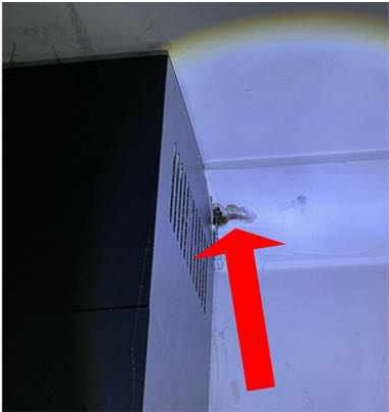
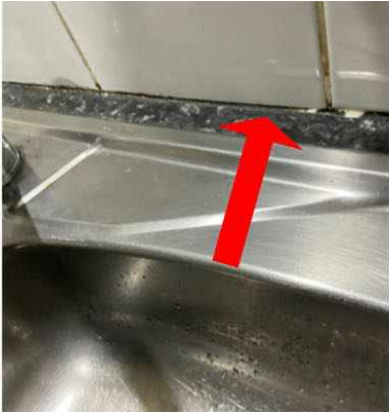
Defects 3.12

Building: Main Building
 Location: Kitchen
 Finding: Defective Finishes to Kitchen Rangehood Area and Splashback
 Information:

Gaps were observed behind the rangehood area, along with a crack at the junction between the underside of the rangehood bulkhead and the adjacent cornice. Additionally, the splashback tiles behind the kitchen tap show deteriorated or missing grout, particularly at the base junction. These conditions indicate incomplete or defective finishes to the kitchen wall and tiled surfaces.

Open gaps and cracked junctions may allow moisture, grease, and contaminants to penetrate into wall cavities, potentially leading to deterioration of internal linings and finishes over time. Defective or missing grout to splashback tiles can permit water ingress behind the tiles, increasing the risk of concealed moisture damage and mould development in the surrounding areas.

A qualified plasterer should be engaged to properly fill and finish the gaps and cracks around the rangehood and cornice junctions, followed by sanding and painting to match adjacent surfaces. A qualified tiler should be engaged to regrout and seal the splashback tiles, particularly at the base, to ensure the area is adequately sealed and protected against moisture ingress.

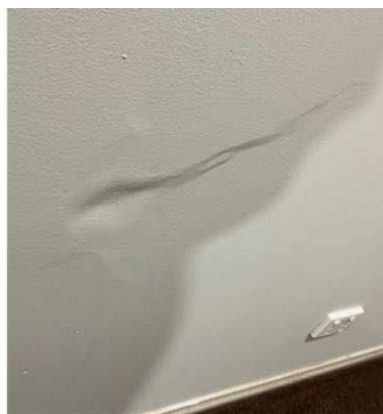
Defects 3.13

Building: Main Building
Location: Bedroom 3
Finding: Defective Plaster Finish to Bedroom Three Wall
Information:

A section of the plaster wall in Bedroom Three was observed to be defective, with visible paint bubbling to the surface. Upon light pressure, the affected area appeared hollow, indicating a lack of proper plaster backing or patching behind the painted finish. This suggests the area has been previously damaged and inadequately repaired.

Defective plaster finishes and poorly patched areas can lead to ongoing deterioration of wall linings and finishes. If left unaddressed, the affected section may worsen over time, resulting in further delamination, cracking, and potential exposure of underlying wall components.

A qualified plasterer should be engaged to remove the defective section, reinstate the wall lining properly, and ensure a sound substrate. Following this, a qualified painter should complete appropriate preparation, finishing, and repainting of the area to match the surrounding surfaces.

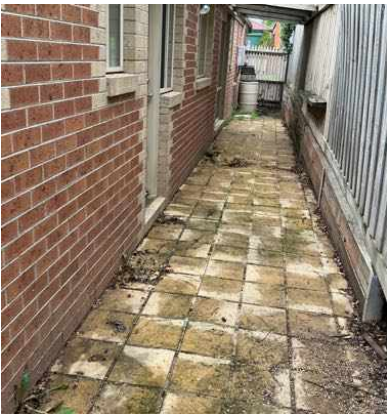
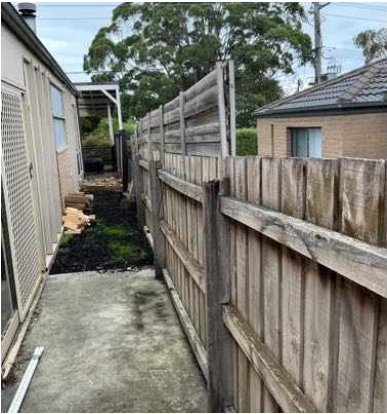
| Finding: | Obstructions and Limitations - Exterior |
| Information: | These photographs are an indication of the obstructions and limitations which impeded the inspection of the external areas of the property at the time of inspection. These obstructions can hide an array of defects and should be removed to allow full inspection to be carried out. A re-inspection is recommended once the areas are made accessible. |
