Building and Timber Pest Inspection Report

Inspection Date: Tue, 17 Feb 2026

Property Address: 16 Ardrossan Cres, St Andrews NSW 2566,
Australia

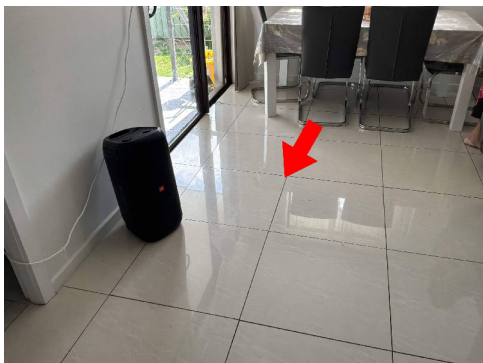
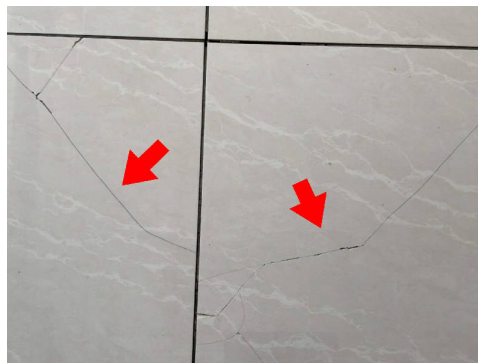
Finding 3.09

Finding: Cracked floor tiles

Information: Cracking in the floor tiles was evident in this area at the time of inspection. It is suspected that this cracking has occurred as a result of minor settlement or shrinkage of the slab.

Cracked tiles throughout the household detract from the overall appearance of the affected areas however it is unlikely to create or lead to any secondary defects.

While not considered a matter of urgency, replacement of cracked floor tiles is recommended at the clients discretion. A tiling contractor may be appointed to perform these works. Where cracks become more numerous, contact a licensed building inspector for further investigation.

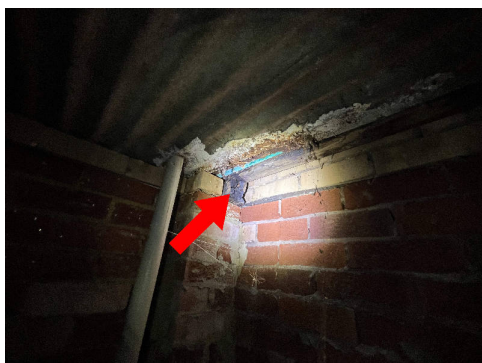
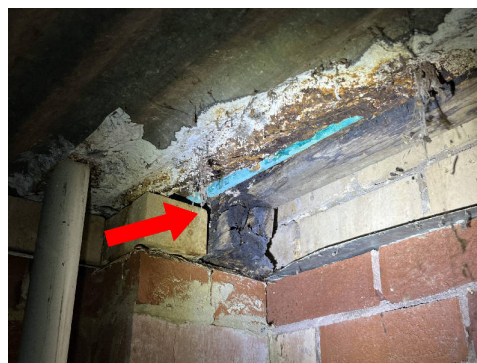
Finding 3.10

Finding: Subfloor – Bathroom Floor Joists

Information: Wood rot was noted to sections of the floor joists beneath the bathroom, likely related to past moisture exposure. It is recommended that a licensed plumber check for any leaking plumbing to the bathroom area and address as required. A licensed builder should assess and repair the affected timbers if deterioration progresses.

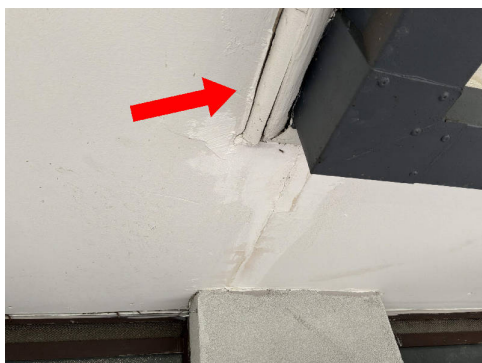
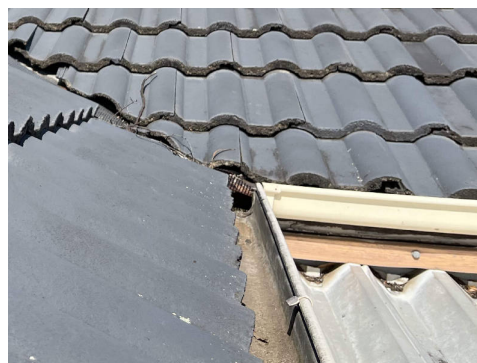
Finding 3.11

Information: Swollen building elements generally indicate that the building materials have been affected by excessive moisture over a prolonged period of time, and have swollen as a result. It is of the opinion of the inspector that the flat roof experiences water pooling in heavy rain, transferring to the affected area.

The structural integrity of swollen building elements can not be guaranteed, and further damage is likely to develop if left unmanaged. Excessive moisture is likely to lead to the development of secondary damage to any associated building elements, which may necessitate major reparation works if prolonged.

Rectification of the cause of the water ingress should be addressed prior to any remedial works to the swollen building elements. A licensed plumber should be appointed immediately to identify the cause of the leak and provide advice on remedial works as necessary. Repair and/or replacement of swollen building elements should be conducted as a matter of urgency by a registered builder or qualified carpenter.

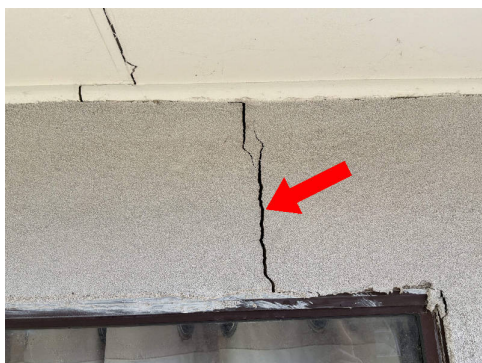
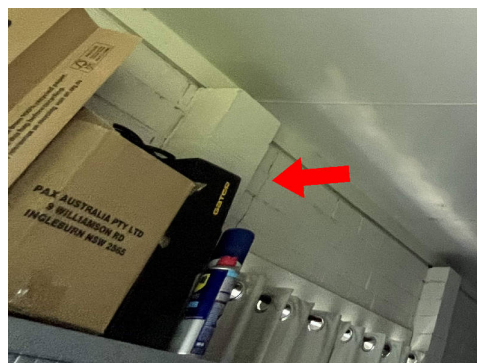
Finding 3.12

Finding: Brickwork - Cracking

Information: Brick work cracking was identified to the brickwork in this area. Cracks of this type are likely to have been caused by minor expected movement of building elements, but may also have a structural cause that is more significant.

A crack of this size may be repaired by extensive filling. Additionally, further remedial works to associated building elements, such as eave sheeting or external door frames, is likely to be required.

A qualified bricklayer should be contacted immediately to estimate and perform repair and restoration works. Consultation with a structural engineer may be required where structural instability is found to be the underlying cause of the cracking.

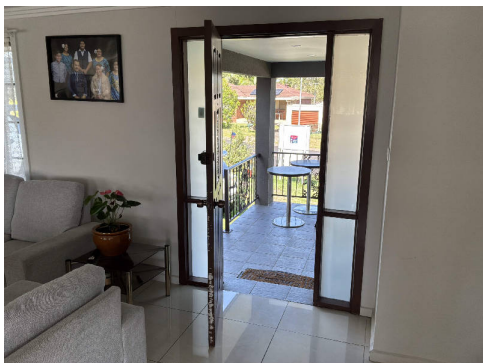
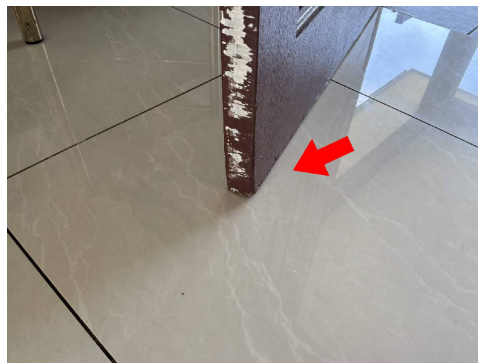
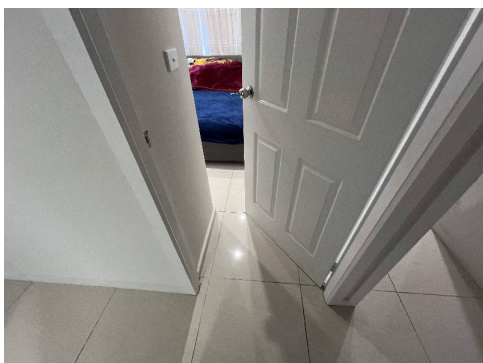
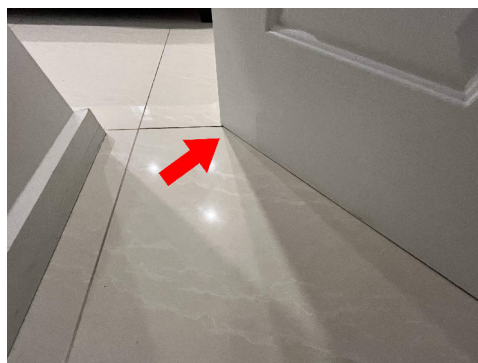
Finding 3.13

Information: Binding and/or jamming of this door is evident during standard operation. This defect inhibits the functionality of the affected door as well as creating potential for secondary defects to associated building elements, such as damage to the floor covering.

A door that binds to flooring or to the associated door frame may have several causes, ranging from minor defects, such as poor installation of the door or deteriorated hinges, through to major structural issues, such as damage to subfloor structures.

Where door binding/jamming appears to indicate major structural issues, a registered builder specialising in re-stumping should be appointed to provide an estimate on the cost of rectification.

For minor causes, a qualified carpenter or general handyperson should be appointed to perform minor rectification works at client discretion.

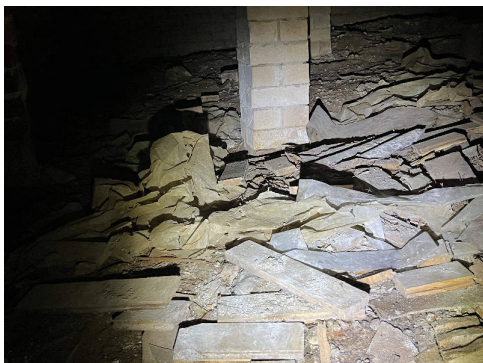
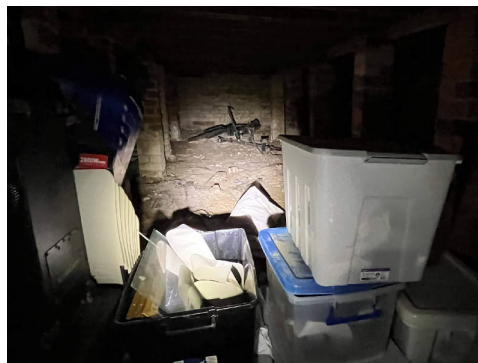
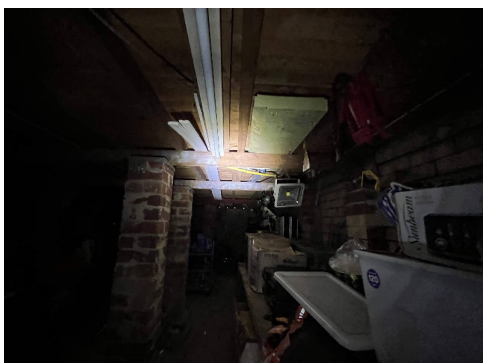
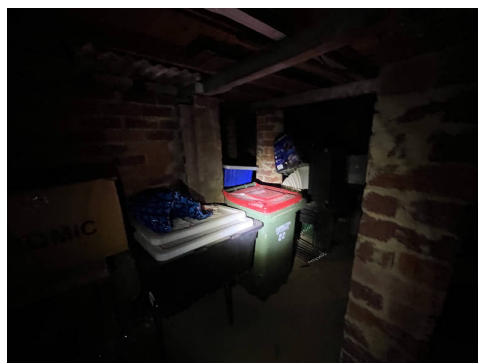
Finding 7.01

Building: Main Building
Location: Beneath bathroom
Finding: Fungal decay

Fungal decay (wood rot) has been identified in an external timber element, likely caused by prolonged exposure to excessive moisture. The decay is localized to a specific area, with no visible spread to other parts of the building element or adjoining structures. Given the temperature range and presence of oxygen, it's likely the decay has developed due to rain penetration.

The hazard class for this element is H3, indicating a moderate decay risk. The decay appears superficial, with minimal impact on structural integrity or tensile strength. Moisture content likely exceeds 20%, creating an environment conducive to fungal growth.

A qualified carpenter should assess and treat the affected area. Treatment should include removing and replacing decayed timber, and applying compatible preservatives. Proper surface preparation and maintenance are crucial to prevent future moisture accumulation.

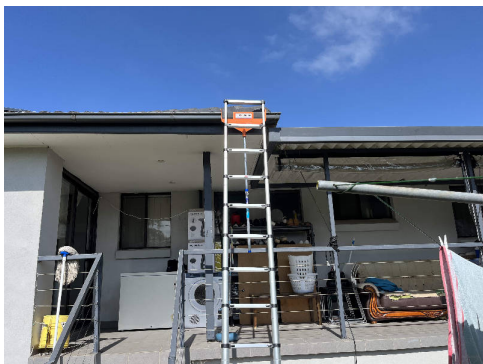
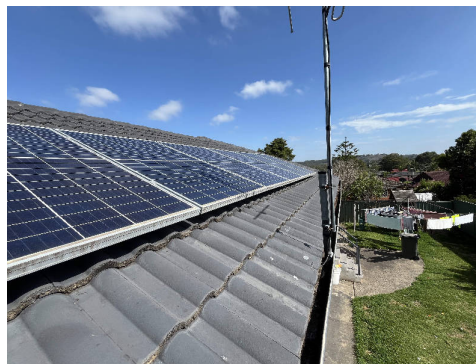
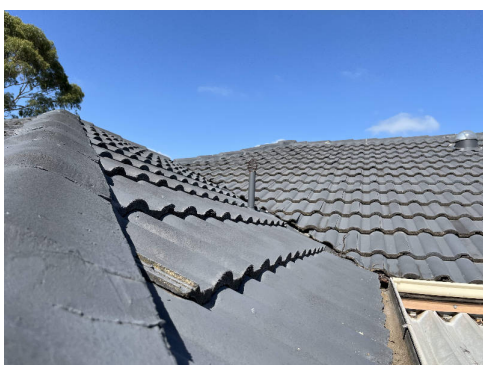
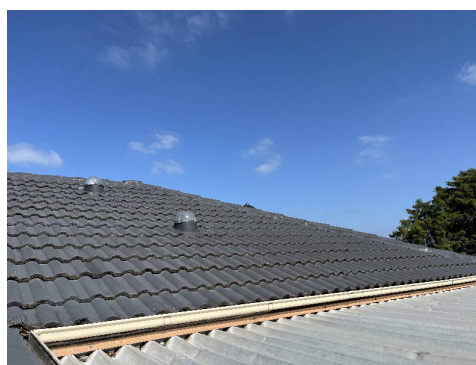
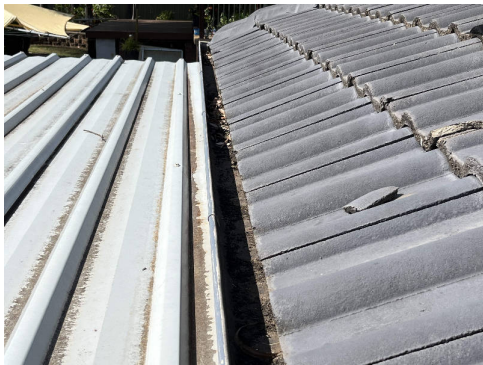
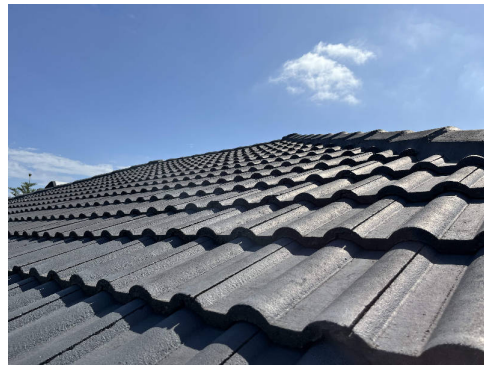
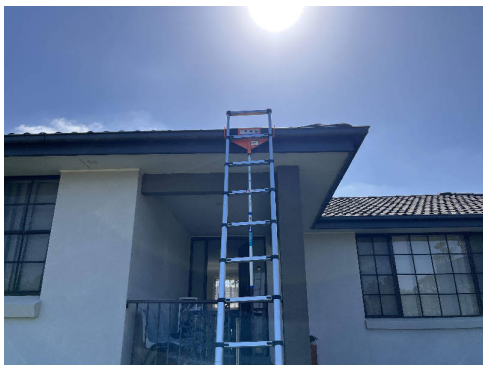
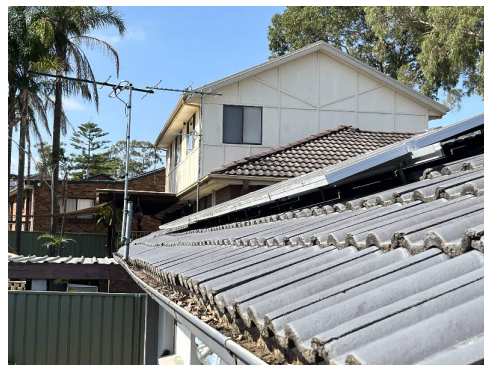
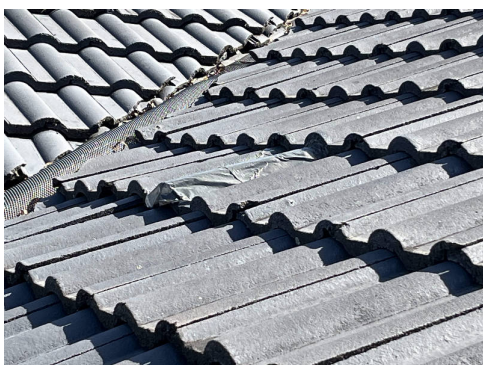
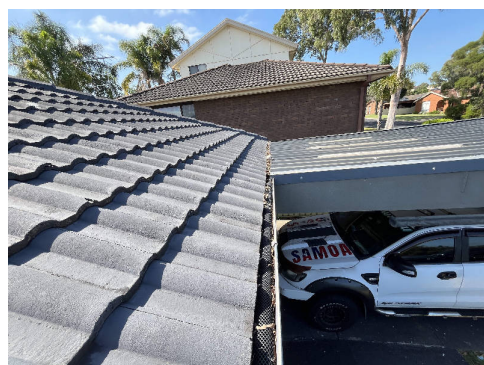
Finding: Additional Photos - Obstructions and Limitations

Information: These photographs are an indication of the obstructions and limitations which impeded full inspection of the property at the time of inspection. These obstructions can hide an array of defects and should be removed to allow full inspection to be carried out. A re-inspection is recommended once the areas are made accessible.

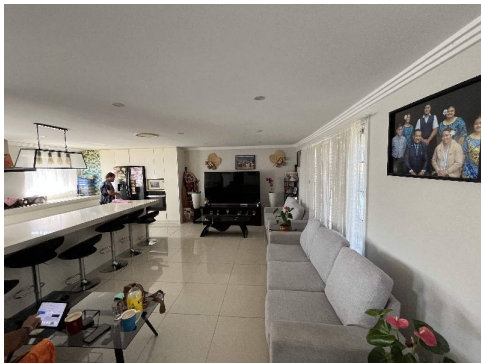
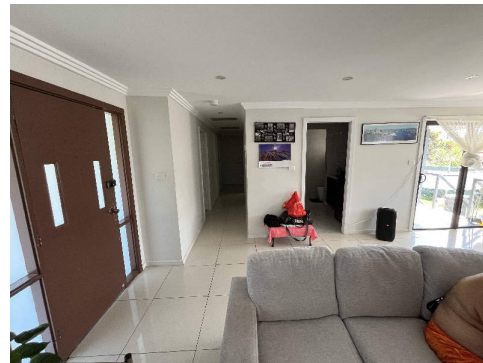
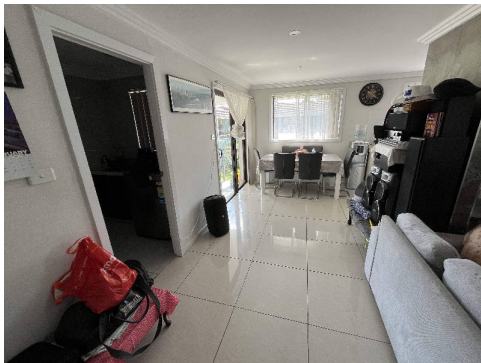
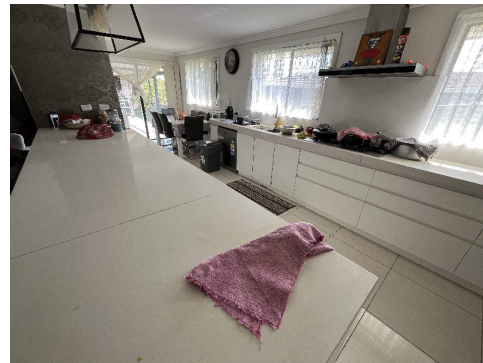
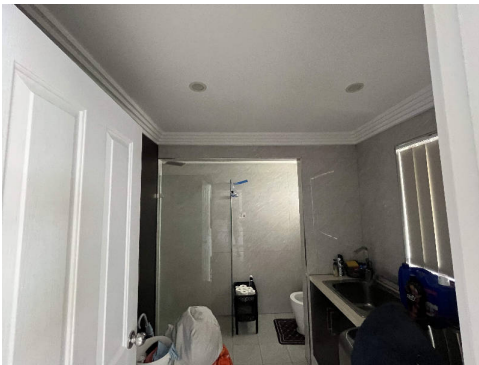
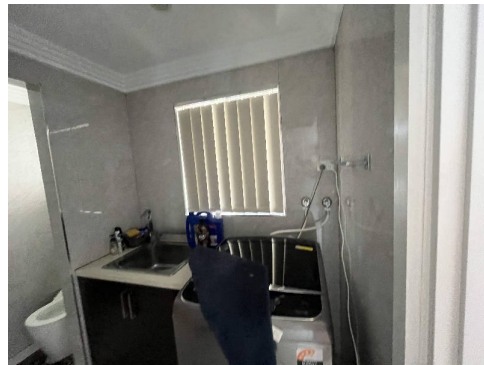
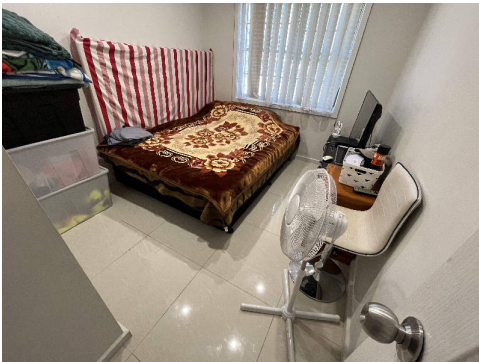
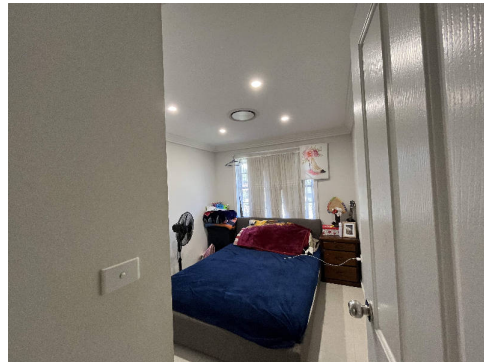
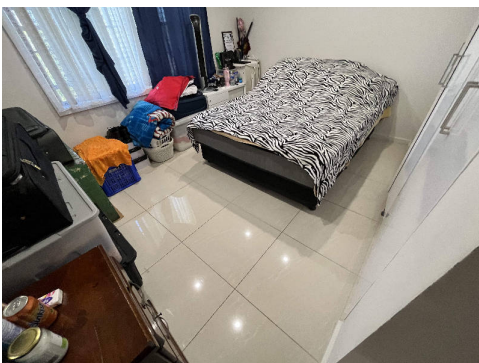
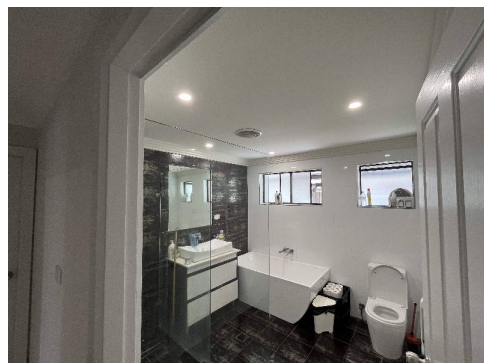
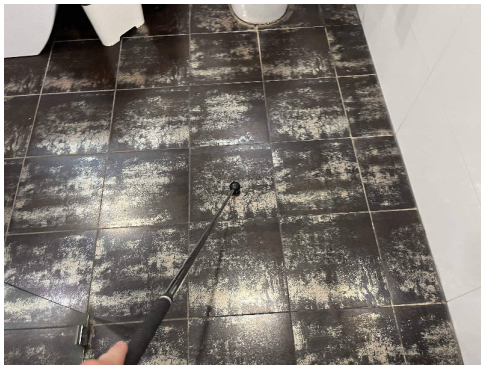
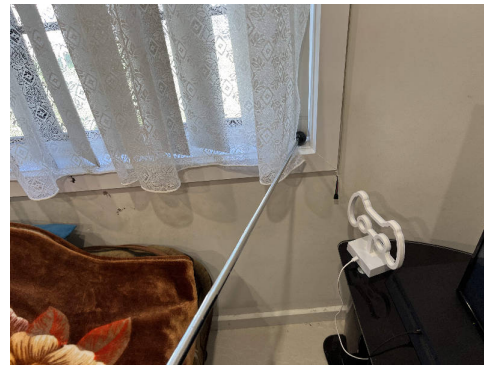
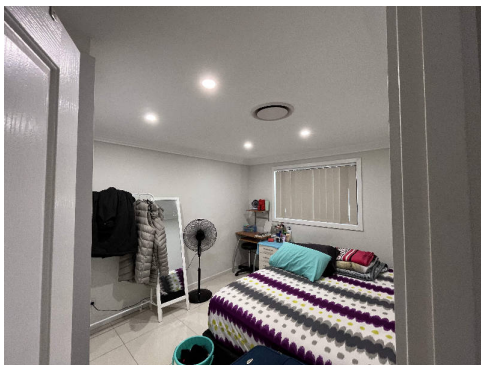
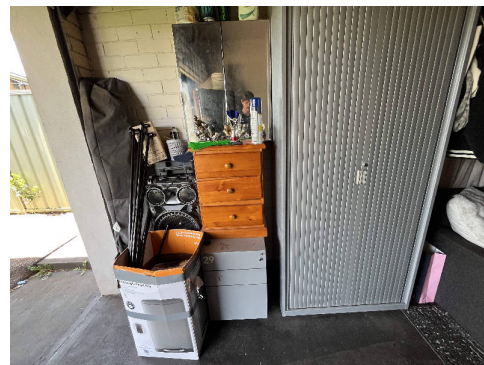
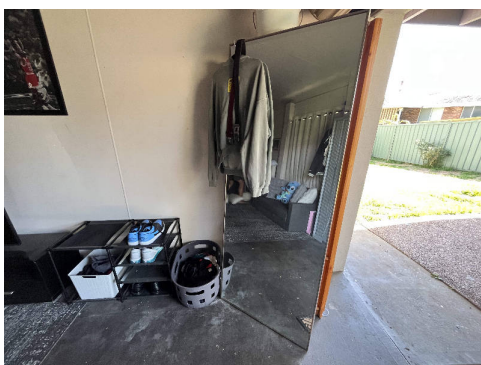
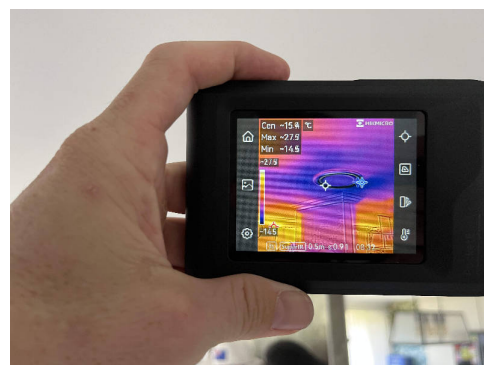
Finding: Additional Photos - Obstructions and Limitations

Information: These photographs are an indication of the obstructions and limitations which impeded full inspection of the property at the time of inspection. These obstructions can hide an array of defects and should be removed to allow full inspection to be carried out. A re-inspection is recommended once the areas are made accessible.

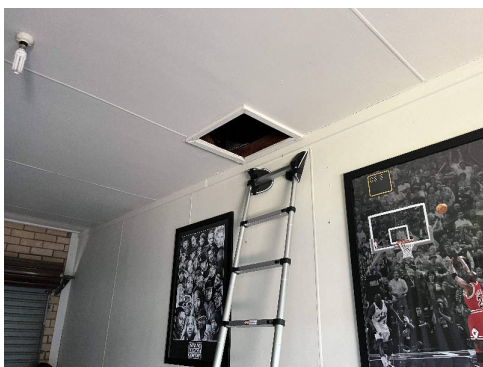
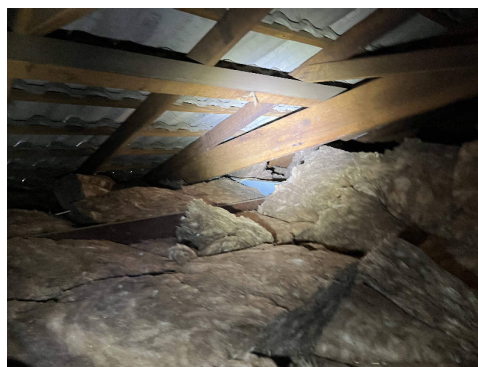
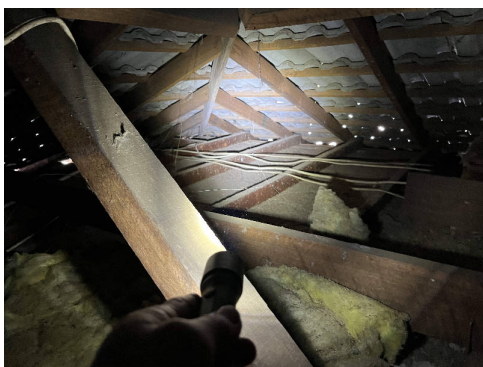
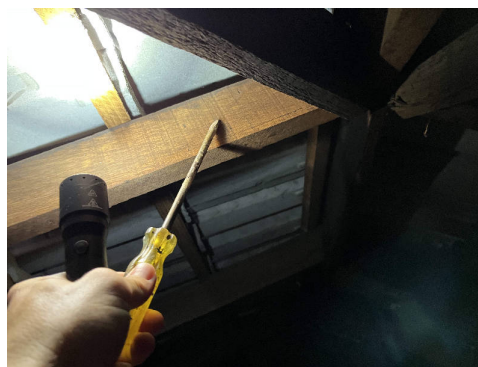
Finding: Additional Photos - Obstructions and Limitations

Information: These photographs are an indication of the obstructions and limitations which impeded full inspection of the property at the time of inspection. These obstructions can hide an array of defects and should be removed to allow full inspection to be carried out. A re-inspection is recommended once the areas are made accessible.

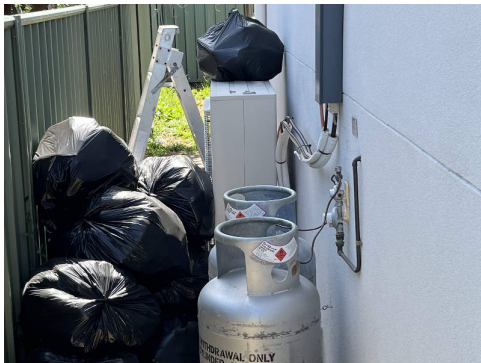
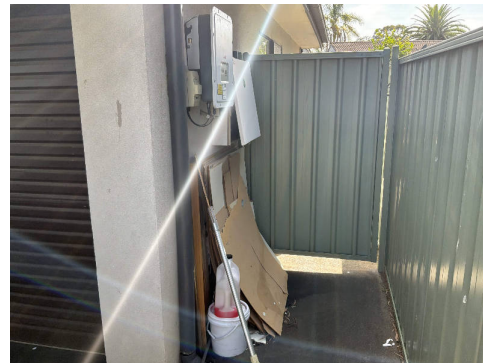
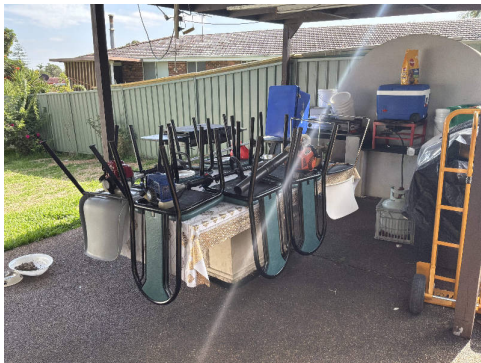
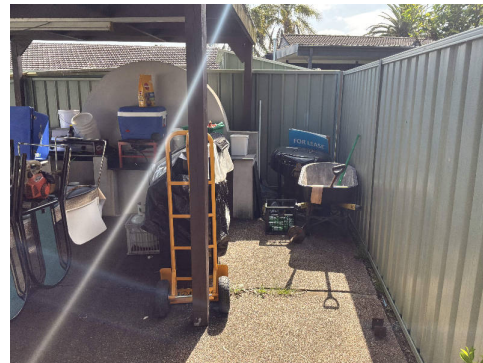
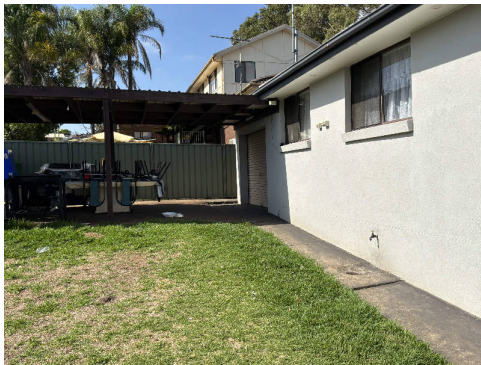
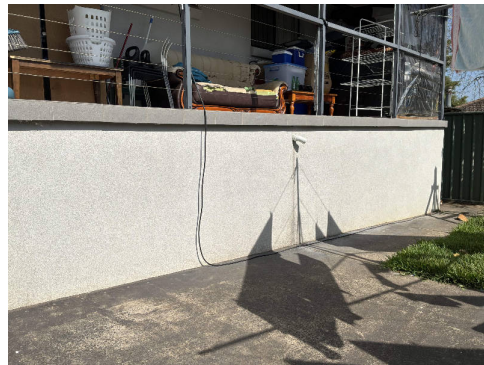
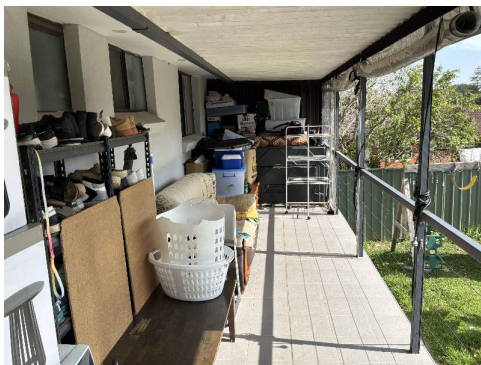
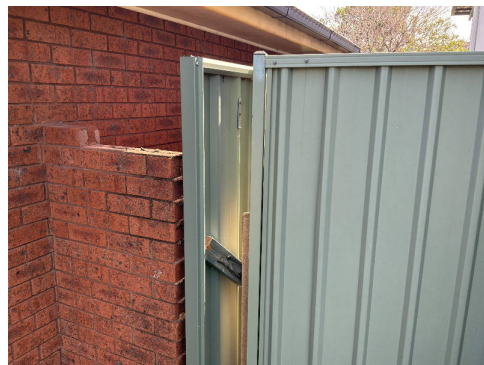
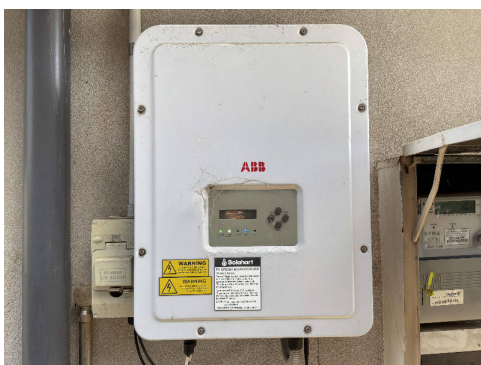
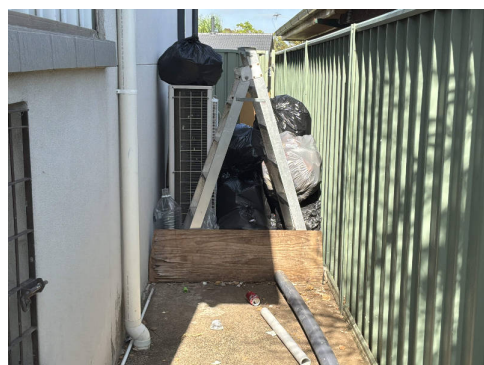
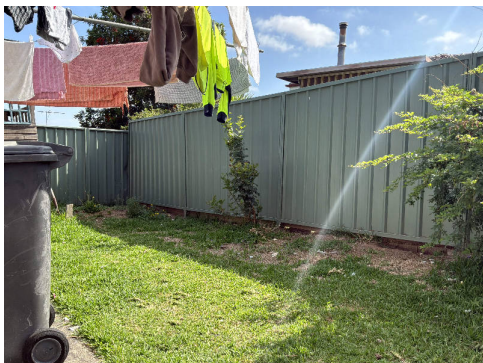
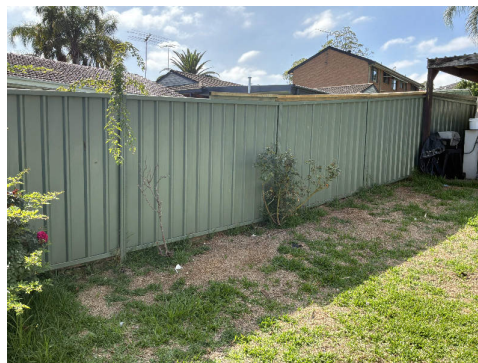
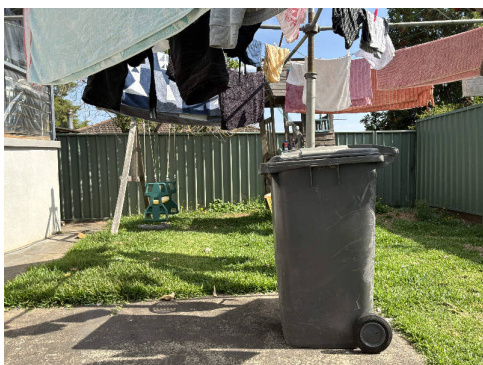
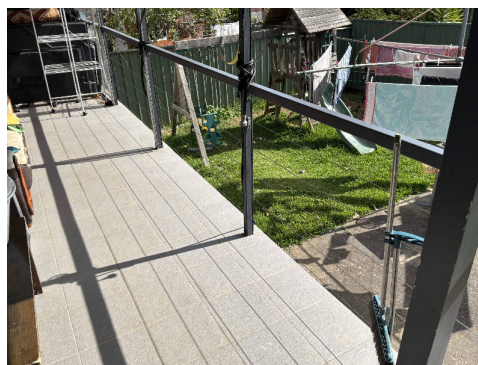
Finding: Additional Photos - Obstructions and Limitations

Information: These photographs are an indication of the obstructions and limitations which impeded full inspection of the property at the time of inspection. These obstructions can hide an array of defects and should be removed to allow full inspection to be carried out. A re-inspection is recommended once the areas are made accessible.

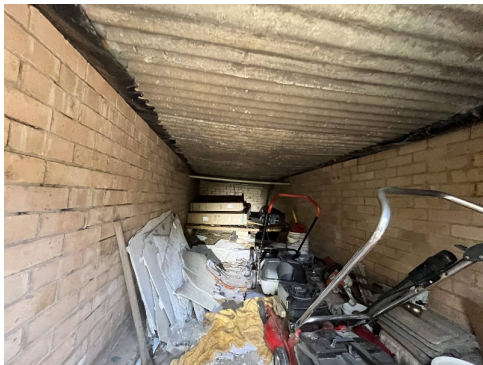
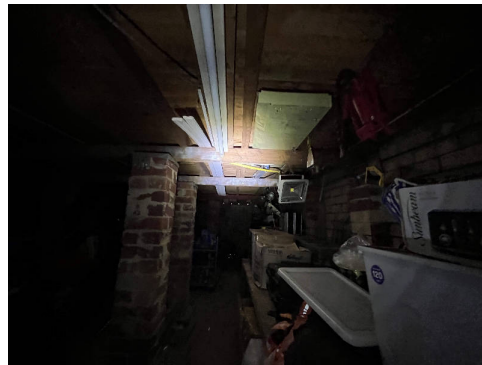
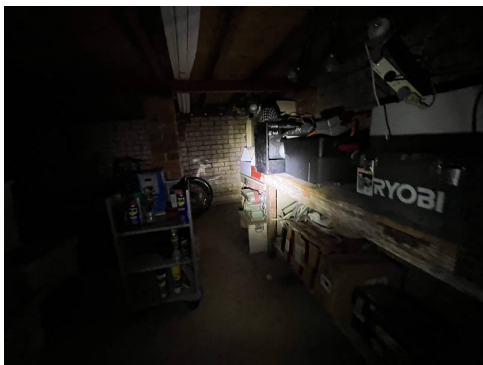
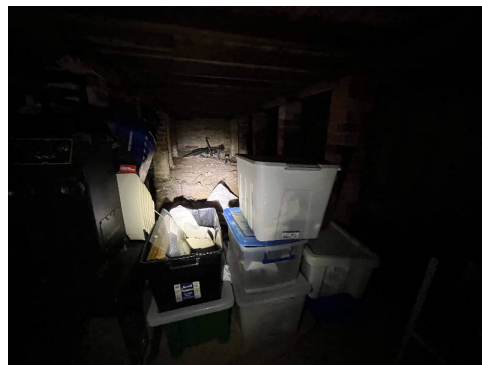
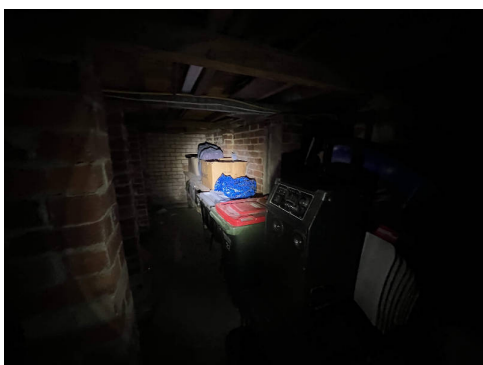
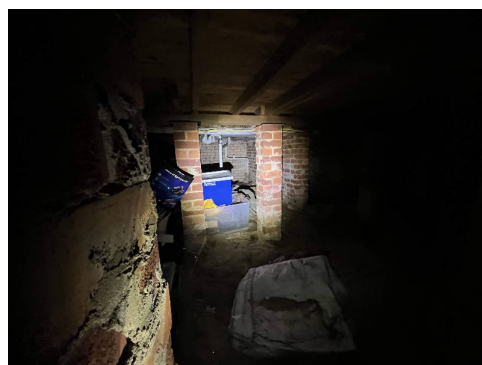
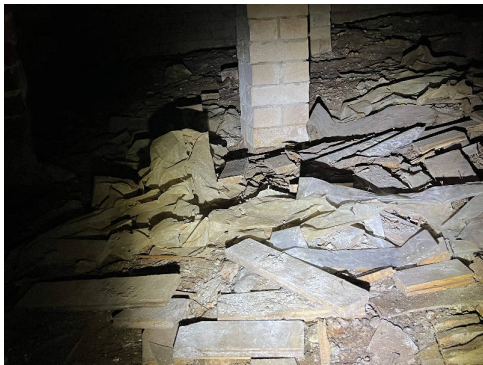
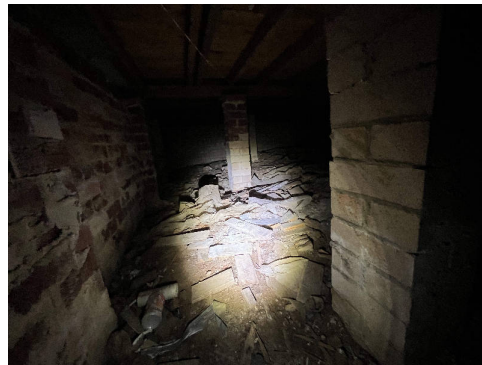
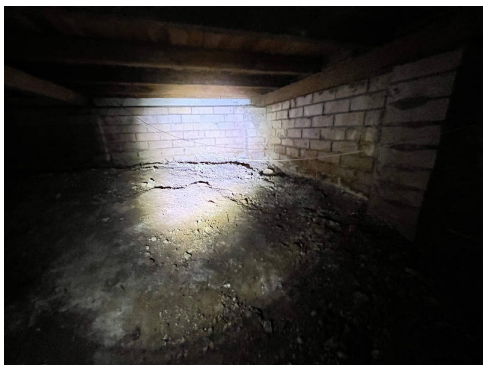
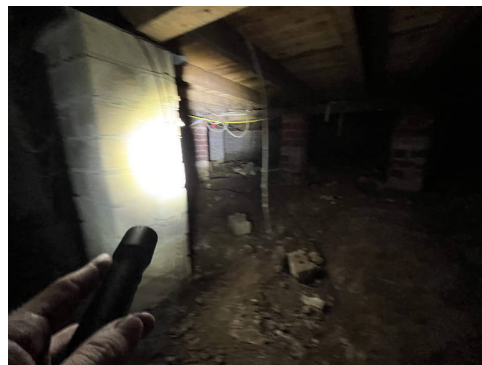
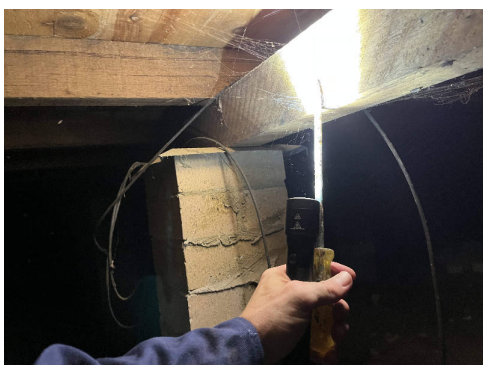
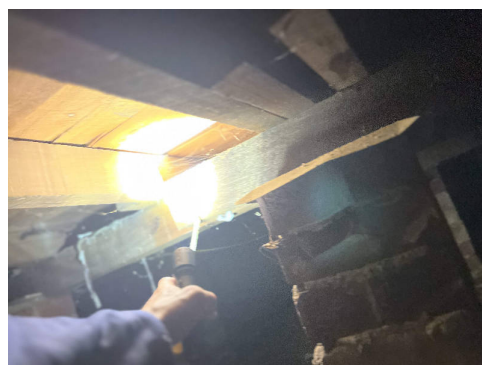
Finding: Additional Photos - Obstructions and Limitations

Information: These photographs are an indication of the obstructions and limitations which impeded full inspection of the property at the time of inspection. These obstructions can hide an array of defects and should be removed to allow full inspection to be carried out. A re-inspection is recommended once the areas are made accessible.

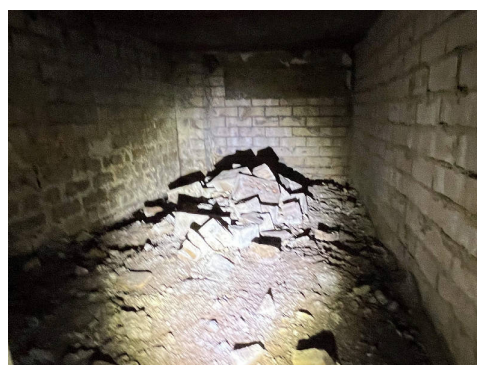
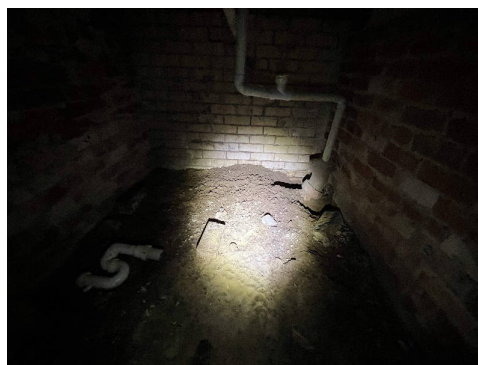
Finding: Excessive moisture - identified

Information: The subfloor area has excessive moisture, which can attract termites and promote fungal growth and wood decay. Likely causes include inadequate drainage, leaking pipes, or poor site drainage. A qualified plumber should inspect to identify the source.

While moisture is common in subfloors, adequate subfloor ventilation aids in preventing excessive moisture wood rot and termite activity by ensuring a dry subfloor environment.

Where ventilation is substandard it is usually caused by factors such as failure to install adequate vents during construction subsequent building works or earth and vegetation covering over vents low subfloor clearance and items or debris in the subfloor restricting airflow.

Subfloor ventilation can be improved in most cases by addressing the causes such as exposing subfloor vents installing additional new vents installing mechanical (forced airflow) ventilation and removing debris from the subfloor.

A registered builder should be appointed as soon as possible to perform these works as necessary.

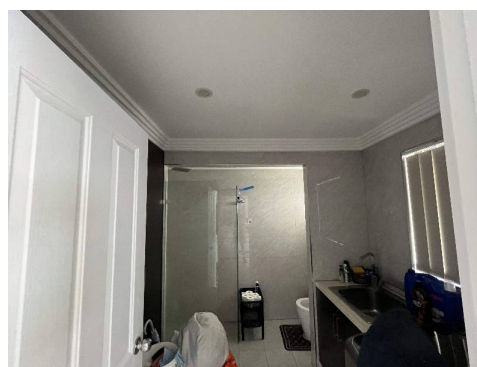
With older property's where this information is unavailable all wet areas should be monitored. Generally waterproofing certificates are only valid for approximately 7-8yrs. If any leaks, water staining, peeling or bubbling of the paint become evident to any adjacent walls or ceilings below a licensed builder or waterproofing specialist is recommended to investigate further.

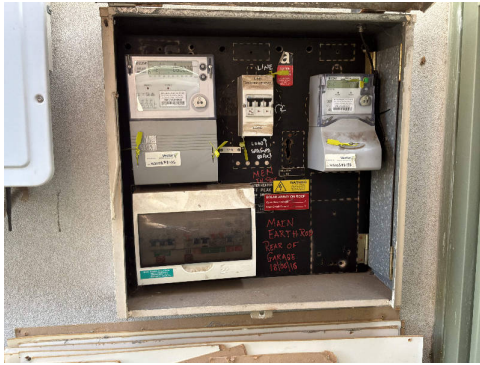
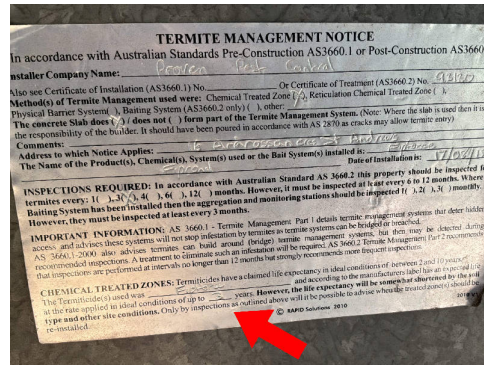
Where a Termite Management System has been identified you should refer to the type of barrier, date of installation, warranty conditions and any documentation provided by a builder or past owner. Consult the company who installed the barrier to confirm whether the system is still under warranty.

Most chemical termite management systems expire and require replenishment and all physical systems are primarily designed to prevent concealed entry.
