Building and Timber Pest Inspection Report VR

Inspection Date: Mon, 9 Mar 2026

Property Address: 290 Valletta Dr, Gables NSW 2765,
Australia

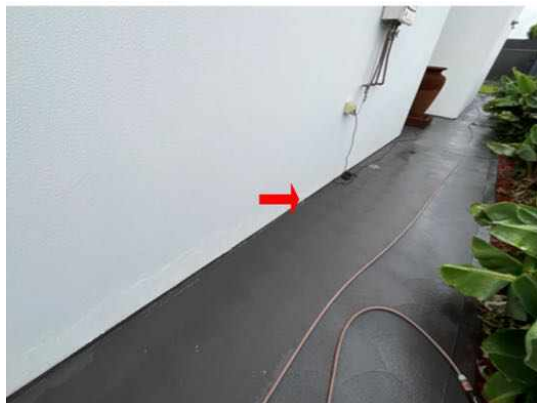
Finding 6.05

Building:	Main Building
Location:	Yard - Side
Finding:	Overflow - Not plumbed for drainage
Information:	The overflow is not plumbed or connected to suitable drainage, which can result in the surrounding area becoming excessively damp.

These damp conditions can lead to secondary defects such as rot, rust or corrosion of associated building elements, the formation of fungal decay, or even the creation of potential slip hazards. When coupled with poor site drainage, pooling of water may also attract termite activity to this area.

It is highly recommended that a licensed plumber be appointed to install adequate drainage to the overflow. These works will ensure that the area remains dry and free of any secondary defects.

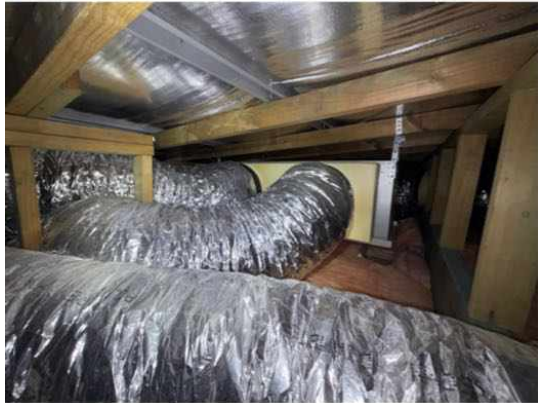
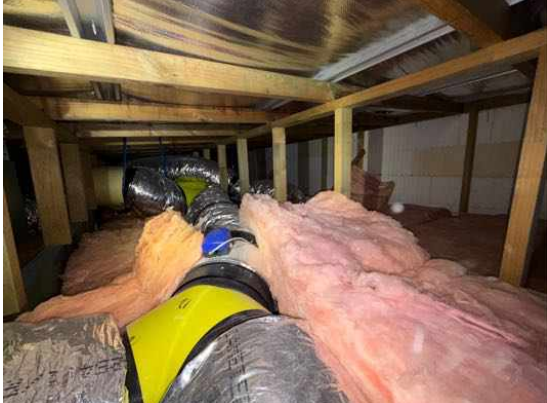
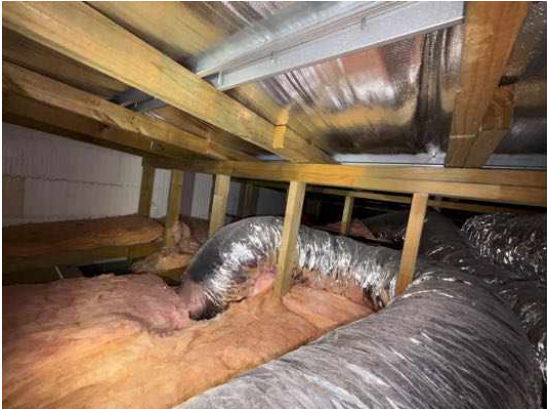
Building: Main Building
Location: Roof Void
Finding: Additional Photos
Information:

Additional photos are provided for your general reference.

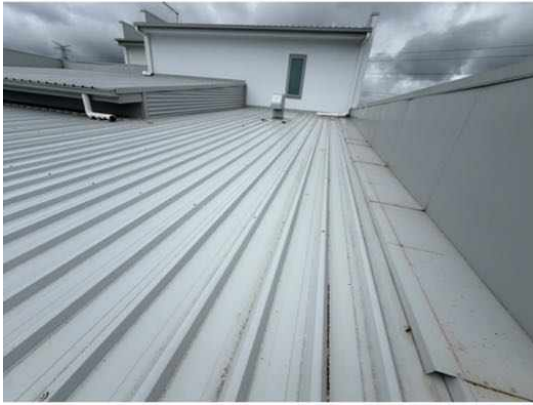
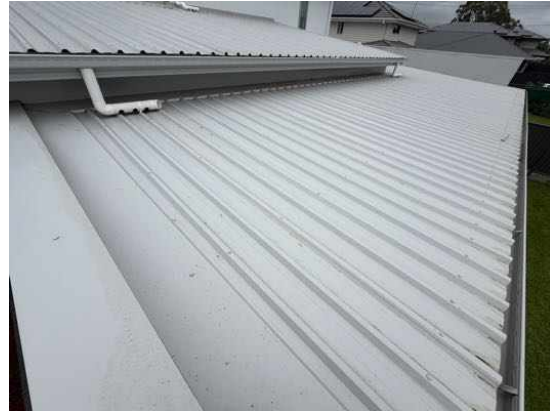
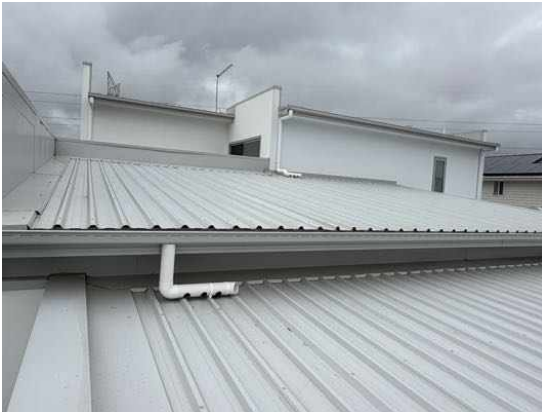
Building: Main Building
Location: Roof Exterior
Finding: Additional Photos
Information:

Additional photos are provided for your general reference.

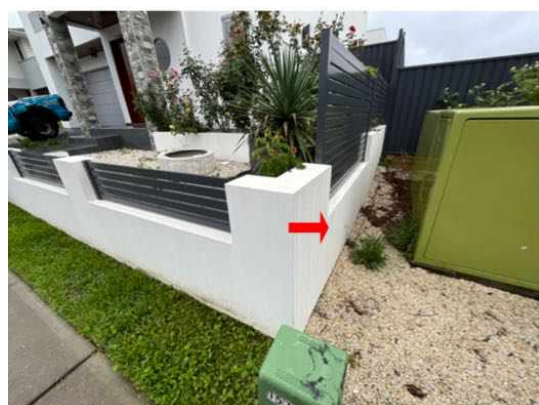
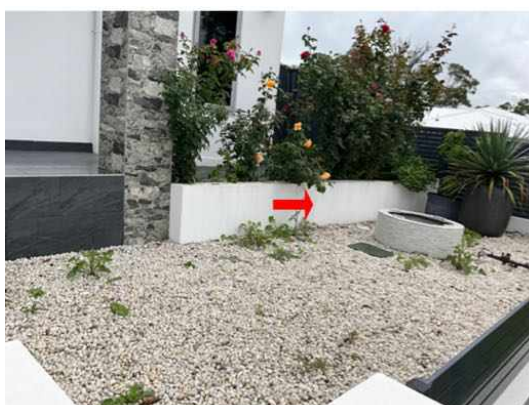
Building: Main Building
 Location: Retaining walls
 Finding: Retaining walls
 Information: At the time of inspection the retaining walls were checked and no defects were observed other than those which May have been mentioned earlier in this report.

AS4349.1-2007 requires all retaining walls in excess of 700mm to be inspected by a licensed and practicing structural engineer.

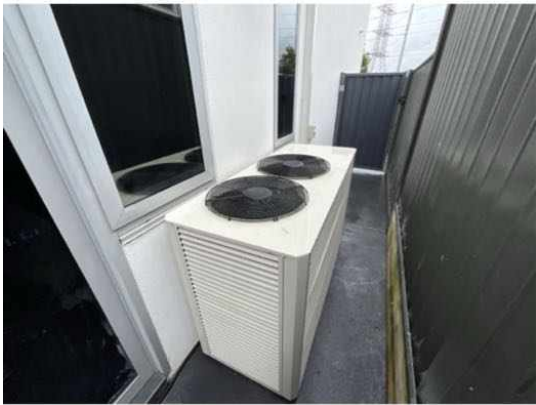
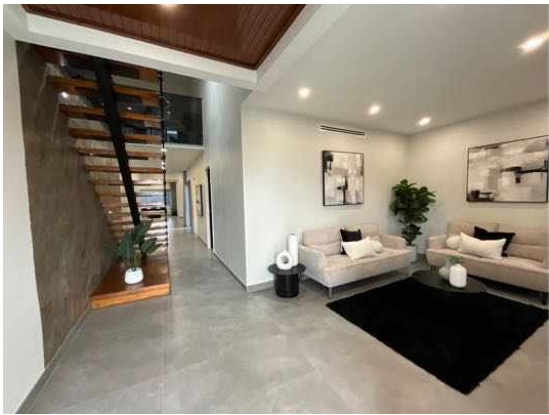
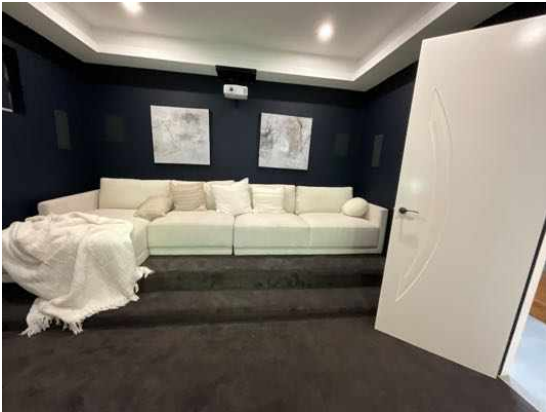
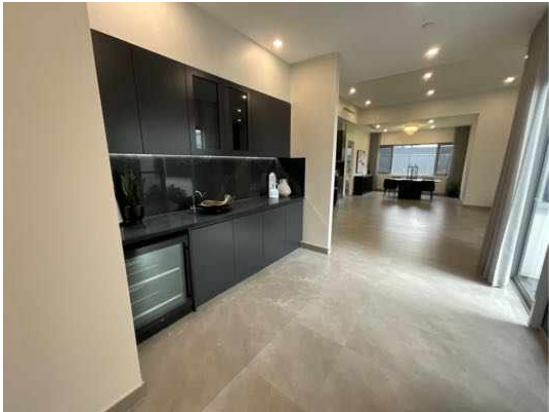
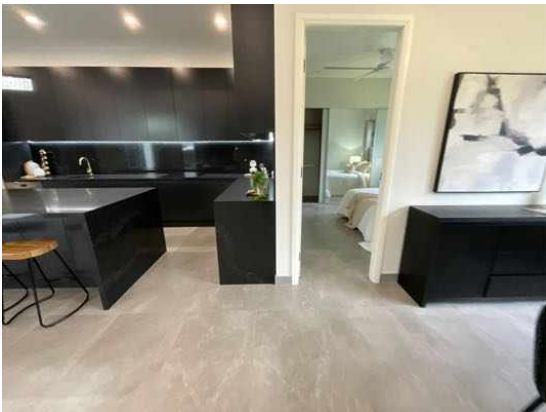
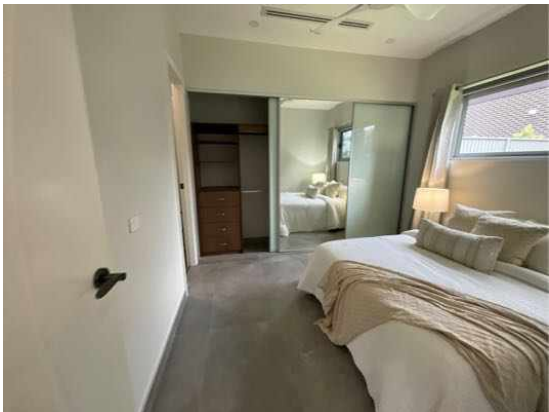
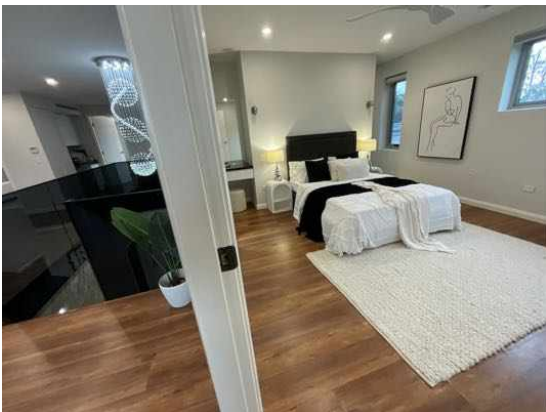
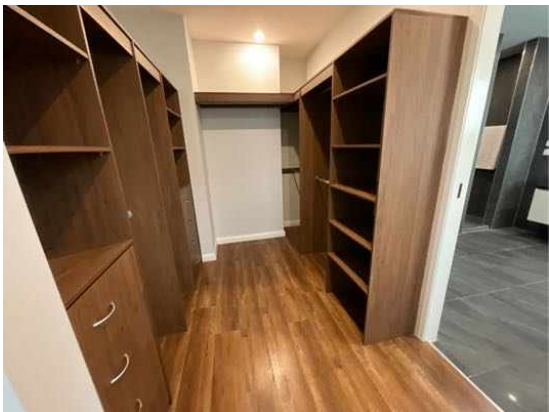
Building: Main Building
 Location: All Areas
 Finding: Additional Photos - Obstructions and Limitations
 Information:

These photographs are an indication of the obstructions and limitations which impeded full inspection of the property at the time of inspection. These obstructions can hide an array of defects and should be removed to allow full inspection to be carried out. A re-inspection is recommended once the areas are made accessible.
