# Building and Timber Pest Inspection Report

Inspection Date: Wed, 14 Jan 2026

Property Address: 31 Lady Jamison Drive, Glenmore Park  
NSW 2745

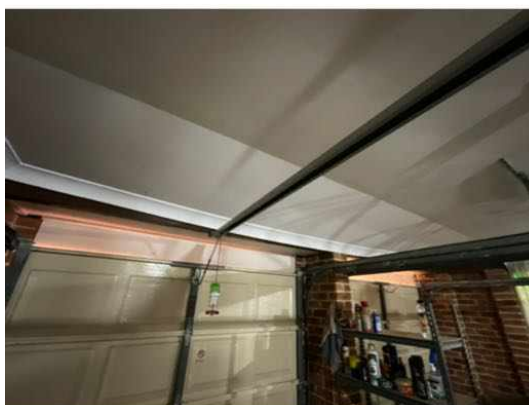
Finding: Ceiling lining - Localised Ceiling Sagging / Damage.

During the inspection, isolated sections of the ceiling lining were observed to be sagging adjacent to the garage doorway. Partial detachment of ceiling sheets and associated cracking were evident. This condition is commonly noted in garage areas and is typically related to long-term wear and environmental exposure.

- Age-related deterioration or failure of ceiling fixings (nails, screws, adhesives)
- Moisture exposure or humidity-related movement, potentially exacerbated by inadequate or low-grade paint coatings

The partial detachment and cracking of the ceiling lining constitute a major defect, as the integrity of the ceiling system has been compromised. If not addressed, further deterioration is likely, increasing the risk of progressive sagging or localised failure of the ceiling lining.

It is recommended that a suitably qualified trade contractor (such as a plasterer or general interior tradesperson) be engaged to assess the extent of the defect and undertake necessary repairs. Works may include re-gluing and re-fixing the ceiling sheets to the joists and, where appropriate, repainting with a moisture-resistant coating suitable for garage environments. Buyers should allow for repair and maintenance costs. Timely rectification is advised to prevent further deterioration and to restore the functional and visual condition of the ceiling.

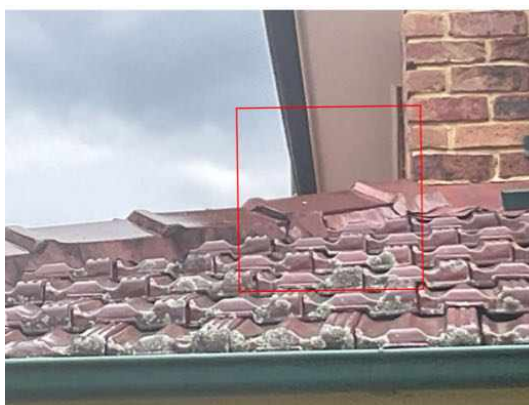
Parts of the roof were not safely accessible from a 3.6 m ladder and were therefore excluded from close inspection. It is strongly recommended that a roofing specialist undertake a more comprehensive inspection of all inaccessible or higher areas, as undetected defects in roof coverings can result in significant moisture ingress and repair costs if not identified early.

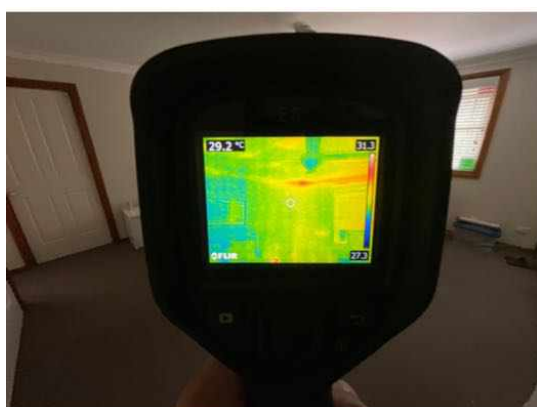
At the time of the inspection, no abnormalities indicating live termite activity were observed. However, it's important to note that various factors—such as obstructions, ambient temperature, and wall material/thickness—can impact the accuracy of thermal readings. In cases where surfaces are visually restricted or obstructed, a comprehensive thermal scan may not always be feasible.

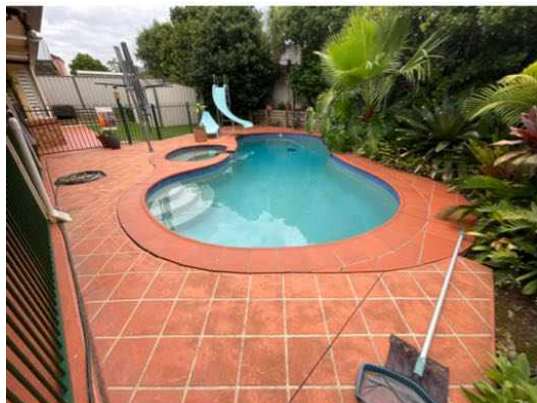
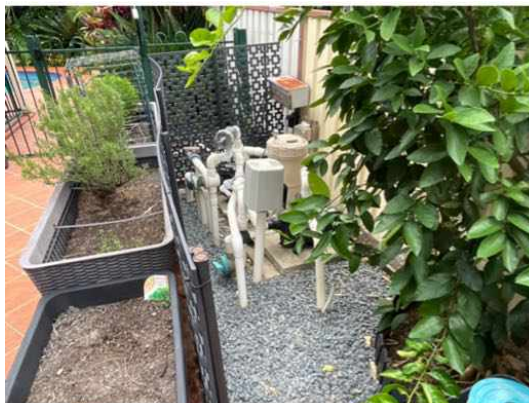
Building:	Yard
Location:	Pool Area
Finding:	Swimming Pool – Excluded from Standard Building Inspection.
Information:	Observation:

Undertaking this inspection will help ensure that any safety, compliance, or

maintenance issues are properly identified and addressed prior to finalising the property purchase.

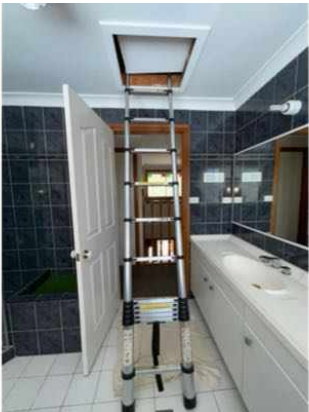
Building: Main Building  
 Location: Roof Void  
 Finding: Roof Void – Limited Accessibility..  
 Information: Observation:

Installation of an additional manhole is recommended to facilitate a re-inspection and enable a more thorough assessment of the roof void in the future. This will help ensure

that all structural elements and concealed areas are properly evaluated.

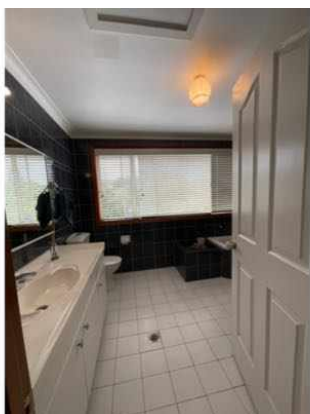
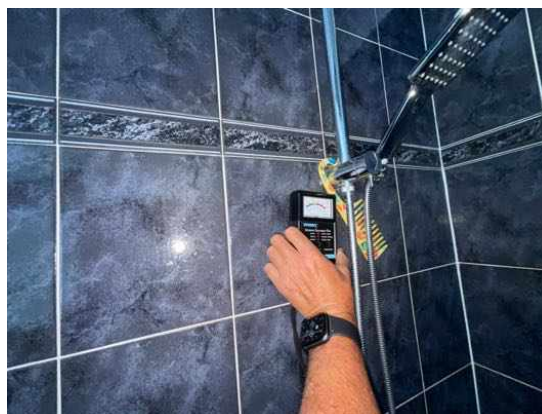
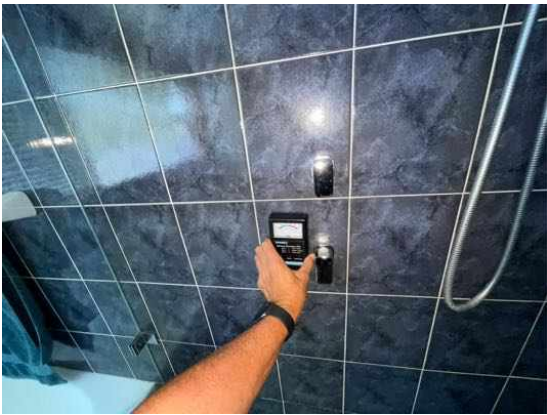
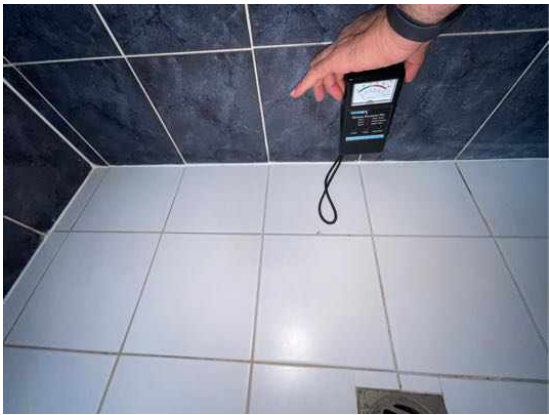
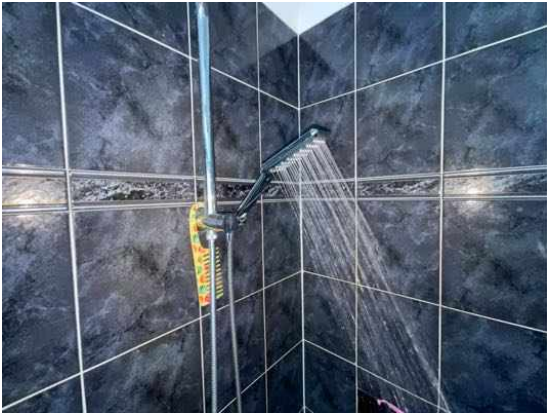
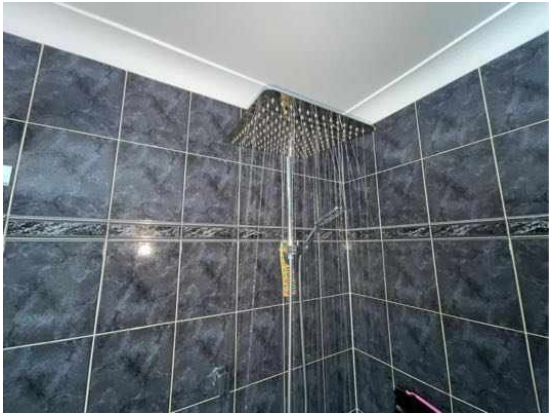
Building: Main Building  
 Location: Bathroom  
 Finding: Wet Areas - Bathroom(s) - Overall Condition & Recommendations.  
 Information: Overall Condition & Recommendations

It is not possible under the visual inspection criteria of a standard pre-purchase report to categorically determine if leaks are present. If a more detailed or accurate assessment is required, a special-purpose inspection should be undertaken.

Alternatively, the assumption should be made that leakage may occur, particularly where historical or environmental conditions are conducive. The visual nature of this inspection cannot detect issues concealed behind wall/floor linings or cabinetry, and invasive investigation may be necessary to confirm the true condition of adjacent or hidden structures.

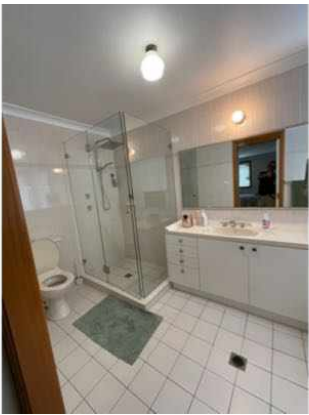
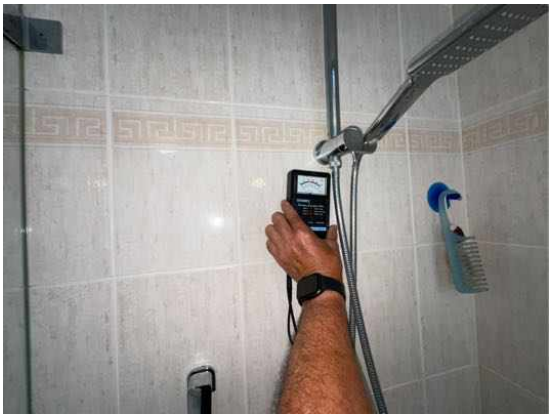
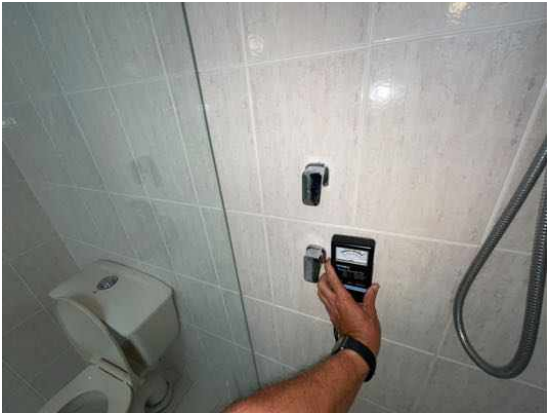
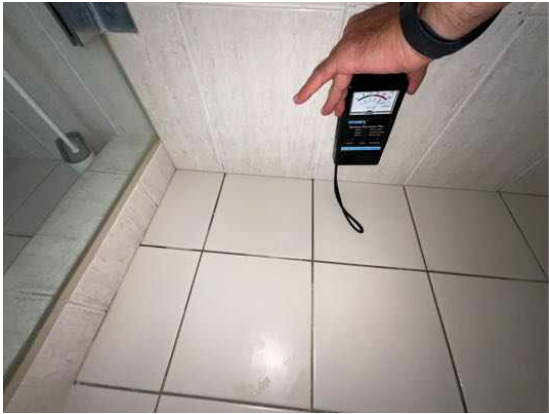
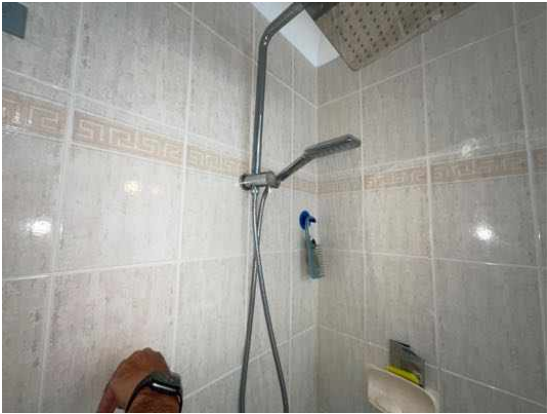
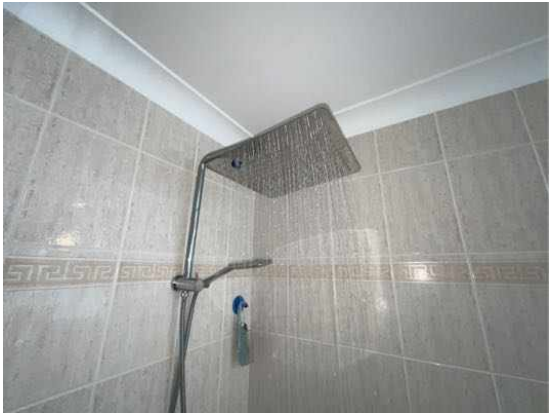
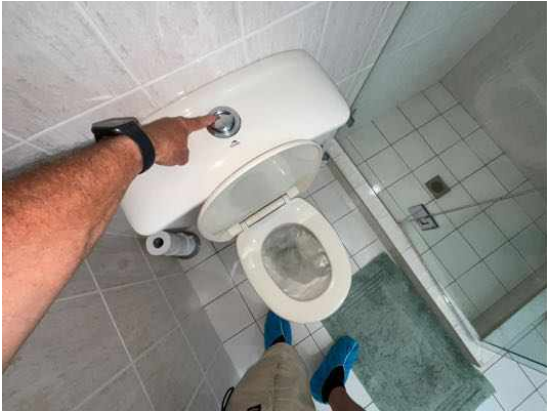
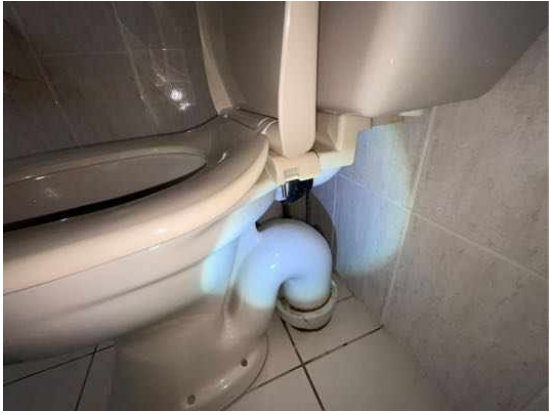
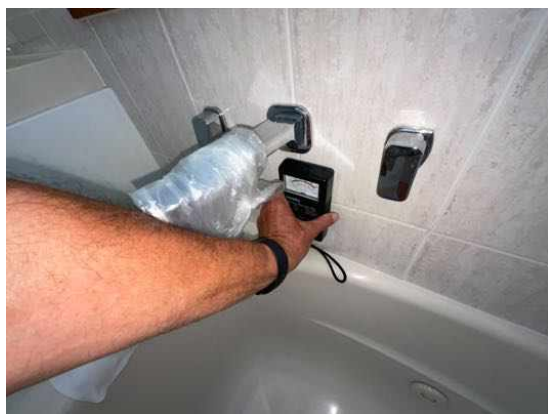
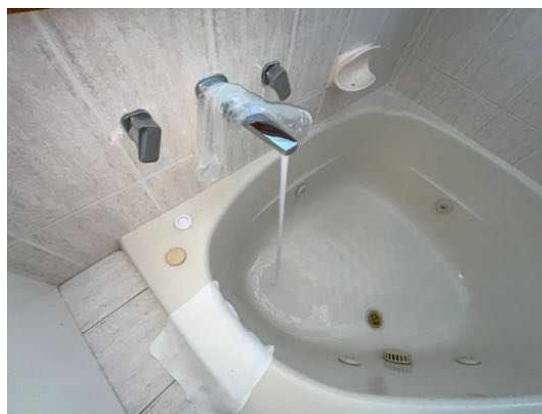
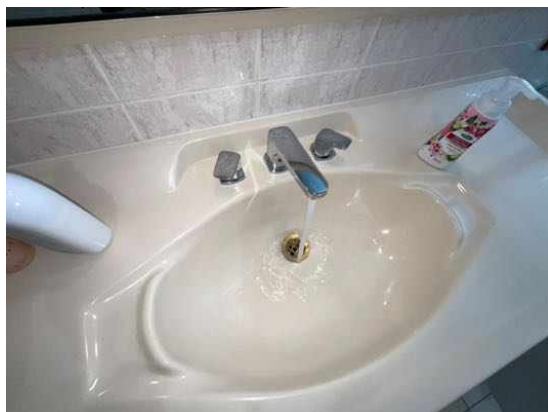
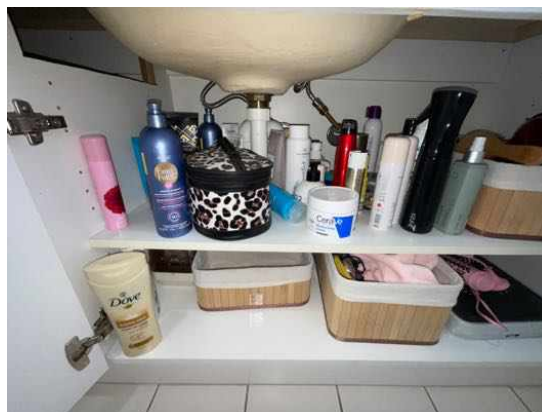
- Elevated moisture readings were found in the lower shower walls, which is a common occurrence with certain tile types that naturally absorb more moisture. This should be monitored over time.

- Sealing of grout and tiles is recommended to prevent moisture buildup and mould growth in damp areas such as showers.
- The condition of grout appeared to be good.

- Grout in wall and/or floor junctions may crack and deteriorate over time. It is recommended to remove any rigid grout from junctions and replace with flexible, mould-resistant sealant in accordance with best building practices.

- Leaks were observed during flushing requiring attention. The toilet operated normally, and the toilet pan appeared to be securely fixed to the floor.

- Basin(s) were water tested and inspected, with no leaks or blockages identified in the plumbing or drainage system at the time of inspection.
- Further monitoring is recommended after the basin(s) are placed under regular use to confirm ongoing performance and cleanliness.
- No visible water damage was observed to the vanity cabinetry at the time of inspection.
- Stored items inside the vanity obstructed full visibility during the inspection. It is advised that the area be re-inspected once all obstructions are removed.

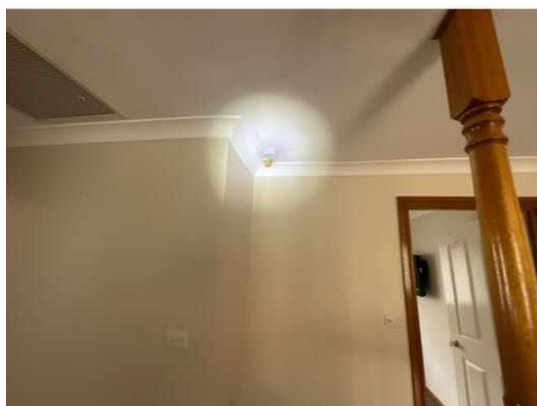
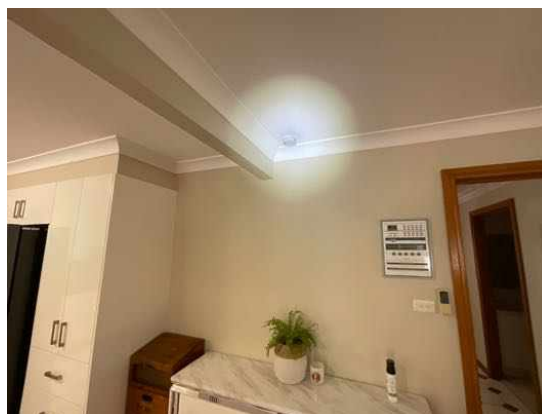
Building: Main Building  
 Location: All Areas  
 Finding: Smoke Detectors / Alarms.  
 Information: Reporting on the presence, type, location, or compliance of smoke detectors or alarms, including hard-wired smoke detection systems and their legislative requirements, is outside the scope of this inspection report.

To ensure compliance and safety, further inspection and/or advisory services from a qualified specialist are recommended. These services can confirm the sufficiency, type, location, and functionality of all smoke detection devices within the property.

- All smoke detectors be tested monthly by the homeowner.
- All systems comply with the requirements of AS 3786 and any applicable state-based legislation.
