Building and Timber Pest Inspection Report

Inspection Date: Fri, 20 Mar 2026

Property Address: 21 Gas St, Singleton NSW 2330, Australia

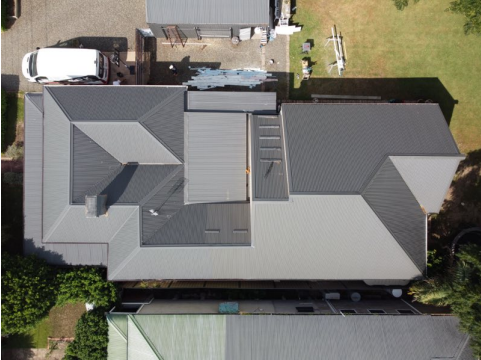
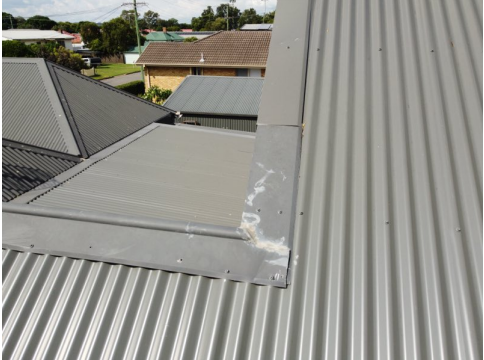
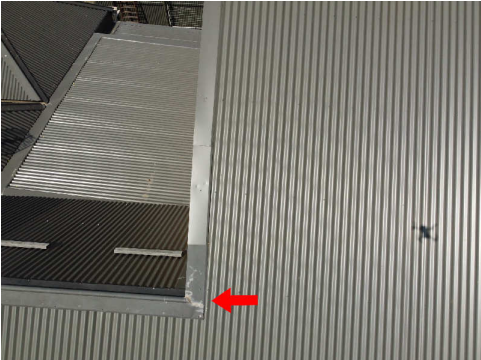
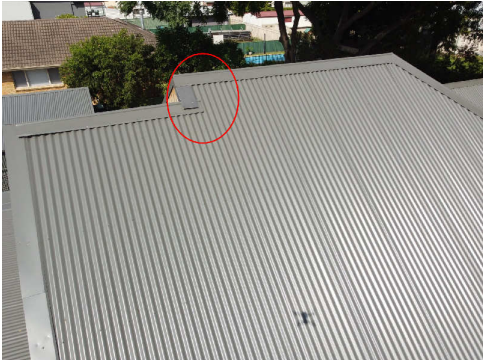
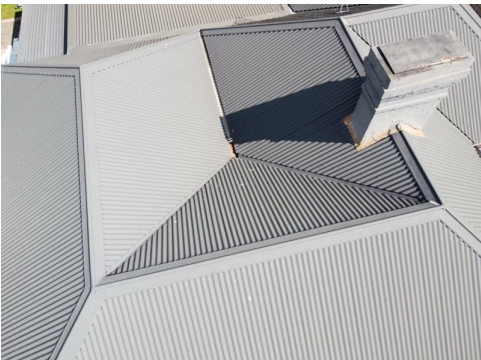
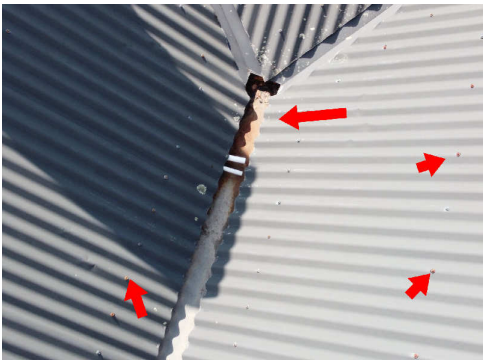
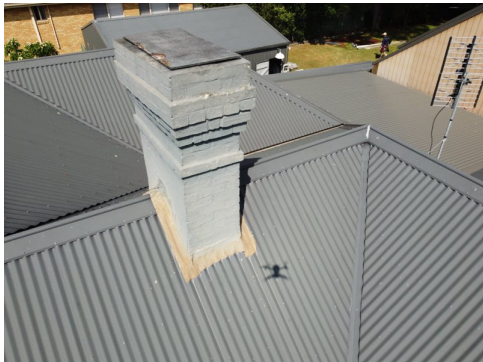
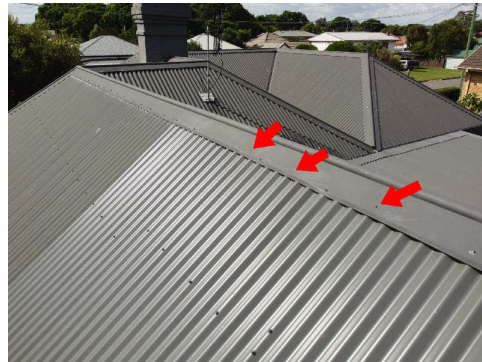
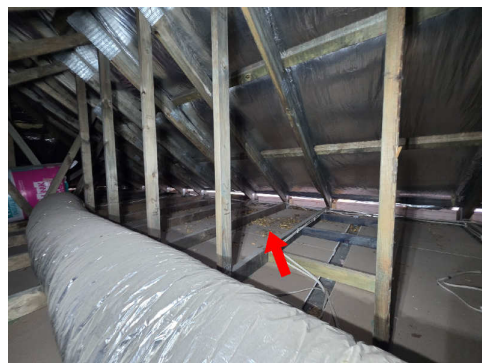
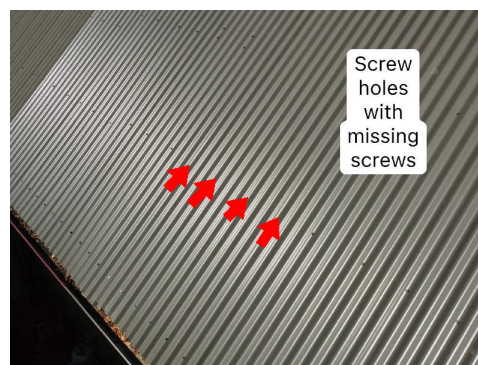
Finding: Defective and incomplete roof flashings, sealing and corrosion – Roof

Information: A number of roof flashings were observed to be incomplete and inconsistently installed across multiple areas. Sections contained holes from previous fixings, and some junctions have been sealed with mastic or silicone rather than properly formed flashing. Flashings showed denting, and barge flashings have been installed in multiple short lengths. Flashings at the base of the chimney appear undersized, with sealant at joints and some fixings exhibiting corrosion. Lichen growth was noted to roof sheeting, along with multiple rusted fixings. The box gutter receiving discharge from three roof planes shows visible corrosion. Within the extension roof space, insulation had not been installed, leaf litter was present indicating debris ingress, and daylight was visible at the roof apex, suggesting incomplete sealing. No active leaks were evident at the time of inspection.

These conditions indicate the roof covering and associated junctions are not fully sealed and may be ineffective in preventing water ingress over time. Corrosion to fixings and the box gutter indicates ongoing deterioration, which may progress to leakage and affect adjacent building elements. The condition of concealed areas could not be confirmed.

A licensed roofer should be engaged to carry out further investigation and rectify as required. This should be done without delay.

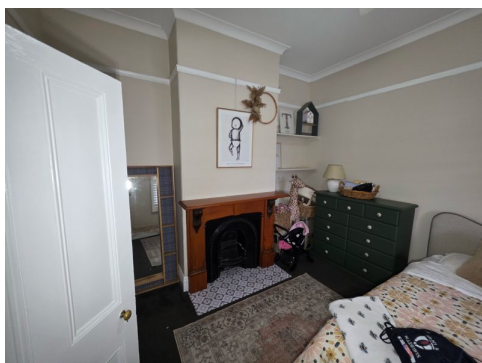
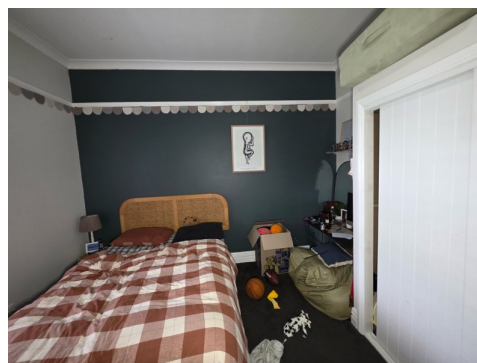
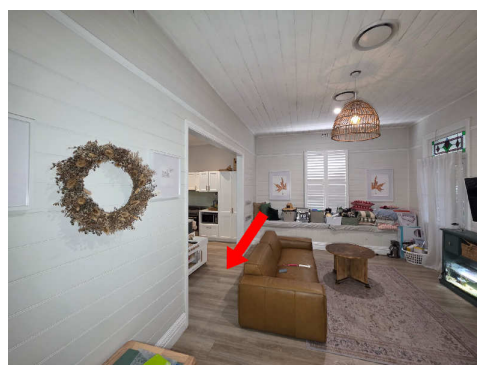
Finding 3.01

Bouncy floors generally indicate that the floorboards or the subfloor structures are coming loose from the joists that they are installed on. Bouncy flooring may also be the result of gaps between flooring and stumps or joist structures, which require packing.

The client is advised to seek quotations for required repairs from a Registered Builder specialising in re-stumping. The potential resolution may range from packing gaps in subfloor structures through to replacement of subfloors stumps and refixing of flooring.

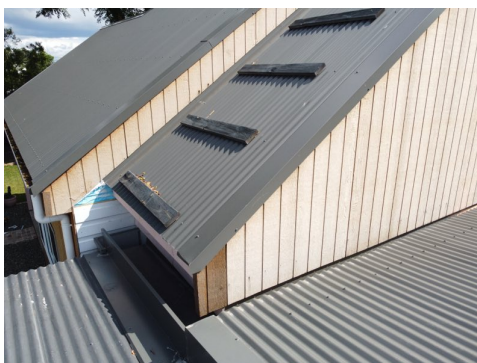
Finding 3.02

Information: External works to the building were observed to be incomplete at the time of inspection, with a builder present on site. Cladding installation is not finished in multiple areas, detailing around windows and doors remains incomplete, and alfresco flooring has not yet been installed. As a result, external envelope detailing and finishes are not complete, and performance in relation to weatherproofing and durability could not be fully assessed.

This condition limits the ability to confirm the standard of workmanship and whether the building envelope will perform as intended once completed. All works should be completed by the current builder, and completion, final detailing, and compliance should be confirmed prior to settlement.

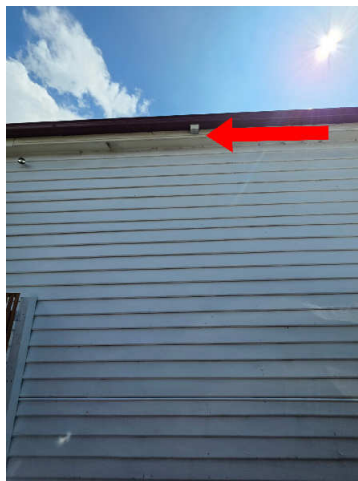
Finding 3.03

Information: A build-up of leaf litter and debris was observed on the verandah roof, within the rear roof valley and to both sides of the extension. This also aligns with debris observed entering the roof void of the new extension above the master suite.

No gutter is installed along the side of the garage adjacent to the boundary. The guttering is incomplete along the side of the original house with a missing downpipe observed along this wall as well.

Debris build-up and incomplete drainage may restrict water flow and contribute to overflow or moisture-related deterioration. A licensed roofer should be engaged to assess and rectify as required. This should be done as soon as practicable.

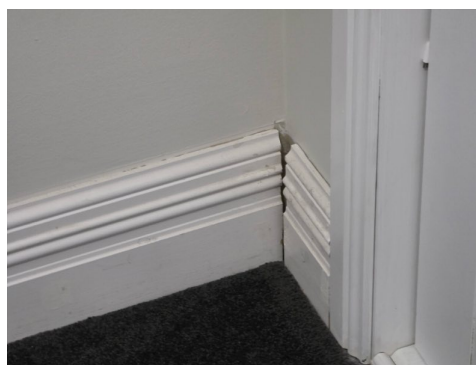
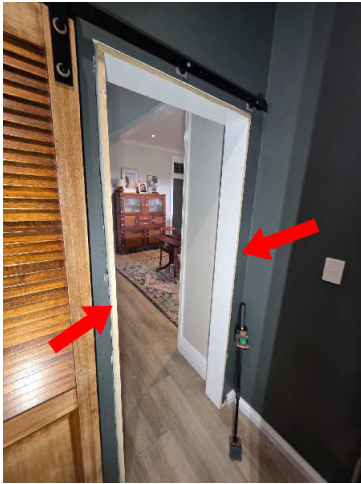
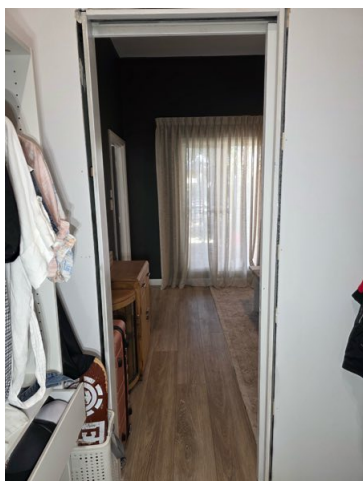
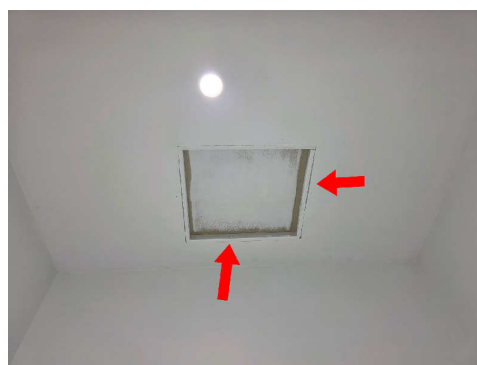
Finding 3.04

Information: A number of internal items remain incomplete following recent renovation works, including joinery, trims, doors and general finishes across multiple areas of the house.

These items are unfinished and may leave building elements more susceptible to damage until completed. A licensed builder should be engaged to assess and complete works as required. This should be done as soon as practicable.

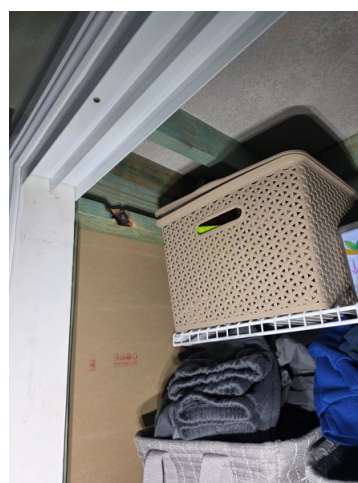
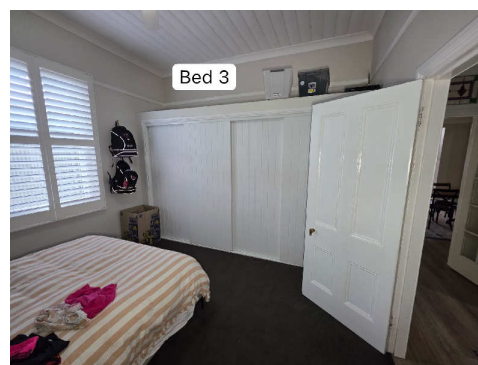
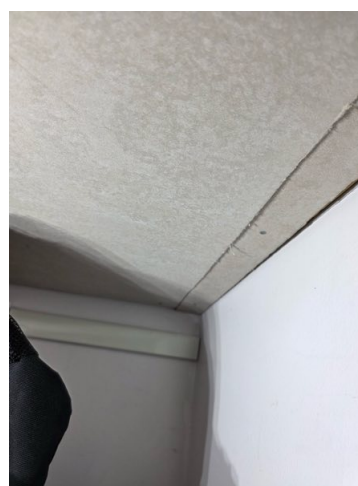
Finding 3.05

Information: The wardrobe in bedroom 2 is incomplete, with a missing sliding door and unlined wall and ceiling. The wardrobe in bedroom 3 has been sheeted but remains unfinished, with no setting, sanding or painting carried out.

A licensed builder should be engaged to assess and complete works as required. This should be done as soon as practicable.

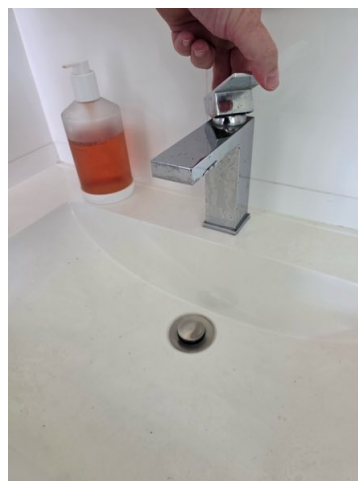
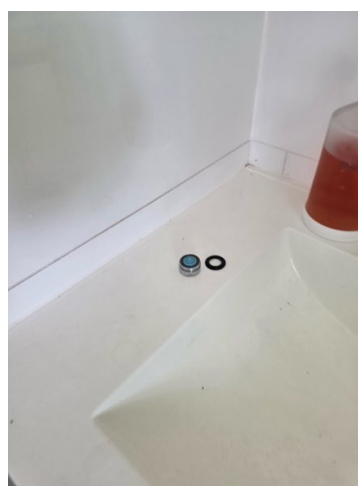
Finding 3.06

Building:	Main Building
Location:	Kitchen, Laundry, Garage
Finding:	Plumbing defects and moisture impact – Kitchen, laundry and garage
Information:	<p>The kitchen tap was loose at its base, moisture damage was observed to the cabinet beneath the laundry sink with low-level elevated moisture readings, and within the garage shower and toilet area no cold water was connected, with hot water discharging irregularly and forcefully. These conditions are consistent with defective or incomplete plumbing and localised moisture exposure.</p> <p>If left unaddressed, ongoing moisture may lead to further deterioration of cabinetry and unreliable use of fixtures. A licensed plumber should be engaged to carry out further investigation and rectify as required. This should be done as soon as practicable.</p>

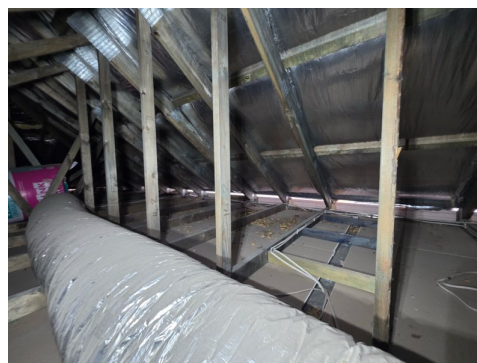
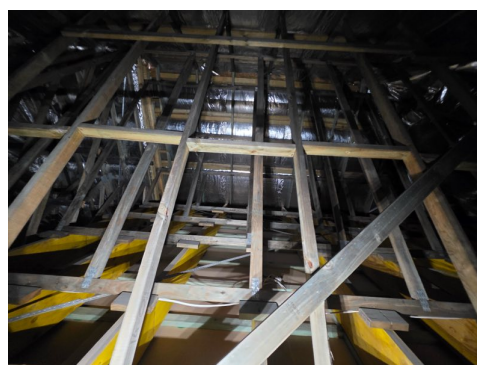
Finding 3.07

Information: Insulation batts were observed in the roof void over the new extension; however, these had not been laid out across the ceiling at the time of inspection. As a result, insulation coverage to this area is incomplete and the thermal performance of the ceiling could not be achieved in its current state.

This may result in reduced energy efficiency and inconsistent internal temperatures until installation is completed. The insulation should be properly laid out across the ceiling by the current builder to ensure full coverage. This should be completed prior to settlement.

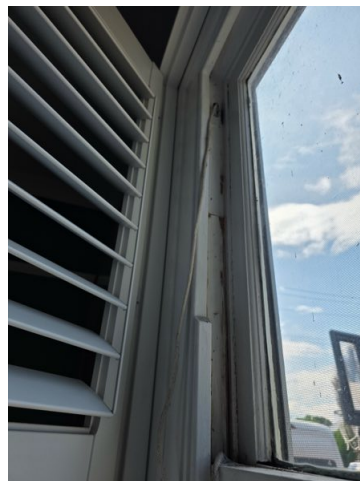
Finding 3.08

Finding: Loose sash cord – Bedroom 3 window

Information: The sash cord to the bedroom 3 window is loose, indicating the sash weight is not properly connected. The sash is unlikely to remain in position when opened.

This affects normal operation and may lead to further damage if used in this condition. A qualified carpenter should be engaged to assess and rectify as required. This should be done as soon as practicable.

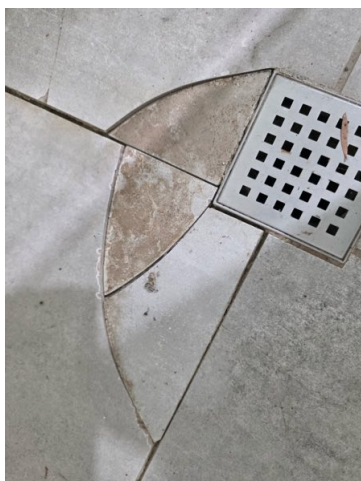
Finding 3.09

Finding: Broken floor tiles – garage shower

Information: Multiple floor tiles in the garage shower were observed to be cracked and fractured around the floor waste, consistent with impact damage from a heavy object. The damage is localised but has resulted in broken tile surfaces and compromised grout lines in this area. The condition of the underlying substrate and waterproofing could not be confirmed at the time of inspection.

Given the location in a wet area, the damaged tiles may allow water to penetrate beneath the surface and affect underlying materials over time. A licensed builder should be engaged to replace the affected tiles and make good as required. This should be done as soon as practicable.

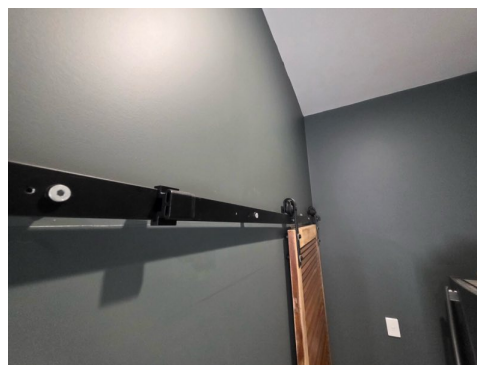
Finding 3.10

Finding: Damaged and restricted sliding doors

The sliding door to the laundry was noted to be stiff and difficult to operate, and also has a scratch to the door face consistent with contact against a protruding fixing within the cavity.

Ongoing use in this condition may result in further damage and reduced functionality of the doors. A qualified carpenter should be engaged to assess and rectify as required, including removal or trimming of protruding fixings and adjustment of door operation. This should be done as soon as practicable.

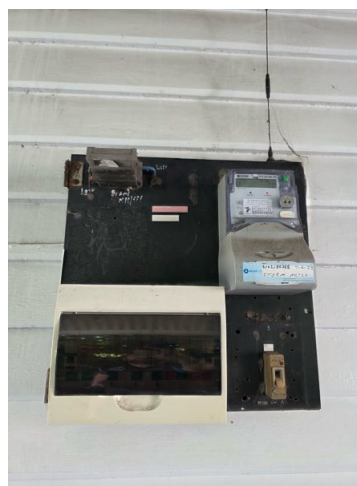
Finding 3.11

Information: The electrical meter board along the side of the verandah is not enclosed within a protective meter box and is exposed to weather.

Exposure may contribute to deterioration of components over time. A licensed electrician should be engaged to assess and rectify as required. This should be done as soon as practicable.

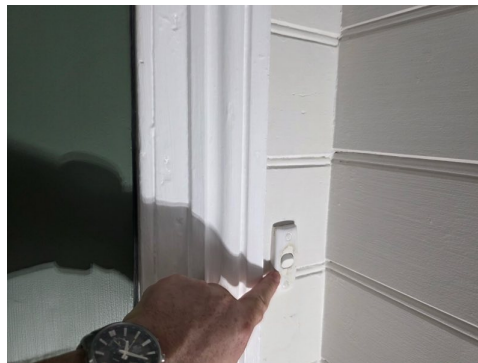
Finding 3.12

Information: The light switch adjacent to the front door did not operate at the time of inspection. The fault appears to be isolated to the switch or local circuit, however no further testing was carried out.

This affects normal use of the area. A licensed electrician should be engaged to assess and rectify as required. This should be done as soon as practicable.

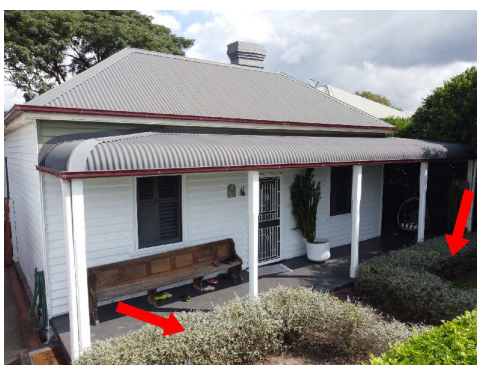
Finding: Garden Beds - Conditions Conducive to Termites

Information: Garden beds, particularly those constructed from untreated timber, were noted adjacent to the dwelling. These create a highly conducive environment for termite activity due to the combination of retained soil moisture from watering, direct soil contact, and the organic material in the soil and timber edging. Such conditions increase the risk of concealed termite ingress into the property, as termites can travel through the garden beds and enter the structure undetected.

Where practical, garden beds should be removed, relocated, or modified so that they do not abut the dwelling. Where this is impractical or undesirable, the risk of concealed termite activity remains. In these cases, a licensed pest controller should establish an ongoing termite management plan, and regular timber pest inspections should be carried out every 6–12 months to assist in protecting the property against infestation.

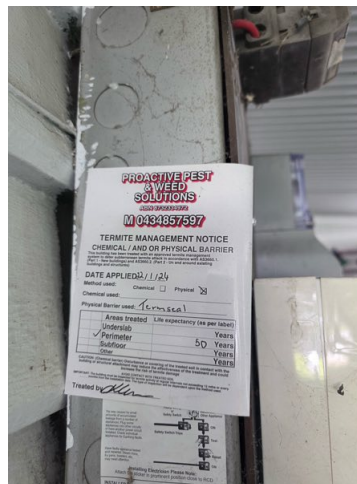
Building: Main Building
 Location: Verandah
 Finding: Durable Present - Durable notice observed in meter box

A durable notice was observed in the meter box at the time of inspection, indicating that a termite management system has been installed at the property. The notice provides information on the type of system and treatment date, as required under AS 3660.1 and AS 3660.2.

While this confirms the presence of a past treatment, it does not verify the current effectiveness of the system. It is strongly advised that an ongoing termite management plan be established by a licensed pest controller. This should be addressed without delay.

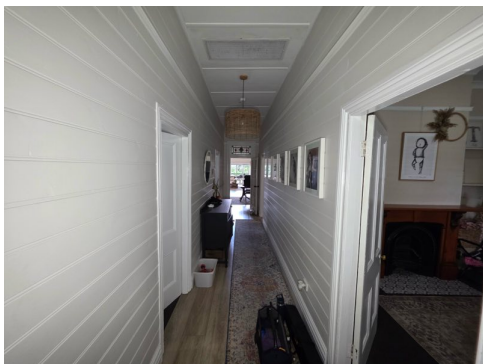
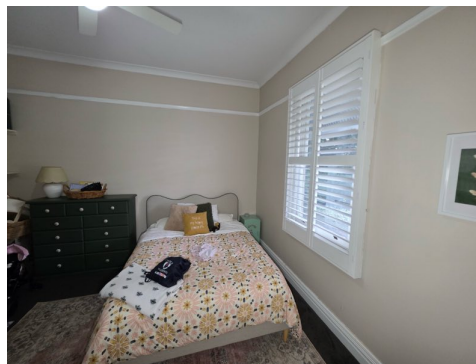
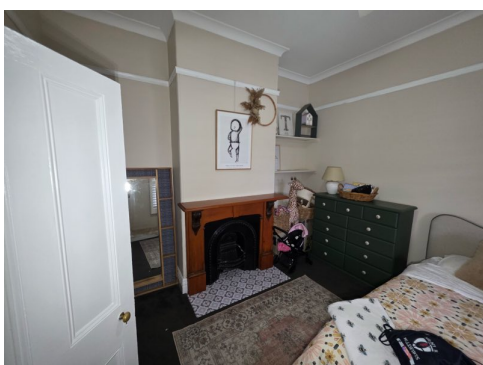
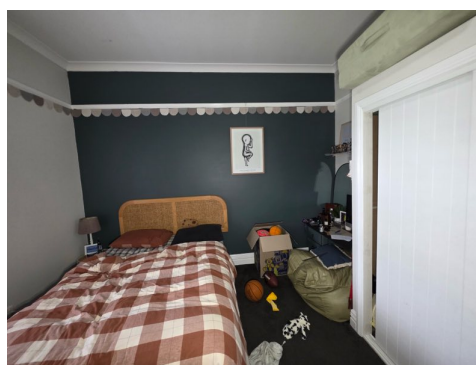
Finding: Additional Photos - Obstructions and Limitations

Information: These photographs are an indication of the obstructions and limitations which impeded full inspection of the property at the time of inspection. These obstructions can hide an array of defects and should be removed to allow full inspection to be carried out. A re-inspection is recommended once the areas are made accessible.

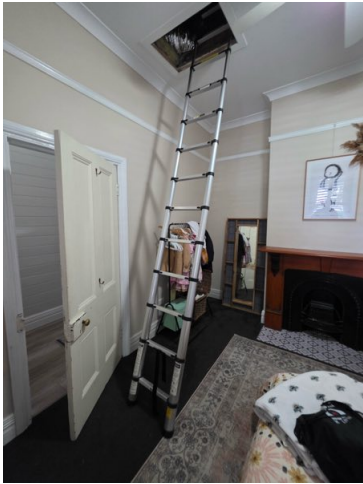
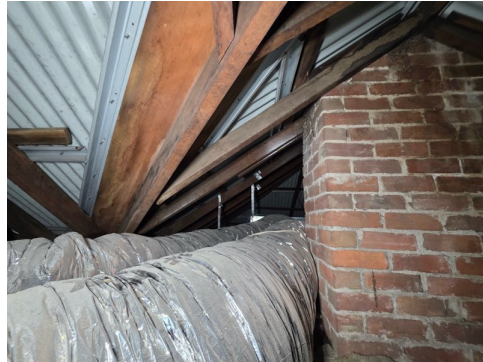
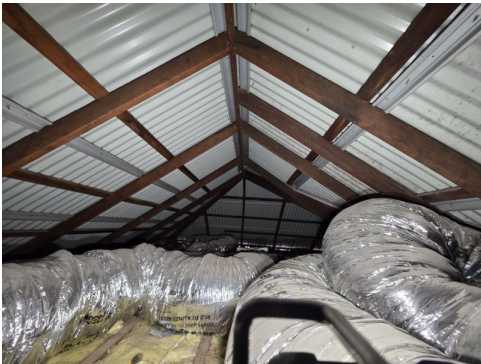
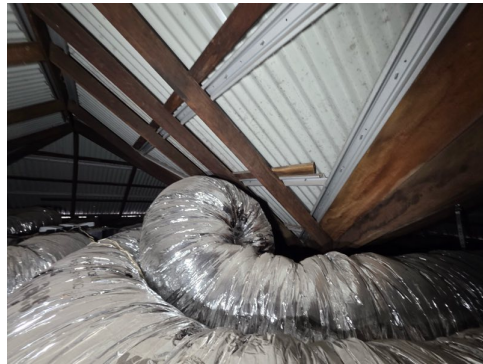
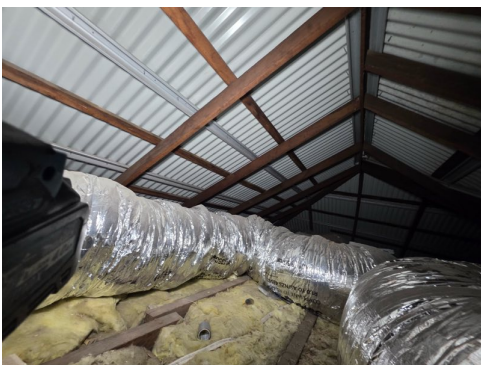
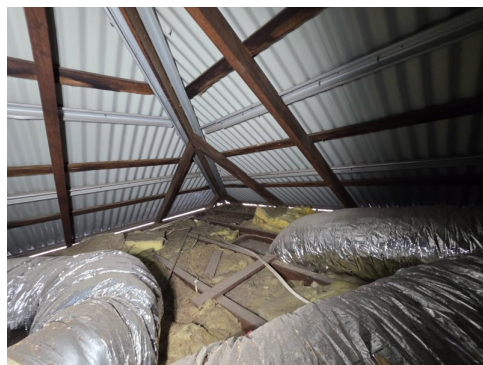
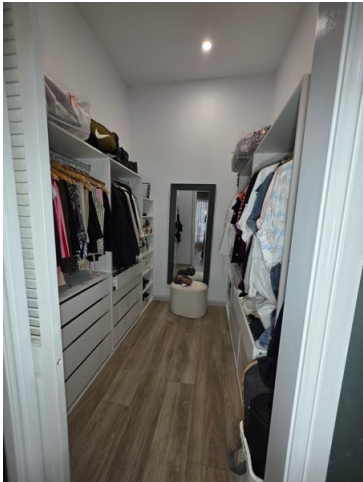
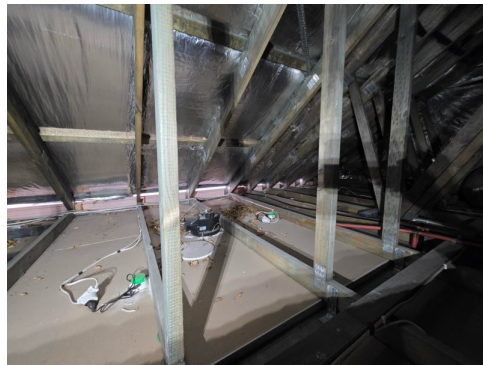
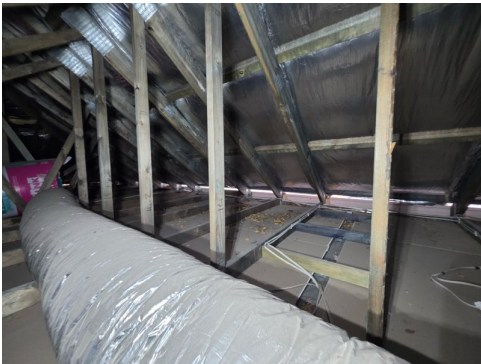
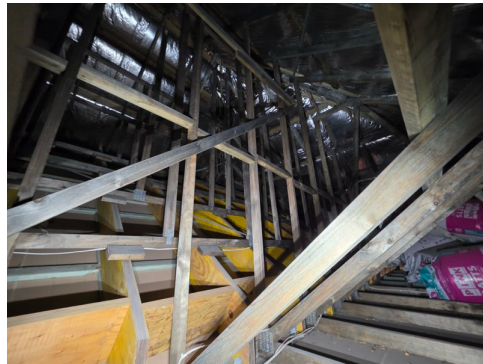
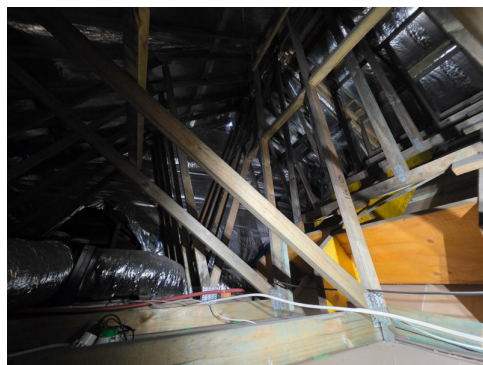
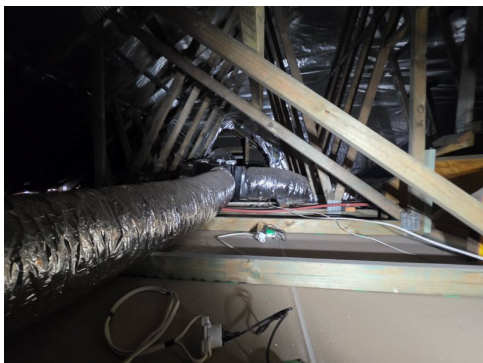
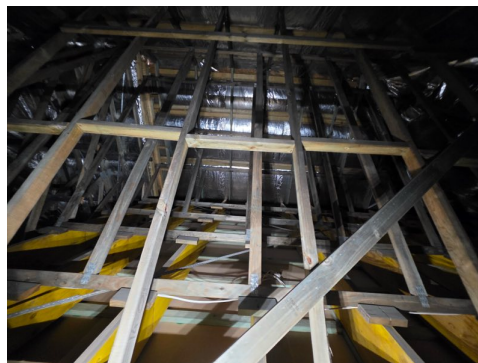
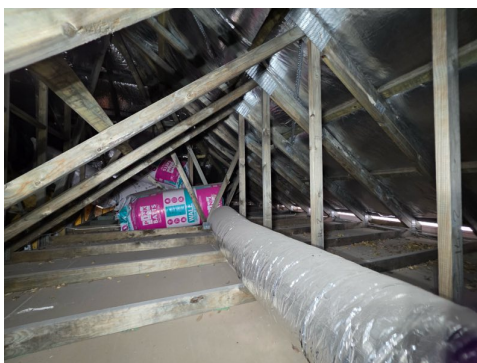
Finding: Access - Roof void

Information: The roof void was not entered due to size restrictions, access limitations, and/or safety concerns. Inspection was carried out from the internal access hatch only, with observations limited to what could be safely viewed and photographed from this position.

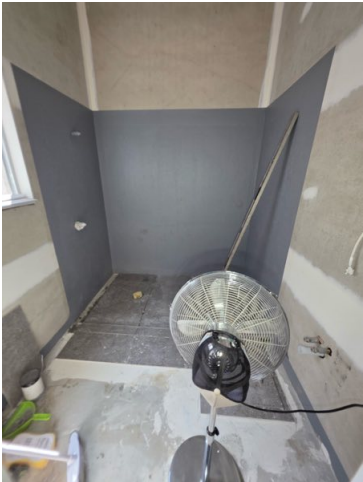
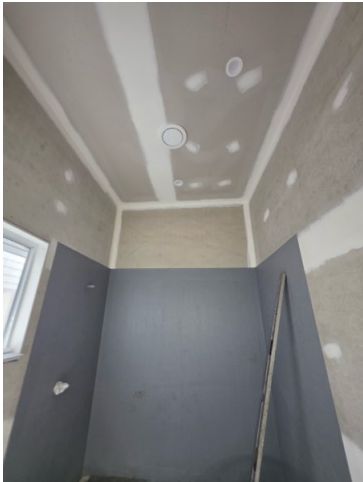
Finding: Incomplete ensuite – Master bedroom

Information: The ensuite to the master bedroom is incomplete, with partial works in place at the time of inspection, including limited tiling and unfinished wet area elements.
