Building and Timber Pest Inspection Report

Inspection Date: Wed, 18 Feb 2026

Property Address: 13 Jamieson Ct, West Wodonga VIC 3690,
Australia

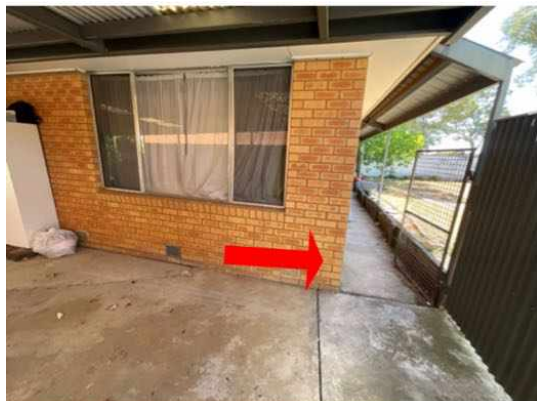
| Finding: | Brickwork - Cracking [Fine] |
| Information: | Although fine cracks are quite noticeable, they are often only considered to be an appearance defect and usually do not indicate any structural damage. Generally, the cause of a fine crack is indicative of a separation between brickwork and mortar throughout the structure, but single bricks may also show cracks of this nature. |

Cracking of this nature can generally be repaired with minor filling and should be conducted by a qualified bricklayer.

Always contact a building inspector should cracks widen lengthen or become more numerous.

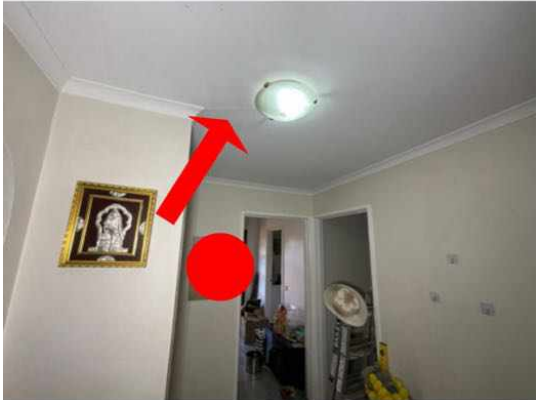
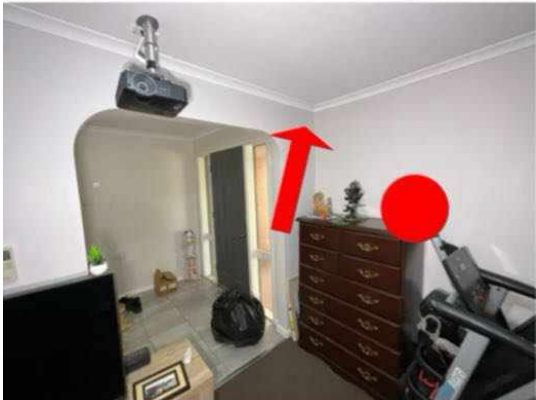
| Finding: | Cracking - Damage Category 2 - Noticeable (up to 5mm) |
| Information: | Noticeable cracks are a common occurrence as a result of many primary defects. Such causes may include age, general wear and tear, expected building movement, general expansion/contraction of building materials in different weather conditions, and/or minor failings in the installation or application of building materials. |

Noticeable cracks may result in minor sticking or jamming of associated doors and windows, which require easement. However, noticeable cracks are easily filled and repaired. A plasterer can be consulted to install an expansion joint at this point to allow for this movement during different weather conditions.

Cracking of this nature can generally be repaired with minor sanding, filling and/or repainting. Such works should be performed by a qualified painter or a general handyman.

Monitoring of all cracking should be conducted frequently. Always contact a building inspector should cracks widen, lengthen, or become more numerous.

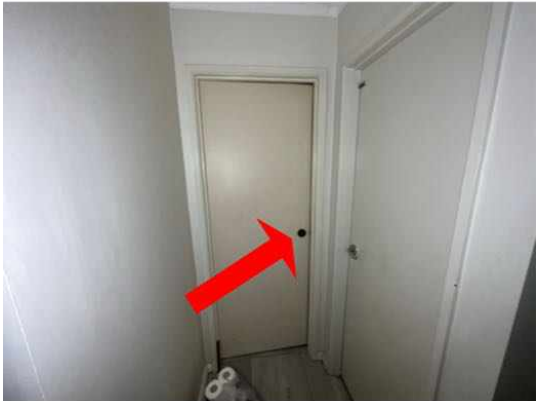
Building: Building 1
 Location: Toilet (WC), bed 3
 Finding: Door handle- Poor operation
 Information: The door handle/ catch in this area was found to be faulty during the visual inspection. This is most probably because of a lack of maintenance or wear and tear over time.

A general Handy person or lock specialist should be contacted to make needed repairs at the discretion of the owner and restore full function.

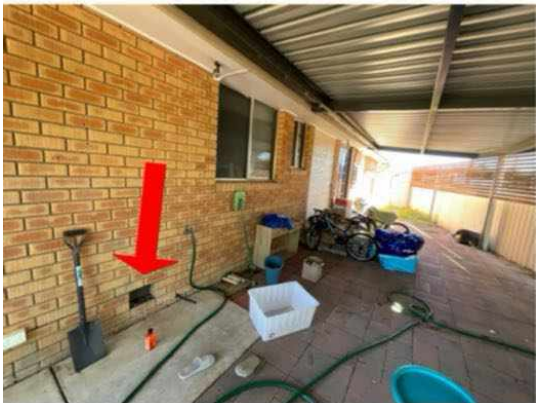
Works that have not been completed to a satisfactory level create potential for the development of building defects and may impede on the safety and integrity of the overall structure.

It is highly recommended that the relevant trades be appointed to complete these works and ensure the safety of the area and the longevity of all associated building elements.

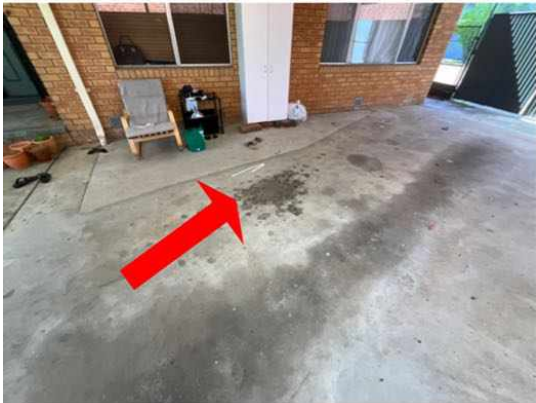
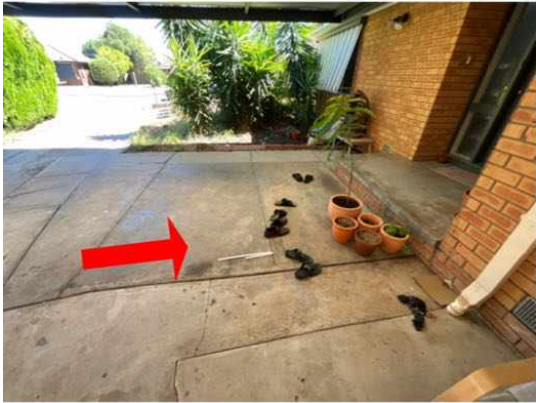
Cracking to this degree may also be due to poor original installation of the concrete. Factors such as poor compaction of the sub surface and/or inadequate reinforcing of the slab may create cracking and other secondary defects.

Repairs are likely to be required to prevent further cracking and to reduce hazards associated with cracking, such as tripping. Monitoring of all cracking should be conducted frequently. Always contact a building inspector should cracks widen, lengthen, or become more numerous.

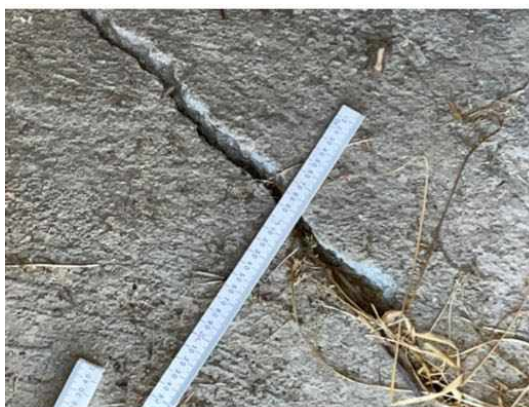
Finding 3.11

Building: Building 1
Location: Shed
Finding: Cracking - External Concrete Paving Damage Category 4 - Gaps in Slab (4mm - 10mm +)
Information: Gaps in the slab were identified in external concrete paving. Gaps in the slab are significant and are likely to lead to the development of safety hazards and secondary defects if left unmanaged, such as the creation of a trip hazard.

Cracking to this degree may also be due to poor original installation of the concrete. Factors such as poor compaction of the sub surface and/or inadequate reinforcing of the slab may create cracking and other secondary defects. Gaps in the concrete paving may also have a more significant structural cause, such as subsidence of soils.

Where gaps in the concrete paving are adjacent to structural elements of the building, the advice of a Structural Engineer is advisable before undertaking repairs. Significant repair and likely replacement of the concrete paving is probable.

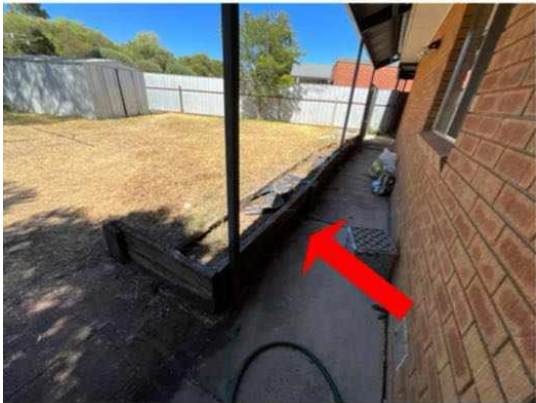
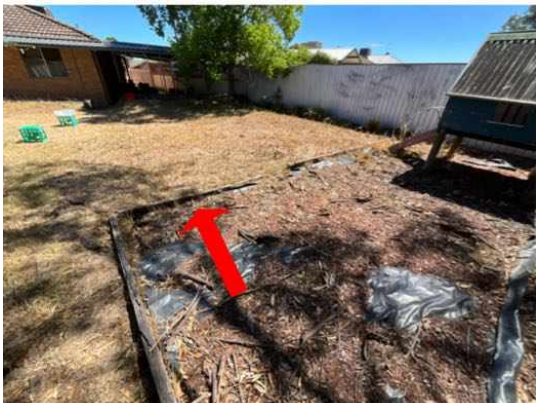
Untreated timbers in direct contact with the ground are likely to develop severe wood rot and/or fungal decay if left unattended creating attraction for subterranean termites to infest the timbers from surrounding areas.

If untreated or non-durable timbers are found to be in a hazardous environment it is highly advised that replacement of these building elements be performed as soon as possible to aid the protection of the property against termite / timber pest attack.

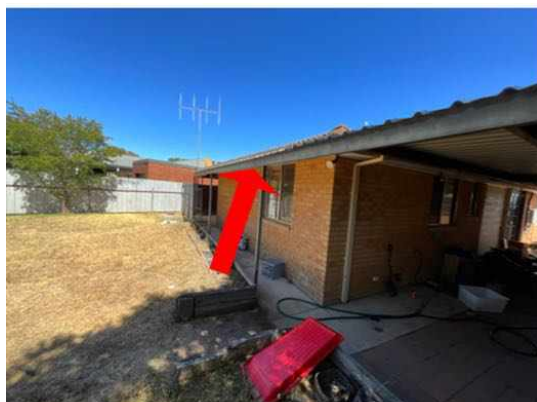
Building: Building 1
 Location: Yard - Back
 Finding: Guttering Missing
 Information: The Guttering in this area was missing at the time of inspection. Guttering, Downpipes and Stormwater drainage are vital to protect the integrity of the structure and to prevent an environment conducive to Timber Pest attack.

A Plumber should be contacted as soon as possible to replace and connect to drainage the missing Guttering.

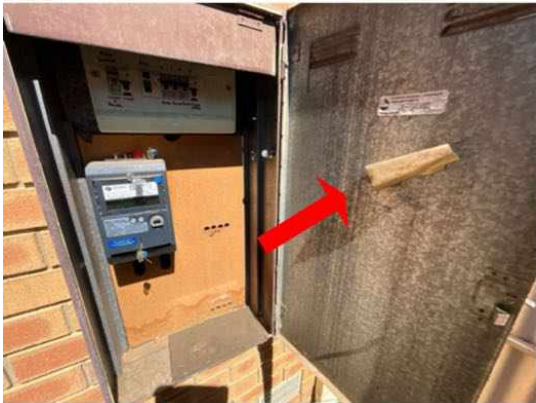
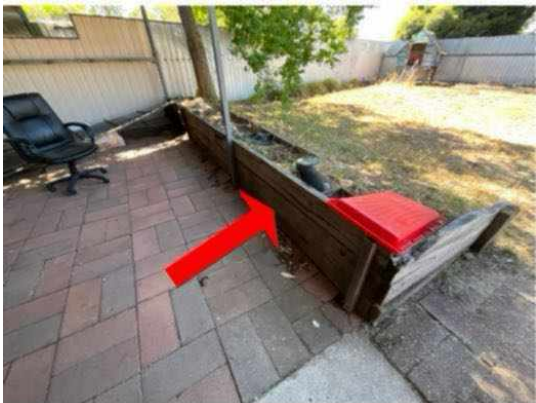
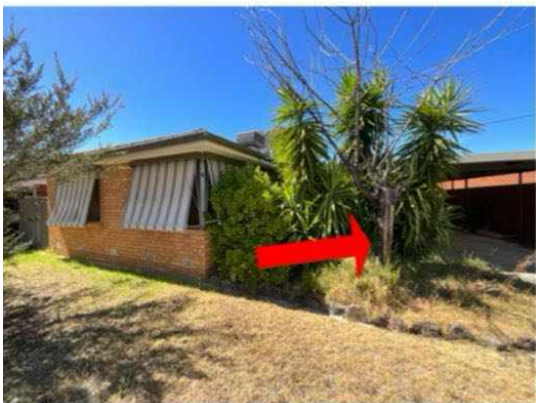
Finding 6.05

Building: Building 1
 Location: All External Areas
 Finding: Termite Management System - no evidence of a chemical installation
 Information: The application of a post-construction chemical termite barrier is highly recommended for all properties, particularly if live termite activity has been found on the site previously. Such barriers are highly effective in preventing termite attack on any timber

A durable notice should be placed in the switchboard unit to indicate current termite barriers. At the time of inspection, it appeared as though no termite management system has been installed, with no evidence to suggest preventative works taking place.

The client may consider gaining further advice from a pest controller as to the costs and procedures involved with this application. It is recommended that obtaining such advice be a short-term priority.
