Building and Timber Pest Inspection Report

Inspection Date: Thu, 5 Mar 2026

Property Address: 60 Yvonne St, Highworth QLD 4560,
Australia

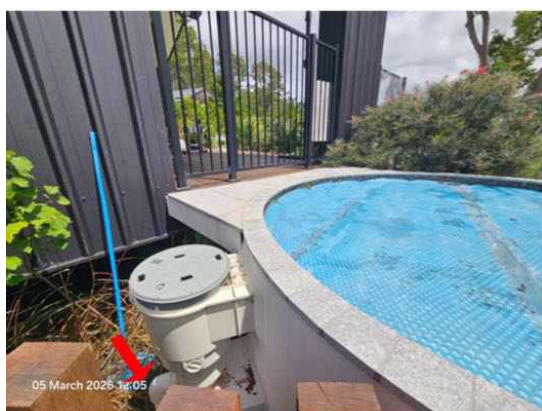
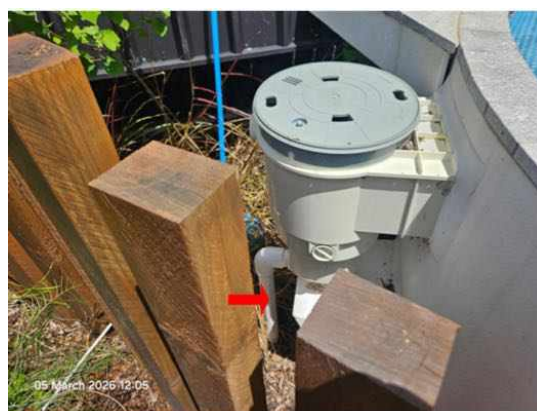
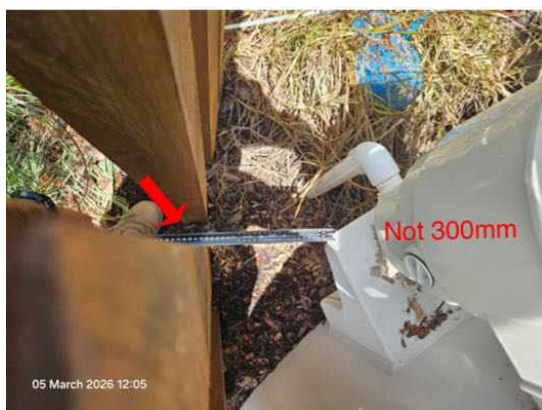
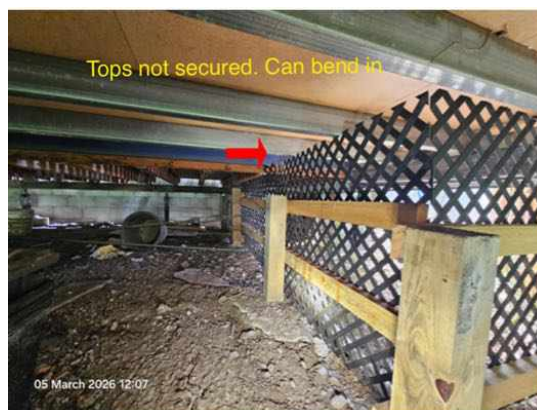
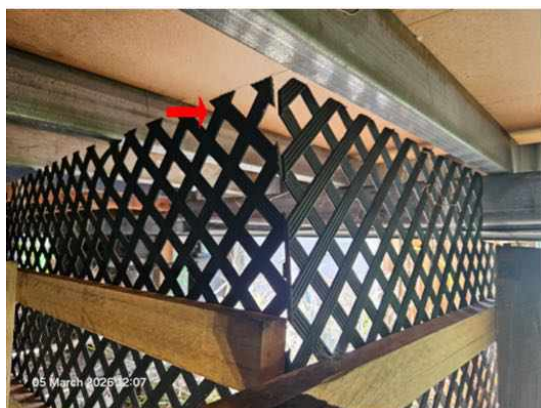
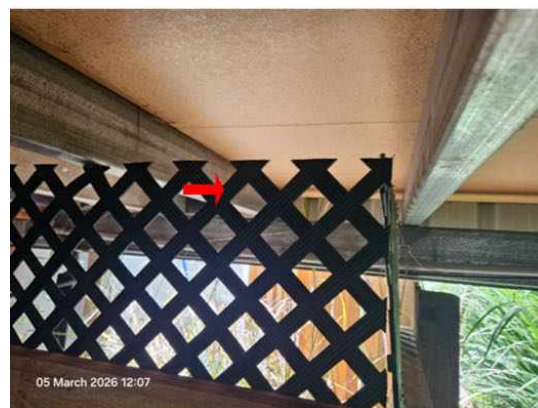
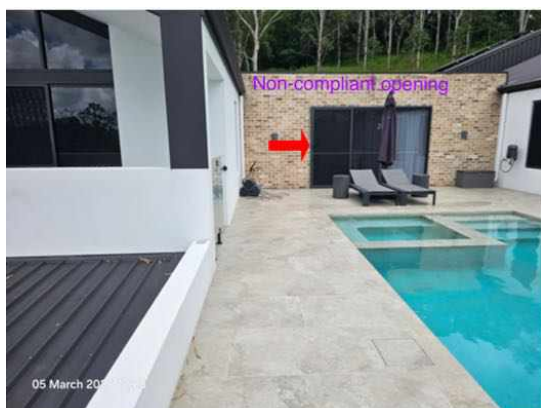
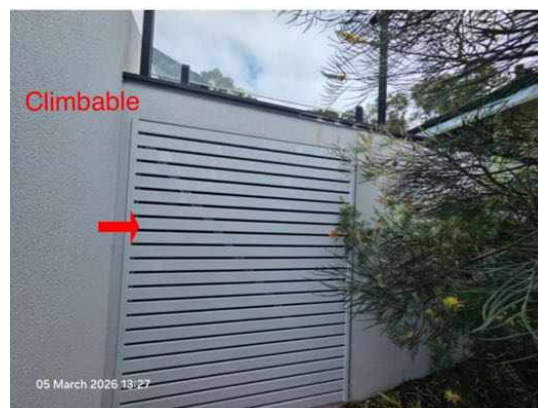
As licensed pool safety inspectors, we have a duty of care to report any possible pool barrier non compliance. There were aspects of the pool barrier and associated elements that did not comply on the day of inspection.

It recommended that a pool safety inspection be carried out.

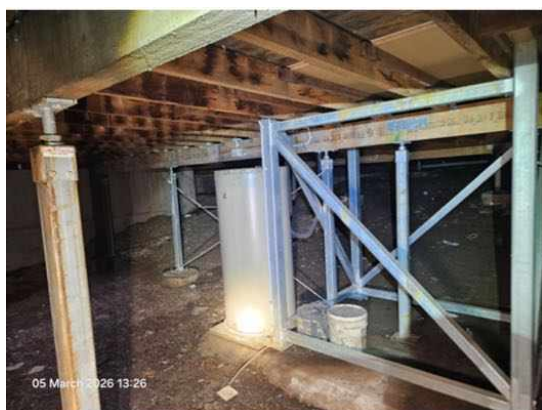
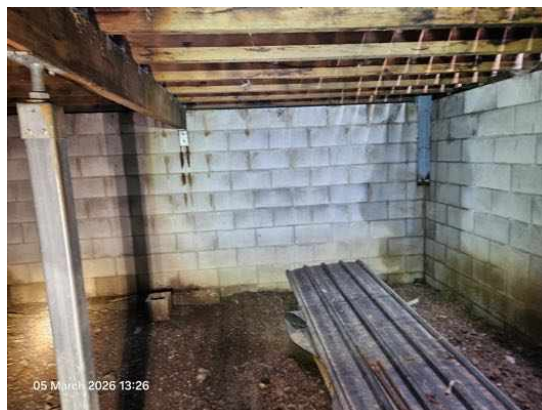
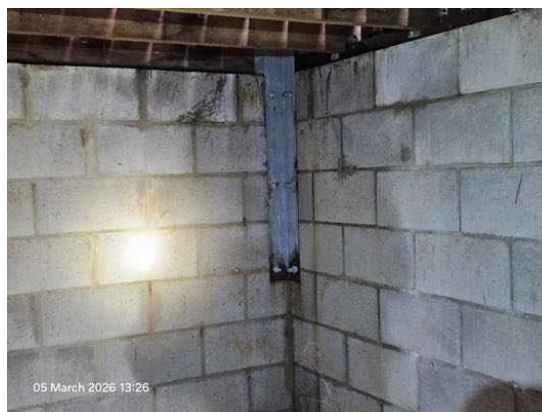
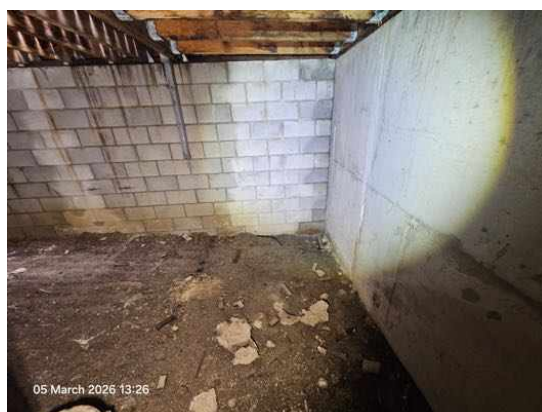
Finding 2.02

Building:	Main Building
Location:	Front deck
Finding:	Subfloor drainage - Inadequate
Information:	The subfloor drainage in the area beneath the front deck was found to be inadequate at the time of inspection, creating potential for subsequent water damage to associated building elements.

Water damage and secondary defects are likely to occur if left unmanaged. Poor site drainage can lead to conducive conditions for timber pest infestation by creating excess moisture against the building perimeter.

Where site drainage is inadequate, a licensed plumber or landscaper should be appointed as soon as possible to further inspect the property and perform any remedial works as necessary.

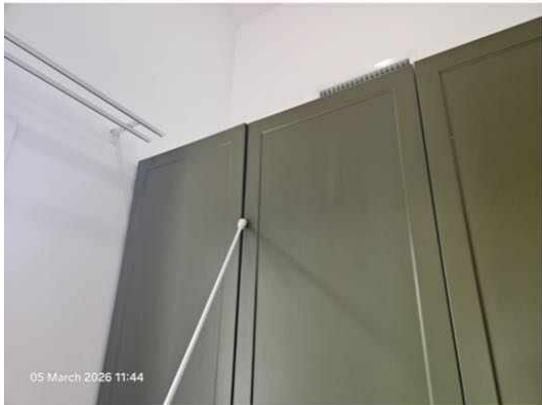
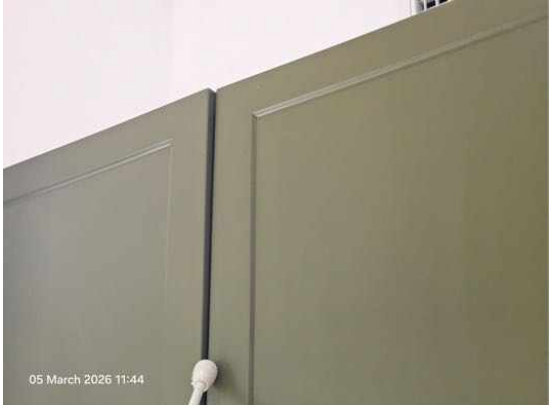
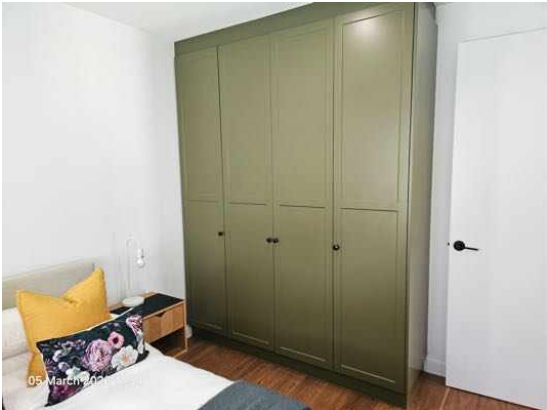
Finding 3.01

Building:	Out Building
Location:	Granny flat as shown
Finding:	Cabinetry defects - granny flat
Information:	It was observed during the inspection that some cabinetry of the interior of the granny flat requires repairs. Generally, the cabinetry is of a good quality; however, a common fault is bowing and cupping of the large panels and doors. Please refer to photos for positions and rooms.

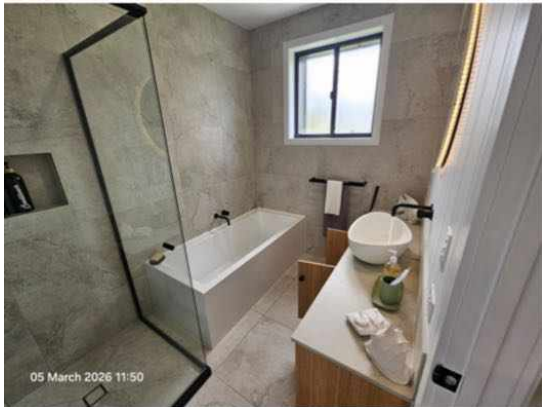
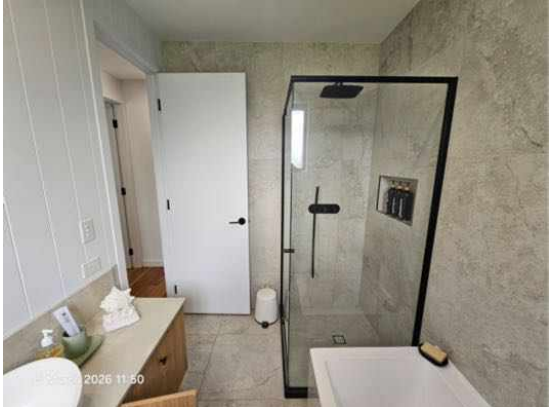
Finding 3.02

Building: Main Building
Location: Bathrooms, ensuite
Finding: No moisture detected in bathroom / ensuite
Information: On the day of inspection the showers in the bathroom/s and ensuite are measure for moisture using a "Tramex" moisture meter. During this inspection no moisture was detected in these areas and the tiled / sheeted surfaces appear to be in good order.

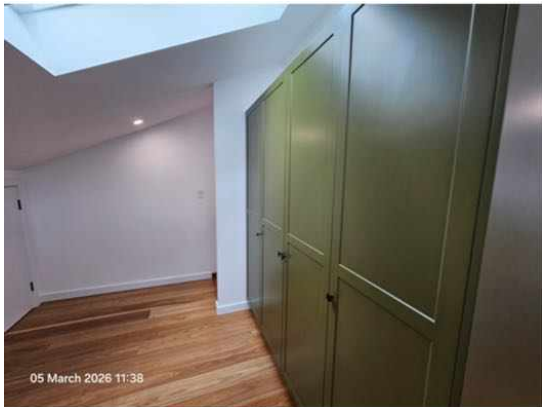
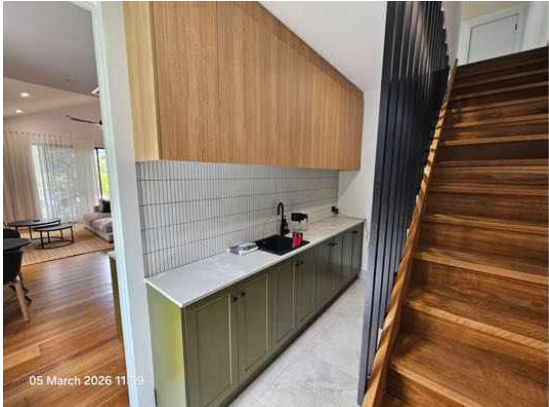
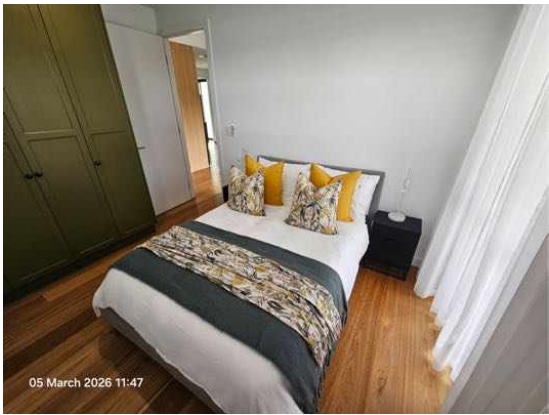
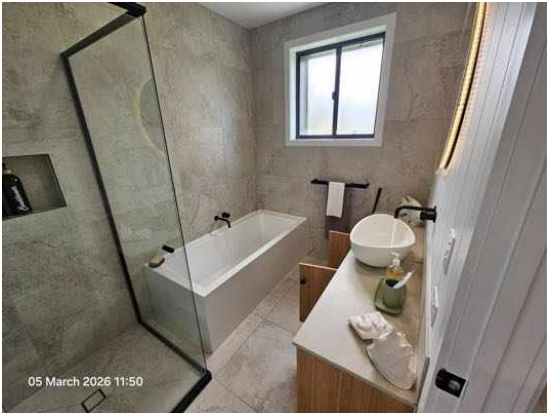
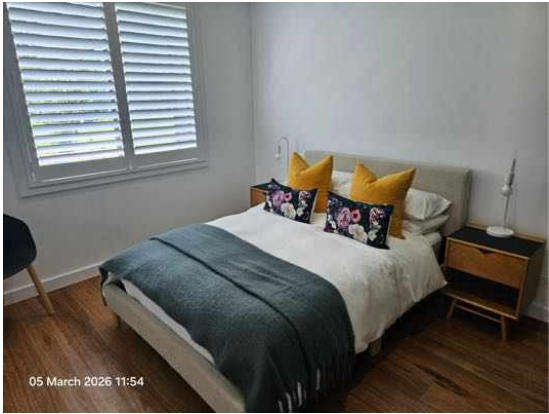
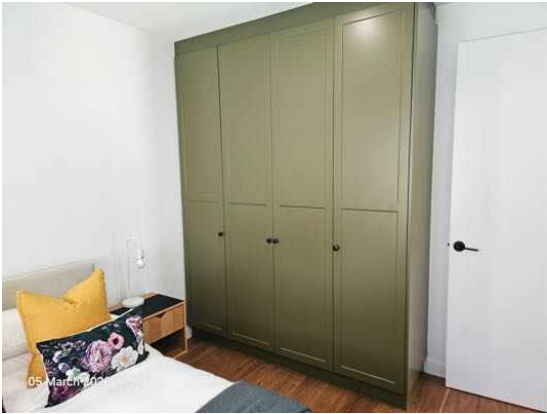
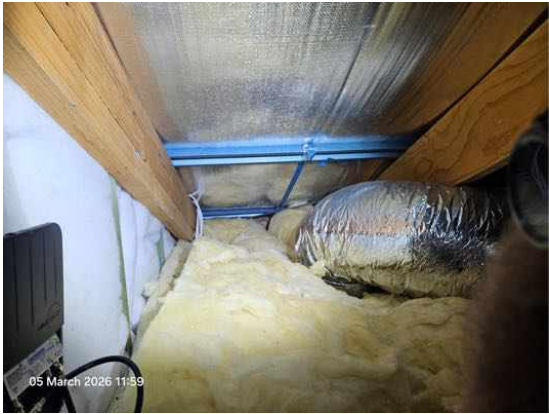
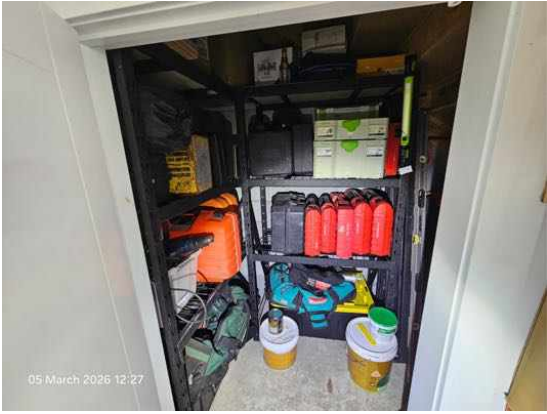
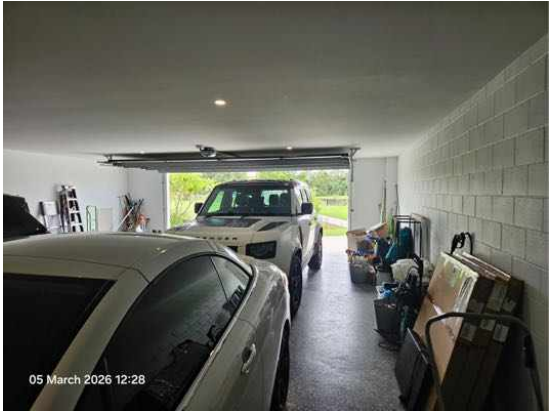
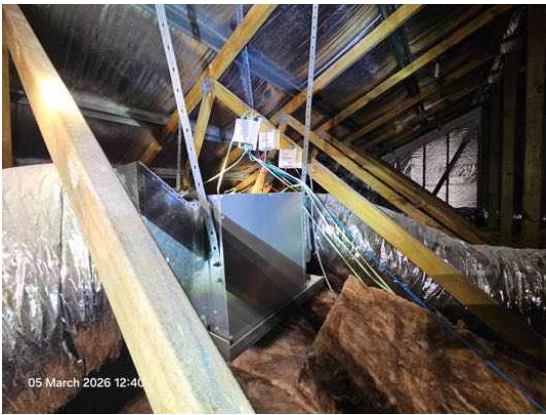
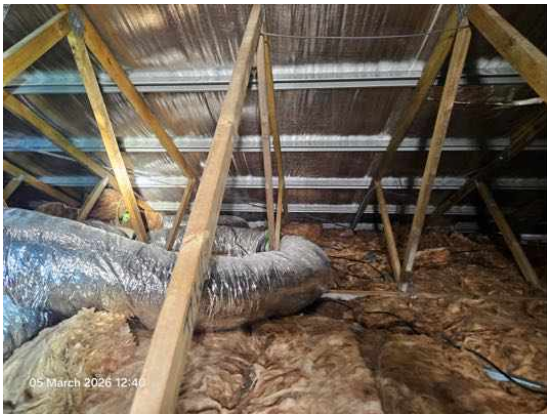
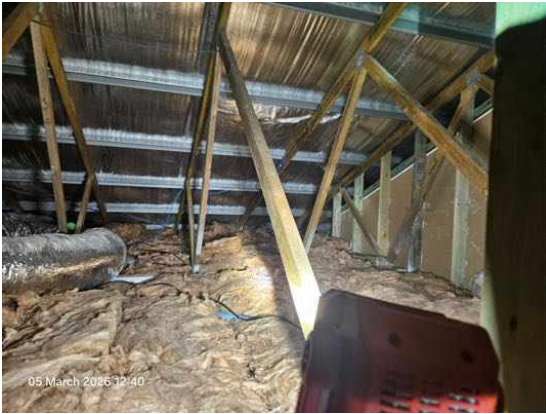
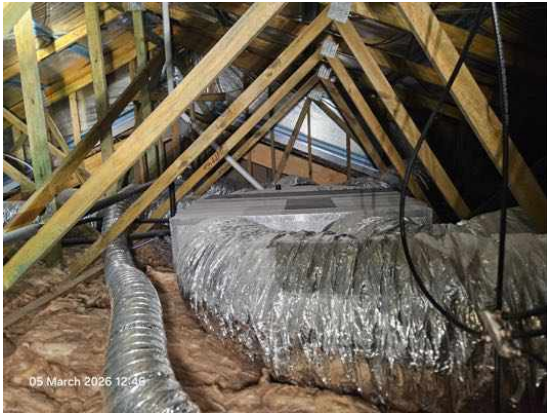
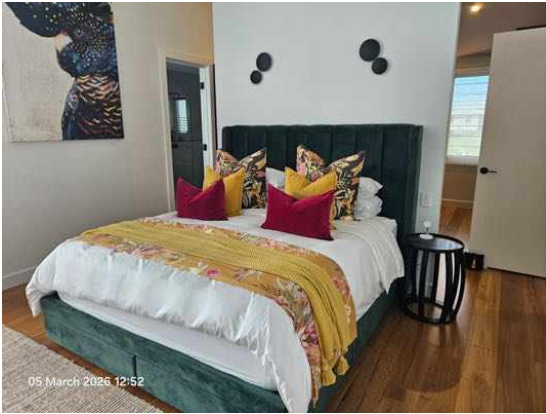
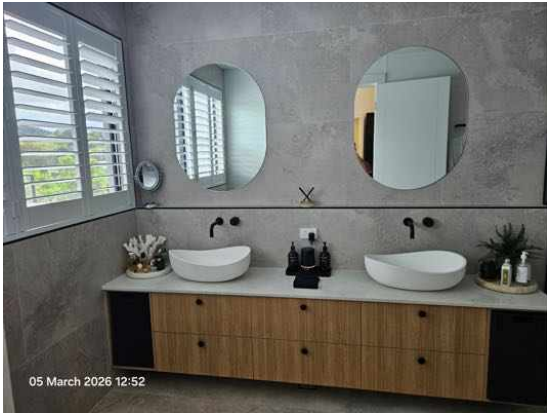
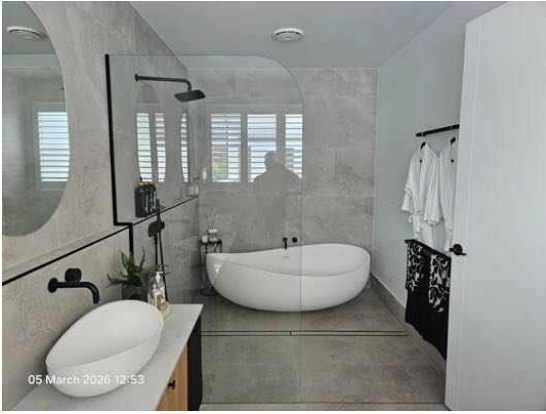
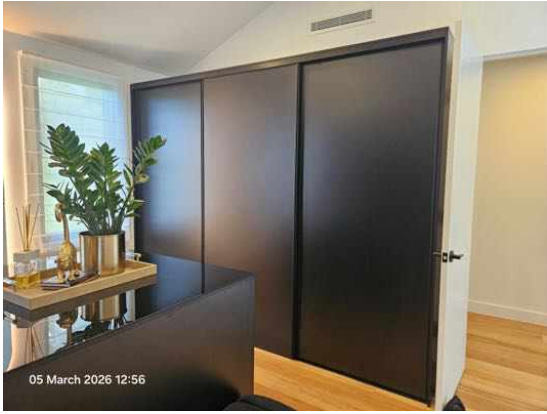
Building: Main Building
Location: All Areas
Finding: Additional Photos - Obstructions and Limitations
Information: These photographs are an indication of the obstructions and limitations which impeded full inspection of the property at the time of inspection. These obstructions can prevent full inspections of the areas shown.

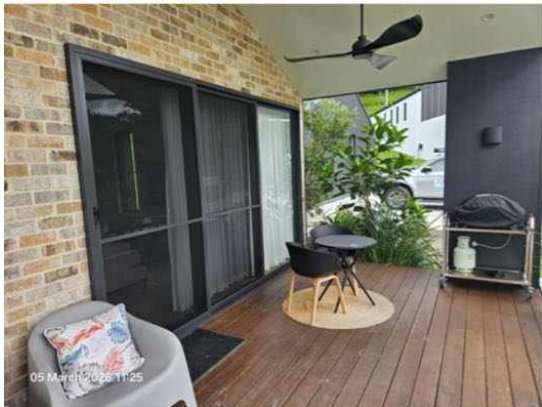
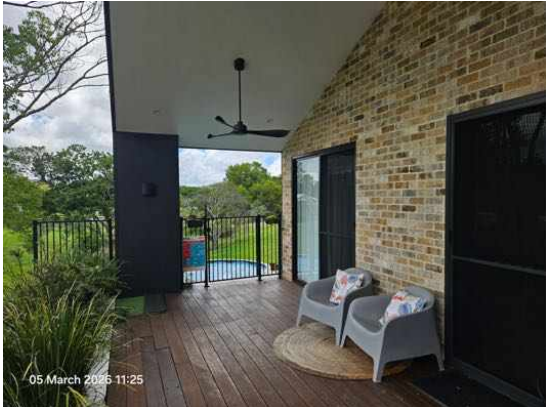
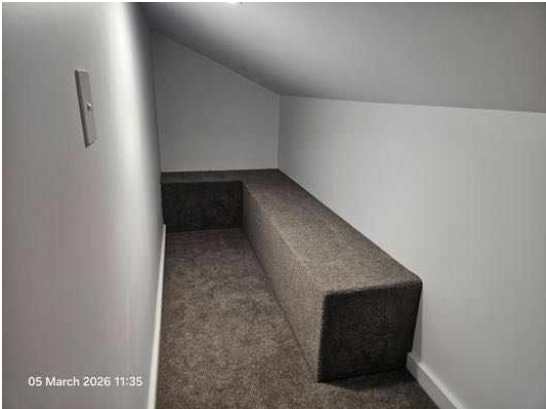
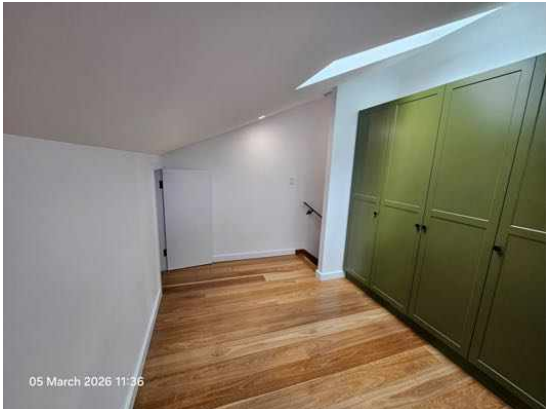
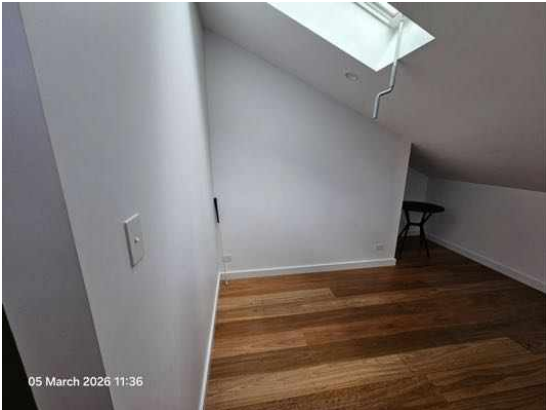
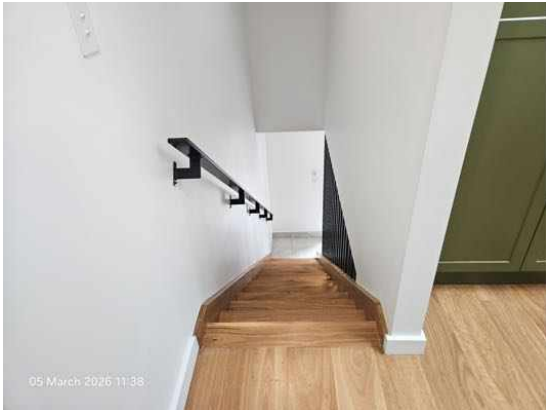
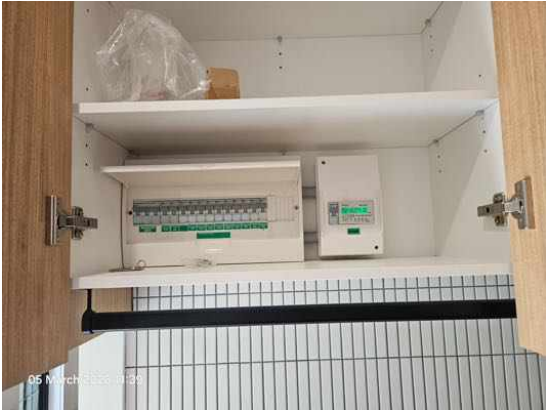
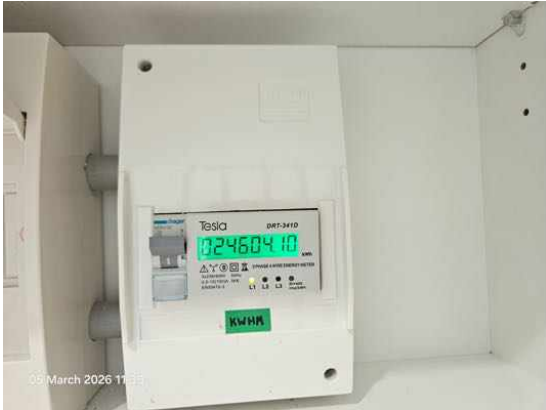
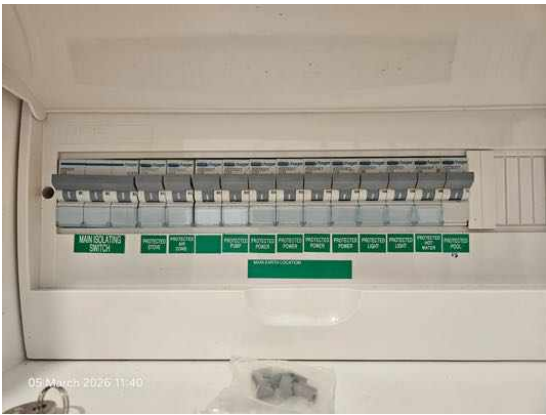
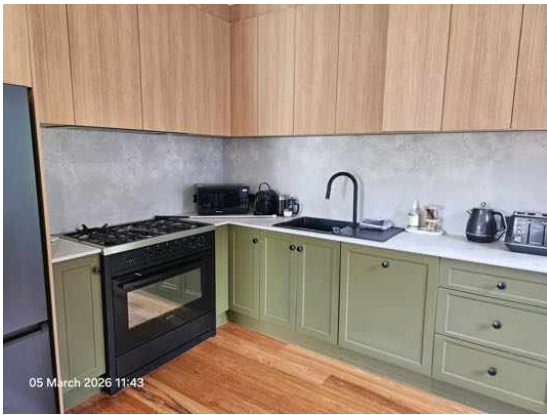
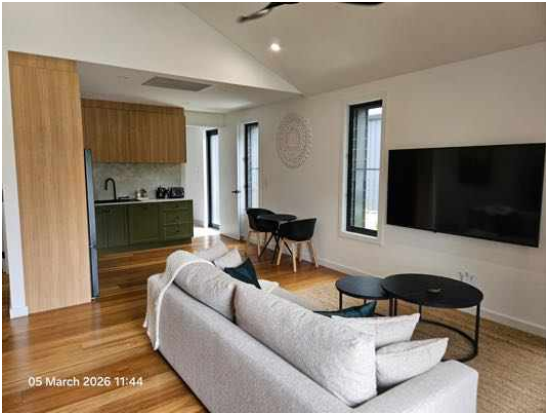
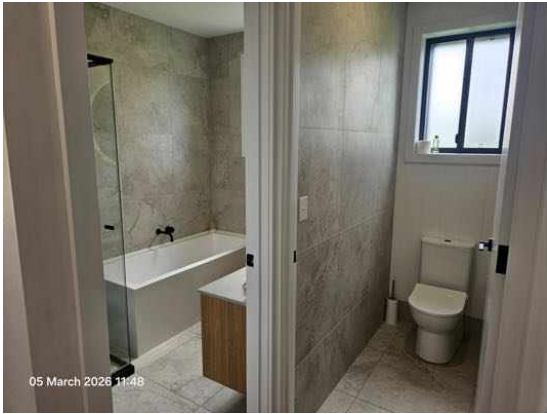
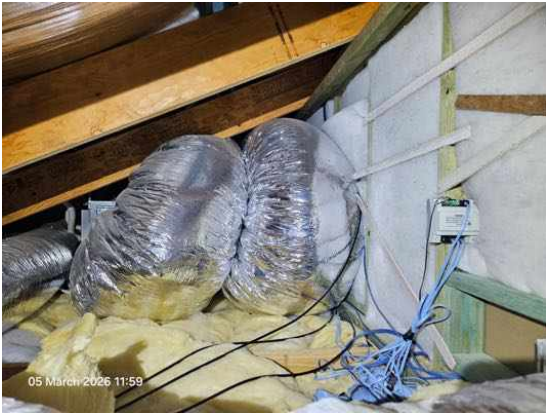
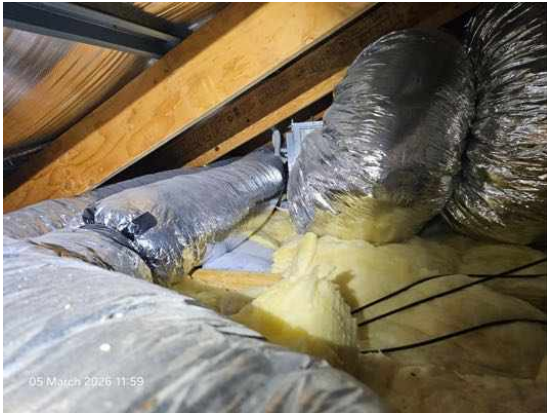
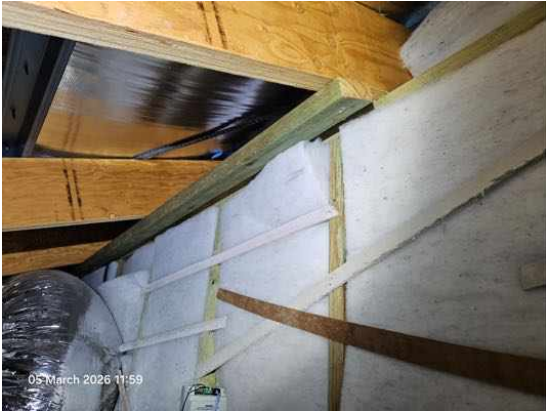
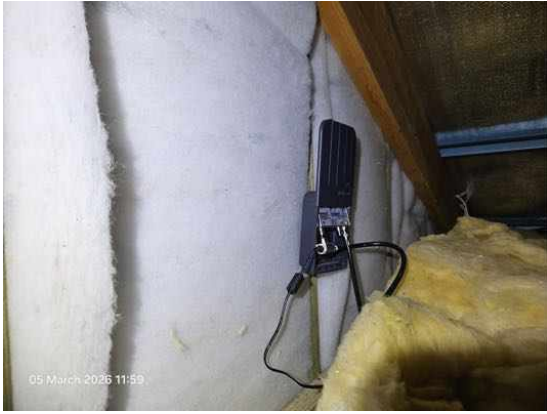
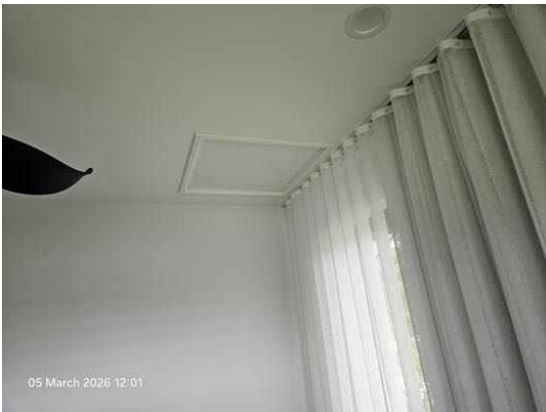
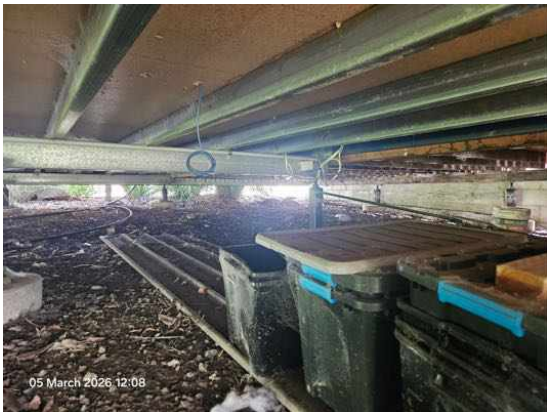
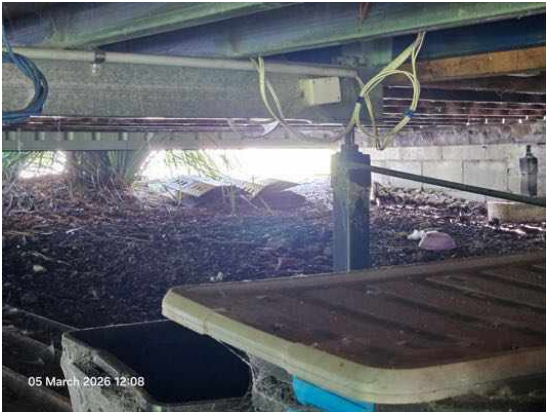
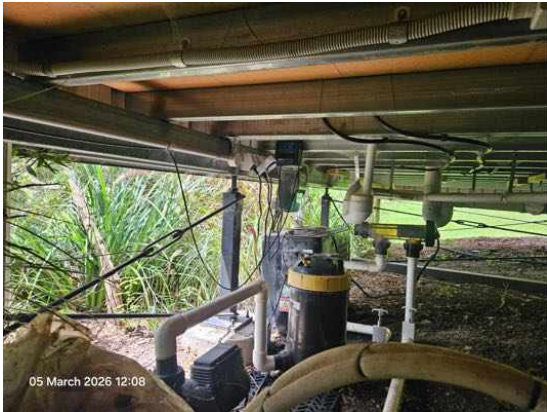
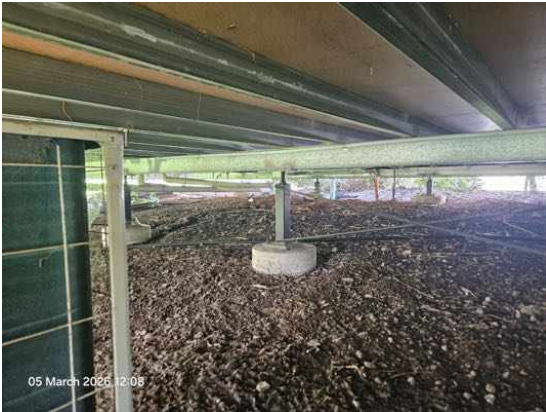
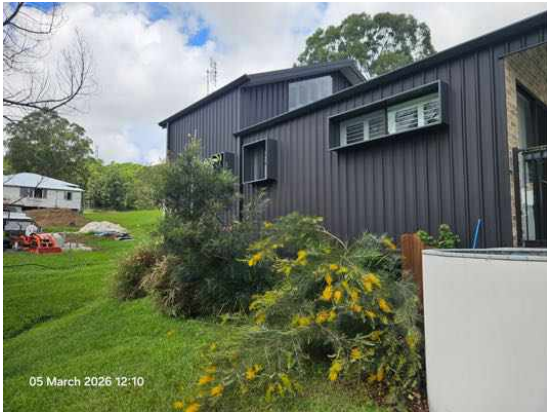
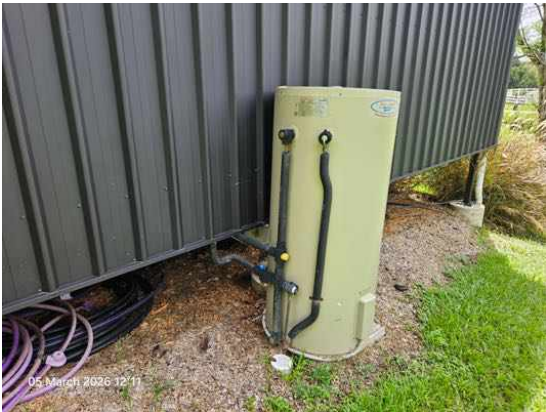
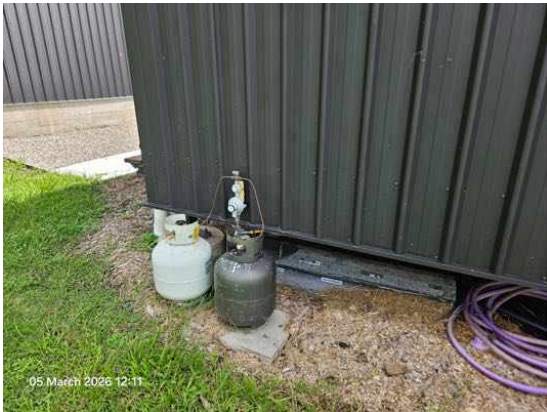
Noted Item

Building: Main Building
Location: All Areas
Finding: Additional Photos for client reference
Information: Additional photos are provided for your general reference.

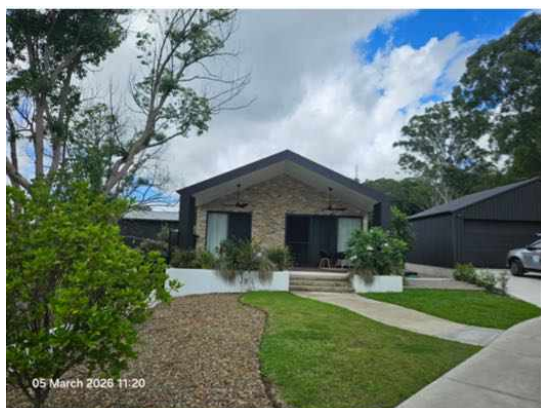
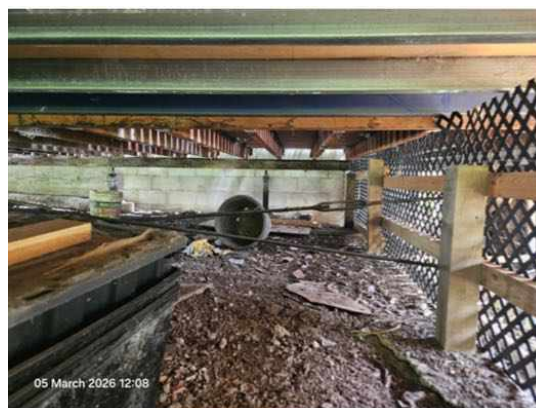
Noted Item

Where a Termite Management System has been identified you should refer to the type of barrier, date of installation, warranty conditions and any documentation provided by a builder or past owner. Consult the company who installed the barrier to confirm whether the system is still under warranty.

The building employs a physical barrier system to the perimeter, subfloor and slab penetrations. A partial chemical reticulation system is installed to the perimeter.

In order for a barrier system to be effective, the property must have regular inspections at intervals of not greater than 12 months. Depending on the risk profile attributed to the property, these inspections may be recommended at lesser time periods.

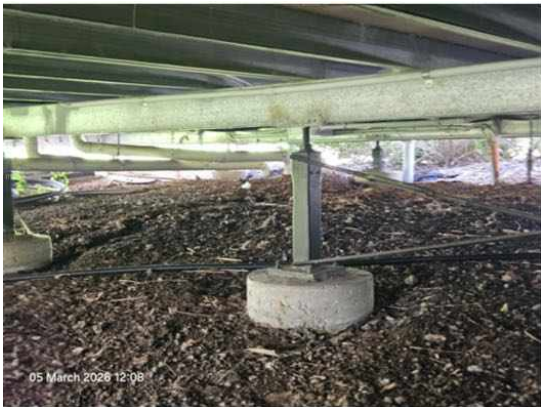
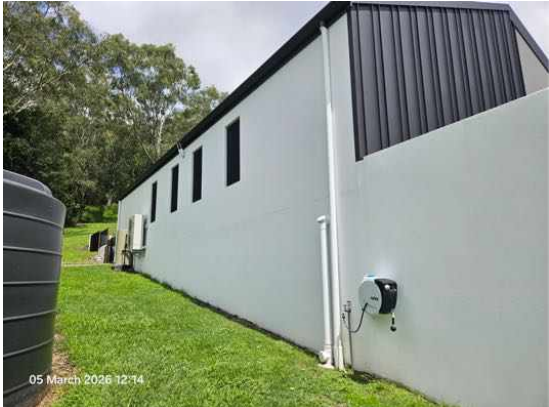
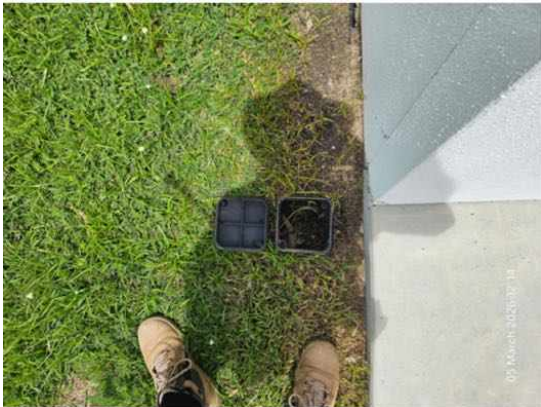
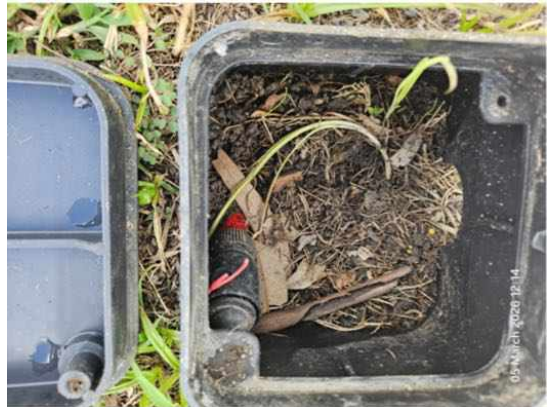
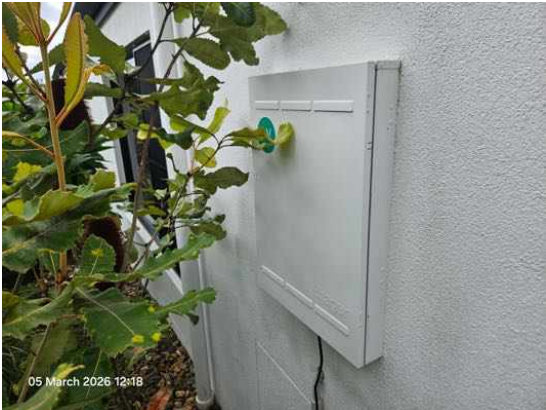
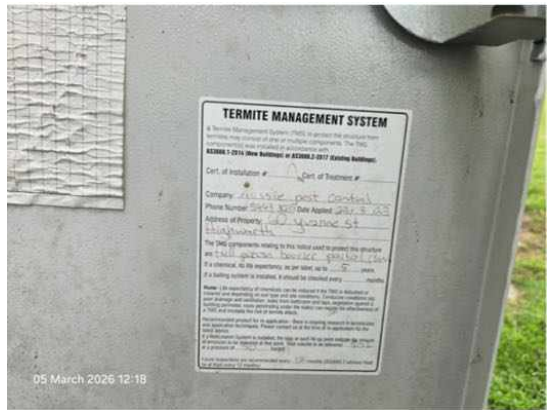
The following items were noted as - Evidence of a previous termite management program
