# Building and Timber Pest Inspection Report

Inspection Date: Thu, 19 Feb 2026

Property Address: 8 Pereira St, Newington NSW 2127,  
Australia

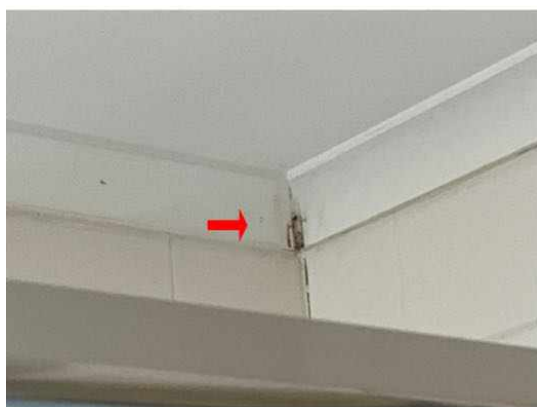
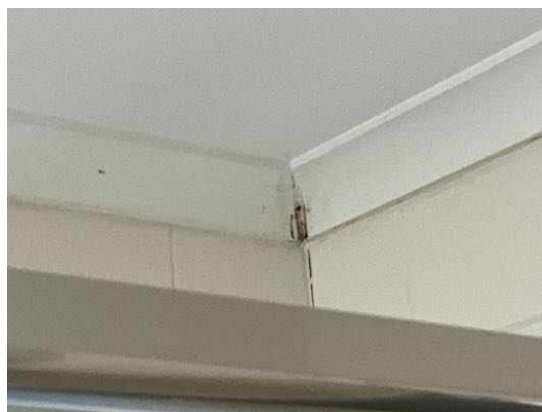
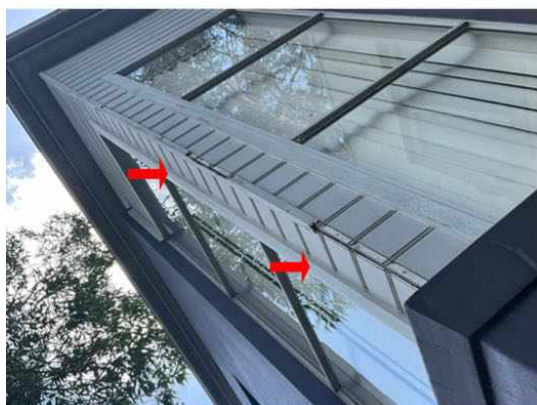
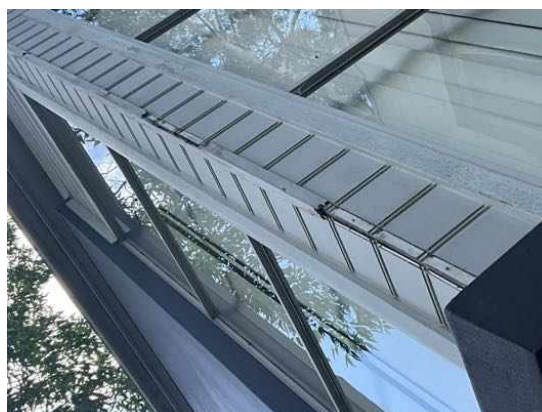
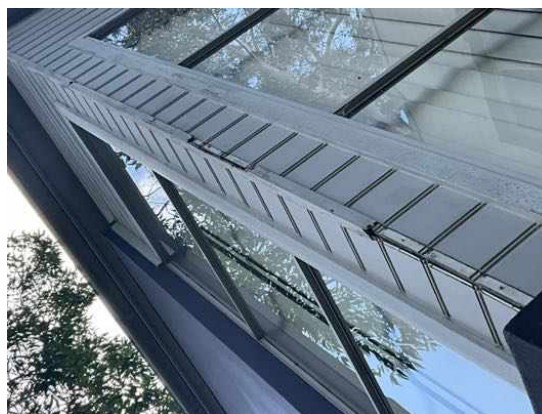
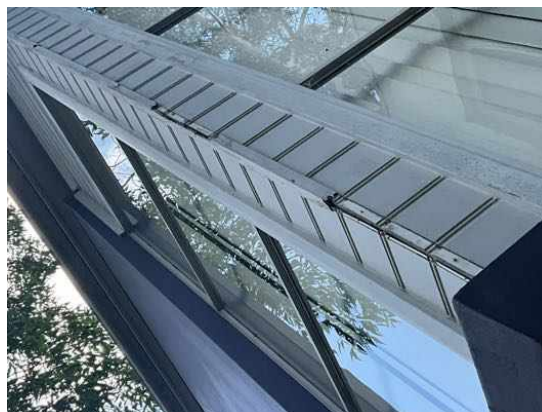
### Finding 2.01

Building: Main Building  
Location: All Areas  
Finding: Rot - Timber Trim with Water Ingress Risk  
Information: The timber trim displays visible signs of deterioration, including delamination, paint peeling, cracking, and possible decay. The damaged section has opened up, exposing the internal substrate.

- Moisture ingress into the wall cavity, potentially leading to structural timber decay or concealed mould growth.
- Reduced durability of the cladding system.
- Potential pest entry point, especially if there's access to framing.
- Aesthetic deterioration impacting long-term maintenance costs.

- A licensed carpenter or building maintenance contractor should remove the damaged timber and inspect the substrate behind it for further decay.
- Replace or repair the affected section, apply appropriate flashing or sealant, and repaint using exterior-grade finishes.
- If moisture ingress has affected the internal framing or caused hidden mould or termite risk, further investigation by a building consultant or pest inspector is recommended.

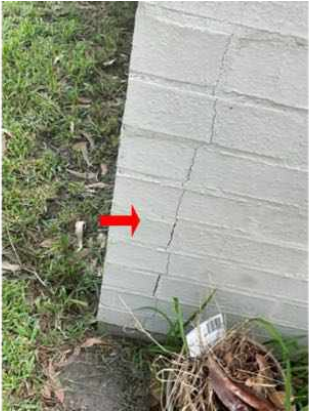
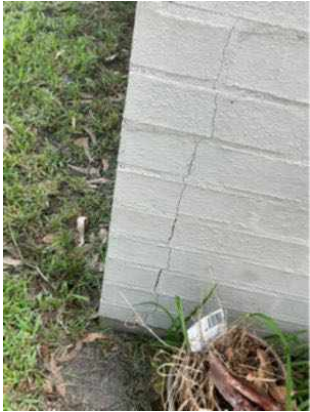
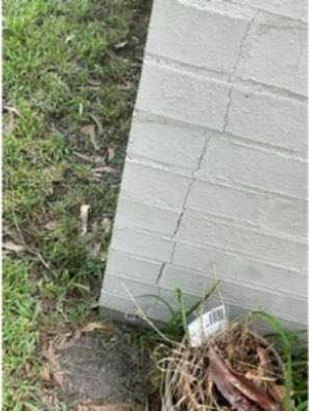
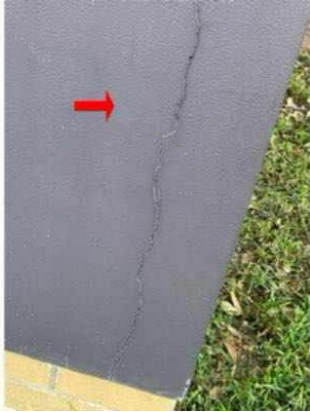
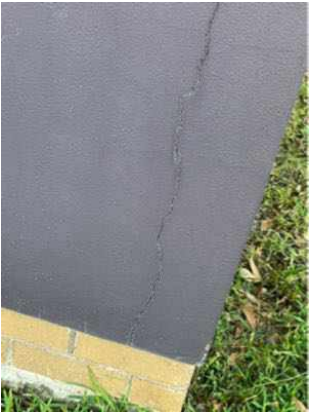
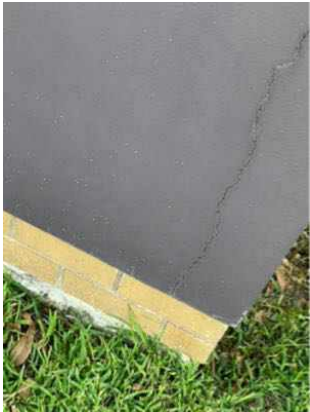
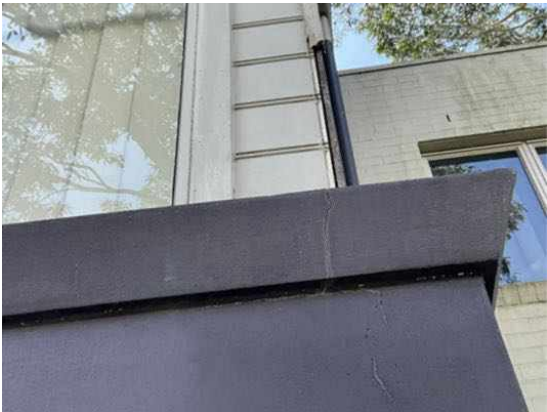
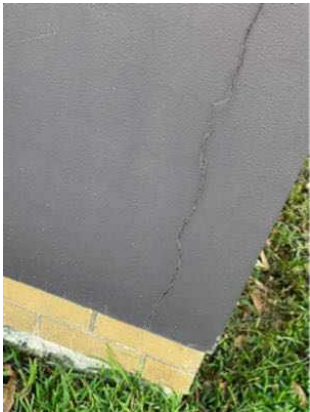
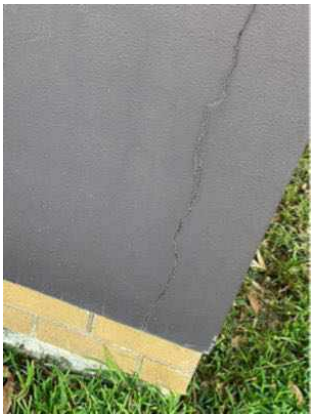
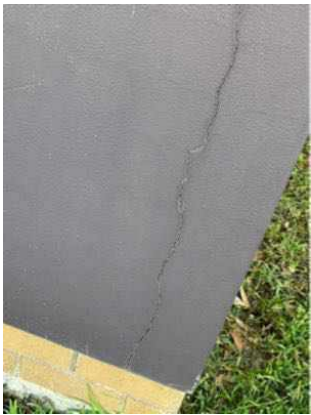
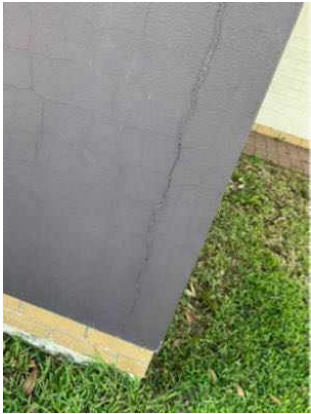
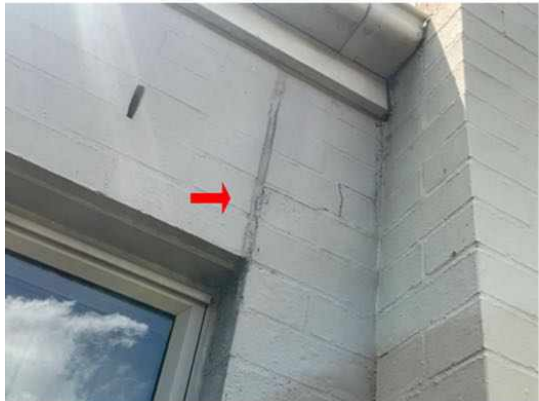
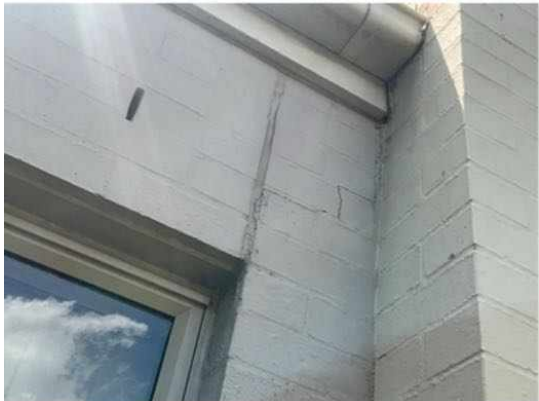
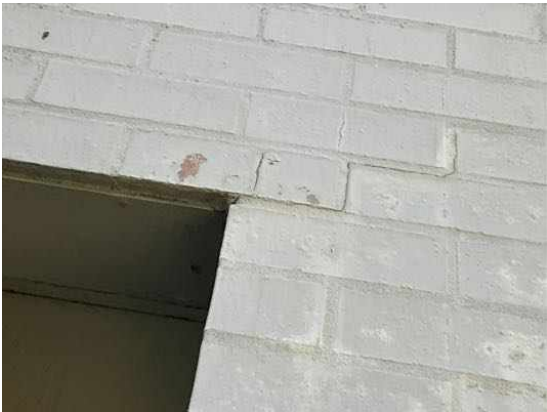
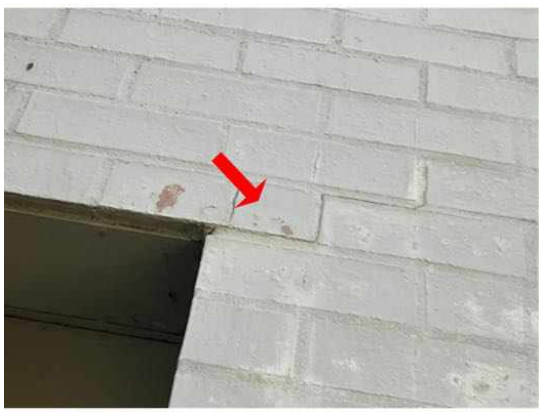
### Finding 3.02

Building:	Main Building
Location:	All Areas
Finding:	Brickwork - Cracking noticeable
Information:	There were several cracks and or crack repairs evident to external brickwork.

Noticeable cracks are a common occurrence in external brickwork and are a likely result of age expected building movement, general expansion, and/or contraction of building materials in different weather conditions. Noticeable cracks in brickwork may develop if left unattended, with potential for necessitating major remedial works or replacement of the brickwork.

It is highly advised that a qualified bricklayer be appointed to provide necessary works to cracked brickwork to prevent any further damage. Such works should be conducted as soon as possible.

Always monitor these cracks and contact a building inspector should cracks widen, lengthen, or become more numerous.

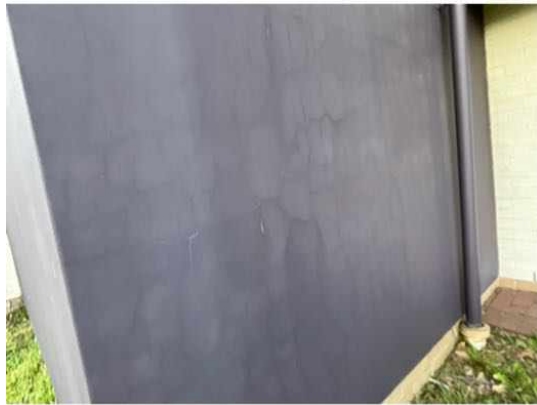
Finding 3.03

Building: Main Building  
Location: All Areas  
Finding: Cracking - rendered surface  
Information: Cracking observed along the vertical and diagonal plane of the rendered surface. The cracks appear as fine to moderate-width cracks, indicating potential shrinkage or movement within the substrate.

According to AS 4349.1-2007 Inspection of Buildings and the Guide to Standards and Tolerances 2017 cracks up to 1mm wide are considered an acceptable tolerable limit for plaster and render finishes in the absence of other symptoms (such as displacement or water ingress). Cracks between 1mm and 5mm wide may require repair depending on their cause and severity.

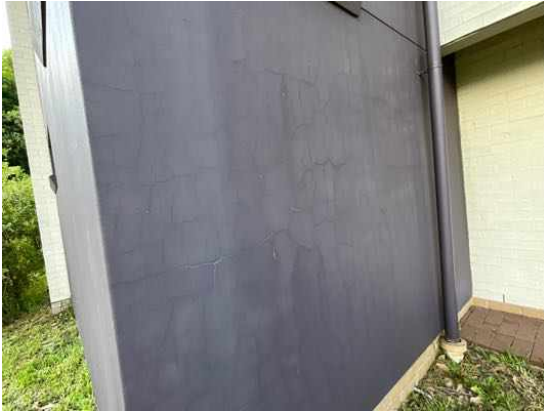
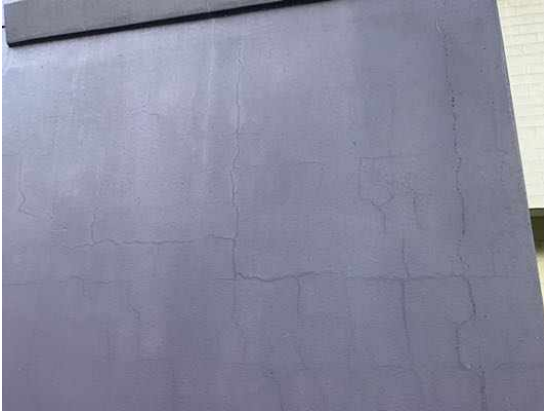
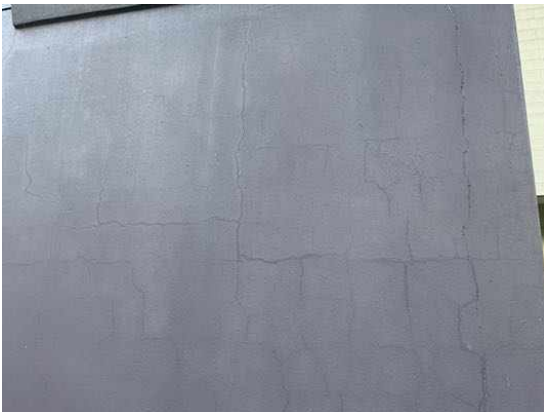
### Finding 3.04

Information: Sections of the paint in this area was found to have deteriorated. Paint deteriorating is generally an indication of excessive moisture in the area that is currently hidden by the painted surface.

The presence of excessive moisture can have major implications on associated building elements if left unattended. While only seemingly minor at this stage, the damage cannot be determined due to the paint, obstructing any further inspection of the damage.

It is highly advised that the affected paint to be cleaned to allow a further, more invasive inspection by a licensed builder/painter. Failure to act on this defect may necessitate major works in the future.

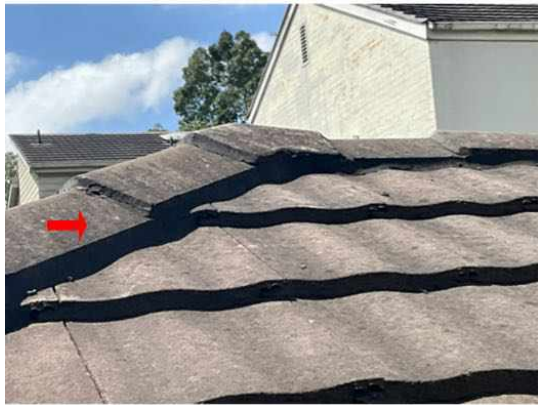
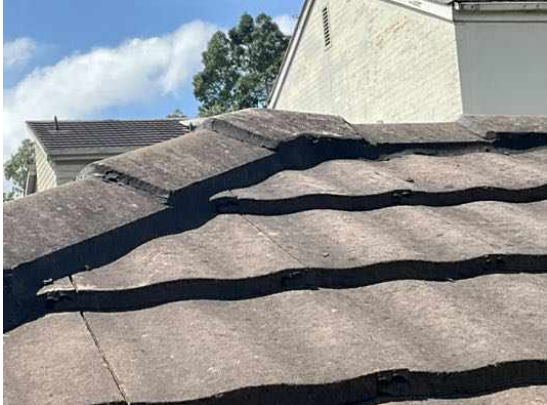
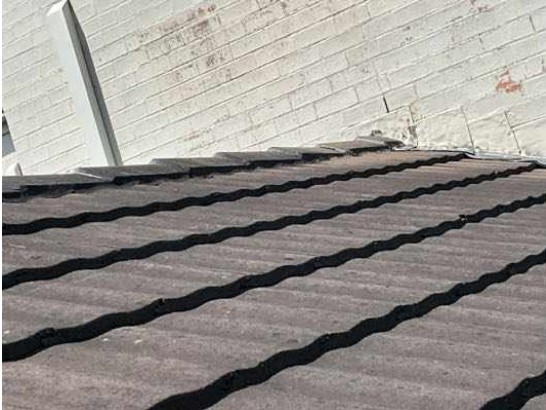
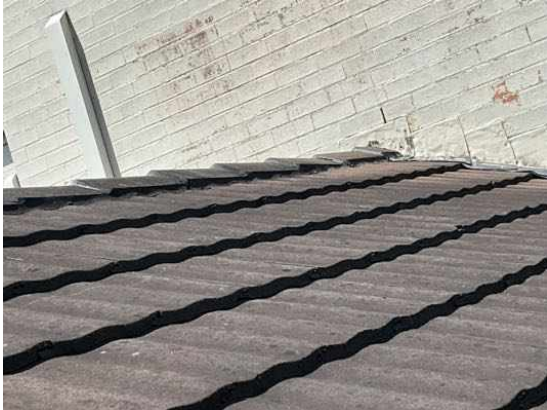
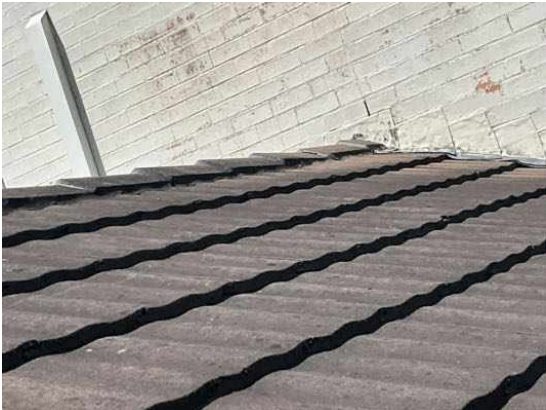
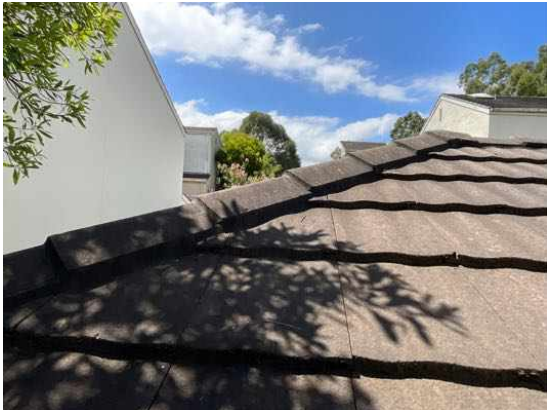
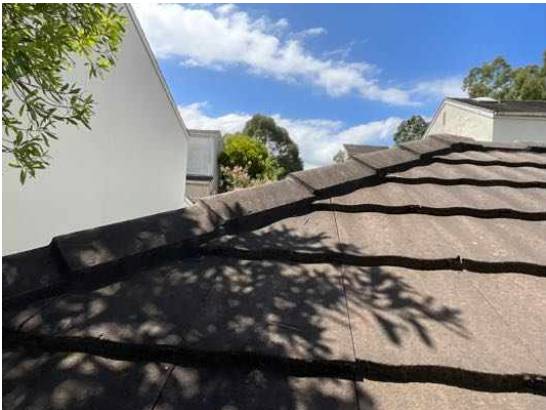
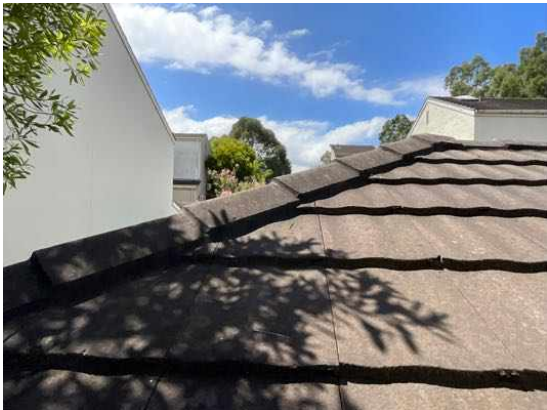
### Finding 3.05

Building:	Main Building
Location:	Roof Exterior
Finding:	Roof Weathered
Information:	Upon inspection of the exterior roofing, the majority of roof was not in a fair condition. While weathering of the roof is consistent with the age of the property, maintenance works are required.

Isolated areas of mortar have come loose in the valleys and minor cracking is also present. Re-pointing and re-sealing the may be considered as an interim solution by the client to help preserve and extend the life span of the tiles.

Where left unmanaged, deteriorating roof are likely to lead to a number of secondary defects, including minor water leaks and weather exposure to internal roofing structures.

Consultation with a roofing contractor is highly advised to gain advice on cost of remedial works that may be required in the short to medium term. Remedial works are likely to increase the longevity of the exterior roofing structure.

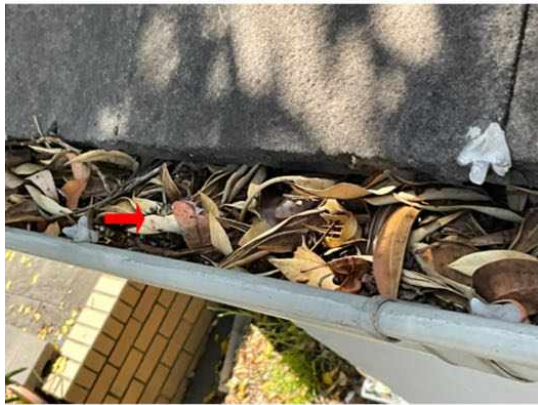
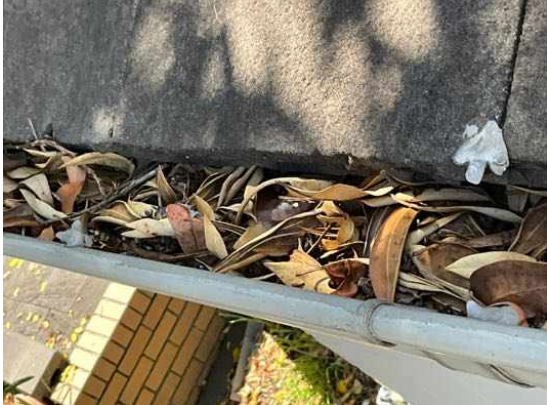
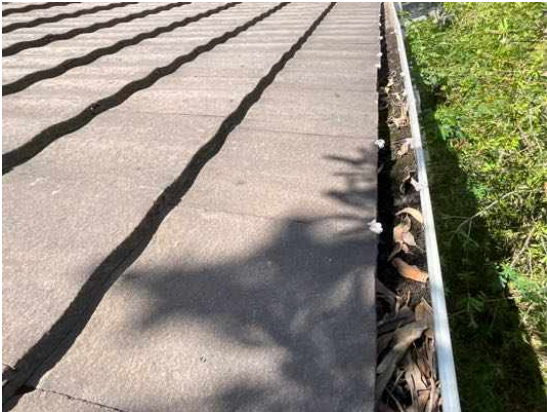
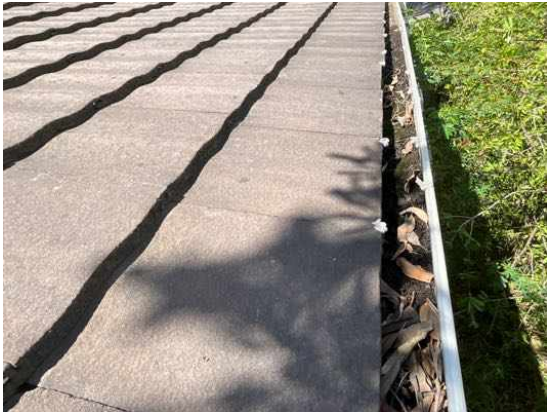
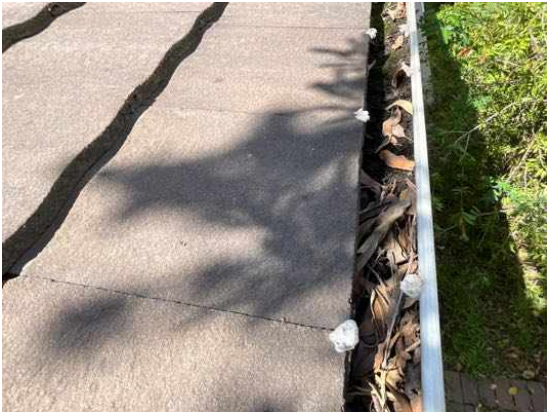
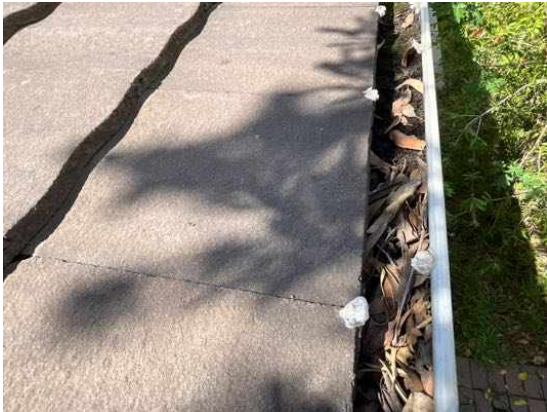
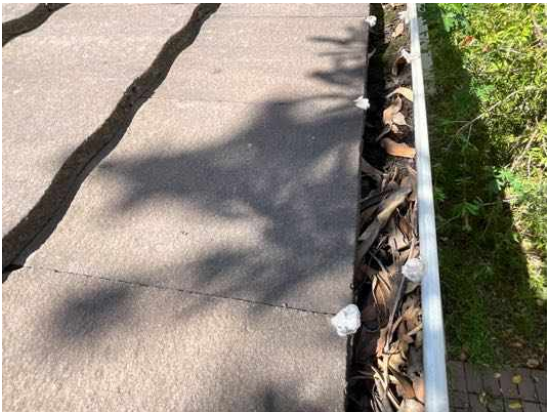
### Finding 3.06

Building:	Main Building
Location:	Roof Exterior
Finding:	Blocked gutters - organic debris
Information:	The roof gutter system was observed to be blocked with organic debris and moss growth, as evident in the provided images.

- Water ingress into the eaves or walls,
- Timber rot or deterioration of fascia and soffits,
- Accelerated moss and algae growth, promoting further blockages,
- Potential foundation issues if water pools near the base of the structure.

A licensed roofing contractor or qualified gutter cleaning service should be engaged to remove the debris and inspect the system for any further issues.

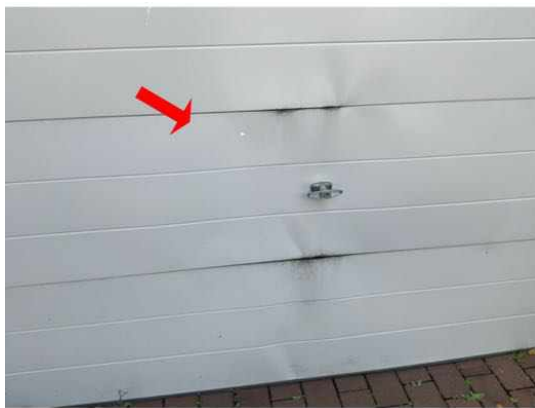
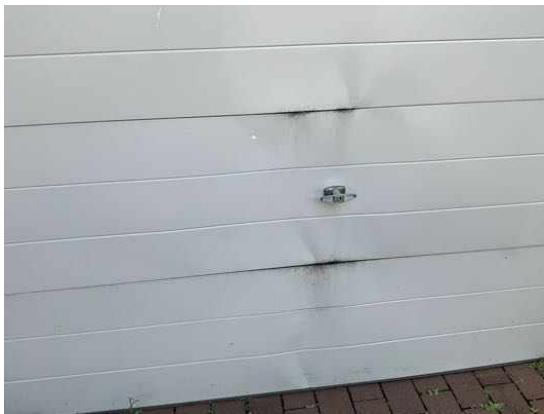
Finding 3.07

Building: Main Building  
 Location: Garage  
 Finding: Minor Dent on Garage Door  
 Information: A minor dent is visible on the lower section of the garage door. It does not affect how the door works but does impact its appearance.

A garage door technician or handyman can repair or replace the panel if needed.

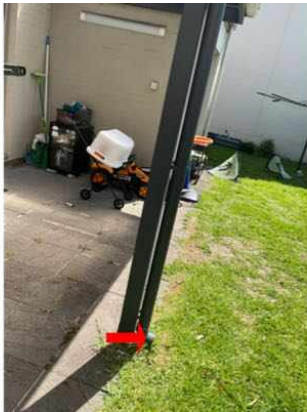
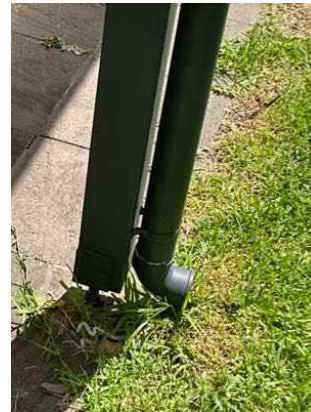
### Finding 3.08

Building: Main Building  
 Location: Pergola  
 Finding: Disconnected downpipe  
 Information: A notable defect with a disconnected downpipe, compromising the efficient drainage of rainwater from the roof. This disconnectivity poses an increased risk of water accumulation, potentially leading to foundation erosion, water damage to the property, and a conducive environment for mold growth.”

1. Foundation Erosion: Accumulated water around the foundation due to the disconnected downpipe can lead to soil erosion, jeopardizing the stability of the property's foundation.
2. Water Damage: Uncontrolled water runoff can result in water penetrating the building envelope, causing interior water damage to walls, ceilings, and other structural components.
3. Mold Growth: The presence of excess moisture provides an ideal environment for mold growth, posing health risks and necessitating costly remediation.

Engage a qualified and licensed roofing or gutter specialist to address the disconnected downpipe. This professional will reconnect the downpipe to ensure proper water drainage, mitigating the associated risks and preserving the integrity of the property.

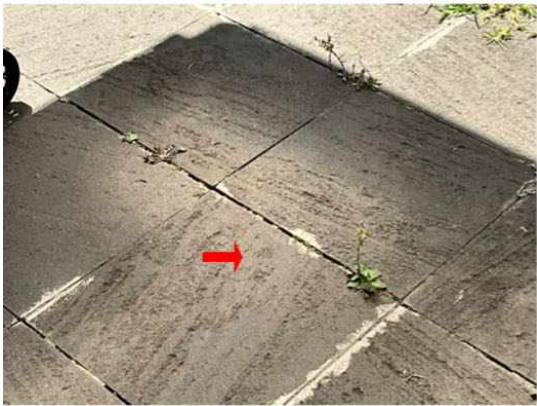
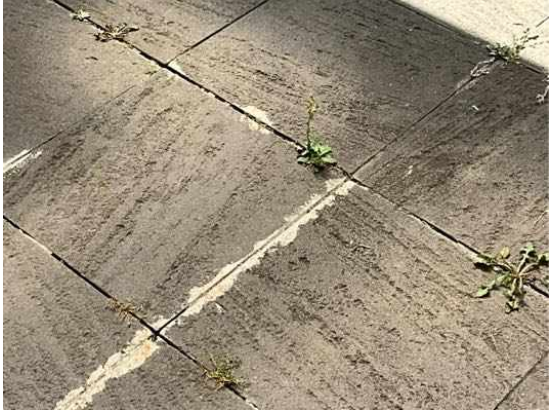
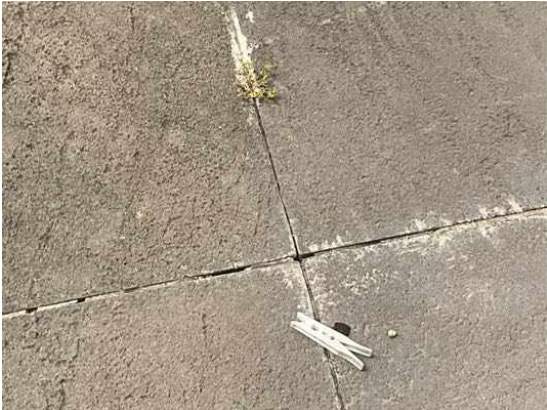
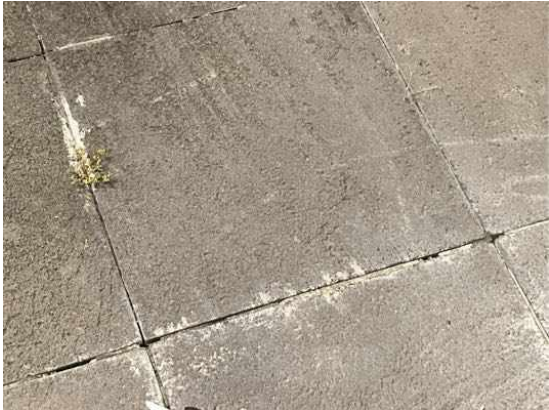
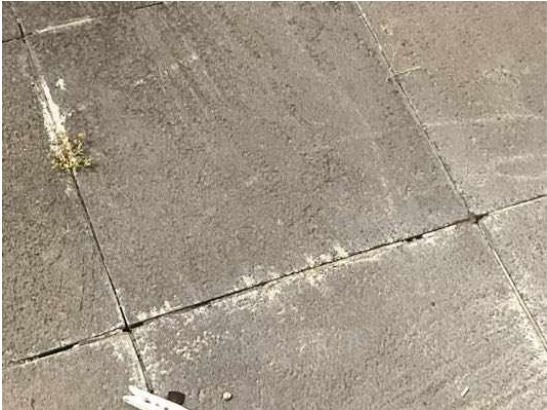
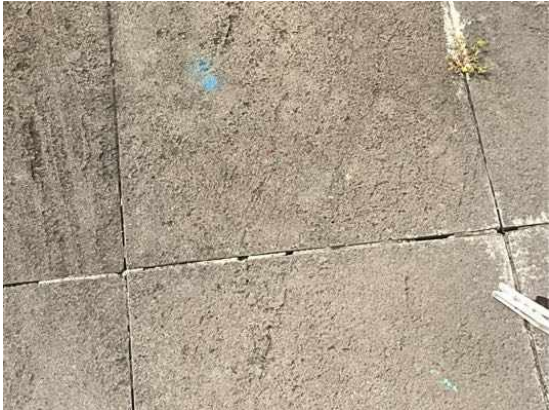
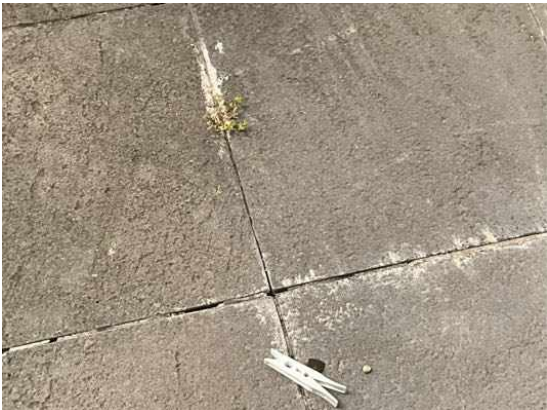
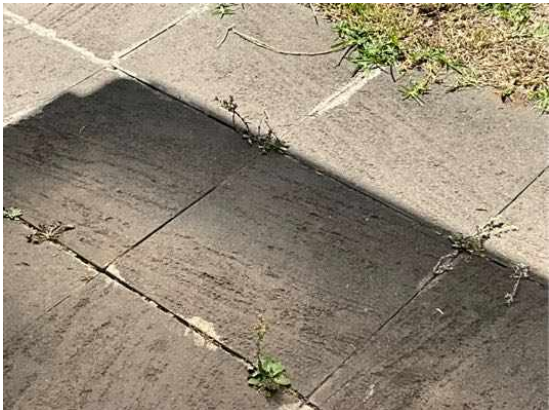
### Finding 3.09

Building:	Main Building
Location:	Pergola
Finding:	Grouting - Missing or damaged
Information:	It was noted on inspection that sealant or grout is Missing or damaged. A flexible sealant is required to allow for expected expansion and contraction, while keeping the joint water tight and protective of all associated building materials.

Flexible and mould resistant materials should be applied to affected areas to prevent any subsequent water damage that is likely to occur. Regular maintenance and replacement of damage or missing or damaged sealant and grout is highly recommended , as this is a regular wear and tear defect.

A sealant specialist or tiling contractor should be appointed to complete these works

as soon as possible

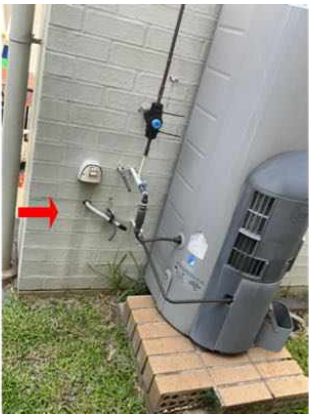
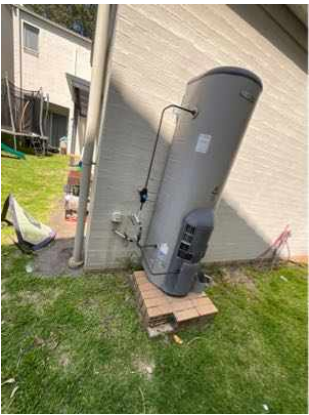
### Finding 3.10

Building:	Main Building
Location:	Garage
Finding:	HWS Overflow - Not Connected
Information:	The Hot Water System (HWS) overflow was found to be disconnected from storm water drainage and is creating excessive moisture in the surrounding area.

These damp conditions can lead to secondary defects such as rot, rust or corrosion of associated building elements, the formation of fungal decay, or even the creation of potential slip hazards. When coupled with poor site drainage, pooling of water may also attract termite activity to this area.

It is highly recommended that a licensed plumber be appointed to connect the HWS overflow in order to prevent such an environment from being created. These minor works should be carried out as soon as possible.

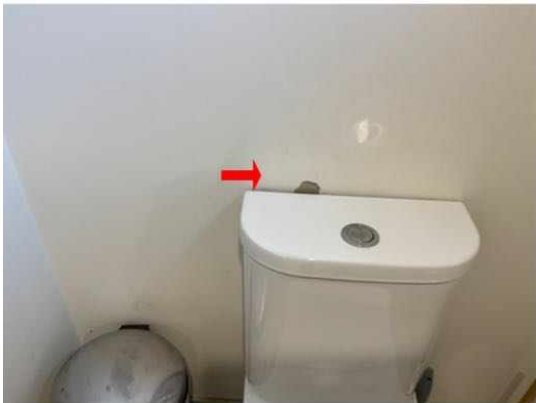
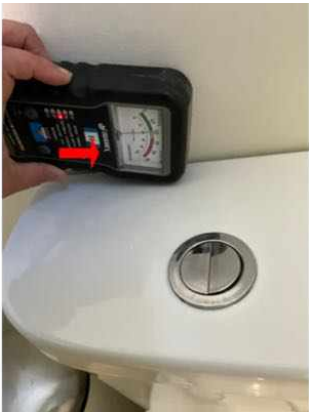
**Finding 3.11**

Building: Main Building  
Location: Toilet (WC)  
Finding: Evidence of excessive moisture - Drywall  
Information: Excessive moisture is present at the time of , indicating a potential water leakage issue within the wall.

The prolonged presence of moisture can lead to mold growth, deteriorate the structure, and create an environment conducive to health hazards. Additionally, it may compromise the adhesive holding the tiles, leading to their detachment.

A licensed plumber or a qualified contractor specializing in water damage remediation should investigate the source of the moisture, fix any leaks, and address the damage. Additionally, replacing affected tiles and ensuring proper waterproofing are crucial to preventing future issues.

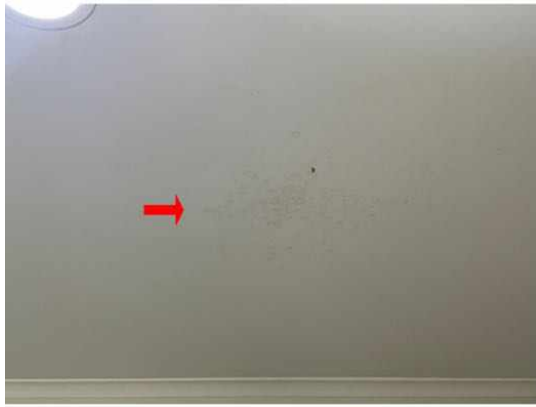
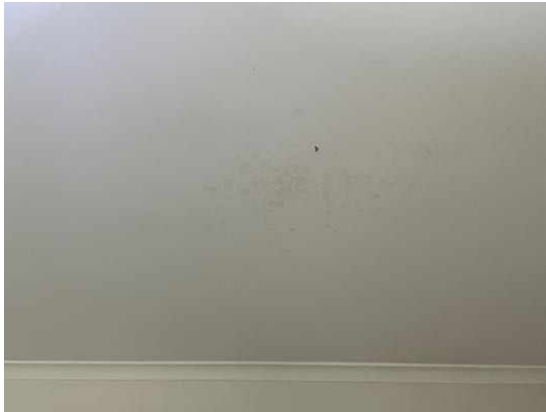
### Finding 3.12

Finding: Water staining

Information: Water staining was evident in this area at the time of inspection. Water staining indicates that surfaces have been exposed to excessive moisture over time. The minerals and other elements in the water lead to staining, which may graduate to corrosion and deterioration if left unmanaged.

While mostly an appearance defect, water staining can be indicative of more serious defects, which may be currently concealed by other building elements.

Where water staining is active, a licensed plumber must be consulted to identify the cause of the staining and to provide advice on any reparation works that may be required. Replacement of any broken or damaged structures is advised.

Conversely, where water staining is old and inactive, affected building materials may be repaired or replaced at client discretion. A qualified carpenter or registered builder may be appointed to perform these works.

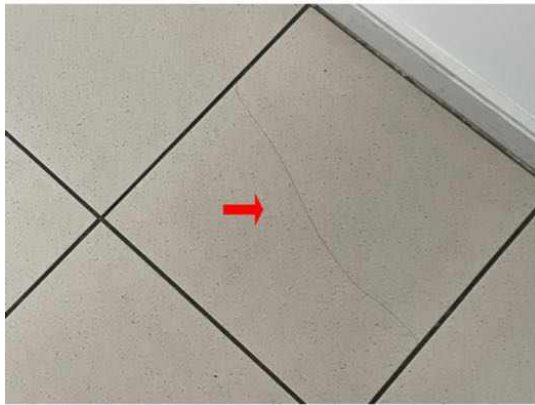
### Finding 3.13

Building: Main Building  
Location: Foyer  
Finding: Floor Tile crack  
Information: A floor tile has a visible crack on the surface.

The damaged tile presents a trip hazard, may lead to cuts if stepped on barefoot, and can allow moisture ingress into the substrate, which may cause further deterioration or loosening of adjacent tiles. It also affects the overall appearance of the floor.

A licensed tiler should be engaged to remove the damaged tile and install a matching replacement. If spare tiles are unavailable, additional remedial work may be required to blend the repair with surrounding finishes.

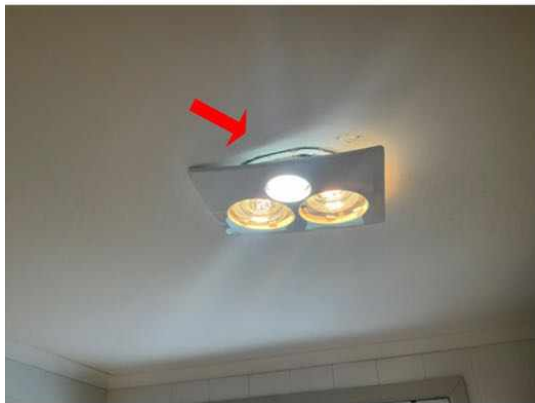
### Finding 3.14

Building: Main Building  
 Location: Bathroom  
 Finding: Poor workmanship  
 Information: The structure exhibits signs of poor workmanship, evident in various aspects of construction and finishing.

Risk: Poor workmanship poses a range of risks, including compromised structural integrity, potential safety hazards, and a decreased lifespan of the structure. It may also lead to aesthetic and functional issues.

Resolution: A qualified contractor or construction professional should be consulted to assess and address the poor workmanship. They can implement corrective measures to ensure structural soundness, safety, and overall quality of the construction.

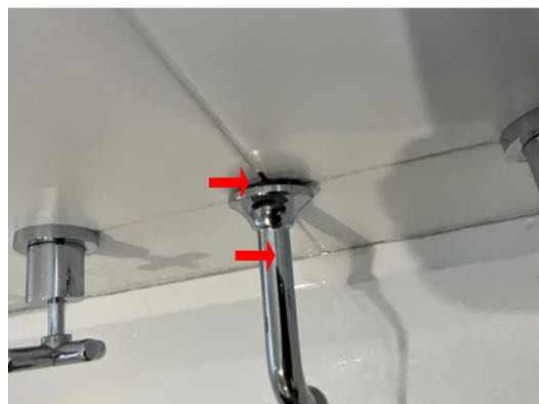
### Finding 3.15

Building: Main Building  
 Location: Bathroom  
 Finding: Leaking plumbing fitting  
 Information: Leaking plumbing fitting identified, posing the risk of water damage and increased water bills.

Potential structural damage, mold growth, and wastage of water resources.

Engage a licensed plumber to inspect and repair the leaking plumbing fitting, ensuring a proper seal and preventing any further water-related issues.

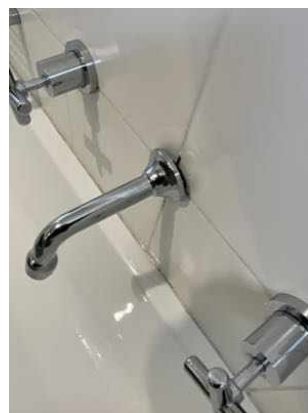
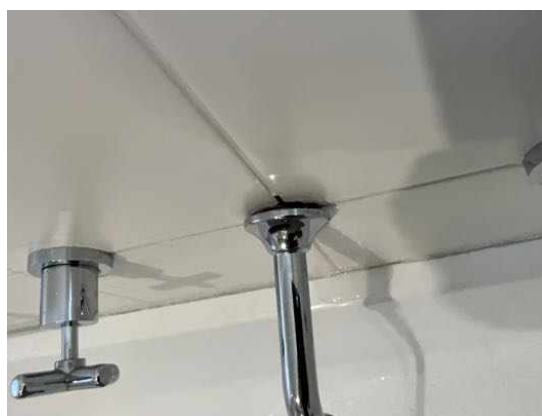
### Finding 3.16

Building:	Main Building
Location:	Bathroom
Finding:	Sealant and grouting - Missing or damaged
Information:	It was noted on inspection that sealant or grout is degraded to the tiled shower alcove and or other areas of the bathroom.

Different materials and floor areas move at different rates, generally causing cracking to grout or sealant at this point. A flexible sealant is required to allow for expected expansion and contraction, while keeping the joint water tight and protective of all associated building materials.

There appears to be excessive mould to the sealant and grout which will likely require scraping out and replacement.

Flexible and mould resistant materials should be applied to affected areas to prevent any subsequent water damage that is likely to occur. Regular maintenance and replacement of damage or missing or damaged sealant and grout is highly

recommended to the wet areas, as this is a regular wear and tear defect. Sealant and grouting in areas that come into regular contact with water should be maintained for the long term care of your property.

A sealant specialist or tiling contractor should be appointed to complete these works as soon as possible

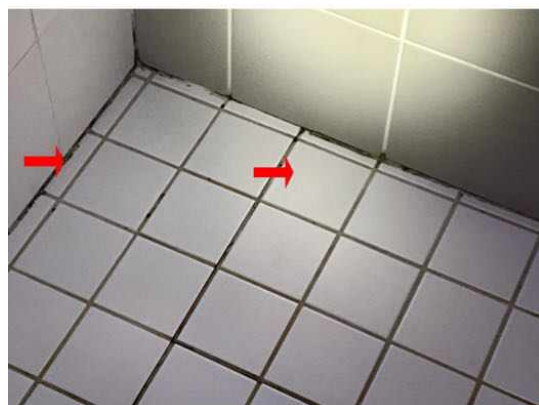
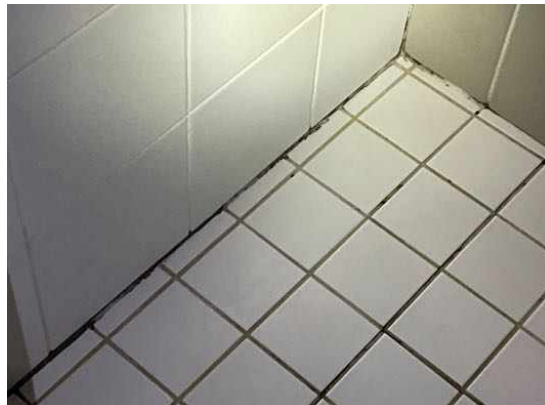
### Finding 3.17

Building: Main Building  
Location: Bathroom  
Finding: Shower - Damp

Information: Damp is evident to the lower 300mm of wall to the shower alcove. This defect is quite common, and is suspected to have been caused by moisture permeating through the grouting in this area, which shows evidence of deterioration. Leaking pipes within the adjoining wall is also a possible cause.

Damp (or structural damp) refers to the presence of unwanted moisture in the structure of a building, either as the result of intrusion from outside, or condensation from within the structure. In the shower area, internal water leaks or other sources of excessive moisture are generally the cause of damp.

Unmanaged damp in the shower recess is likely to facilitate the formation and development of mould and fungi growth, decaying associated building materials and compromising their structural integrity. It is important to address damp conditions, as the World Health Organisation notes that excess moisture leads - on almost all indoor materials - to growth of microbes such as moulds, fungi and bacteria, which subsequently emit spores and other matter into the indoor air. Exposure to these contaminants is associated with a wide range of respiratory and other health-related problems.

Consultation with a qualified plumber or bathroom specialist is advised immediately to identify the cause of damp and to perform remedial works as required. Where excessive mould growth is present, further inspection by a specialist environmental health inspector should also be considered.

Always ensure that sealant and grout is in good condition to prevent any moisture issues occurring in the future.

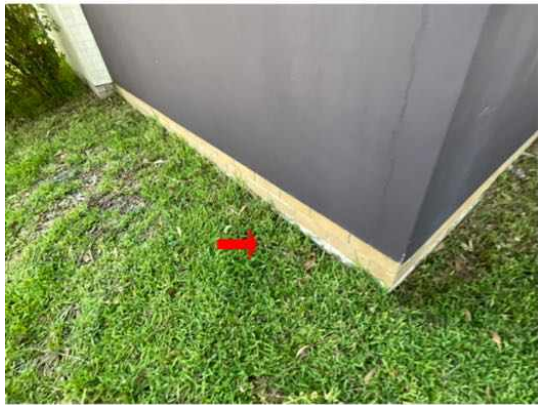
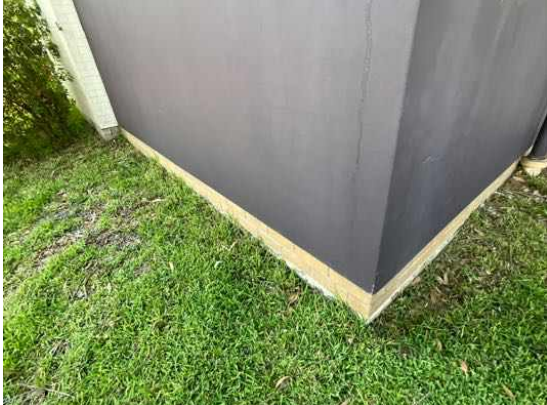
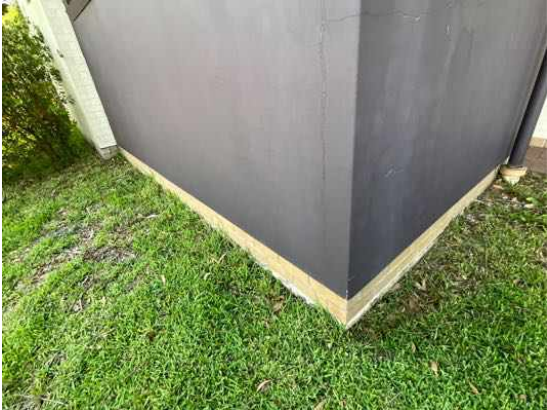
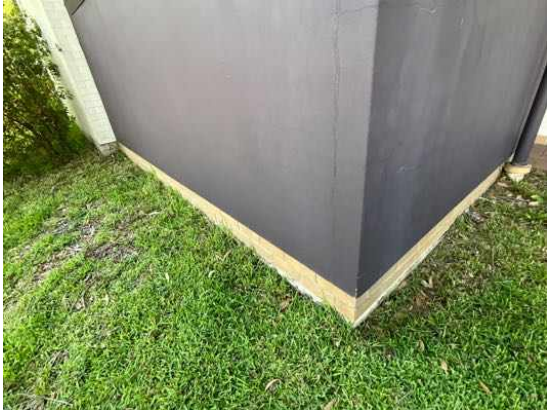
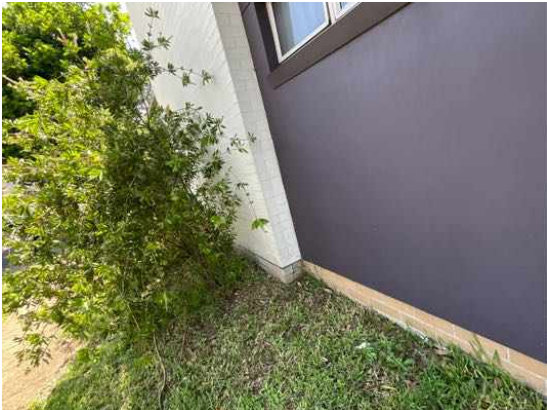
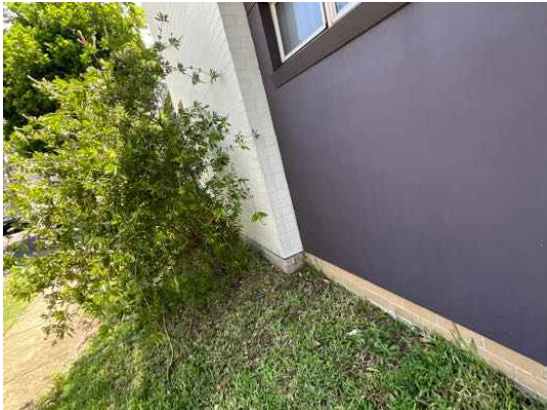
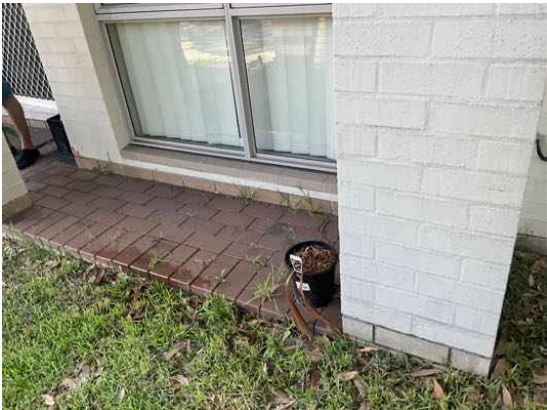
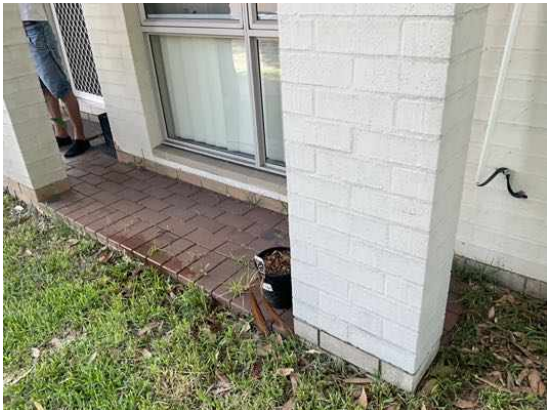
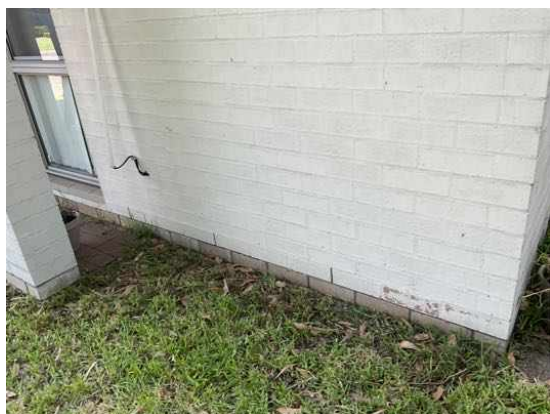
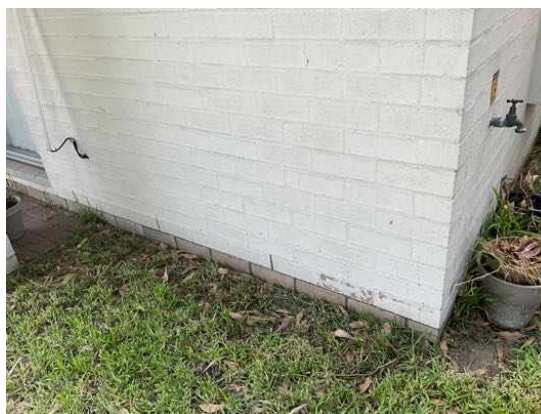
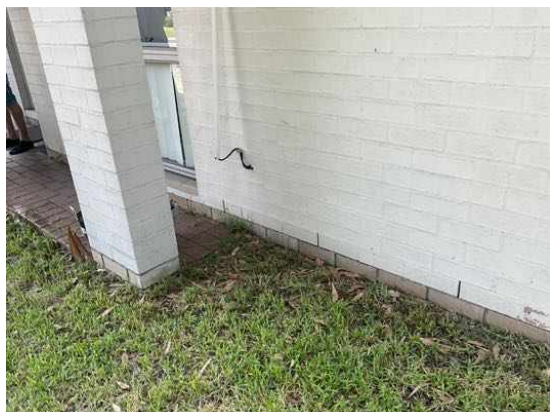
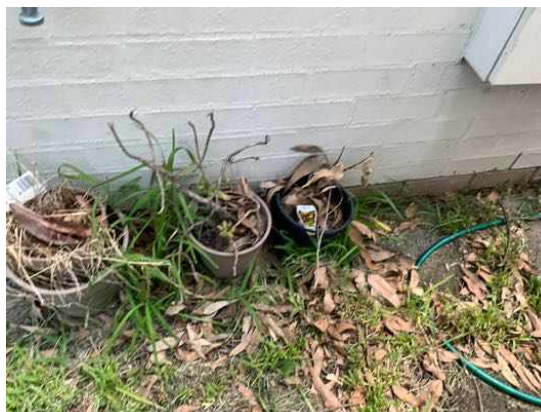
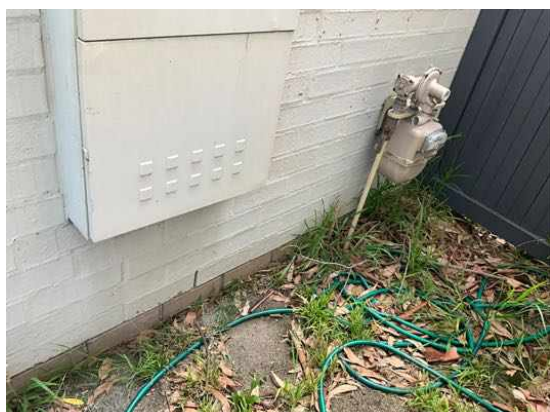
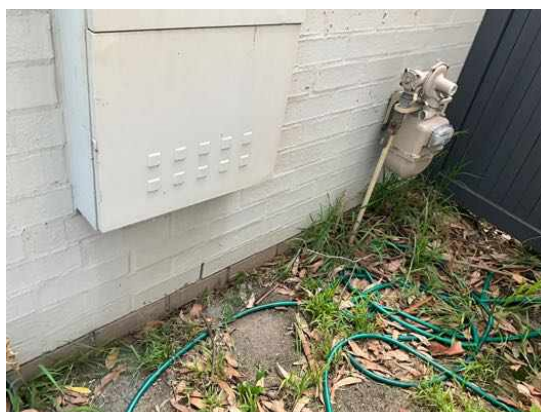
If the slab edge is not properly exposed there is a high risk of termite attack. Sometimes, in order to determine the type of slab, a suitably qualified person such as an architect or builder may be required to consult the construction plans.

Where the slab edge cannot be properly inspected, it is highly recommended that termite or timber pest inspections be carried out every 6-12 months to aid protection of the property against infestation.
