# Building and Timber Pest Inspection Report

Inspection Date: Thu, 19 Feb 2026

Property Address: 8 Pereira St, Newington NSW 2127,  
Australia

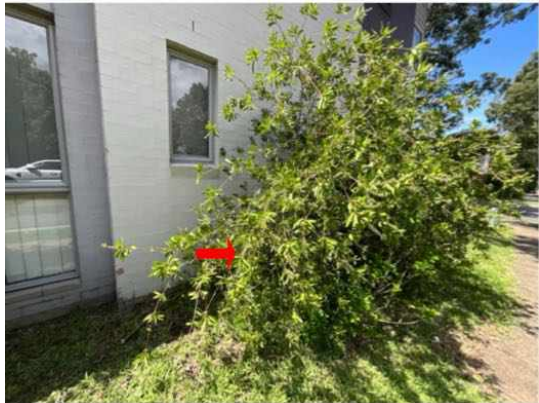
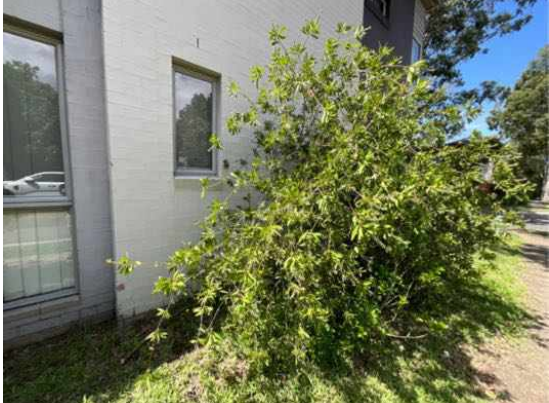
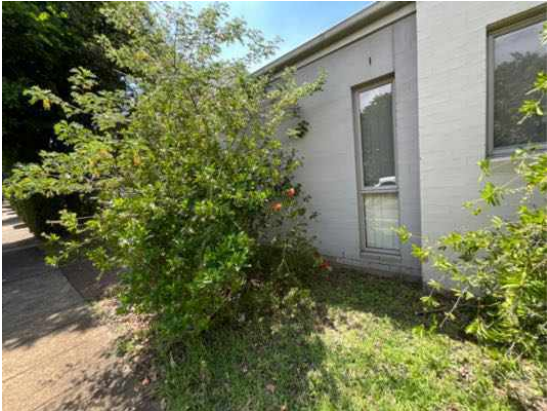
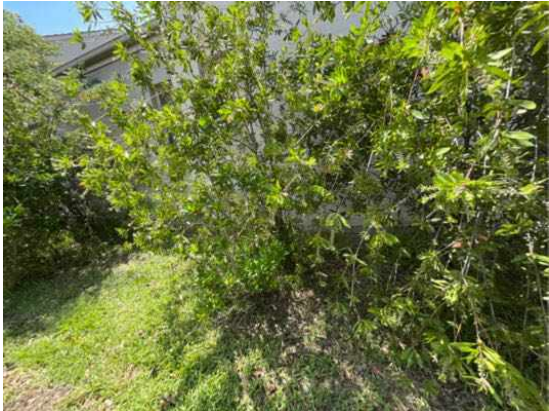
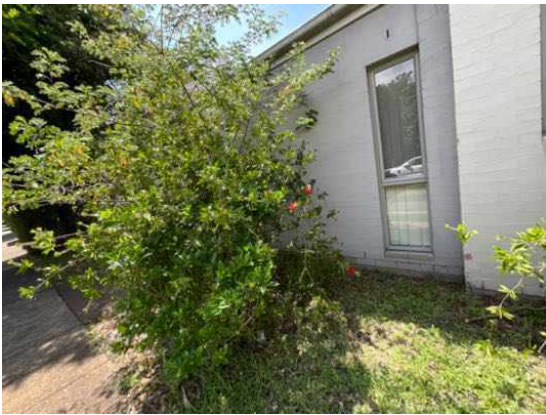
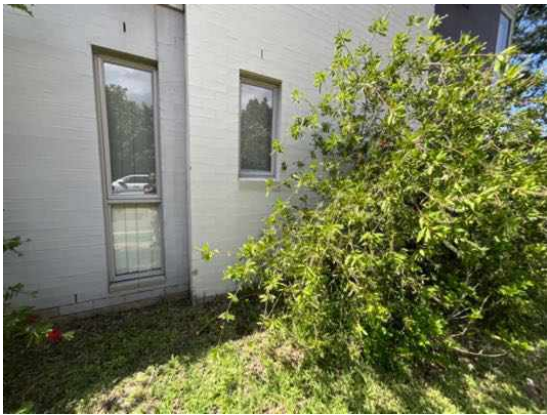
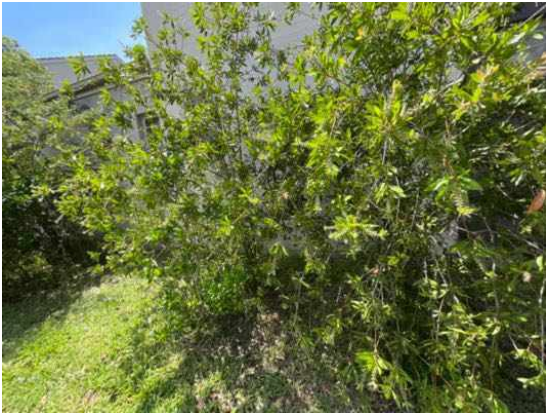
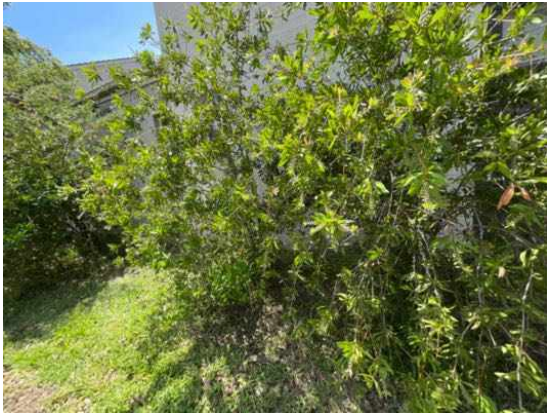
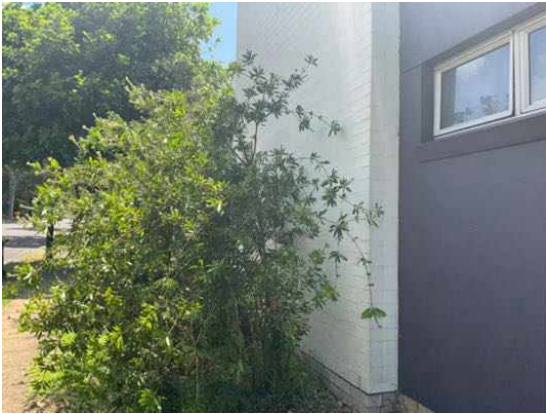
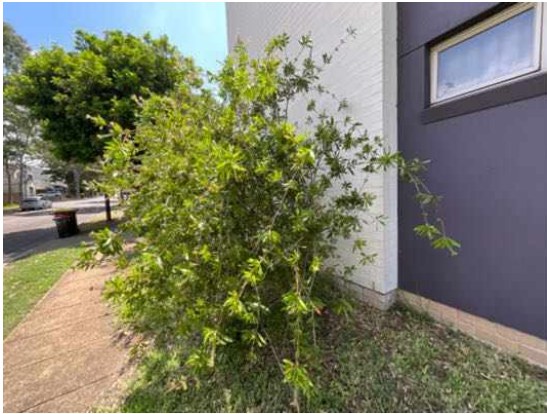
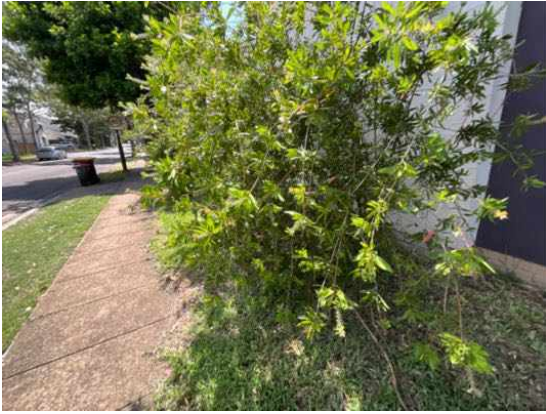
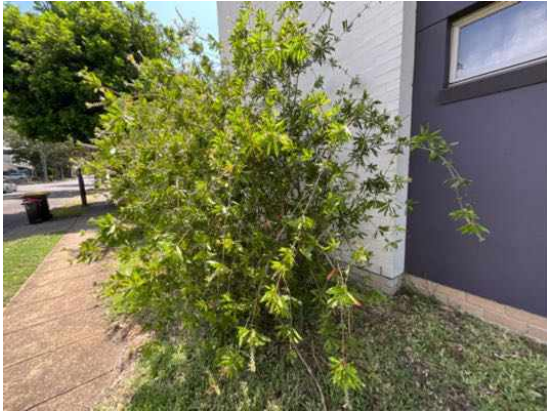
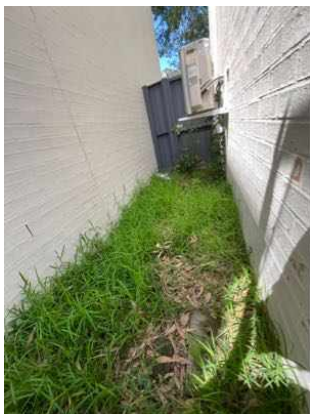
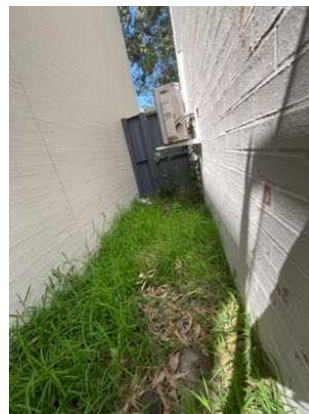
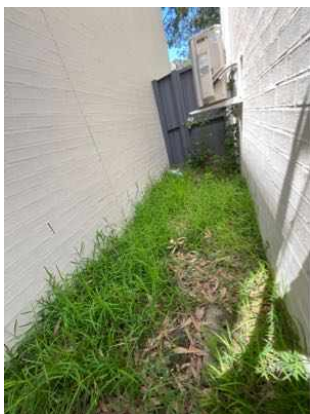
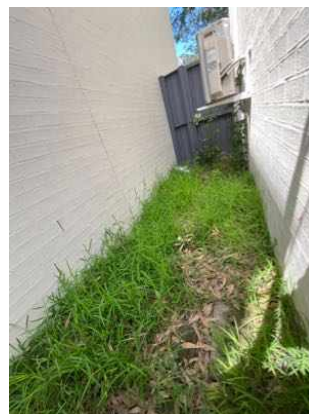
**Finding 6.03**

Building: Main Building  
Location: All Areas  
Finding: Dense vegetation around a property can increase the risk of termite infestation  
Information: The presence of dense vegetation around a property can increase the risk of termite infestation, as it provides a conducive environment for them. To address this, consider maintaining a clear space between the vegetation and your home. If you suspect a termite issue, it's advisable to consult with a licensed pest control professional for inspection and treatment.

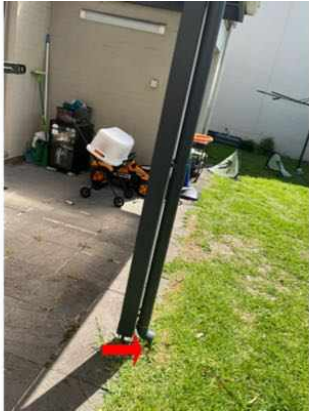
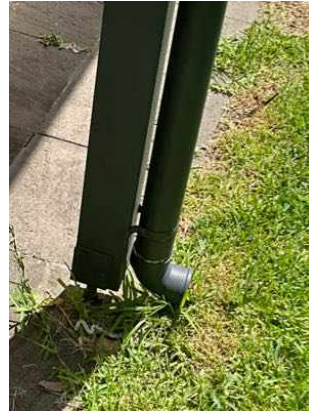
### Finding 6.04

Building:	Main Building
Location:	Pergola
Finding:	Downpipes not connected- Conducive conditions for timber pest
Information:	<p>Unconnected downpipes can indeed pose a risk for attracting termites, as they provide a source of moisture near a building's foundation. Termites are attracted to moisture and wood, so it's important to address this issue to prevent potential infestations. Connecting downpipes to the stormwater system or ensuring proper drainage away from the building can help mitigate this a licensed plumber is the most qualified professional to handle plumbing-related tasks, including connecting downpipes to the stormwater system. They have the necessary expertise and tools to ensure proper installation.</p>

Please remember that proper installation is essential to ensure effective drainage and prevent future issues, so it's often best to hire a qualified professional, especially for complex or extensive downpipe installations.

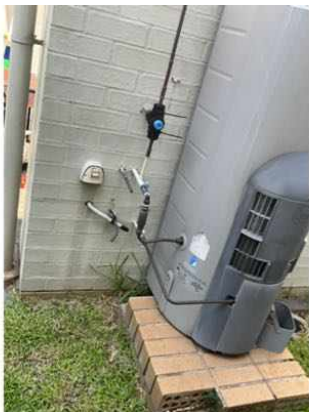
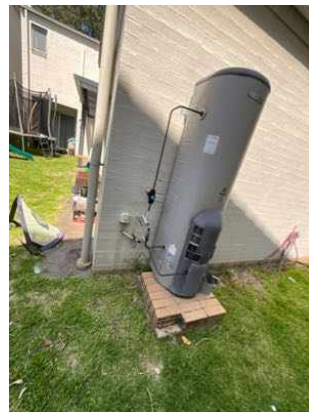
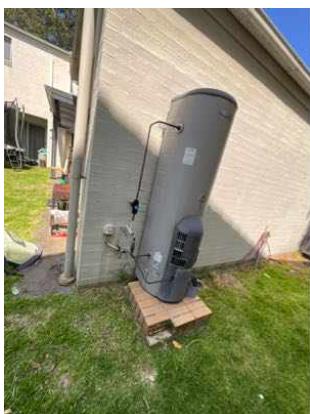
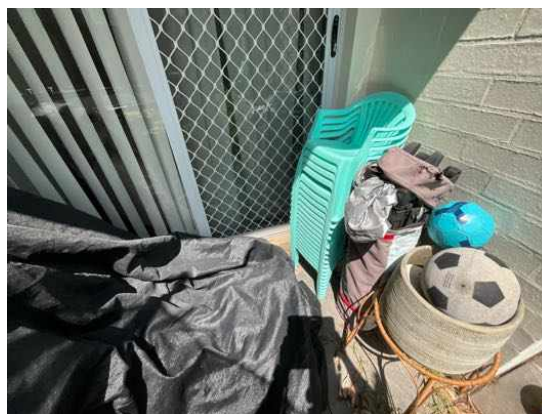
### Finding 6.05

Building:	Main Building
Location:	All Areas
Finding:	Bridging or Obstruction Conducive environment for Termites
Information:	Bridging of termite barriers occurs when termites bridge (usually by building a mud tunnel) a termite barrier or inspection inspection zone or where termites have a passage, allowing them to bridge the barrier.

Where bridging has occurred full inspection is prevented and termites may enter a property in a concealed or undetected manner.

Recommended moving obstructions away from the external walls for further and future inspections.

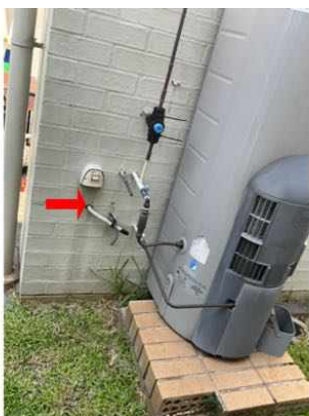
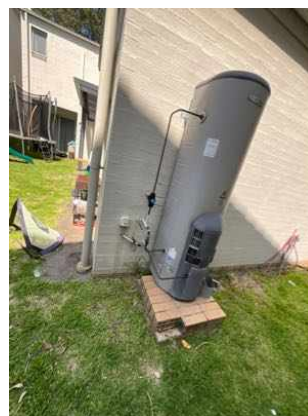
Building:	Main Building
Location:	Garage
Finding:	HWS not connected - conducive conditions for timber pest attacks
Information:	The hot water system (HWS) is not connected, leaving exposed pipes and creating conducive conditions for timber pest attacks.

**Risk of Timber Pest Attack:** The risk of timber pest attack is heightened when the hot water system is not connected. Exposed pipes provide easy access points for timber pests like termites and ants to infiltrate the building structure. These pests are attracted to moisture, and the absence of flowing water through the system can lead to moisture buildup, creating an ideal environment for pests to thrive and cause damage to timber components within the building.

A licensed plumber or qualified plumbing technician should be engaged to reconnect the hot water system. They will assess the existing plumbing infrastructure, determine the appropriate connection points, and ensure proper installation and functionality of the HWS. Additionally, they may inspect for any signs of timber pest activity and recommend preventive measures, such as installing physical barriers or implementing moisture control measures, to deter pest infestations and protect the building from damage. Regular maintenance and inspections by homeowners or property managers are also essential to detect and address potential issues before they escalate.

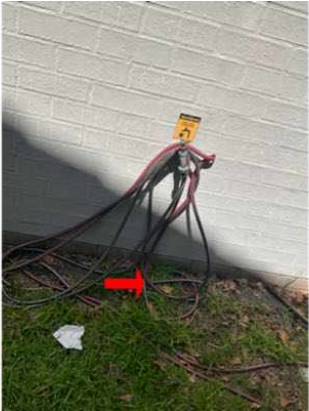
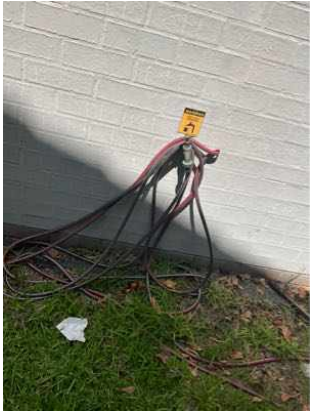
## Finding 6.07

Building:	Main Building
Location:	All Areas
Finding:	No Drain under tap
Information:	There is no drain installed under the tap, leading to water accumulation and creating conducive conditions for timber pests. This defect needs immediate attention to prevent potential damage and pest infestation.

1. Water Accumulation: Without proper drainage, water can accumulate around the base of the tap, leading to persistent dampness in the surrounding area.
2. Timber Pest Infestation: The damp environment created by standing water is highly conducive to timber pests, such as termites and wood borers, which thrive in moist conditions and can cause significant damage to wooden structures.
3. Structural Damage: Prolonged exposure to moisture can lead to wood rot and deterioration of structural timber, compromising the integrity of the building.
4. Health Hazards: Persistent dampness can also promote mold and mildew growth, posing health risks to occupants.
5. Aesthetic Damage: Water stains and damage to finishes and materials around the tap area can detract from the appearance of the building and lead to costly repairs.

A licensed plumber or a qualified building contractor can address this defect by:

3. Repair and Prevention: Inspecting and repairing any existing water damage and implementing measures to prevent future water accumulation and pest infestations.

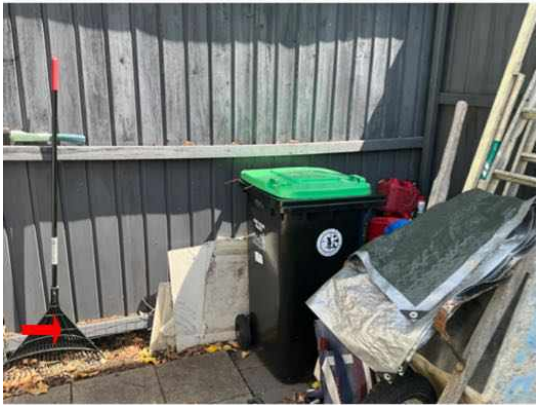
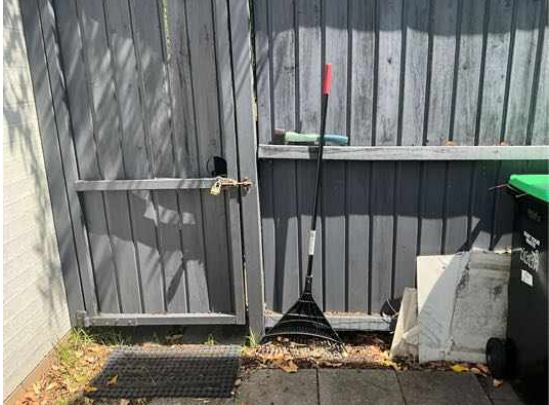
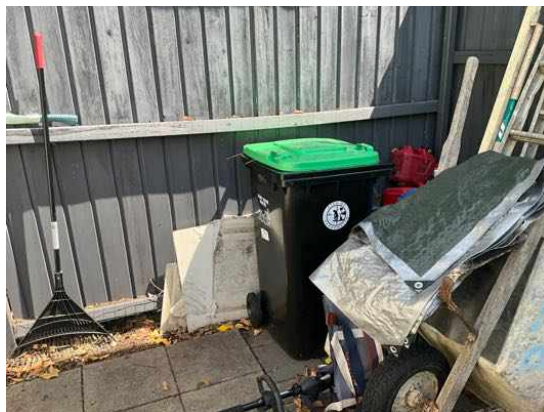
**Finding 6.08**

Building: Main Building  
Location: All Areas  
Finding: Timber on ground / conducive conditions to termite damage  
Information: Timber on the ground is indeed conducive to termite damage. Termites are known to thrive in moist environments, and wood in contact with soil or moisture is more susceptible to infestation.

To prevent this, it's important to keep timber elevated and away from direct ground contact. Regular inspections and proper termite control measures are also essential to protect your wooden structures from termite damage.

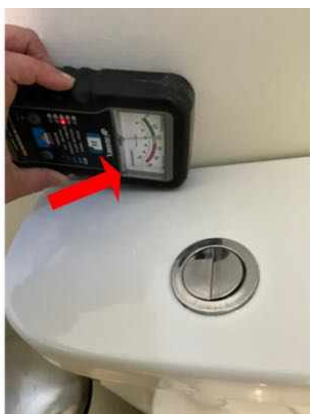
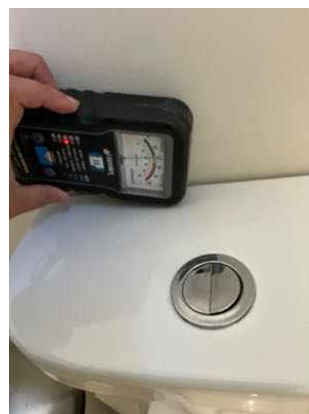
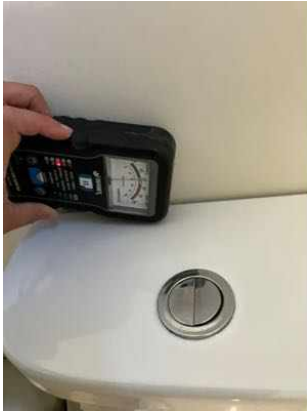
### Finding 6.09

Building:	Main Building
Location:	Toilet (WC)
Finding:	Excessive moisture - Conducive to Timber pest
Information:	Excessive moisture can attract termites and produce conditions that promote fungal growth and wood decay.

Excessive moisture is generally caused by deteriorated inadequate or missing roof drainage leaking plumbing pipes or fixtures poorly plumbed HWS overflows or condenser units and poor site drainage.

Prior to any remedial works being performed a qualified plumber should be appointed to further inspect the property and to identify the cause of the excessive moisture. Works to remove affected building elements may then be necessary and should be performed by an appropriate tradesperson.

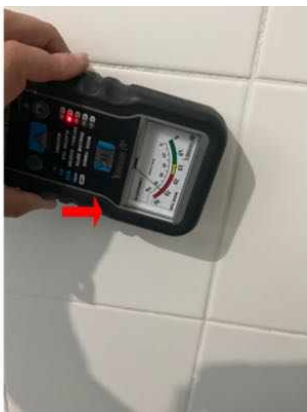
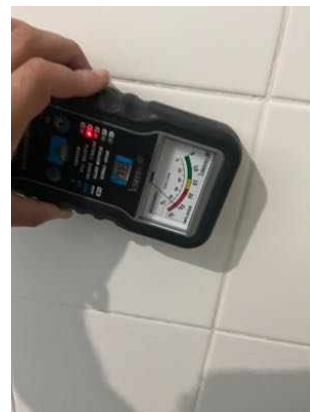
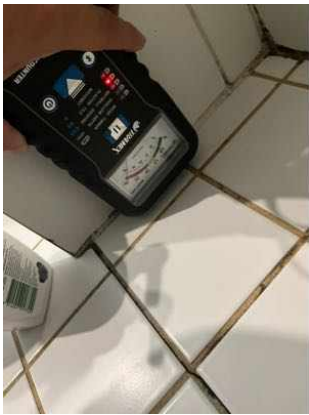
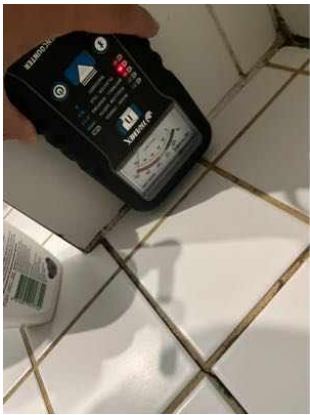
### Finding 6.10

Building:	Main Building
Location:	Bathroom
Finding:	Excessive moisture - Conducive to Timber pest
Information:	Excessive moisture can attract termites and produce conditions that promote fungal growth and wood decay.

Excessive moisture is generally caused by deteriorated inadequate or missing roof drainage leaking plumbing pipes or fixtures poorly plumbed HWS overflows or condenser units and poor site drainage.

Prior to any remedial works being performed a qualified plumber should be appointed to further inspect the property and to identify the cause of the excessive moisture. Works to remove affected building elements may then be necessary and should be performed by an appropriate tradesperson.

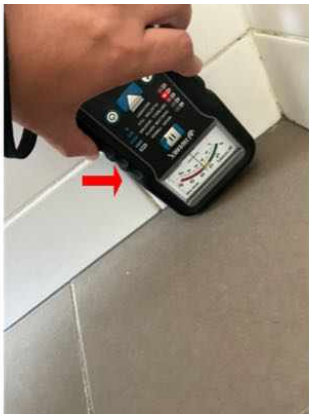
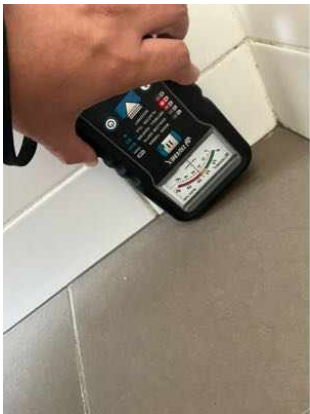
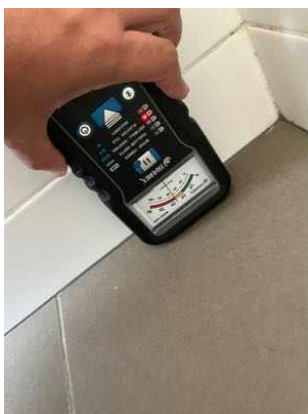
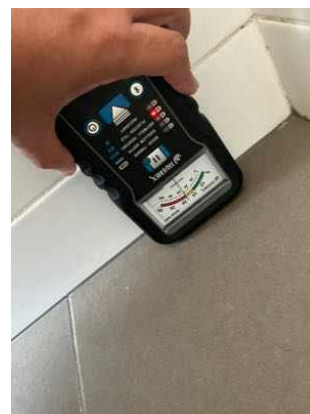
**Finding 6.11**

Building: Main Building  
Location: Ensuite  
Finding: Excessive moisture - Conducive to Timber pest  
Information: Excessive moisture can attract termites and produce conditions that promote fungal growth and wood decay.

Excessive moisture is generally caused by deteriorated inadequate or missing roof drainage leaking plumbing pipes or fixtures poorly plumbed HWS overflows or condenser units and poor site drainage.

Prior to any remedial works being performed a qualified plumber should be appointed to further inspect the property and to identify the cause of the excessive moisture. Works to remove affected building elements may then be necessary and should be performed by an appropriate tradesperson.

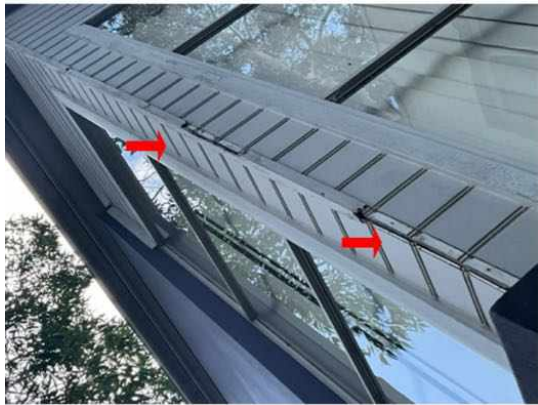
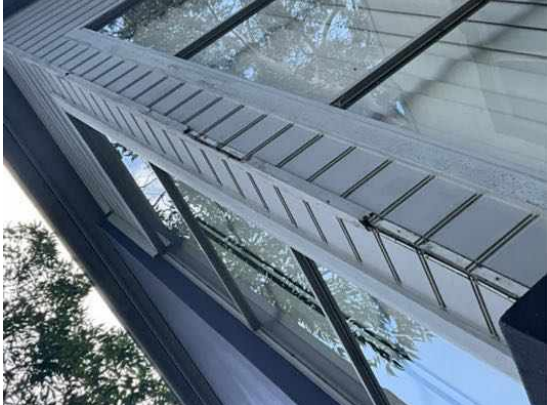
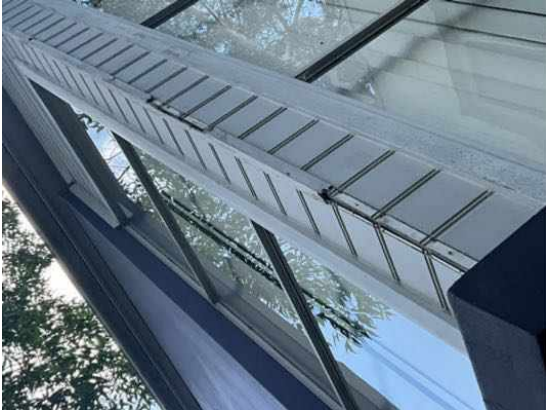
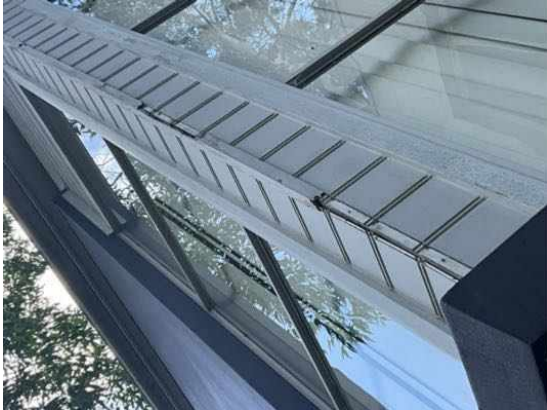
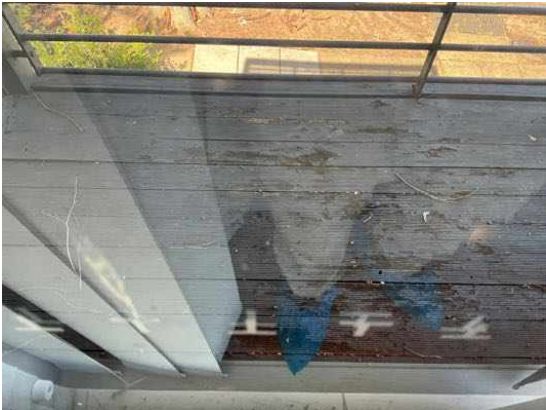
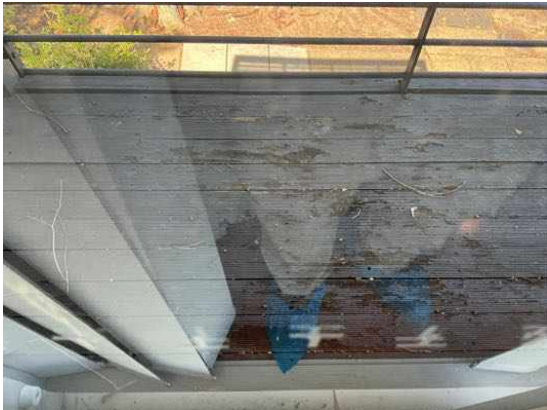
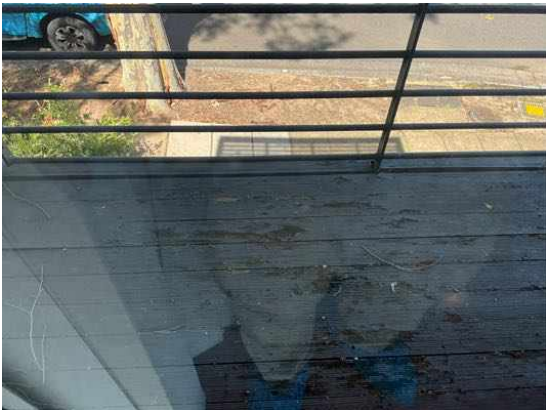
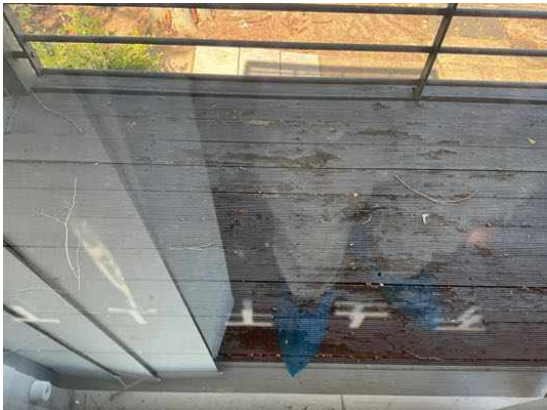
### Finding 7.01

Finding: Wood rot

Information: This building element shows evidence of wood rot. Wood rot, also known as Fungal Decay, occurs when timbers and other cellulose building materials are exposed to damp conditions on an ongoing basis. This could be the result of exposure to weathering over a prolonged period of time, or the attraction of excessive moisture from other abutting building materials. Contributing factors also include poor air ventilation in the area.

Early intervention and regular maintenance, particularly of exterior timbers, will prolong the useful life of these building elements. Prior to any works being performed, the cause of the moisture that has created the visible wood rot should be identified and addressed in a suitable manner. Replacement of affected timbers may then be a necessary step in protecting surrounding building elements from such deterioration.

A qualified plumber may be appointed to assess the cause of excessive moisture and to provide advice on any remedial works as required. A qualified carpenter or registered builder may also be required to replace affected building materials.

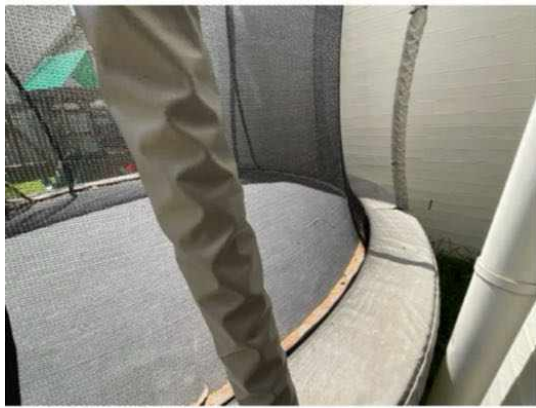
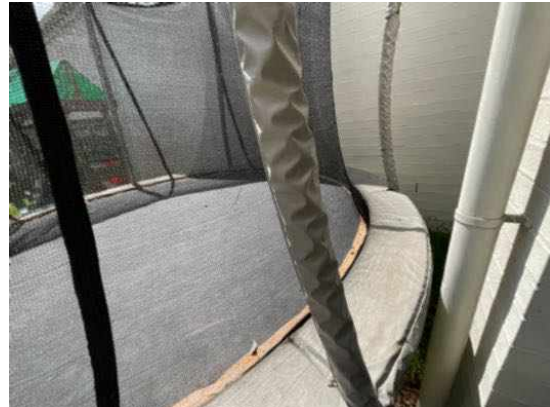
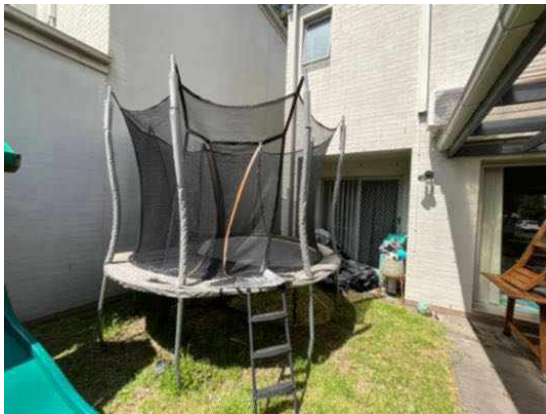
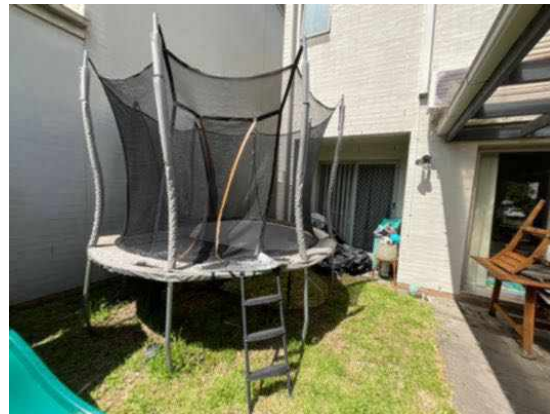
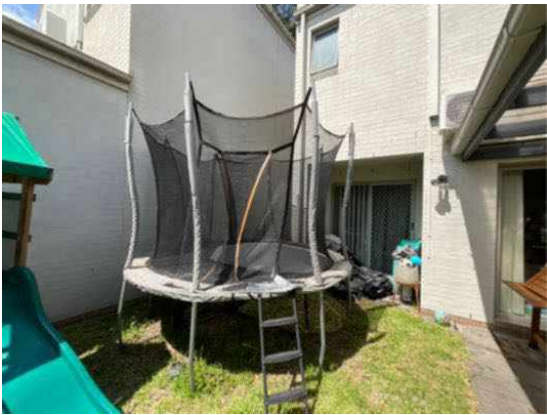
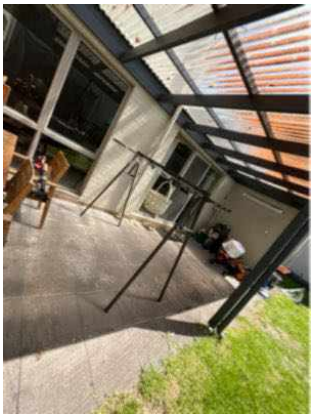
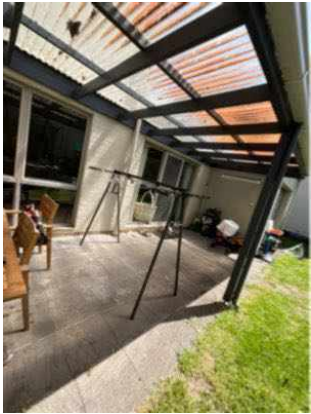
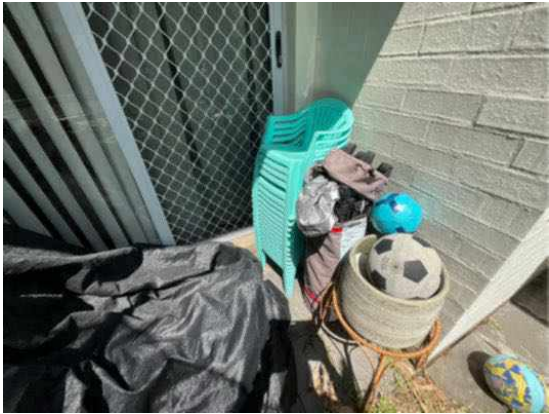
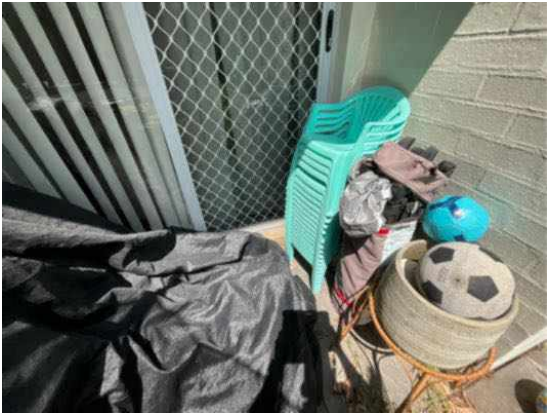
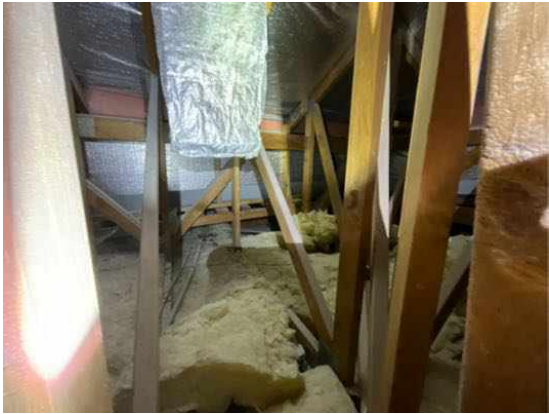
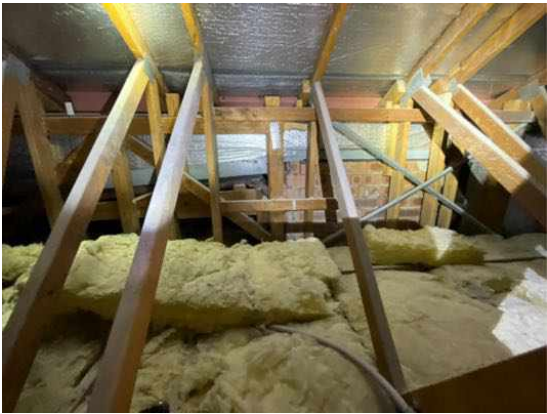
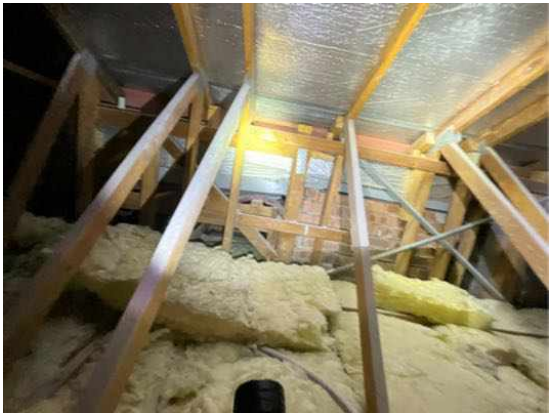
### Noted Item

Building: Main Building  
Location: All Areas  
Finding: Additional Photos - Obstructions and Limitations  
Information: These photographs are an indication of the obstructions and limitations which impeded full inspection of the property at the time of inspection. These obstructions can hide an array of defects and should be removed to allow full inspection to be carried out. A re-inspection is recommended once the areas are made accessible.

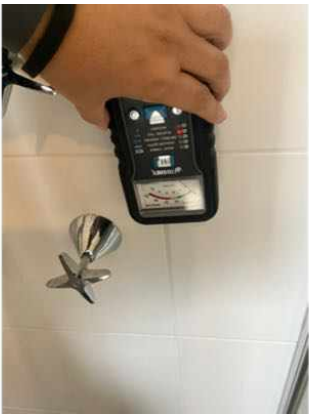
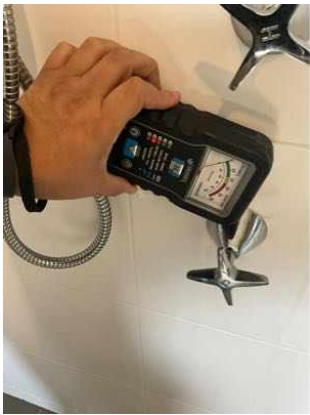
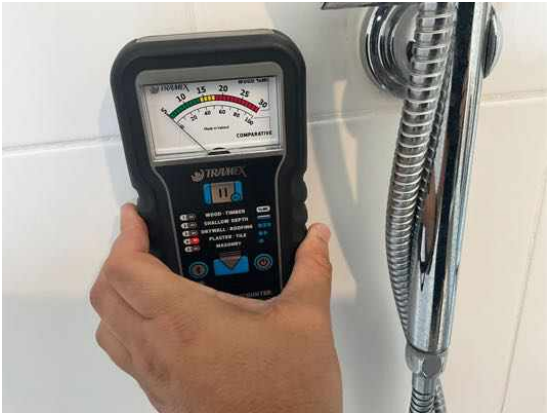
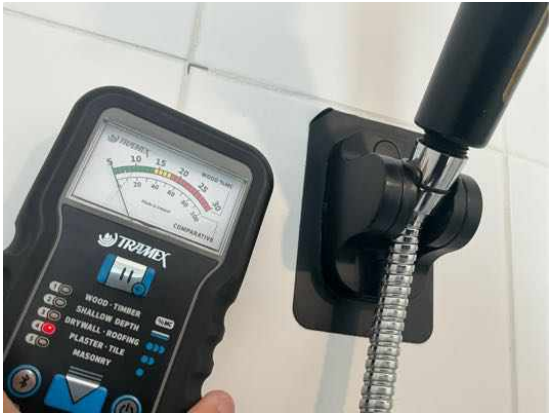
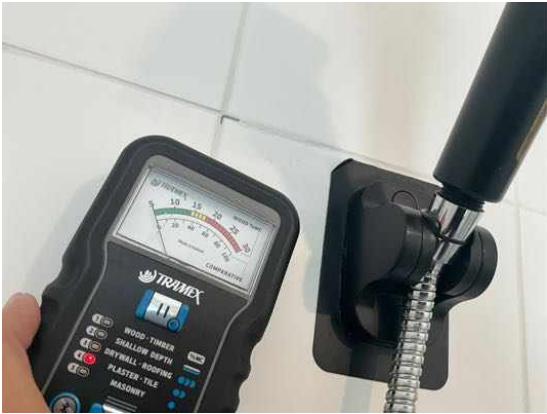
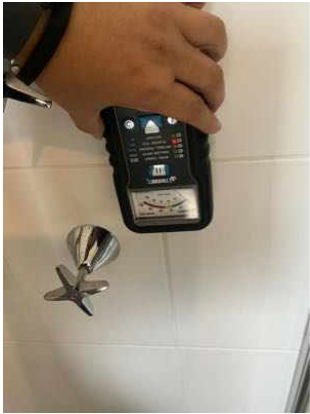
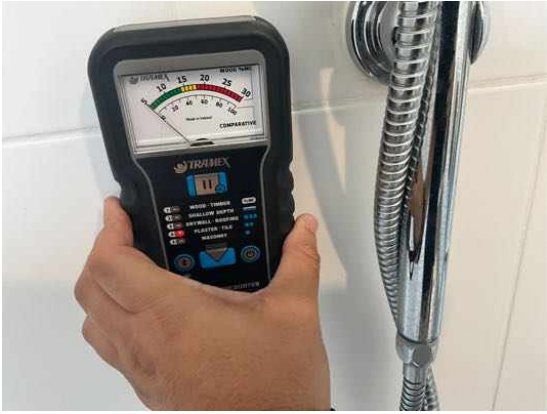
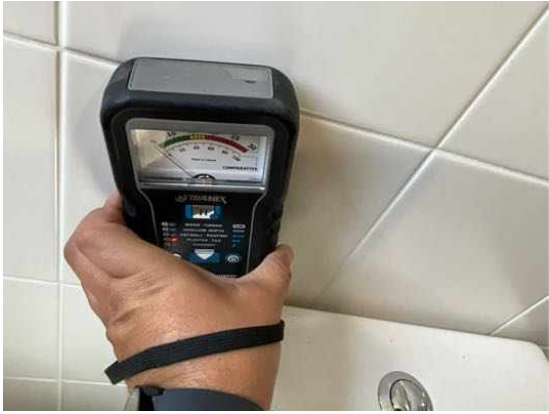
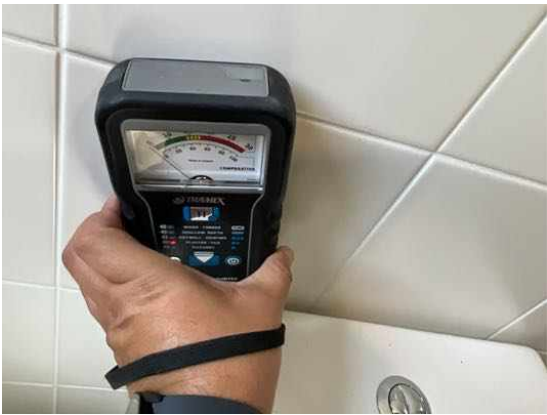
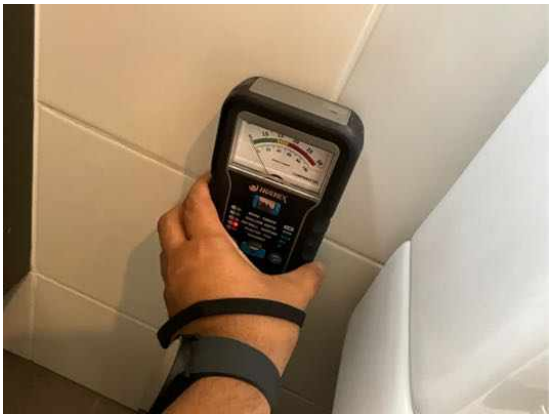
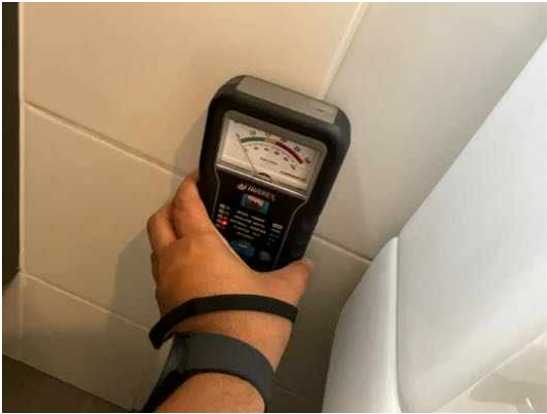
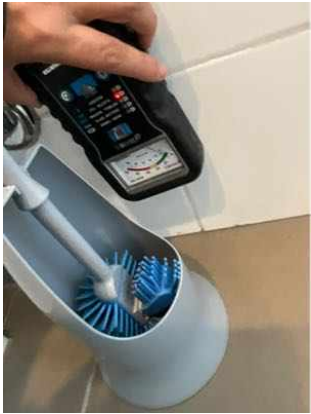
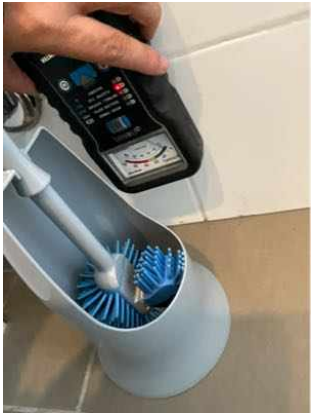
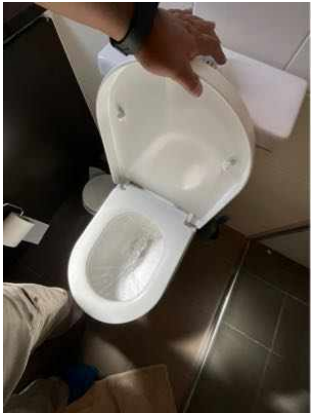
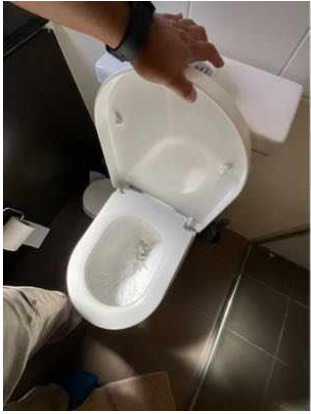
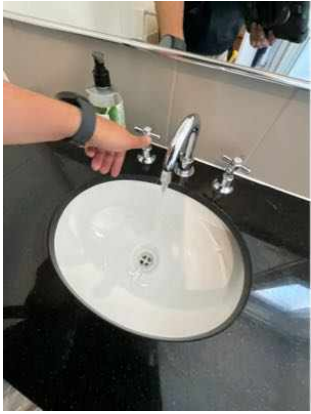
Building: Main Building  
Location: All Areas  
Finding: Additional Photos  
Information: Additional photos are provided for your general reference

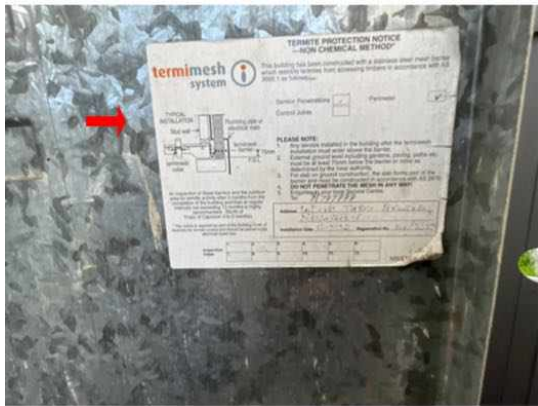
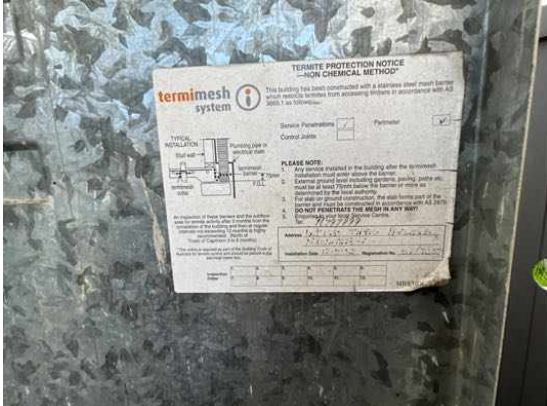
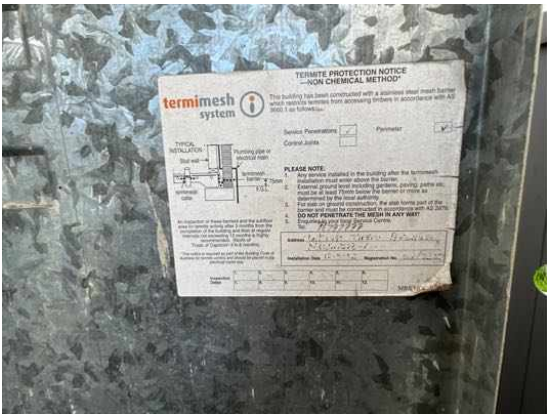
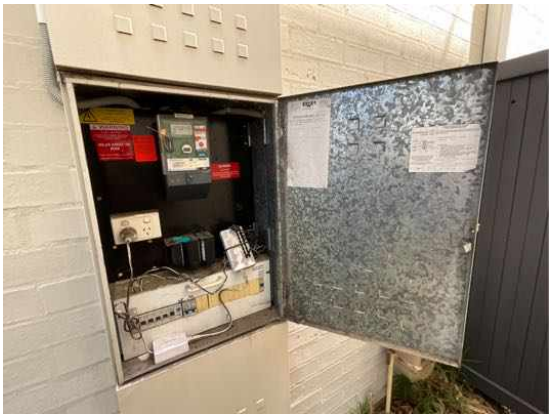
- Building: Main Building
- Location: Exterior walls - right side
- Finding: Evidence of Termite Management System - Durable notice / Legible Sticker - seek further information
- Information: The application of a pre & post-construction chemical termite barrier is highly recommended for all properties. Such barriers are highly effective in preventing termite attack on any timber building elements throughout the property.

A durable notice placed in the switchboard unit to indicate termite barriers at the time of inspection.

Client must seek further information from the vendor or real estate agent if the conditions of termite management systems were maintained as per the label or seek advise from licensed pest controller.
