Building and Timber Pest Inspection Report

Inspection Date: Wed, 1 Apr 2026

Property Address: 147 St Johns Rd, Glebe NSW 2037,
Australia

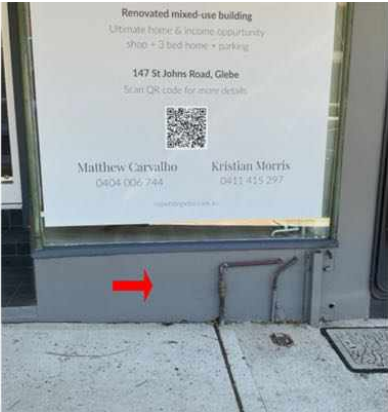
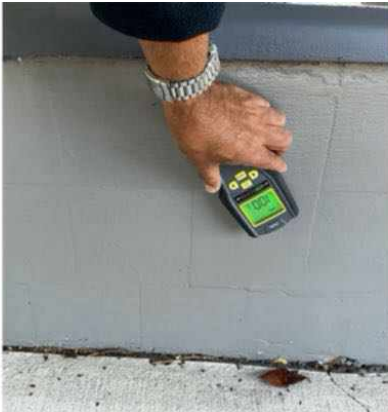
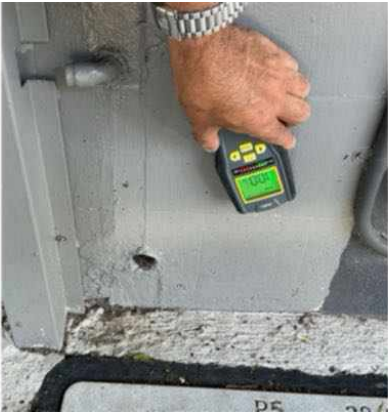
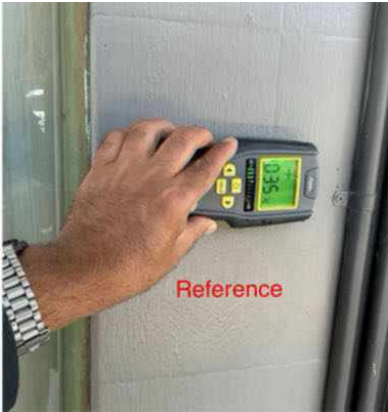
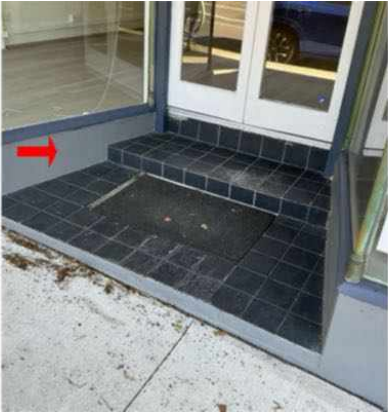
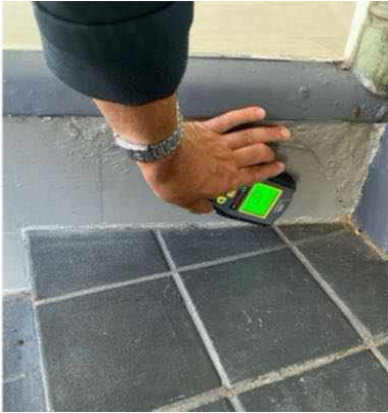
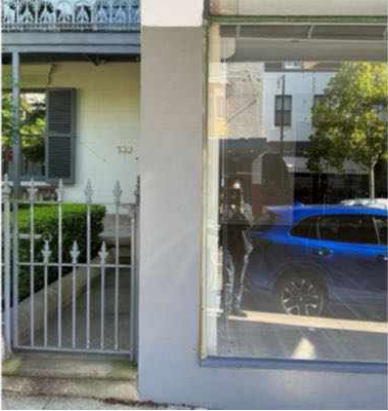
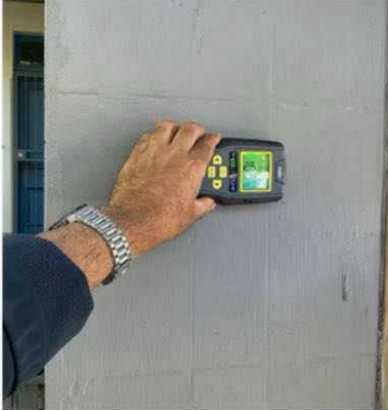
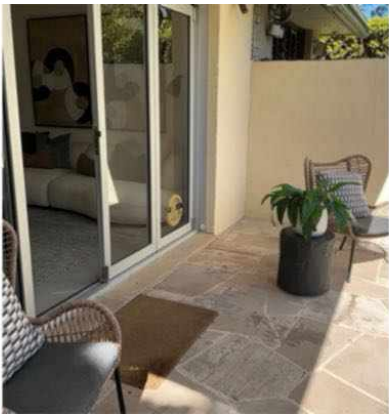
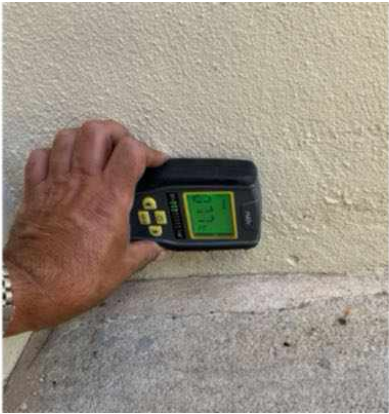
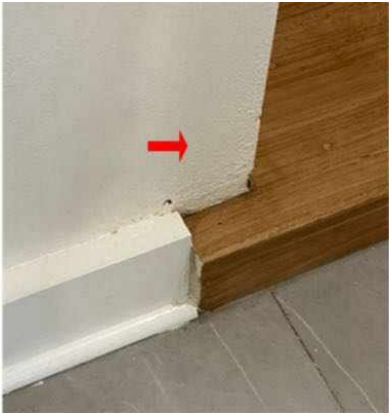
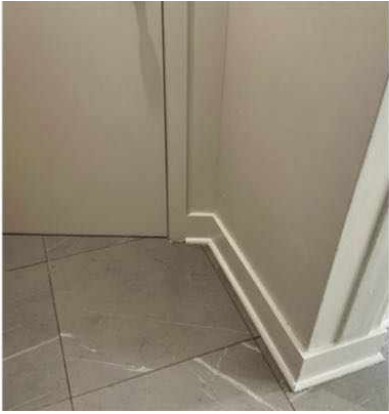
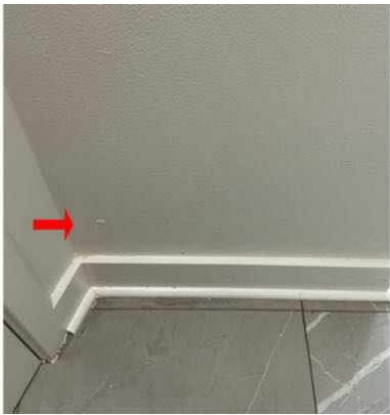
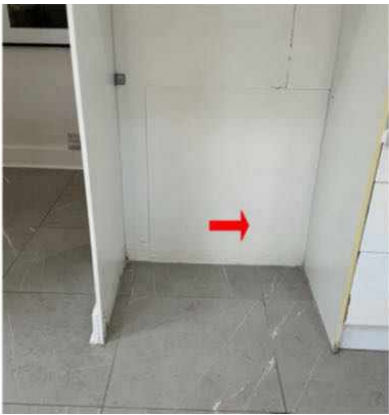
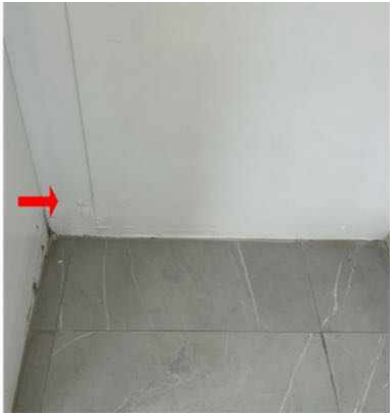
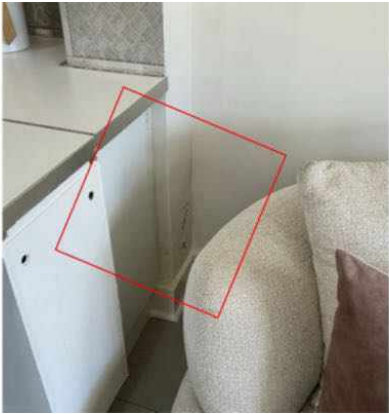
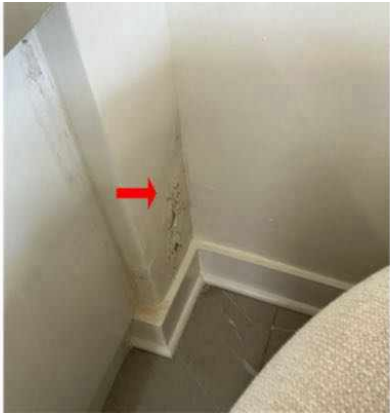
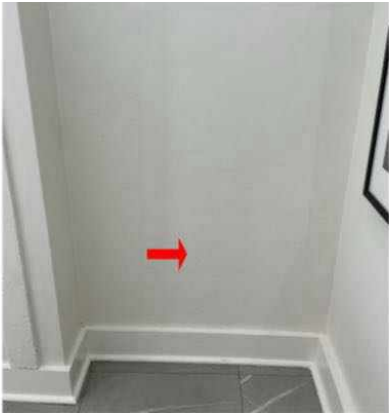
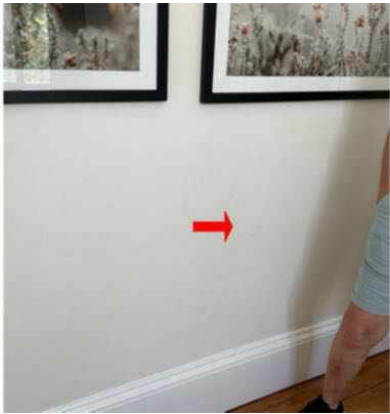
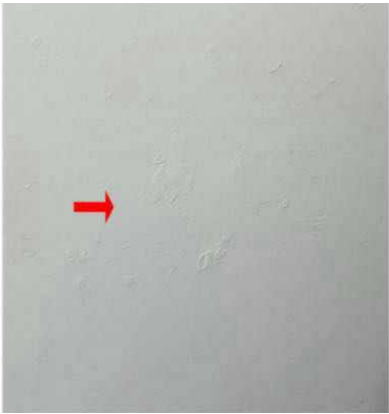
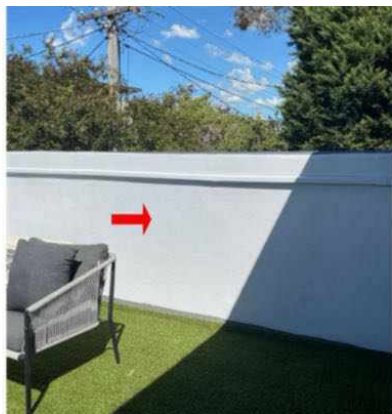
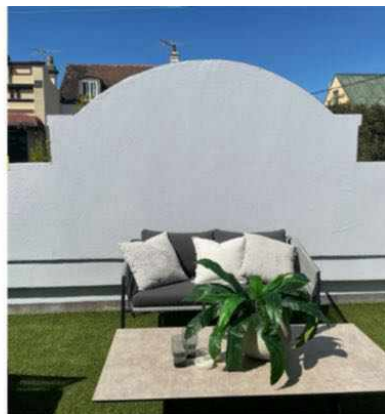
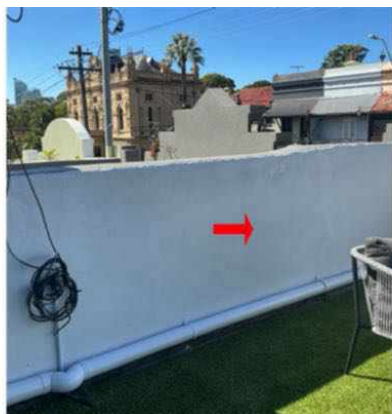
Finding 2.01

| Finding: | Damp (Internal and External) |
| Information: | Moisture ingress was observed affecting both internal and external building elements, with evidence including damp staining and/or elevated moisture readings. The distribution of moisture suggests a potential ongoing or systemic issue rather than isolated occurrence. If left unaddressed, this may lead to material deterioration, mould growth, and reduced durability of building elements. Further investigation by a qualified damp proofing specialist is recommended to determine the source and extent of moisture ingress. |

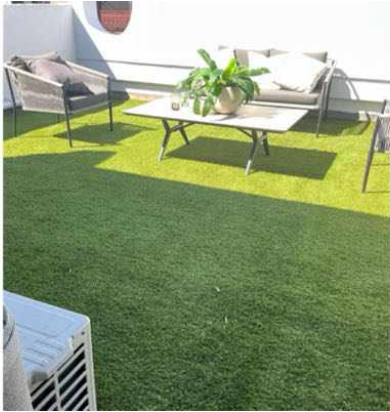
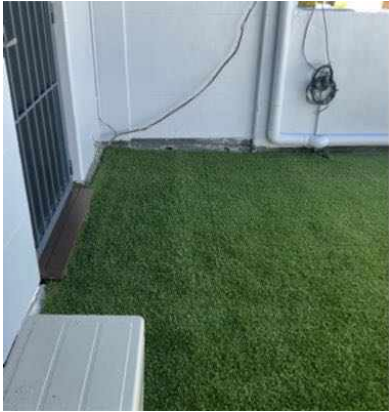
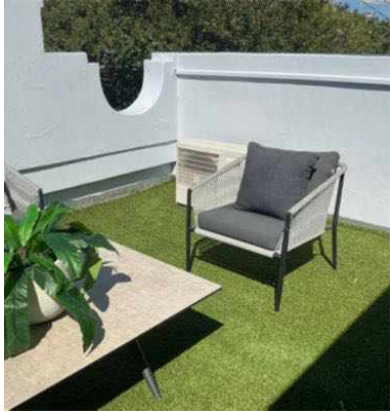
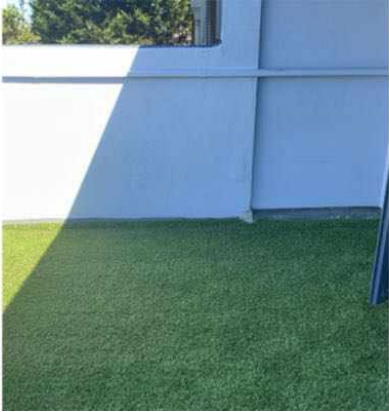
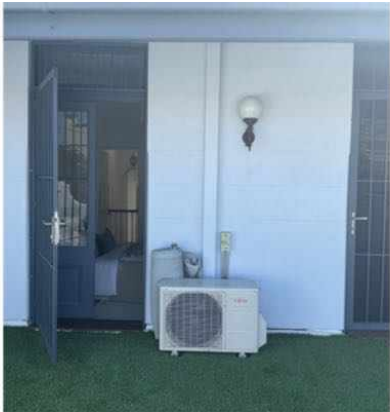
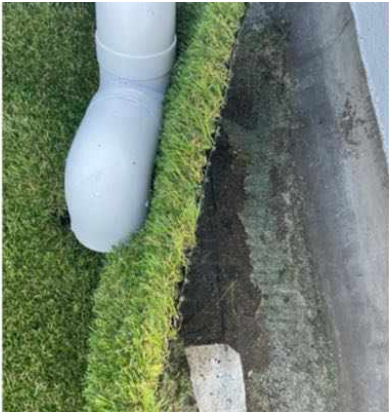
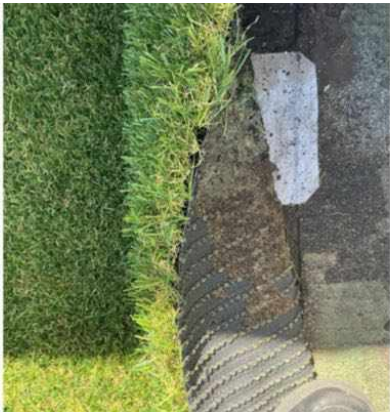
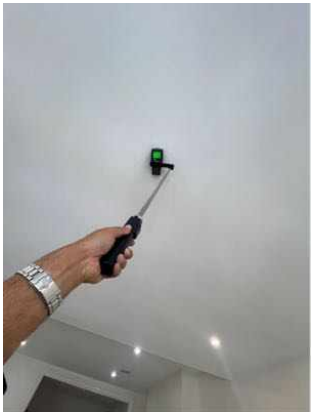
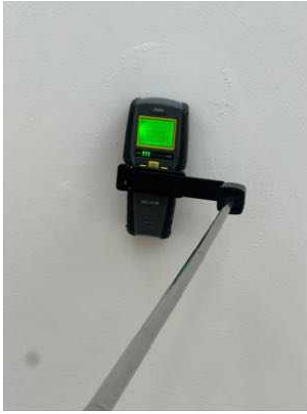
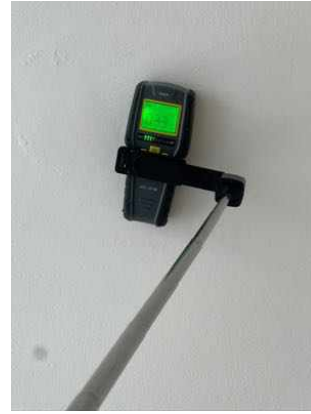
Finding 2.02

| Information: | Deterioration and breakdown of the waterproofing membrane were observed along the perimeter drainage zone, including areas concealed beneath artificial turf, with visible wear, patching and surface degradation noted. The turf installation appears to bridge drainage pathways and may restrict effective water runoff, increasing the likelihood of moisture retention and membrane failure. In conjunction with these findings, water damage and elevated moisture were identified to the ceiling below, indicating active or recent water ingress. This condition is consistent with compromised waterproofing performance and may lead to concealed structural damage and significant repair costs if not addressed. Further investigation and rectification by a licensed waterproofing contractor is recommended as a priority. |

Given the presence of internal moisture ingress, this condition is considered indicative of failure of the waterproofing system and may lead to significant repair costs if not promptly addressed.

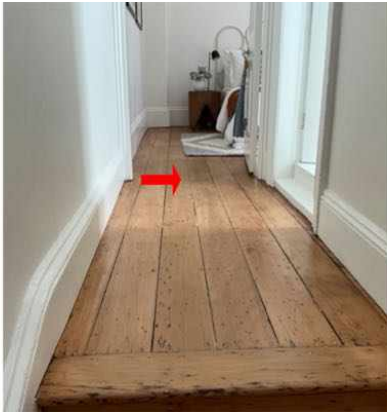
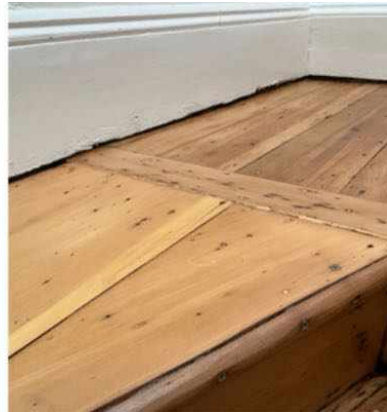
Finding 2.03

| Finding: | Uneven flooring and gaps between floor and skirting |
| Information: | unevenness was observed to the first floor, with gaps exceeding ~ 20mm between the flooring and skirting boards, as well as separation noted to sections of the staircase. The extent and irregular nature of these gaps are not consistent with normal material shrinkage and indicate movement or deformation within the floor structure, potentially associated with subfloor settlement or deflection of supporting elements. This condition represents a major defect due to its potential impact on structural performance and serviceability. Further assessment by a qualified builder or structural engineer is recommended to determine the cause, extent, and required rectification works. |

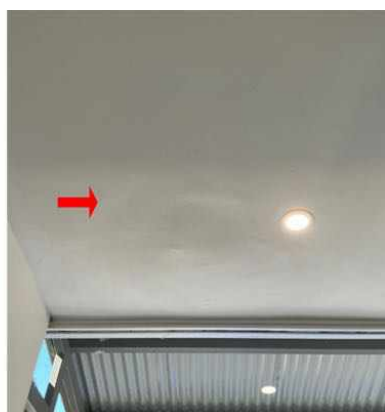
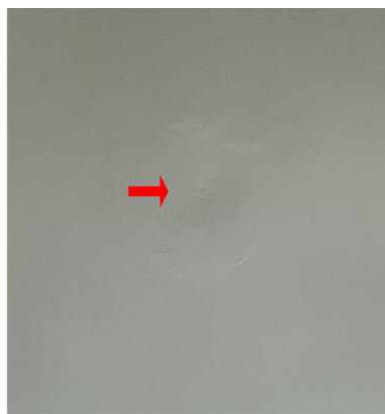
Finding 3.01

| Finding: | Ceiling - Water damaged (Repaired) |
| Information: | Water damage to the ceiling lining is generally an indication of excessive moisture being present in the roof void, usually via a leak to the roof covering. |

Where water damage is evident to the ceiling, the primary requirement is to identify and rectify the source of the leak. A roofing plumber should be appointed as soon as possible to identify the leak and perform rectification works as necessary, ensuring the water damage is restricted.

Once the leak is repaired, consultation with relevant tradespeople, including plasterers and painters, is advised. Rectification works may include replacement of ceiling lining or minor repainting, depending on the extent of the damage.

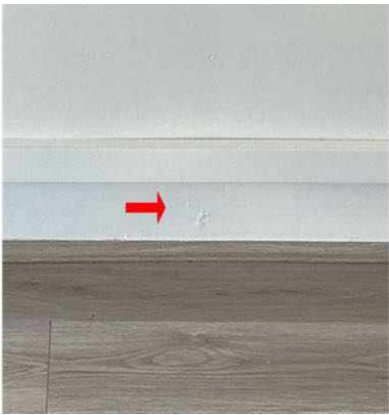
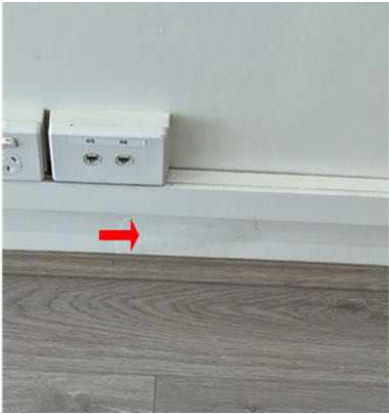
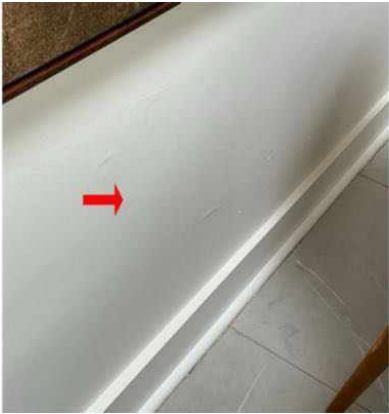
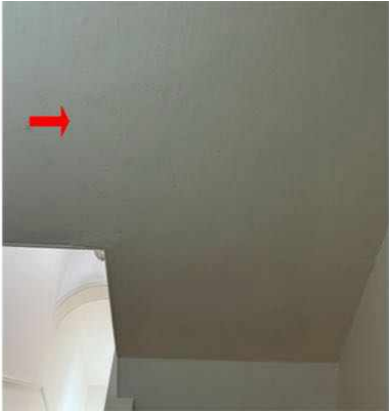
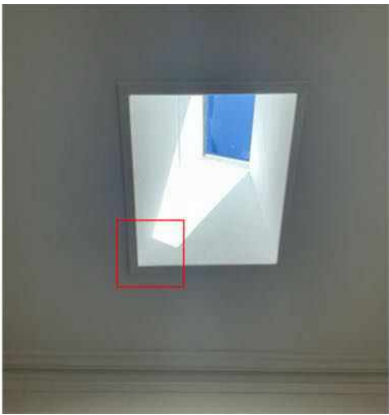
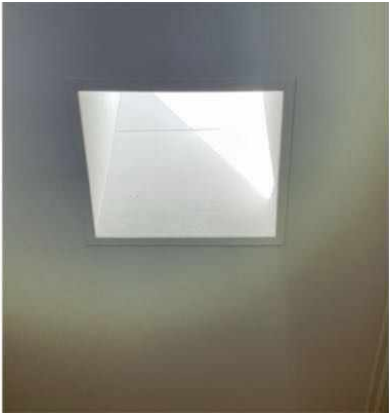
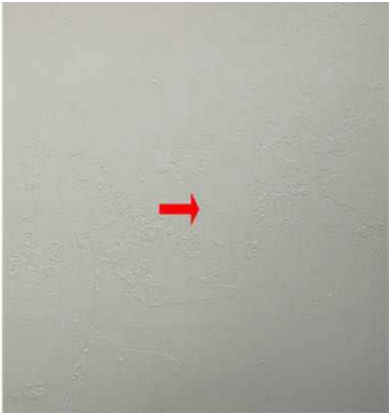
Finding 3.02

| Finding: | Painted surface - Bubbling or moisture related deterioration to some areas |
| Information: | Sections of paint in this area was found to have bubbled and deteriorated. Paint bubbling is generally an indication of excessive moisture in the area, that is currently hidden by the painted surface. |

The presence of excessive moisture can have major implications on associated building elements if left unattended. While only seemingly minor at this stage, the damage cannot be determined due to the paint obstructing any further inspection of the damage.

It is highly advised that the affected paint be cleaned to allow a further, more invasive inspection by a licensed plumber. Failure to act on this defect may necessitate major works in the future.

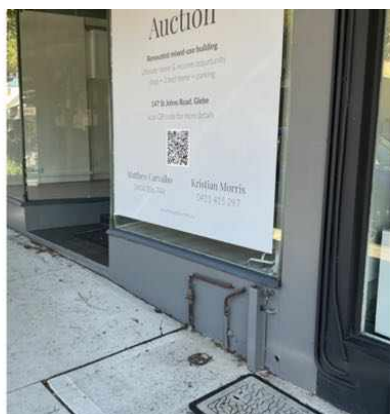
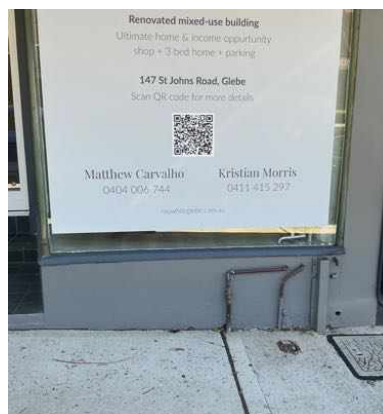
| Finding: | Render Finish Covering Damp Membrane |
| Information: | During the inspection, it was noted that the applied render finish could be covering the damp-proof membrane. This could affect the membrane's ability to prevent moisture movement above it, leading to moisture-related issues over time. It is recommended to consult a qualified builder to ensure the damp-proof membrane is properly exposed, maintaining its effectiveness in preventing moisture ingress. |

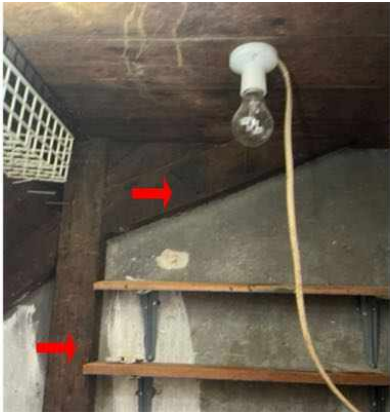
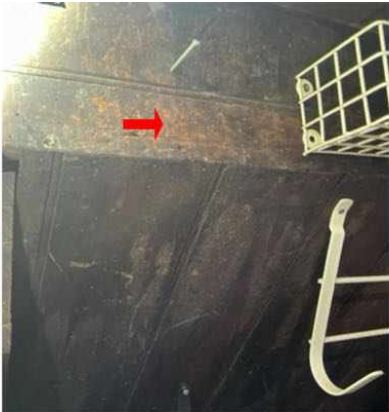
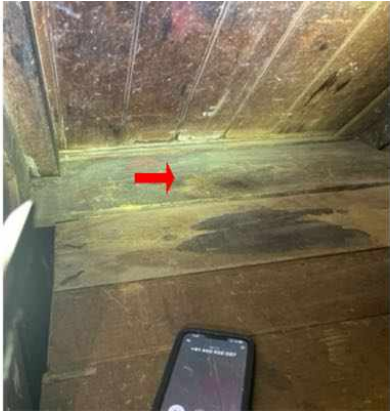
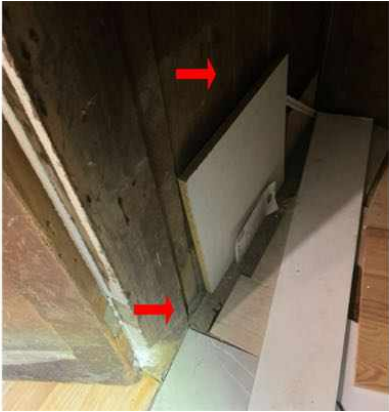
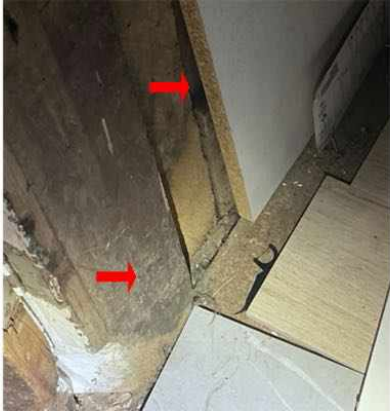
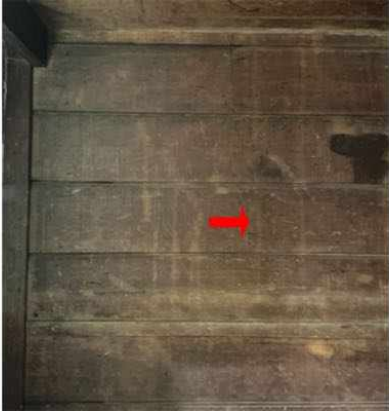
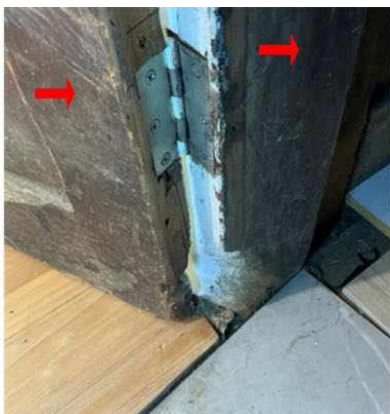
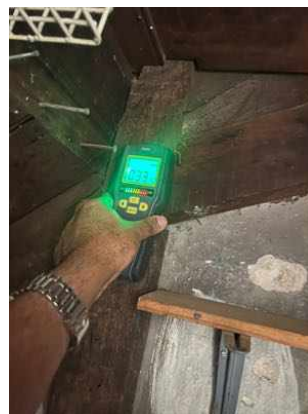
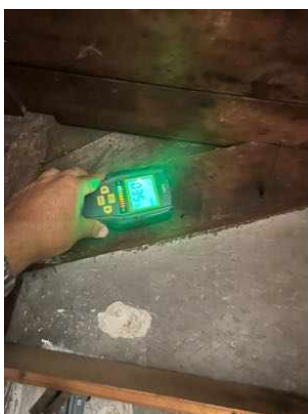
Finding 3.05

Building: Main Building
Location: All Internal Areas - Under staircase
Finding: Timber observation & elevated moisture
Information: Internal lining and adjacent timber elements were observed to be darkened and aged in appearance, with discolouration consistent with prolonged moisture exposure and elevated moisture. The condition suggests long-term dampness and may indicate concealed degradation of timber components behind the lining, including potential loss of material integrity over time. While the full extent could not be confirmed due to the non-invasive nature of the inspection, this raises concern for hidden damage within the structure. Further investigation is recommended to identify the moisture source and assess any concealed deterioration, with appropriate rectification to follow.

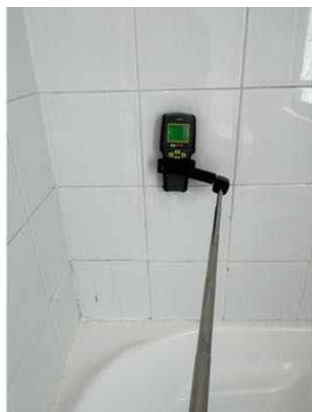
Finding 3.06

| Finding: | Elevated Moisture Bathroom |
| Information: | Elevated moisture levels were detected to tiled surfaces in bathroom/shower areas. Persistent moisture ingress can lead to concealed damage, including timber rot and mould growth. |

Elevated moisture readings in tiled wet areas can occur from normal shower use, age/deterioration of waterproofing membranes, plumbing leaks or moisture absorption through grout lines. While no damage was visible, elevated readings may indicate moisture retention behind tiles, which can be a conducive condition for future deterioration if not monitored.

Monitor the area over time for signs of drumming, efflorescence, tile movement, or grout deterioration. Further inspection by a licensed waterproofing is recommended (e.g., pressure testing, membrane assessment).

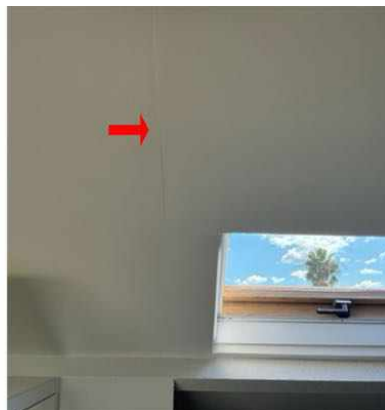
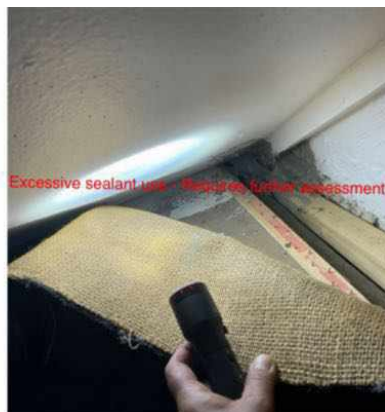
Finding 3.07

| Finding: | Renovations and/or repairs to some areas |
| Information: | Recent renovations, refurbishments or repairs were observed at the time of inspection. As this is a visual inspection only, the inspector is unable to determine the quality, compliance, or durability of such works where construction details are concealed. No comment can be made on whether these works were undertaken with the appropriate permits, approvals, or by licensed tradespersons. It is recommended that the purchaser seek clarification from the vendor or builder and request relevant documentation such as occupation certificates, warranties, or council approvals to confirm compliance and workmanship quality. |

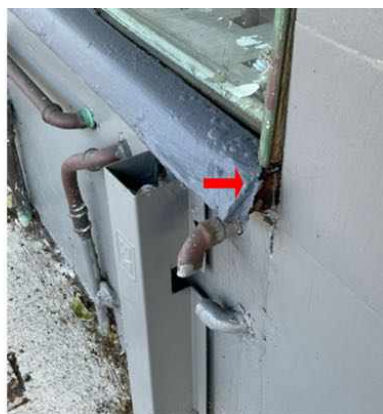
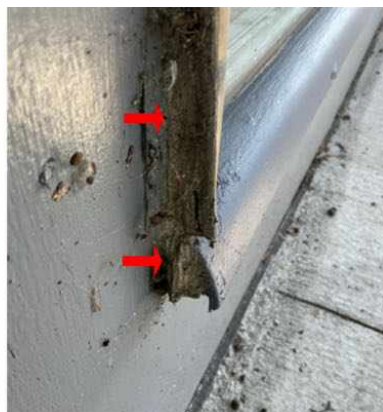
| Finding: | Wood rot to some areas |
| Information: | This building element shows evidence of wood rot. Wood rot, also known as Fungal Decay, occurs when timbers and other cellulose building materials are exposed to damp conditions on an ongoing basis. This could be the result of exposure to weathering over a prolonged period of time, or the attraction of excessive moisture from other abutting building materials. Contributing factors also include poor air ventilation in the area. |

Wood rot is often associated with general damp problems and is evidenced by a 'musty' smell or mould and mildew occurring on surfaces. If left unmanaged, damp conditions can lead to further health problems and the decay of timbers will continue.

Early intervention and regular maintenance, particularly of exterior timbers, will prolong the useful life of these building elements. Prior to any works being performed, the cause of the moisture that has created the visible wood rot should be identified and addressed in a suitable manner. Replacement of affected timbers may then be a necessary step in protecting surrounding building elements from such deterioration.

A qualified plumber may be appointed to assess the cause of excessive moisture and to provide advice on any remedial works as required. A qualified carpenter or registered builder may also be required to replace affected building materials.

Even though Liverpool termite activity was not visible. A further invasive inspection by a licensed termite technician its also highly recommended to eliminate possibility of potential termite activity.

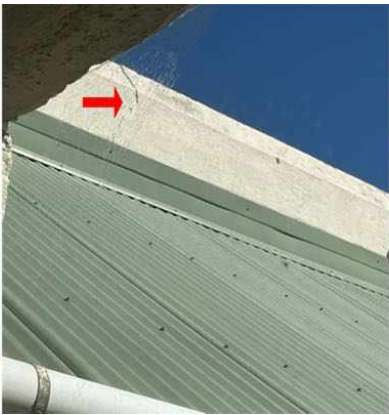
Finding 3.10

| Finding: | Brickwork - Cracking noticeable - Further closer inspection required |
| Information: | Noticeable cracks are a common occurrence in external brickwork and are a likely result of age expected building movement, general expansion, and/or contraction of building materials in different weather conditions. Noticeable cracks in brickwork may develop if left unattended, with potential for necessitating major remedial works or replacement of the brickwork. |

It is highly advised that a qualified bricklayer be appointed to provide necessary works to cracked brickwork to prevent any further damage. Such works should be conducted as soon as possible.

Always monitor these cracks and contact a building inspector should cracks widen, lengthen, or become more numerous.

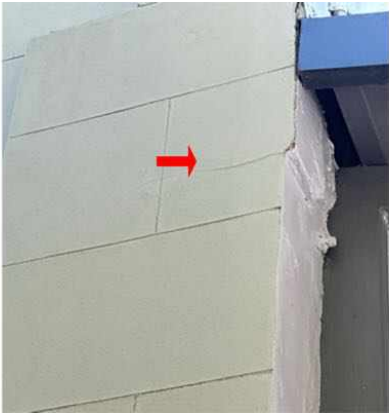
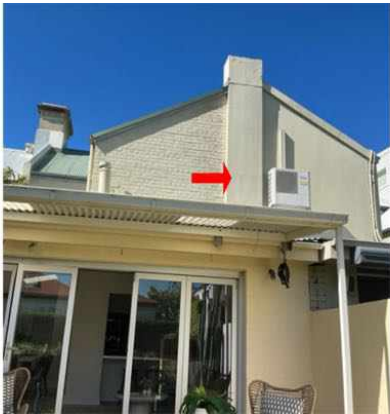
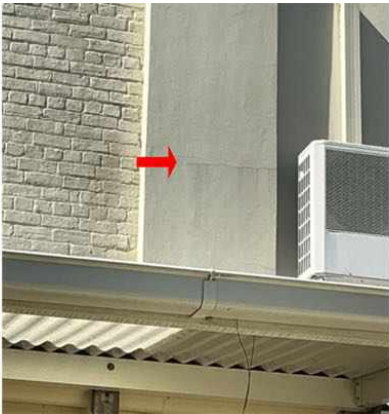
Finding 3.11

Building: Main Building
Location: All External Areas - Front , Side
Finding: Cracks to render - Category 1
Information: It has been observed that cracking to rendered surfaces has occurred. The degree of damage falls within Category 1 , described as fine cracks that do not need repair and which are less than 1.0mm in width limit.

Damage of this category is not considered a defect for rectification. Always contact your building inspector should cracks widen, lengthen, or become more numerous.

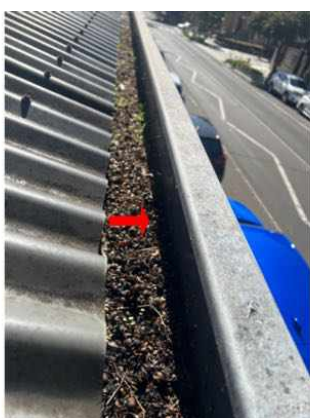
Finding 3.12

Blocked gutters are likely to lead to high levels of moisture in the affected areas. Such moisture will not only cause rust and decay of the associated building materials, but can also provide conditions that are conducive to termite and timber pest activity. Blockages in gutters should therefore be removed immediately to ensure dry conditions are maintained.

Consult a Licensed Plumber for further specific advice on remedial works that may be required. In the interim, it is highly advised that blocked gutters be removed by the homeowner or a general handyperson as a matter of urgency.

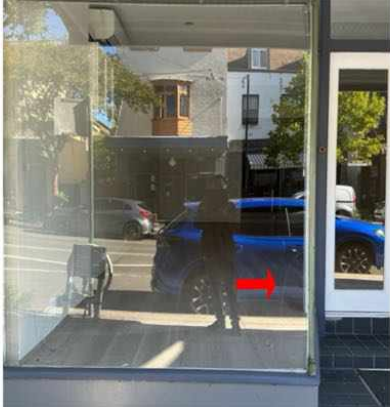
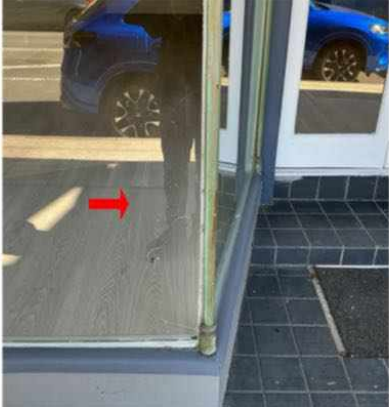
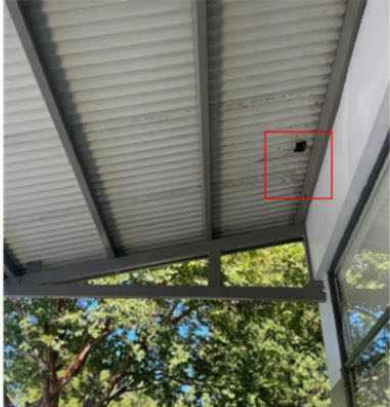
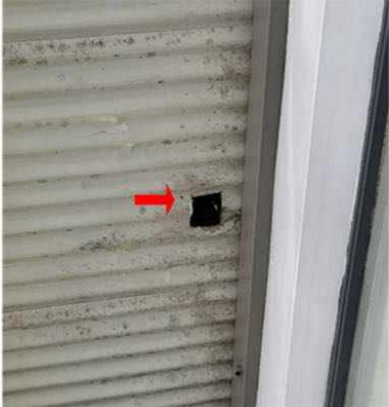
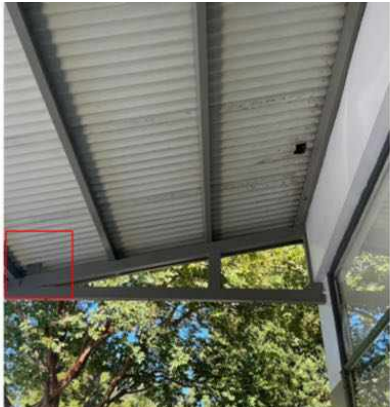
| Finding: | Building element - Damaged - Cracked glass front , hole not sealed awning (Moisture ingress) |
| Information: | Breakage occurs generally when the building materials have either aged and decayed, or as a result of damage (accidental or deliberate). |

Repair and/or replacement of broken elements is advised to ensure that additional secondary defects do not arise as a consequence. Such works are necessary, as all

building elements play a key role in the operation and function of the overall structure and its performance.

A relevant tradesperson should be appointed to repair or replace the affected building element prior to any subsequent damage being caused.

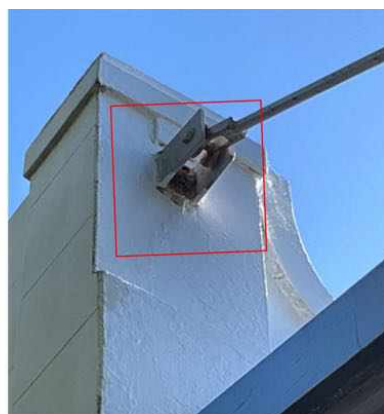
Finding 3.14

| Finding: | Building element - Rusted or corroded - Awning fixings rusted |
| Information: | This building element shows evidence of rusting and corrosion, which is likely to have |

developed as a result of excessive exposure to moisture and or inadequate coatings.

As surface rust provides no protection to the underlying iron, the deteriorating condition is likely to worsen if not addressed in the short-term future.

Where possible, the use of galvanized (treated) metals or aluminium coated metals aid in rust prevention, as does regular general maintenance. Rust formation can be controlled with coatings, such as paint, that isolate the iron from the environment.

Rusting and corrosion should be managed by ideally removing or limiting the affected surface from exposure to moisture. A registered builder may be appointed to replace any building elements that have been severely affected by rust or water damage.

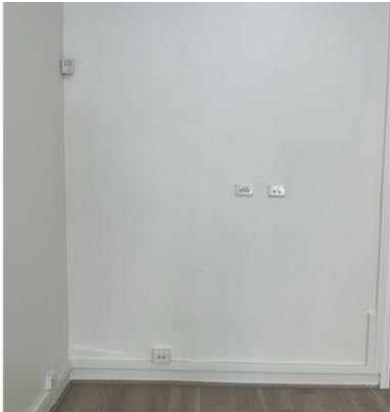
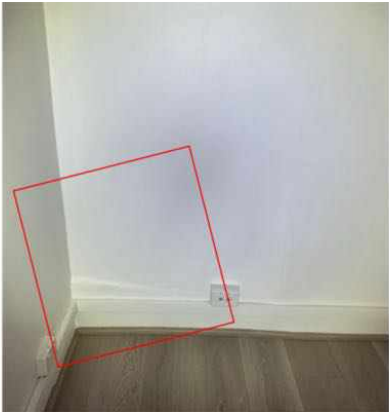
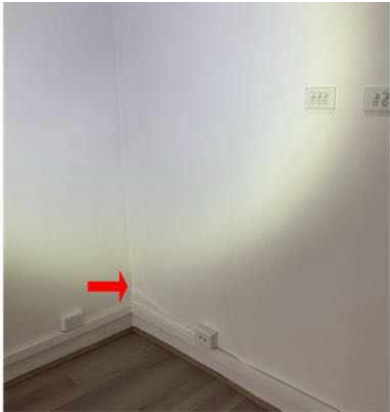
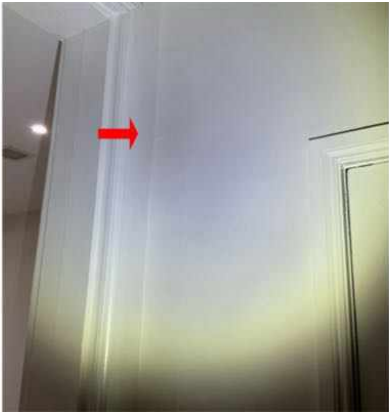
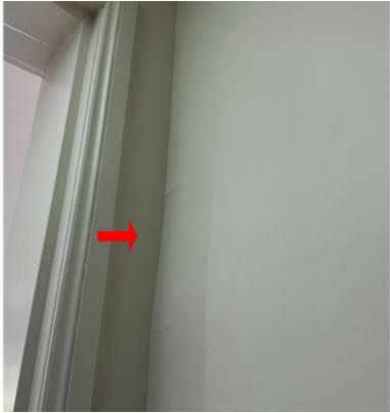
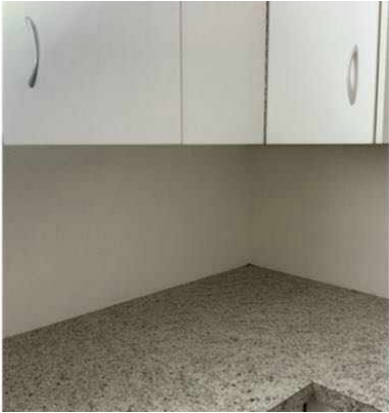
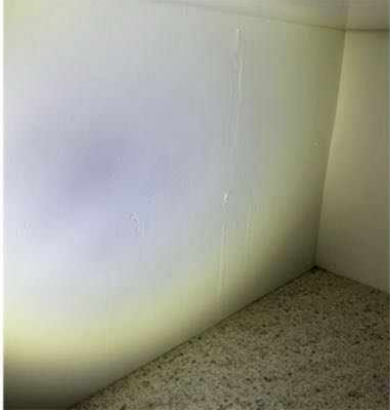
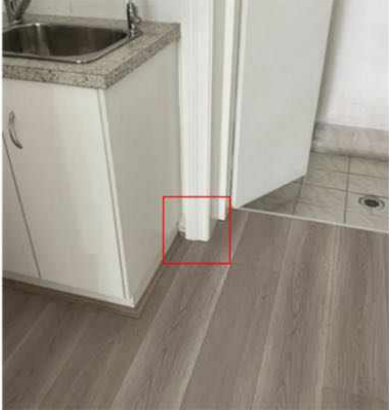
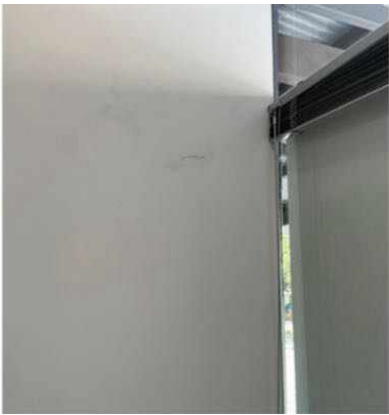
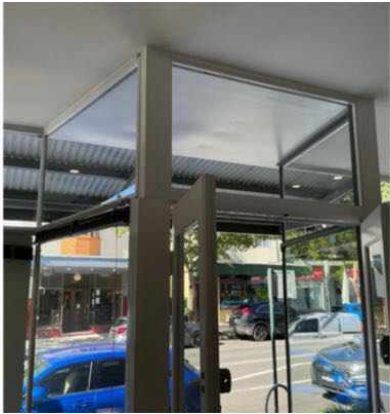
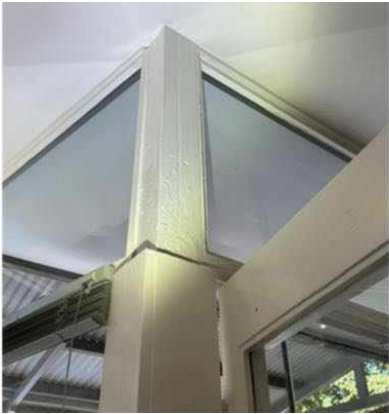
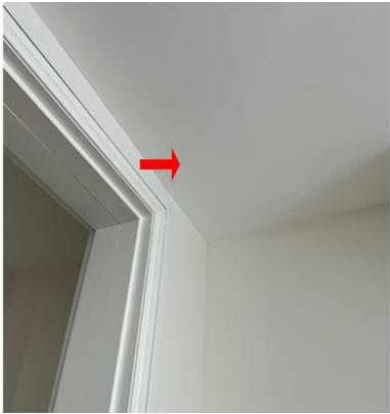
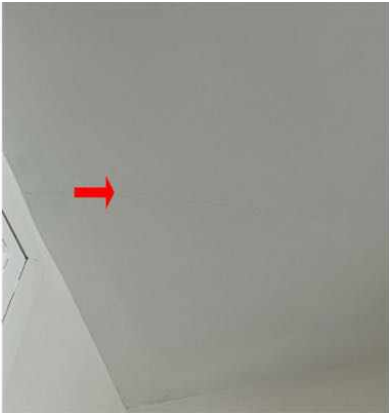
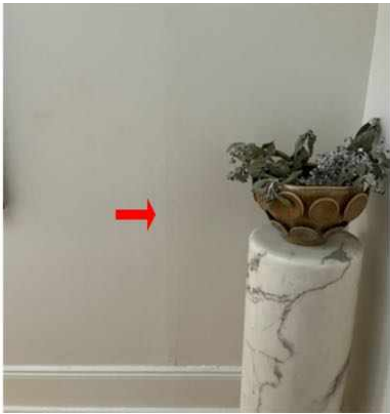
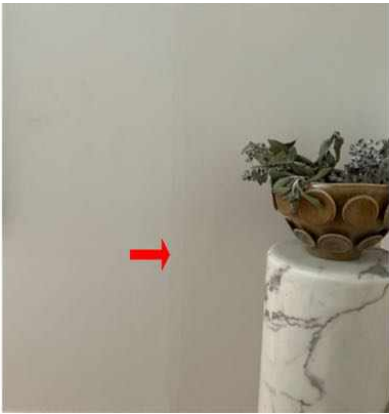
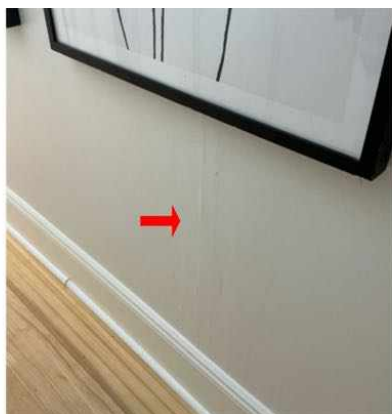
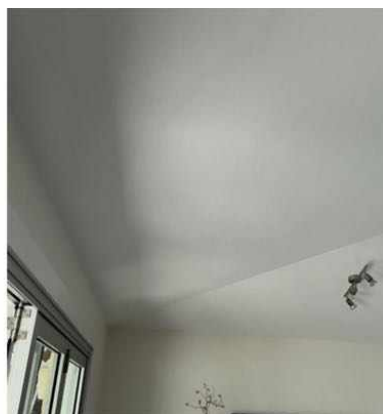
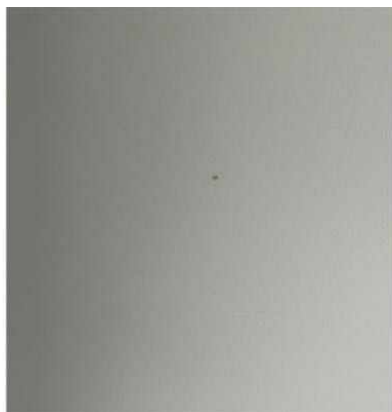
Finding 3.15

| Finding: | Paint Finish & Hairline Cracking - To some areas |
| Information: | The paint finish in this area was identified as being incomplete at the time of inspection including some hairline minor cracking. |

Whilst incomplete or missing paint and minor cracking and imperfections in finish is generally an appearance defect, it can also lead to the development of secondary building defects over time. Incomplete areas of paint finish expose the area to moisture, potentially accelerating the deterioration of underlying building materials.

Incomplete paint finishes should be sanded back, filled, leveled and painted, as applicable. Where inadequate or missing paint protection has led to the deterioration of the associated building element, repair and/or replacement of this building element may be required.

A painting contractor should be appointed as soon as possible to perform necessary works to aid the appearance of the affected area and to ensure the area is protected against further deterioration. Alternatively, the homeowner following manufacturer instructions may perform these works.

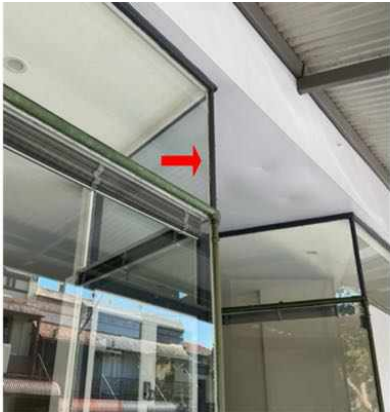
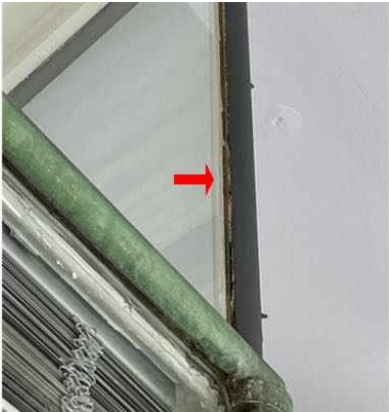
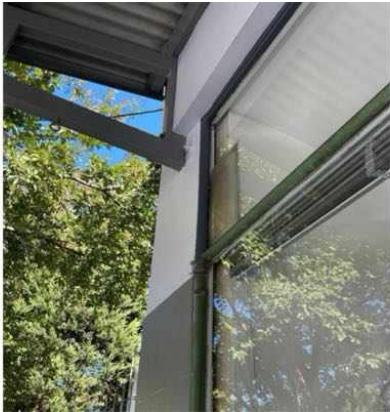
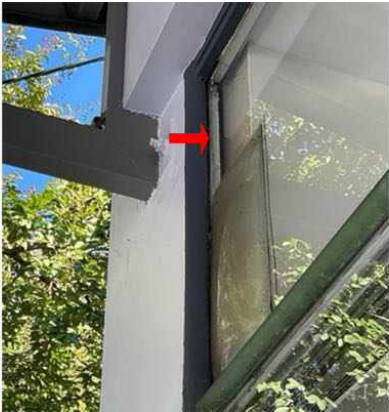
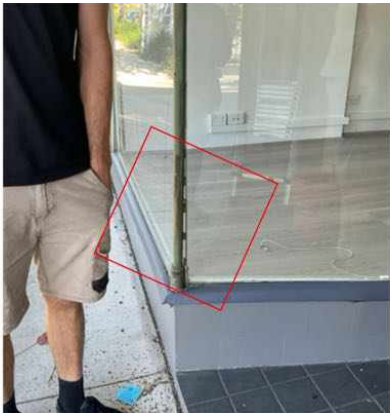
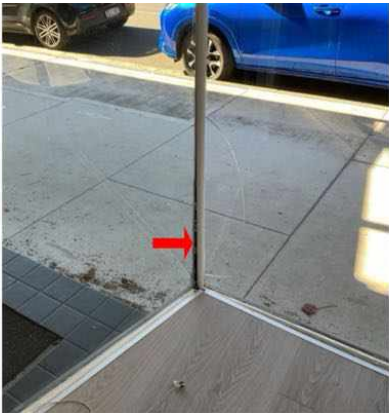
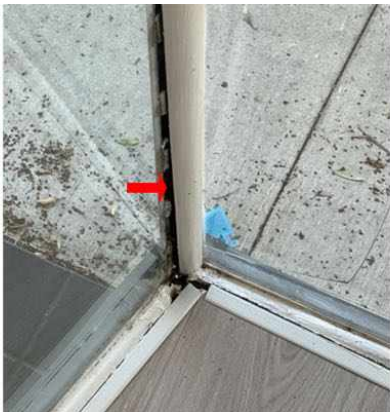
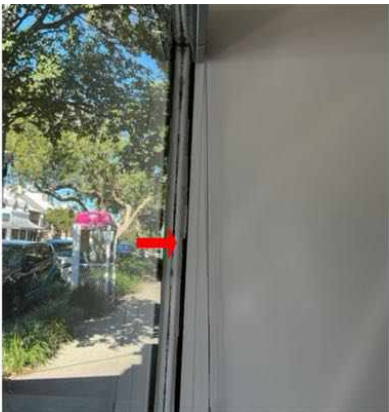
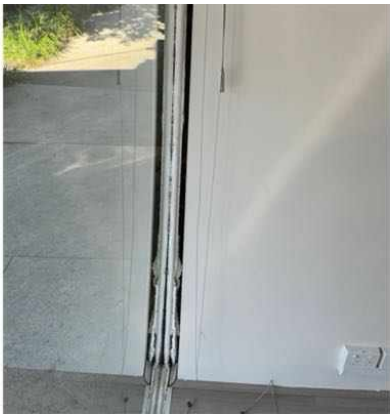
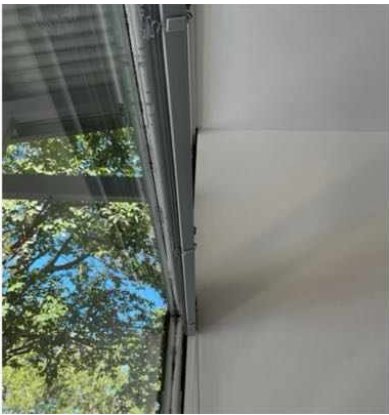
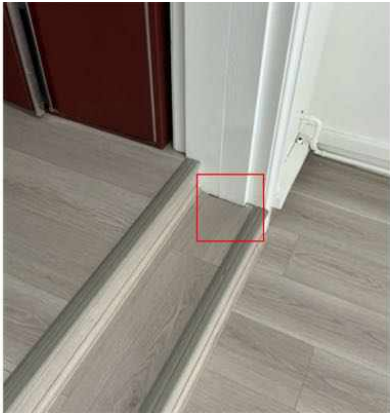
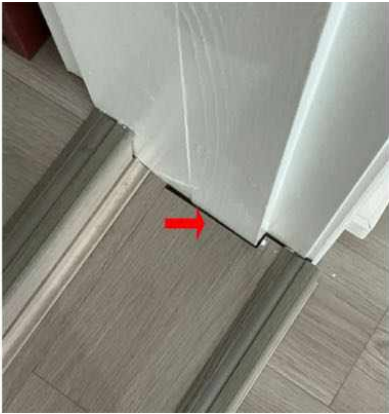
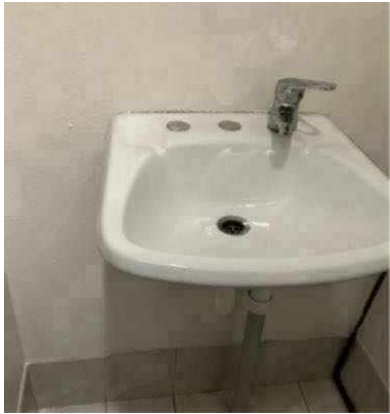
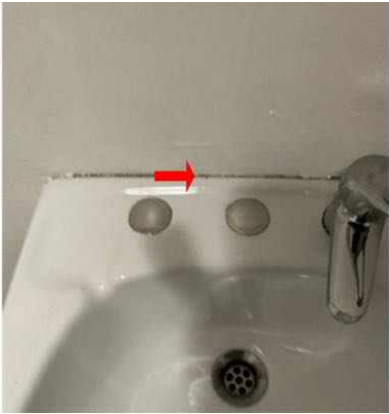
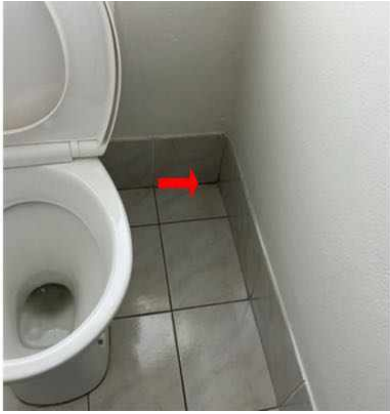
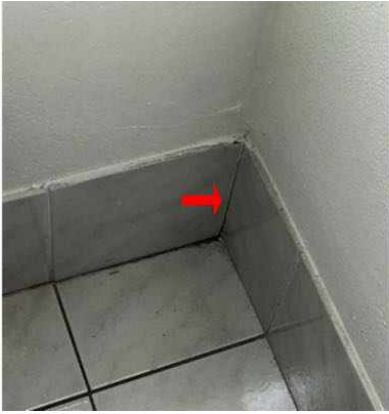
Finding 3.16

| Finding: | Sealant and grouting - Missing or degraded to some areas |
| Information: | It was noted on inspection that sealant or grout is degraded. |

Different materials and floor areas move at different rates, generally causing cracking to grout or sealant at this point. A flexible sealant is required to allow for expected expansion and contraction, while keeping the joint water tight and protective of all associated building materials.

There appears to be excessive mould to the sealant and grout which will likely require scraping out and replacement.

Flexible and mould resistant materials should be applied to affected areas to prevent any subsequent water damage that is likely to occur. Regular maintenance and replacement of damage or missing or damaged sealant and grout is highly recommended to the wet areas, as this is a regular wear and tear defect. Sealant and grouting in areas that come into regular contact with water should be maintained for the long term care of your property.

A sealant specialist or tiling contractor should be appointed to complete these works as soon as possible

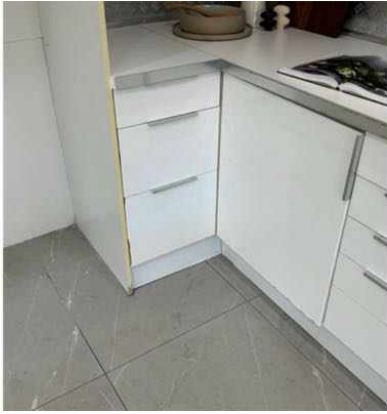
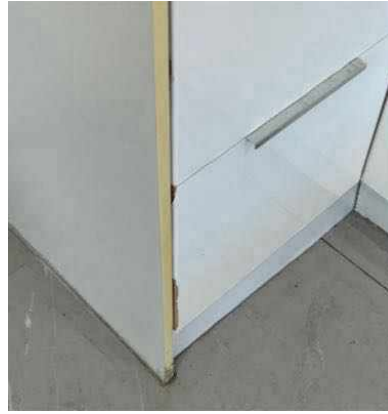
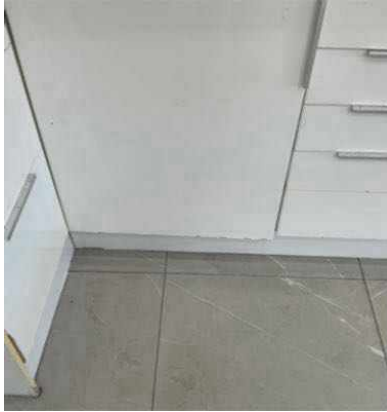
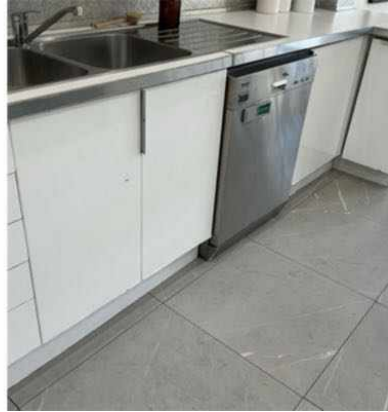
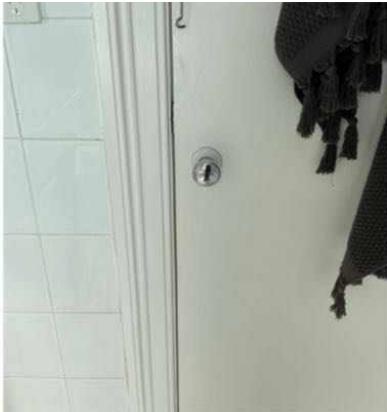
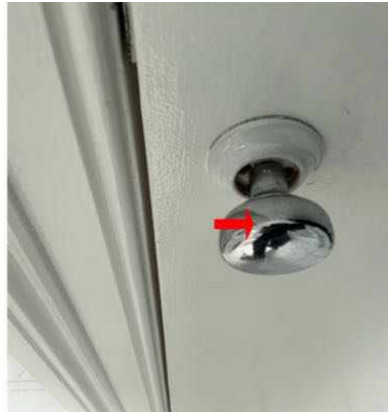
Finding 3.20

Works that have not been completed to a satisfactory level create potential for the development of building defects and may impede on the safety and integrity of the overall structure.

It is highly recommended that the relevant trades be appointed to complete these

works and ensure the safety of the area and the longevity of all associated building elements.

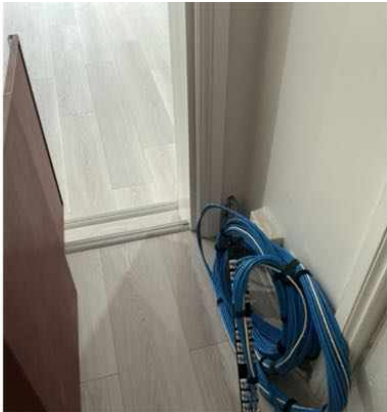
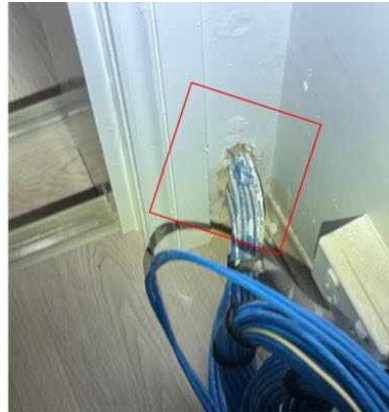
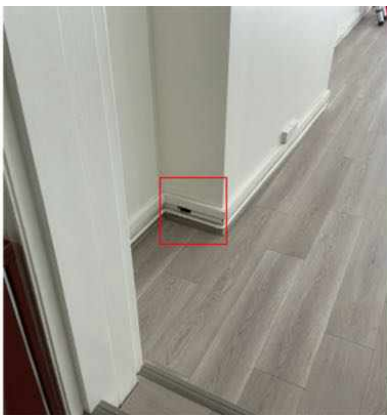
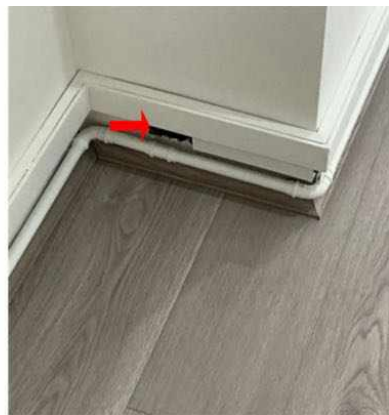
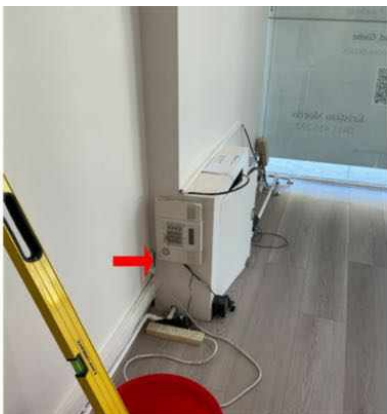
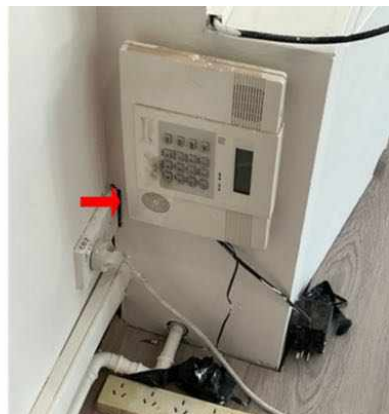
Finding 3.21

| Finding: | Incomplete or substandard works (Sealant or ground missing) |

development of building defects and may impede on the safety and integrity of the overall structure.

It is highly recommended that the relevant trades be appointed to complete these works and ensure the safety of the area and the longevity of all associated building elements.
