Building and Timber Pest Inspection Report

Inspection Date: Wed, 1 Apr 2026

Property Address: 147 St Johns Rd, Glebe NSW 2037,
Australia

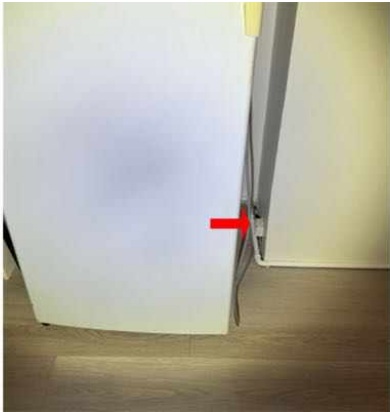
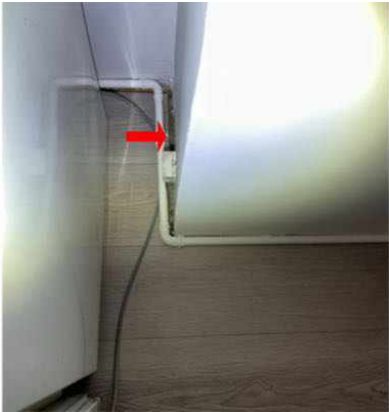
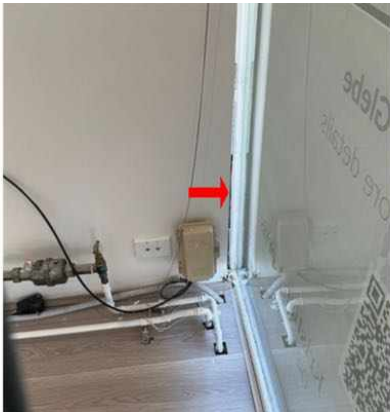
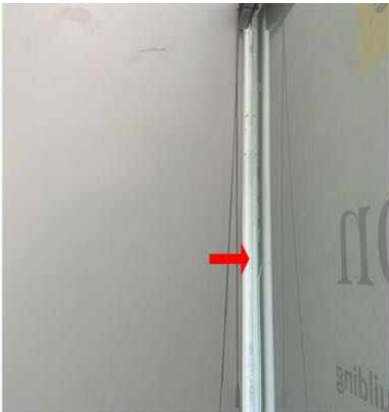
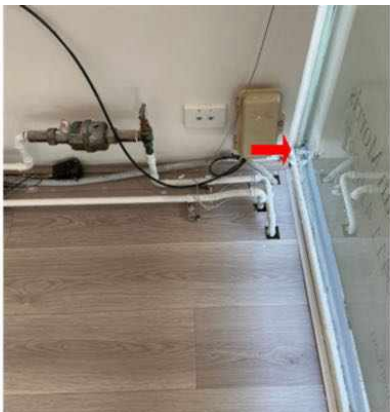
Finding 3.22

Building: Main Building
Location: All Internal Areas
Finding: Incomplete or substandard works - Exposed timber framing and moisture staining

Works that have not been completed to a satisfactory level create potential for the development of building defects and may impede on the safety and integrity of the overall structure.

It is highly recommended that the relevant trades be appointed to complete these works and ensure the safety of the area and the longevity of all associated building elements.

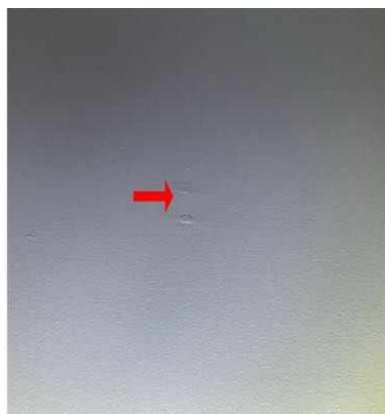
Finding 3.24

| Finding: | Tiles - Cracked or damaged |
| Information: | Cracking was evident to the tiling in this area at the time of inspection. While the cracking appears to be minor, this area is frequently exposed to water, allowing potential for water penetration into adjoining sections of walls or flooring. |

If left unmanaged, water penetration to these areas may lead to subsequent water damage, which is likely necessitate repair work to affected building elements.

A tiling contractor should be appointed to ensure that no further water damage occurs. The re-application of silicone and grouting throughout remaining tile work is also advised, to further protect the area against water penetration.

Where water penetration has led to water damage, appointment of a relevant tradesperson may be required to repair damaged building elements.

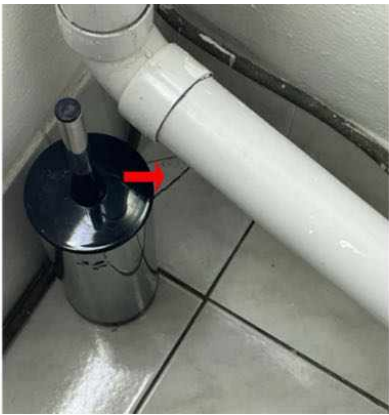
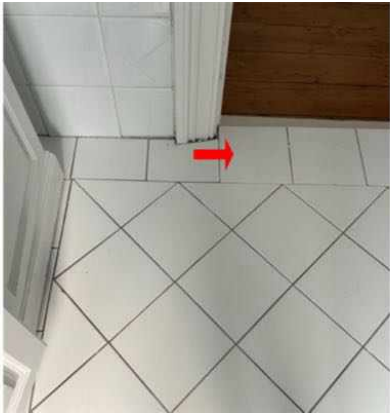
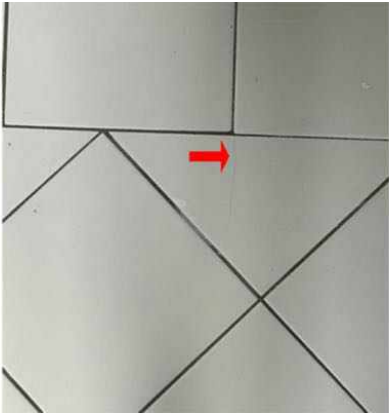
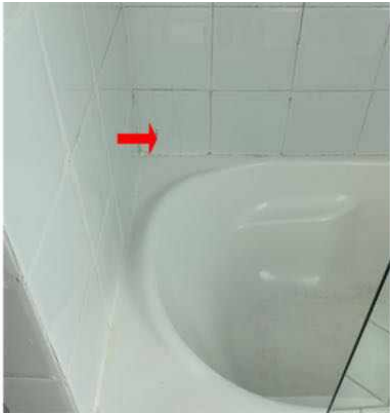
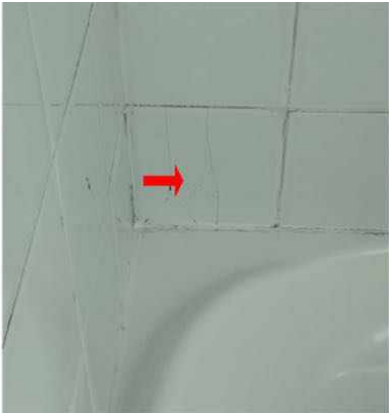
Finding 3.25

Building: Main Building
Location: All Internal Areas
Finding: Pest Activity

Information: The presence of pest-related material indicates possible concealed activity. As this inspection is non-invasive, the full extent of any infestation could not be determined at the time of inspection. The debris appeared consistent with insect e.g ant activity.

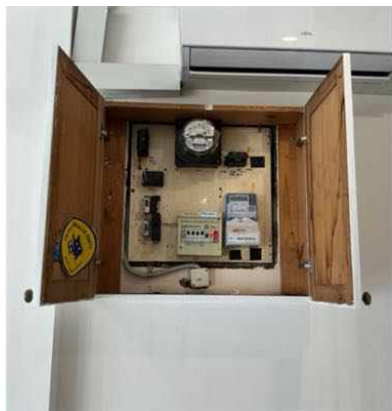
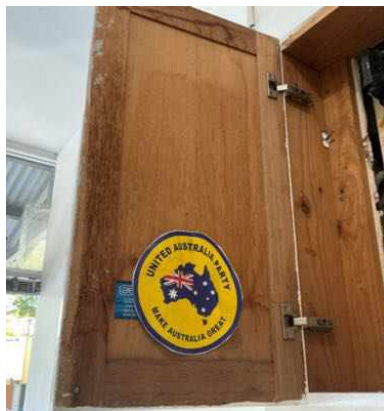
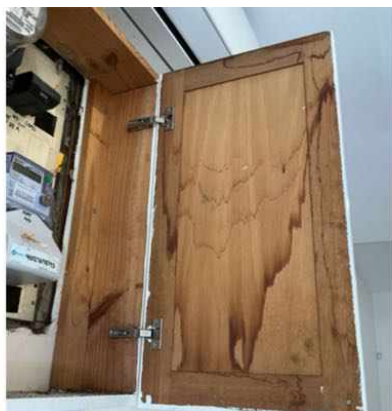
system has been installed, with no evidence to suggest preventative works taking place.

The client may consider gaining further advice from a pest controller as to the costs and procedures involved with this application. It is recommended that obtaining such advice be a short-term priority.

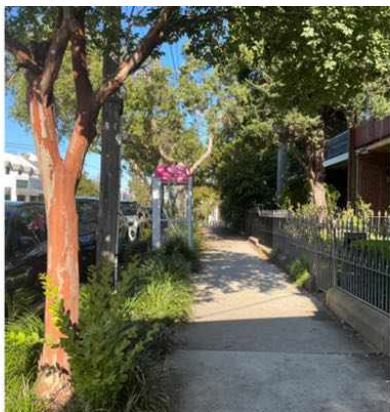
Finding 6.02

| Finding: | Trees within 50m |
| Information: | Trees within 50m of the property can be conducive to termite activity. It is recommended an invasive inspection of all trees with 50m to the property be carried out by a qualified pest control expert. |

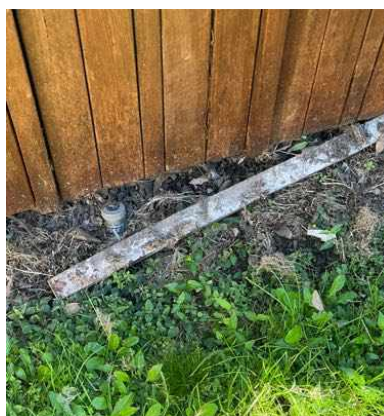
Finding 6.03

| Information: | Any timbers in direct ground contact provide opportunity for concealed termite entry and are likely to be subject to premature rot and decay as the soil retains moisture or damp conditions against the timbers. |

Remove untreated timber that is in direct contact with external grounds. Consider replacement with more durable materials i.e. treated timber or non timber elements. Frequent pest inspections are advised to readily identify any termite activity in these areas.

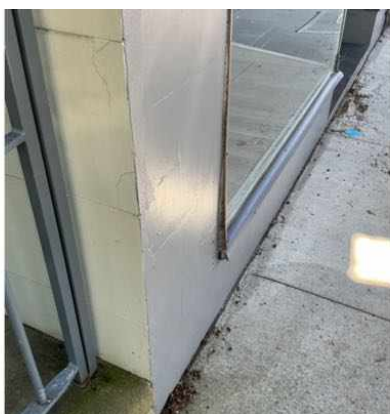
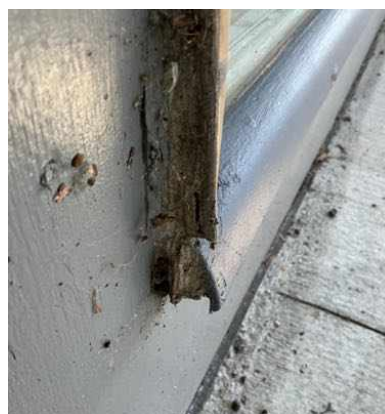
Finding 6.04

| Finding: | Fungal decay - present to some areas |
| Information: | Fungal decay also known as wood decay or wood rot generally refers to the deterioration of timber elements when in contact with excessive levels of moisture for a prolonged period of time. |

The development of fungal decay is accelerated by temperatures in the range of 5degreeC to 40degreeC as well as the presence of oxygen. Generally fungal decay develops on timber elements that are in use in an external environment which are exposed to rain penetration.

In this case although the affected timber element is in a decaying state the extent of any visible damage appears to be localised to a specific area and is yet to spread to other parts of the building element or affect adjoining structures. The fungal decay is therefore likely to be of a relatively superficial nature with minimal impact on the structural integrity or tensile strength of the timber element.

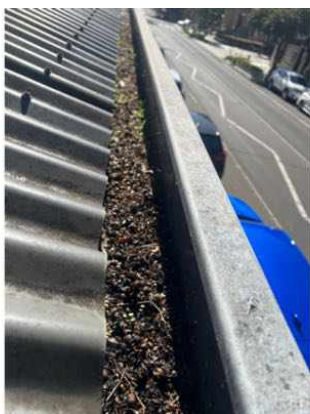
Finding 6.05

Blocked gutters are likely to lead to high levels of moisture in the affected areas. Such moisture will not only cause rust and decay of the associated building materials, but can also provide conditions that are conducive to termite and timber pest activity. Blockages in gutters should therefore be removed immediately to ensure dry conditions are maintained.

Consult a Licensed Plumber for further specific advice on remedial works that may be required. In the interim, it is highly advised that blocked gutters be removed by the homeowner or a general handyperson as a matter of urgency.

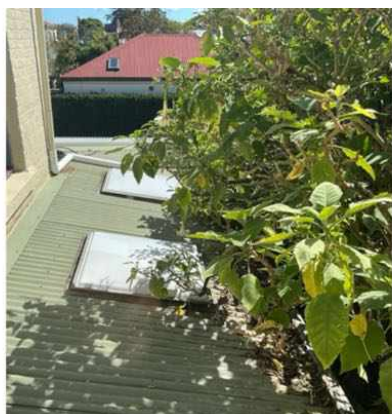
Finding 6.06

| Finding: | Elevated moisture - identified |
| Information: | Elevated moisture can attract termites and produce conditions that promote fungal growth and wood decay. |

Elevated moisture is generally caused by deteriorated, inadequate or missing roof drainage, leaking plumbing pipes or fixtures, poorly plumbed HWS overflows or condenser units and poor site drainage.

If mould growth has been found there may be environmental biological or health issues involved. In these cases an appropriately qualified inspector should also be contacted.

Prior to any remedial works being performed a qualified plumber should be appointed to further inspect the property and to identify the cause of the excessive moisture. Works to remove affected building elements may then be necessary and should be performed by an appropriate tradesperson.

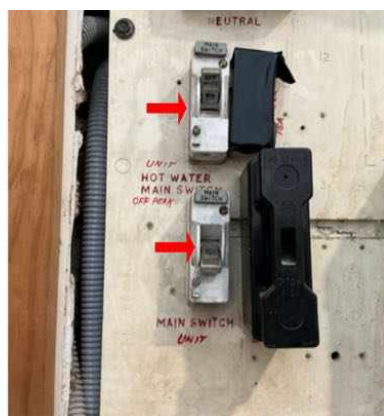
| Information: | The electrical switchboard while appearing to have adequate safety switches installed has old ceramic fuses in place. |

While this on its own on is not considered a defect it is noted for the clients consideration that a switchboard upgrade may be required in the short to mid term to improve the functionality of the electrical system. A licensed electrician could be appointed to provide quotation for the works at the client's discretion which may in turn expose other required works to bring the system up to a compliant state.

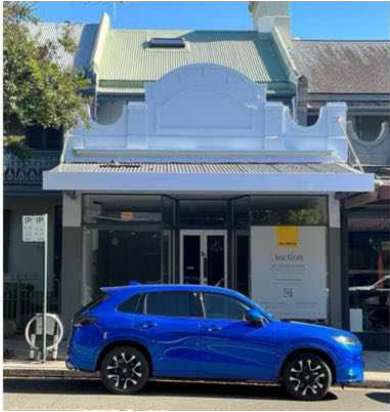
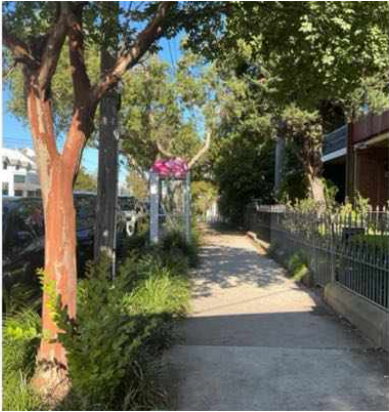
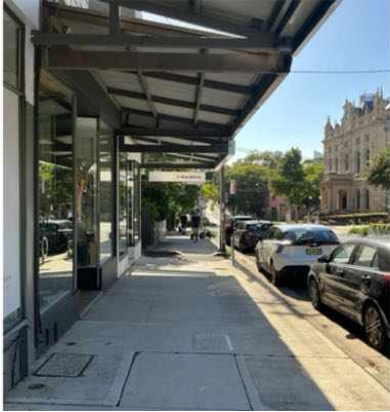
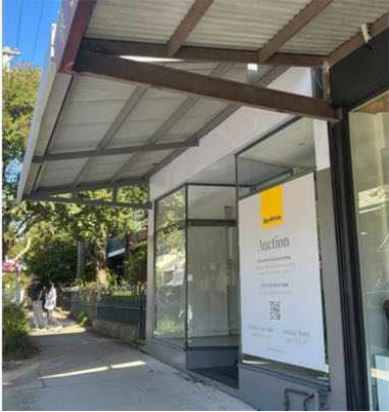
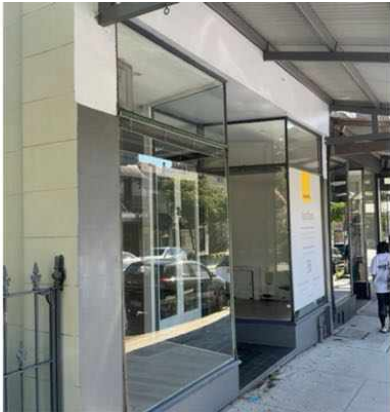
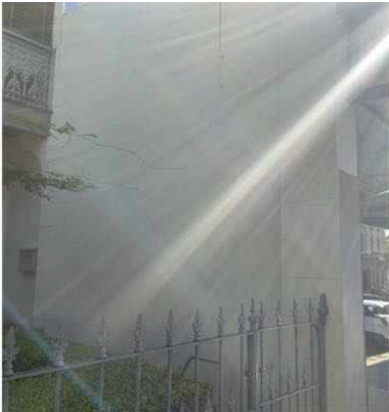
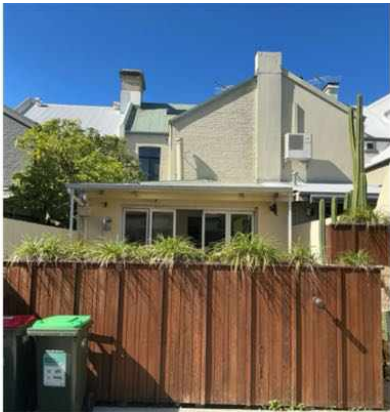
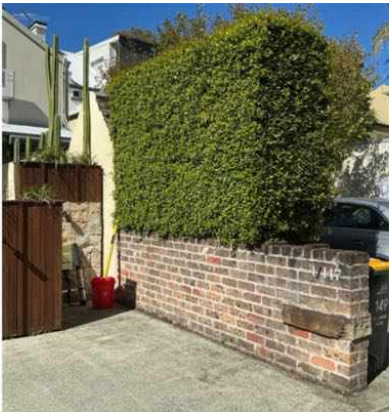
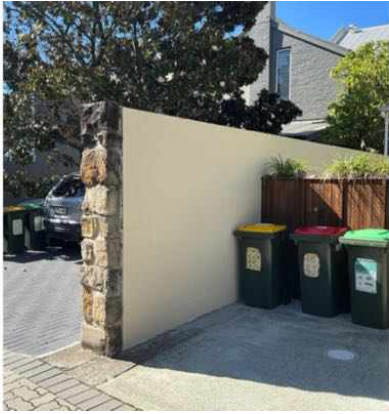
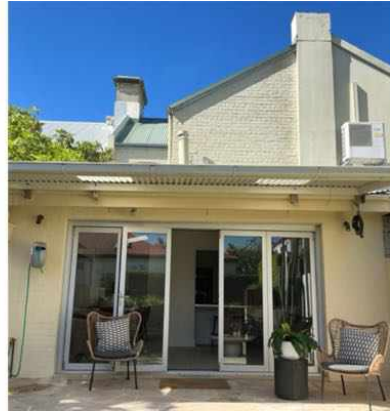
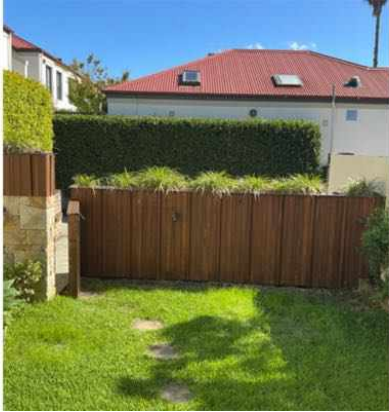
Noted Item

| Finding: | Additional Photos - Obstructions and Limitations |
| Information: | These photographs are an indication of the obstructions and limitations which impeded full inspection of the property at the time of inspection. These obstructions can hide an array of defects and should be removed to allow full inspection to be carried out. A re-inspection is recommended once the areas are made accessible. |

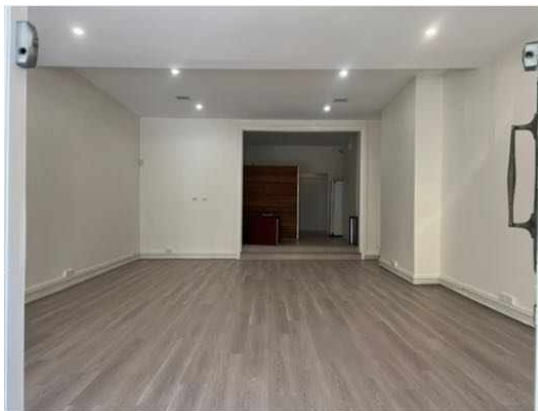
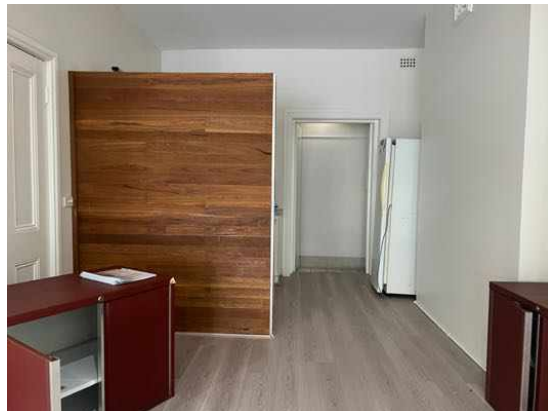
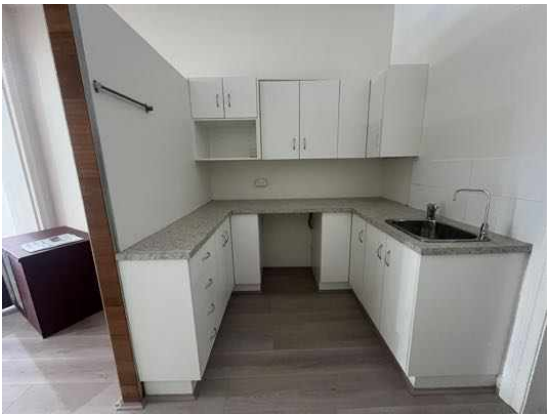
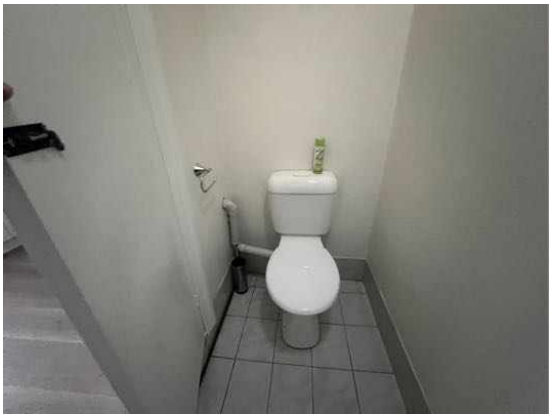
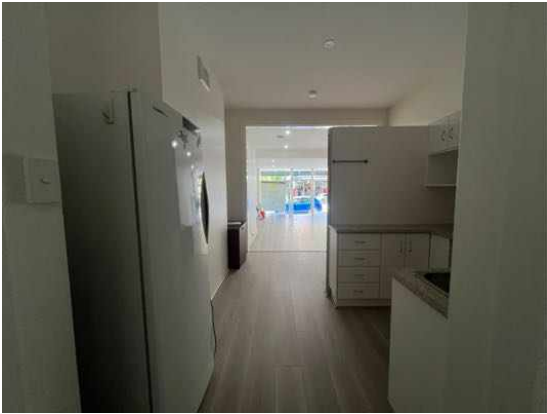
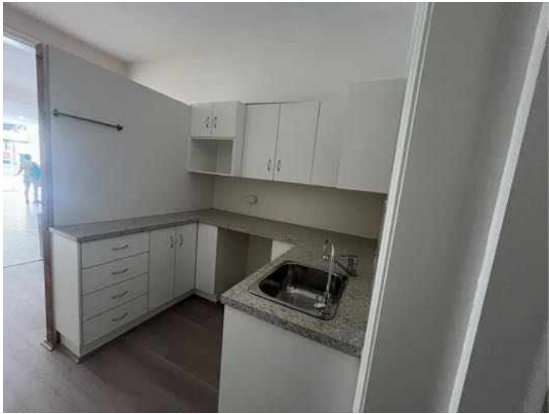
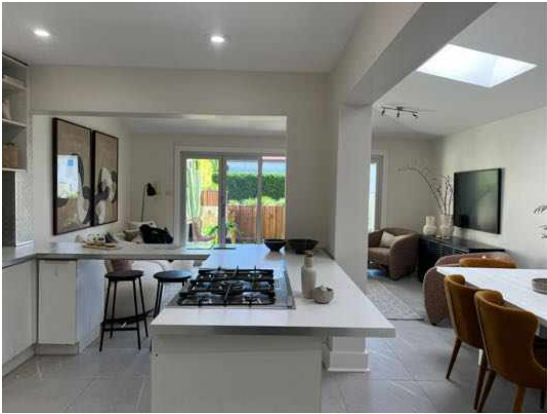
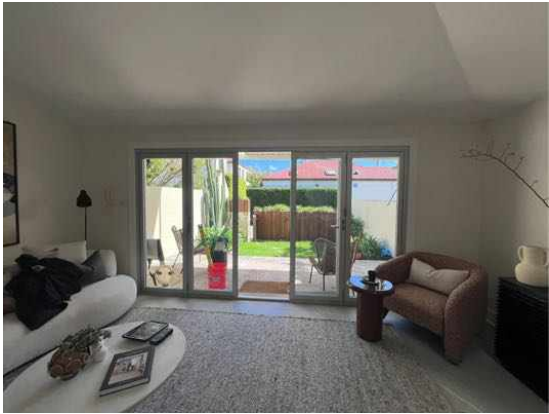
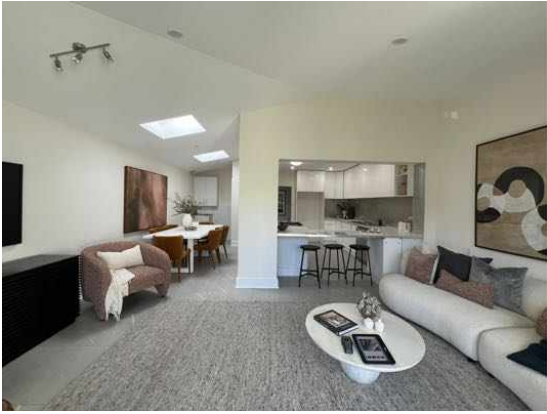
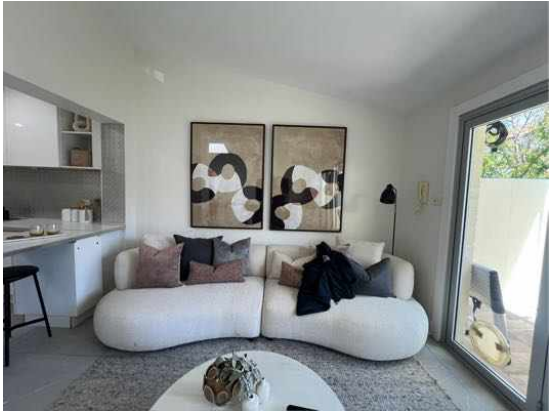
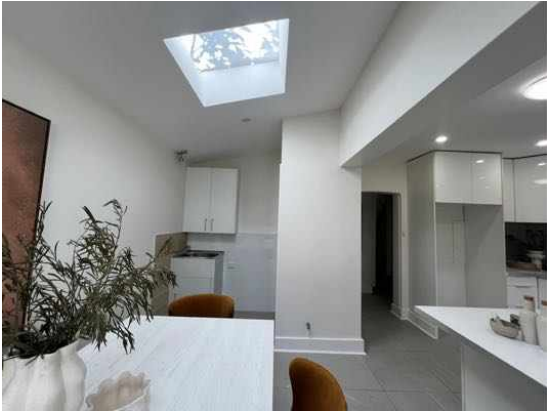
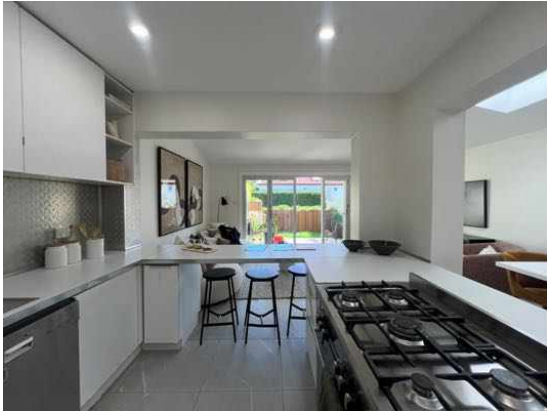
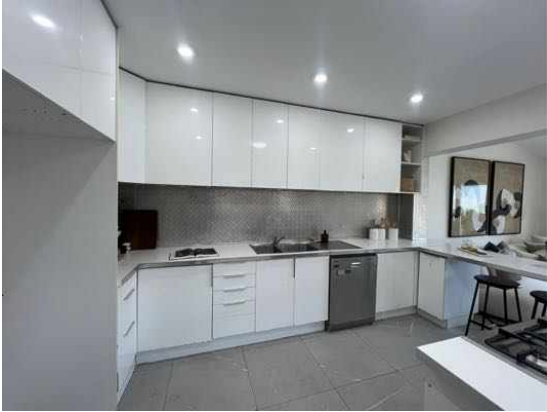
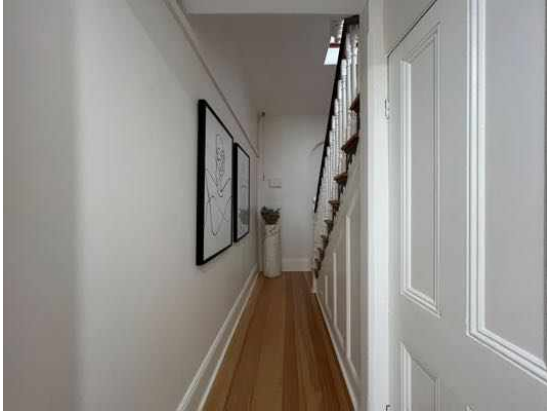
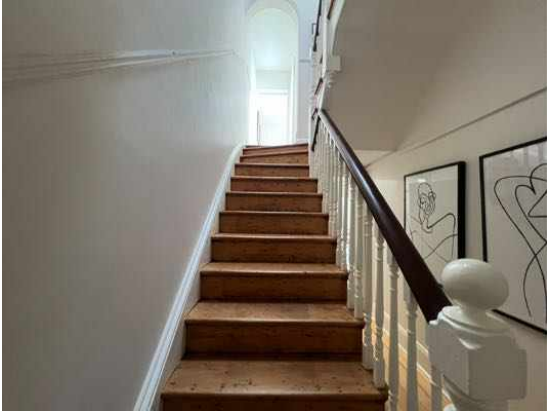
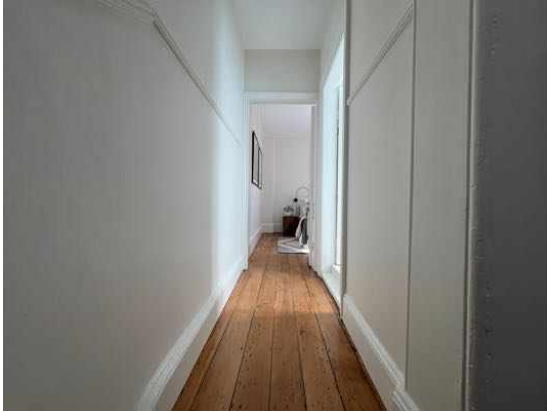
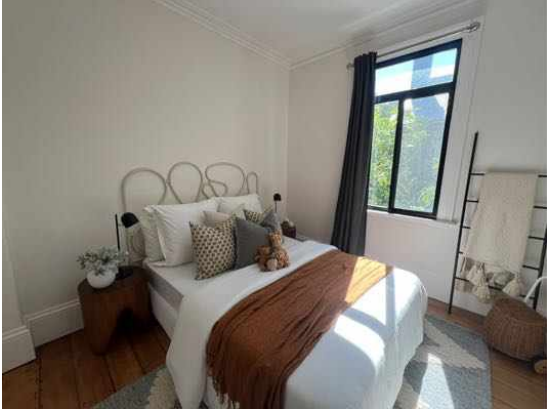
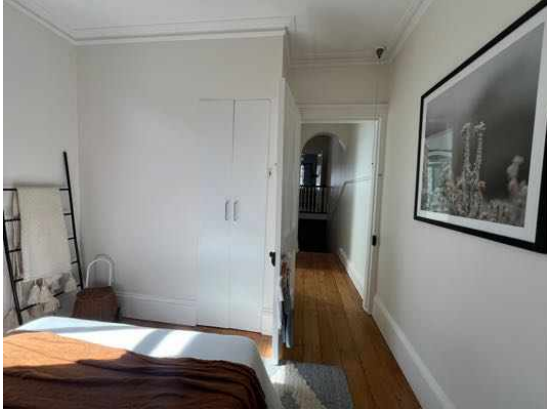
Noted Item

| Finding: | Additional Photos - Obstructions and Limitations |
| Information: | These photographs are an indication of the obstructions and limitations which impeded full inspection of the property at the time of inspection. These obstructions can hide an array of defects and should be removed to allow full inspection to be carried out. A re-inspection is recommended once the areas are made accessible. |

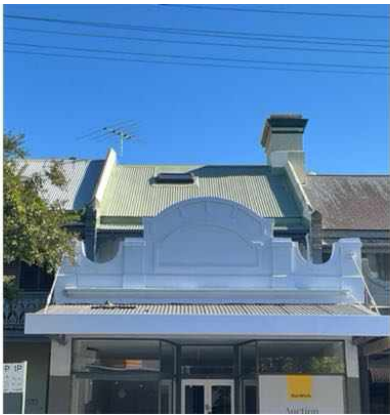
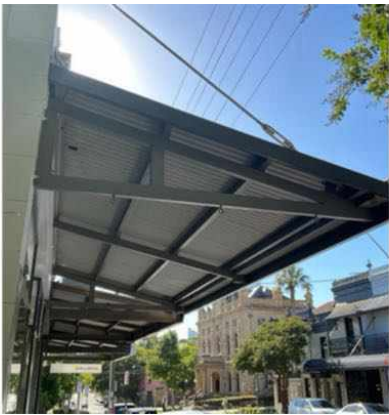
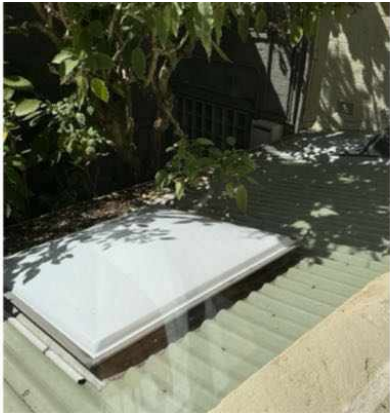
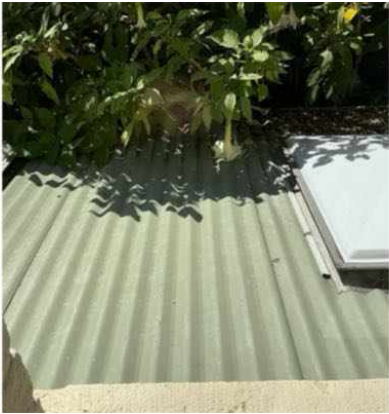
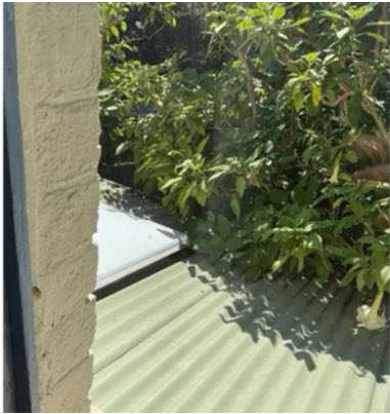
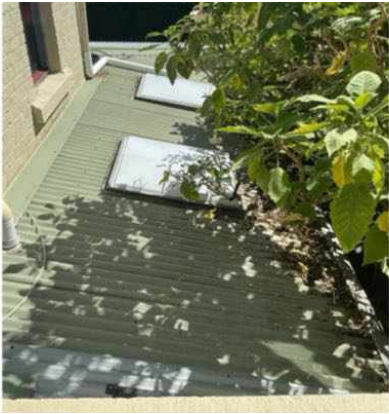
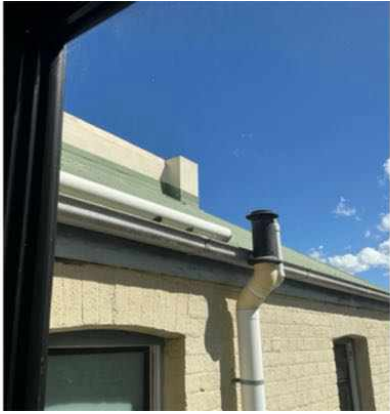
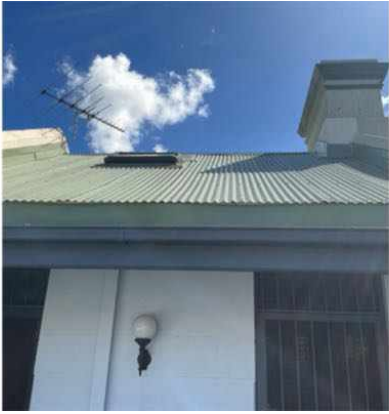
| Finding: | Additional Photos - Obstructions and Limitations |
| Information: | These photographs are an indication of the obstructions and limitations which impeded full inspection of the property at the time of inspection. These obstructions can hide an array of defects and should be removed to allow full inspection to be carried out. A re-inspection is recommended once the areas are made accessible. |
