Building and Timber Pest Inspection Report VR

Inspection Date: Tue, 3 Mar 2026

Property Address: 5 McFarlane St, South Grafton NSW 2460, Australia

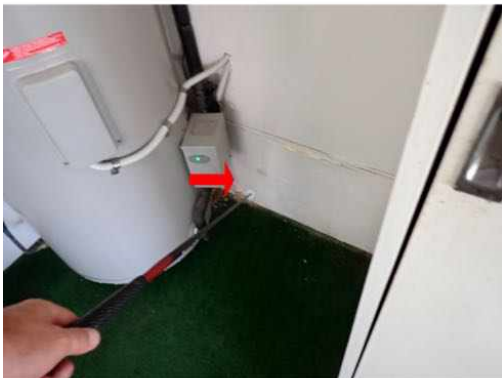
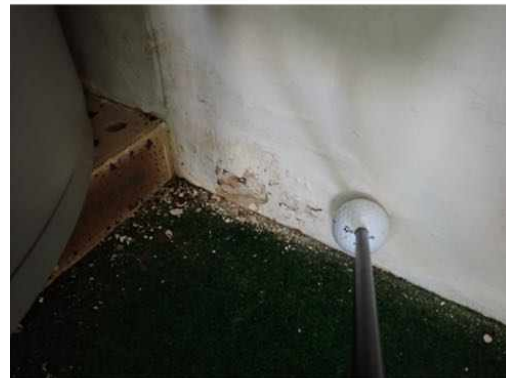
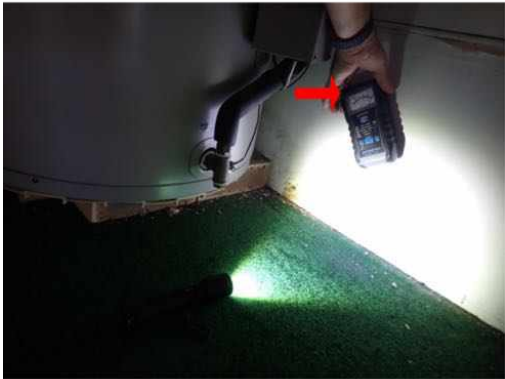
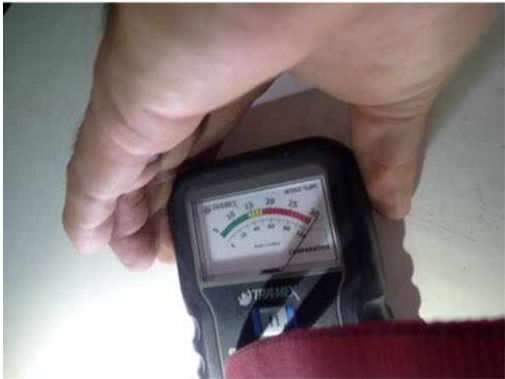
Finding 2.02

Building:	Main Building
Location:	Garage
Finding:	Elevated Moisture Readings and Water Damage to Garage Wall Near Hot Water Unit
Information:	Higher than normal moisture meter readings and signs of water damage were identified to the lower section of the wall in the garage near the hot water unit. The plasterboard in this location appears to be directly adhered to the brickwork, which may have contributed to deterioration due to moisture ingress through the masonry. Moisture penetration through brickwork can occur over time, particularly where wall linings are installed directly against the masonry without an adequate cavity. Further investigation is recommended to determine the source of moisture and prevent further deterioration. Assessment and any necessary repairs should be carried out by a licensed plumber, builder, or suitably qualified tradesperson.

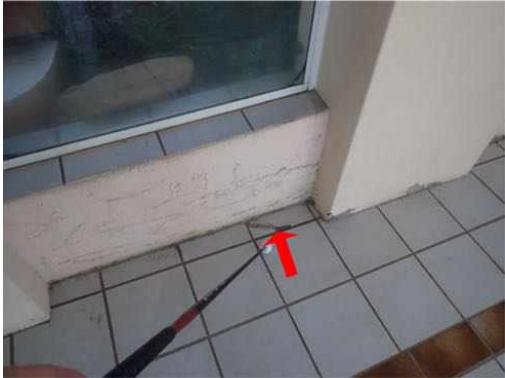
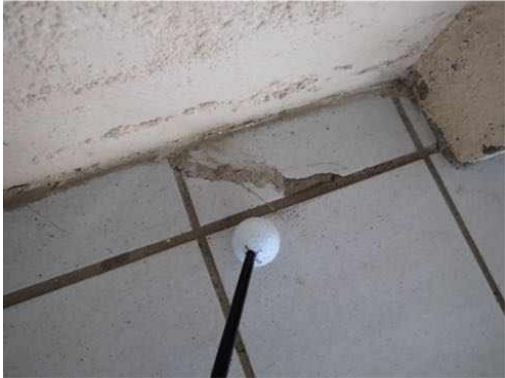
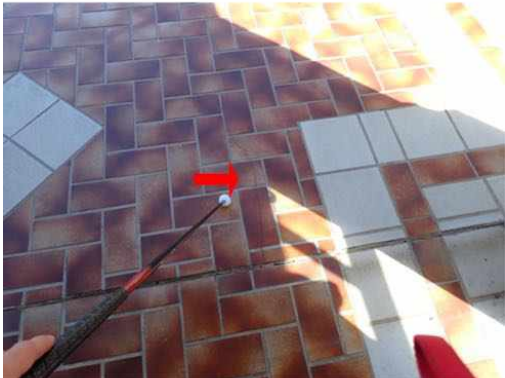
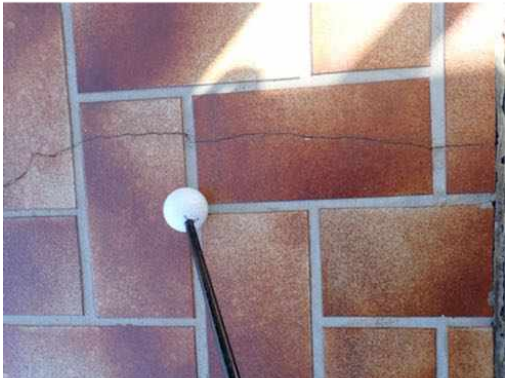
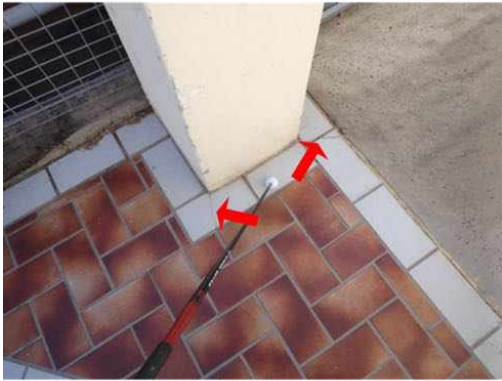
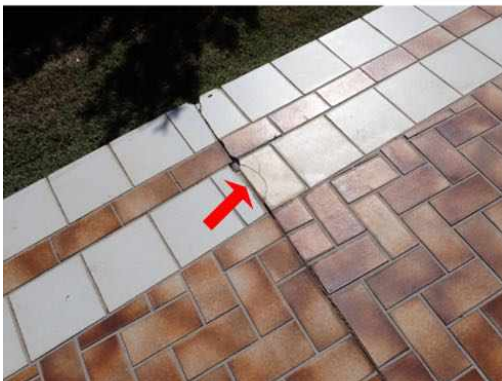
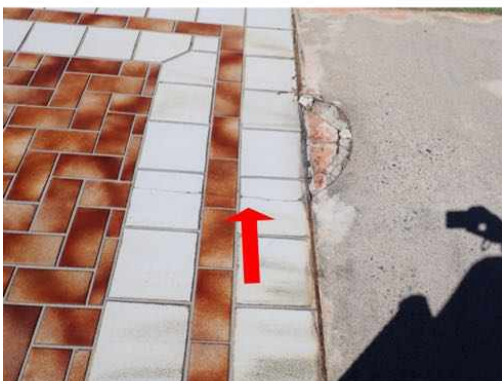
Finding 2.03

Building: Main Building
Location: Carport and driveway
Finding: Cracked Tiles to Carport and Driveway
Information: Cracked floor tiles were identified to areas of the carport and driveway. The cracking may be associated with movement of the underlying surface, impact damage, or general wear over time. If left unaddressed, the damage may worsen and may allow water to penetrate beneath the tiles. Replacement of the damaged tiles as required is recommended. Repairs should be carried out by a licensed tiler or suitably qualified tradesperson.

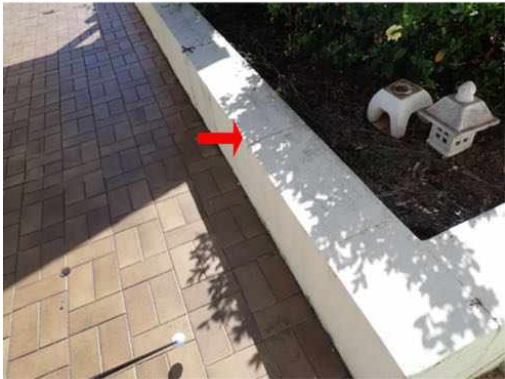
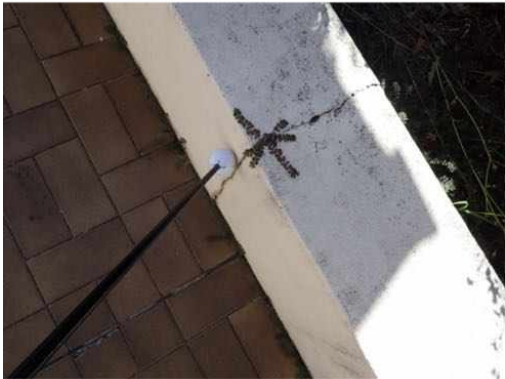
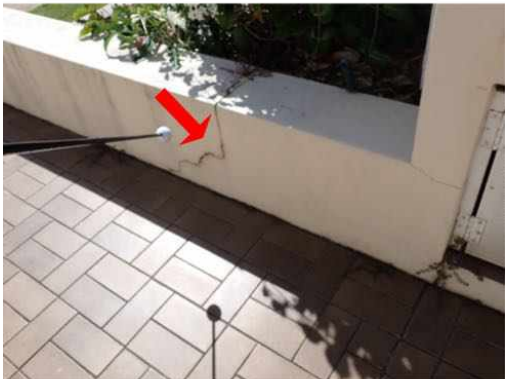
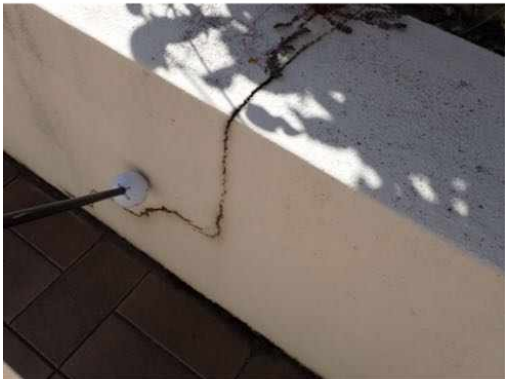
Finding 2.04

Building:	Yard
Location:	Carport
Finding:	Major and Minor Cracks to Brick Rendered Retaining Walls and Garden Beds
Information:	Major and minor cracks were identified to the low brick rendered retaining walls and garden beds around the property at multiple locations. Cracking to these types of structures can occur over time due to ground movement, soil pressure, and general weathering. Continued deterioration may occur if the cracking worsens or allows moisture penetration. Maintenance and repairs as required are recommended to prevent further deterioration. Repairs should be carried out by a licensed builder, bricklayer, or suitably qualified tradesperson.

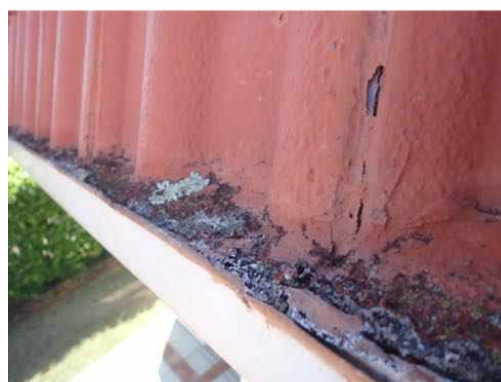
Finding 2.06

Building:	Carport
Location:	Carport roof
Finding:	Deterioration to Roof Tiles at Base of Carport Parapet
Information:	Deterioration was identified to the edges of the roof tiles around the base of the carport parapet. The deterioration may allow moisture ingress beneath the roof covering if left unaddressed and may worsen over time due to ongoing exposure to weather. Maintenance and repairs to the affected roof tiles and surrounding flashing as required are recommended to maintain the weatherproofing of the roof area. Repairs should be carried out by a licensed roofer or suitably qualified tradesperson.

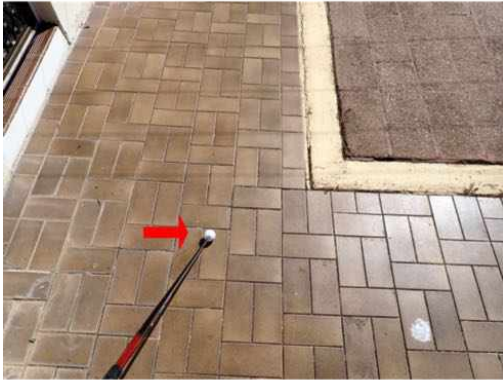
Finding 2.07

Building:	Yard
Location:	Rear tiled patio area
Finding:	Cracked, Drummy and Damaged Tiles to Rear Patio Area
Information:	Cracked, drummy and damaged tiles were identified to sections of the rear patio area. Drummy tiles indicate that the tiles have become debonded from the substrate and may loosen or crack further over time. The damage may be associated with movement of the underlying surface, deterioration of the adhesive, or general wear and this is a common defect. Replacement and re-fixing of the affected tiles as required is recommended to prevent further deterioration. Repairs should be carried

out by a licensed tiler or suitably qualified tradesperson.

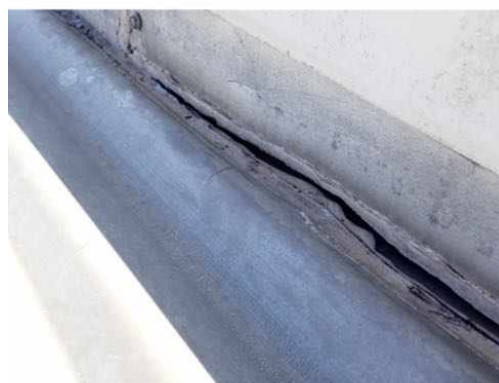
Finding 2.10

Building:	Main Building
Location:	Carport roof
Finding:	Poor and Deteriorated Silicone to Carport Parapet Roof
Information:	Poor and deteriorated silicone sealant was identified to the parapet roof area of the carport. The sealant appears aged and inadequately applied in areas, which may allow water ingress if left unmaintained. Deterioration of sealants in exposed roof areas is commonly associated with weathering and is a common defect with a property of this age. Removal of the deteriorated silicone and re-sealing of the affected areas with appropriate roofing sealant is recommended to maintain weatherproofing. Repairs should be carried out by a licensed roofer or suitably qualified tradesperson to prevent further damage to associated building materials.

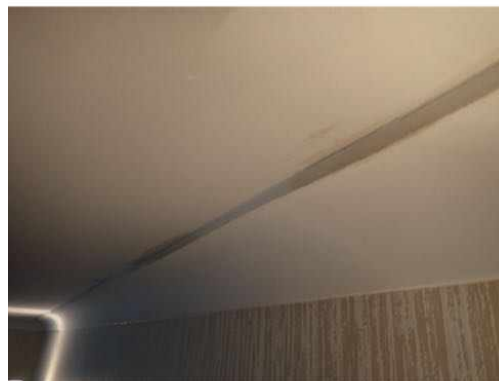
Finding 3.01

Building:	Main Building
Location:	Living Room
Finding:	Sagging Cornice to Living Room
Information:	Age-related sagging was identified to the cornice in the living room. The condition may

also be associated with previous water damage; however, no elevated moisture readings were detected to the ceiling in this area at the time of inspection. This type of movement and deterioration can occur over time and is a common defect with a home of this age. Repairs or refixing of the cornice as required is recommended. Works should be carried out by a licensed builder, plasterer, or suitably qualified tradesperson.

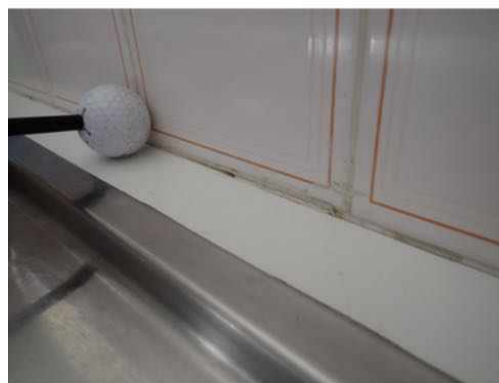
Finding 3.02

Building:	Main Building
Location:	Kitchen
Finding:	Deteriorated Silicone to Kitchen Benchtop and Tile Splashback Junction
Information:	Deteriorated silicone sealant was identified at the junction between the kitchen benchtop and the tiled splashback. The sealant has perished and is no longer providing an effective waterproof seal, which may allow moisture to penetrate behind the benchtop or wall lining and cause deterioration to adjacent materials over time. This condition is commonly associated with general wear and tear. Removal of the existing silicone and re-sealing with an appropriate sanitary grade sealant is recommended. Repairs should be carried out by a handyman or suitably qualified tradesperson.

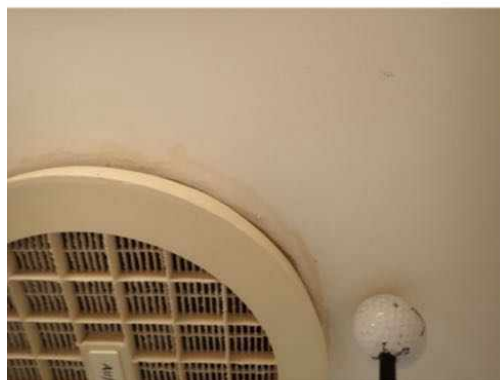
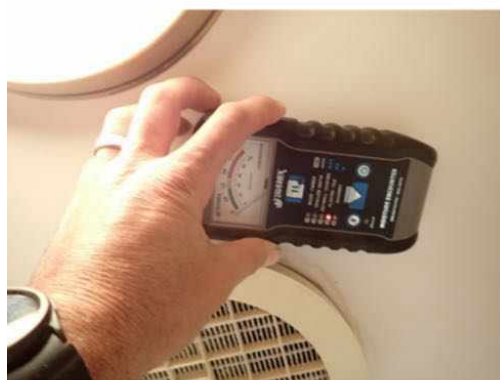
Building:	Main Building
Location:	Toilet (WC)
Finding:	Possible Old Water Stains to Plasterboard Around Ceiling Fan
Information:	Possible old water stains were identified to the plasterboard around the ceiling fan. The staining may be associated with previous moisture ingress; however, no elevated moisture readings were detected with the moisture meter at the time of inspection. This type of condition can occur over time and may relate to past roof leaks, condensation, or previous water ingress that has since dried. Continued monitoring and maintenance of the roof and ceiling areas is recommended. Repairs or further investigation, if required, should be carried out by a licensed roofer, builder, or suitably

qualified tradesperson.

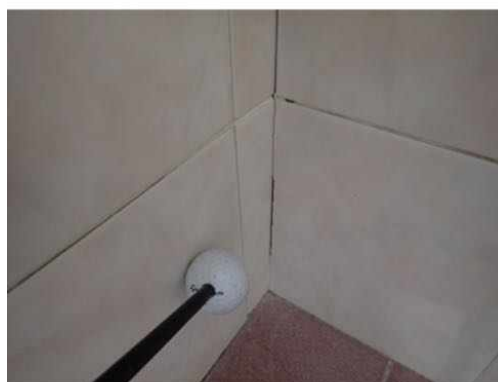
Finding 3.05

Building:	Main Building
Location:	Ensuite
Finding:	Deteriorated Grout and Silicone to Ensuite Shower
Information:	Deteriorated grout and silicone sealant were identified to the tiled areas of the ensuite shower. The deterioration may allow moisture to penetrate behind the tiles and surrounding materials over time. This condition is commonly associated with ongoing moisture exposure and is a common defect with a property of this age. Maintenance is recommended including regrouting and resealing the affected areas to maintain the waterproof integrity of the shower. Repairs should be carried out by a licensed tiler or suitably qualified tradesperson.

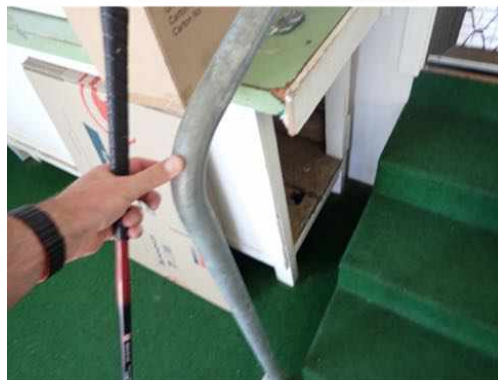
Finding 3.06

Building: Main Building
 Location: Garage
 Finding: Loose Handrail to Steps from Laundry to Garage
 Information: The handrail to the steps leading from the laundry to the garage was found to be loose at the time of inspection. Loose handrails may reduce stability and can present a potential safety hazard when using the steps. Re-fixing and securing of the handrail is recommended to ensure it is adequately supported and safe for use. Repairs should be carried out by a licensed builder, carpenter, or suitably qualified tradesperson.

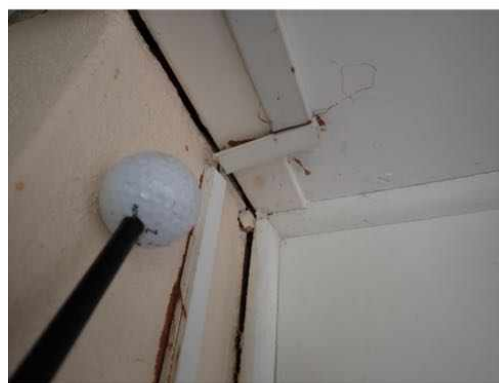
Finding 3.07

Building:	Main Building
Location:	Carport
Finding:	Movement Between Main Building and Carport Structure
Information:	Movement was identified at the junction between the main building and the carport structure. The carport appears to have been constructed at a later stage than the original dwelling, which may result in differential movement between the two structures over time. This type of movement is not uncommon where additions are connected to an existing structure. Continued monitoring is recommended and repairs or separation detailing may be required if movement continues. Assessment and any necessary repairs should be carried out by a licensed builder or suitably qualified tradesperson.

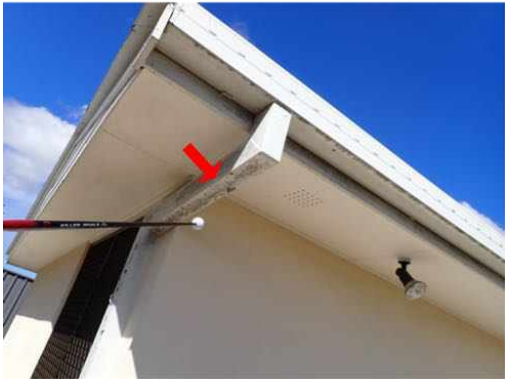
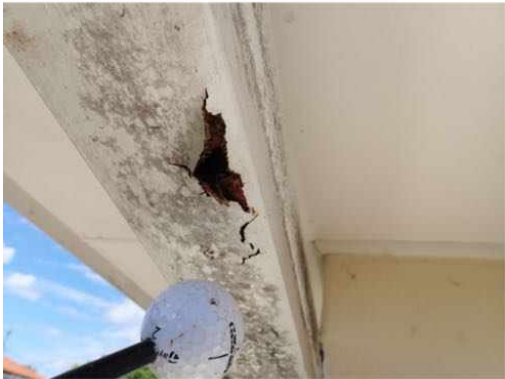
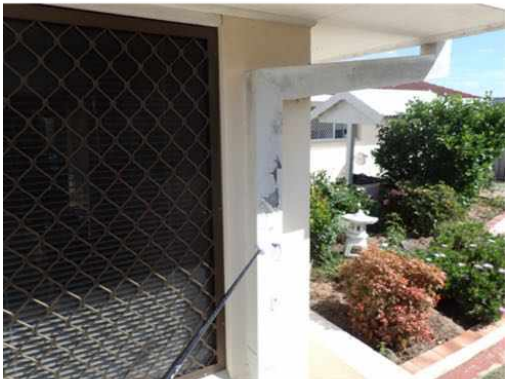
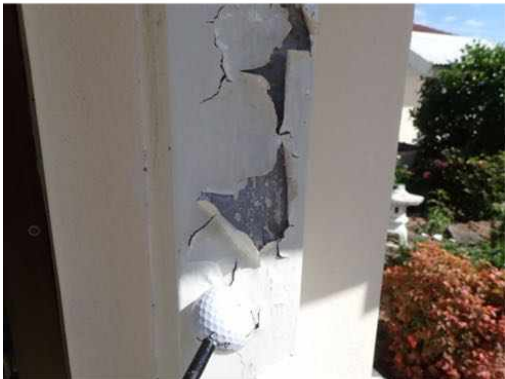
Finding 3.08

Building:	Main Building
Location:	Down pipes
Finding:	Rust and Paint Deterioration to Downpipes
Information:	Rust and deterioration of the painted finish were identified to the downpipes. This condition is commonly associated with prolonged exposure to weather and moisture and is a common defect with a property of this age. If left unmaintained, corrosion may continue to deteriorate the metal and affect the serviceability of the downpipes over time. Maintenance including preparation, treatment of rusted areas and repainting or replacement of affected sections as required is recommended. Repairs should be carried out by a licensed plumber or suitably qualified tradesperson.

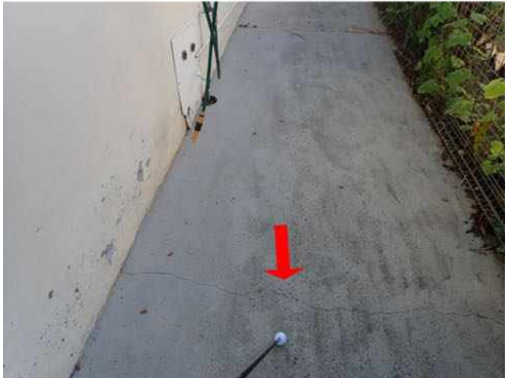
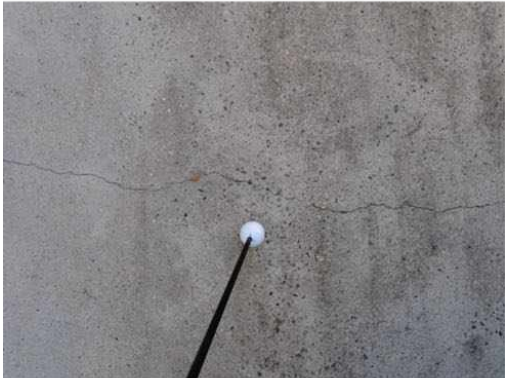
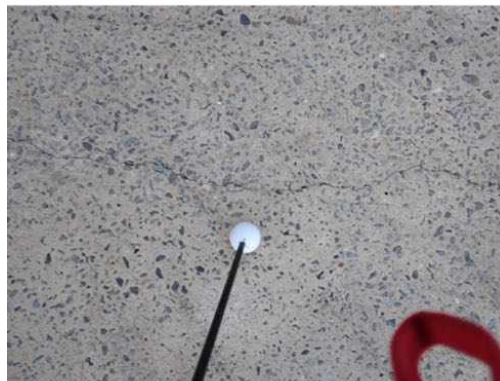
Finding 3.09

Building: Yard
 Location: Bbq area
 Finding: Minor Cracks to Concrete Path and Concrete Beside Garden Shed
 Information: Minor cracks were identified to the concrete path and the concrete area beside the garden shed. This type of cracking is commonly associated with minor settlement, shrinkage, or normal movement of concrete over time and is a common defect with a property of this age. The cracks appeared minor at the time of inspection; however, continued monitoring and maintenance is recommended to ensure the cracking does not worsen. Repairs, if required, should be carried out by a licensed builder, concreter, or suitably qualified tradesperson.

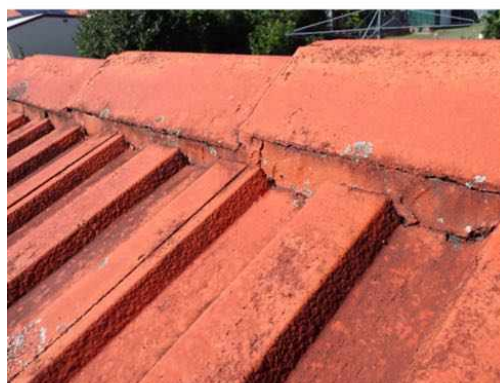
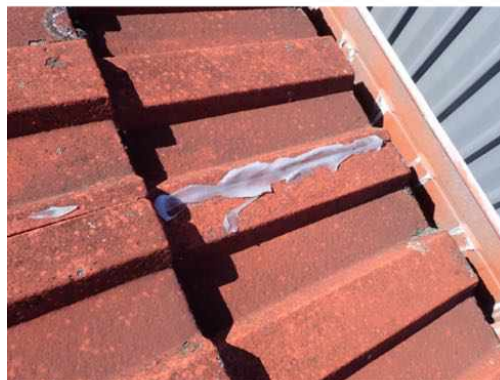
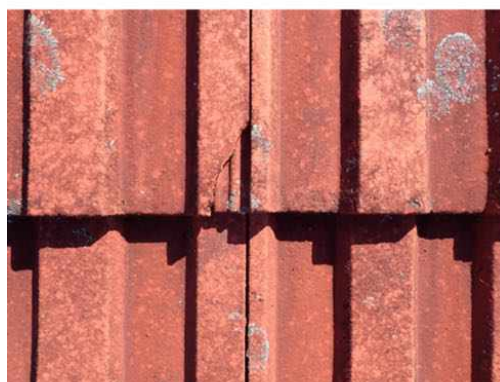
Finding 3.10

Building:	Main Building
Location:	Roof
Finding:	Roof Tiles Weathered with Cracked Tiles, Lichen Growth and Cracked Ridge Caps
Information:	The roof tiles were found to be generally in fair condition; however, they were noted to be weathered. Some cracked tiles were identified along with areas of lichen growth and cracking to the ridge capping. These conditions are commonly associated with age and prolonged exposure to weather and are common defects with a property of this age. Damaged tiles and cracked ridge capping may allow water ingress if left unmaintained. Maintenance including replacement of cracked tiles, cleaning of lichen growth and repairs to the ridge capping as required is recommended. Inspections and necessary repairs should be carried out by a licensed roofer or suitably qualified tradesperson to prevent further damage to associated building materials.

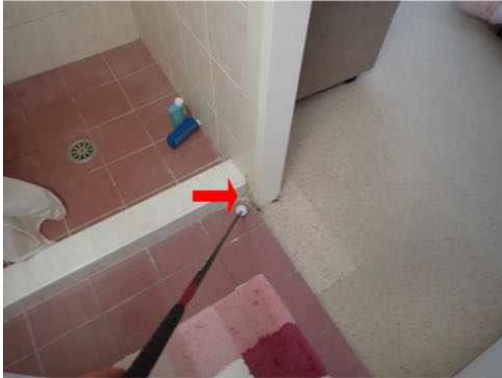
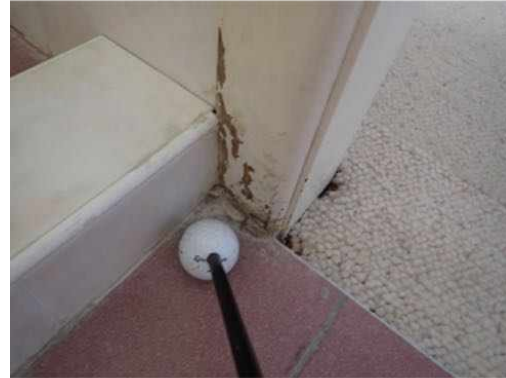
Building:	Main Building
Location:	Ensuite
Finding:	Wood Rot to Architrave and Door Jamb at Ensuite Shower
Information:	Wood rot was identified to the bottom of the architrave and door jamb to the ensuite near the edge of the shower. The deterioration is likely associated with ongoing moisture exposure from the nearby wet area. If left unaddressed, the damage may

continue to worsen and affect surrounding materials. Repairs including removal of the deteriorated timber and replacement of affected components are recommended. Works should be carried out by a licensed builder, carpenter, or suitably qualified tradesperson.

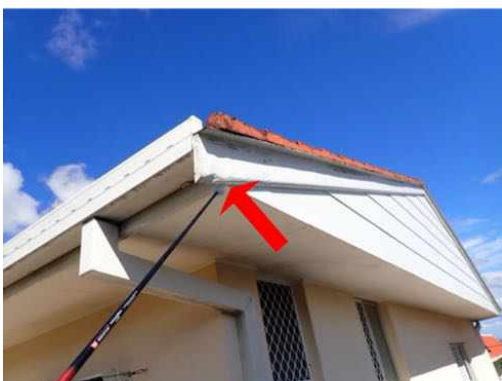
Finding 7.02

Building: Main Building

Finding: Possible Wood Rot to Ends of Fascia Boards

Information: The ends of several fascia boards were found to be soft behind the painted surface, indicating possible wood rot to these locations. Deterioration of timber fascia boards is commonly associated with prolonged exposure to moisture and weathering and is a common defect with a property of this age. If left unaddressed, the deterioration may worsen over time and affect the integrity of the affected sections. Further assessment and repairs including replacement of deteriorated timber as required are recommended. Repairs should be carried out by a licensed builder, carpenter, or suitably qualified tradesperson.

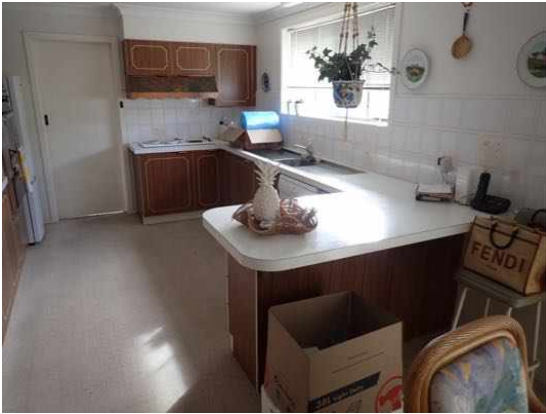
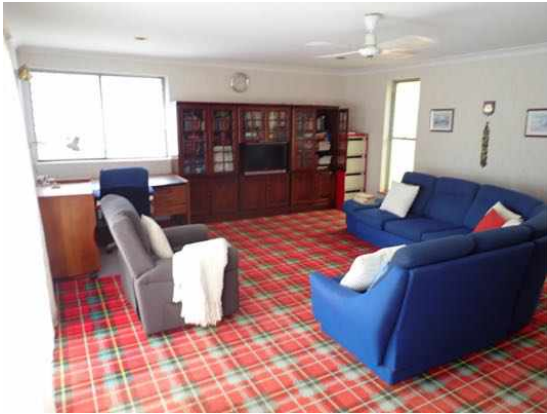
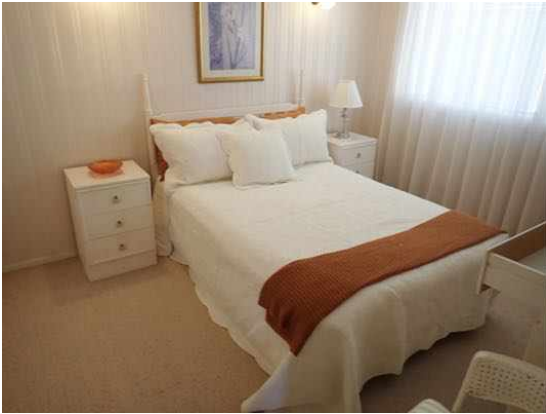
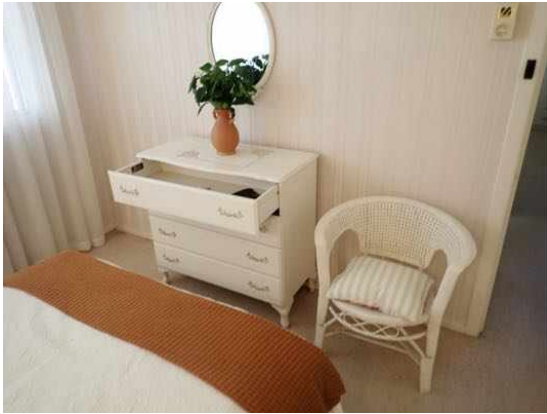
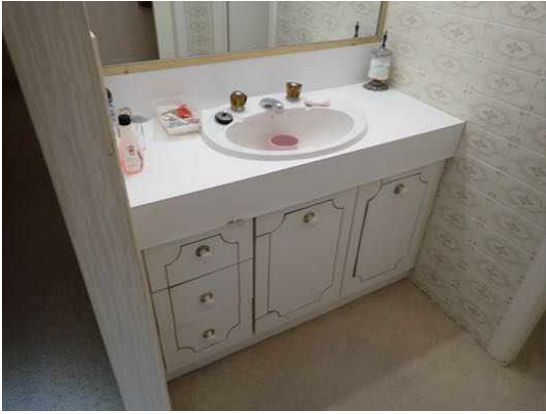
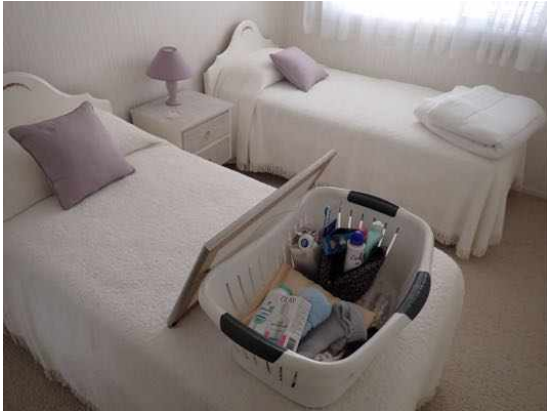
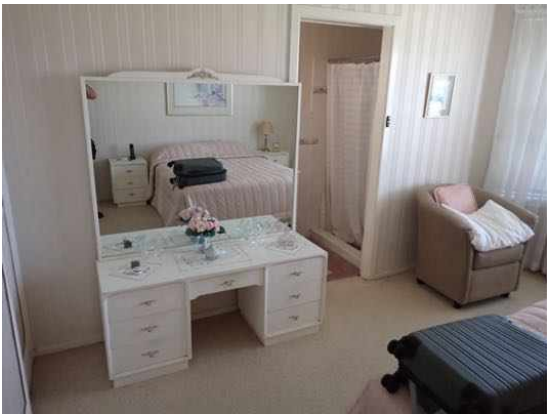
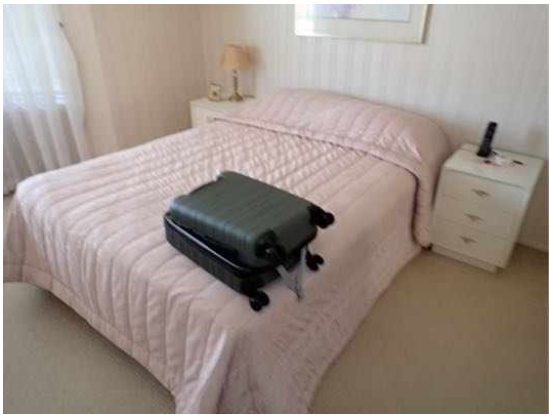
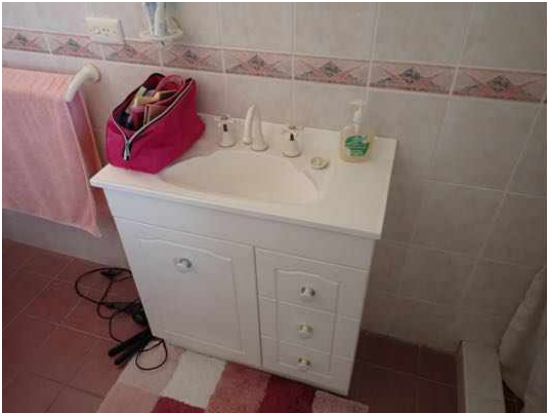
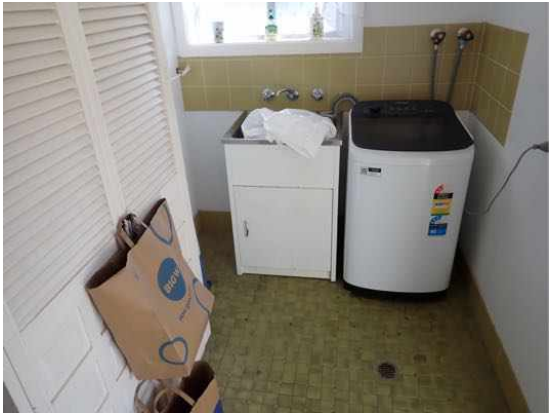
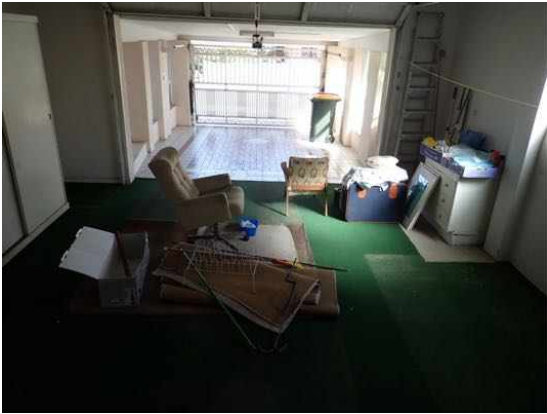
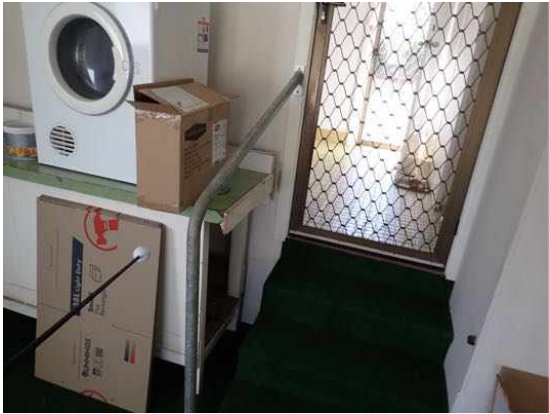
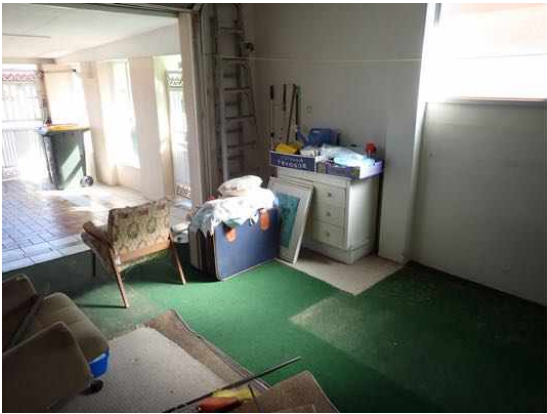
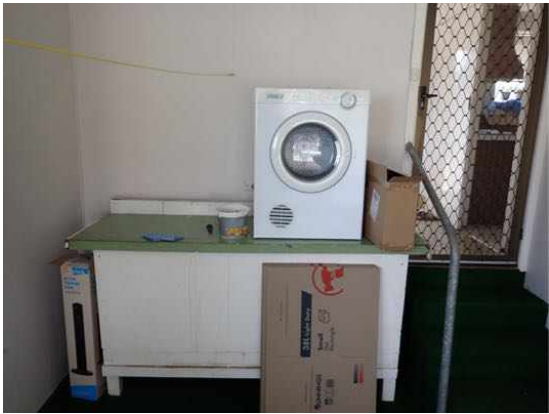
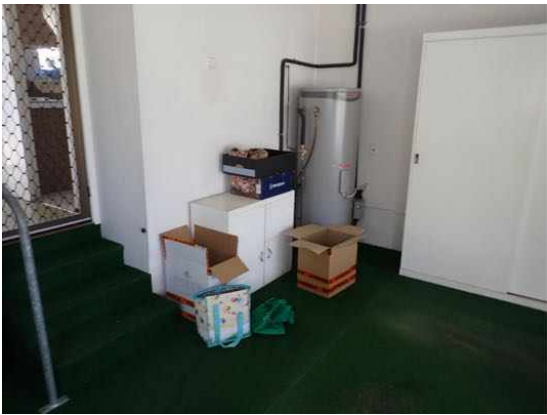
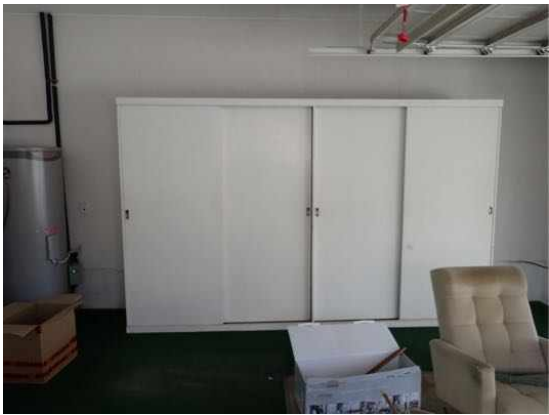
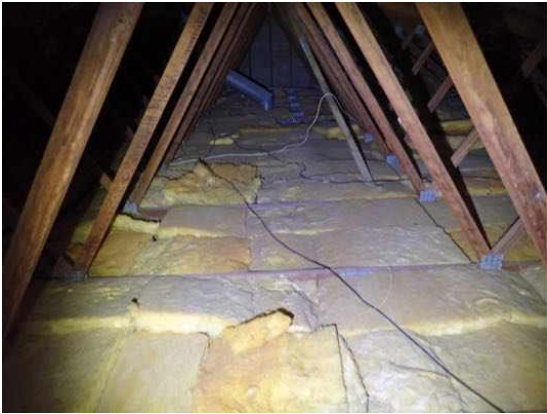
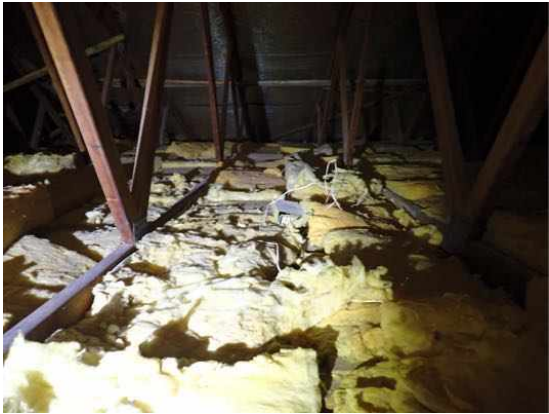
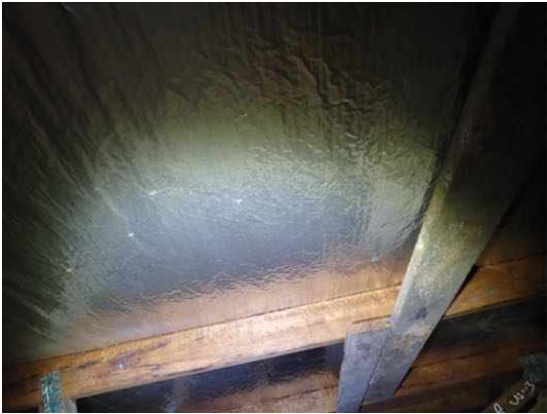
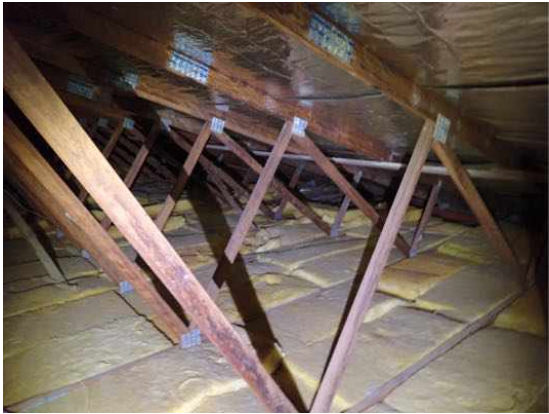
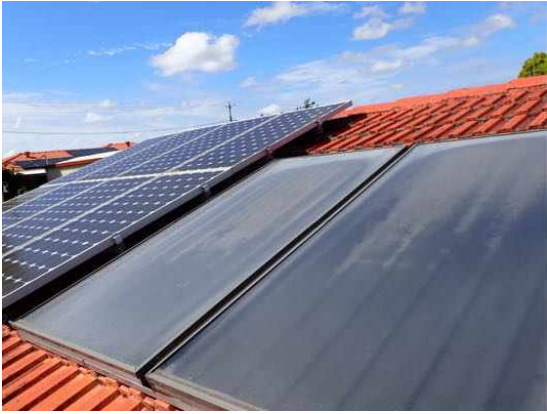
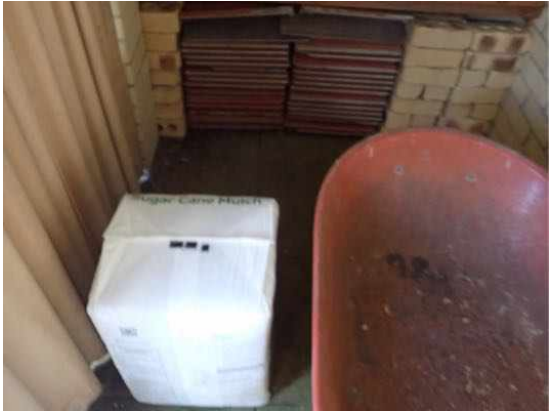
Building: Main Building
Location: All Areas
Finding: Additional Photos - Obstructions and Limitations
Information: These photographs are an indication of the obstructions and limitations which impeded full inspection of the area at the time of inspection. These obstructions can hide an array of defects and should be removed to allow full inspection to be carried out. A re-inspection is recommended once the areas are made accessible.
